✓  
✓  
DETERMINATION OF TIRE QUALITY.  
FROM NONDESTRUCTIVE INSPECTION

S. N. Bobo

U.S. DEPARTMENT OF TRANSPORTATION  
RESEARCH AND SPECIAL PROGRAMS ADMINISTRATION  
Transportation Systems Center  
3 Cambridge MA 02142

NOVEMBER 1979  
FINAL REPORT

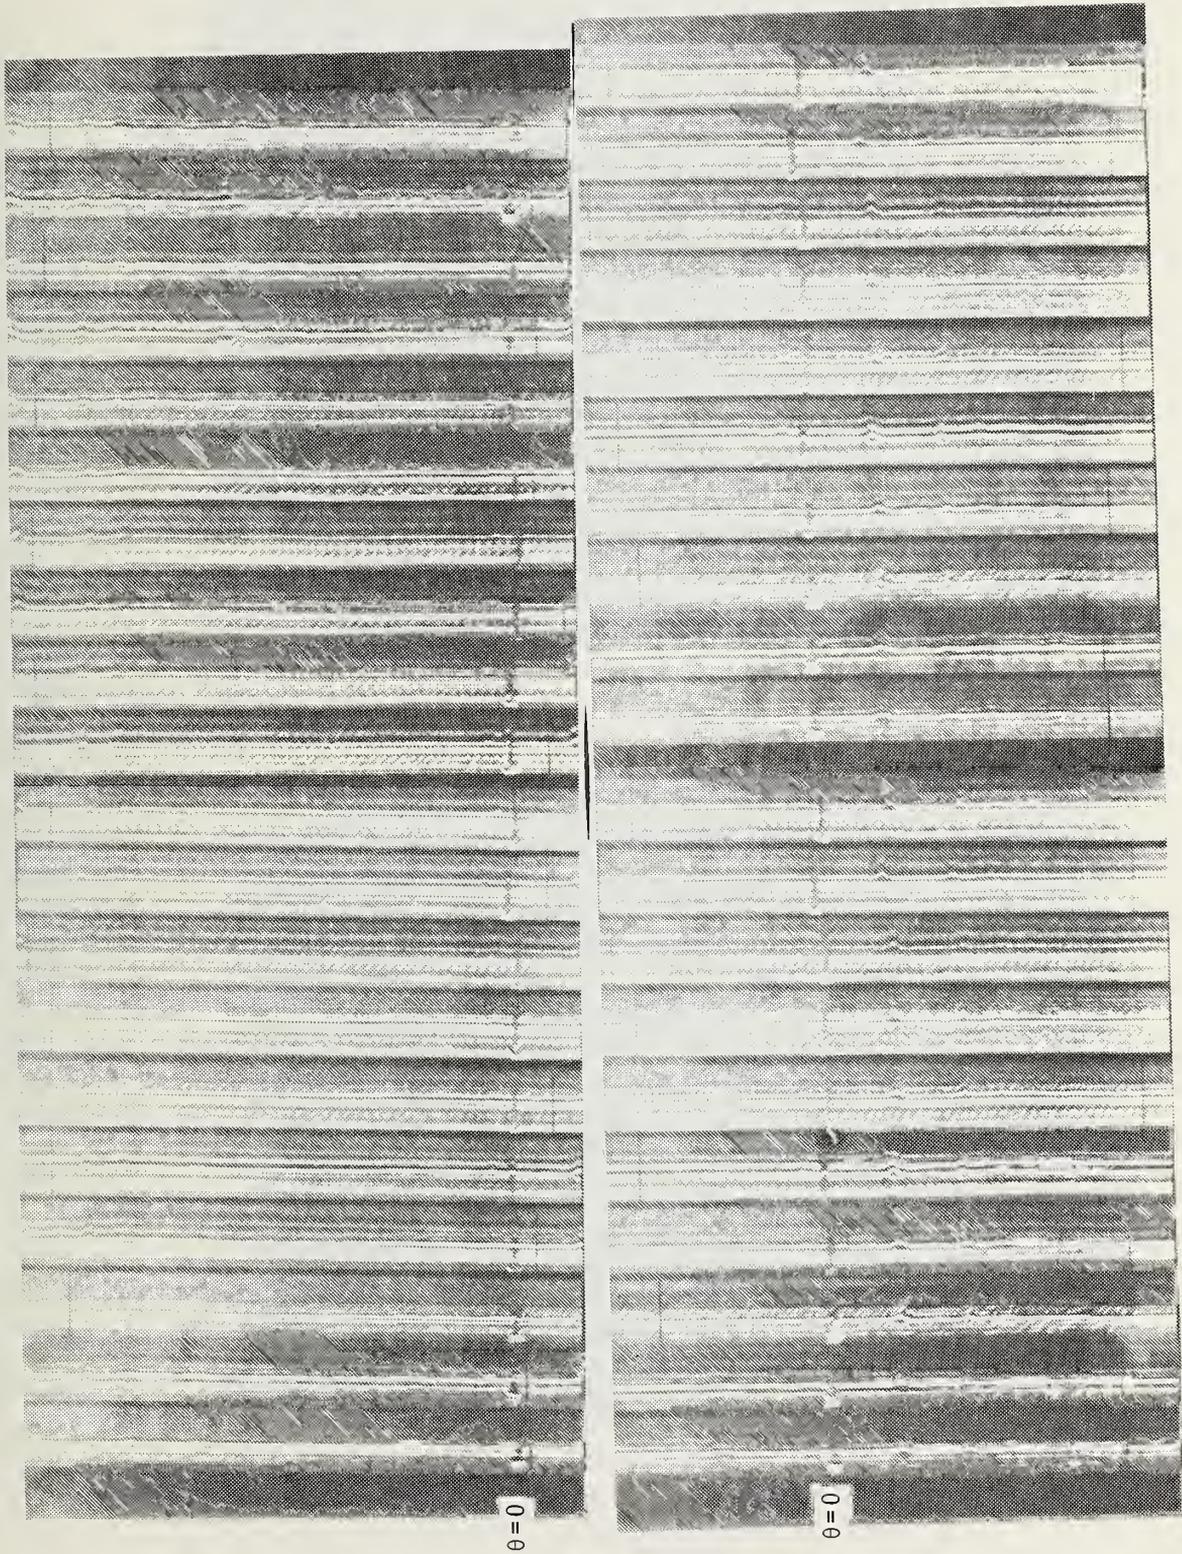
FIGURE A-4 EXAMPLE OF REGISTRATION ERROR

In some cases it is desirable to superimpose traces as in "before and after" data on the same tire. It is therefore necessary to have the  $\Theta=0$  location always at the top of the display. When this does not occur, it is called a registration error. Figure 4 shows two examples of this condition on the same tire.

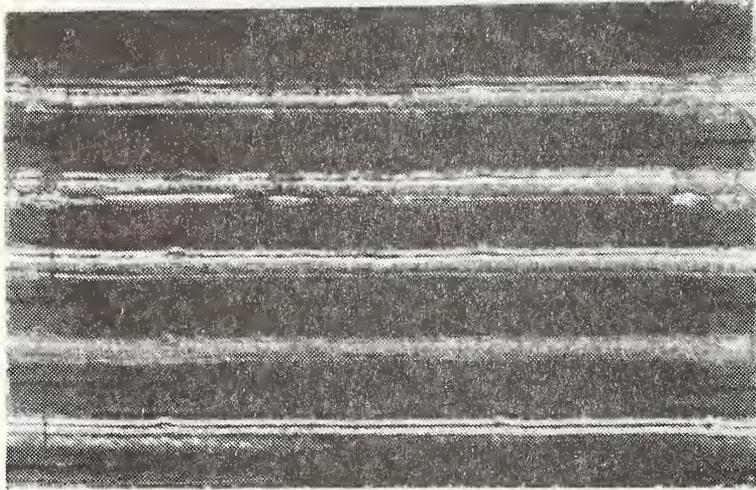
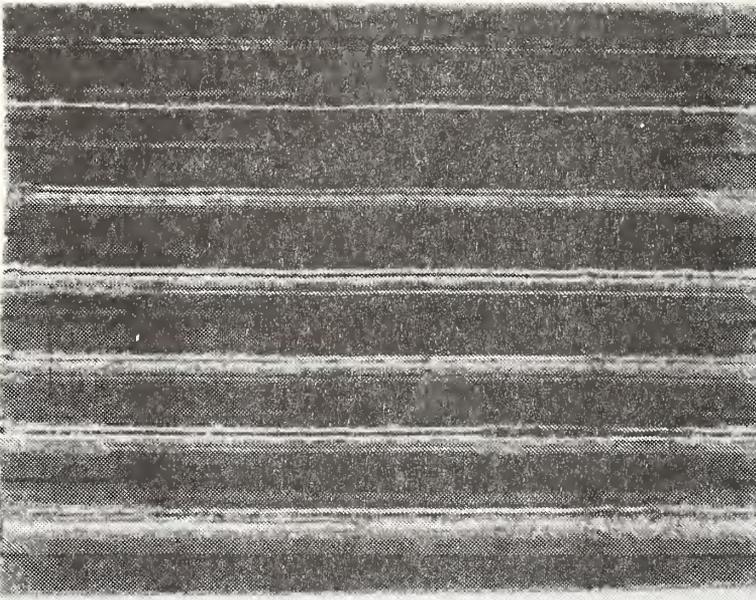
FIGURE A-5 TURN-UP AREA

Abrupt brightness change (Figure A-5). It is caused by overlapping or separation of material near the tire beads.

SEVERE TURNUP  
MODULATION

LITTLE OR NO  
TURNUP MODULATION

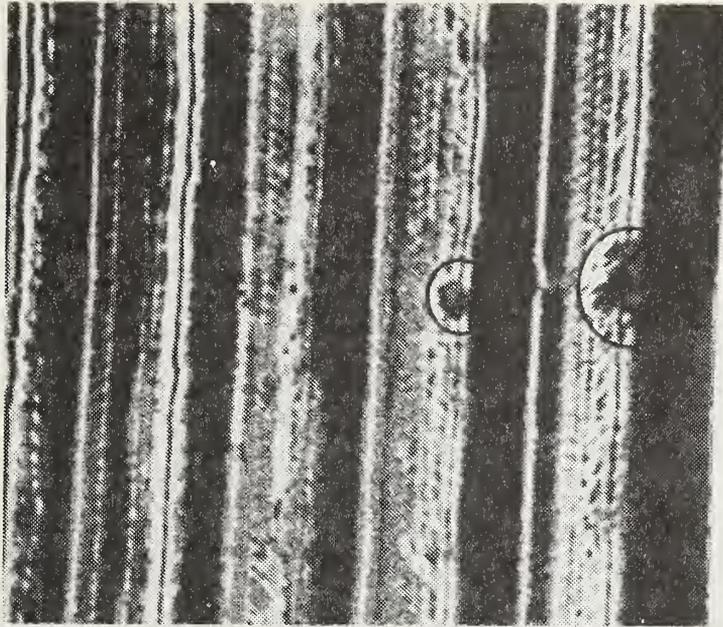
FIGURE A-6. EXAMPLE OF INCLUSION

A lack of reflection from several depths and generally present in more than one channel (see Figure A-6), not to be confused with a single trace separation or fading of a trace. It is caused by a hole or foreign material in the tire structure.

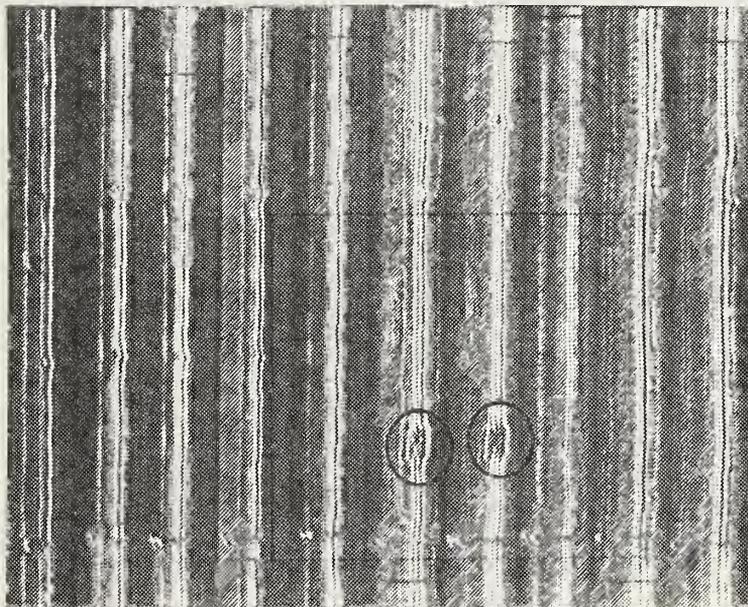
FIGURE A-7 EXAMPLE OF SINGULARITY/SHADOW

A bright spot adjacent to a shadow (Figure A-7). It is caused by a separation or other discontinuity.

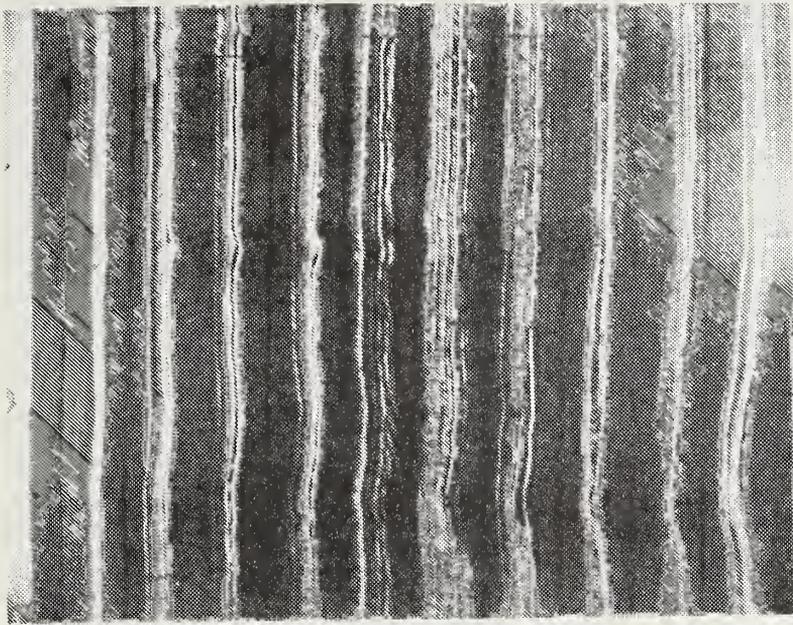
FIGURE A-8. RADIAL RUNOUT

Skewed or wavy trace (Figure A-8). Caused by "out of roundness"; the resulting "high spot" passes closer to transducer #10 than the remainder of the tire.

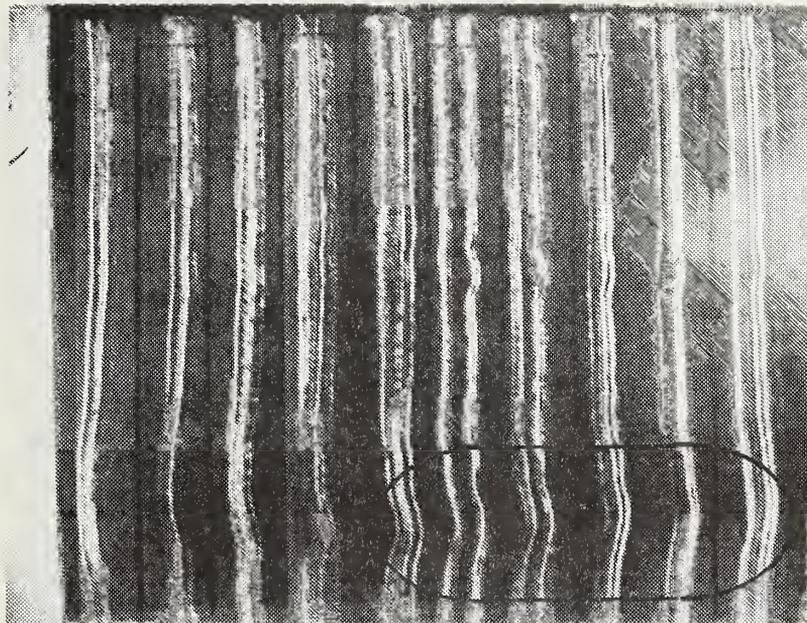
FIGURE A-9. LATERAL RUNOUT

Wavy trace (Figure A-9). Caused by a change in tire width.

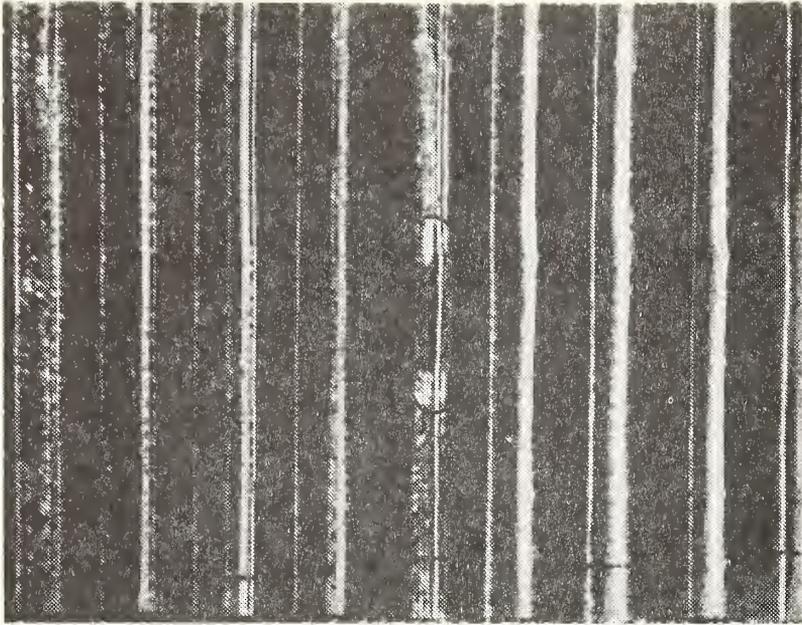
FIGURE A-10. INTENSITY CHANGE

Abrupt brightness change (Figure A-10). Caused by a change of material thickness.

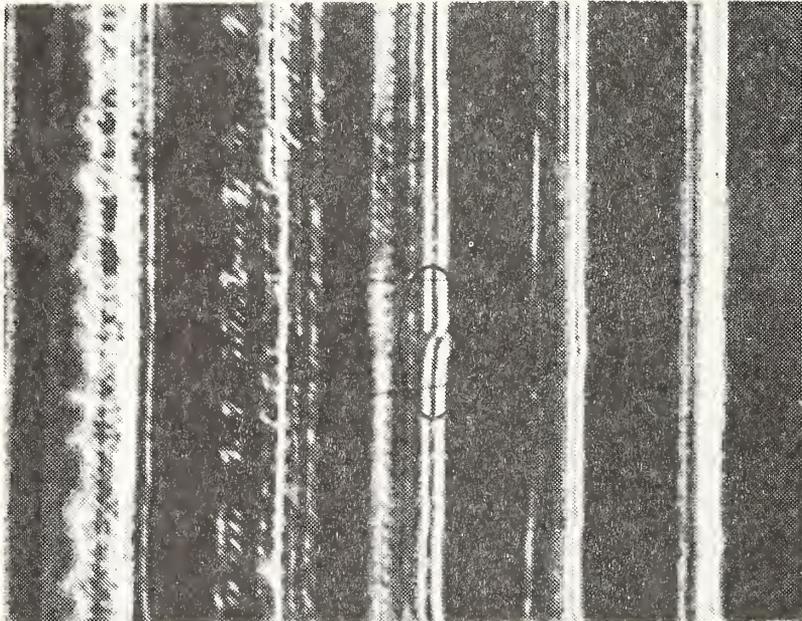
FIGURE A-11. TRACE DISCONTINUITY

Interruption of a trace (Figure A-11), not to be confused with an inclusion which is usually indicated in more than one channel. It is caused by abnormal displacement of material.

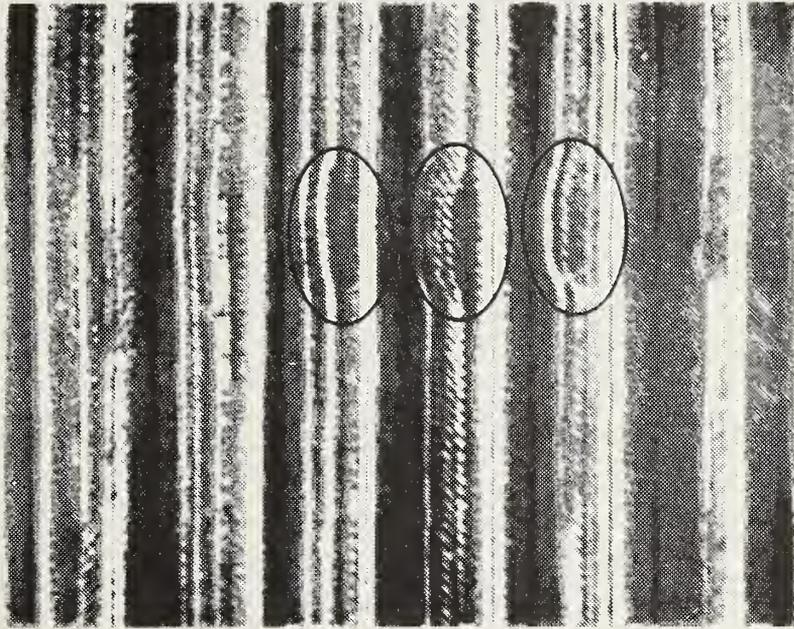
Abrupt change of shape of trace (Figure A-12). It is caused by excess of material or distorted ply structure.
