UMTA-MA-06-0152-84-3
DOT-TSC-UMTA-84-25

Evacuation and Rescue of Elderly and Disabled Passengers from Paratransit Vans and Buses

Transportation Systems Center
Cambridge MA 02142

October 1984
Final Report

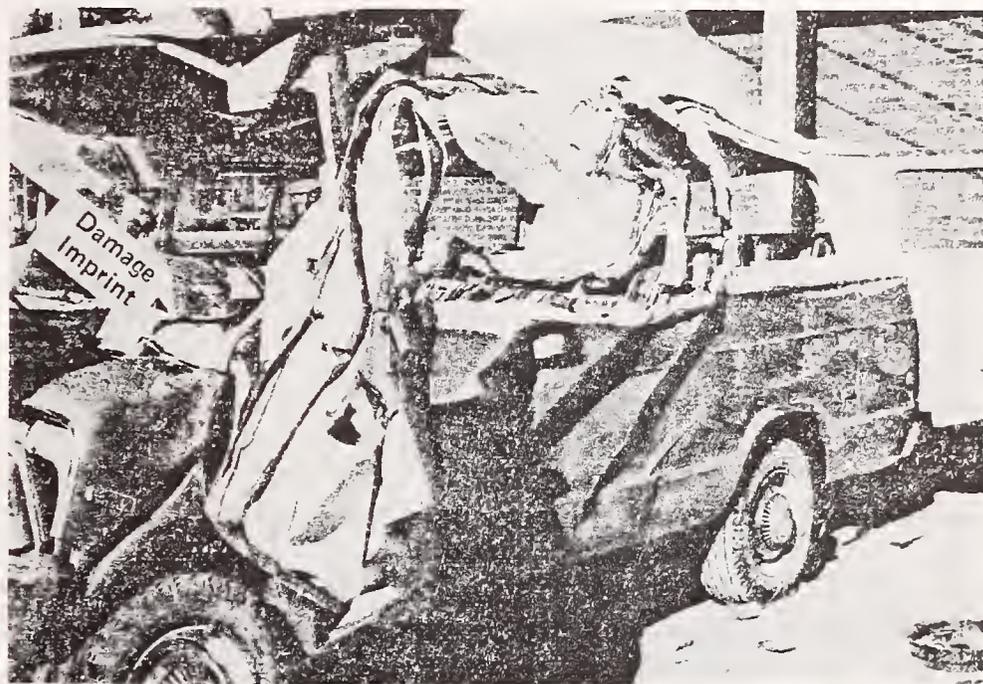
Figure 3-9 shows the front left of the van. The damage to the roof, left side, roof supports, and seatbacks was caused by the parapet when it penetrated the van along the left side windows from

Note damage imprint from bridge parapet at top of left front fender and at top of left side instrument panel. Note buckling of side panel to rear tire area.

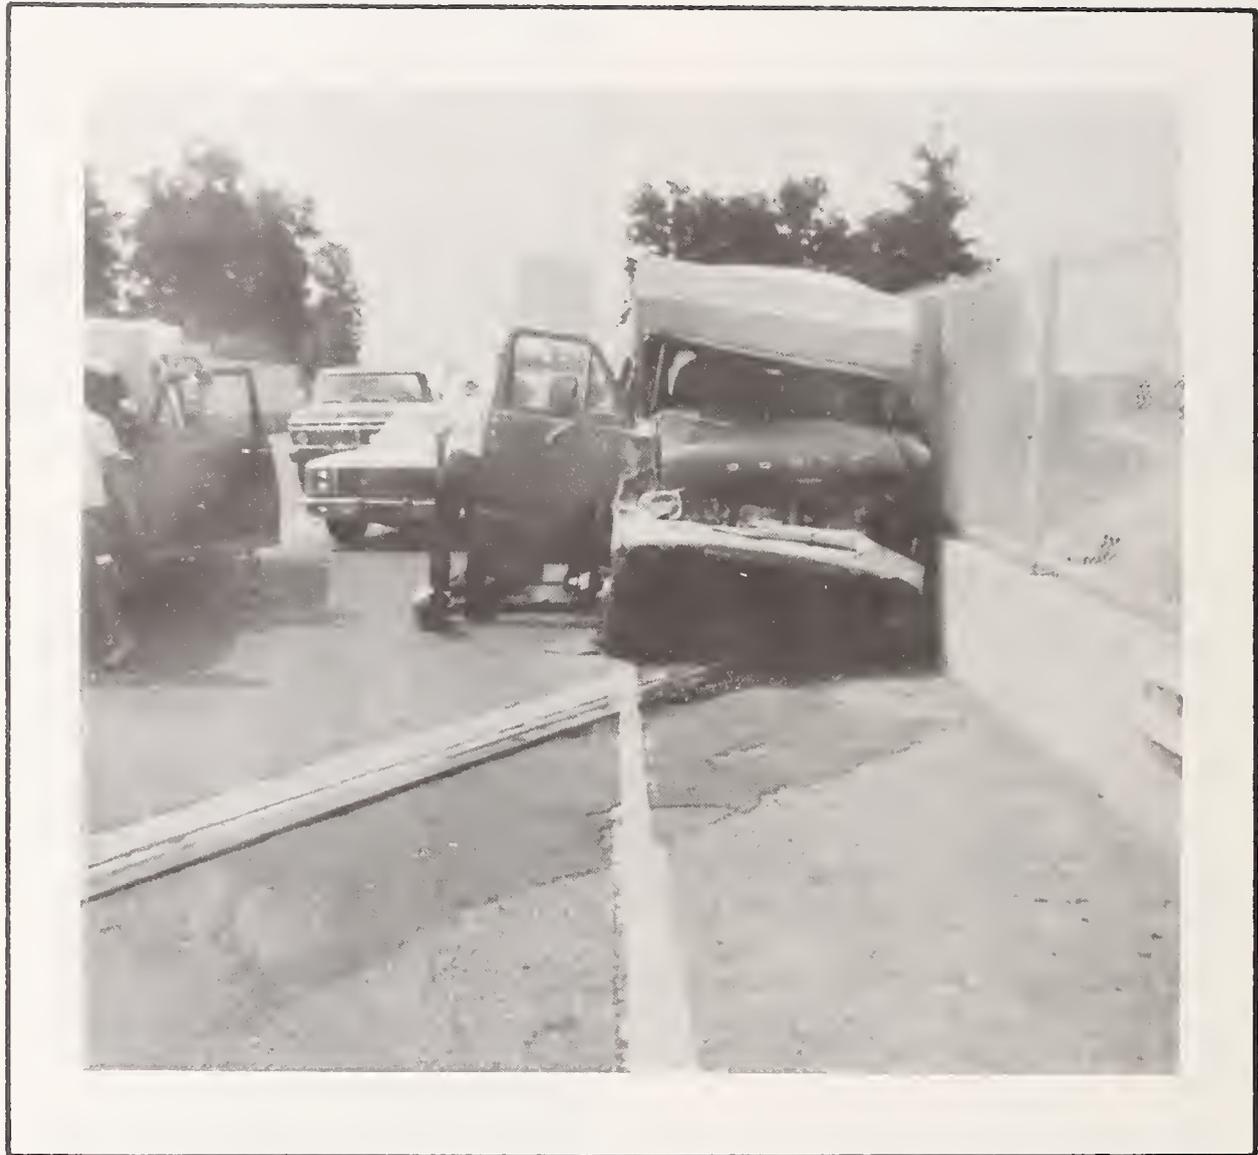
FIGURE 3-12. PARATRANSIT VAN IN FINAL RESTING POSITION AFTER MULTIPLE VEHICLE COLLISIONS: HOWARD COUNTY, MARYLAND

Despite the four collisions, the van remained nearly intact. Figure 3-12 shows the front of the van crushed considerably, but the raised roof stayed in position and the wheelchair lift at the side doors remained operable (Figure 3-13). Figure 4-14 shows emergency first aid being provided to one of the six persons (aged 68, 74, 80+, 84, and 89) on board. It appears from Figure 3-14 that one of the passenger bench seats partially failed as a result of the collisions. Evacuation of the passengers was facilitated by using the side doors and by lowering the wheelchair lift.
