Report No. FHWA/RD-80/059

EVALUATION OF HIGHWAY CULVERT COATING PERFORMANCE

June 1980
Final Report

Prepared for
FEDERAL HIGHWAY ADMINISTRATION
Offices of Research & Development
Structures & Applied Mechanics Division
Washington, D.C. 20590

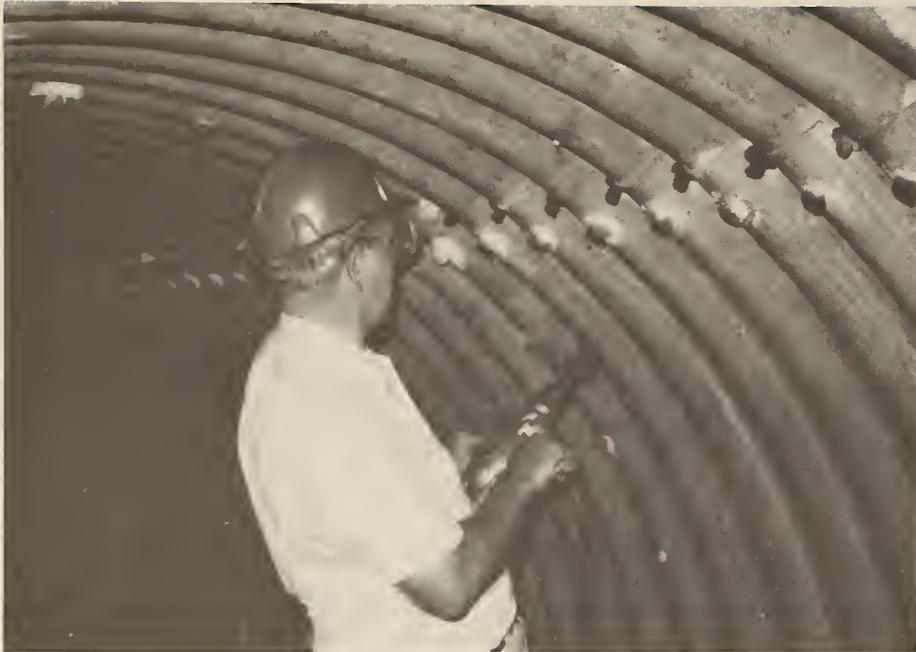
FIGURE 1 - Removing Core Sample From Culvert
to Inspect Exterior Coating

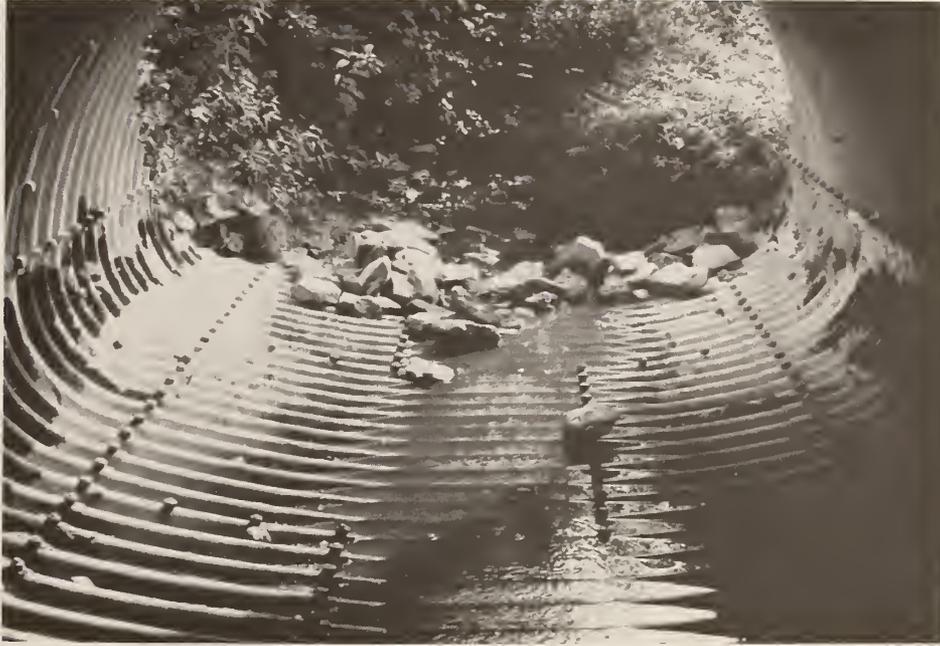
FIGURE 7 Field Applied Asphalt Mastic
Site No. 7

Figures 7 and 8 illustrate two culverts with field applied mastic which were subject to abrasive flow conditions. Figure 9 shows a culvert with field applied mastic exposed to alkali water. Generally speaking, the field applied mastics inspected exhibited poor performance. Coating thickness measurements revealed that coatings were not uniformly applied. The average thickness being below the .127 cm (.050-inch) minimum specified by AASHTO and the states.

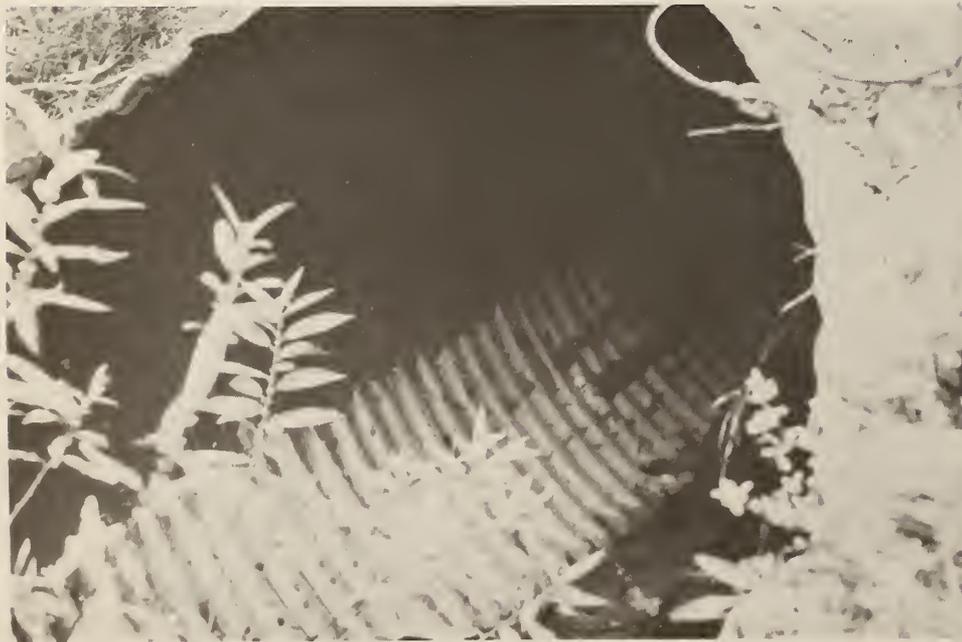
FIGURE 10 - Asphalt. Site No. 16

Figures 10 and 11 illustrate damage to asphalt dipped culvert pipe. The damage in Figure 10 was caused by abrasion and impact while that in Figure 11 was

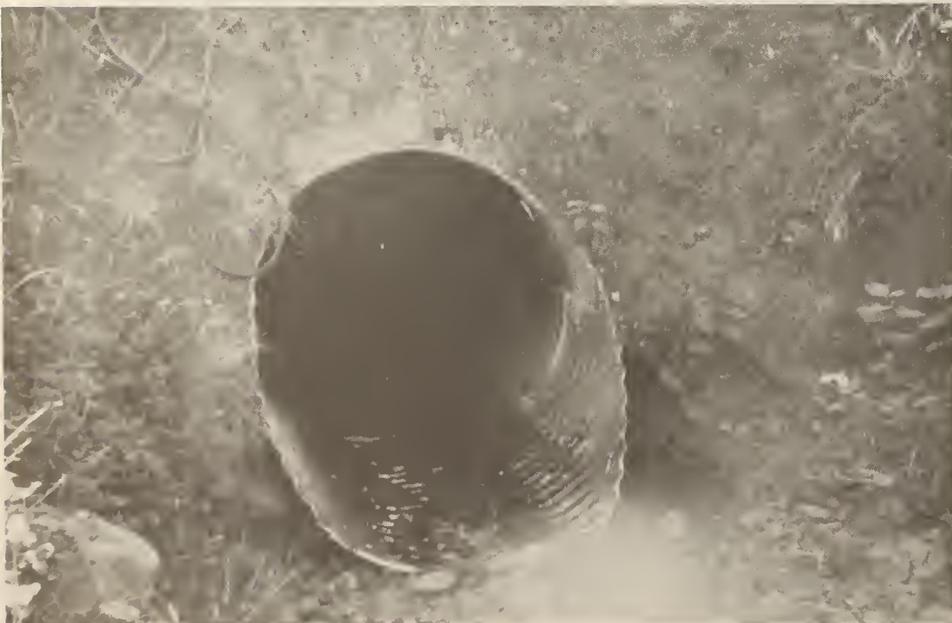
FIGURE 18 - Asphalt Coated Aluminum.
Site No. 25

Inspections included only four asphalt coated aluminum culverts (two at test sites). Figure 18 shows a three year old aluminum coated culvert which was installed with a settling basin at the inlet. Some chipping of the coating is seen on the invert. Coatings on both aluminum culverts examined in field use were in good condition with little coating deterioration and no corrosion of the aluminum. Abrasion and rapid stream flows did not appear to be factors in the two culverts examined. Asphalt exhibits a poor bond to aluminum, being easily removed by prying. Figure 19 shows a test culvert from Louisiana exposed to a moderately corrosive environment in which almost no coating remains. While the condition in Figure 19 could be the result of periodic removals during inspections, it does illustrate the poor adhesion between aluminum and asphalt when conventional application techniques are used.
