Report No. FHWA-RD-73-13

**FHWA- INVESTIGATION OF THE EFFECTIVENESS OF EXISTING
RD- GE DESIGN METHODOLOGY IN PROVIDING ADEQUATE
73-13 STRUCTURAL RESISTANCE TO SEISMIC DISTURBANCES.**

Phase I: Literature Survey

**November 1972
Final Report**

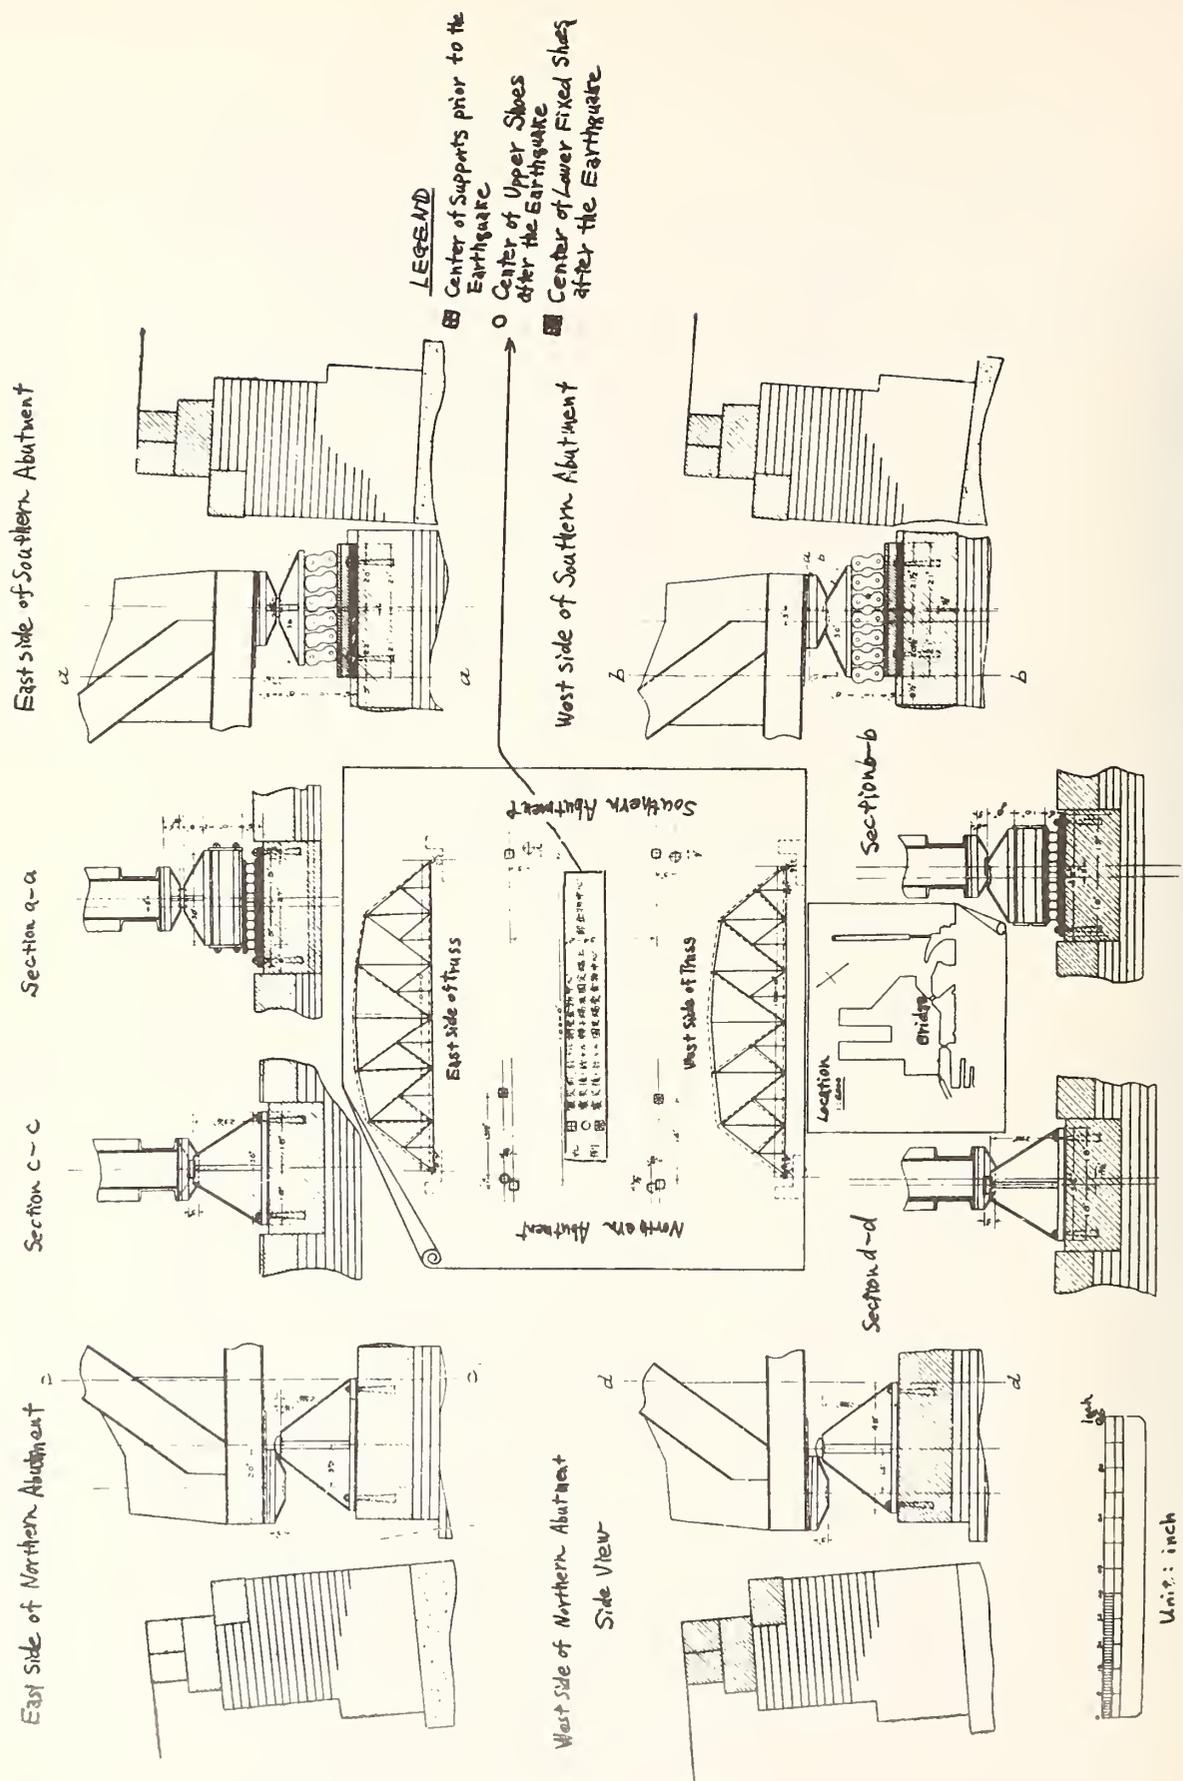
Fig. 2.3 Damage to the Tsuruno-bashi bridge

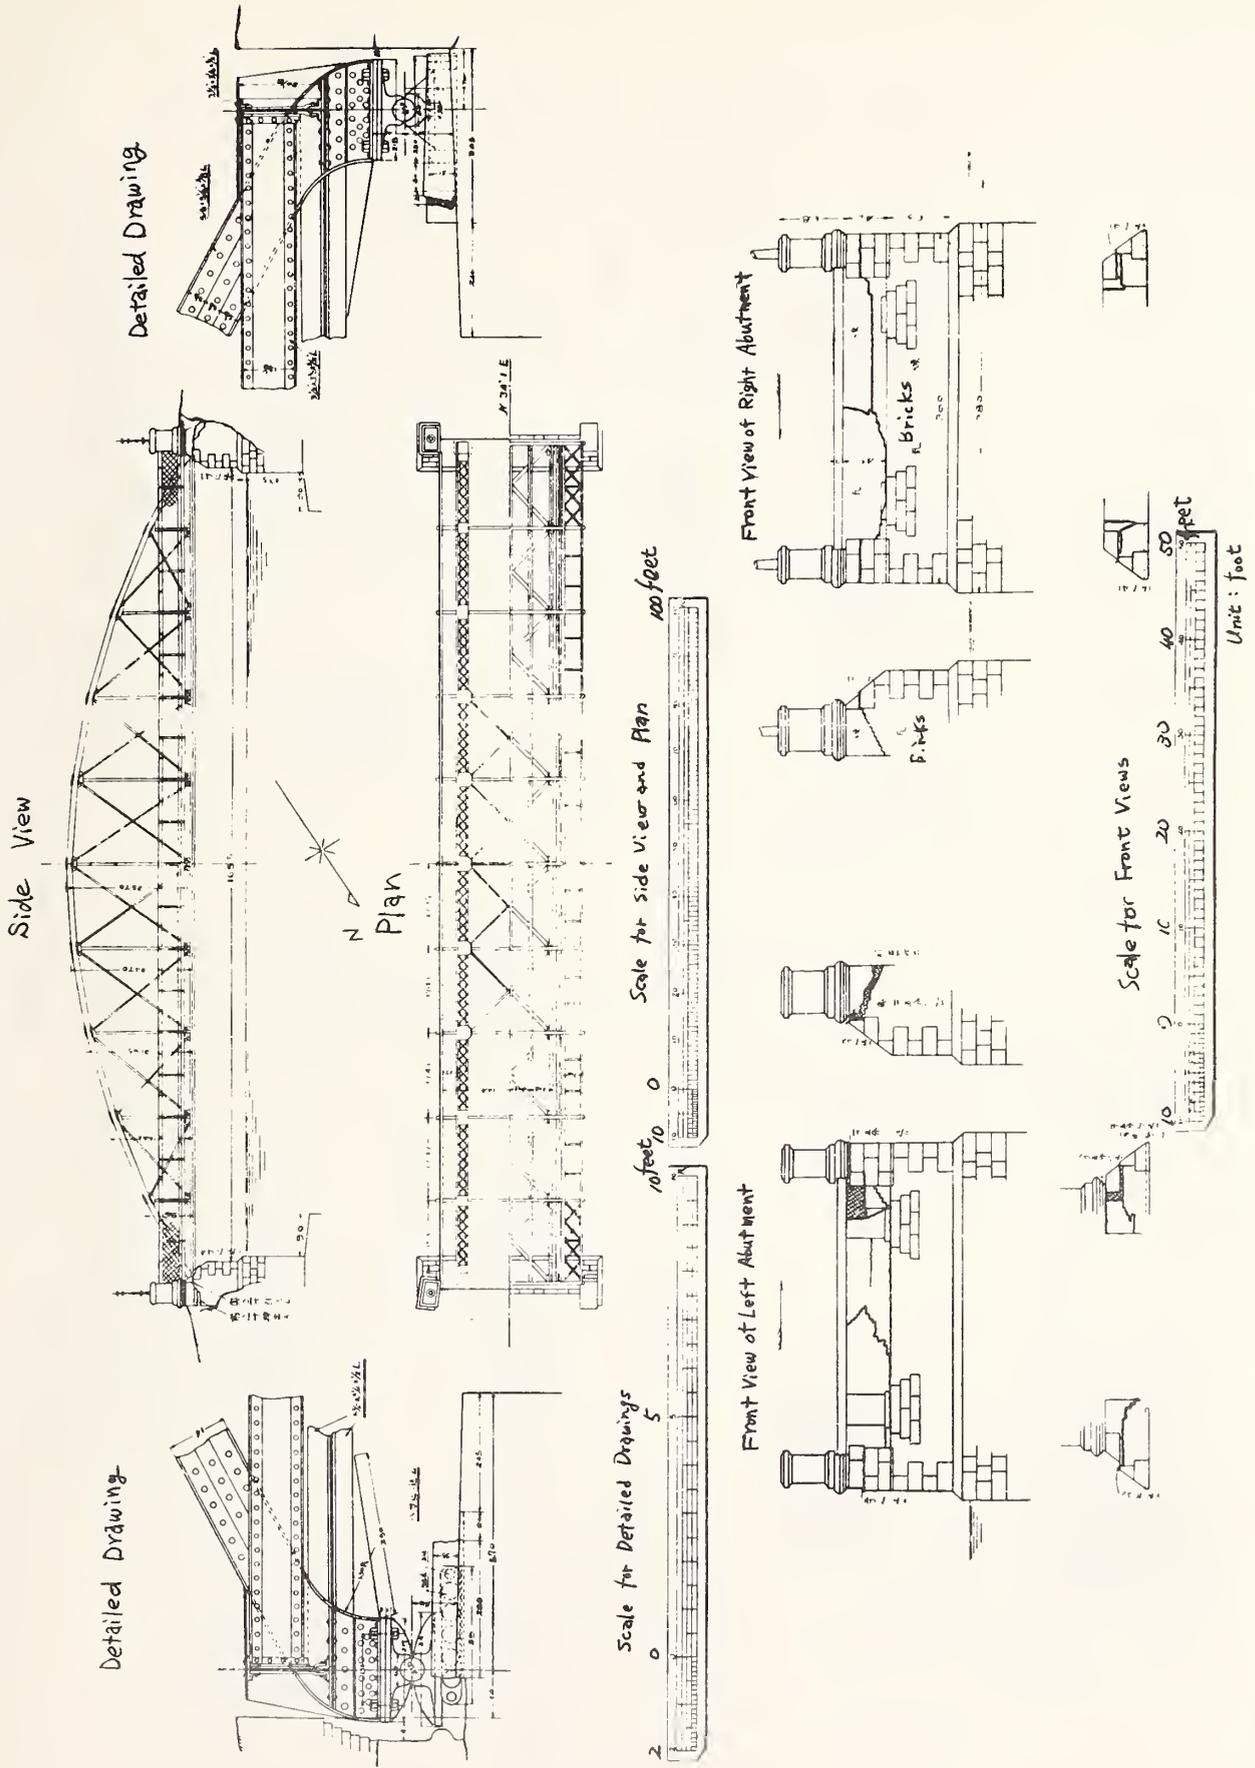
Fig. 2.5 Damage to the abutments of the Shinminato bridge

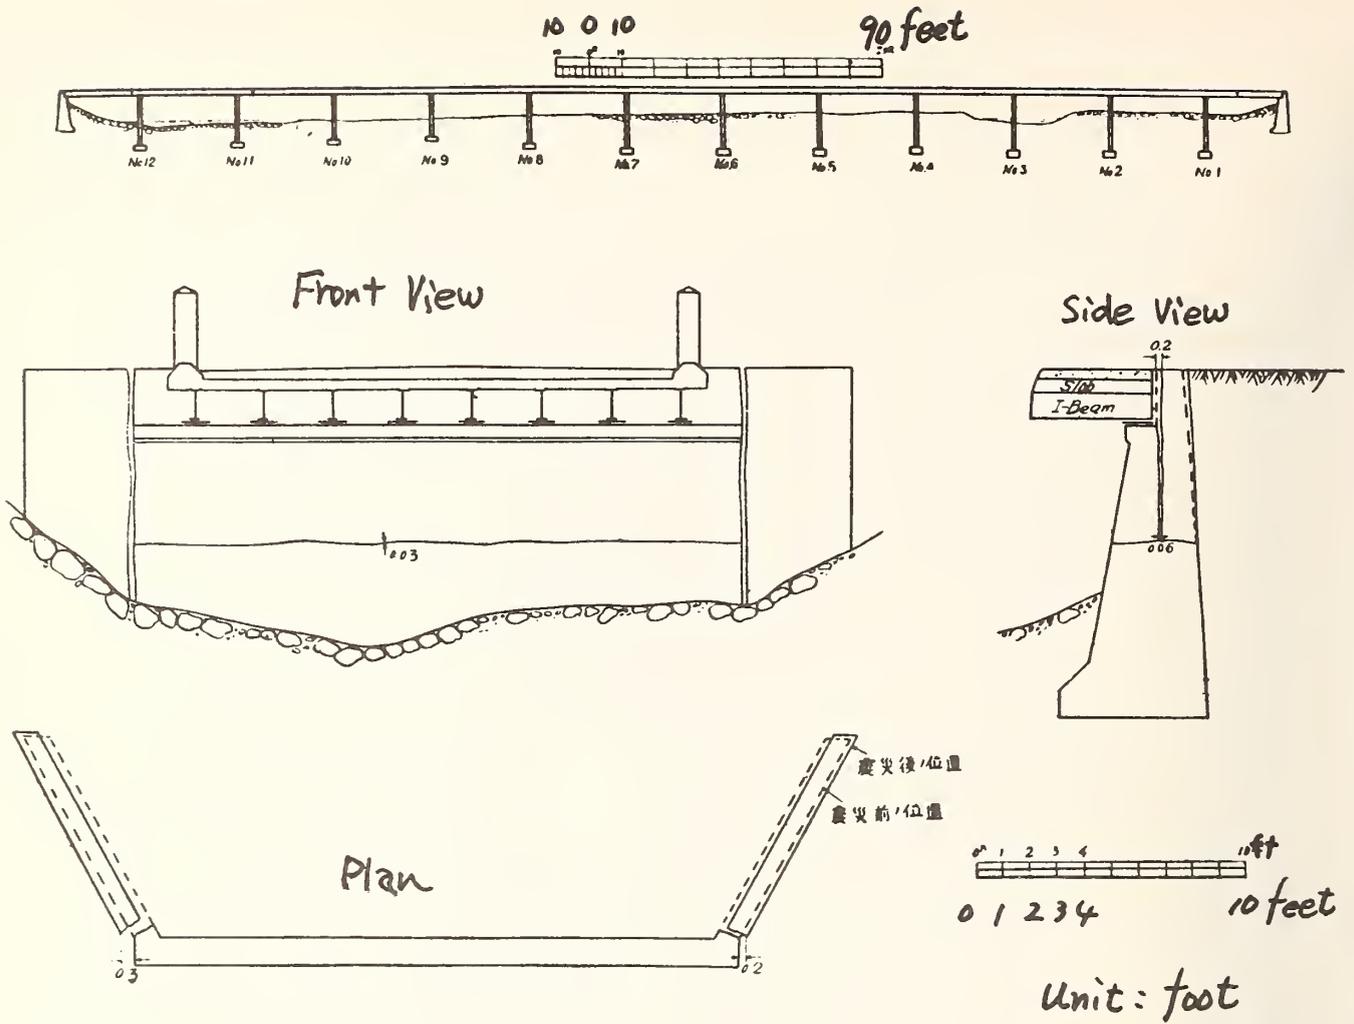
Fig. 2.11 Damage to the Hayakawa bridge

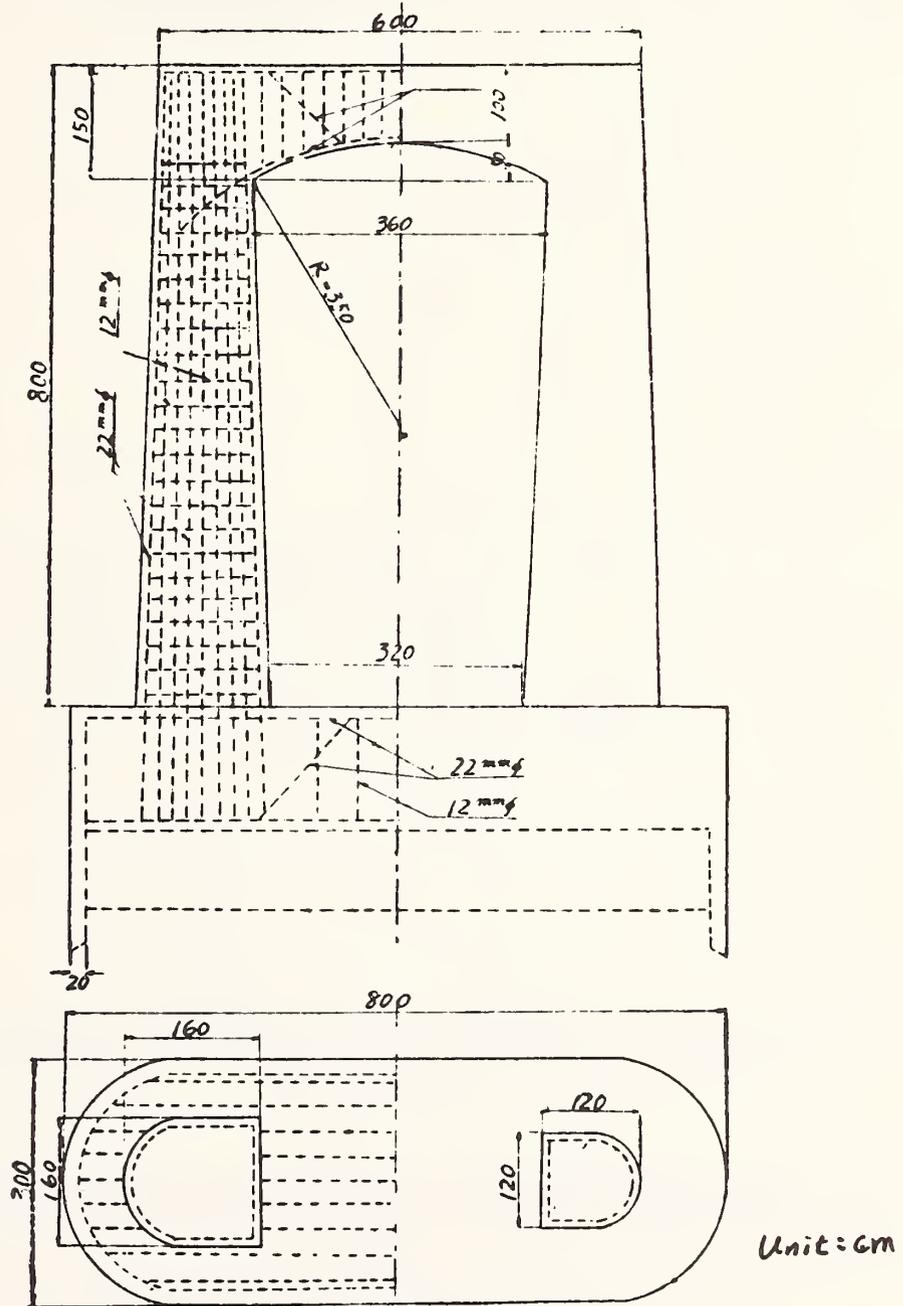
Fig. 2.15 Damage to the Nakazuno bridge

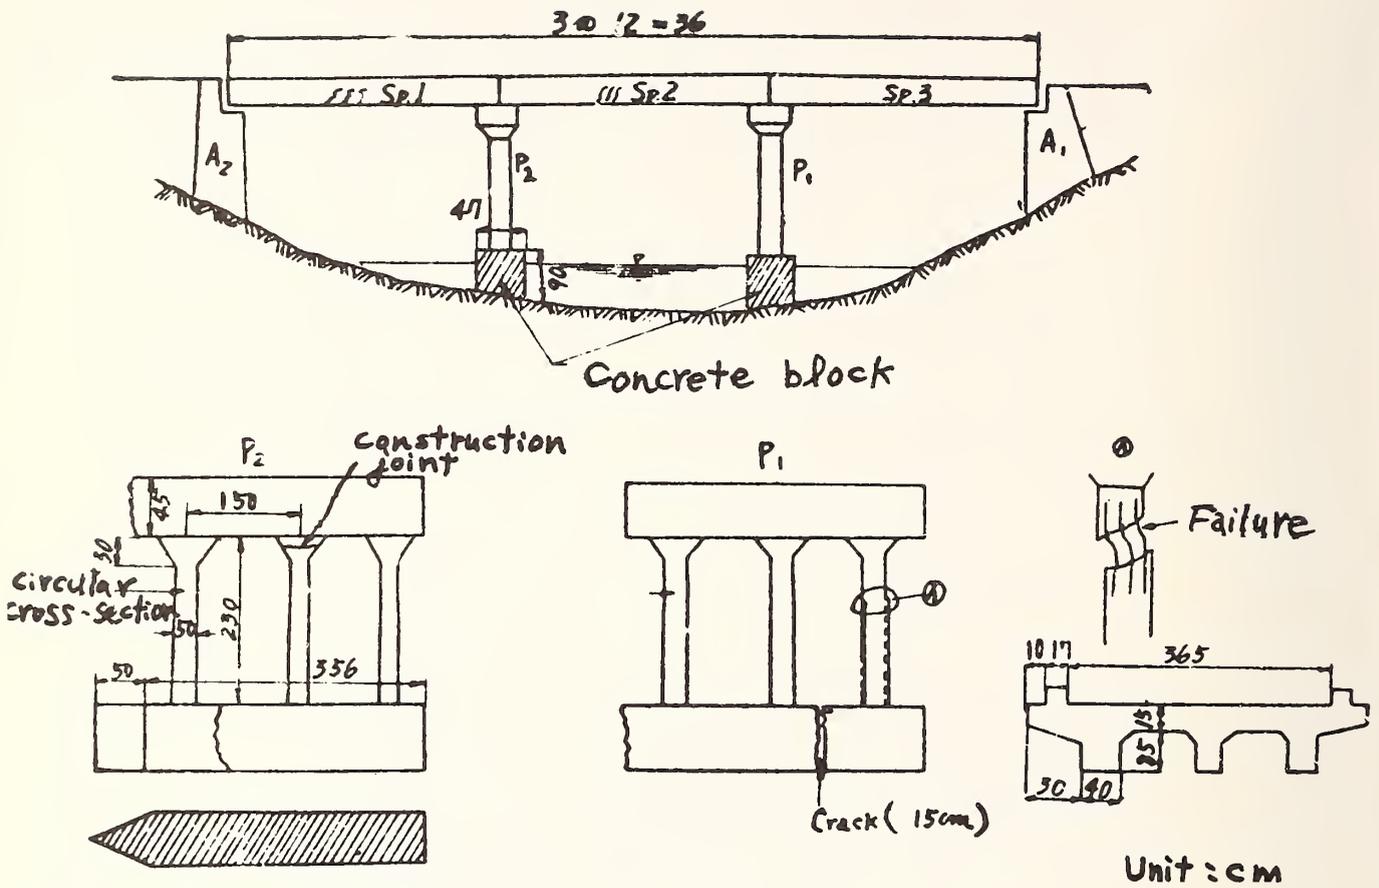
Figures indicate horizontal movements in cm

Fig. 2.20 Damage to the Itagaki bridge

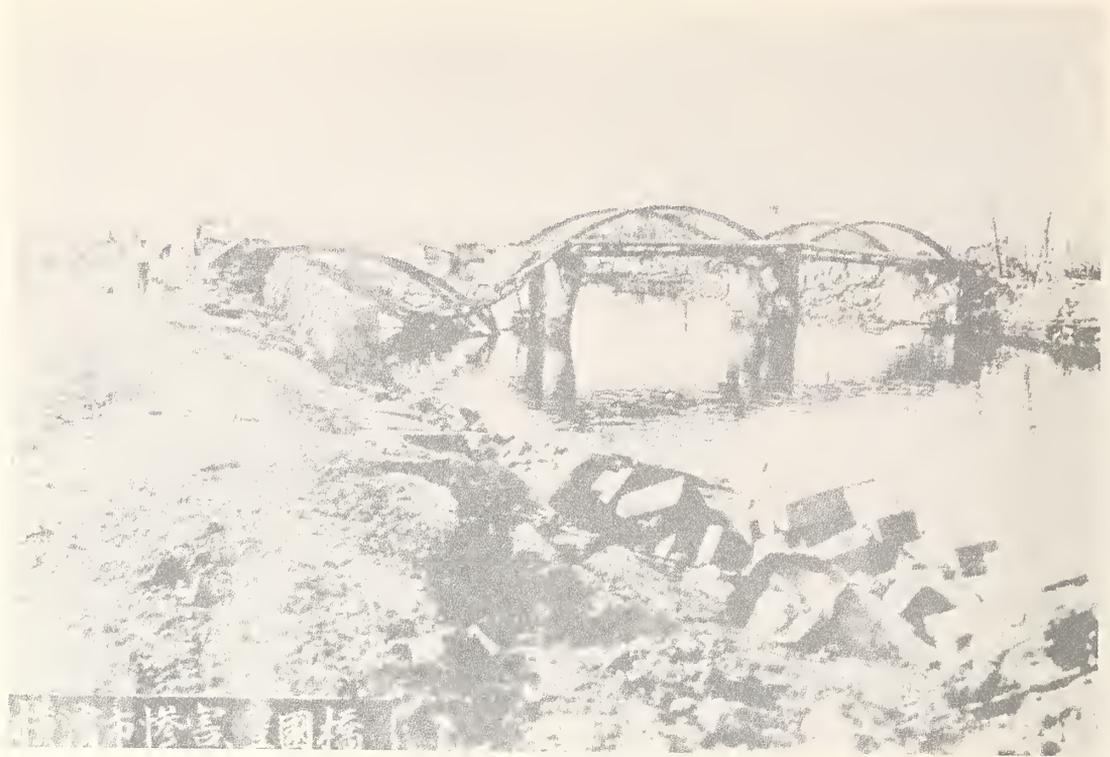
Photo. 2.6 Damage to the right-bank abutment of the Yamashita bridge.

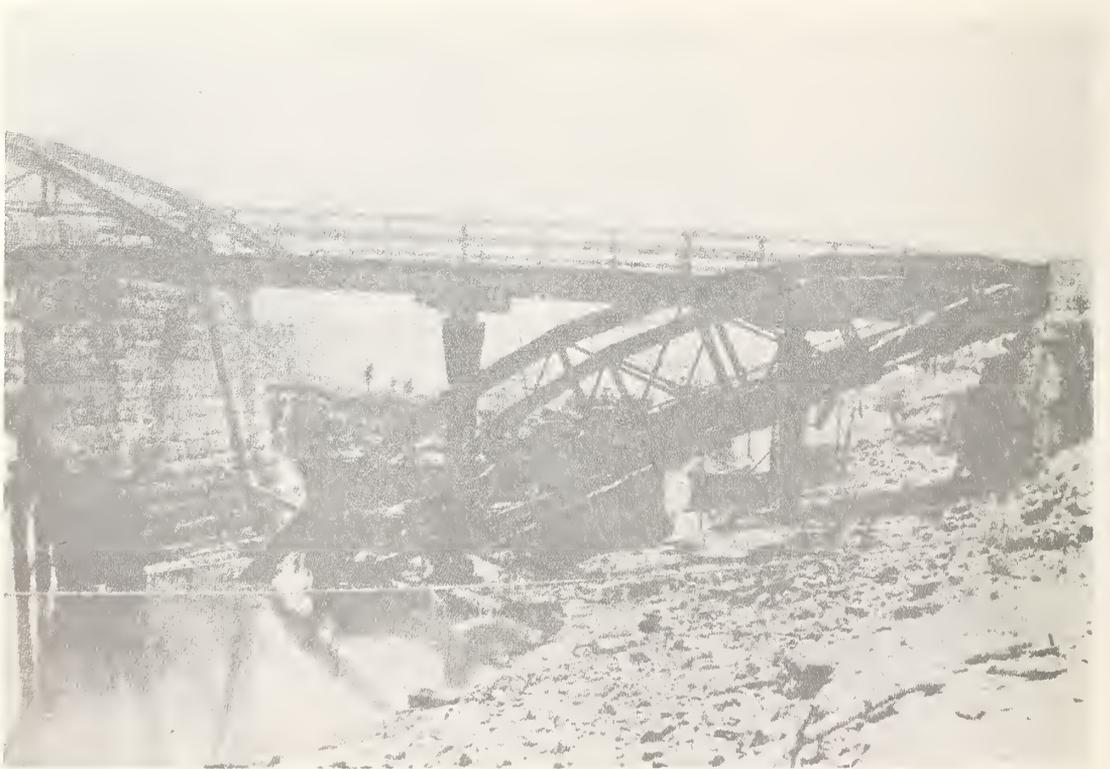
Photo.2.7 Damage to the Toyokuni bridge

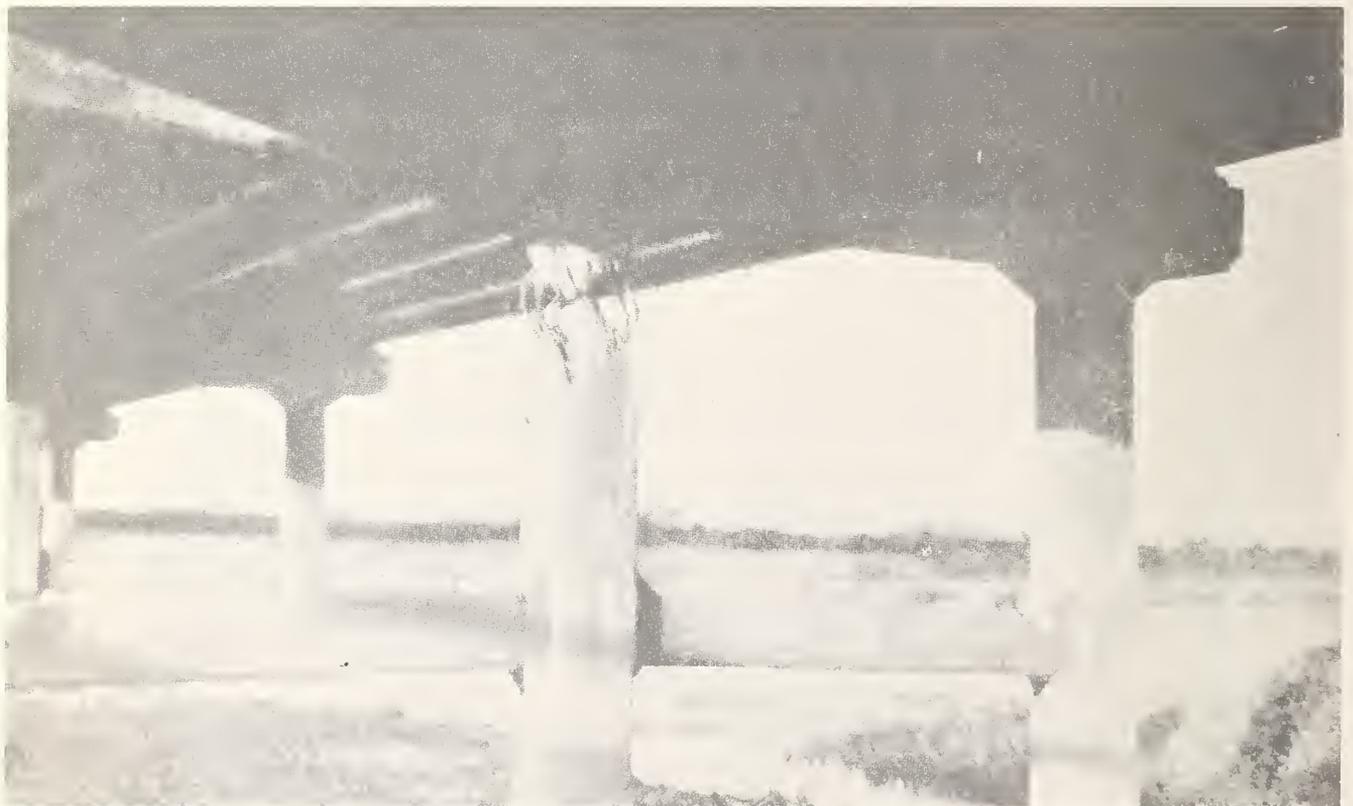
Photo. 2.15 Damage to the Hayakawa bridge

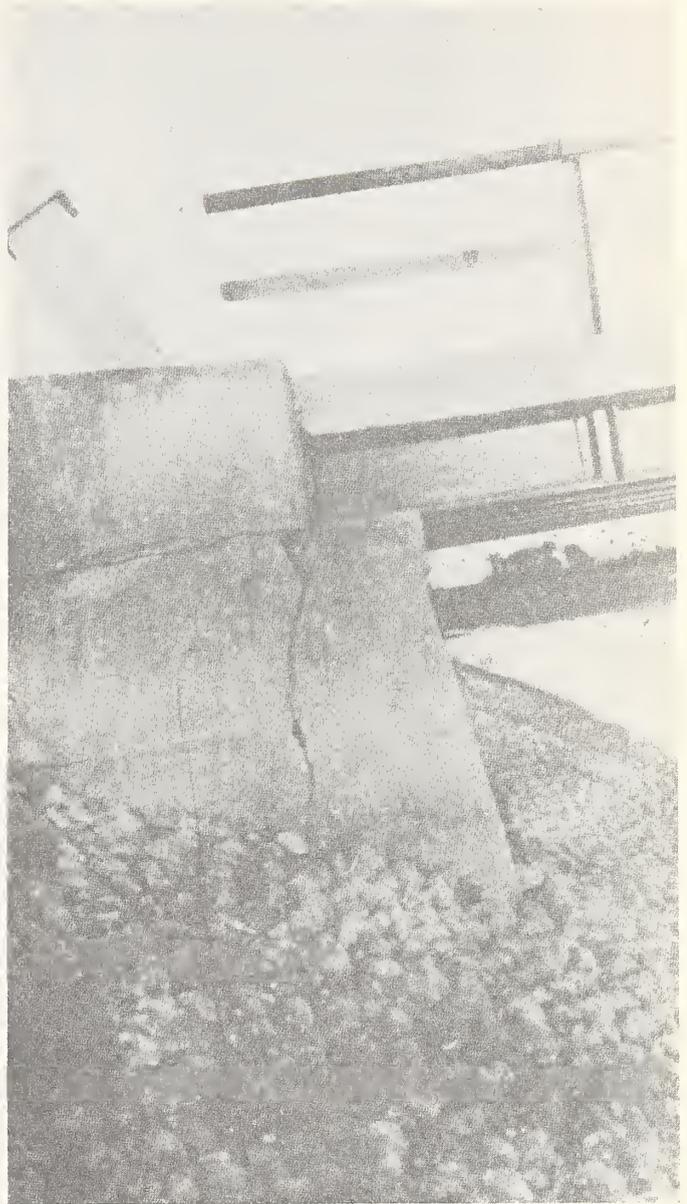
Photo. 2.17 Damage to the fifth pier of the Takahata bridge.

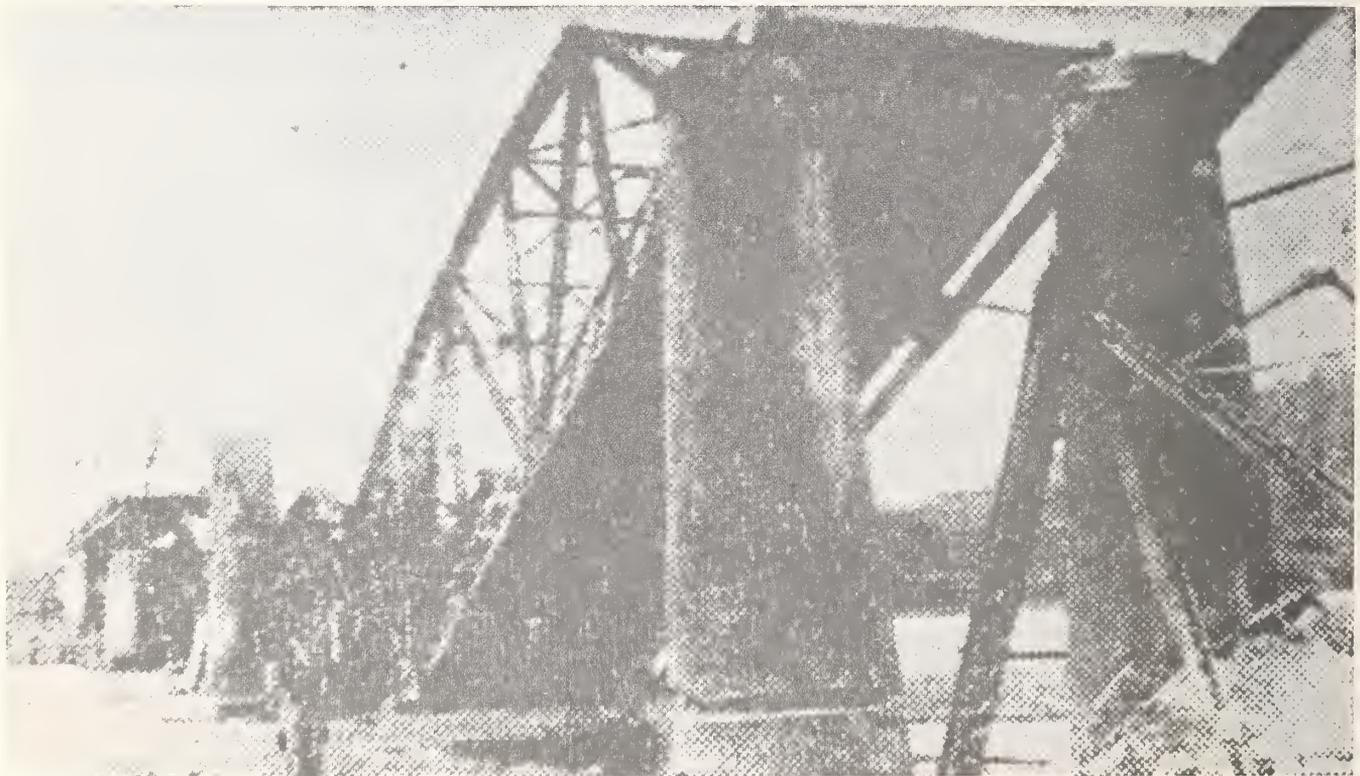
Photo.2.19 Damage to the support shoes of the Kumano bridge

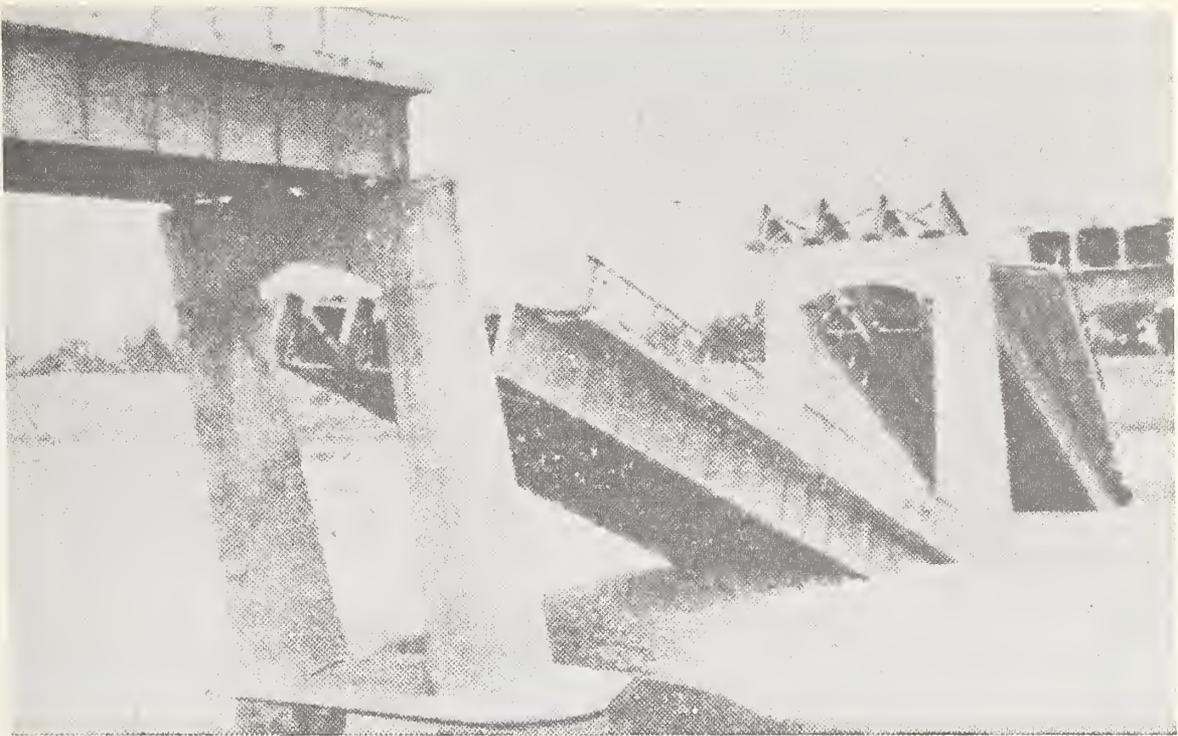
Photo.2.20 Damage to the Shimantogawa bridge

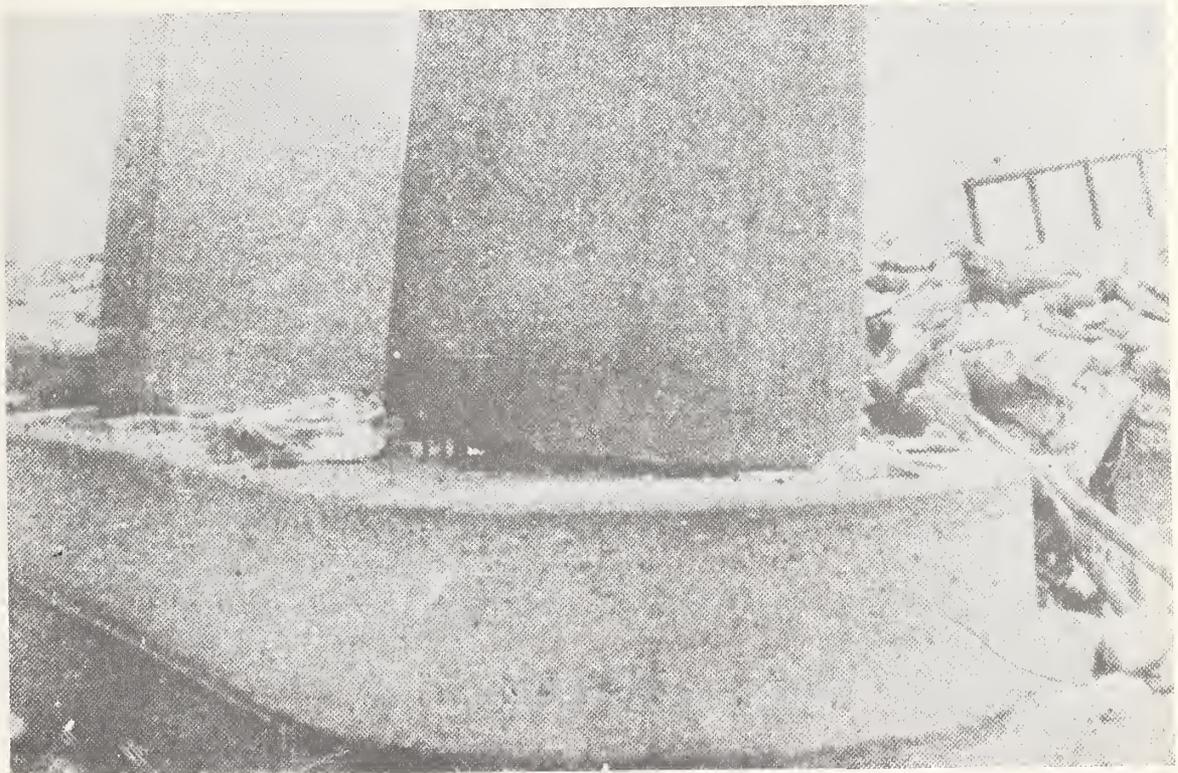
Photo.2.21 Damage to the Nakazuno bridge

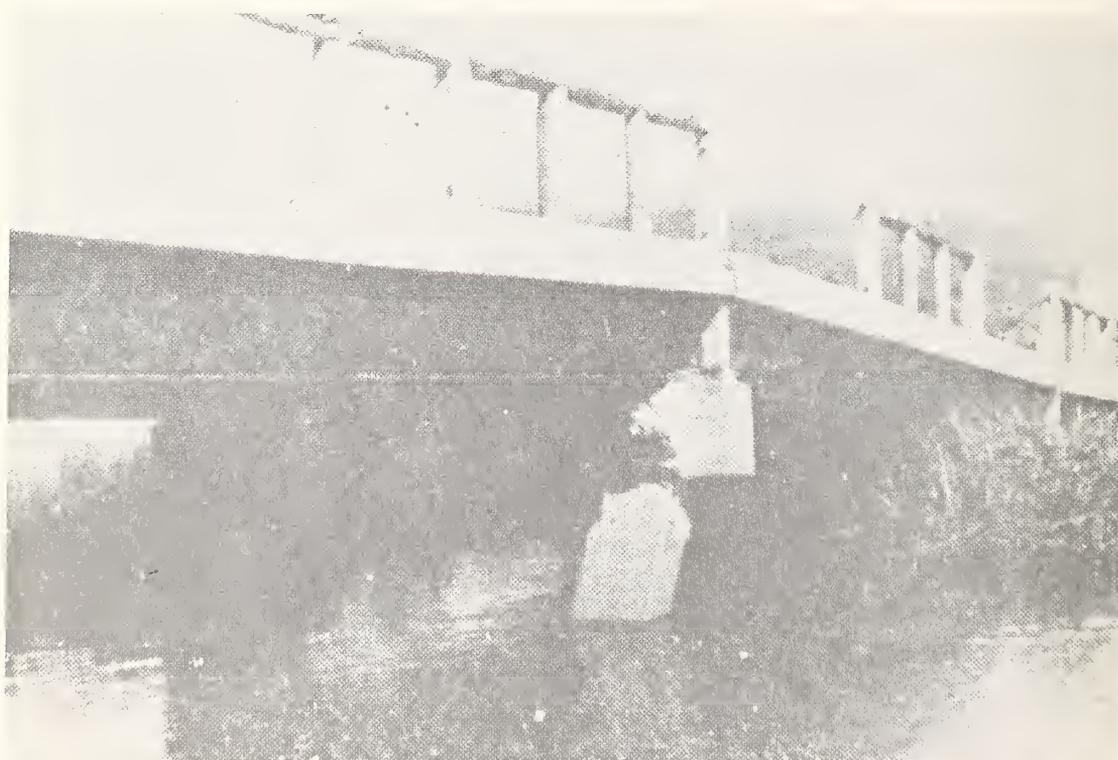
Photo.2.27 Damage to the Nagaya bridge

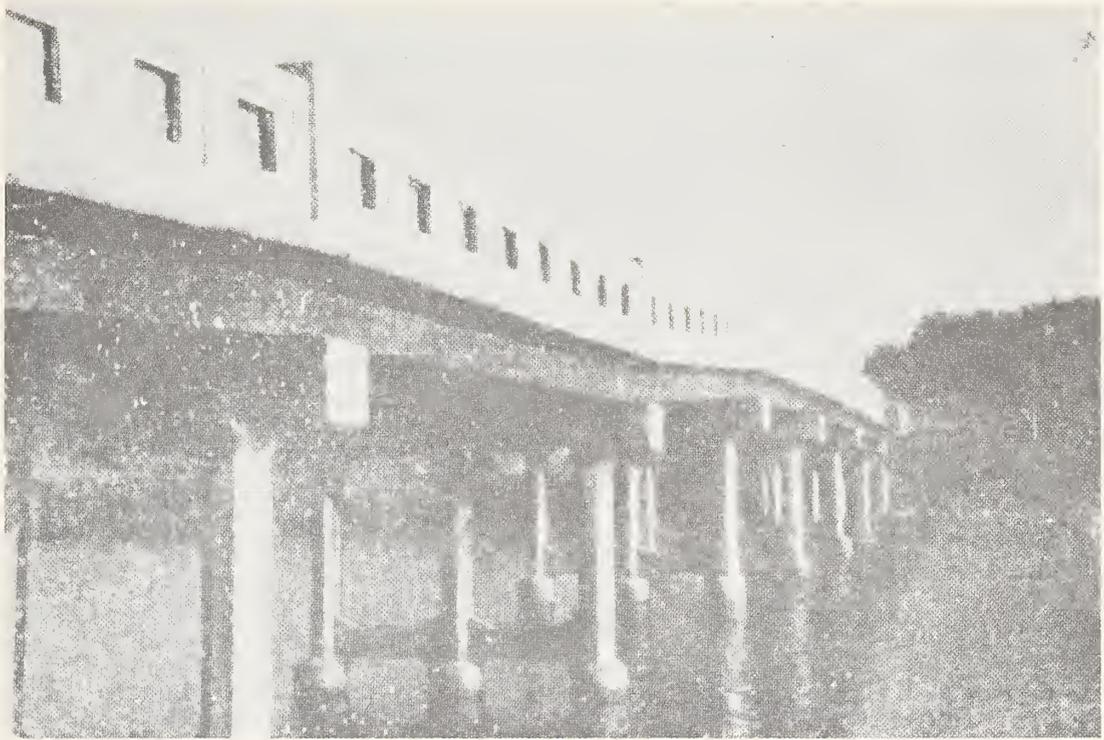
Photo.2.28 Damage to the piers of the Nagaya bridge

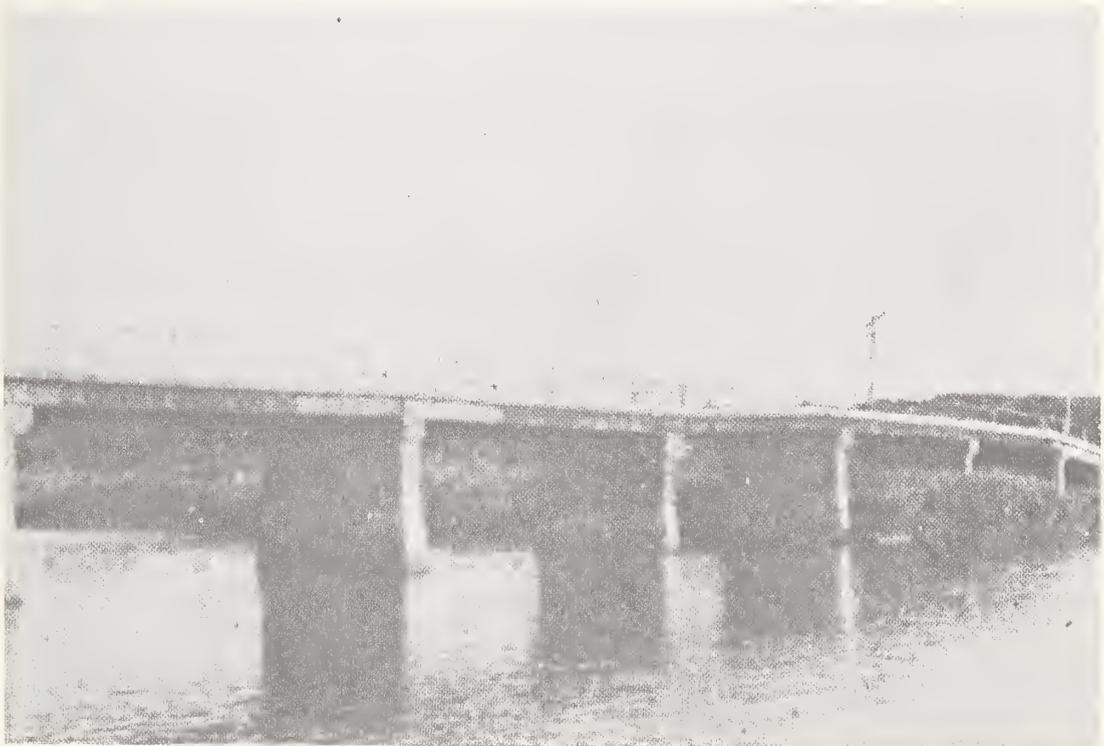
Photo.2.29 Damage to the Shioya bridge

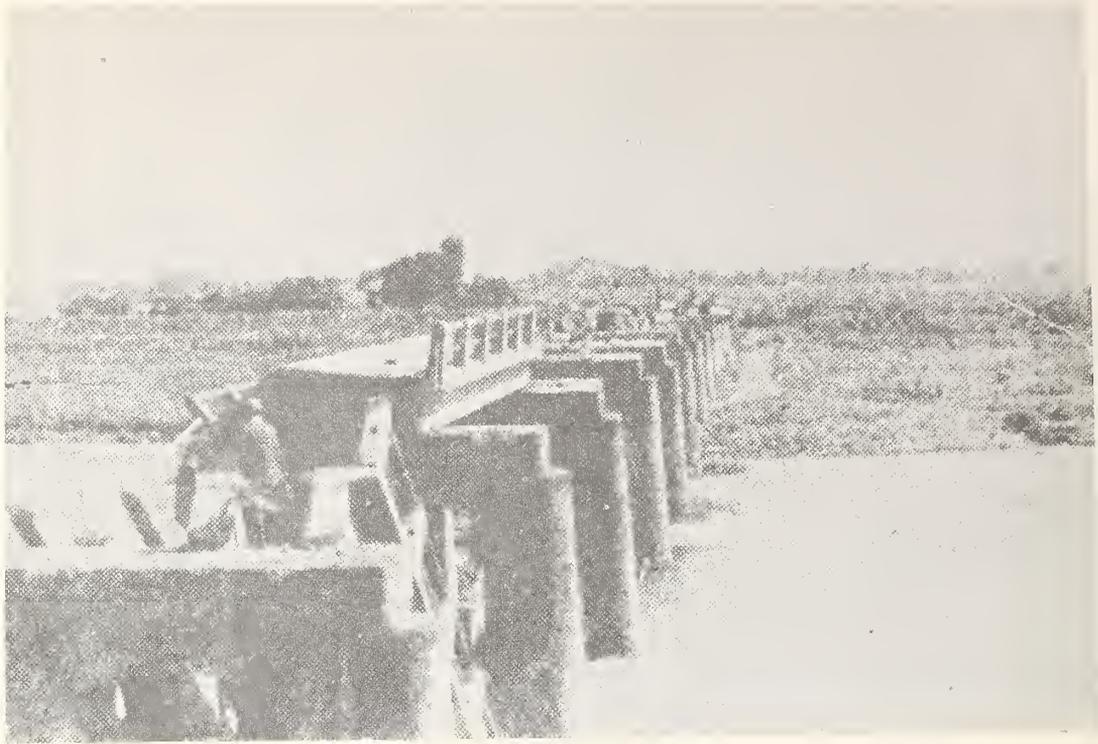
Photo.2.30 Damage to the Segoshi bridge

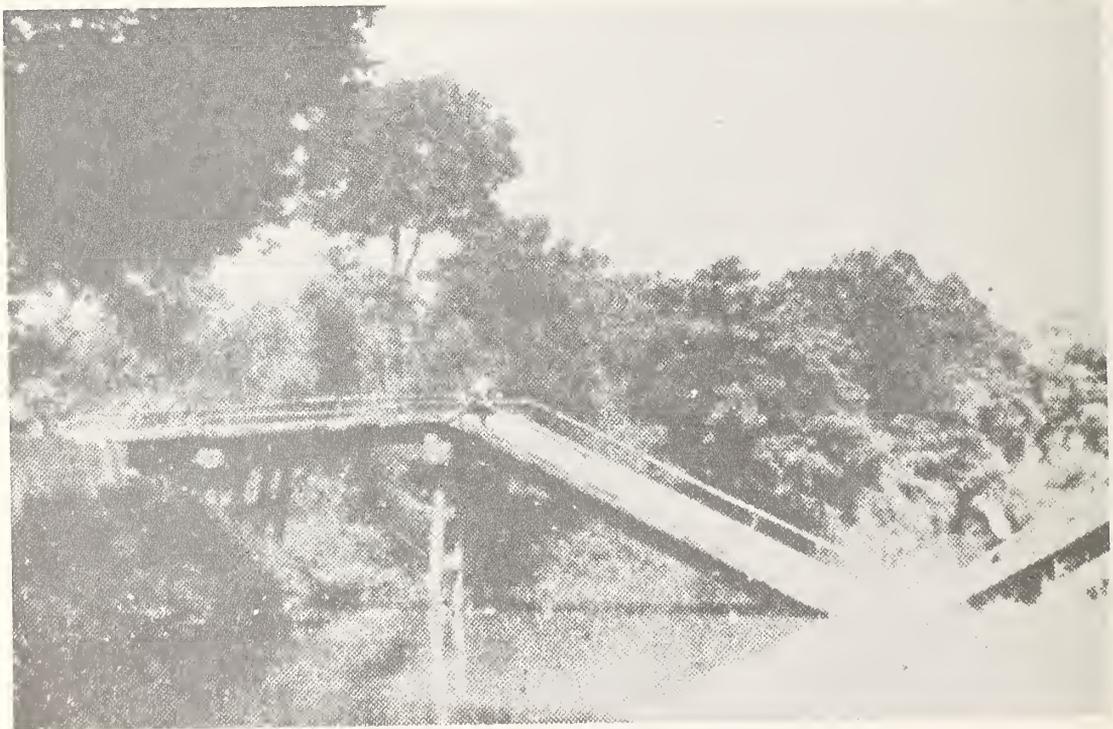
Photo.2.31 Damage to the Itagaki bridge

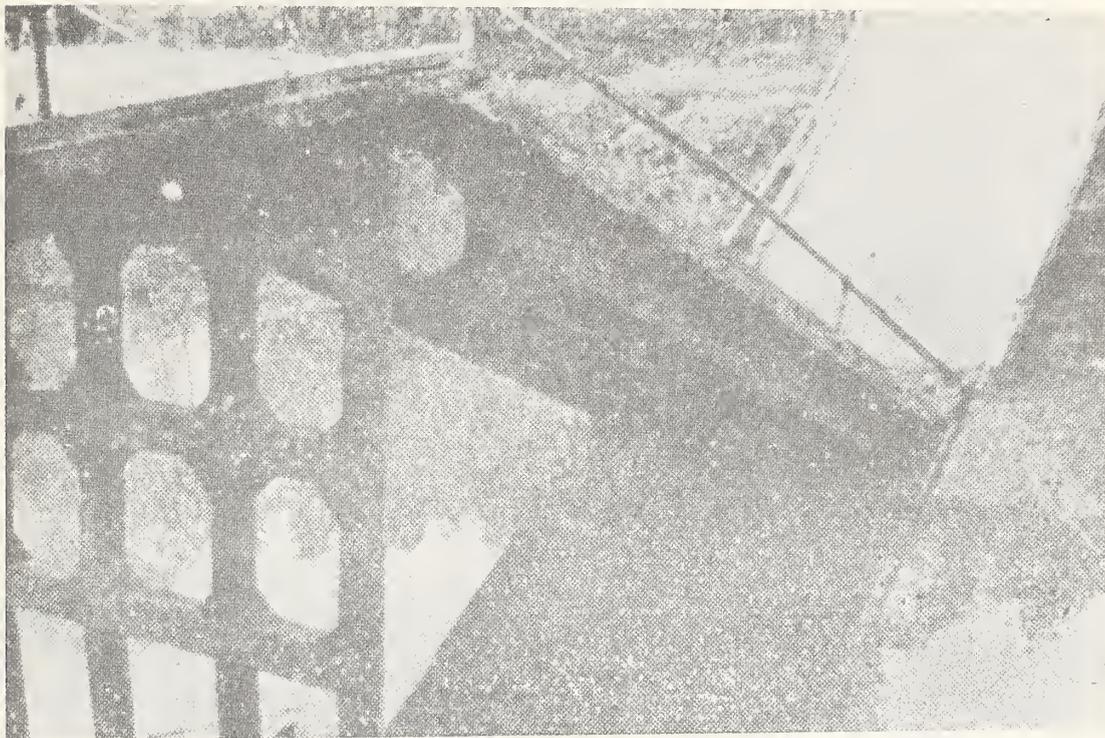
Photo.2.32 Damage to the Benten bridge

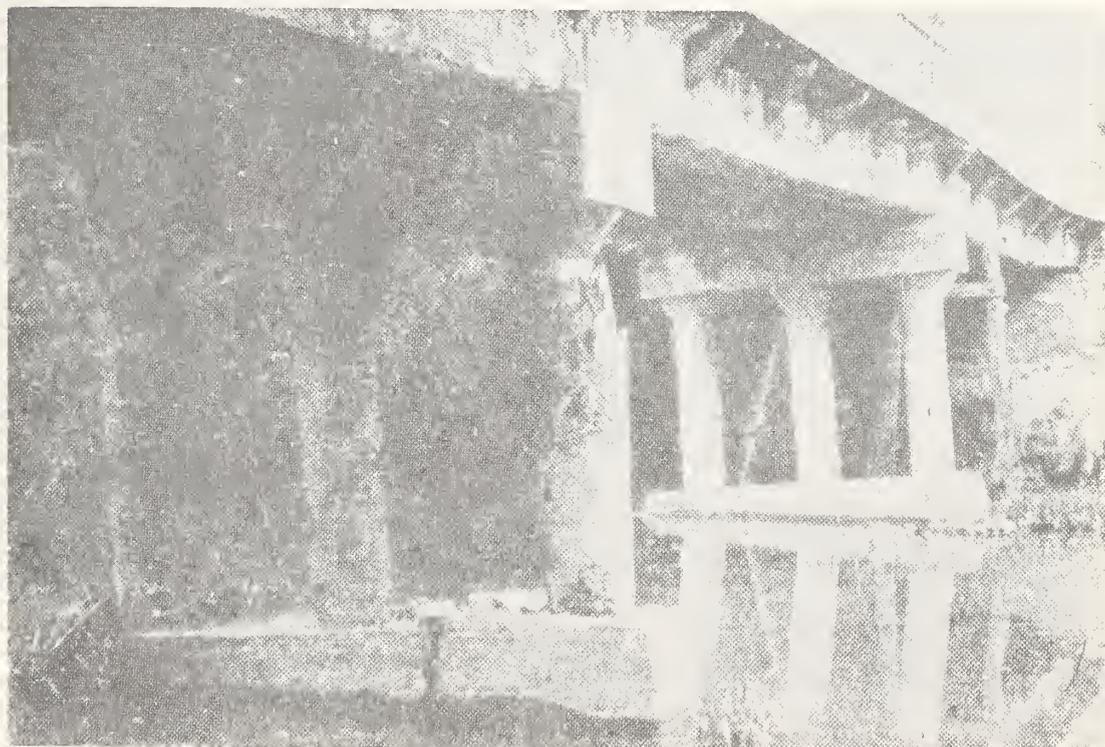
Photo.2.33 Damage to the Benten bridge

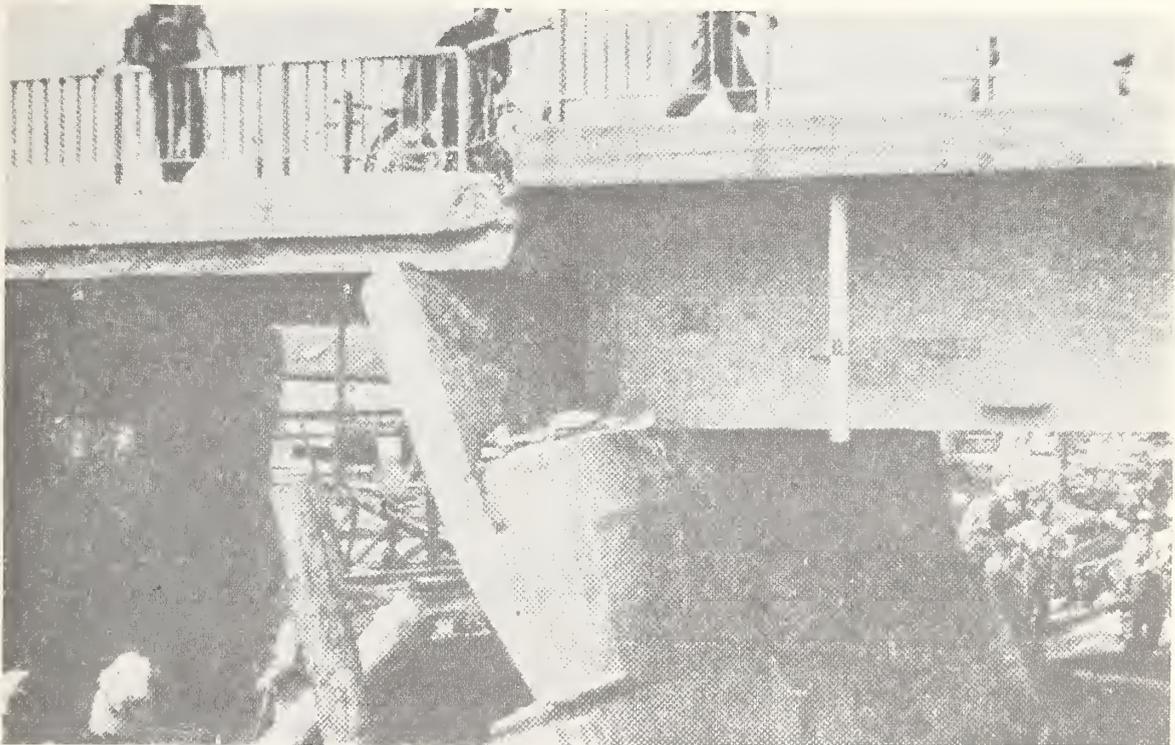
Photo. 2.49 Damage to the Yachi o bridge.

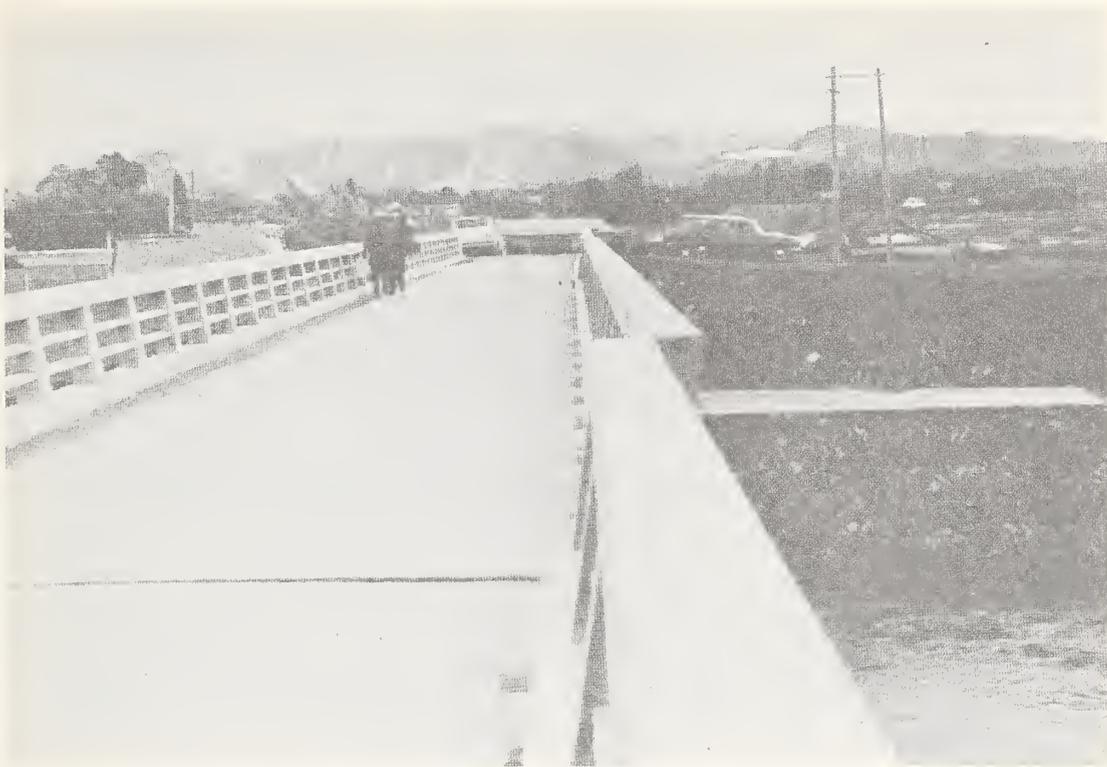
Photo.2.60 Damage to the PC girder and the abutment of the Kamezawa bridge.

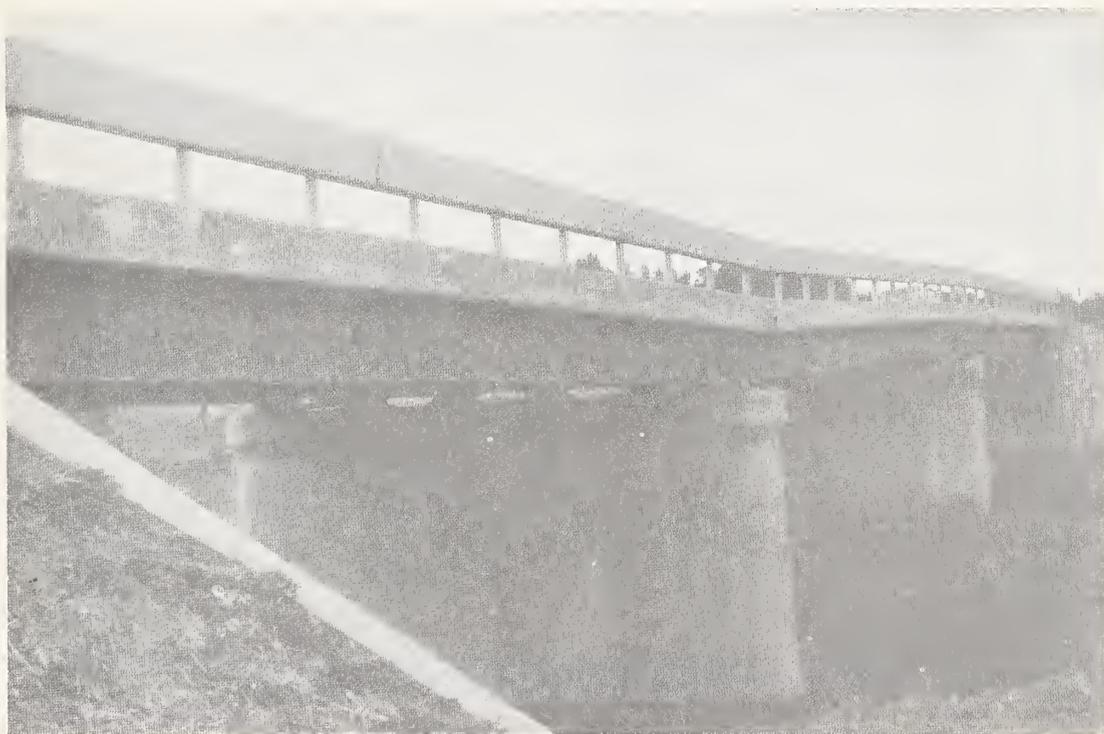
Photo.2.61 Damage to the Kamimasaki bridge
