Report No. FHWA-RD-73-13

**FHWA- INVESTIGATION OF THE EFFECTIVENESS OF EXISTING
RD- GE DESIGN METHODOLOGY IN PROVIDING ADEQUATE
73-13 STRUCTURAL RESISTANCE TO SEISMIC DISTURBANCES.**

Phase I: Literature Survey

**November 1972
Final Report**

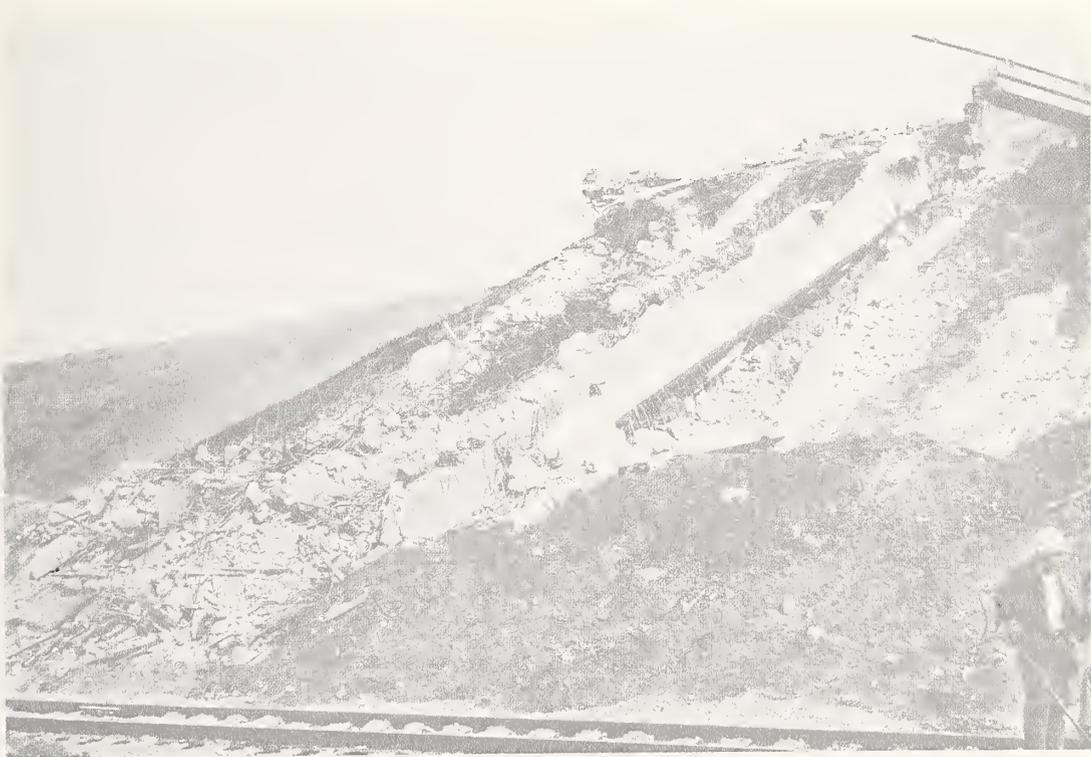
Photo. 2.69 Failure of the concrete girders
of the Komoto bridge

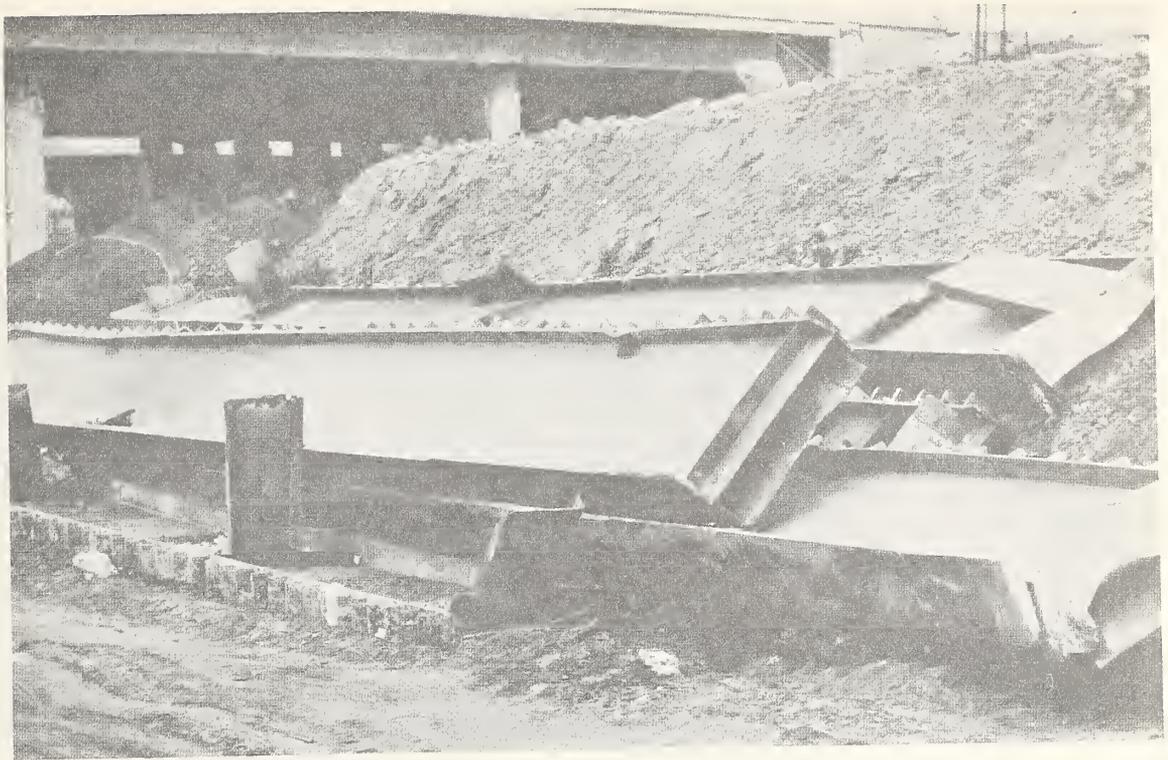
Photo. 2.72 Damaged San Fernando Road Overhead

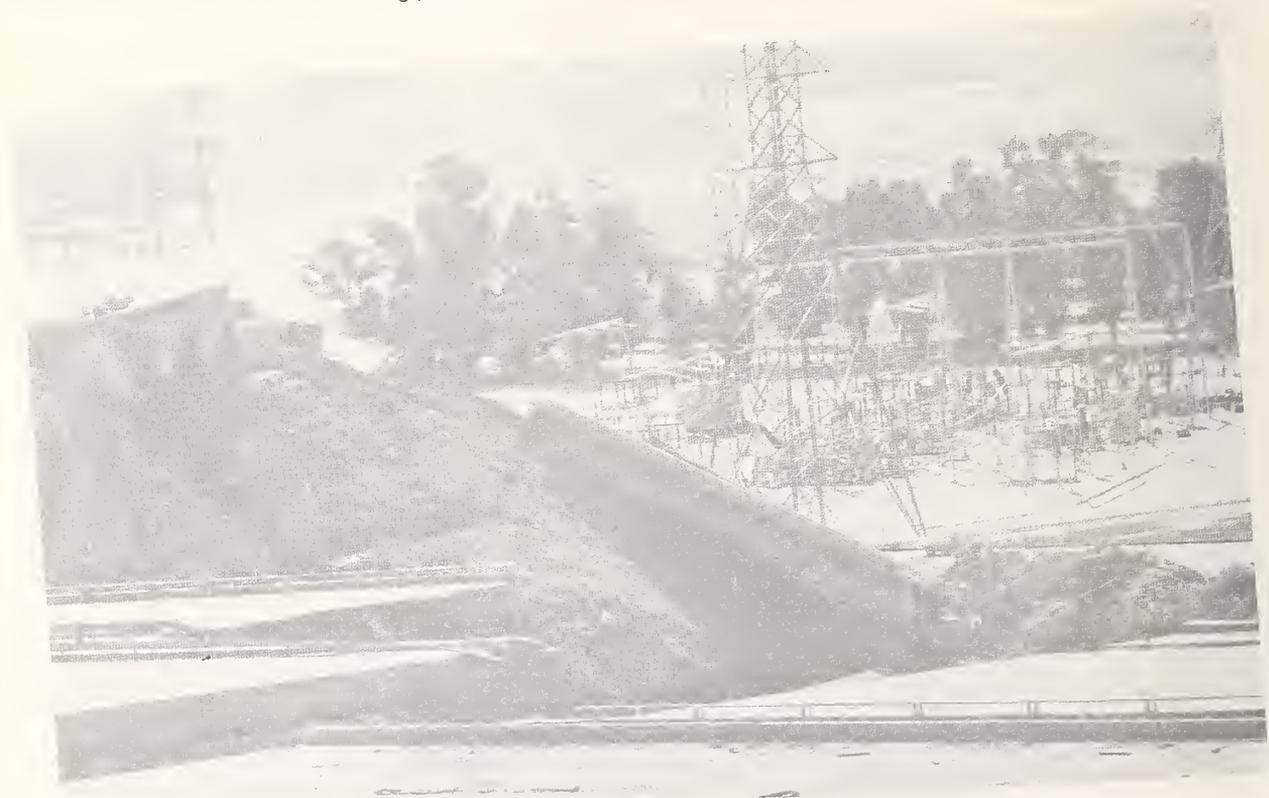
Photo. 2.83 Settlement of backfill - San Fernando Road Overhead

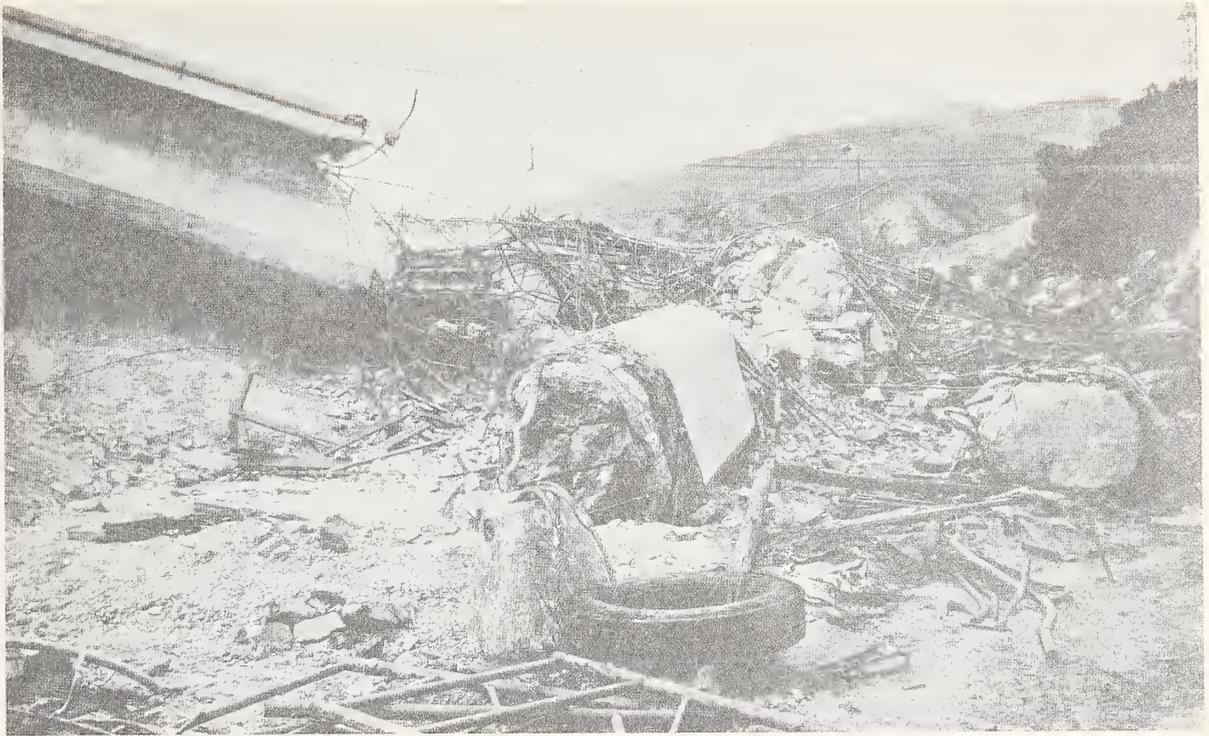
Photo. 2.84 Damaged overcrossing at Golden State Freeway and Foothill Freeway interchange

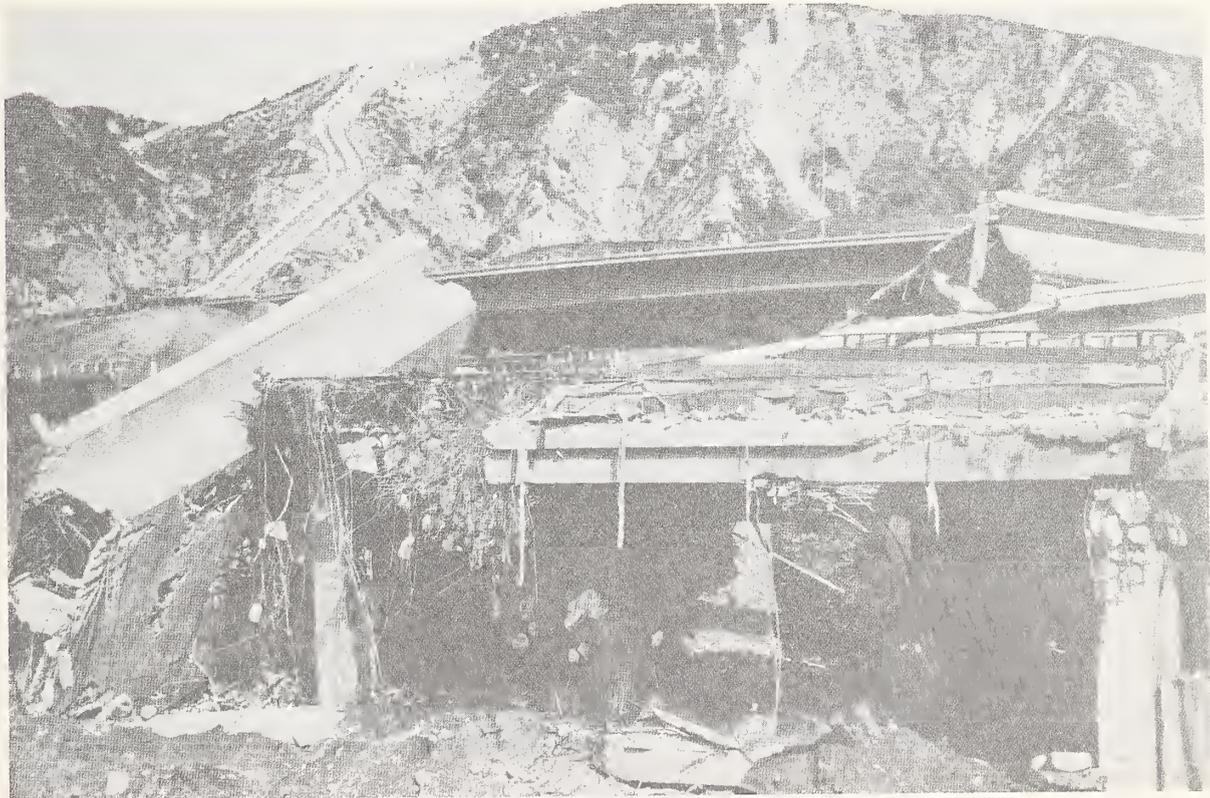
Photo. 2.85 Damaged overcrossing at Golden State Freeway
and Foothill Freeway interchange

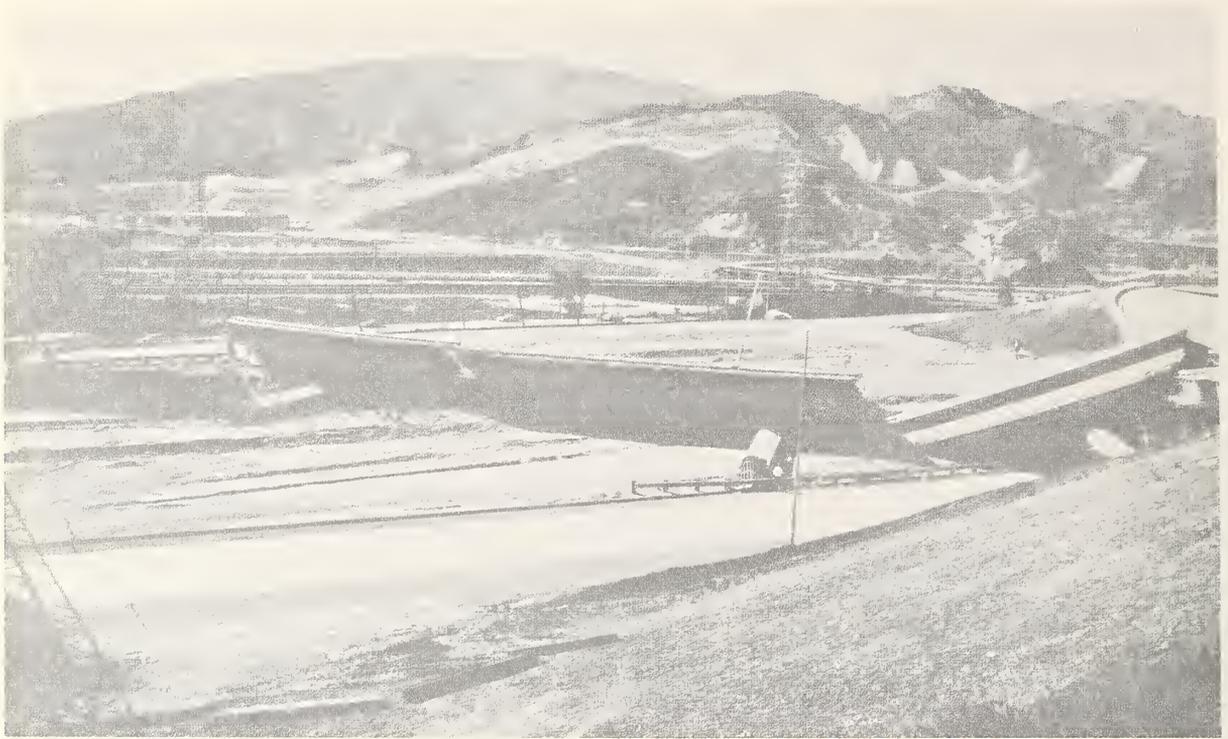
Photo. 2.86 Damaged overcrossing at Golden State Freeway
and Foothill Freeway interchange

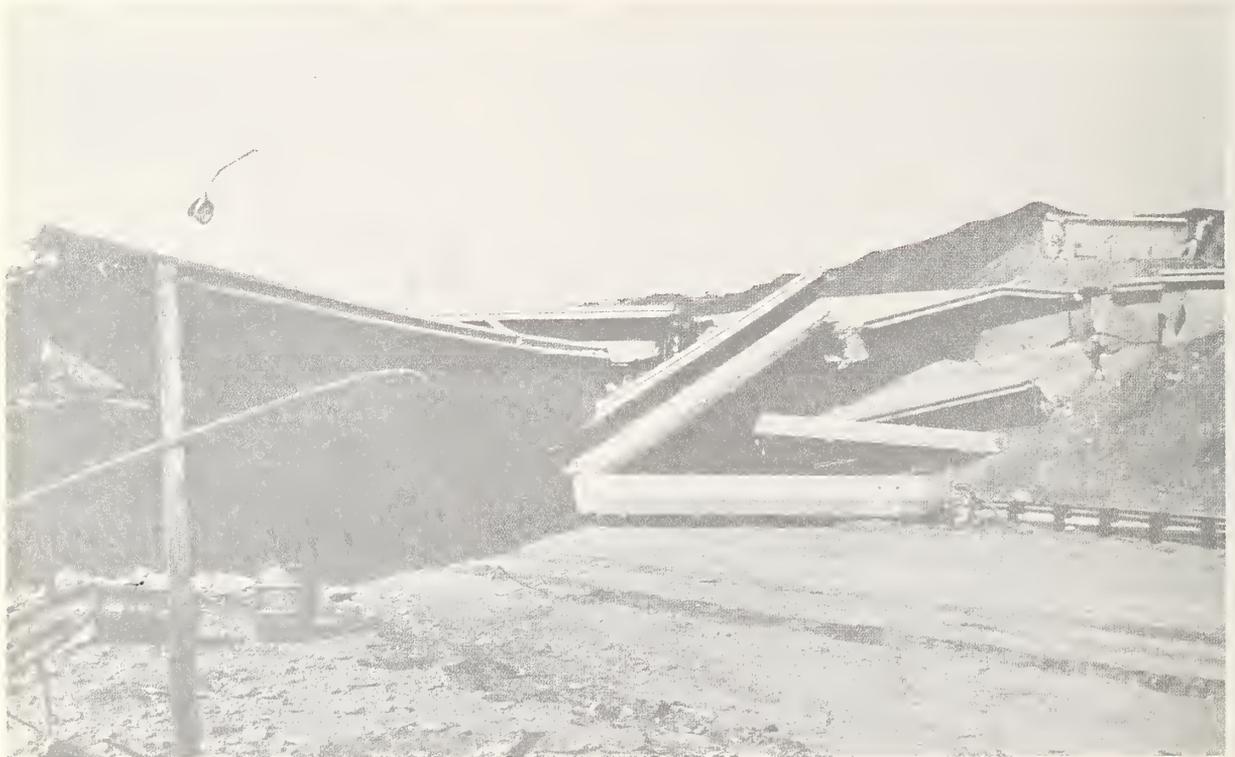
Photo. 2.87 Damaged overcrossing at Golden State Freeway and Foothill Freeway interchange

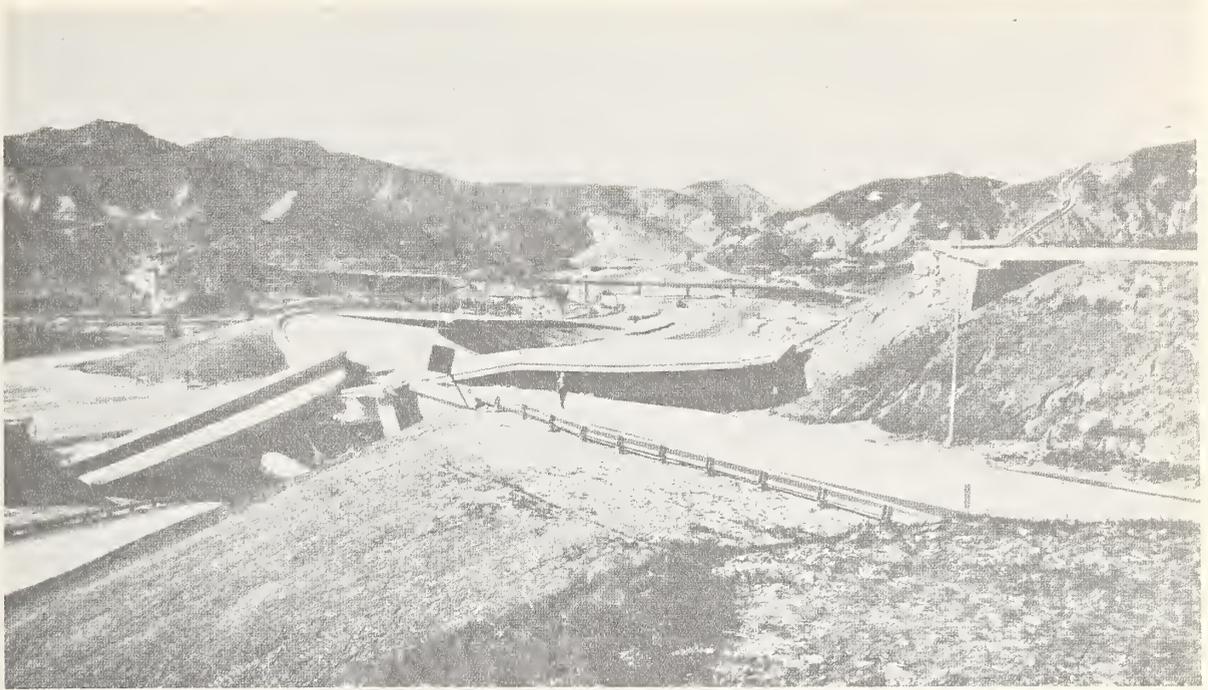
Photo. 2.88 Damaged overcrossing at Golden State Freeway and Foothill Freeway interchange

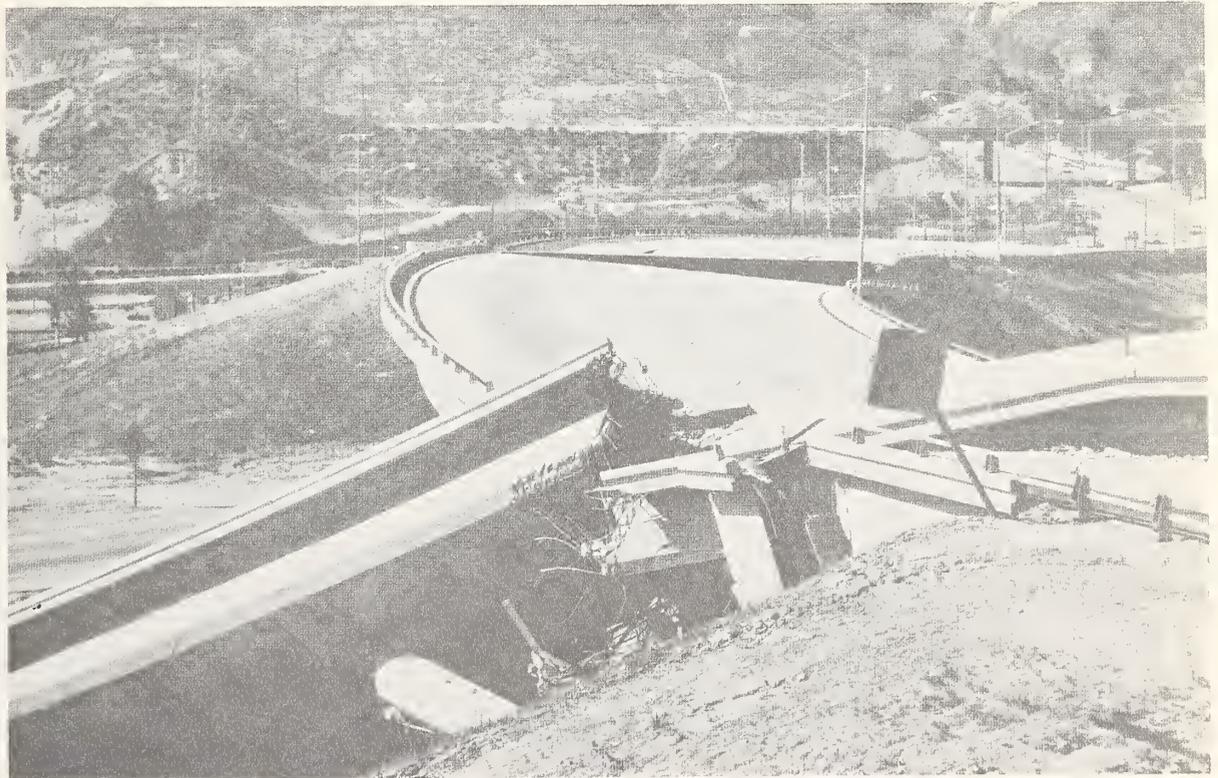
Photo. 2.89 Damaged overcrossing at Golden State Freeway and Foothill Freeway interchange

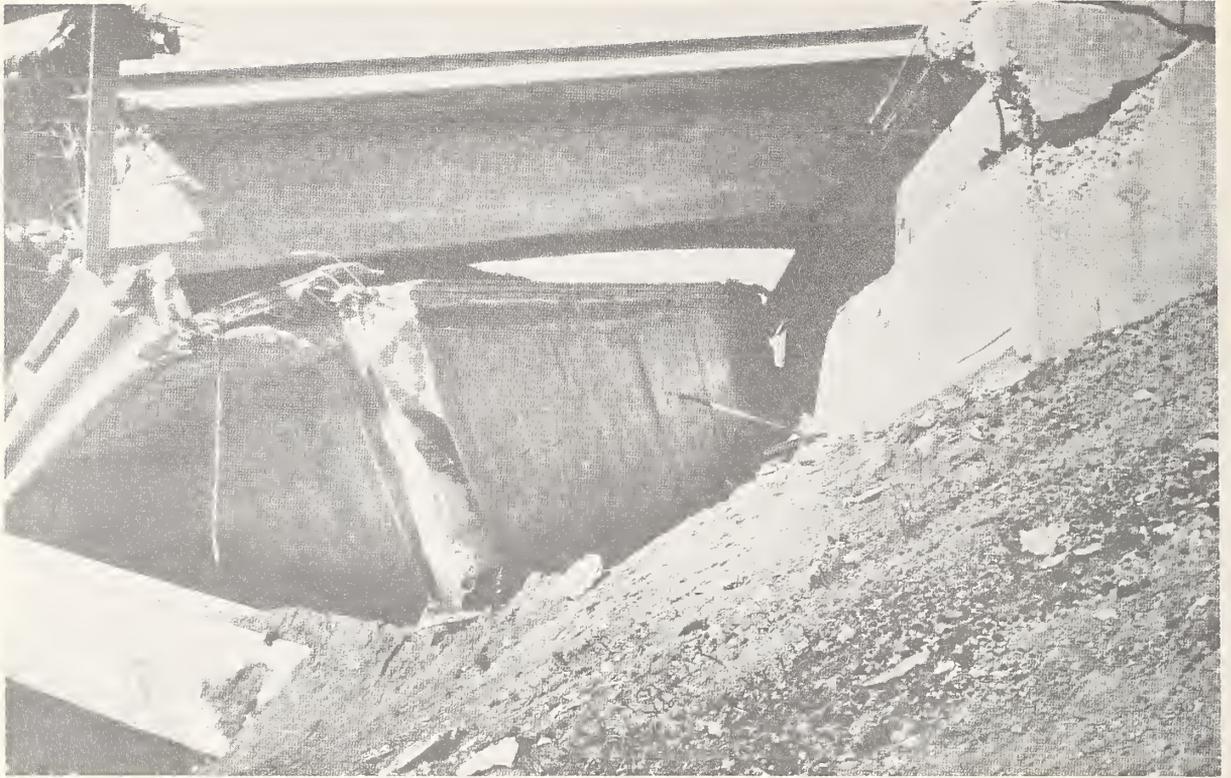
Photo. 2.90 Damaged overcrossing at Golden State Freeway and Foothill Freeway interchange

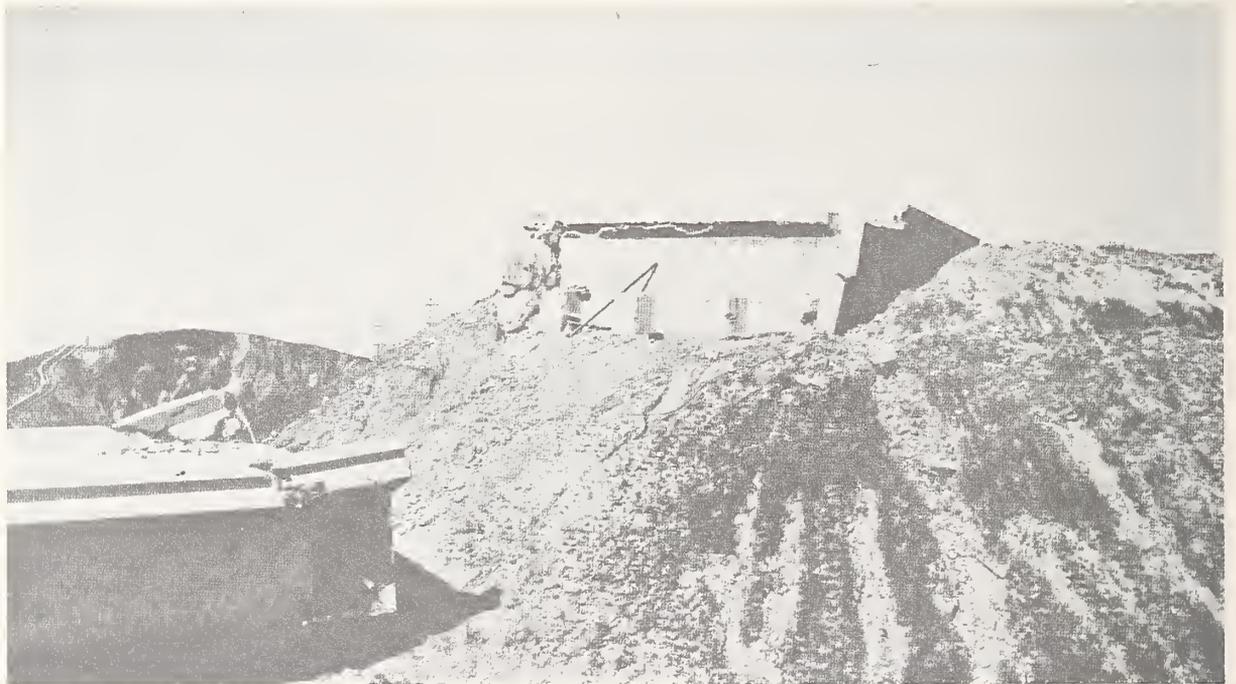
Photo. 2.91 Damaged overcrossing at Golden State Freeway and Foothill Freeway interchange

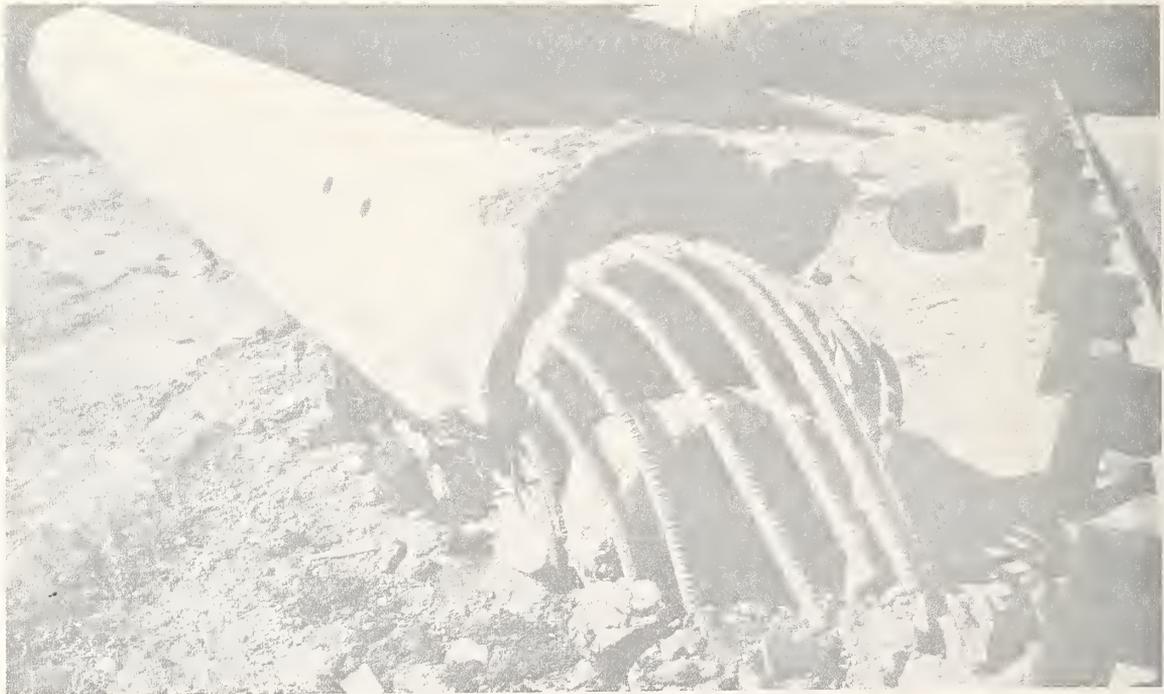
Photo. 2.95 Column of overcrossing at Golden State Freeway and Foothill Freeway interchange

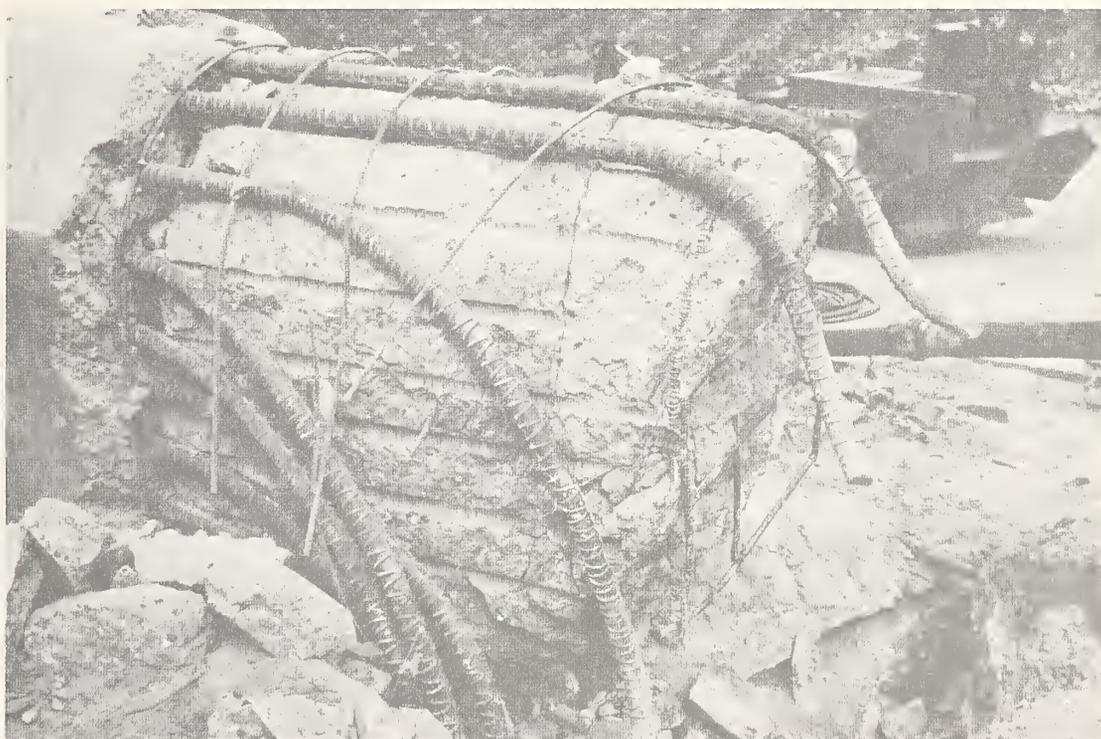
Photo. 2.97 Failure at base of column supported on a single 6 foot diameter cast-in-drilled-hole pile - Golden State Freeway and Foothill Freeway interchange

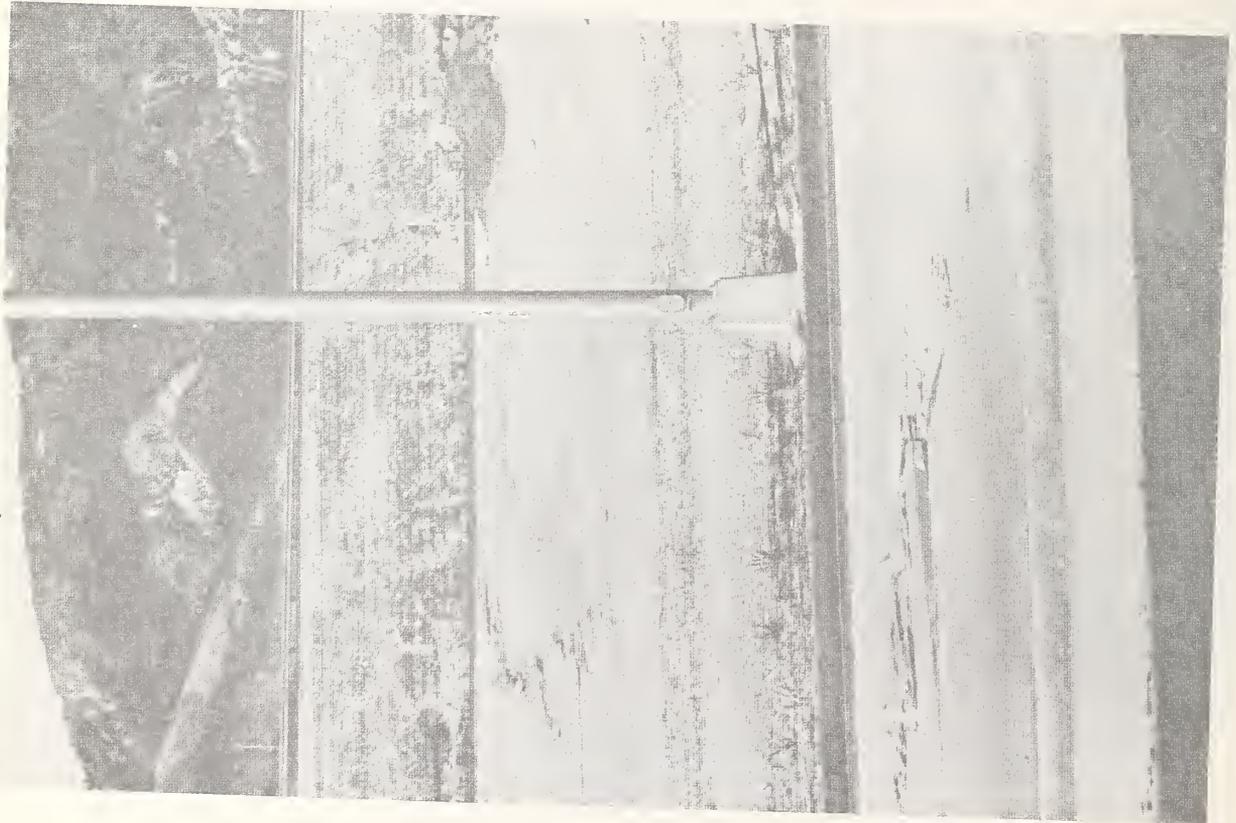
Photo. 2.100 Damaged railroad tracks near Golden State Freeway and Foothill Freeway interchange

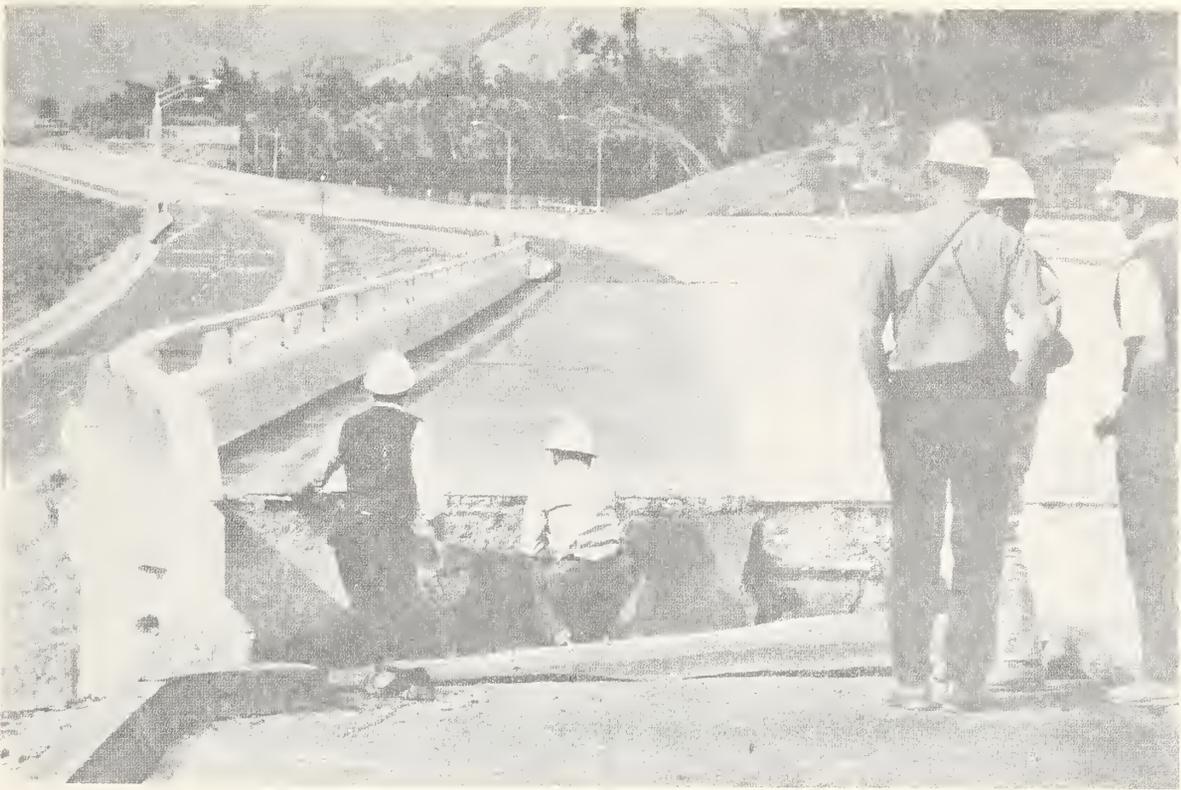
Photo. 2.119 Damaged concrete apron on
abutment slope - Roxford
Street Undercrossing at
Foothill Freeway

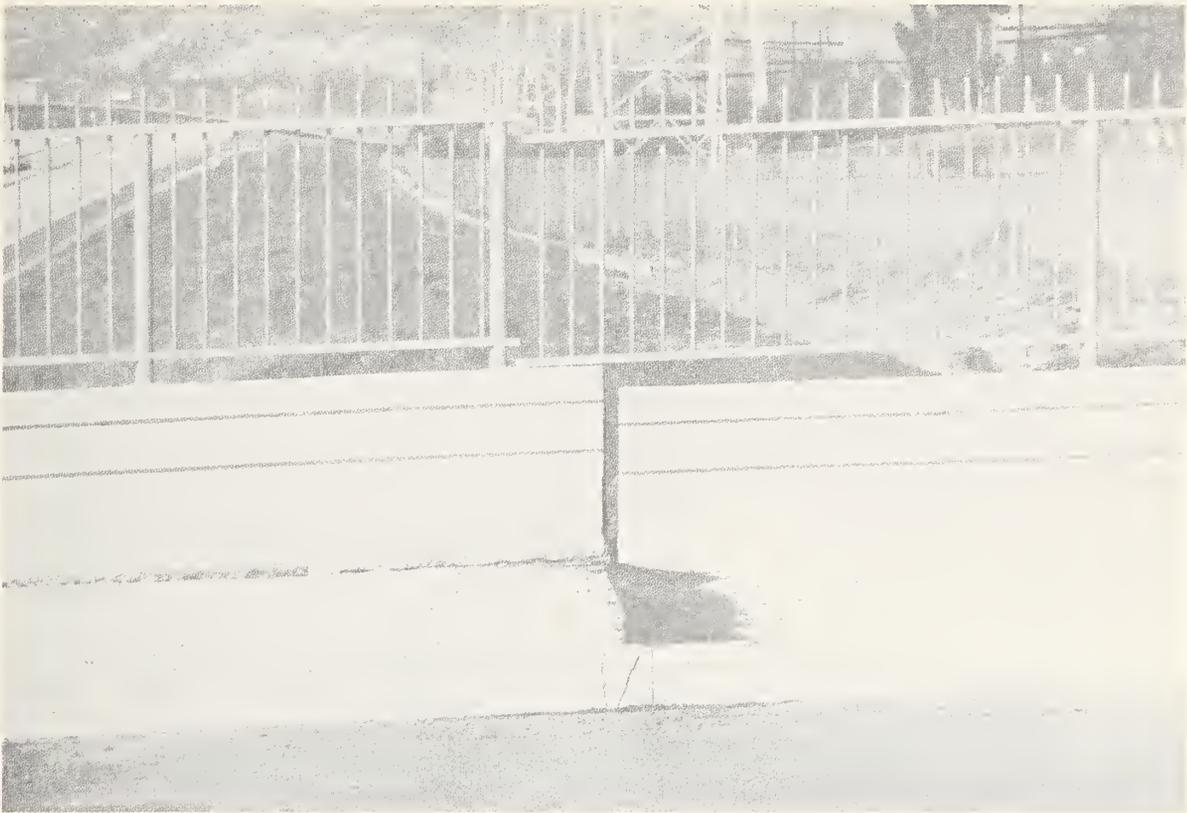
Photo. 2.128 Buckled asphalt pavement caused by large
compressive ground deformations

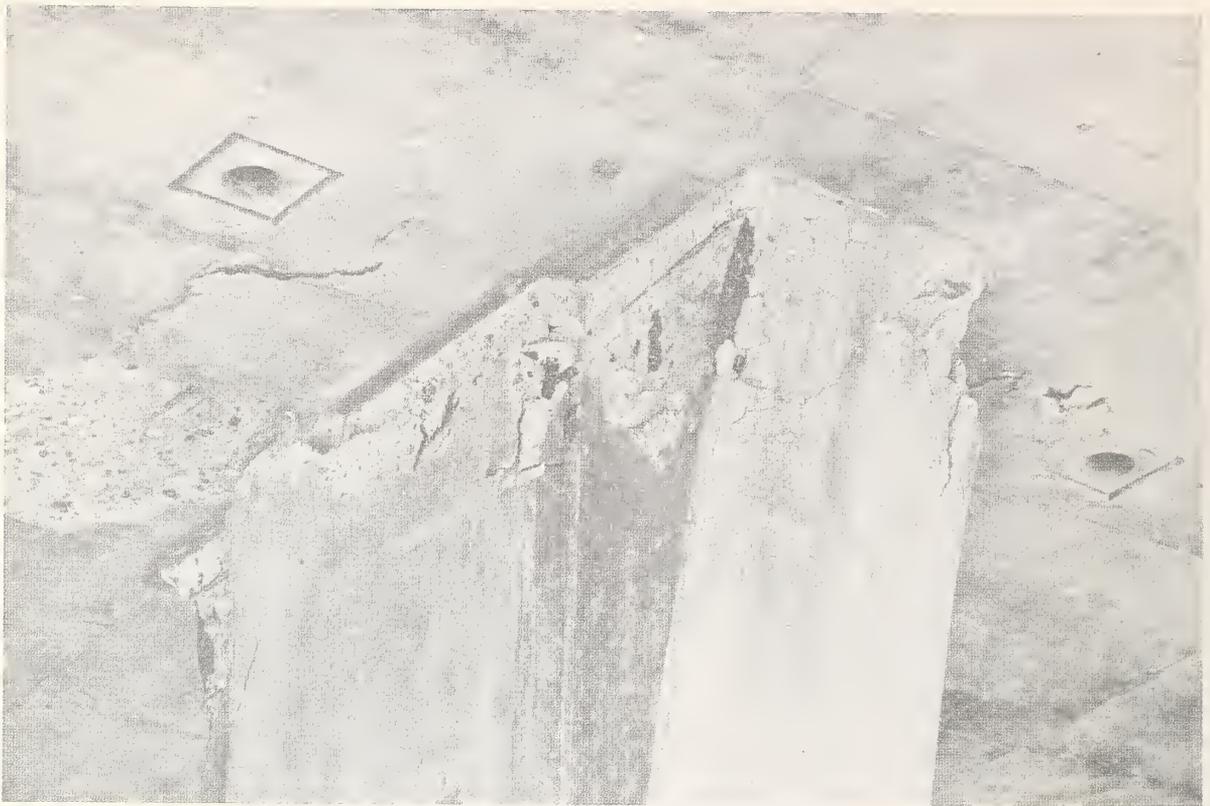
Photo. 2.138 Flexural damage at top of column - Tyler Street Pedestrian Overcrossing at Foothill Freeway

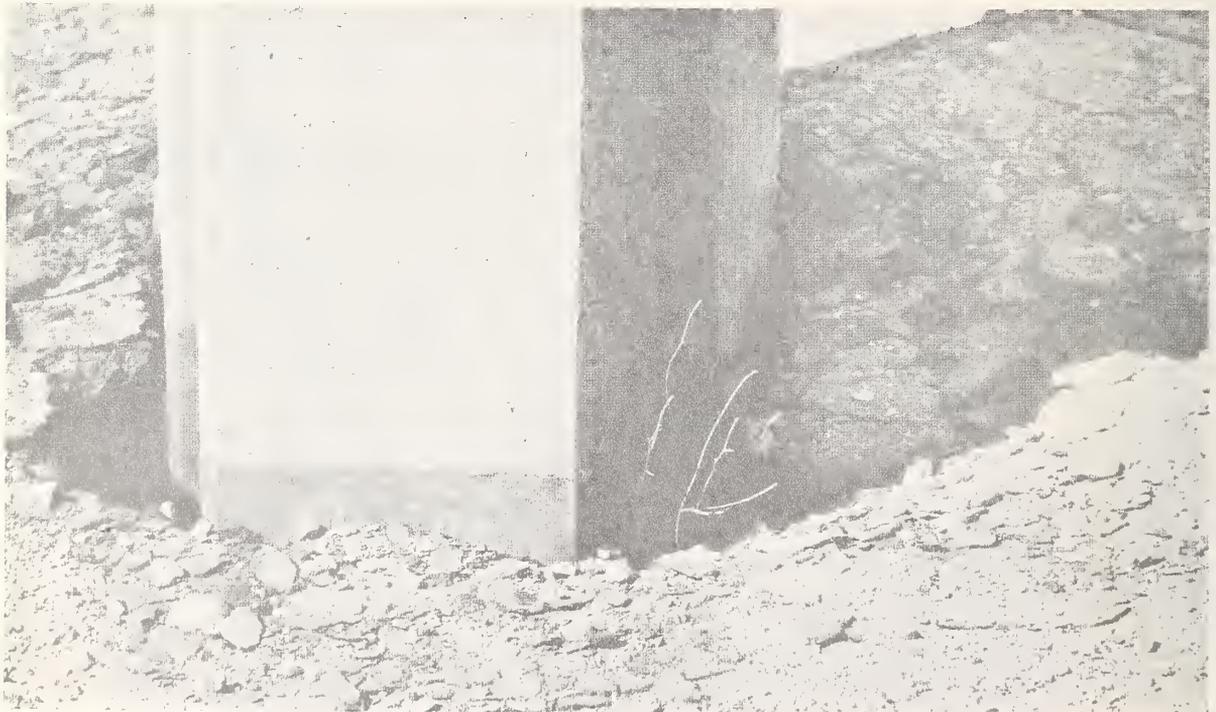
Photo. 2.139 Flexural damage at top of column - Tyler Street Pedestrian Overcrossing at Foothill Freeway

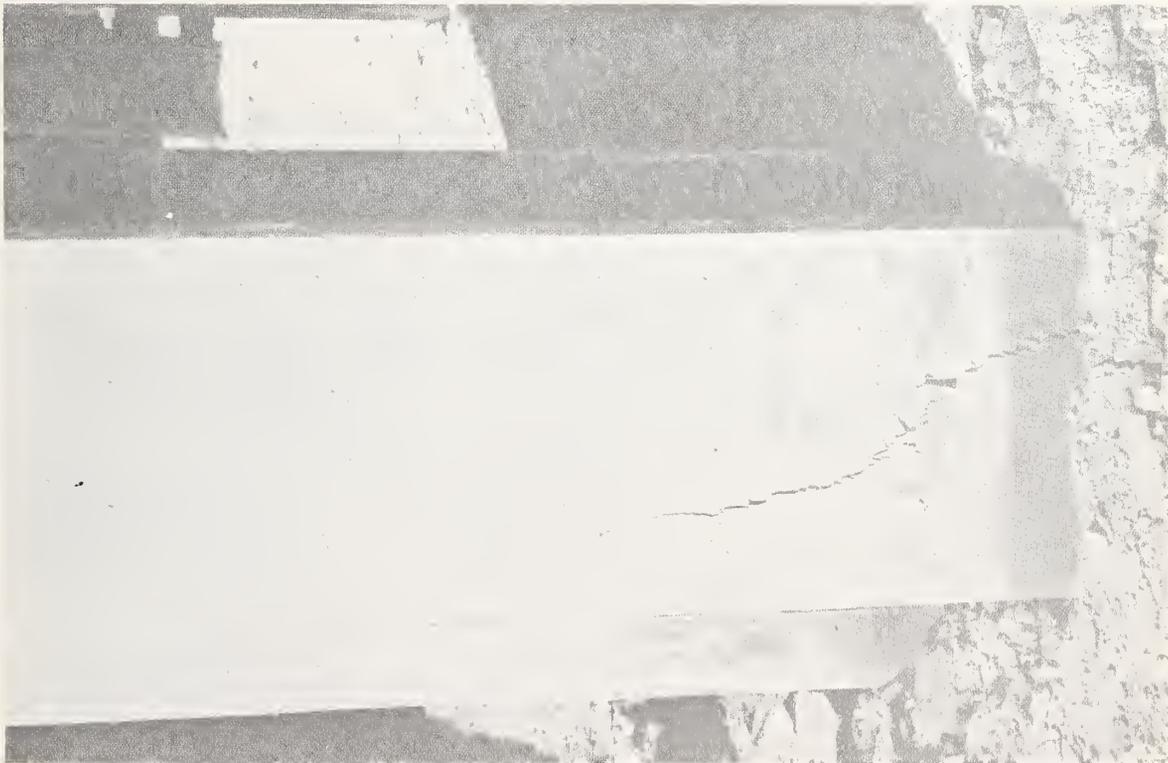
Photo. 2.142 Damaged wing wall of culvert
which passes under Foothill
Freeway
