THE NATIONAL PARTS RETURN PROGRAM

Volume III: PRP News and Program Inputs

1. Report No. DOT HS 805 146		2. Government Accession No.		3. Recipient's Catalog No.	
4. Title and Subtitle NATIONAL PARTS RETURN PROGRAM FINAL REPORT VOLUME 3 PRP NEWS AND PROGRAM INPUTS				5. Report Date 1 July 1979

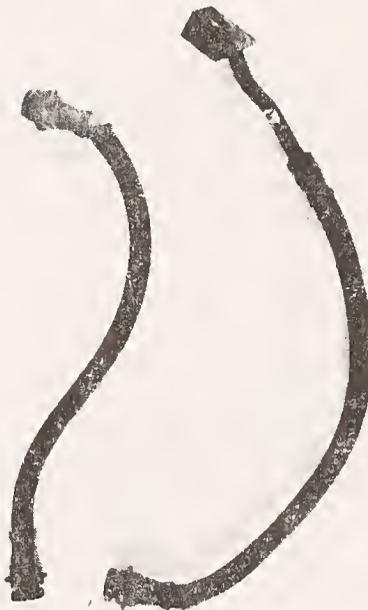
PLYMOUTH/DODGE BRAKE HOSE CRACKS

Based upon a large number of parts received from PRP members, the NHTSA has recently opened an engineering analysis into brake hoses on Chrysler Corporation vehicles. The analysis involves brake hoses from 1973 and 1974 Plymouth Valiants and Dodge Darts. The hoses allegedly develop cracks and splits near the fitting.

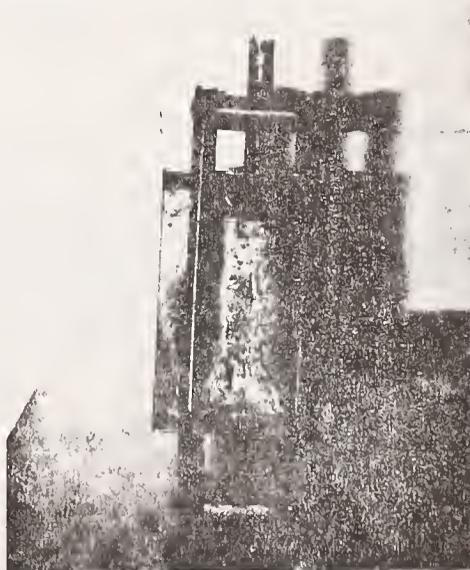
Photograph of failed Hein Werner scissors jack submitted by RIVERSIDE AUTO PARTS.

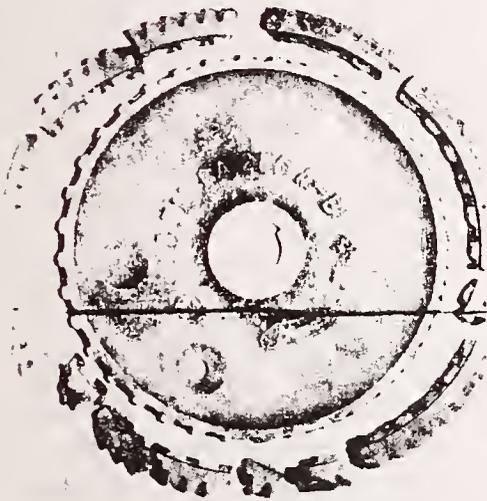
The broken camshaft gear from a 1977 Ford Pinto was submitted to the PRP from **Maddox Auto Service** in Atlanta, Georgia. The gear consists of a metal body with hard plastic teeth bonded to it. As seen in the photo, the teeth broke free of the metal disc. The vehicle was in motion at the time of failure and required towing for repairs. The mileage at the time of failure was 45,000.

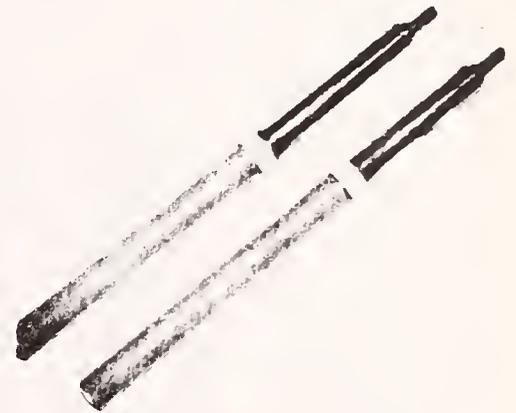
Tony Valinoti of **Las Vegas Wheel Alignment and Brake Service** submitted to the PRP a pair of McPherson Strut cartridges from the front suspension of a 1975 VW Super Beetle Convertible with 16,662 miles. Both cartridges would not collapse causing a very stiff ride and could reportedly result in handling difficulties and excessive strain on front suspension components.
