JRC2016-5811

**REDUCING THE HARM IN RAIL CRASHES:
ANALYSIS OF INJURY MECHANISMS AND MITIGATION STRATEGIES**

Bruce Wilson
David Tyrell
Volpe National Transportation Systems Center
United States Department of Transportation
Cambridge, Massachusetts, USA

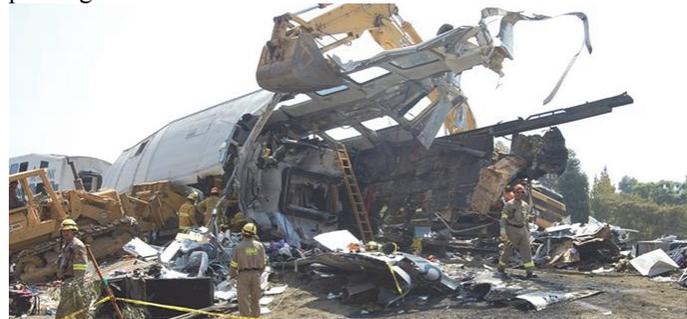
A locomotive-led commuter train and locomotive-led freight train collided head-on in the Chatsworth district of Los Angeles, California, with each train initially travelling at more than 40 mph [38]. Twenty-four passengers and one crew member were killed on the passenger train, and approximately 138 train occupants were injured, many severely. The operator of the locomotive and twenty-two passengers were fatally injured due to loss of survival space. During the accident, the front of the passenger locomotive was crushed such that the operator’s cab was pushed back over the heavy equipment inside the locomotive, eliminating the survival space for the operator. Nearly simultaneously, the first passenger car broke into two pieces at the lead end gooseneck, and the leading portion telescoped into the trailing portion, eliminating the survival space for twenty-two passengers. Two passengers in the telescoped portion are known to have survived. Two passengers inside the trailing passenger cars suffered fatal injuries by being thrown into the lower stepwells and sustaining severe head trauma. Figure A1 is a post-accident photograph of the first passenger car.

Figure A1. Post-collision Photographs of First Trailer Car, Passenger-to-Freight Train Collision, Chatsworth, CA

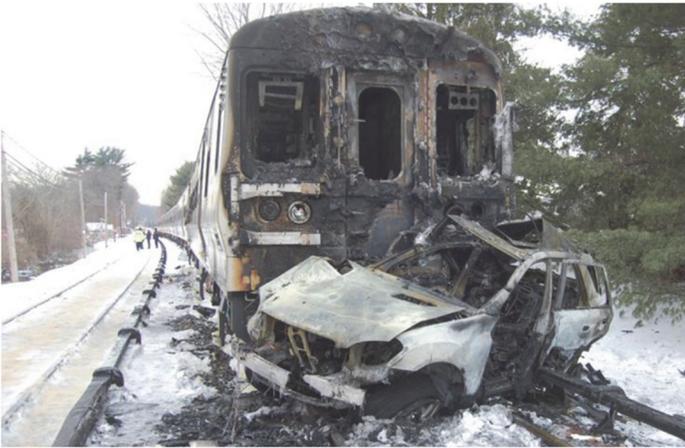
Figure A2. Photograph of Colliding Cab Car and SUV, Valhalla, New York, February 13, 2015.

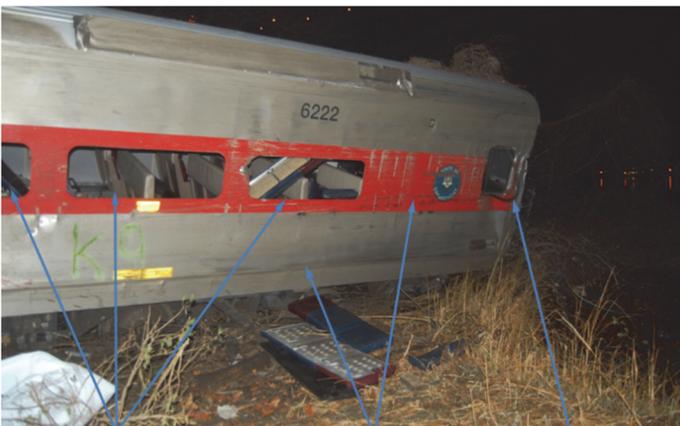
On December 1, 2013, a Metro-North commuter train derailed just north of Spuyten Duyvil station in The Bronx [29]. Inbound train #8808 consisted of a cab car, 6 trailer cars, and a locomotive. The train was in push-mode, approaching a 30 mph curve at 82 mph, when it derailed. Four passengers died at the scene of the accident. The seven passenger cars and the locomotive all derailed during the accident. The leading four cars appeared to roll to the right further than others. Many windows on the right side of the train were broken, displaced, and/or missing after the derailment and subsequent rollover. Significant amounts of dirt and ballast had accumulated in several of the cars. It appears that three fatally injured passengers were ejected from the train via window openings during the derailment. The bodies were located outside or under the train when first responders arrived. There is some uncertainty about where the fourth fatally injured passenger came to rest after the accident; the body had been moved before the coroner arrived on the scene. All train occupants that were contained within the cars survived the derailment. Figure A3 shows the right side of the leading cab car as it came to rest after the accident, with several windows dislodged.

Dislodged Windows Ballast Scrapes Partially Dislodged Gasket

Figure A3. Photograph of Leading Cab Car, Spuyten Duyvil, New York, December 1, 2015.
