## **Final Report**

Concrete Pipe – Electrochemical Cell, Phase II  
BDV27-977-03

Submitted to  
Florida Department of Transportation Research Center  
605 Suwannee Street  
Tallahassee, Florida 32399

August 2016

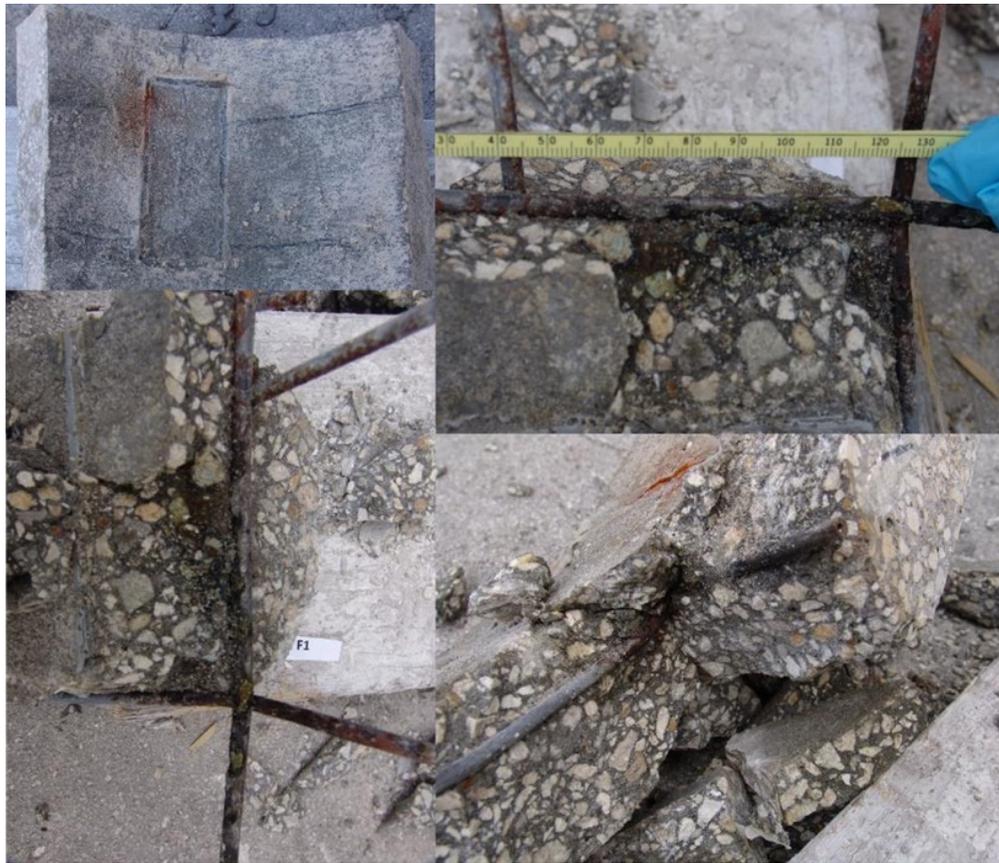
The initial high chloride concentration in the reservoir during chloride migration might explain the significant extent of corrosion observed on the steel wire mesh exposed from F1 specimen, combined with the exposure history of this specimen (See Table 3). Figure 79 shows picture of the several steps followed to obtain the steel wire mesh. The images with exposed steel show significant amount of corrosion under the solution reservoir. The color of the corrosion products were dark green and penetrated the concrete several mm. Figure 80 was taken a few days later and by then the corrosion products have turned to dark brown rust in some areas.

Figure 79 – Removal of concrete on specimen F1.

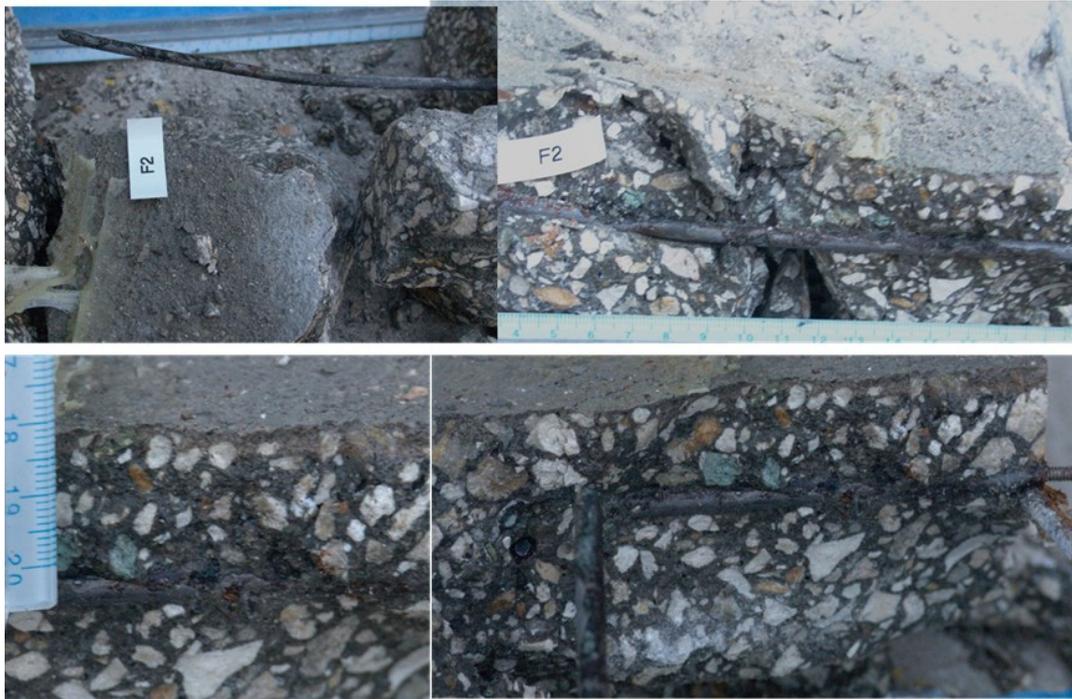
Specimen F2 was exposed in a high humidity chamber for an extended period of time. Figure 81 shows the corrosion extent that took place at several locations of the steel wire mesh. On this specimen, significant corrosion took place on the steel underneath the solution reservoir. The corrosion products upon removing the concrete were black to dark green. The corrosion products penetrated close to 10 mm at multiple locations.

Figure 81 – Removal of concrete on specimen F2.

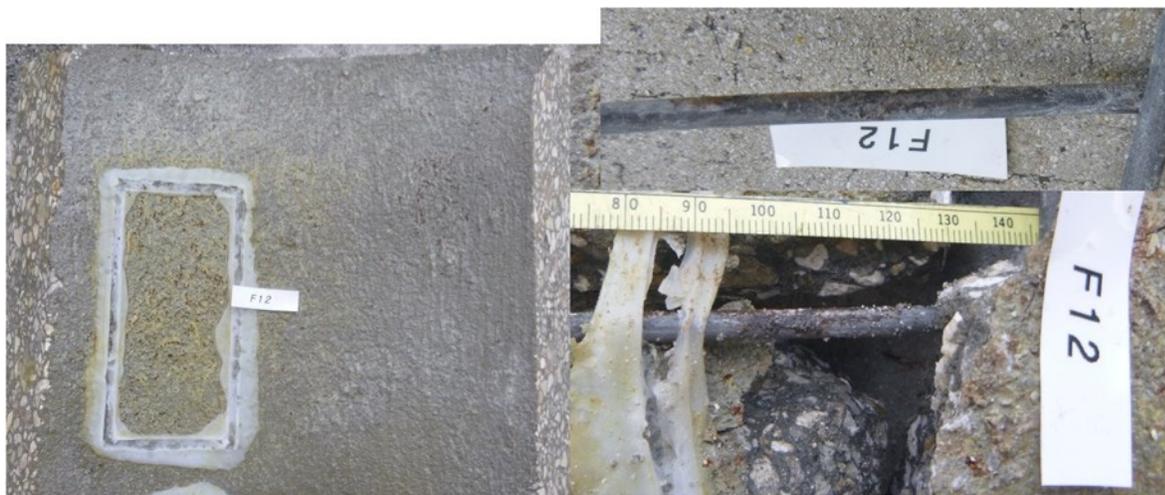
Figure 87 shows pictures taken on Specimen F12. The picture on the left shows that there were several red corrosion spots on the concrete surface within the area occupied by the solution reservoir. Upon removing the concrete (see pictures on the right) a modest amount of corrosion was observed. Corrosion took place on the steel wire underneath the reservoir.

Figure 87 – Steel wire removed from specimen F12.

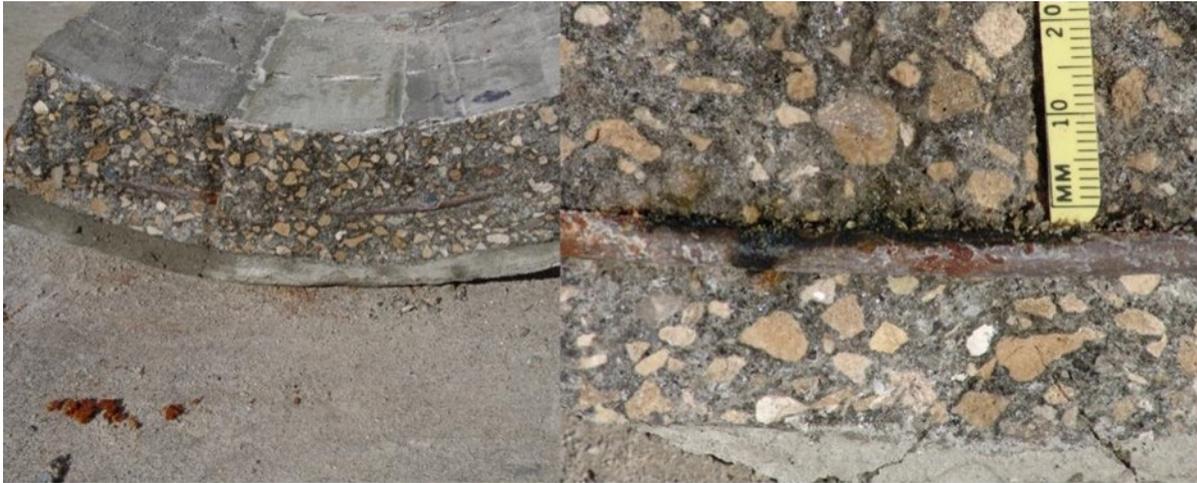
wire obtained after removing the concrete on specimen C1. It is evident that significant corrosion took place at two of the transverse (circumferential) steel wires.

Figure 93 – Specimen C1 while removing concrete.

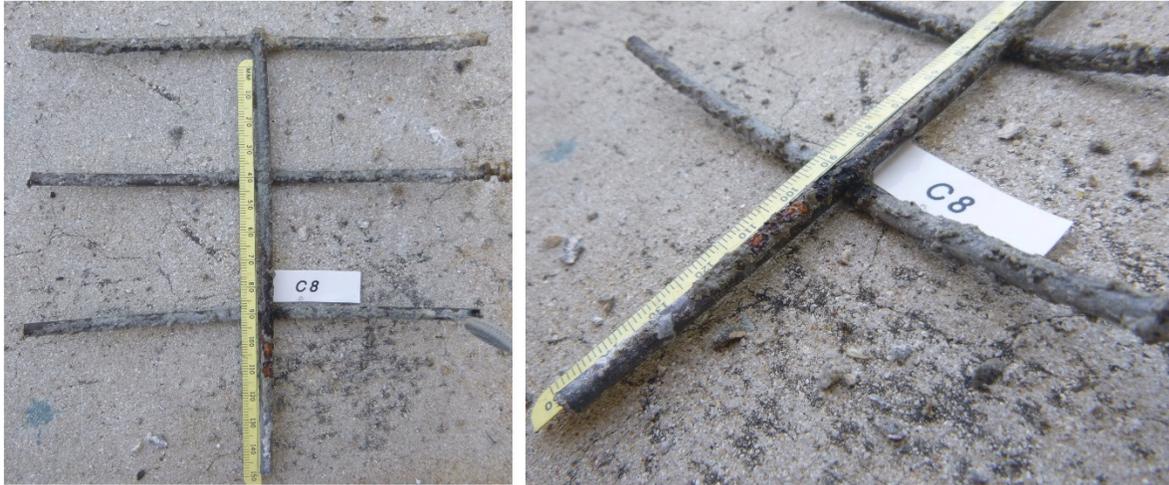
Figure 101 – Steel wire after removing concrete for specimen C8.

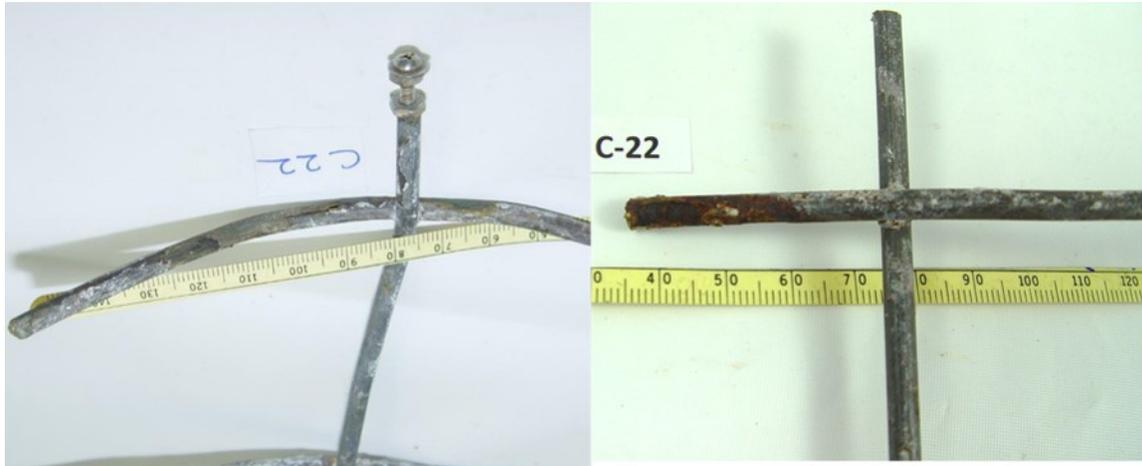
Figure 103 – Steel wire areas showing the most corrosion (specimen C22).

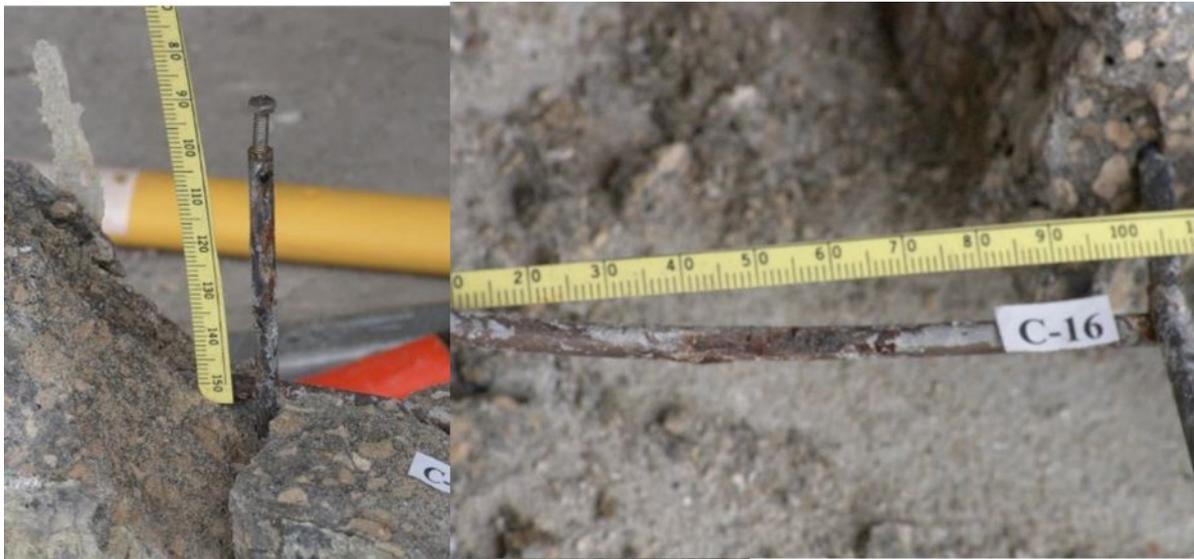
Figure 105 – Corrosion extent on steel while removing concrete specimen C16.

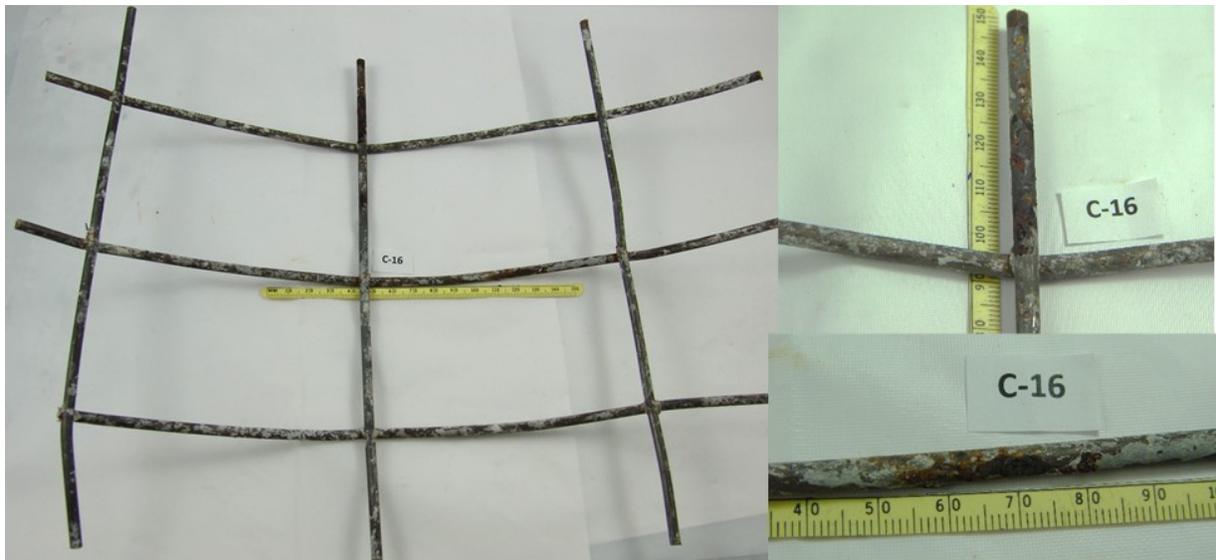
Figure 106 – Steel wire removed from specimen C16.

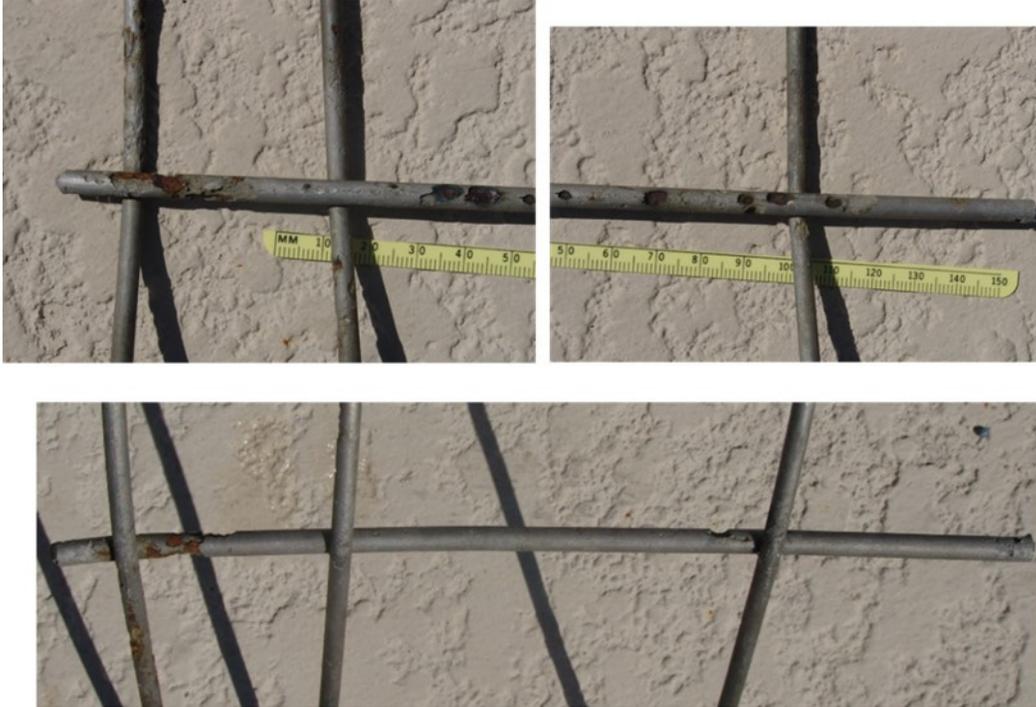
Figure 129 – Close-up of corroding sites for specimen F0 (along the ponding reinforcement), top and back side.

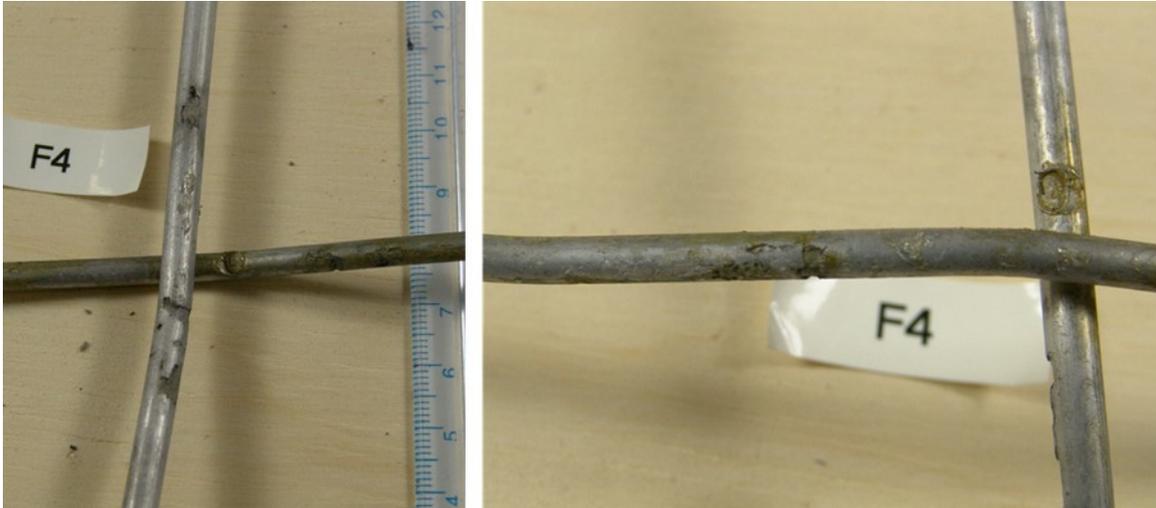
Figure 133 – Steel wire mesh after cleaning for specimen F4.

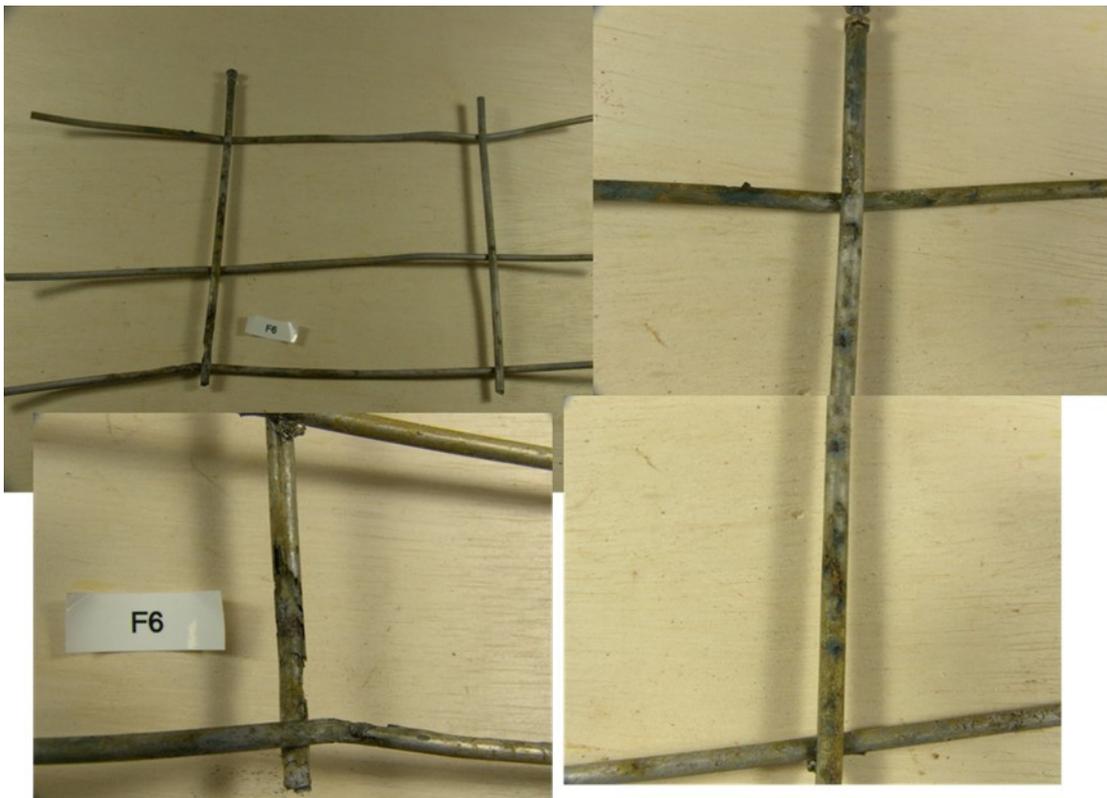
Figure 134 – Steel wire mesh for specimen F6 after cleaning.

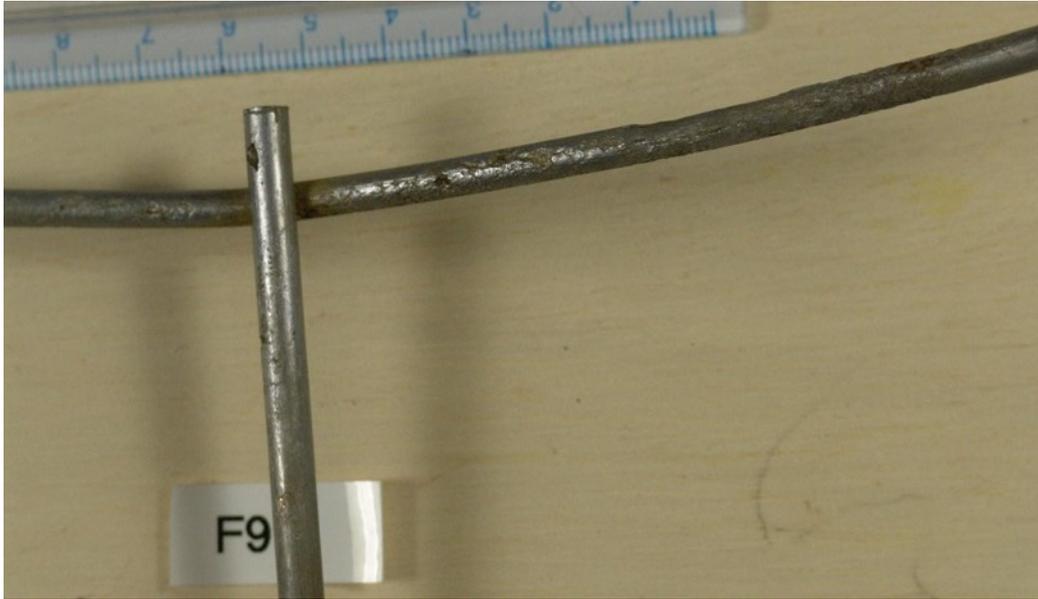
Figure 135 – Steel wire mesh of specimen F9 after cleaning.

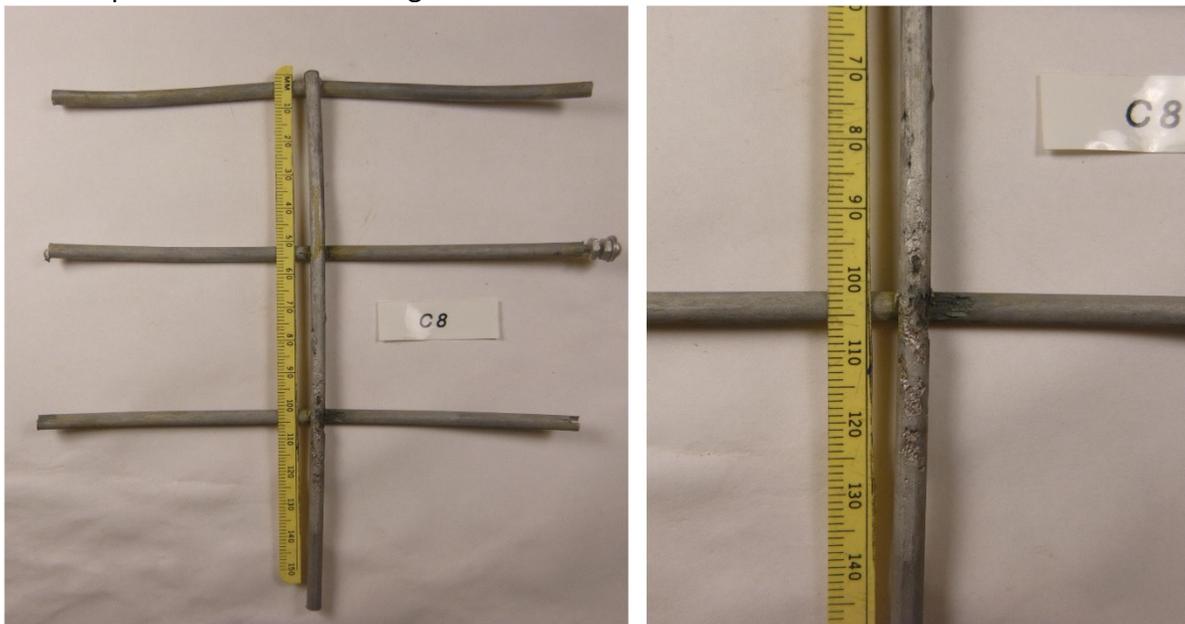
Figure 142 – Steel wire mesh after cleaning for specimen C8.

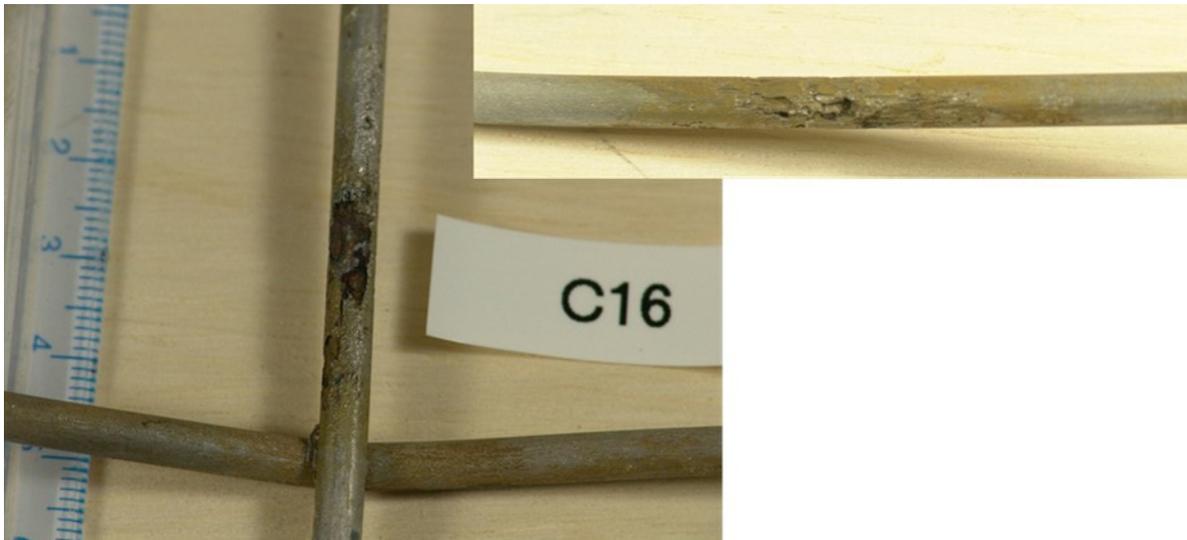
Figure 144 – Close-up after cleaning steel wire of specimen C16.

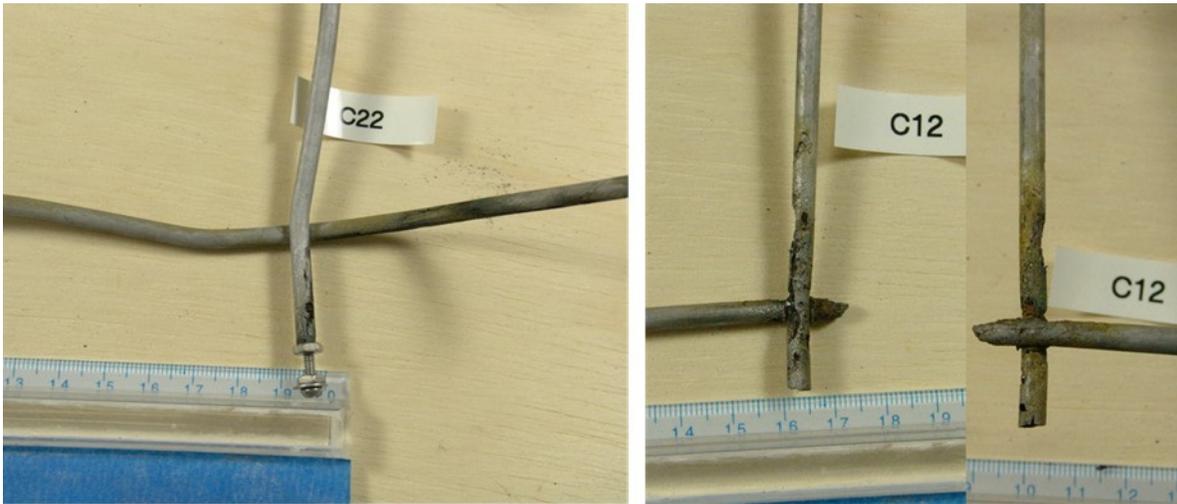
direction. The steel wire for specimen C12 showed corrosion on both sides of the wire (the two pictures on the right show front and back surface).

Figure 145 – Steel wires after cleaning for specimen C22 and specimen C12.

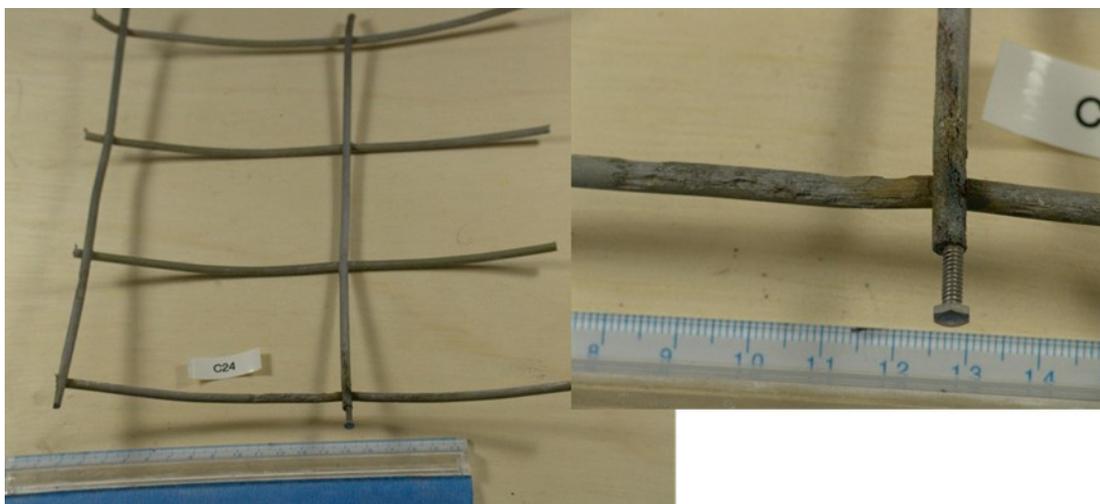
Figure 146 – Close-up after cleaning steel wire for specimen C24.

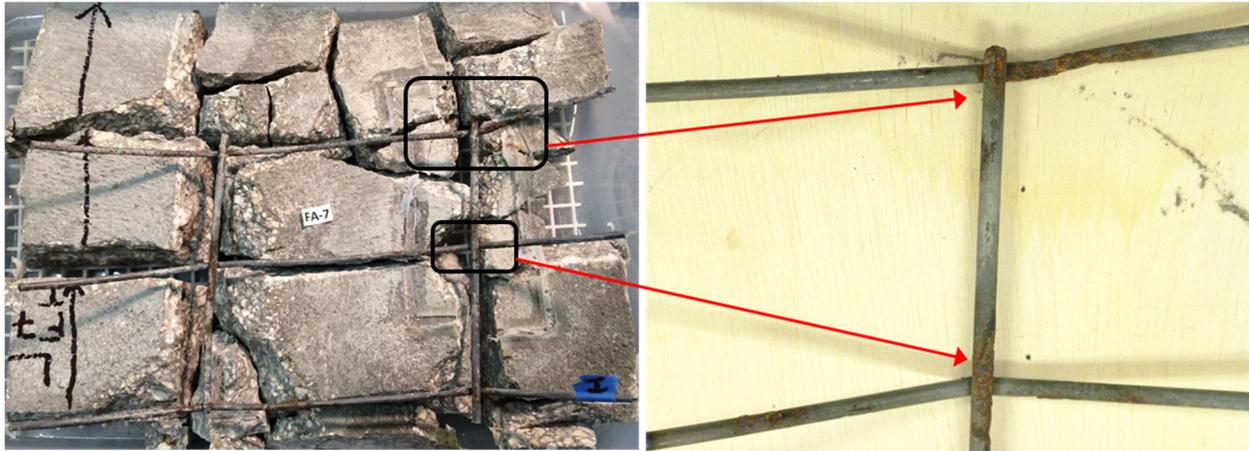
Figure 147 – Specimen F7: Left: shortly after opening. Right: locations under the ponding.

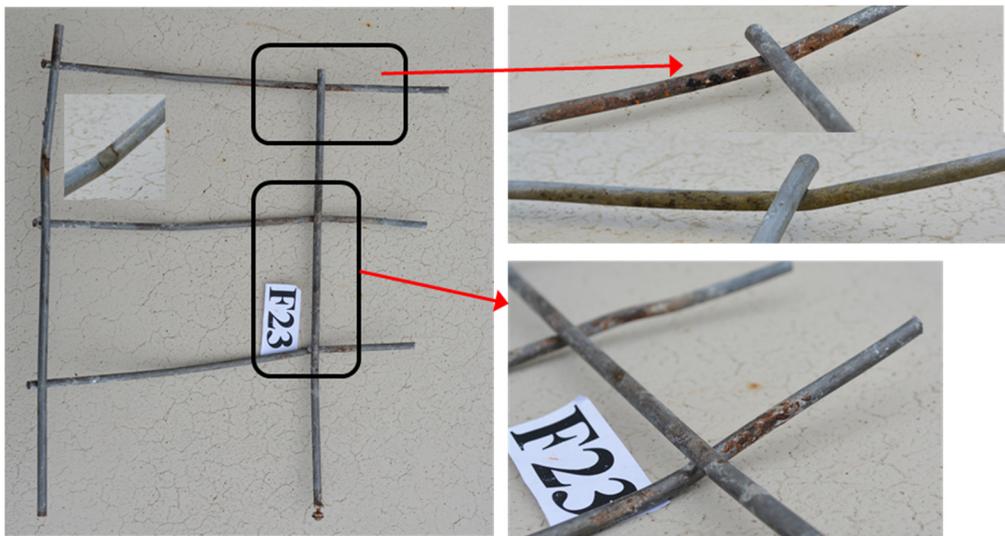
Figure 150 – Autopsy result of specimen F23. Left: all steel wire. Right: corroding sites.

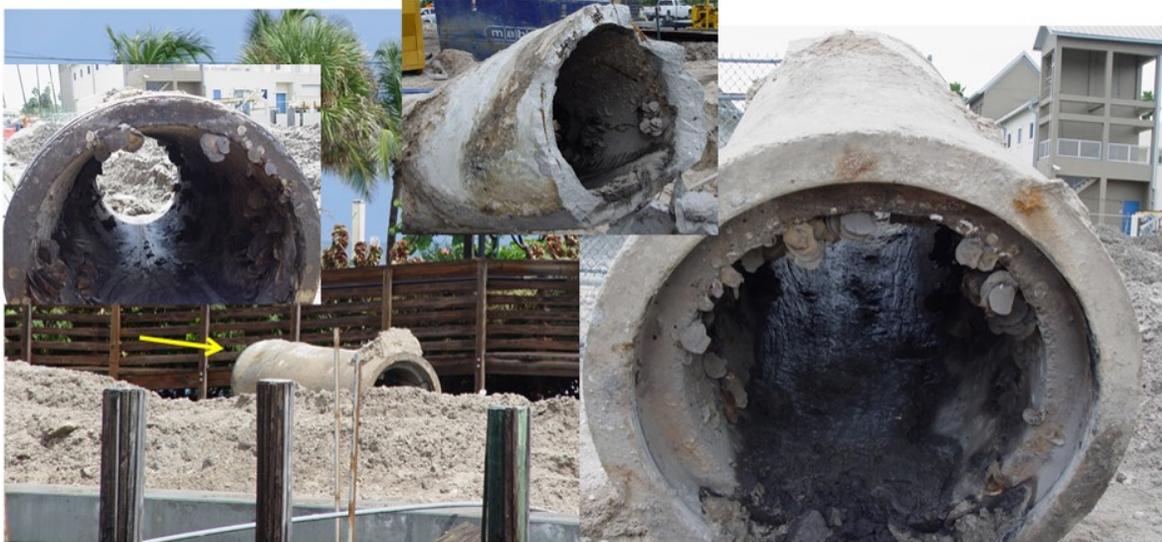
Figure 153 – Two of the pipes removed at Dania Beach Marina.

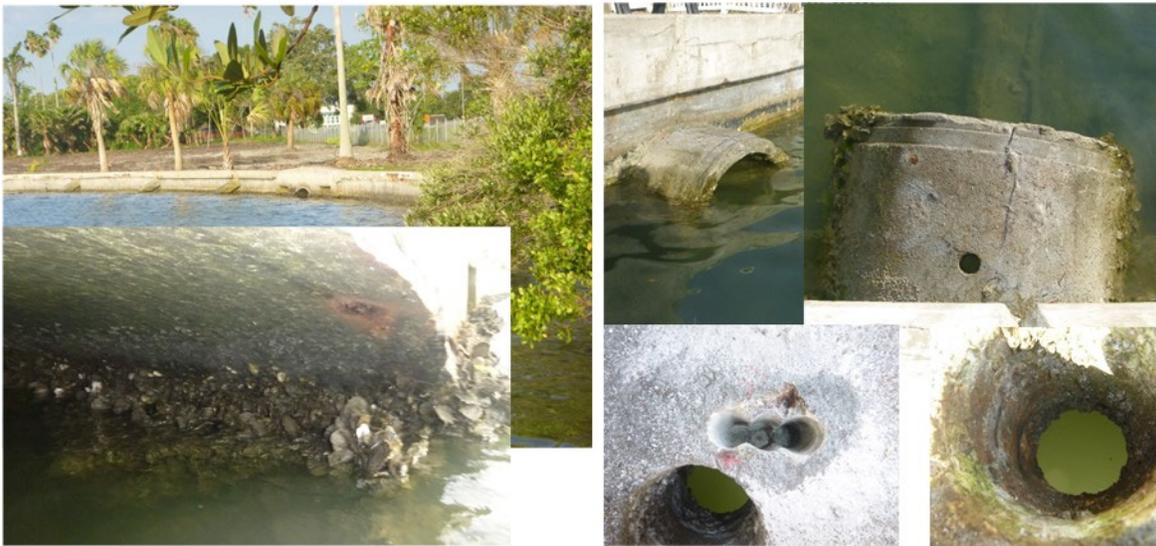
Figure 167 – Pictures of pipes found in Madeira Beach, FL (Left – SR-666, right –127<sup>th</sup> Ave).

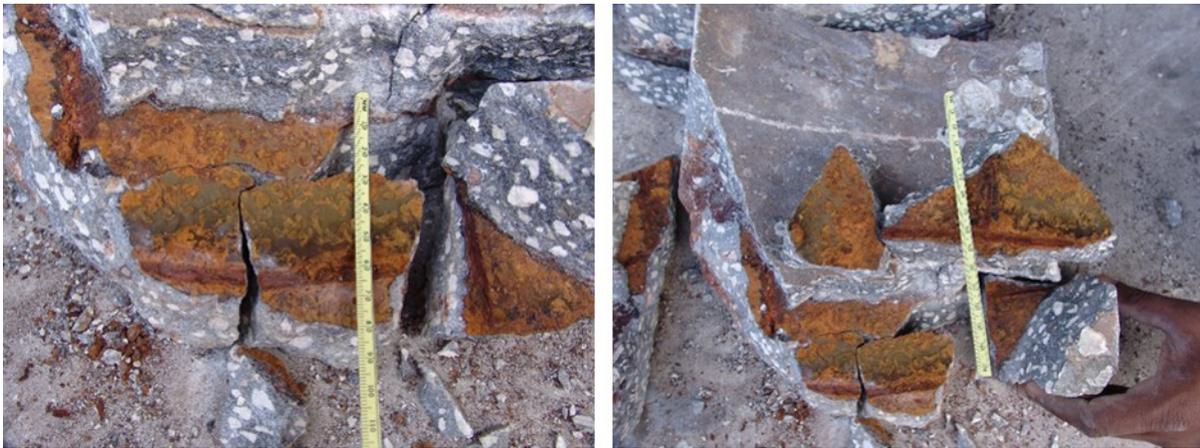
Figure 181 – Section with no solid steel wire

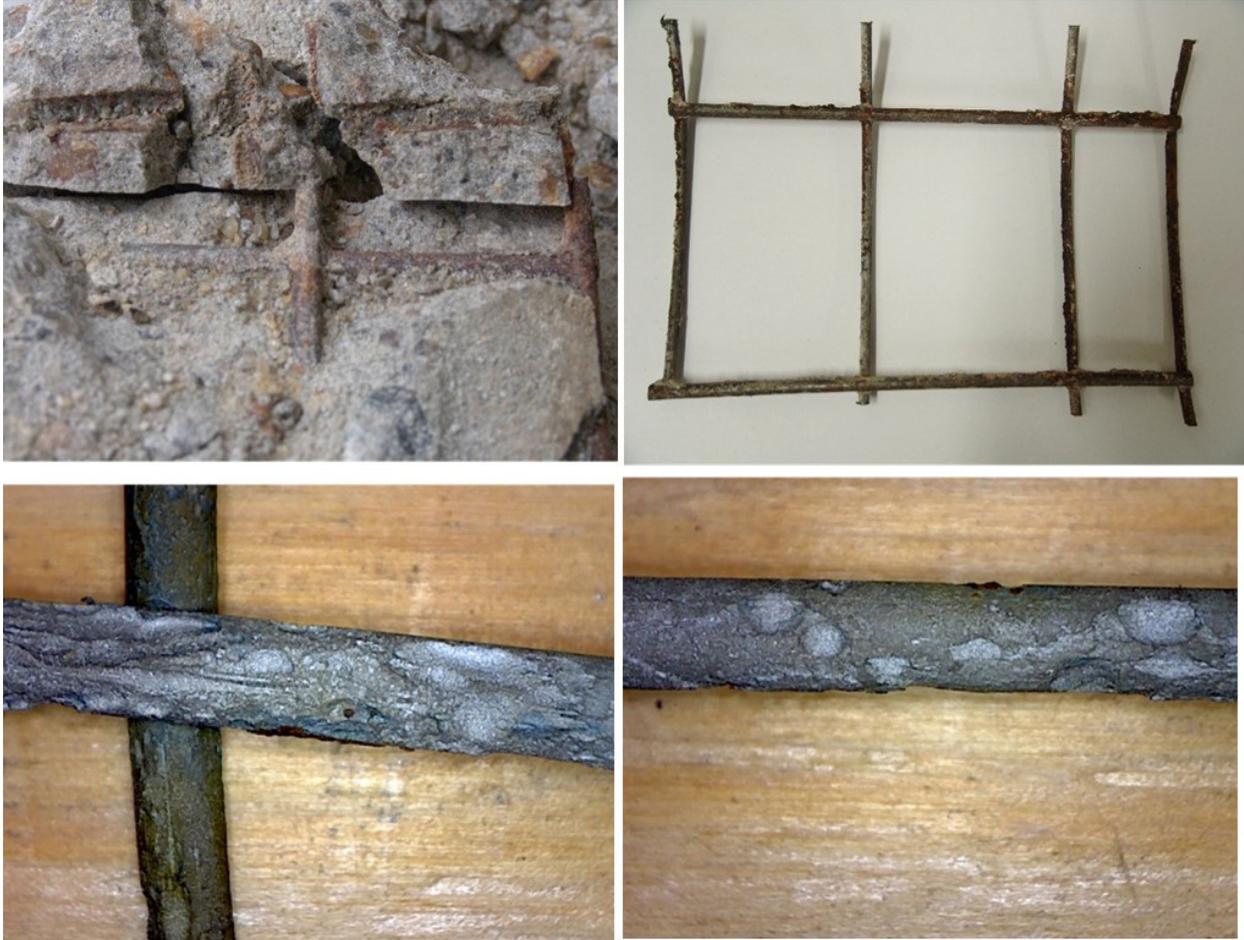
Figure 185 – Corrosion extent observed on the wire mesh from segment obtained at Tallahassee site.

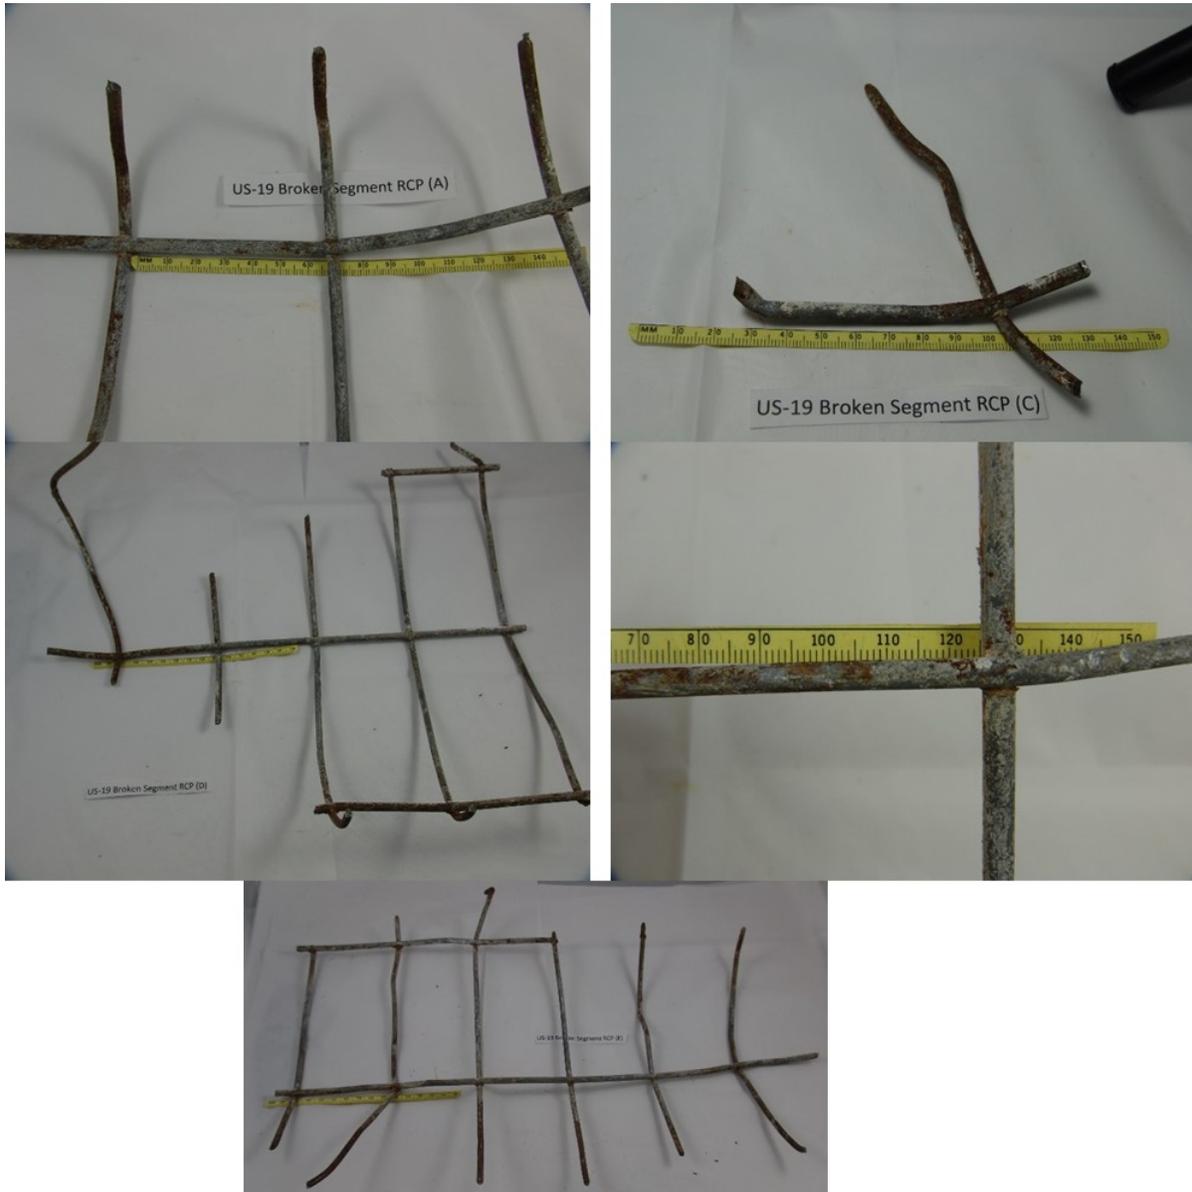
Figure 186 – Wire mesh after removing concrete on several segments.

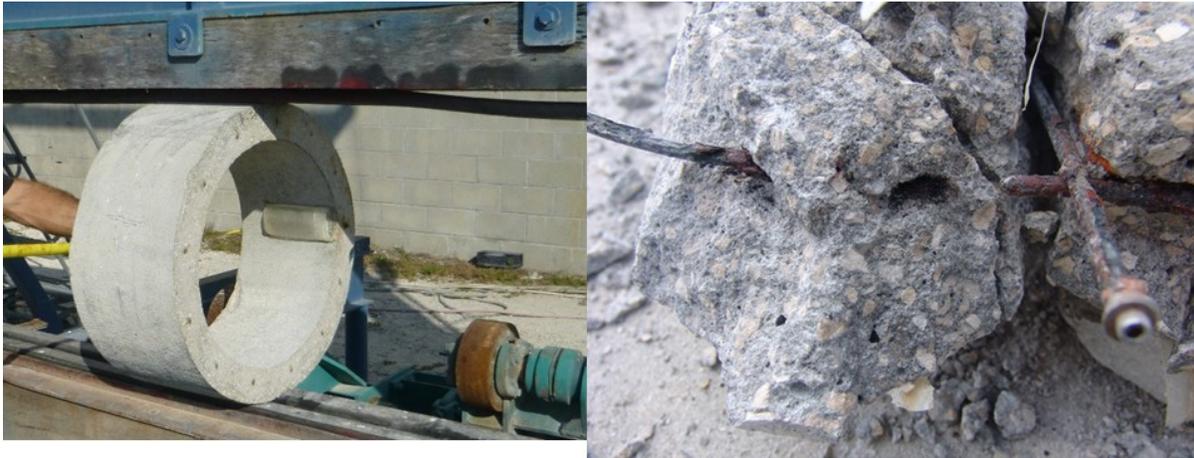
Figure 188 – CHH specimen prior to 3EB load test and on the right after starting to remove the concrete.

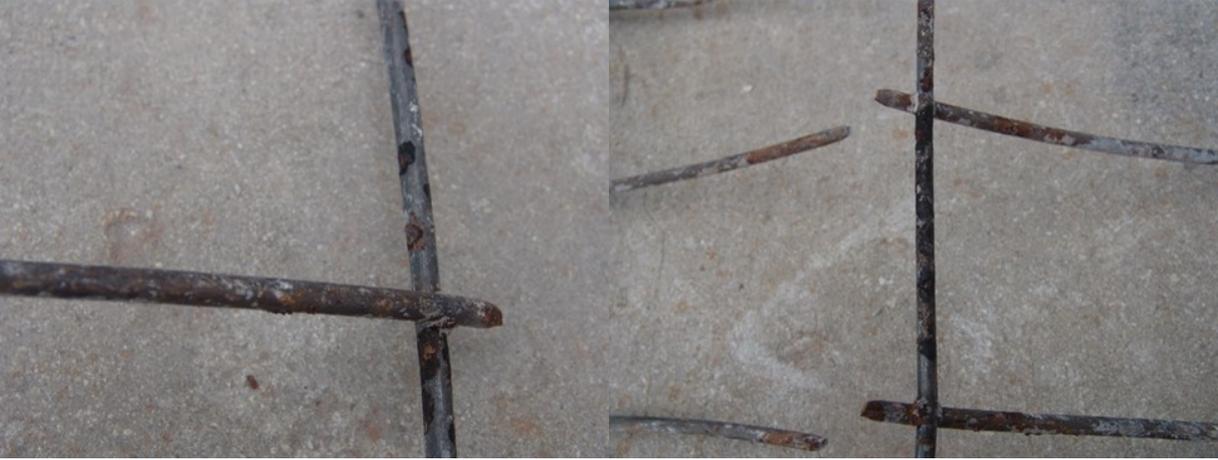
Figure 191 – Close-ups of sites showing corrosion for steel wire from CI2 specimen.

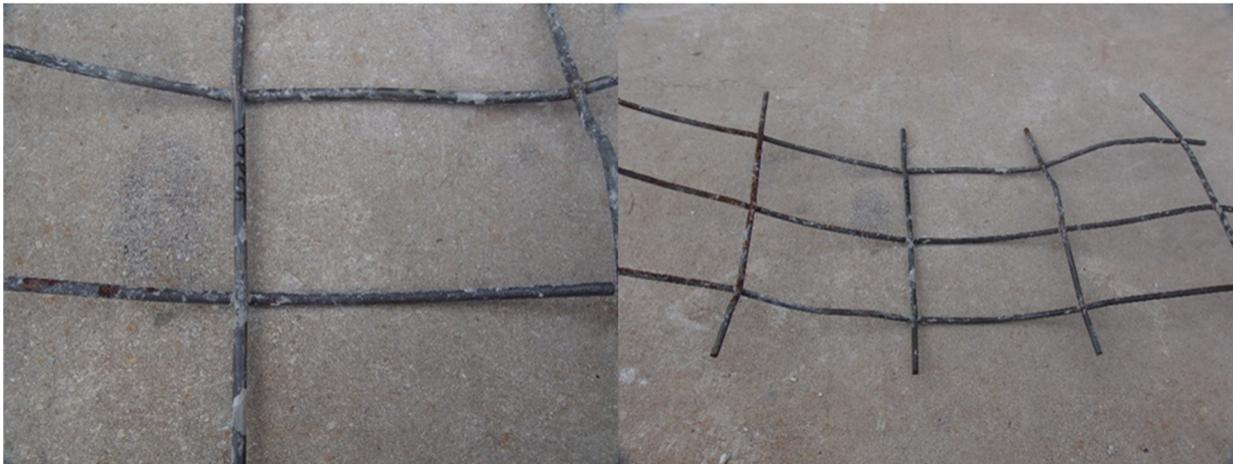
Figure 192 – Steel wire mesh after removing concrete on a segment for CS2 specimen.

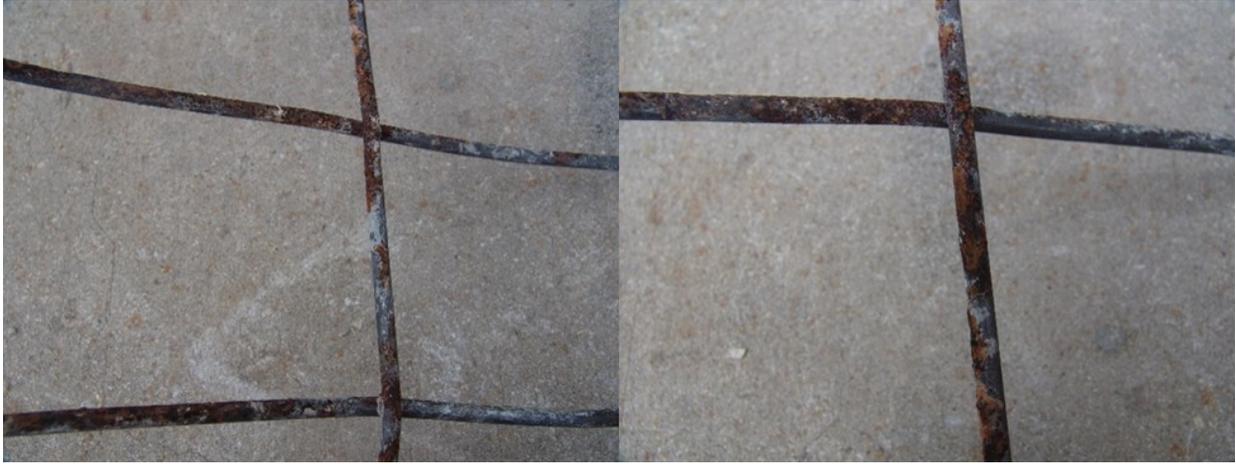
Figure 193 – Close-ups pics for sites showing corrosion of the steel wire from CS2 specimen.

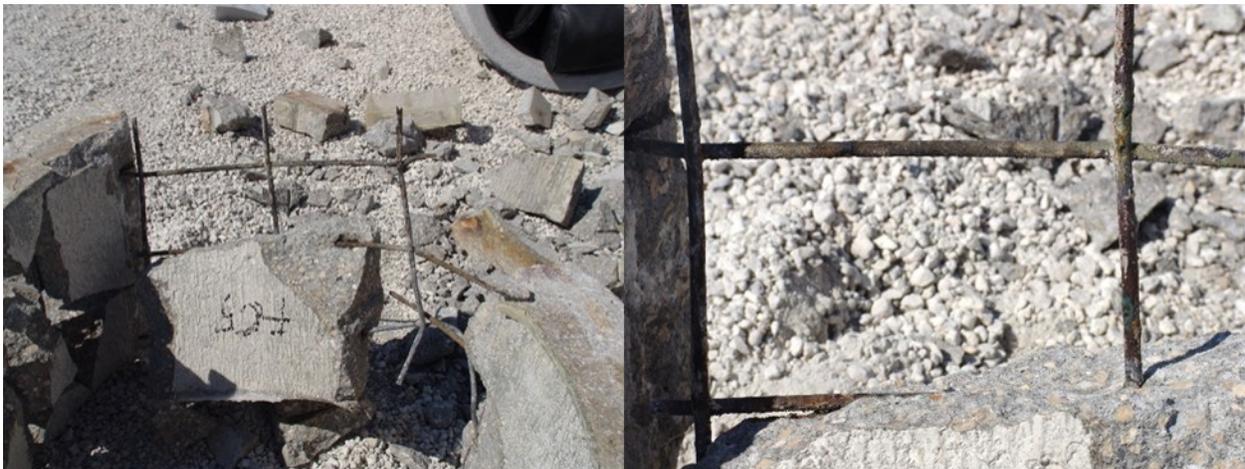
Figure 194 – Steel wire while removing the concrete on segment 1 of FI1 specimen.

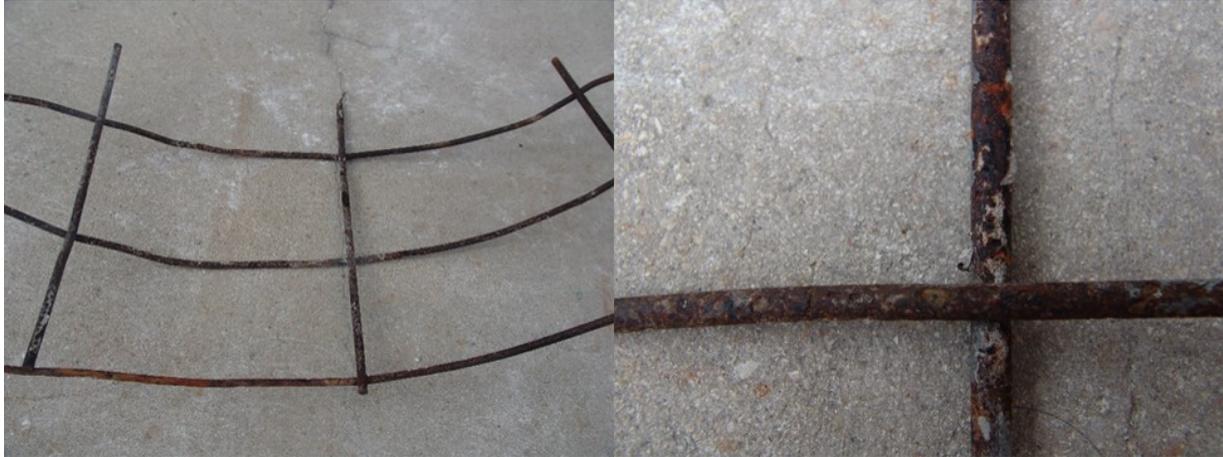
Figure 197 – Steel wire upon removing the concrete on a segment (Specimen FS3).

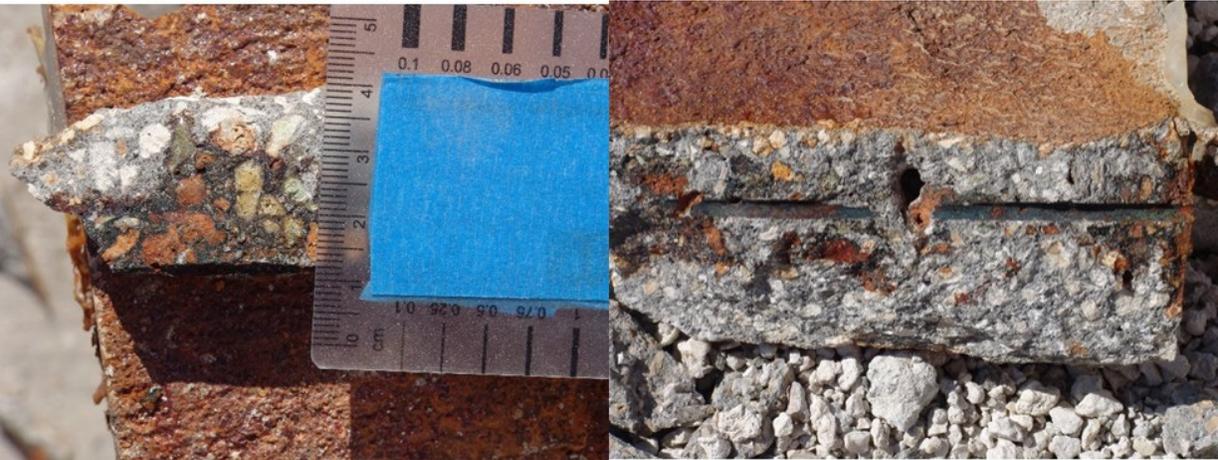
Figure 200 – Penetration into the concrete from the corrosion products (FS2).

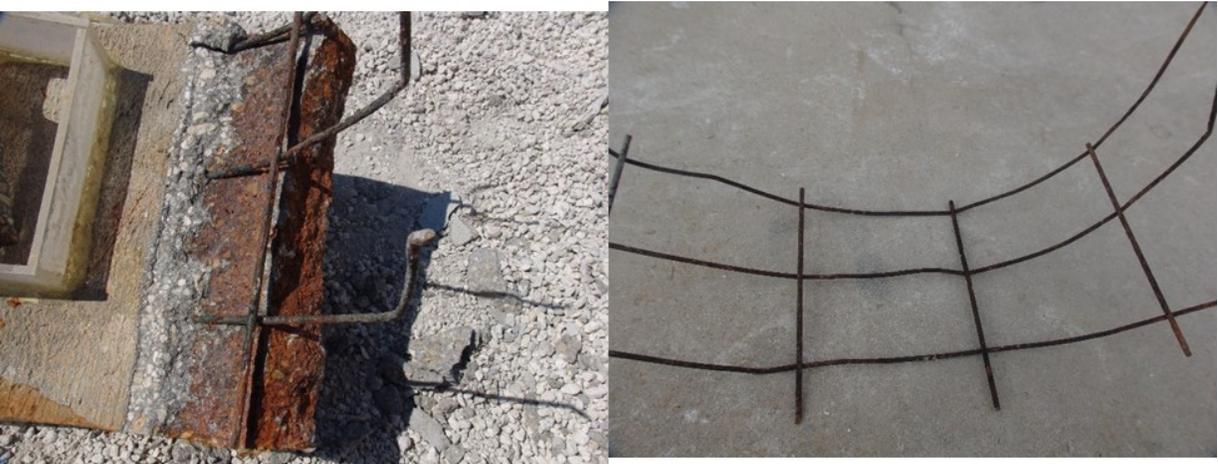
Figure 201 – Partial and full concrete removal exposing steel wire mesh (FS2).

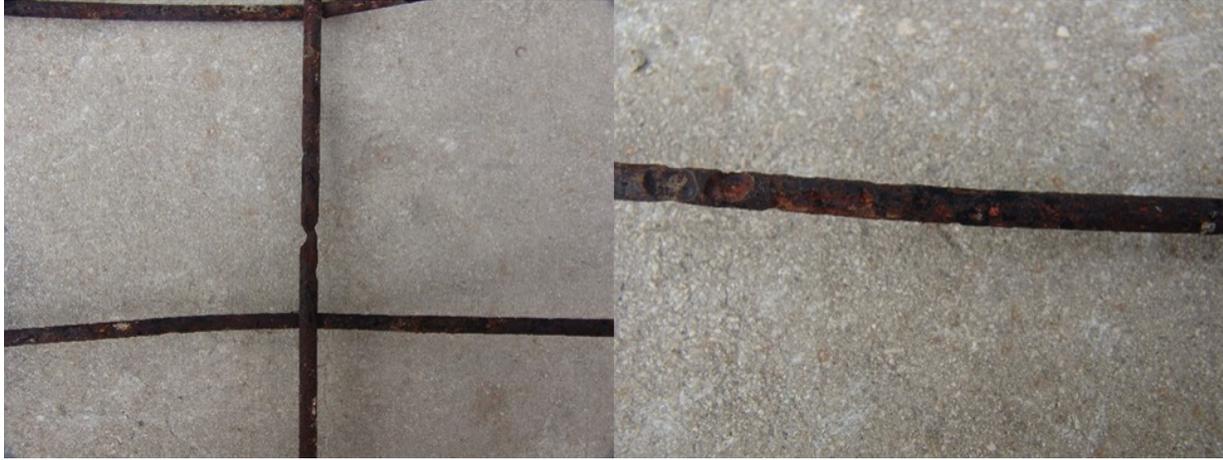
Figure 202 – Close-ups of selected sites where significant cross-section took place (FS2).
