Long-Term Performance of a Hot In-Place Recycling Project – Final Report

WA-RD 738.2

Long-Term Performance of a Hot In-Place Recycling Project Final Report

Contract 7648
SR-542
Britton Road to Coal Creek Bridge Vicinity
MP 3.38 to MP 19.27

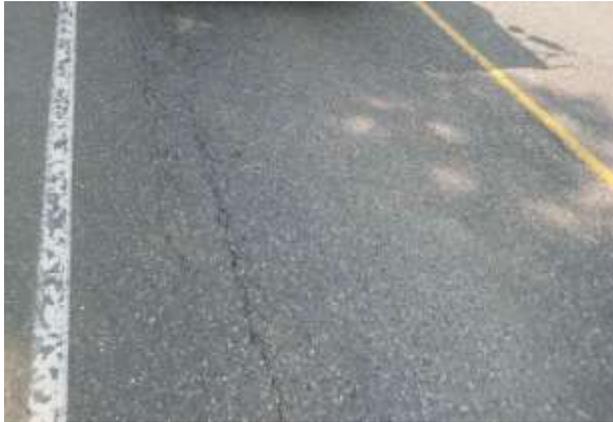
Figure 21. Pre-construction longitudinal cracking. (0776)

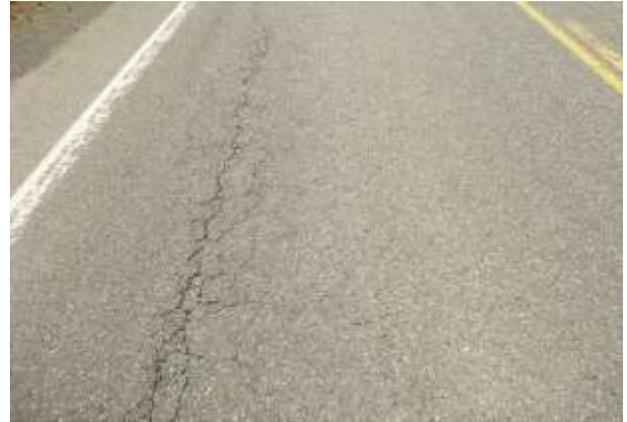
Figure 22. Pre-construction alligator cracking. (1363)

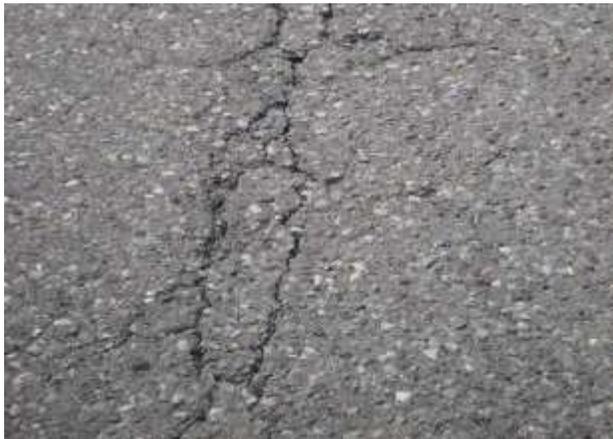
Figure 23. Pre-construction alligator cracking. (1364)

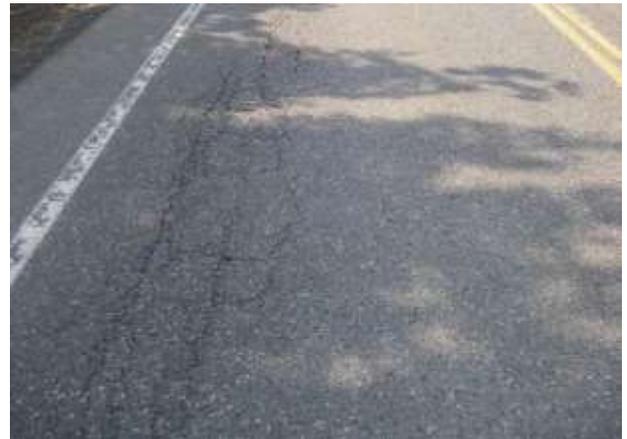
Figure 24. Pre-construction alligator and longitudinal cracking. (1365)

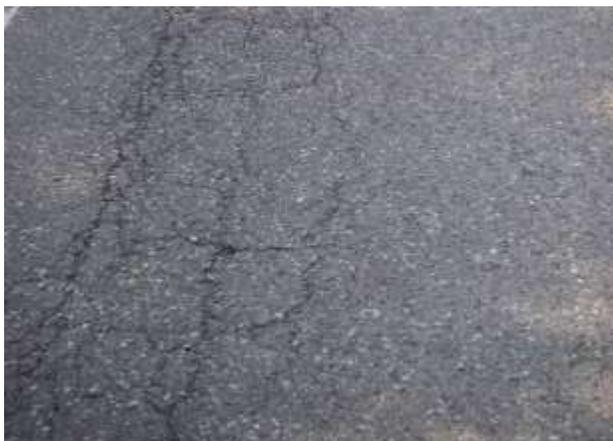
Figure 25. Pre-construction alligator and longitudinal cracking. (1366)

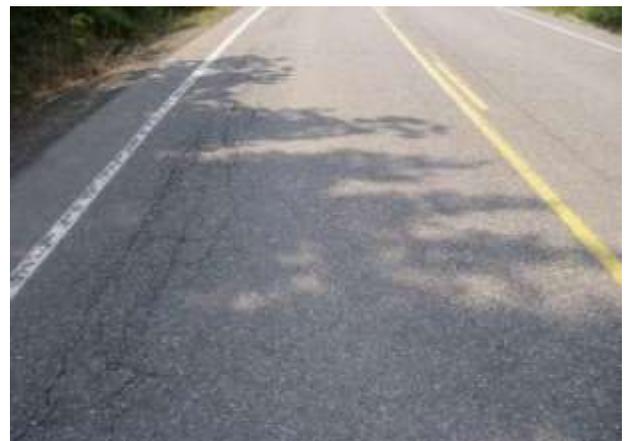
Figure 26. Pre-construction alligator and longitudinal cracking. (1367)

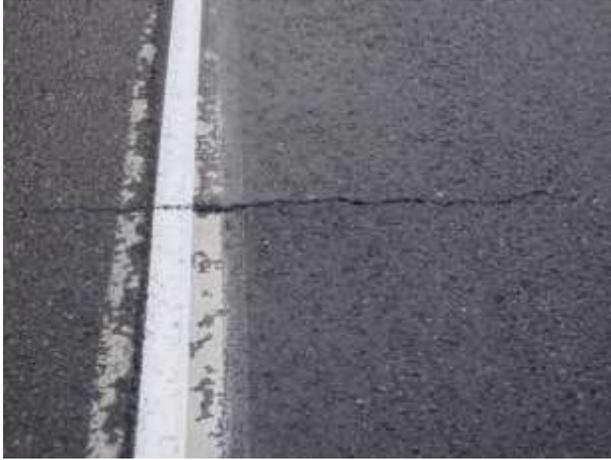
Figure 27. Transverse crack at MP 14.10. (4826)

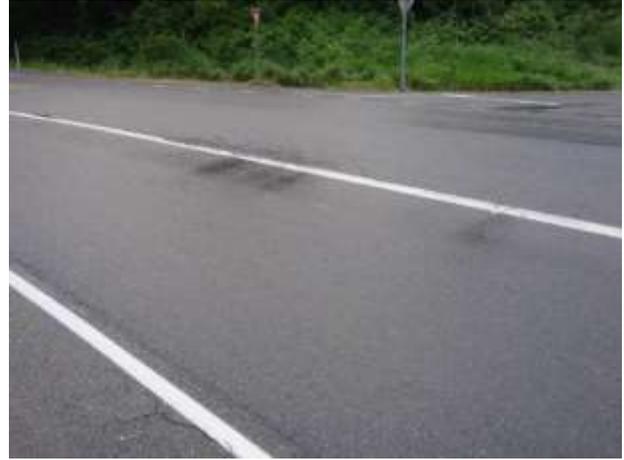
Figure 28. Alligator cracking at MP 14.5. (4818)

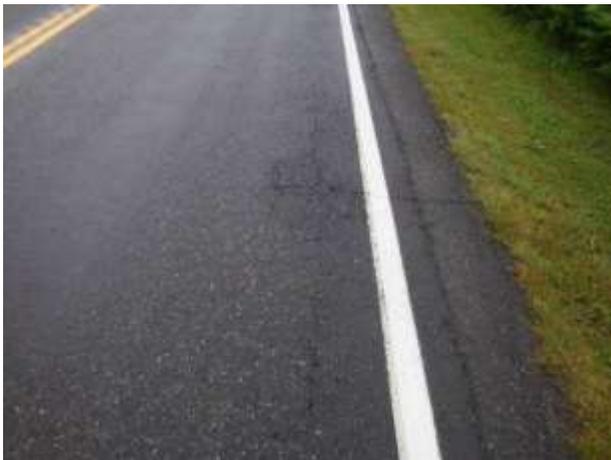
Figure 29. Alligator and longitudinal cracking at MP 17.2. (4807)

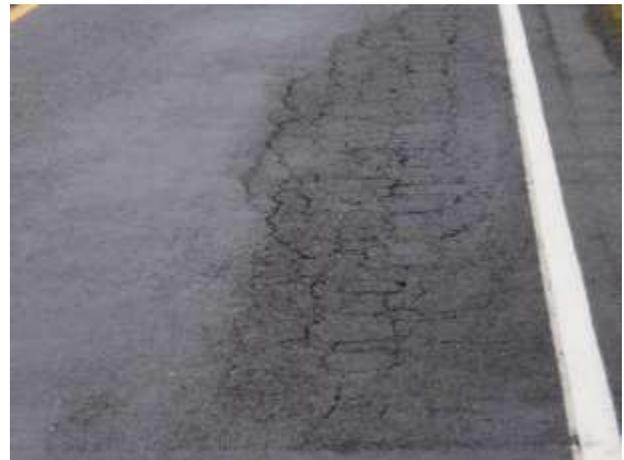
Figure 30. Close-up of alligator cracking at MP 17.2. (4870)

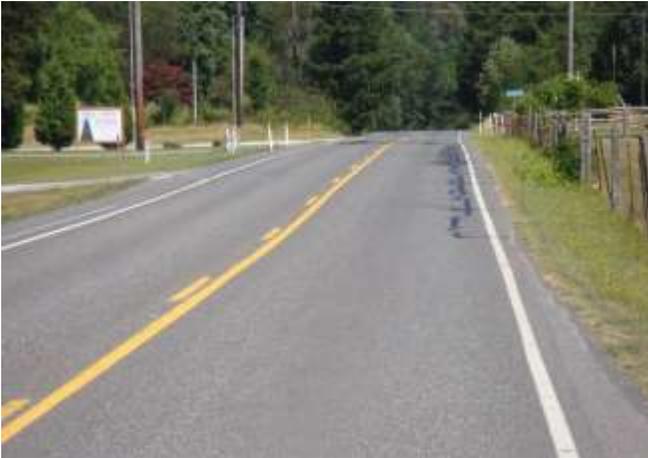
Figure 31. Sealed alligator cracking at MP 17.24. (6593)

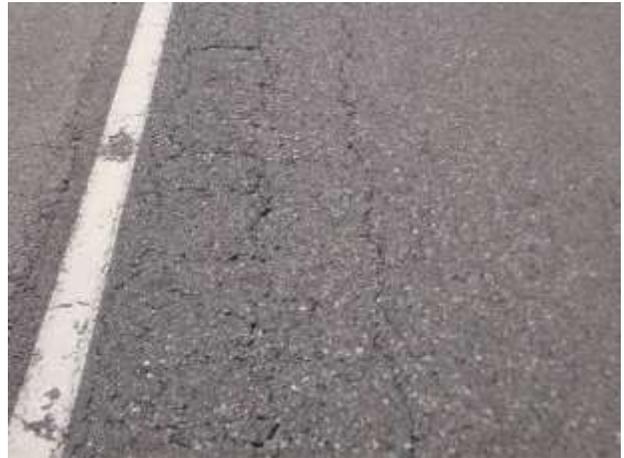
Figure 32. Alligator and long. cracking at unknown location. (6594)

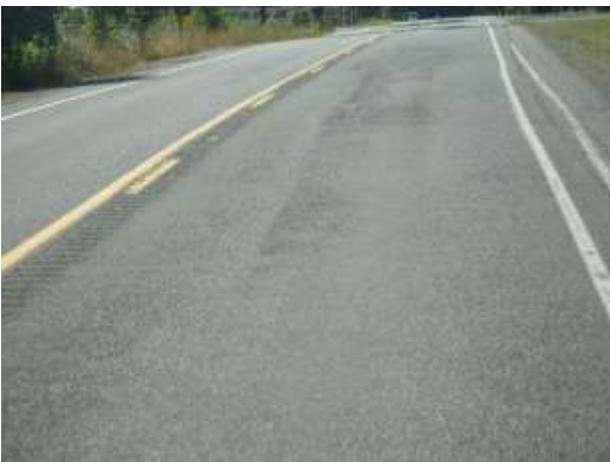
Figure 33. Alligator cracking at unknown location. (6590)

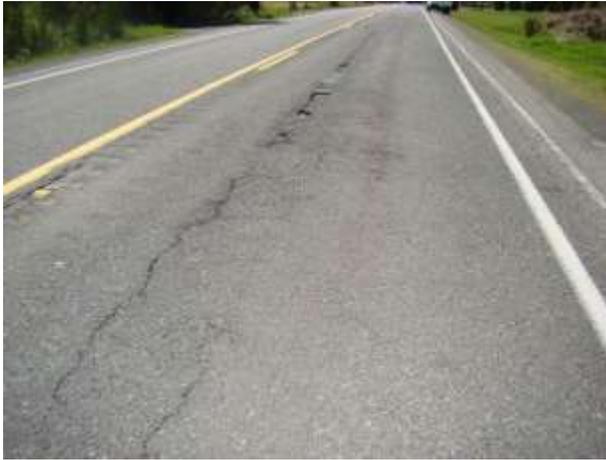
Figure 34. Alligator, longitudinal cracking and potholes in the westbound lane at MP 17.2 in May 2013. (1334)

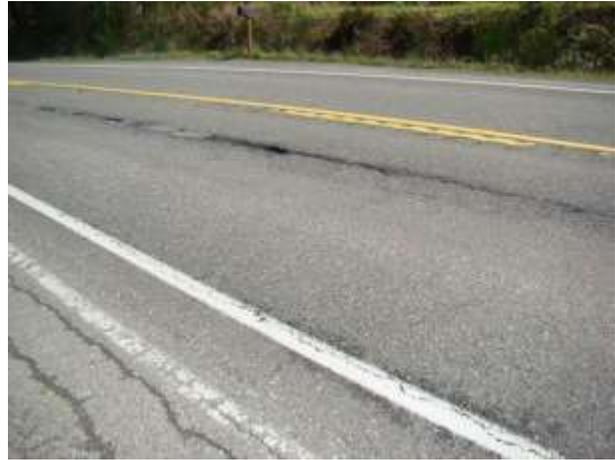
Figure 35. Alligator, longitudinal cracking and potholes in the westbound lane at MP 17.2 in May 2013. (1335)

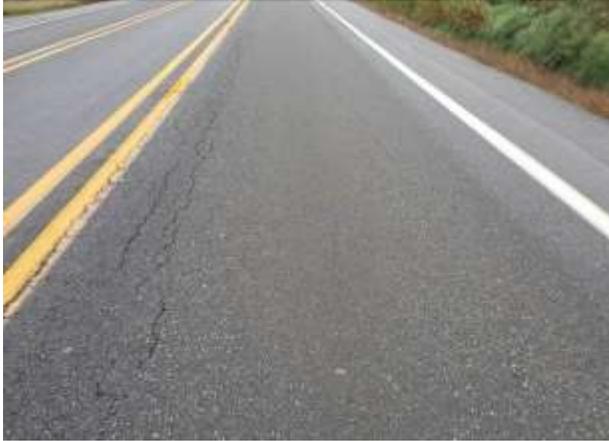
Figure 36. Longitudinal and alligator cracking at MP 4.8. (85258)

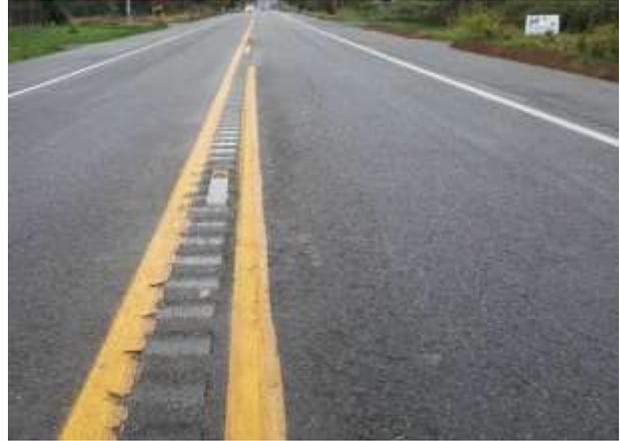
Figure 37. Open-texture and raveling at MP 10.1. (90232)

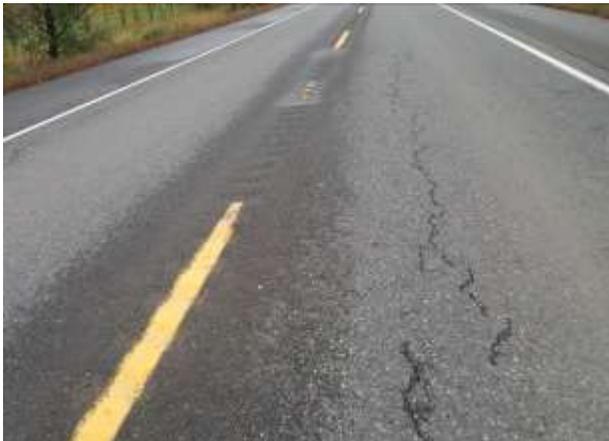
Figure 38. Open-texture, raveling and longitudinal cracking at MP 11.8. (90910)

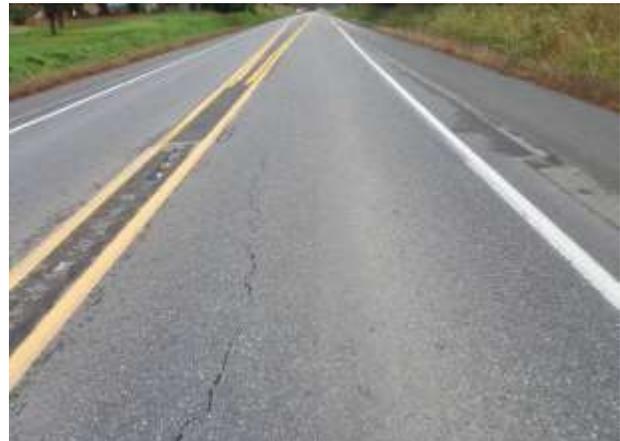
Figure 39. Open-texture, raveling and longitudinal cracking at MP 13.15 (90910)

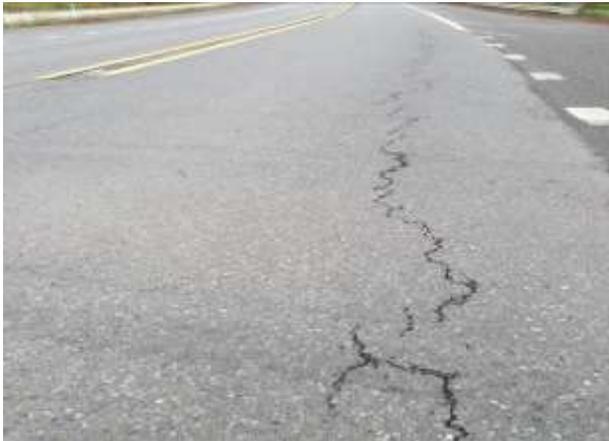
Figure 40. Open-texture, raveling, alligator and longitudinal cracking at MP 14.1. (92525)

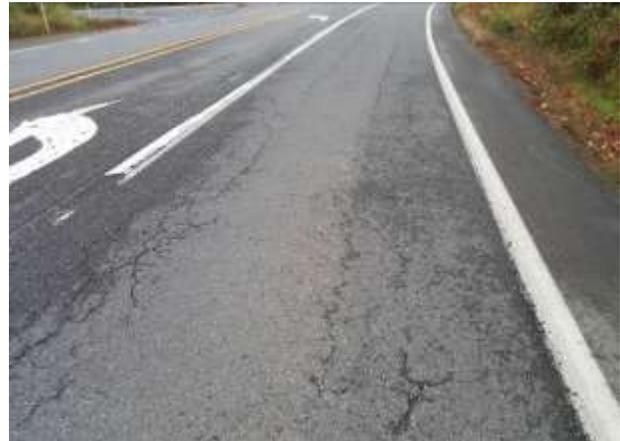
Figure 41. Open-texture, raveling, alligator and longitudinal cracking at MP 14.6. (93117)

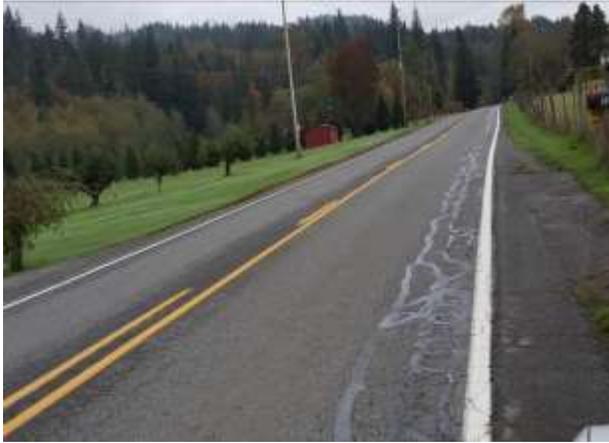
Figure 42. Sealed cracks at MP 17.1. (93723)

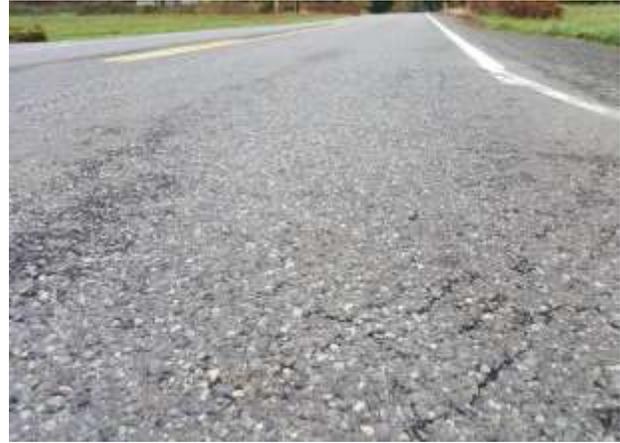
Figure 43. Close-up view at MP 17.2. (94003)

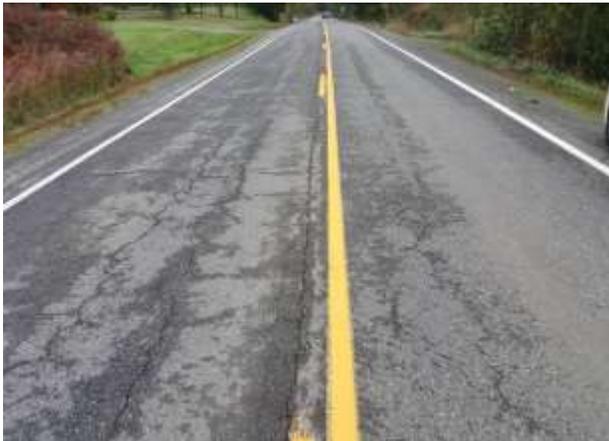
Figure 44. Alligator and longitudinal cracking at MP 17.3. (94210)

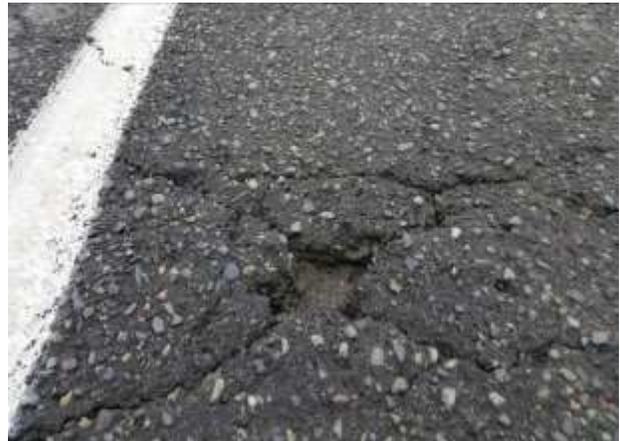
Figure 45. Alligator cracking, raveling and pothole at MP 17.3. Note erosion of the binder surrounding the aggregate. (94527)

The photos show that the deterioration of the pavement began almost immediately after construction. The most recent set of photos show the current poor condition of the HIPR pavement that is characterized by a dry surface appearance which is raveling and cracking and forming potholes at the intersection of the many cracks. The cause of the early distress may be attributable to problems with the underlying structure or a problem with the quality of the mix placed. Initial observations during and following completion of the paving were that the mix was dry and that the finished pavement had an open texture. It was reported that GreenRoads Recycling recommended increasing the asphalt content of the mix during paving. Laboratory testing of the mix indicated that the voids filled with asphalt were higher than allowed; therefore, the decision was made to not increase the asphalt content. A dry mix in combination with the aging of the asphalt binder due to the heating that takes place in the recycling process could result in a brittle binder that might be more prone to raveling and early cracking.

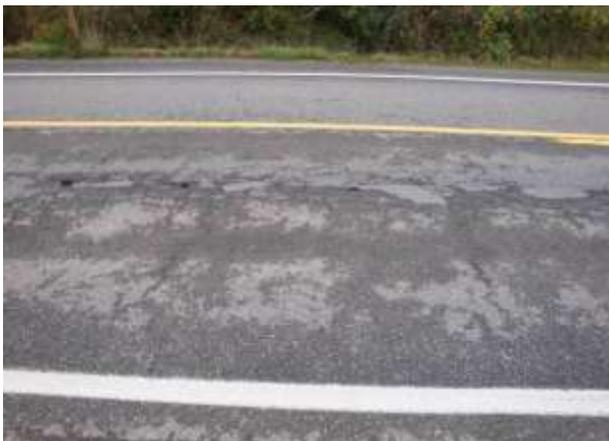
Figure 46. Alligator and transverse cracking and potholes at MP 17.3. (00562)

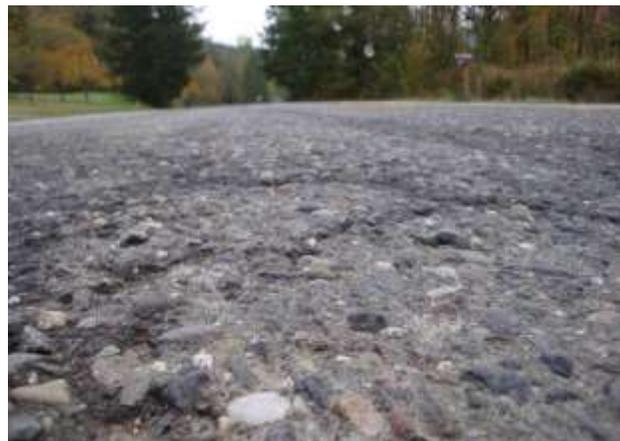
Figure 47. Close-up of raveled surface of pavement at MP 17.3. (00559)

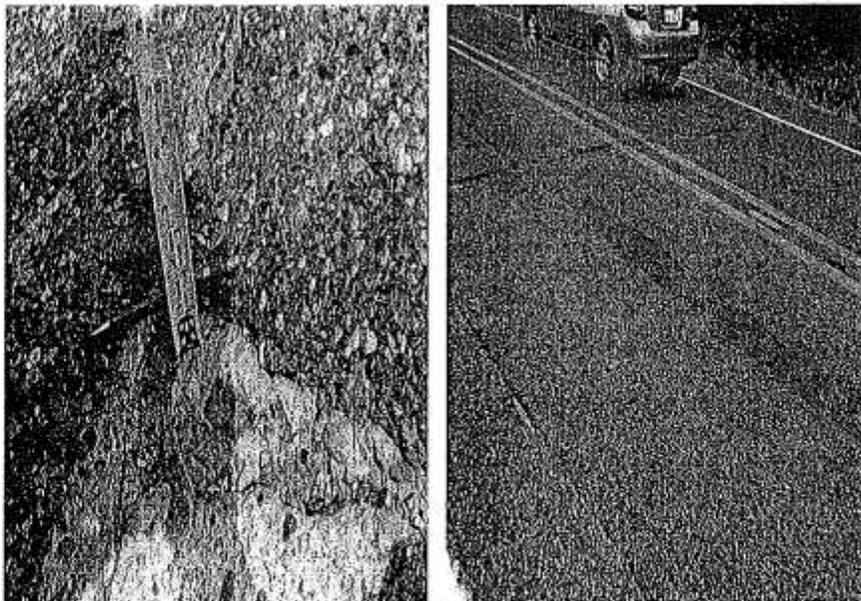
Photos 1 & 2 (~MP 3.10): ACP over the PCCP slabs has low to medium severity longitudinal and transverse cracking. The HMA layer thickness was measured ~.08'.

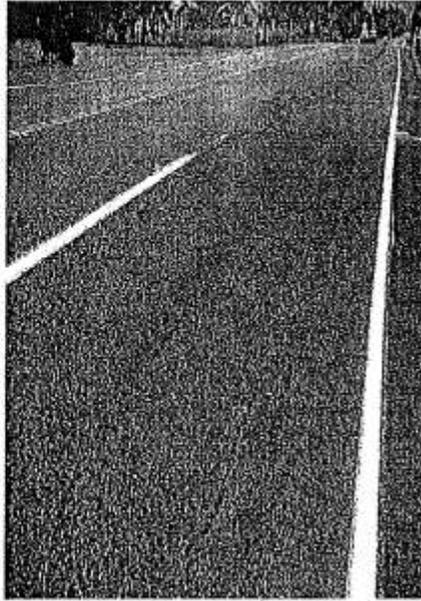
Photo 3 (~MP 4.8): Low to medium severity transverse & longitudinal reflective cracking.

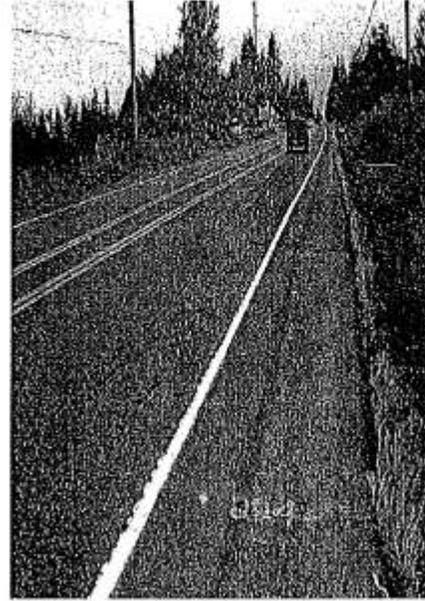
Photo 4 (~MP 7.05): Medium to high severity transverse and longitudinal cracking

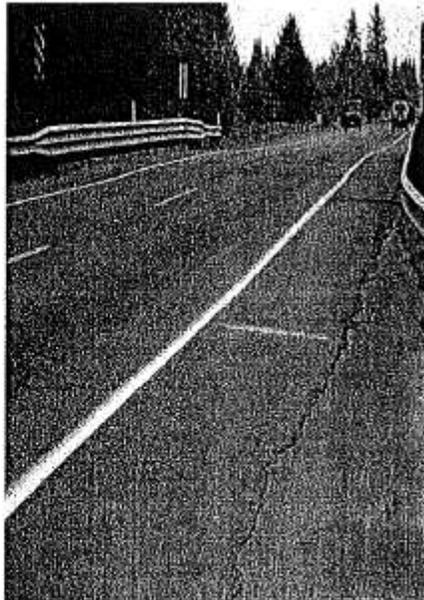
Photo 5 (~MP 11.29): Maintenance patching of HMA over the bridge deck # 542/016.

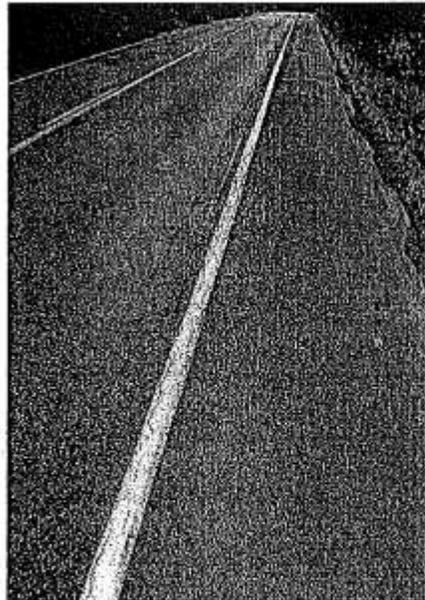
Photo 6 (~MP 14.27): Medium to high severity alligator cracking along the fog line and shoulder on WB lane.

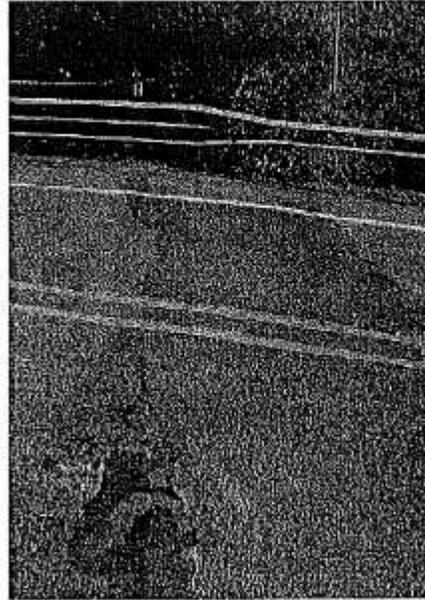
Photo 8 (~MP 17.65): High severity alligator cracking and settlement that was patched with HMA by maintenance at both ends of the bridge #542/21.

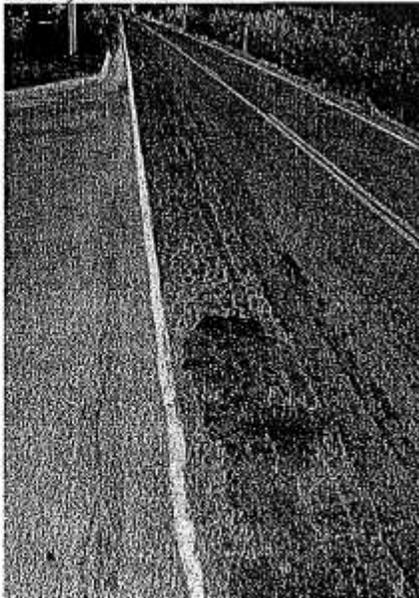
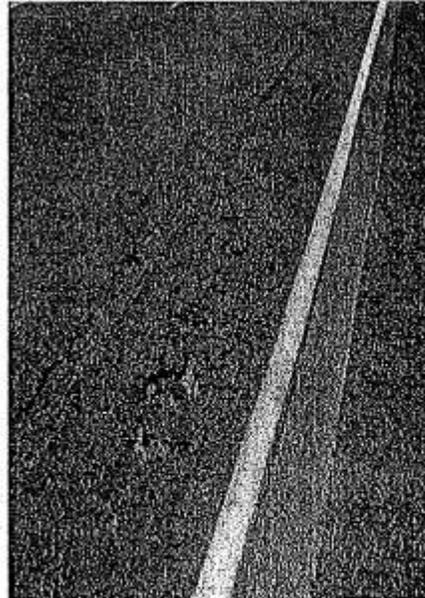
Photos 9 & 10 (SR 9 at ~ MP 84.06): Medium to high severity alligator cracking occurring in the wheel path between the edge of the PCCP panels and HMA pavement.
