### 4.3 Analytical Methods and Results

**4.3.6 Span Condition Ratings**

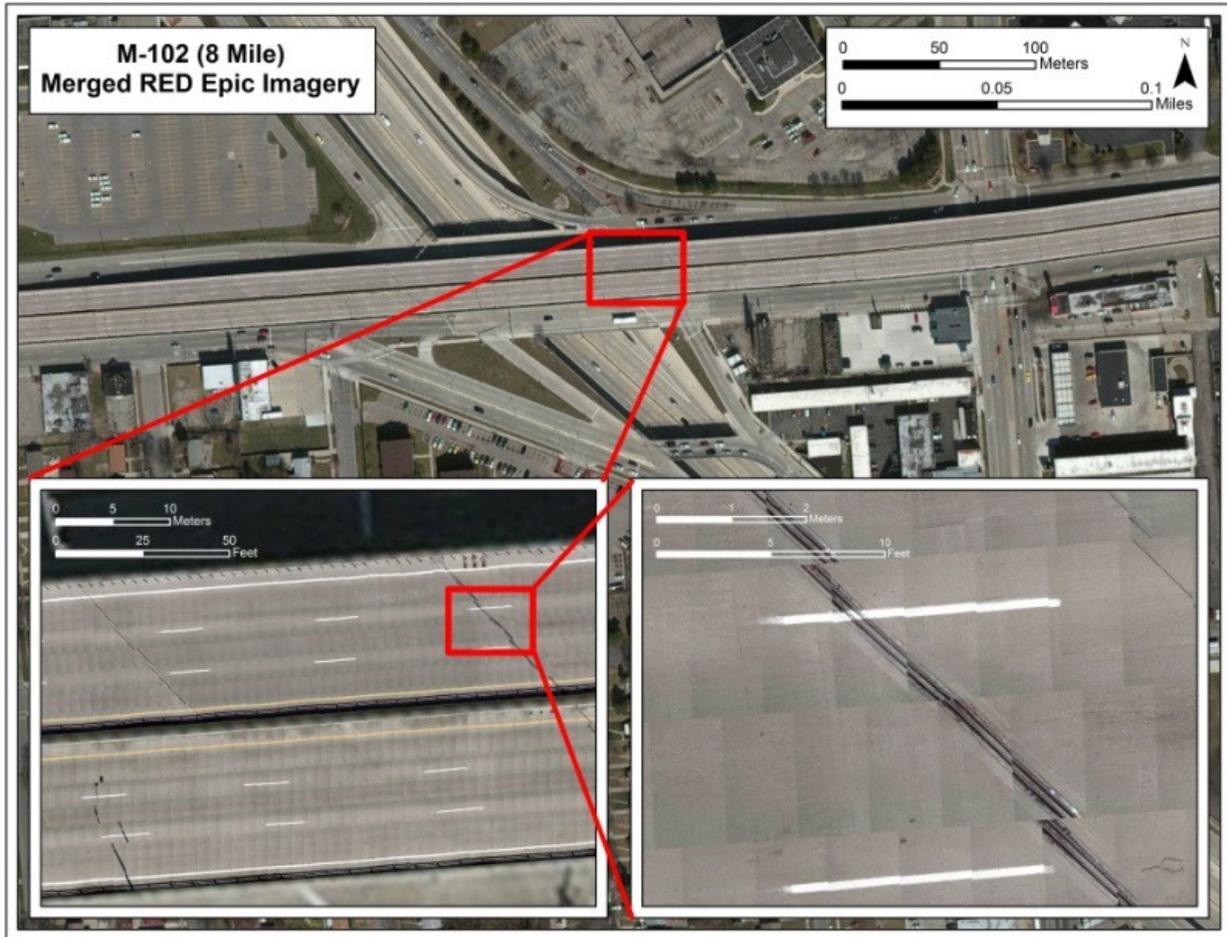
After processing, merging, and georeferencing both optical and thermal imagery data sets, the outputs were placed within GIS software to provide visualization of distress features. Through using an automated script created to correct the overlap in individual frames extracted from RED Epic video imagery, individual frames were cropped and placed end-to-end, resulting in a single image for subsets of the bridge deck. The subsets were then merged together and georeferenced to ESRI base maps to create a single image per pass over the bridge. For the optical imagery, this serves as the visual basis of the bridge deck. As seen in Figure 23, the separate passes over the bridge deck do not necessarily line up with one another, resulting in slight distortion of pavement markings and bridge joints. However, the merged optical imagery proved useful as it provided an overview of how the bridge deck appeared during data collection. This bridge deck contained no spalls outside of the bridge joint area.

**Figure 23: RED Epic imagery merged together to form spall locations on the bridge deck of M-102 (8 Mile) eastbound and westbound.**

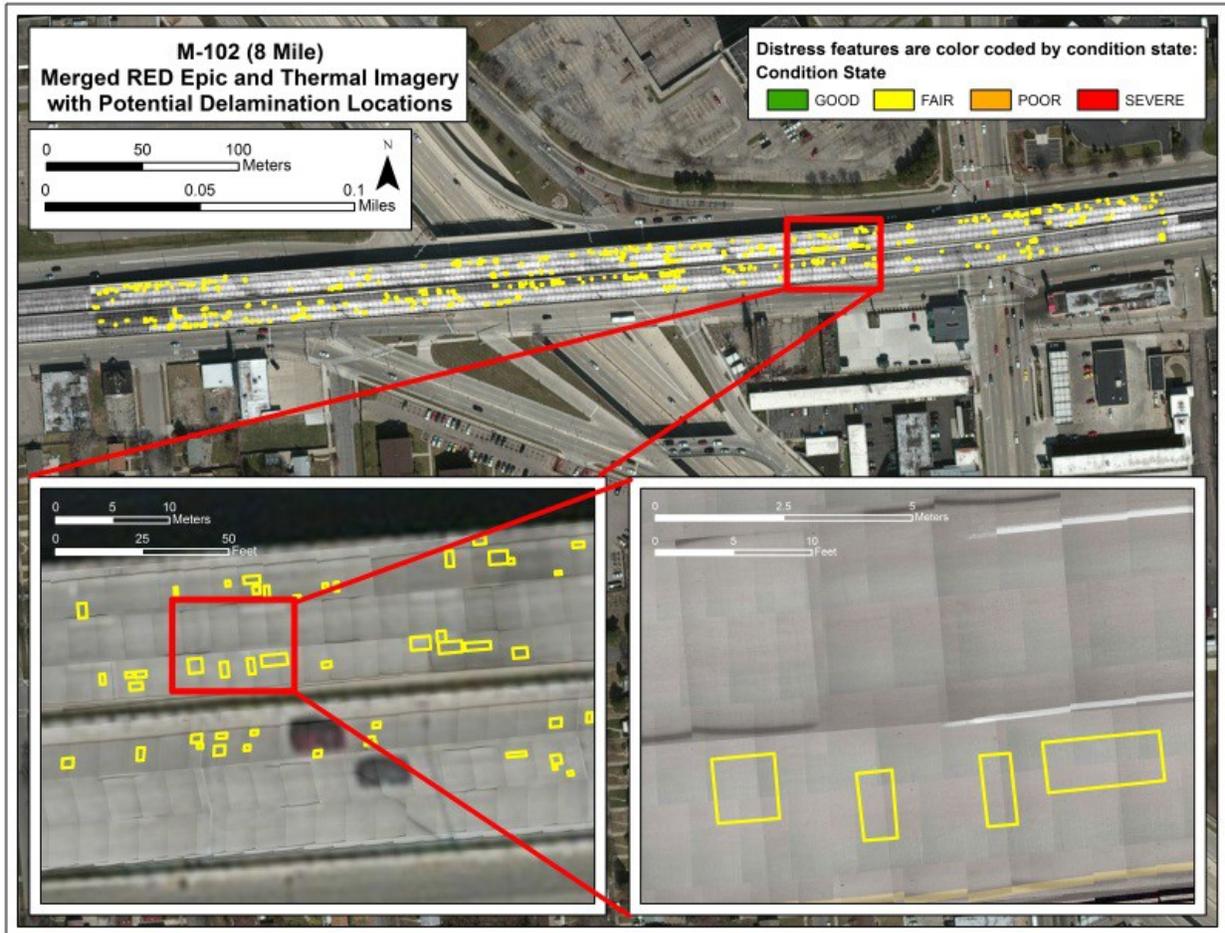
Similarly, the thermal imagery was also merged together through the same automated script. Individual frames were cropped and placed end-to-end, resulting in a single image for subsets of the bridge deck. The subsets were then merged together and georeferenced to ESRI base maps to create a single image per pass over the bridge (Figure 24). GS Infrastructure, Inc. inspected the thermal imagery and indicated any location that appeared to have a potential delamination. The merged optical and thermal images can then be placed on top of another and by using transparent layers in the GIS software; a better overview of where potential delaminations exist on the bridge deck can be seen (Figure 25). In total, 398 potential delaminations were identified by GS Infrastructure, Inc., totaling an area of 2,942 ft<sup>2</sup>, or approximately 1.73% of the entire bridge deck.

**Figure 25: Locations of potential delaminations for M-102 (8 Mile) eastbound and westbound bridge decks.**

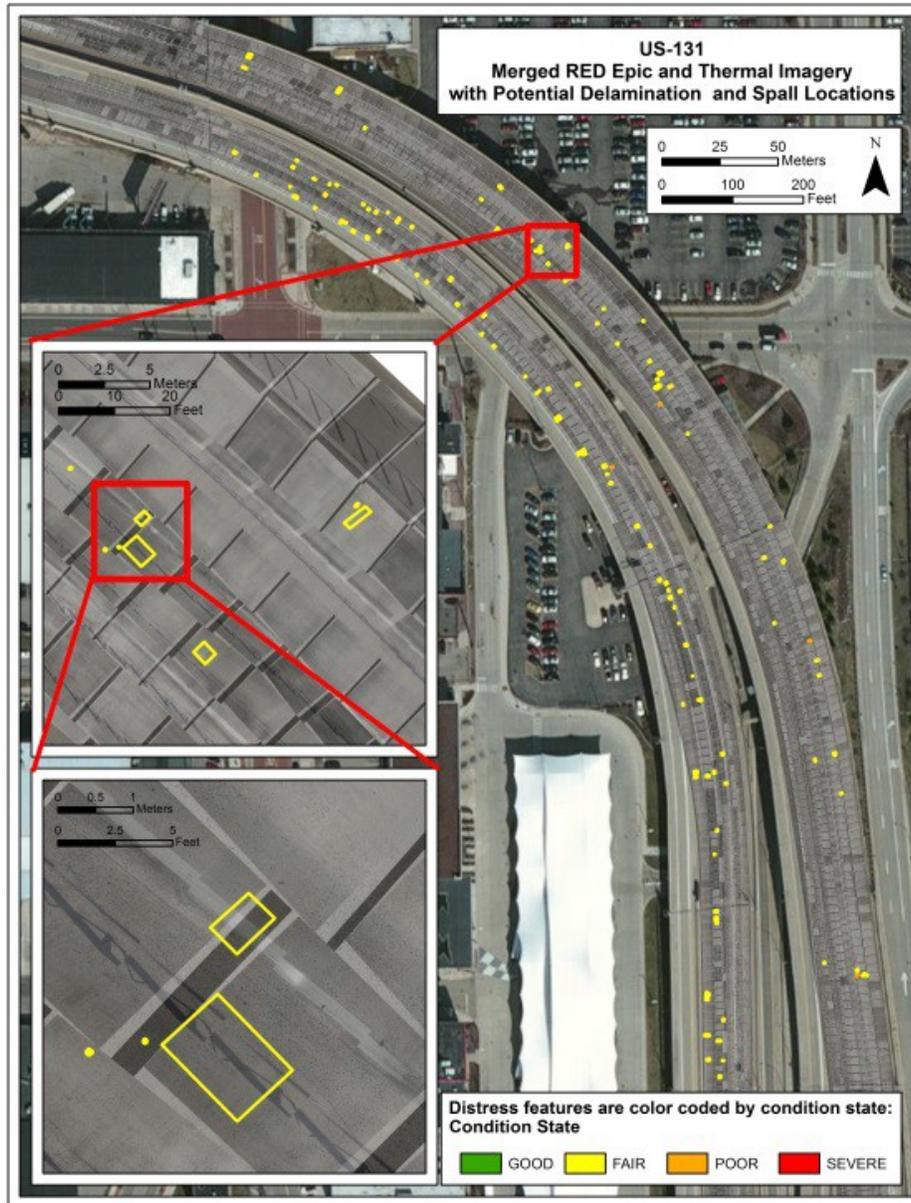
After merging the thermal imagery from US-131 through the use of the automated merging script, the merged output was georeferenced to ESRI base maps (Figure 27). GS Infrastructure, Inc. inspected the thermal imagery and indicated any location that appeared to have a potential delamination. The merged optical and thermal images were then placed on top of one another and through the use of transparent layers in the GIS software, an overview of potential delaminations and spalls appear on the bridge deck (Figure 28). In total, 133 potential delaminations (34 northbound and 90 southbound) were identified by GS Infrastructure, Inc. totaling an area of 532 ft<sup>2</sup>, or approximately 0.25% of both bridge decks combined. For the overall summary of each span's condition, please reference figures 41 and 42 and tables 9 and 10 in Section 4.3.6.

**Figure 28: Location of potential delaminations and spalls on US-131 northbound and southbound bridge decks.**

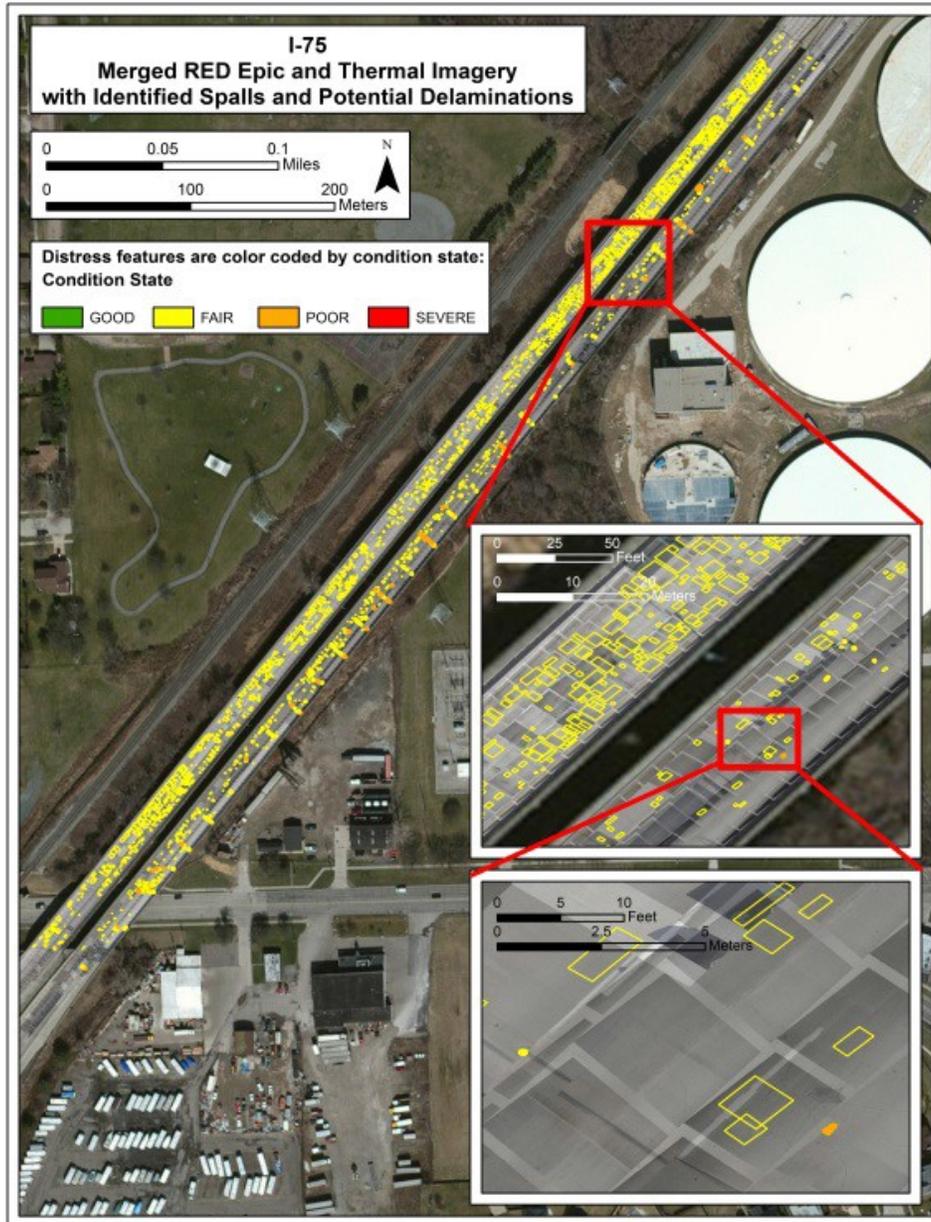
through the use of the automated merging script, the merged output was georeferenced to ESRI base maps (Figure 30). GS Infrastructure, Inc. inspected the thermal imagery and indicated any location that appeared to have a potential delamination. The merged optical and thermal images were then placed on top of one another and through the use of transparent layers in the GIS software, an overview of potential delamination locations and spalling appear on the bridge (Figure 31). In total, 1,877 potential delaminations (515 northbound and 1,362 southbound) were identified by GS Infrastructure, Inc. totaling an area of 16,328 ft<sup>2</sup>, or approximately 8.50% of both bridge decks combined. As previously noted, spalls and delaminations are color-coded by condition state as noted in AASHTO BEIM (2015). For the overall summary of each span's condition, please reference figures 43 and 44 and tables 11 and 12 in Section 4.3.6.

**Figure 31: Location of potential delaminations and spalls for I-75 northbound and southbound decks.**

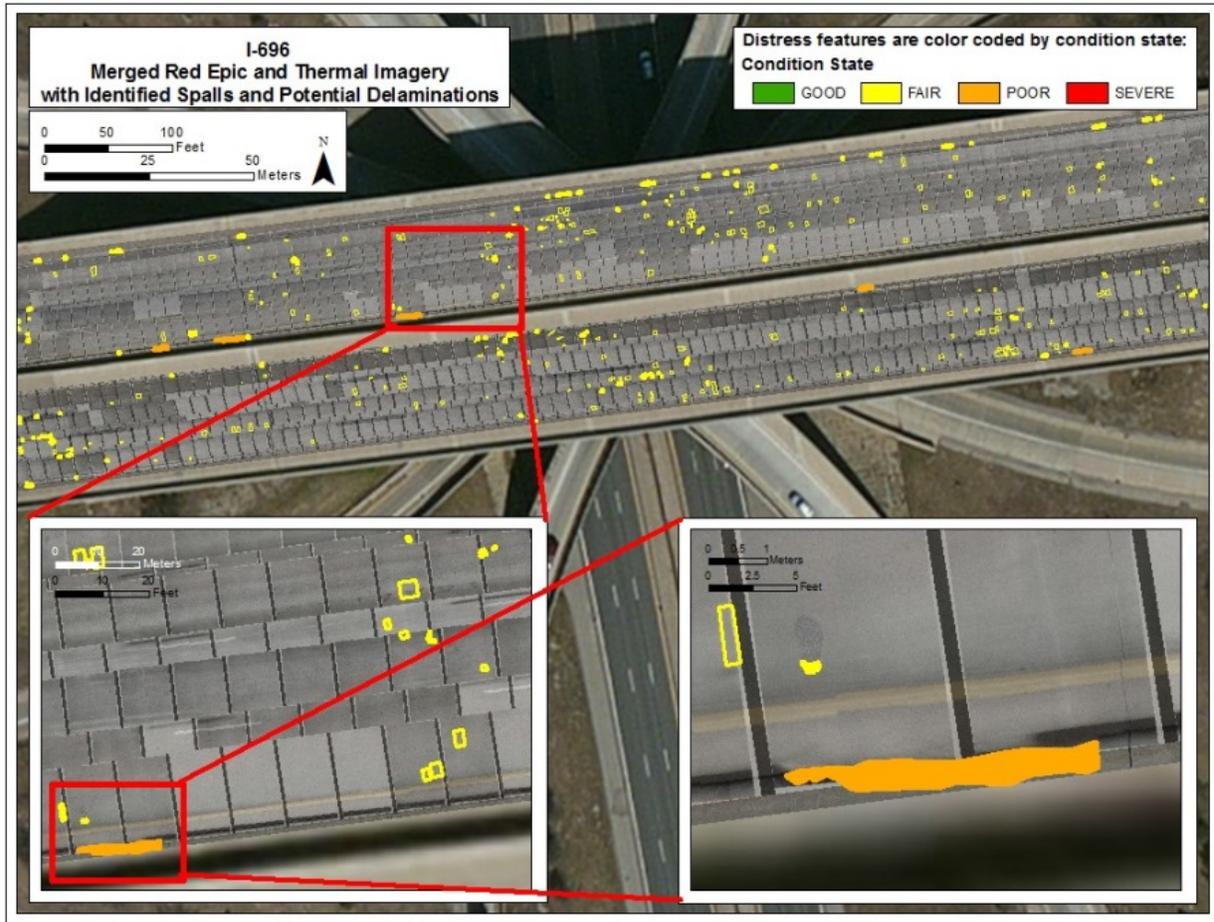
delamination. The merged optical and thermal images were then placed on top of one another and through the use of transparent layers in the GIS software, a better overview of where potential delaminations exist and how it appears on the bridge deck can be seen (Figure 34). In total, 203 potential delaminations were identified by GS Infrastructure, Inc., totaling an area of 1,125 ft<sup>2</sup>, or approximately 1.10%. For the overall summary of each span's condition, please reference Figure 45 and Table 13 in Section 4.3.6.

Figure 34: Location of potential delaminations and spalls on the I-696 bridge deck.

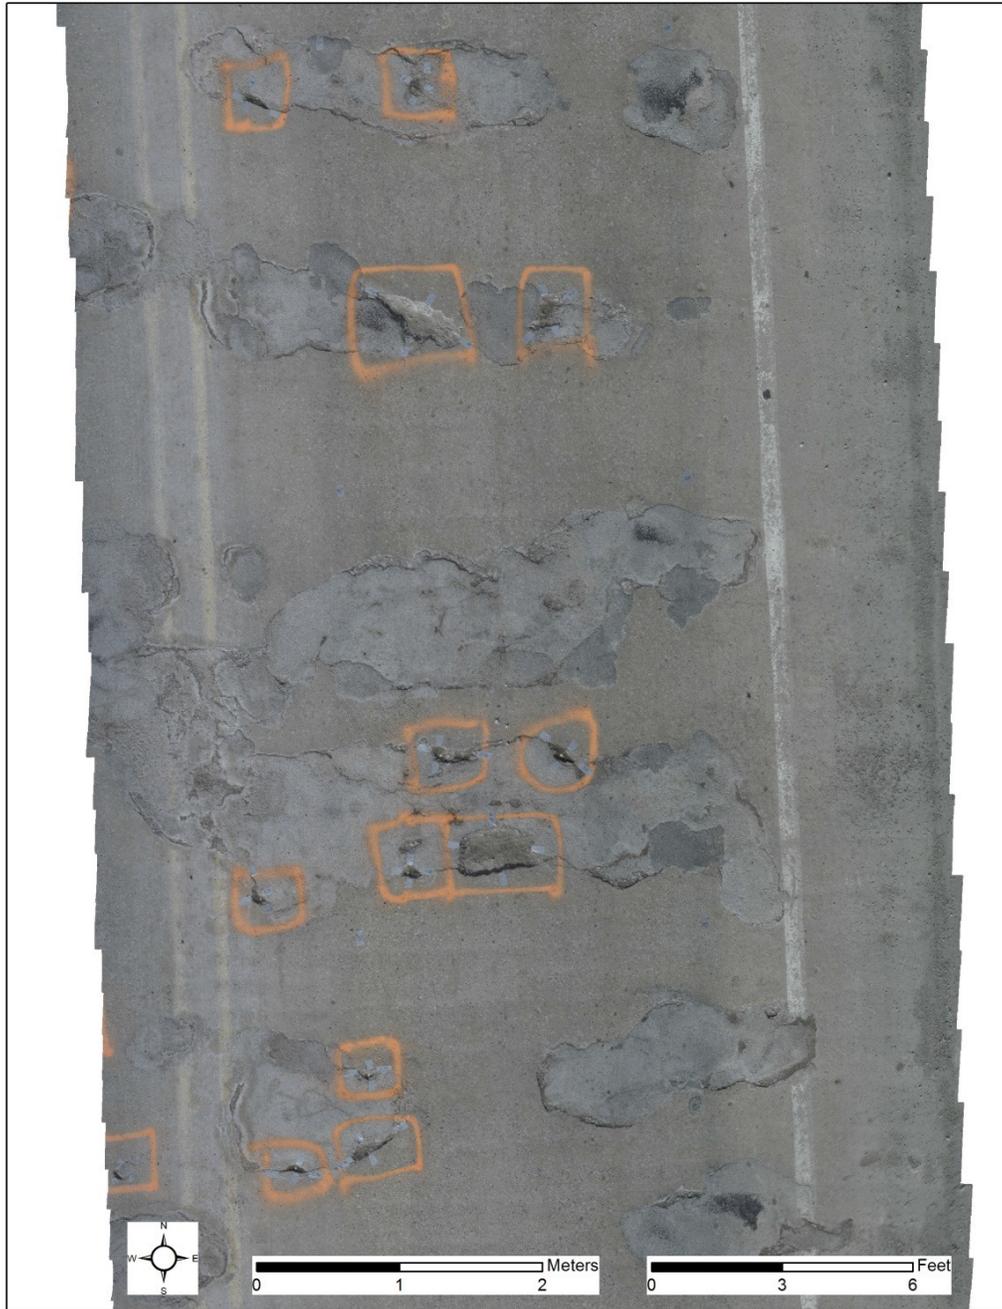
Figure 37 shows a zoomed in section of the northbound lane of Lake Nepessing Rd. bridge deck. With a high-resolution orthoimage model, spalls and patches can be located and measured to compare to the in situ measurements. The hillshade of the DEM was reconstructed to show the detail of the patches and spalls (Figure 38). The increased noise on the right and left sides of the hillshade is a result of those areas being mostly flat and with less imagery overlap. There is less overlap on the sides than the center of the model. The edges were reconstructed from a single pass resulting in a point on the ground being represented in five frames. The center of the model was reconstructed from the overlap of both passes of the data collection resulting in a point on the ground being represented in at least 10 frames. The noise in the z-axis, or the amount of random error in the model reconstruction, in the center of the model is 0.16 in. (4.2mm) while on the sides of the model is up to 1.79 in. (4.5cm). Features such as spalls cannot be distinguished if they are less than this error.

**Figure 37: Zoomed in portion of the Orthoimage of northbound Lake Nepessing Rd. bridge deck.**

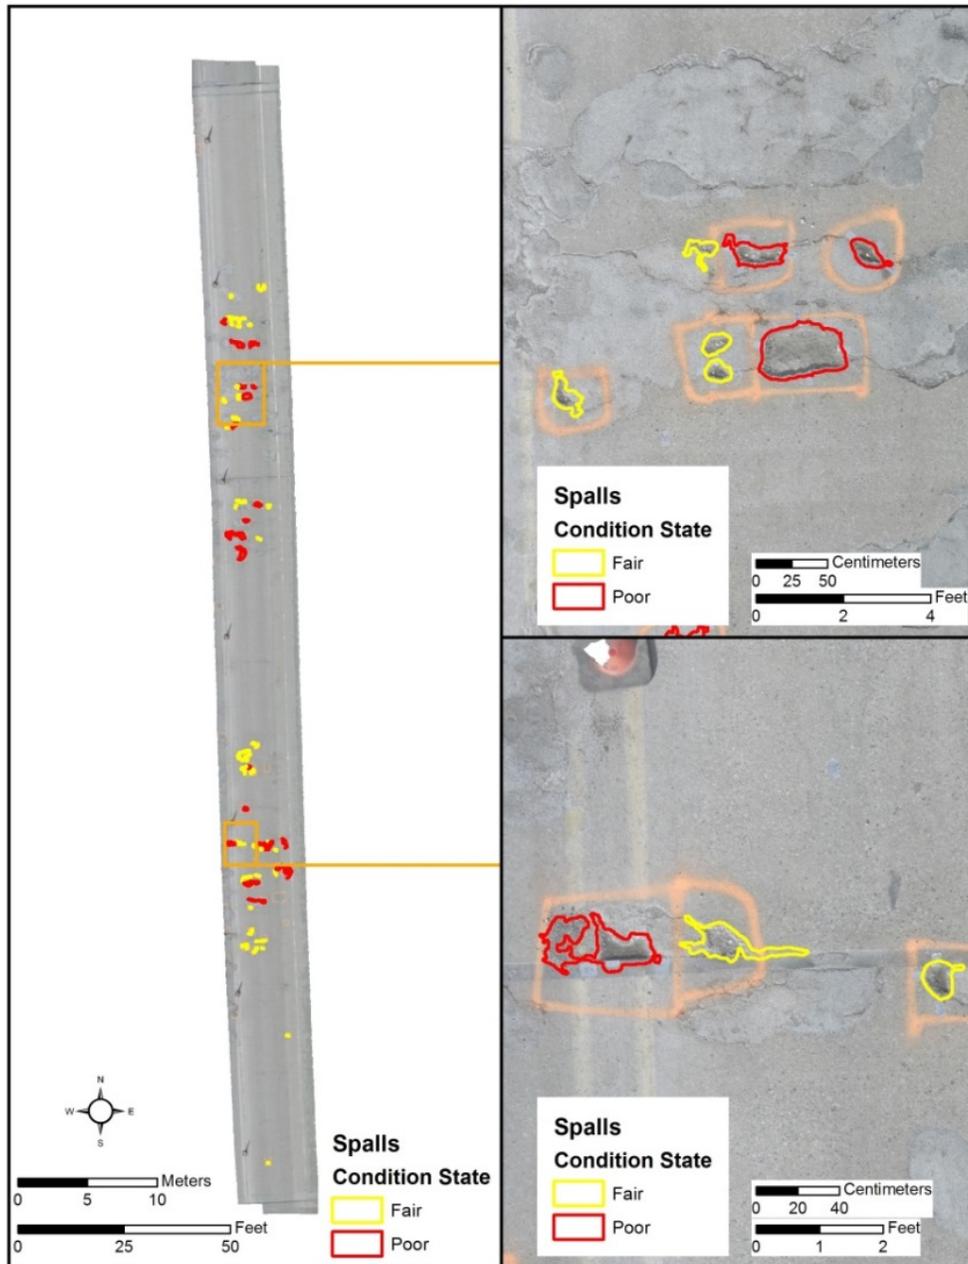
A spall detection algorithm developed under the USDOT/RITA Bridge Condition Assessment Using Remote Sensors project (Ahlborn et al., 2013) was used on the resulting DEMs to create a spalls shapefile for the Lake Nepessing Rd. bridge deck. Figure 39 is an example of the northbound lane of Lake Nepessing Rd with the detected spalls layer. The spalls layer also contains area and volume of the detected spalls. Lake Nepessing Rd bridge deck is estimated to be 80.4 ft<sup>2</sup> or about 1% of the bridge deck is spalled based on the detected spalls layer. Of the spalls detected 68% were in Condition State 2 and 32% were in Condition State 3.

**Figure 39: Northbound Lake Nepessing Rd bridge deck orthoimage with the detected spalls layer showing the location of spalls.**

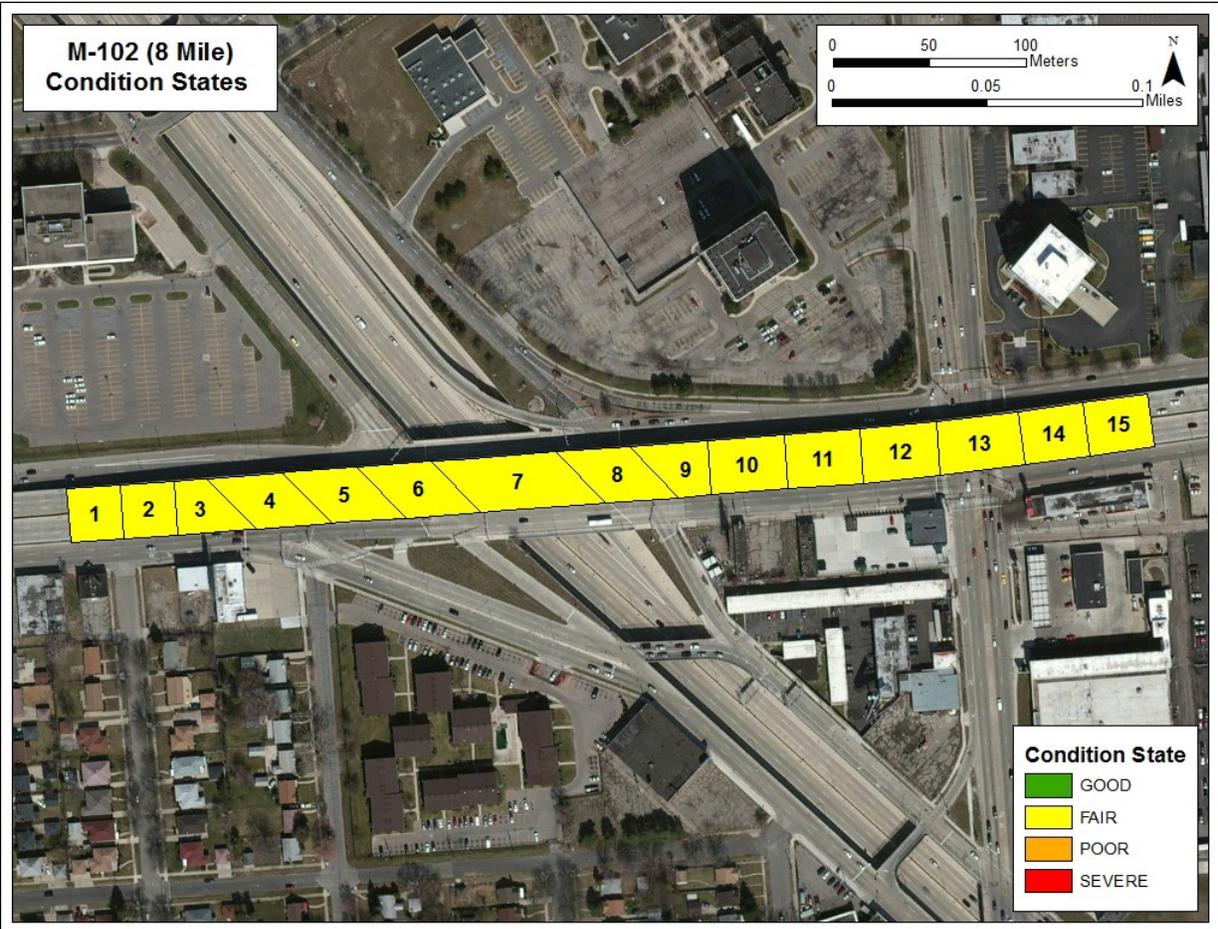
spalls, and therefore the condition state of each span was based on the presence or absence of a delamination. All 15 spans (3 main spans and 12 approach spans) of the bridge contained the presence of at least one delamination. Through GIS analysis, the total bridge deck area was calculated to be 167,660 ft<sup>2</sup>. The total delaminated area as reported through digitization and georeferencing of thermal infrared digital imagery was calculated to be 3,092 ft<sup>2</sup>, or 1.84% of the total bridge deck. This also indicates that 3,092 ft<sup>2</sup> (1.84%) of the total bridge deck falls under Condition State 2 – Fair. As there were no reported spalls on the bridge deck, the remaining 164,568 ft<sup>2</sup> (98.16%) of bridge deck is classified as Condition State 1 – Good (Table 8 and Figure 40). The spans with the greatest and least area of delaminations are span 8 and span 12, respectively. For the location of individual distress features, please reference Figure 25 in Section 4.3.1.

Figure 40: Summary of Condition state per span at M-102 (8 Mile).

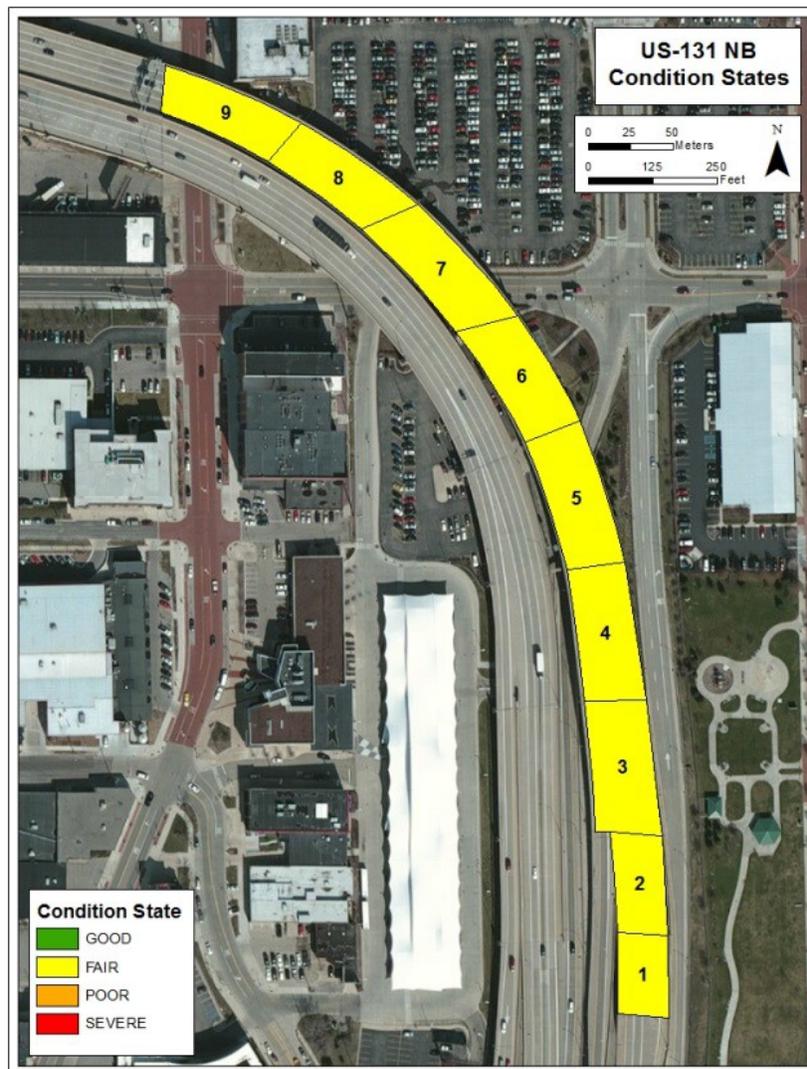
The US-131 northbound bridge contained 24 spalls and 37 delaminations within the defined 9 spans of the bridge deck (9 main spans and 0 approach spans). Through GIS analysis, the total bridge deck area was calculated to be 115,926 ft<sup>2</sup>. The total area of Condition State 2 – Fair distress features was determined to be 168 ft<sup>2</sup>, or approximately 0.15% of the total bridge deck (168 ft<sup>2</sup> classified as delaminations and 0.35 ft<sup>2</sup> classified as spalls that are 6 inches or less in diameter). Likewise, the total area of Condition State 3 – Poor distress features was determined to be 0.23 ft<sup>2</sup>, or approximately 0% of the total bridge deck (consisting of only spalls that are greater than 6 inches in diameter because delaminations are always classified as Condition State 2). The remainder of the bridge deck not containing spalls or delaminations was classified as Condition State 1 – Good and equates to 115,757 ft<sup>2</sup>, or approximately 99.85% (Table 9 and Figure 41). For the location of individual distress features, please reference Figure 28 in Section 4.3.2.

**Figure 41: Summary of condition state per span at US-131 northbound.**

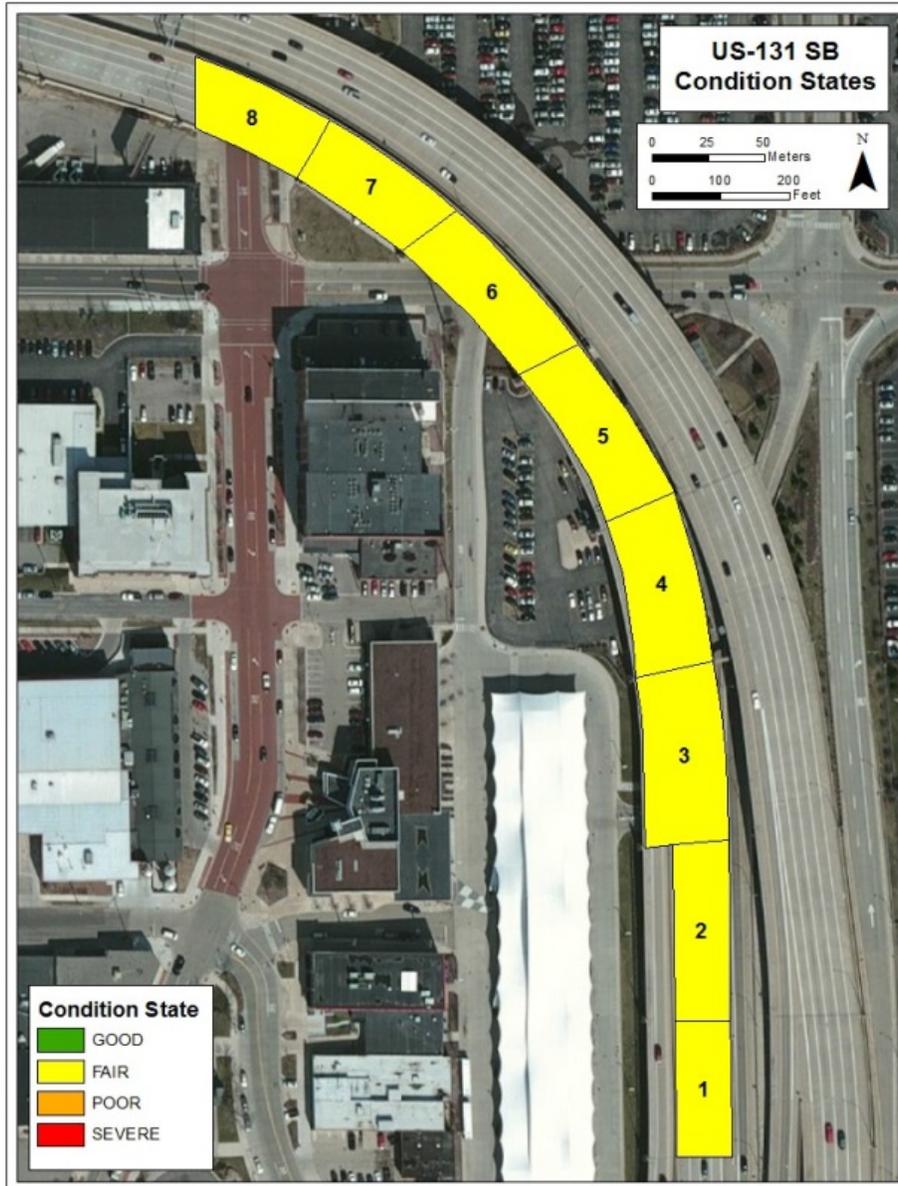
The US-131 southbound bridge contained 1 spall and 96 delaminations within the defined 8 spans of the bridge deck (8 main spans and 0 approach spans). Through GIS analysis, the total bridge deck area was calculated to be 98,090 ft<sup>2</sup>. The total area of Condition State 2 – Fair distress features was determined to be 364 ft<sup>2</sup>, or approximately 0.37% of the total bridge deck (364 ft<sup>2</sup> classified as delaminations and 0.07 ft<sup>2</sup> as spalling). The remainder of the bridge deck not containing spalls or delaminations was classified as Condition State 1 – Good and equates to 97,726 ft<sup>2</sup>, or approximately 99.63% (Table 10 and Figure 42). For the location of individual distress features, please reference Figure 28 in Section 4.3.2.

**Figure 42: Summary of condition state per span at US-131 southbound.**

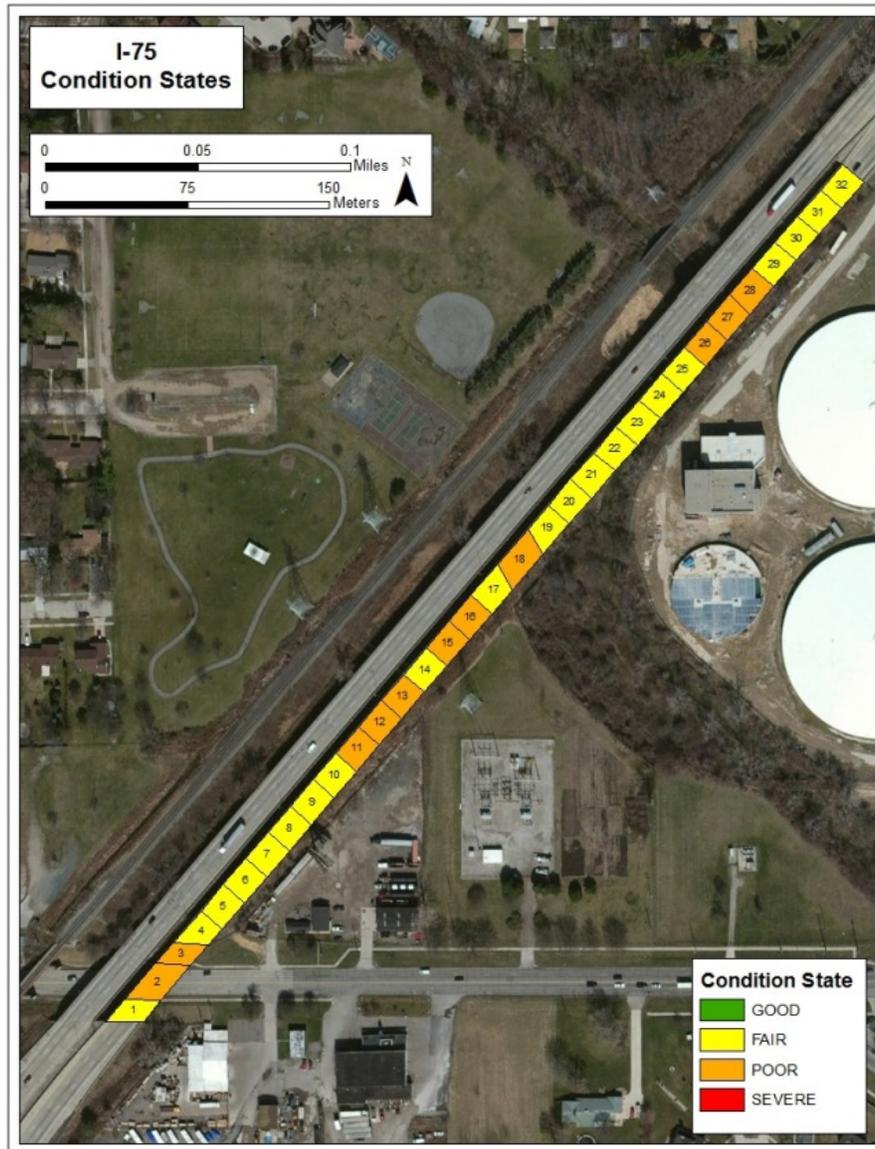
The I-75 northbound bridge contained 227 spalls and 529 delaminations within the defined 32 spans of the bridge deck (27 main spans and 5 approach spans). Through GIS analysis, the total bridge deck area was calculated to be 95,014 ft<sup>2</sup>. The total area of Condition State 2 – Fair distress features was determined to be 2,211 ft<sup>2</sup>, or approximately 2.33% of the total bridge deck (2,204 ft<sup>2</sup> classified as delaminations and 7 ft<sup>2</sup> classified as spalls that are 6 inches or less in diameter). Likewise, the total area of Condition State 3 – Poor distress features was determined to be 28 ft<sup>2</sup>, or approximately 0.03% of the total bridge deck (consisting of only spalls that are greater than 6 inches in diameter because delaminations are always classified as Condition State 2). The remainder of the bridge deck not containing spalls or delaminations was classified as Condition

State 1 – Good and equates to 92,776 ft<sup>2</sup>, or approximately 97.64% (Table 11 and Figure 43). For the location of individual distress features, please reference Figure 31 in Section 4.3.3.

**Figure 43: Summary of condition state per deck span at I-75 northbound.**

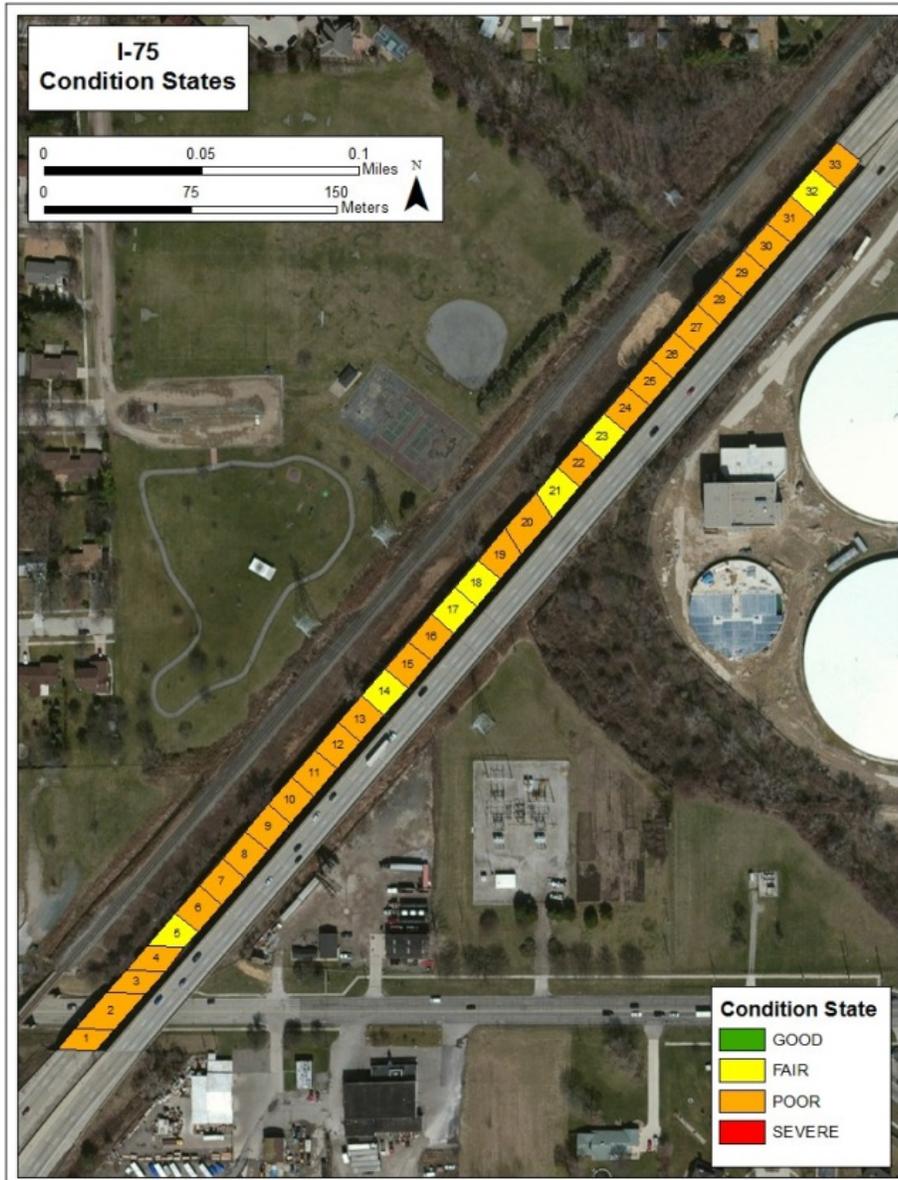
The I-75 southbound bridge contained 905 spalls and 1,410 delaminations within the defined 33 spans of the bridge deck (6 main spans and 27 approach spans). Through GIS analysis, the total bridge deck area was calculated to be 97,401 ft<sup>2</sup>. The total area of Condition State 2 – Fair distress features was determined to be 14,139 ft<sup>2</sup>, or approximately 14.52% of the total bridge deck (14,119 ft<sup>2</sup> classified as delaminations and 20 ft<sup>2</sup> classified as spalls that are 6 inches or less in diameter). Likewise, the total area of Condition State 3 – Poor distress features was determined to be 44 ft<sup>2</sup>, or approximately 0.04% of the total bridge deck (consisting of only spalls that are greater than 6 inches in diameter because delaminations are always classified as Condition State 2). The remainder of the bridge deck that did not contain any spalls or delaminations was classified as Condition State 1 – Good and equated to 83,219 ft<sup>2</sup>, or approximately 85.44% (Table 12 and Figure 44). For the location of individual distress features, please reference Figure 31 in Section 4.3.3.

**Figure 44: Summary of condition state per deck span at I-75 southbound.**

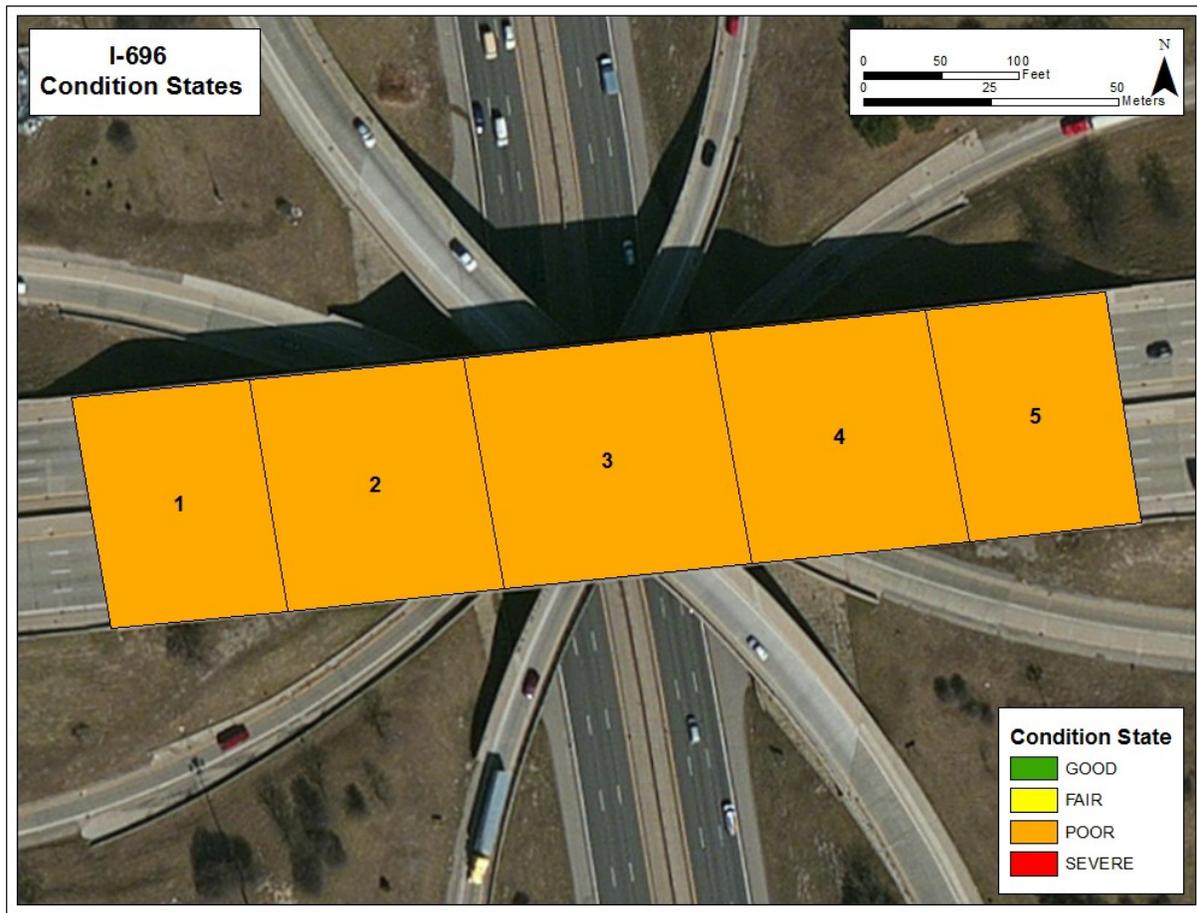
The I-696 bridge contained 118 spalls and 261 delaminations within the defined 5 spans of the bridge deck (3 main spans and 2 approach spans). The total area of Condition State 2 – Fair distress features was determined to be 808 ft<sup>2</sup>, or approximately 0.79% of the total bridge deck (806 ft<sup>2</sup> classified as delaminations and 2 ft<sup>2</sup> classified as spalls that are 6 inches or less in diameter). Likewise, the total area of Condition State 3 – Poor distress features was determined to be 91 ft<sup>2</sup>, or approximately 0.08% of the total bridge deck (consisting of only spalls since delaminations are always classified as Condition State 2). The remainder of the bridge deck that did not contain spalls or delaminations was classified as Condition State 1 – Good and equated to 101,309 ft<sup>2</sup>, or approximately 99.12% (Table 13 and Figure 45). For the location of individual distress features, please reference Figure 34 in Section 4.3.4.

**Figure 45: Summary of condition state per deck span at I-696.**

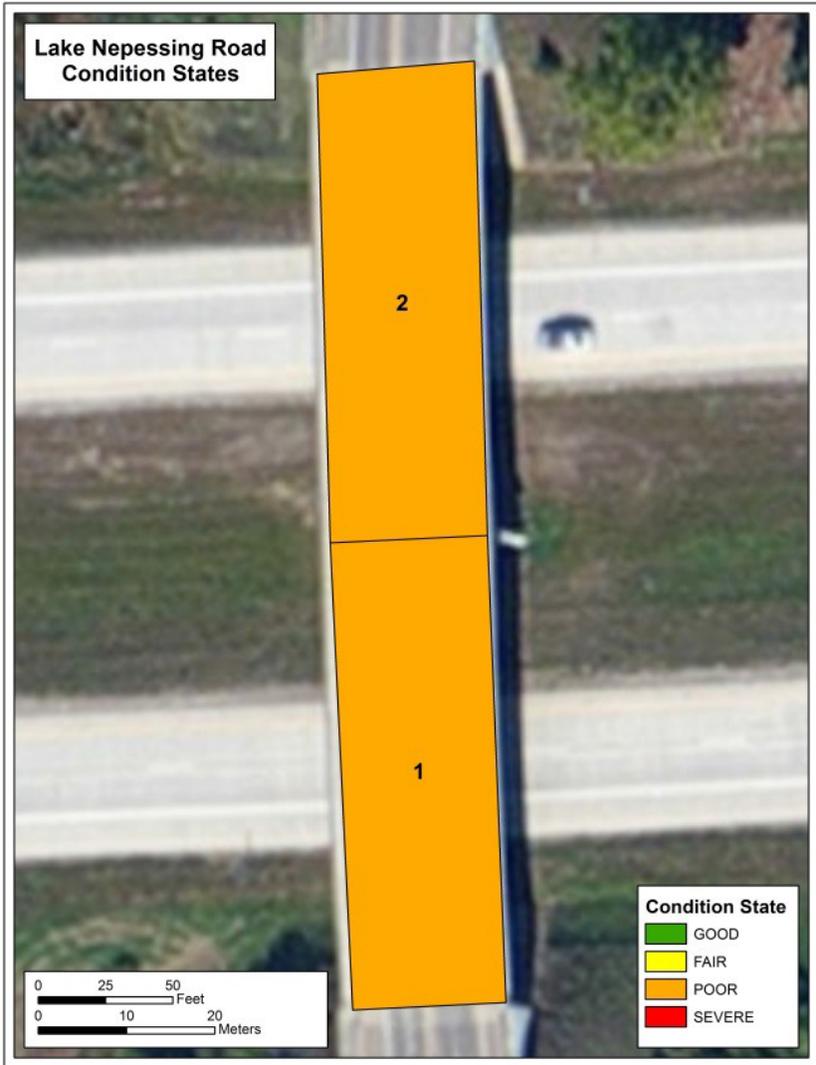
In the 3DOBS accuracy assessment, the Lake Nepessing Rd. bridge deck contained 75 spalls manually measured within the defined two spans of the bridge deck (2 main spans and 0 approach spans). The detection of delaminations through the use of thermal imagery was not conducted on this bridge and therefore the condition state values do not contain any delamination measurements. Based on MDOT bridge inspection reports, the total bridge deck area is 11,721 ft<sup>2</sup>. The total area of Condition State 2 – Fair distress features was determined to be 1 ft<sup>2</sup>, or approximately 0.01% of the total bridge deck. Likewise, the total area of Condition State 3 – Poor distress features was

determined to be 36ft<sup>2</sup>, or approximately 0.31% of the total bridge deck (consisting of only spalls that are greater than 6 inches in diameter). The remainder of the bridge deck that did not contain any spalls was classified as Condition State 1 – Good and equated to 11,684 ft<sup>2</sup>, or approximately 99.68% (Table 14 and Figure 46).

**Figure 46: Summary of condition state per deck span at Lake Nepessing Rd.**
