**Report No. K-TRAN: KSU-98-6
Final Report**

ANALYSIS OF RURAL INTERSECTION ACCIDENTS CAUSED BY STOP SIGN VIOLATION AND FAILURE TO YIELD THE RIGHT-OF-WAY

Final Report
September 2000

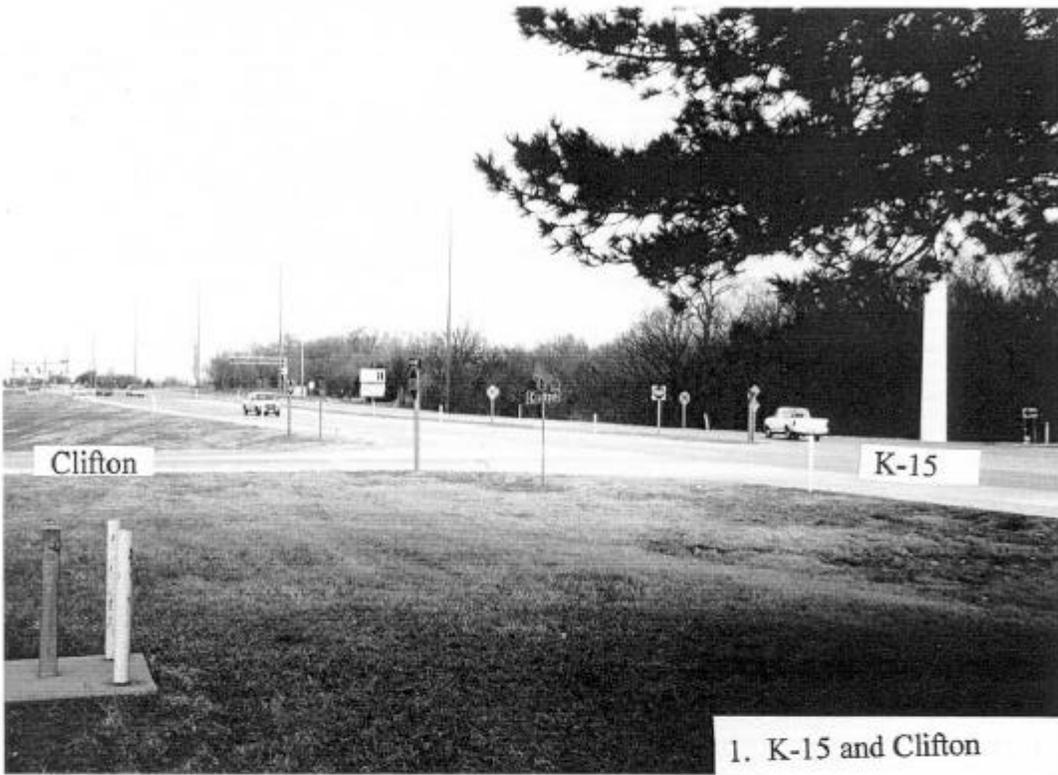
Clifton is a two-lane residential collector with a posted speed limit of 30 mph. K-15 is a four-lane divided highway with a posted speed of 50 mph. The intersection is just south of the intersection of K-15 and MacArthur in far southeast Wichita. The intersection experienced two fail-to-yield accidents during the period 1994-1996. Both accidents involved vehicles attempting left-turns from Clifton onto K-15. The intersection is a "T" intersection with good sight distance on all approaches to the intersection (see Photo 1, Appendix).

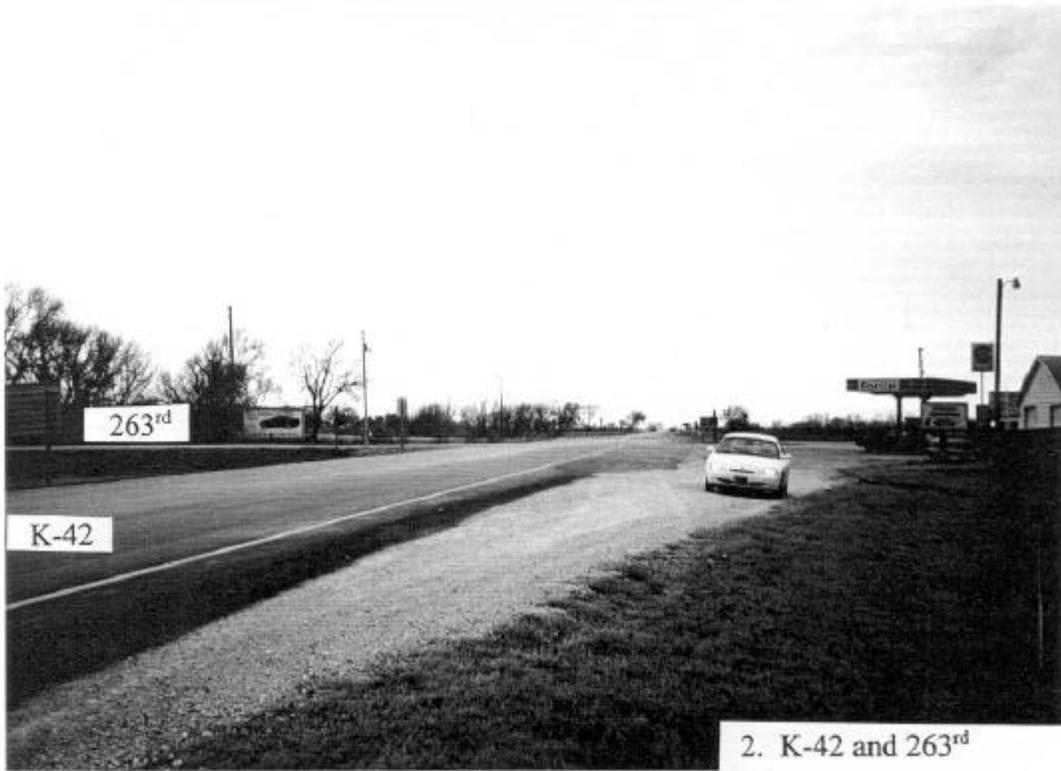
The minor roadway (263rd Street) is a two-lane rural arterial street with a posted speed of 55 mph. K-42 is a two-lane state highway with a posted speed of 55 mph. The intersection is just north of the city of Viola in southwest Sedgwick County. The intersection experienced two fail-

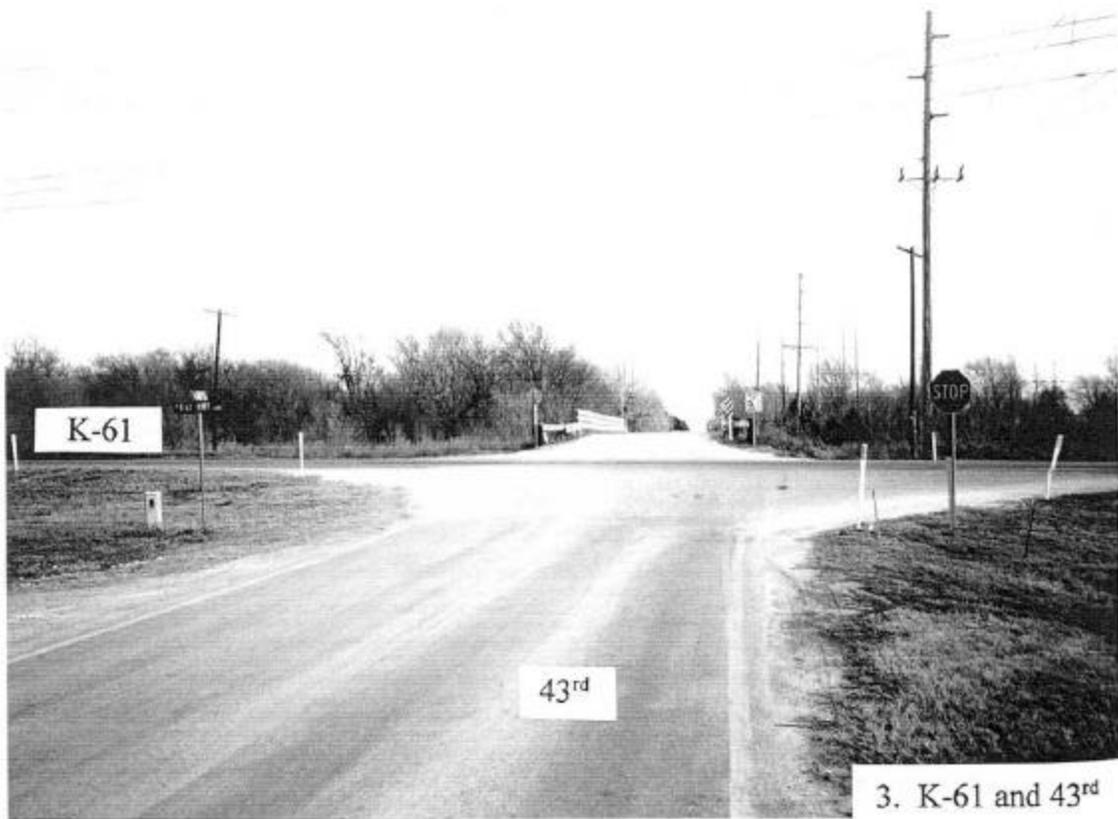
3. K-61 and 43rd

The minor roadway (43rd Avenue) is a two-lane rural collector highway with a posted speed of 55 mph. K-61 is a two-lane state highway with a posted speed of 55 mph. The intersection is just north of the city of Hutchinson in Reno County. The intersection experienced two fail-to-yield accidents during the period 1994-1996. Both accidents involved vehicles attempting crossing maneuvers on 43rd Avenue. K-61 has a gentle grade through the intersection but sight distances appear adequate on all approaches to the intersection (see Photo 3).

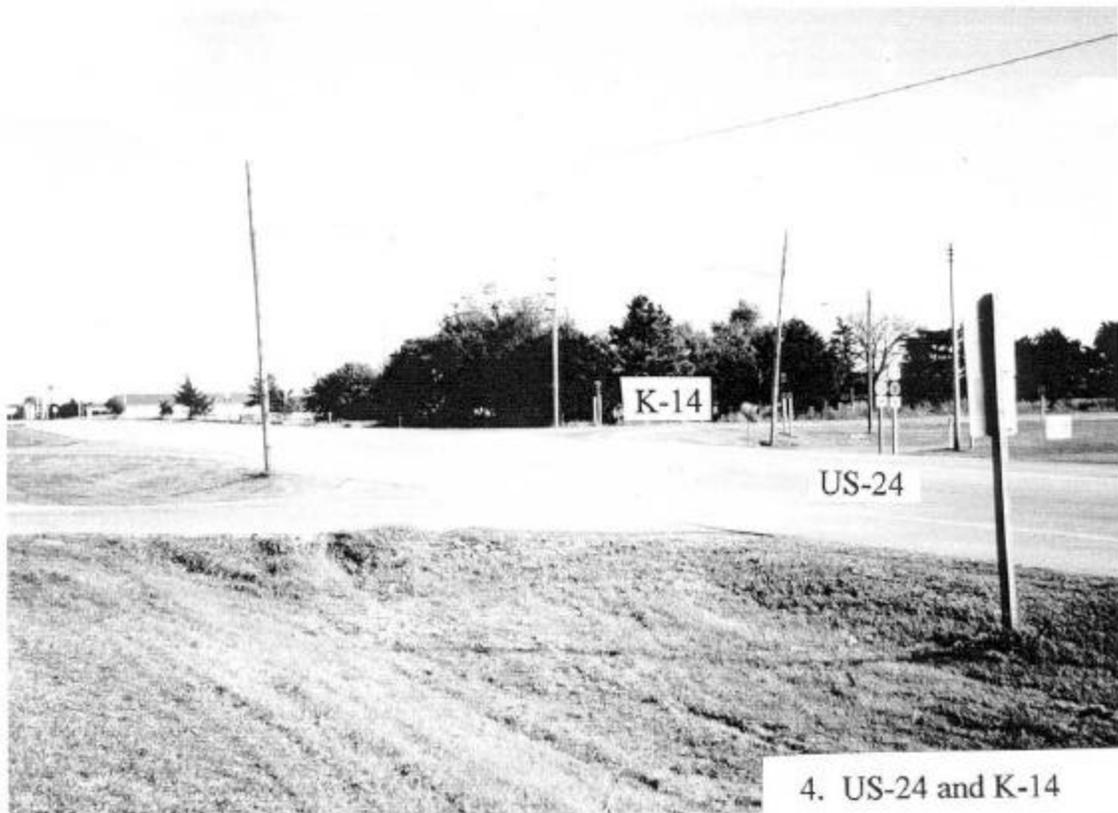
4. US-24 and K-14

The intersection of US-24 and K-14 is located just north of the city of Beloit in Mitchell County. Both roadways have posted speed limits of 45 mph. The intersection experienced two fail-to-yield accidents during the period 1994-1996. Both accidents involved vehicles on K-14 (Stop controlled) attempting to cross US-24. US-24 has a slight grade through the intersection but sight distance is good on all four approaches to the intersection (see Photo 4).

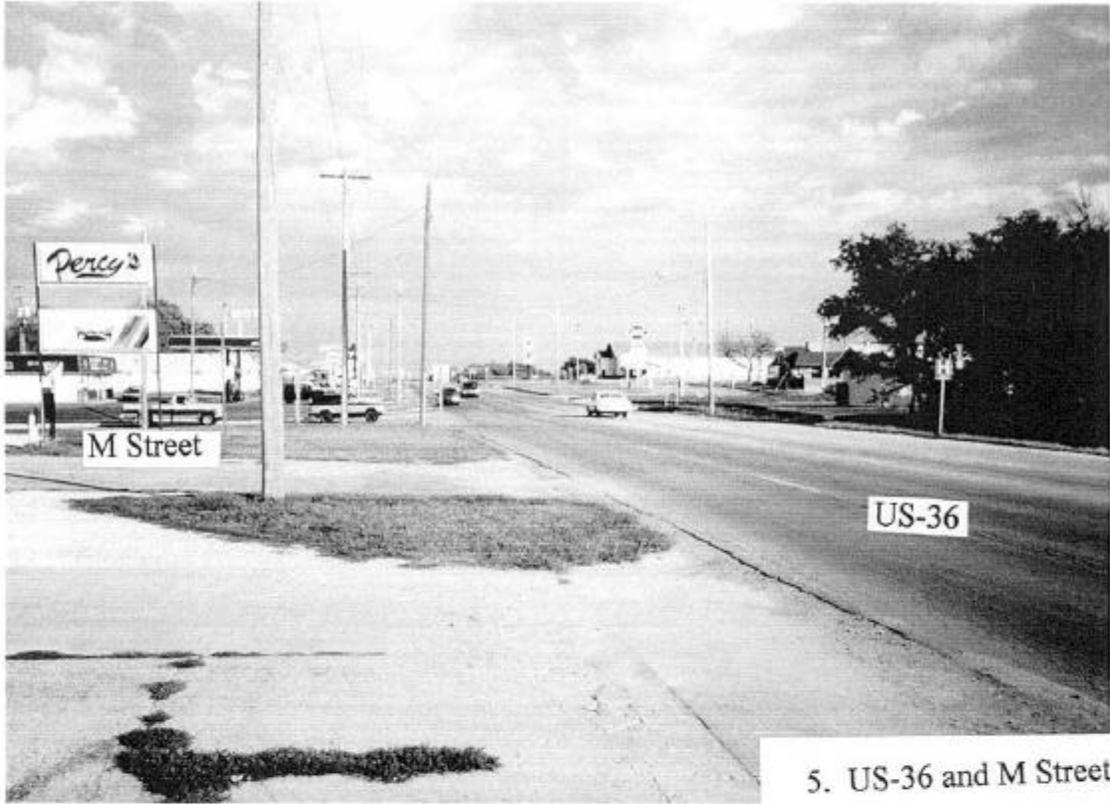
5. US-36 and M Street

The intersection of US-36 and M Street is a “T” intersection on the southern edge of the city of Belleville in Republic County. The intersection experienced two fail-to-yield accidents during the period 1994-1996. Both accidents involved vehicles on M Street (Stop controlled) attempting to make a left turn onto US-36. There is considerable “visual clutter” (signs, utility poles, etc.) along US-36, but sight distances appear to be adequate (see Photo 5).

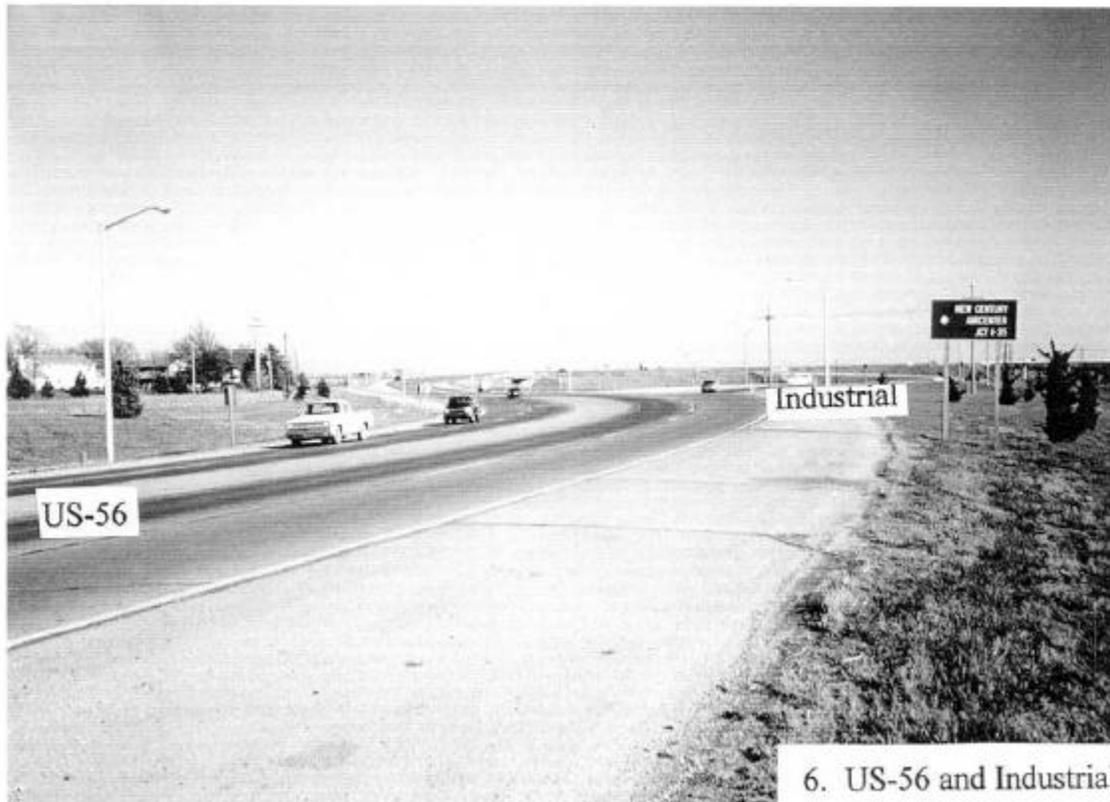
6. US-56 and Industrial

The intersection of US-56 and Industrial is a “T” intersection on the eastern edge of the city of Gardner, Johnson County. The intersection experienced two fail-to-yield accidents during the period 1994-1996. Both accidents involved vehicles on Industrial (Stop controlled) attempting to make a left turn onto US-56. The posted speed on US-56 is 50 mph. Industrial has a posted speed of 35 mph. Industrial intersects US-56 on a long horizontal curve, but sight distances appear to be adequate on all approaches to the intersection (see Photo 6).

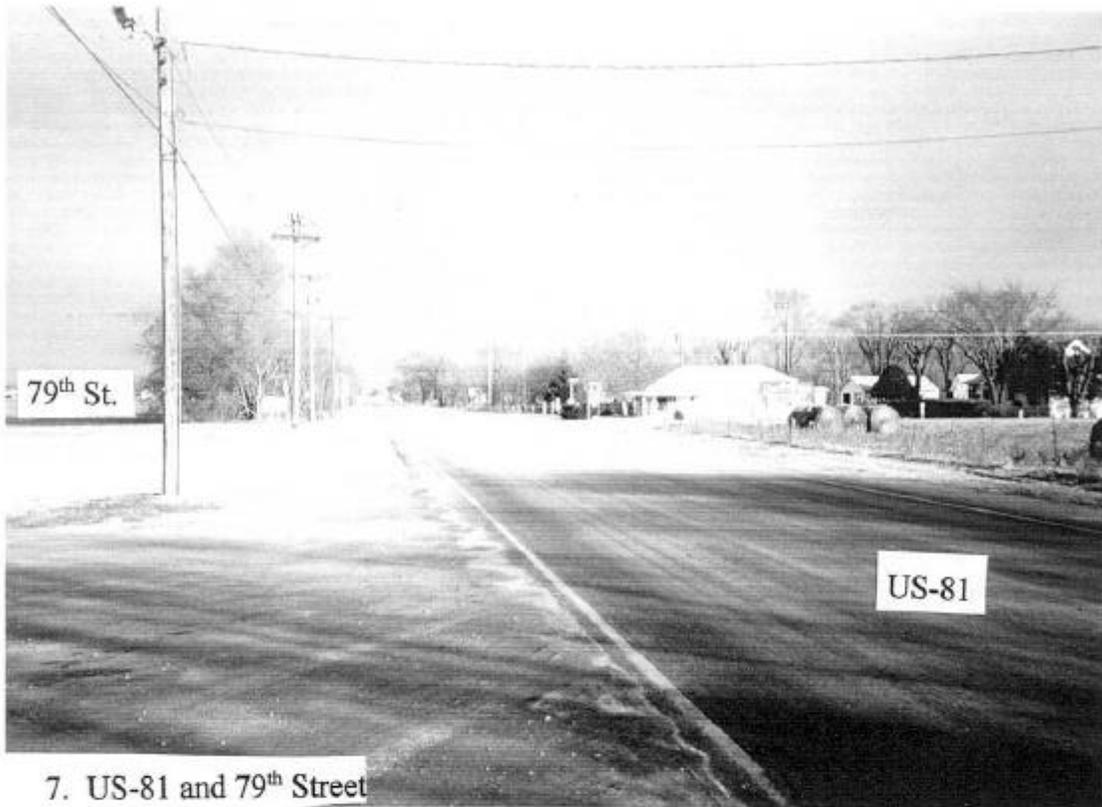
7. US-81 and 79th Street

The intersection of US-81 and 79th Street is located south of Wichita in Sedgwick County. The intersection experienced two fail-to-yield accidents during the period 1994-1996. Both accidents involved vehicles on 79th Street (Stop controlled) attempting to make a left turn onto US-81. The posted speed on US-81 is 50 mph and 79th Street has a posted speed of 35 mph. There are utility poles and large trees along the western edge of US-81, but sight distances appear to be adequate on all approaches to the intersection (see Photo 7).

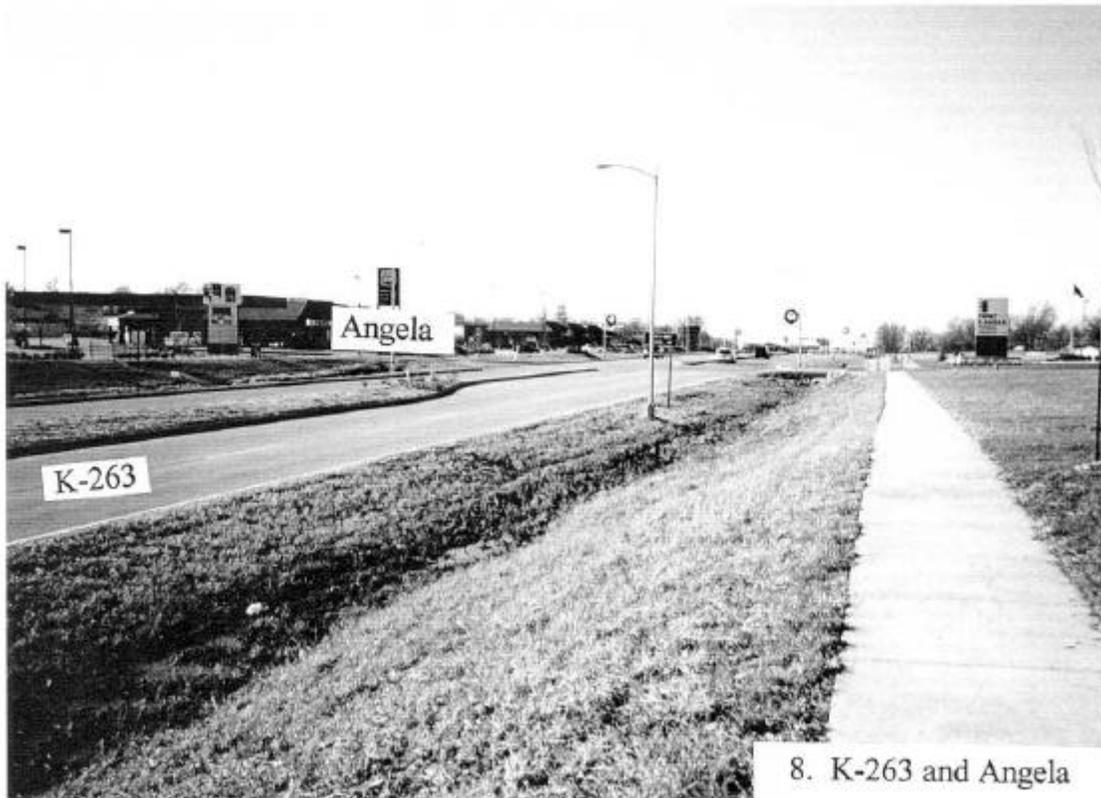
8. K-263 and Angela

intersection experienced three fail-to-yield accidents during the period 1994-1996. Two of the accidents involved vehicles on Angela (Stop controlled) attempting to make a left turn onto K-263. The third accident involved a vehicle on Angela (Stop controlled) attempting to cross K-263. The posted speed on K-263 is 45 mph. Angela has a posted speed of 30 mph. Angela is basically a driveway serving commercial activities on both sides of K-263. Sight distances appear to be adequate on all approaches to the intersection (see Photo 8).

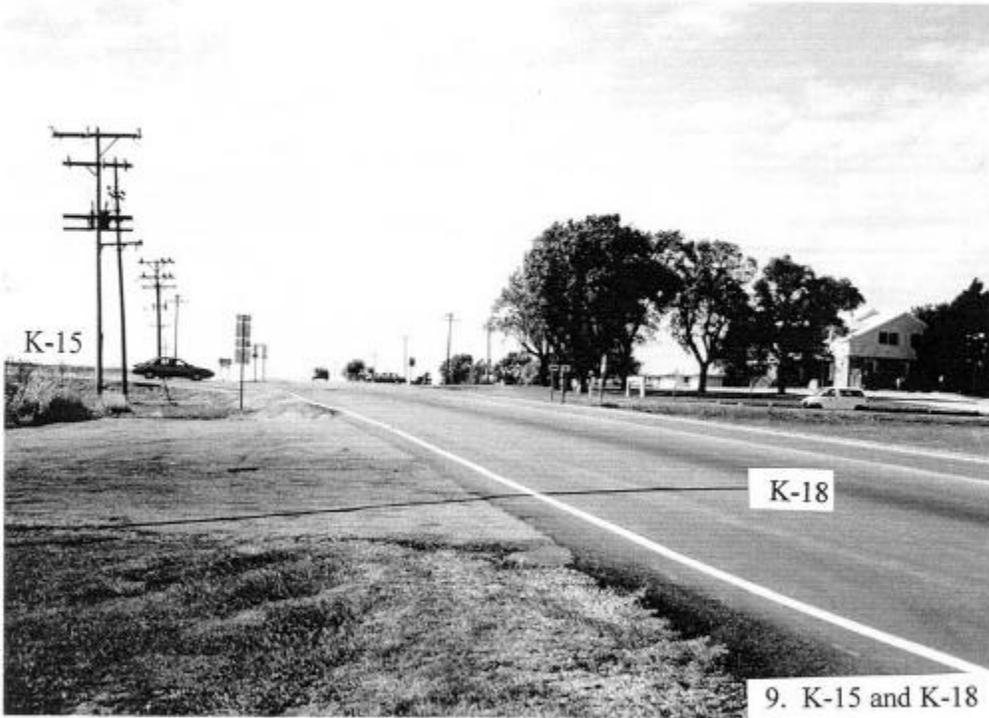
9. K-15 and K-18

The intersection of K-15 and K-18 is an isolated rural intersection in Dickinson County. The intersection experienced two fail-to-yield accidents during the period 1994-1996. Both of the accidents involved vehicles on K-15 (Stop controlled) attempting to cross K-18. The posted speed on both roadways is 55 mph. K-15 intersects K-18 near the crest of a long vertical curve and sight distance to the west of K-15 may be restricted (see Photo 9). It should be noted, however, that both accidents involved westbound vehicles on K-18 (i.e., vehicles approaching the crest of the vertical curve on K-18).
