# Evaluation of Salvage and Replanted Native Plants on ADOT Projects

Final Report 587  
June 2012

Arizona Department of Transportation  
Research Center

Logan Simpson Design, Inc.  
51 West Third Street, Suite 450  
Tempe, AZ 85281

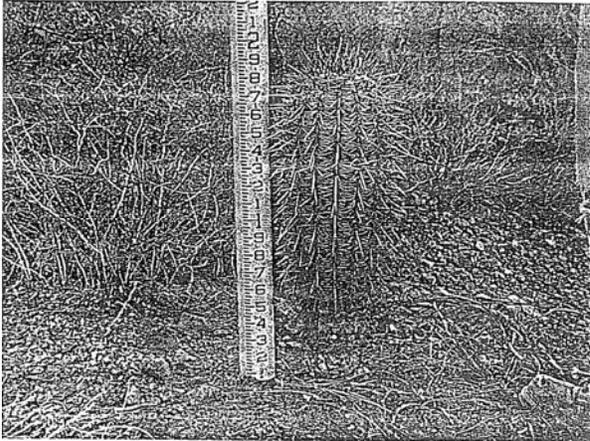
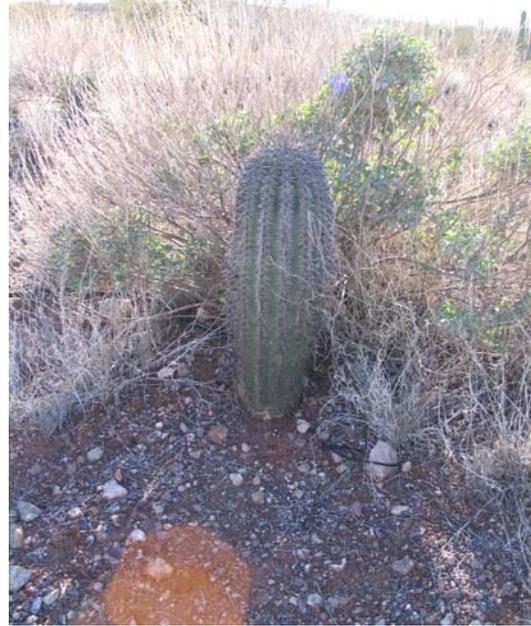
Above: Contractor's presalvage photo of saguaro tag #71, 2002.

Right: Saguaro in excellent condition at time of inventory, January 28, 2008. Original tag #71, LSD #166.

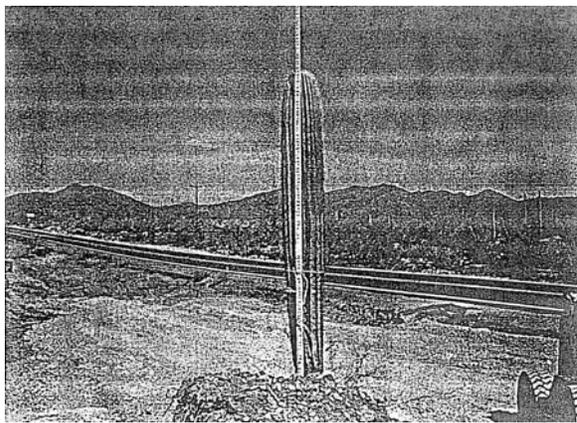
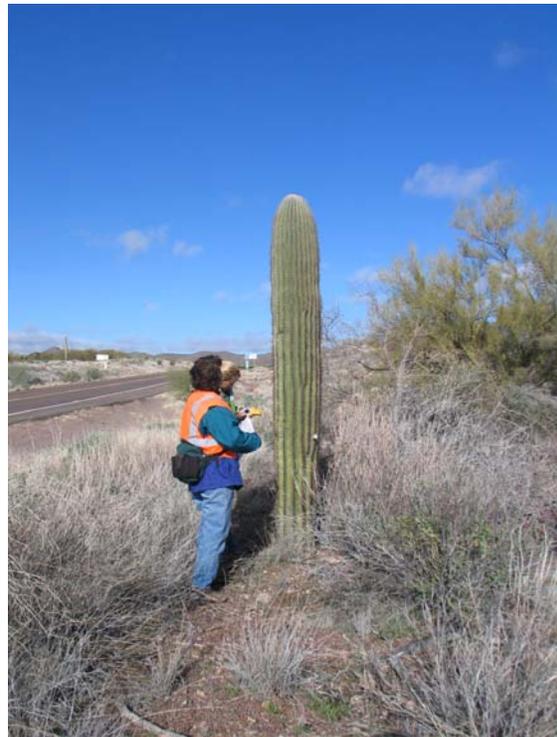
Above: Contractor's presalvage photo of saguaro tag #36.

Right: Saguaro in good condition at time of inventory, January 28, 2008. Original tag #36, LSD #100.

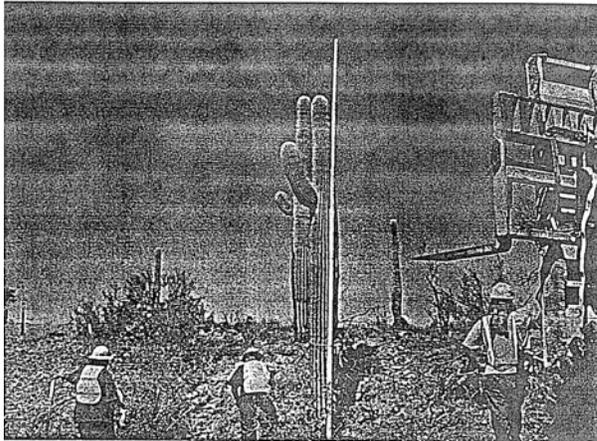
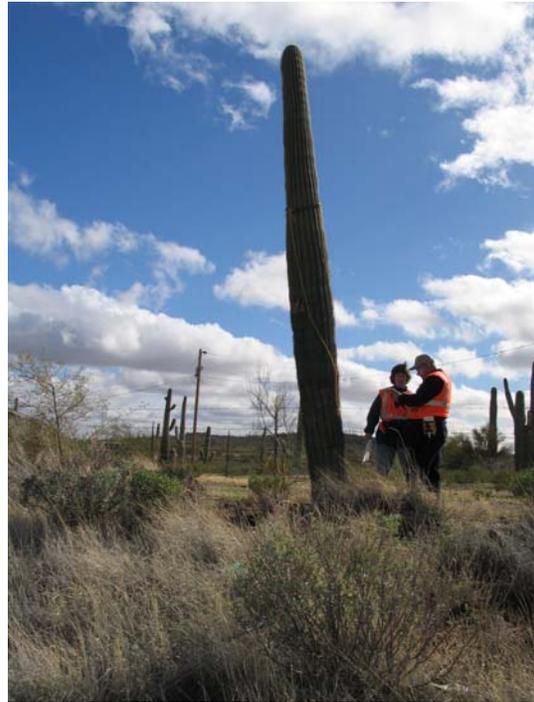
Above: Contractor's presalvage photo of saguaro tag #40.

Right: Saguaro in fair condition at time of inventory, January 28, 2008. Original tag #40, LSD #136.

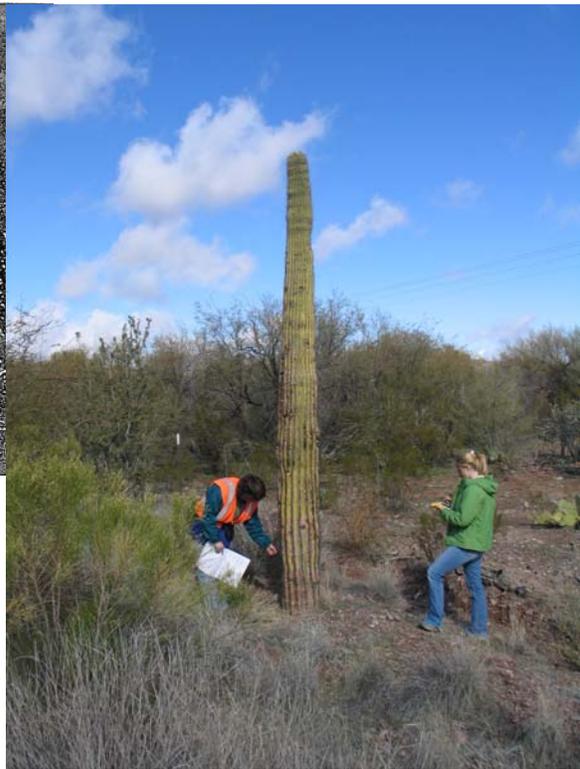
Above: Contractor's presalvage photo of saguaro tag #50.

Right: Saguaro in poor condition at time of inventory, January 28, 2008. Original tag #50, LSD #114.

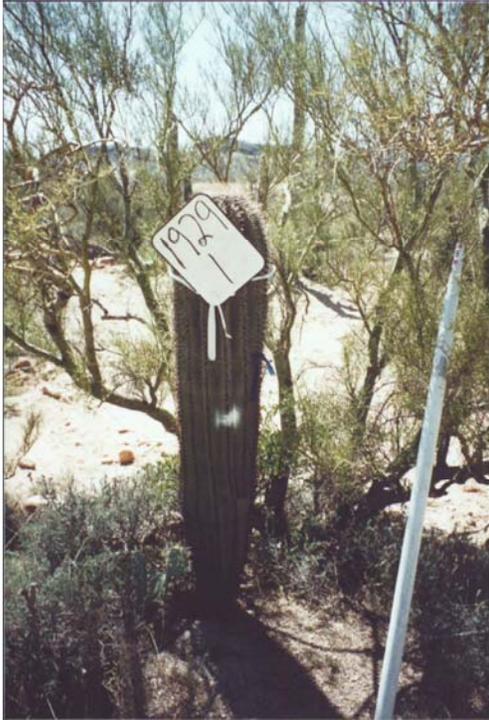
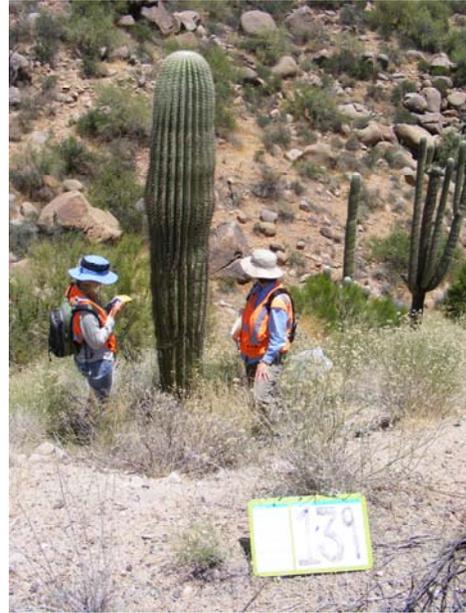
Left: Contractor's presalvage photo of saguaro tag #1929-1.

Above: Saguaro in excellent condition at time of inventory, June 19, 2008. Original tag #1929-1, LSD #139.

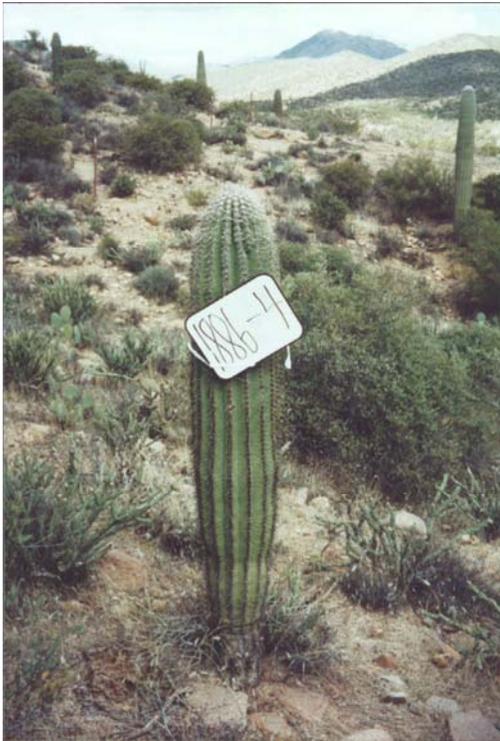
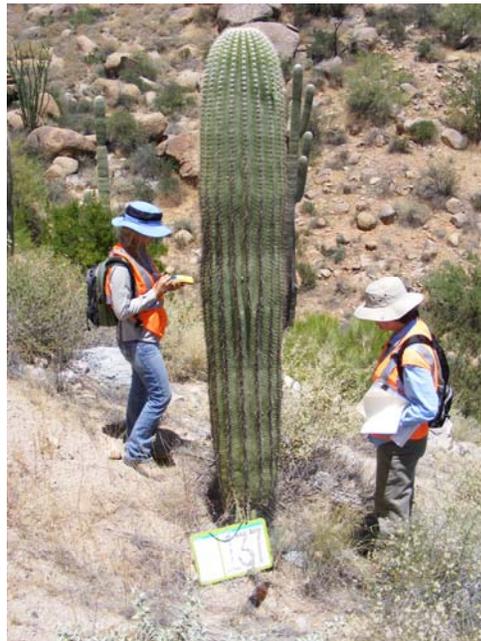
Above Left: Contractor's presalvage photo of saguaro tag #1886-4.

Above Right: Saguaro in good condition at time of inventory, June 19, 2008. Original tag #1886-4, LSD #137.

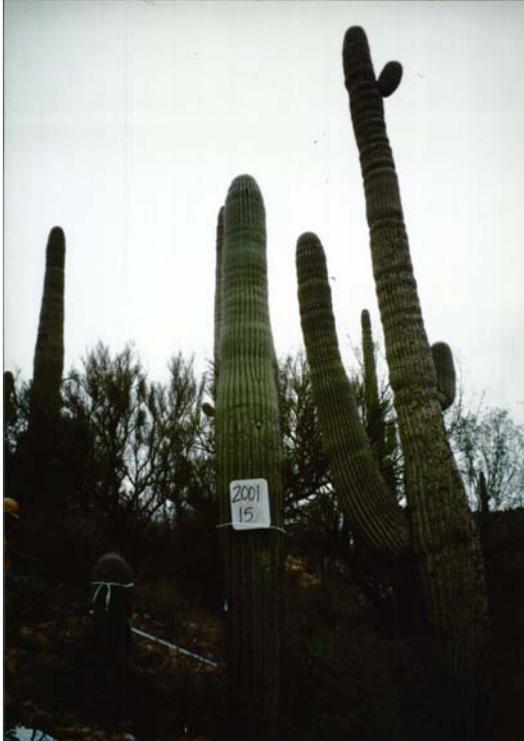
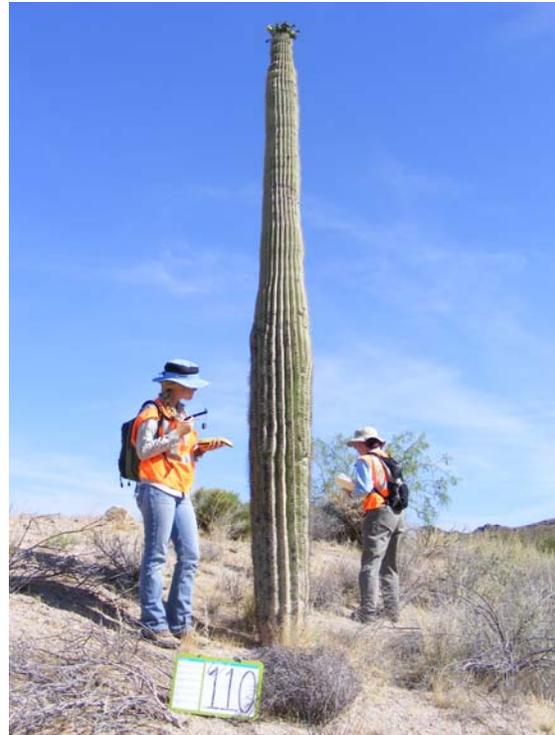
Above: Contractor's presalvage photo of saguaro tag #2001-15.  
Right: Saguaro in fair condition at time of inventory, June 19, 2008.  
Original tag #2001-15, LSD #110.

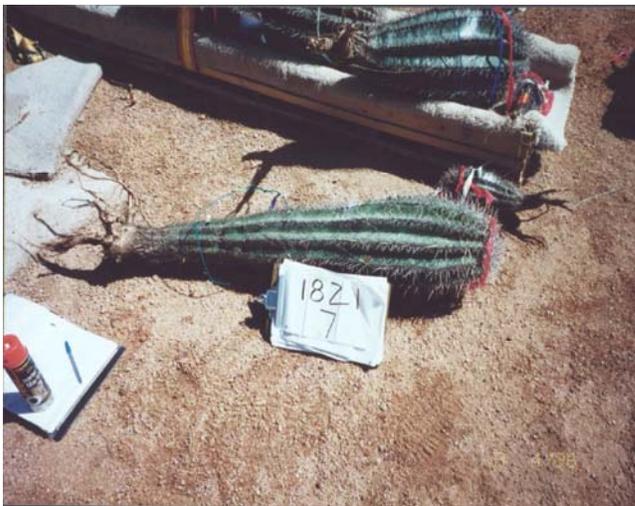
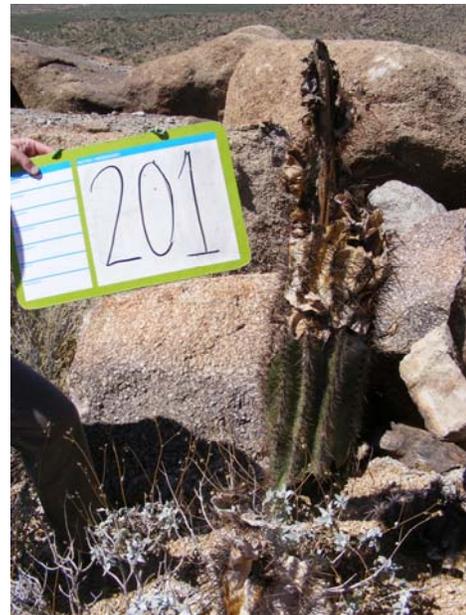
Above: Contractor's presalvage photo of saguaro tag #1821-7.  
Right: Saguaro in poor condition at time of inventory, June 19, 2008.  
Original tag #1821-7, LSD #201.

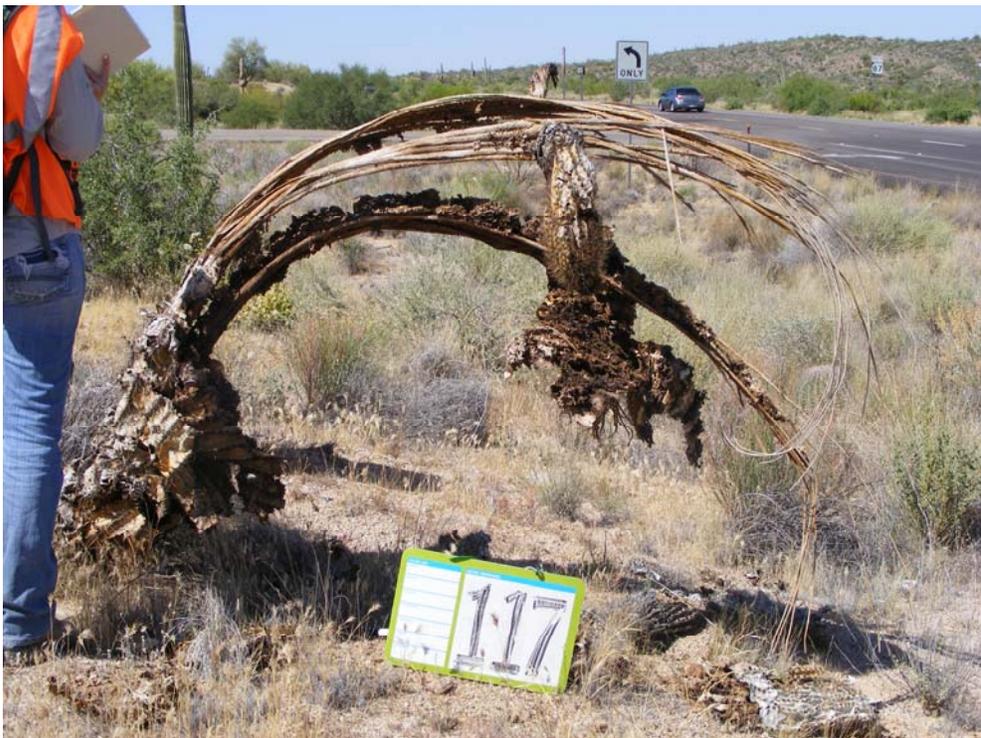
Below: Saguaro dead at time of inventory, June 19, 2008.  
Original tag #1670-17, LSD

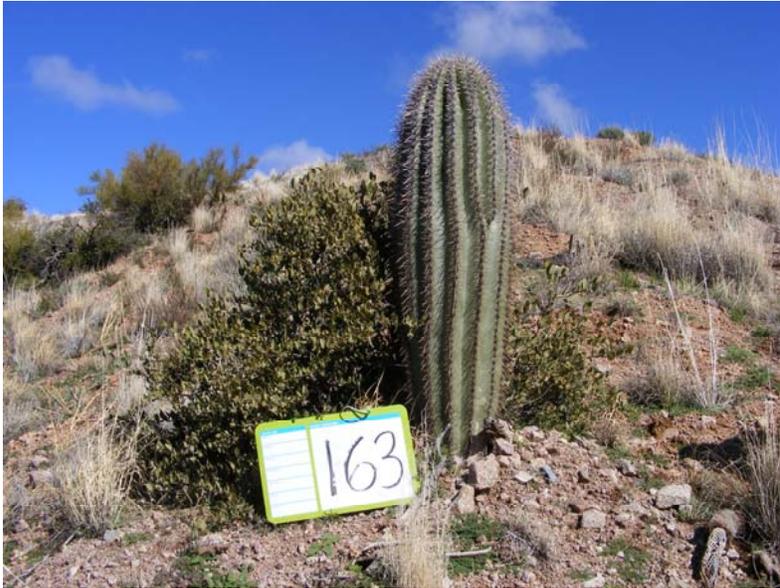
Left:  
Saguaro in excellent condition at time of inventory, February 5, 2008.  
Original tag #N/A, LSD #163.  
NOTE: No Contractor's presalvage photo available.

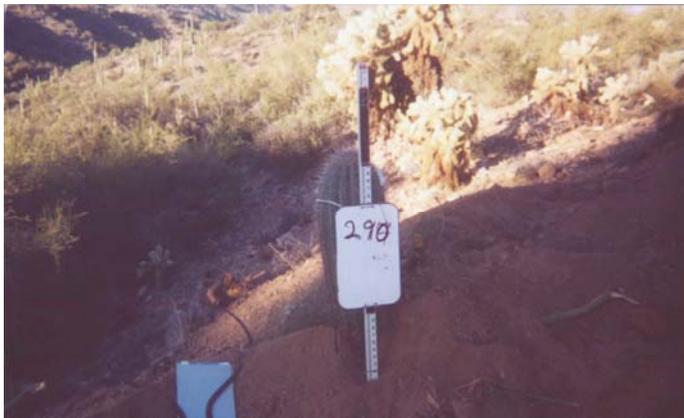
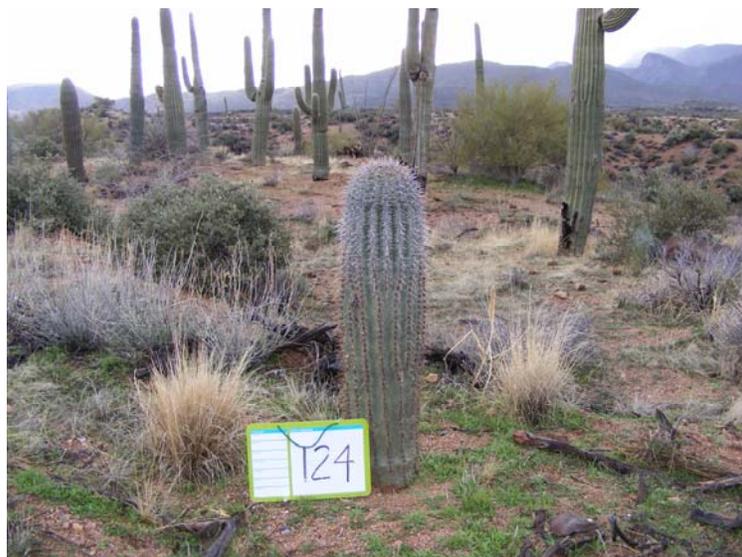
Left:  
Contractor's presalvage photo of saguaro tag #290.

Right:  
Saguaro in good condition at time of inventory, February 4, 2008.  
Original tag #290, LSD #124.

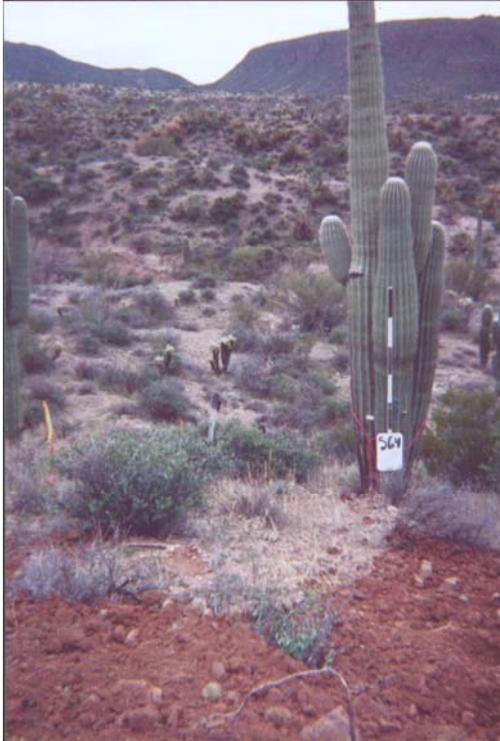
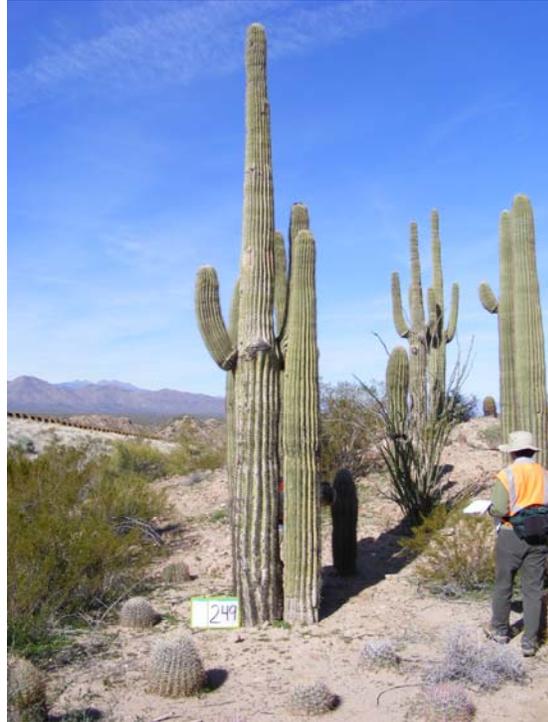
Above, Left: Contractor's presalvage photo of saguaro tag #564.  
Right: Saguaro in fair condition at time of inventory, February 13, 2008.  
Original tag #564, LSD #249.

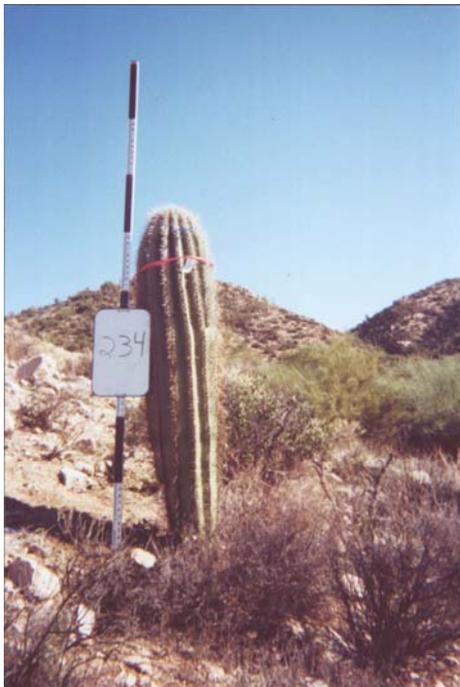
Left: Contractor's presalvage photo of saguaro tag #234.

Right: Saguaro in poor condition at time of inventory, February 4, 2008. Original tag #234, LSD #106.

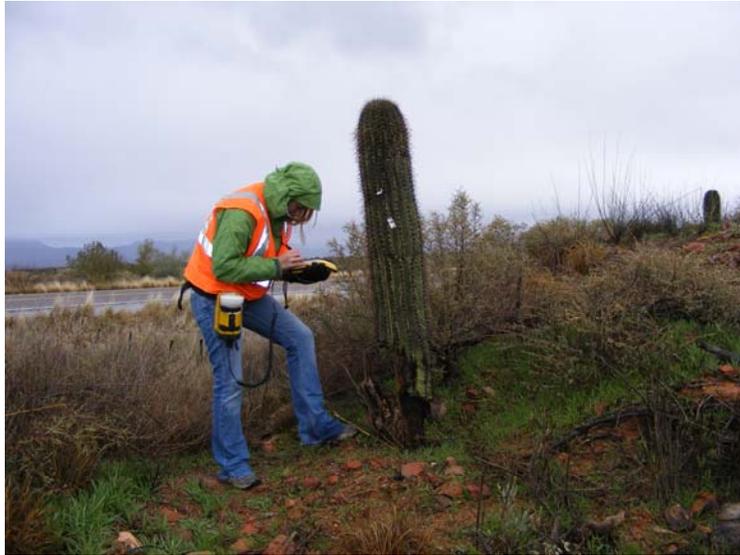
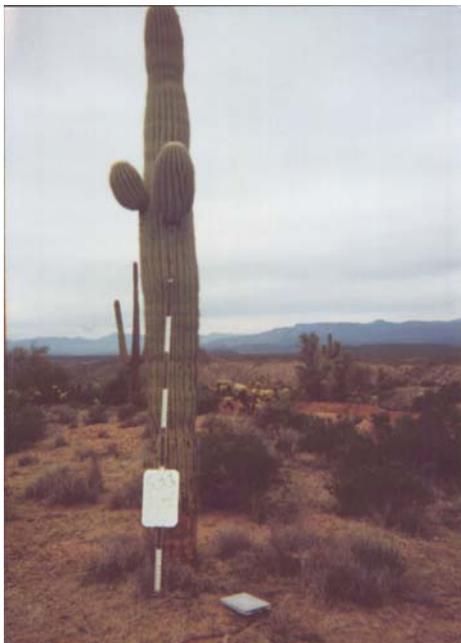
Above: Contractor's presalvage photo of saguaro tag #530.  
Right: Saguaro dead at time of inventory, February 13, 2008. Original tag #530, LSD #246.

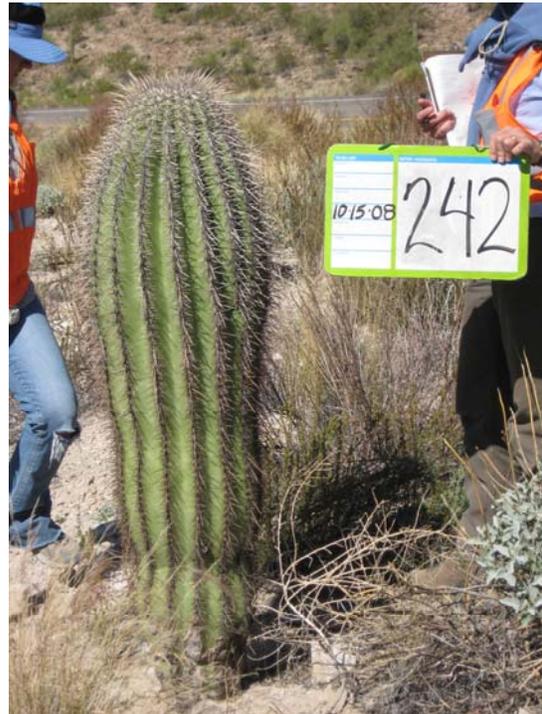
Left: Contractor's presalvage photo of saguaro tag #8251.  
Right: Saguaro in excellent condition at time of inventory, October 15, 2008.  
Original tag #8251, LSD #242.

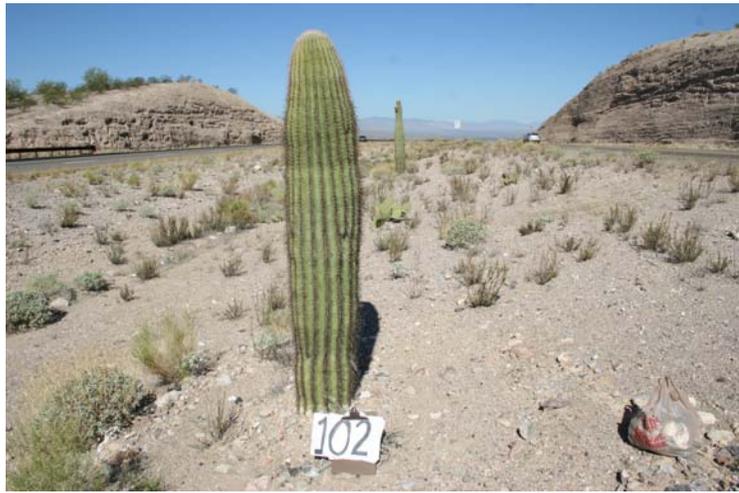
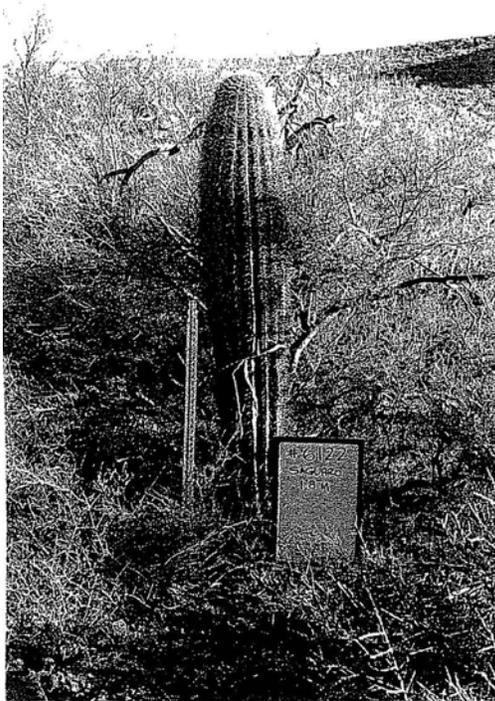
Left: Contractor's presalvage photo of saguaro tag #6122.  
Above: Saguaro in good condition at time of inventory, October 9, 2008.  
Original tag #6122, LSD #102.

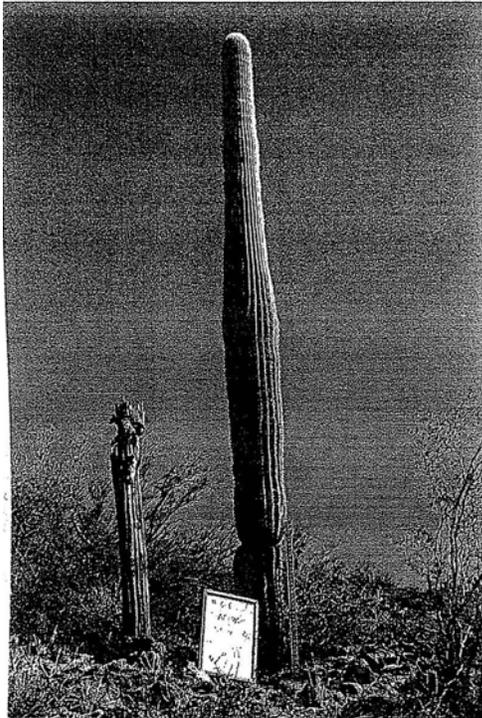
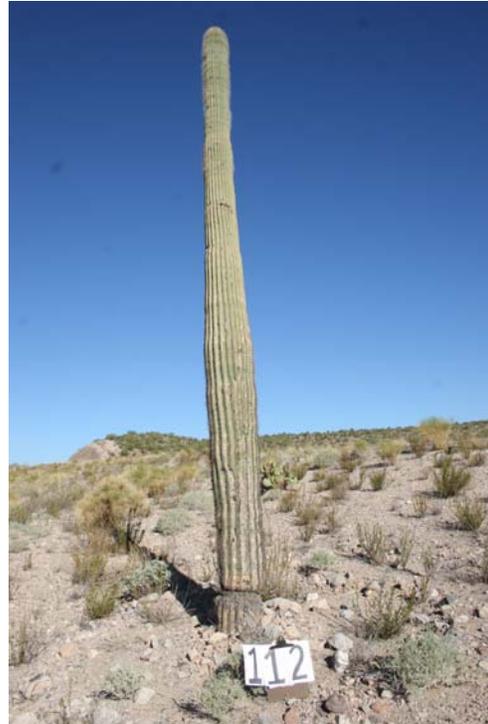
Above Left: Contractor's presalvage photo of saguaro tag #6655.  
Above Right: Saguaro in fair condition at time of inventory, October 9, 2008.  
Original tag #6655, LSD #112.

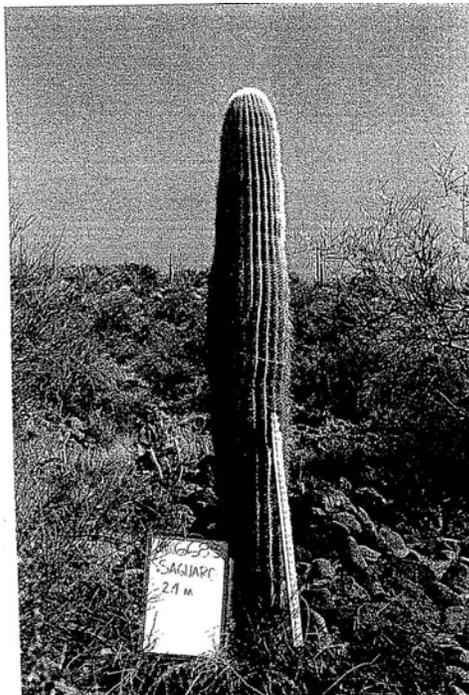
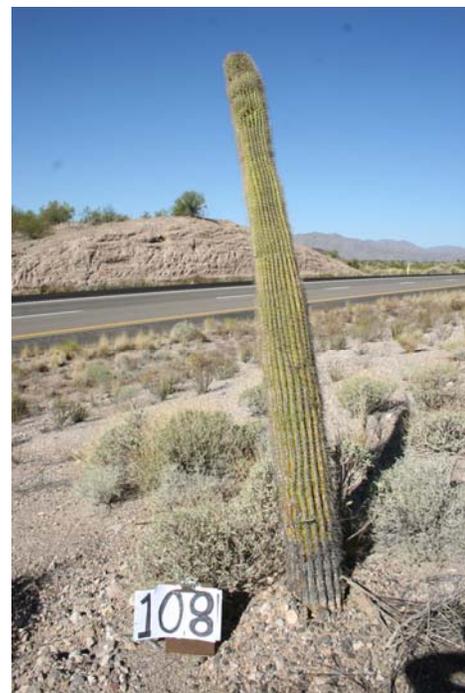
Above Left: Contractor's presalvage photo of saguaro tag #6683.  
Above Right: Saguaro in poor condition at time of inventory, October 9, 2008.  
Original tag #6683, LSD #108.

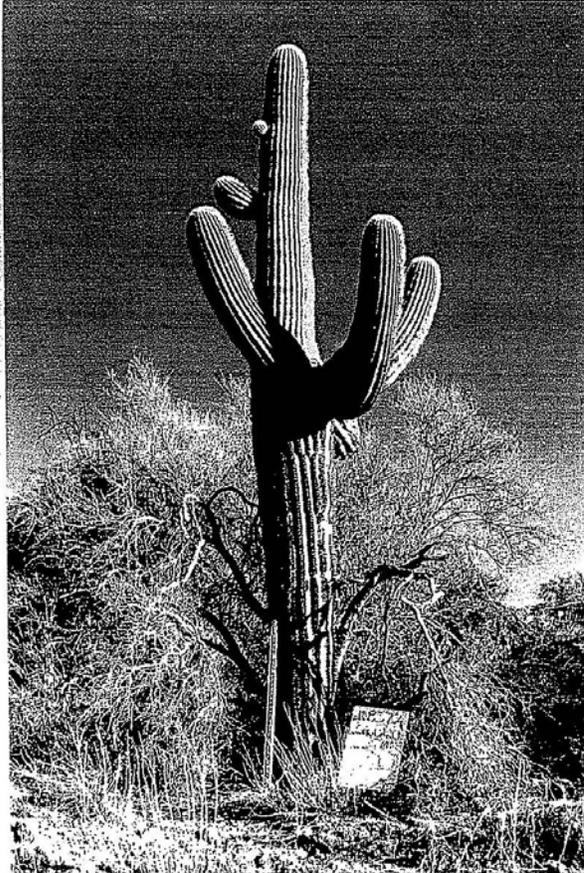
Left: Contractor's presalvage photo of saguaro tag #8372.  
Below: Saguaro dead at time of inventory, October 9, 2008. Original tag #8372, LSD #135.
