Research Report

KTC-15-19/MTIC7-14-1F

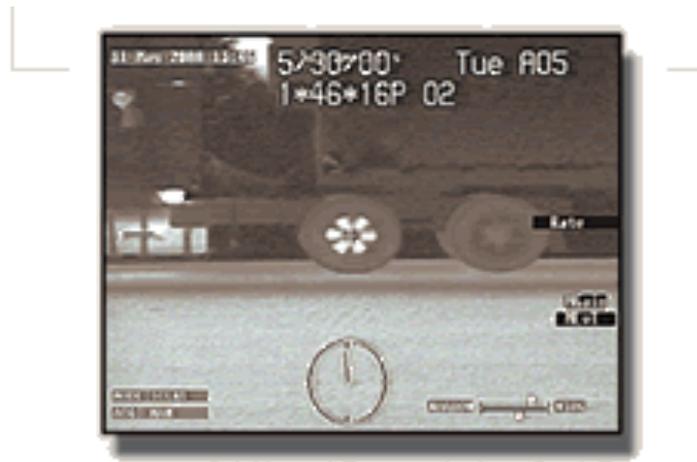
**Figure 1.** Thermal Imaging Displaying an Inoperable Brake

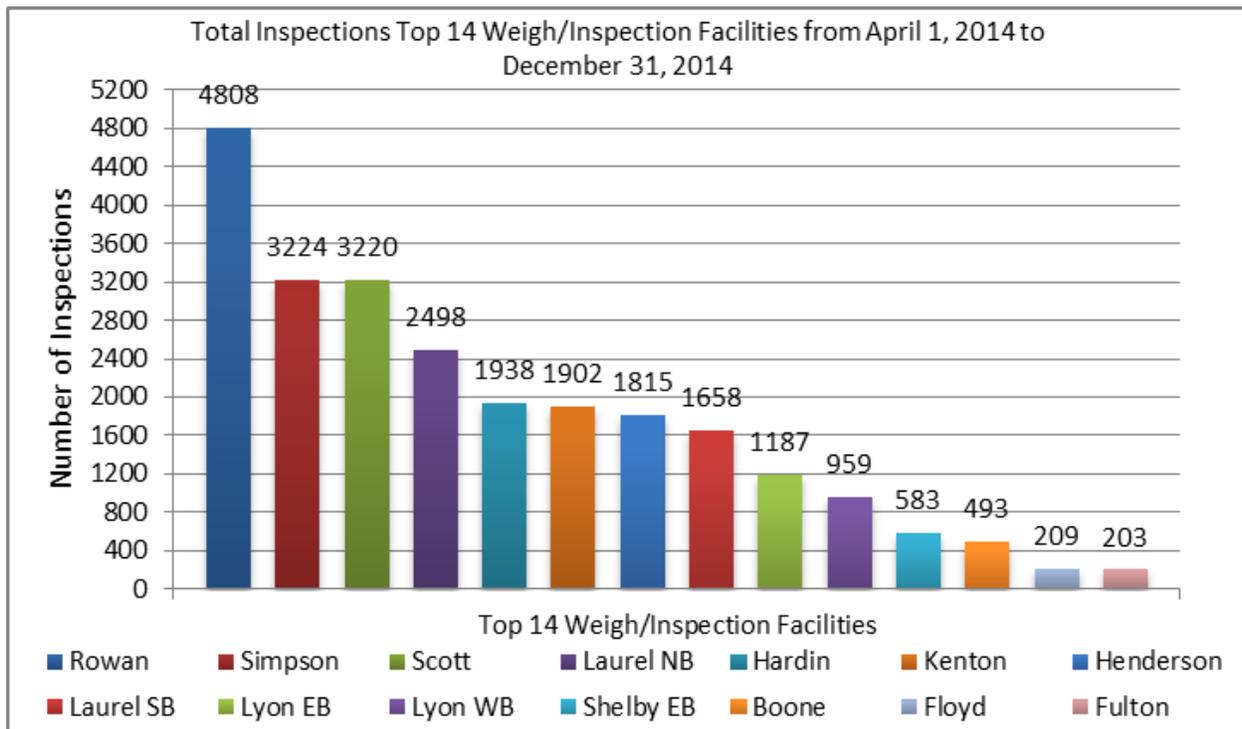
**Figure 3.** Number of Inspections at Inspection Facilities (April 1 - December 31, 2014)
