### 3.6 Pavement Performance

## 3.7 Results and Conclusions

### **4.1 Pavement Structure**

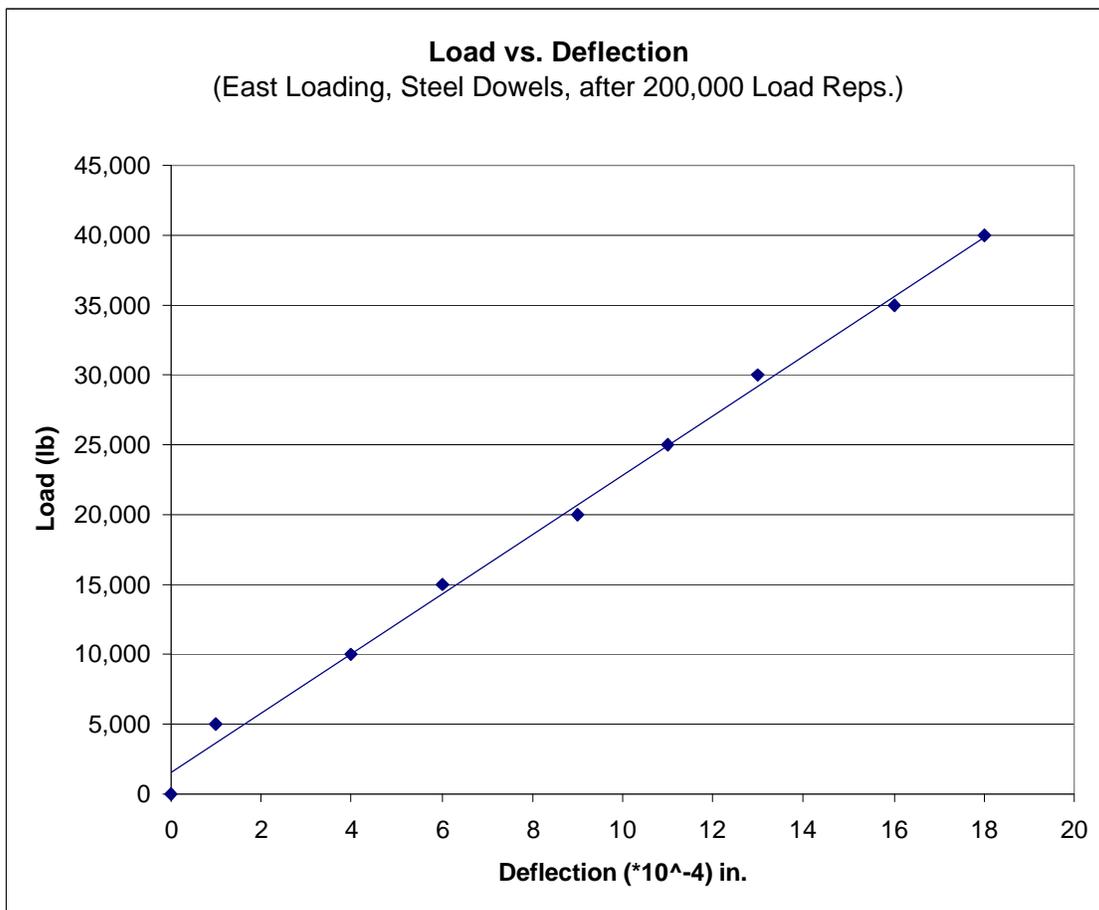
Figure 3.10 Load vs. Deflection After 200,000 Cycles  
(Measurement from Gage 1)

Vertical displacement of the slabs was measured at about 25.4 cm (10 in) from each side of the joints, in both the steel dowel slab and the FRP slab. Displacement tests were conducted before applying any load (at zero repetition) and every 200,000 repetitions afterwards up to one million repetitions. Displacement measurements were made in order to draw load/deflection curves. For these tests, the fatigue cyclic loads were stopped, and static loads were applied in 5,000 lbs increments up to a maximum axle load of 40,000 lbs. The four dial indicators with 0.001" accuracy shown in Figure 3.7 were read and recorded manually. One load/deflection curve was drawn from each gage reading. When the east beam was loaded (east loading), gages 1 and 3 were considered "under load" (or on the loaded slab) and gages 2 and 4 were considered "across load" or (across from the loaded slab). This is the opposite when the west beam was loaded (west loading). A typical load/deflection curve is shown in Figure 3.10 from gage No. 1 for the case of east loading, after the first 200,000 cycles were applied.

The slope of the load/deflection curve is an indication of the stiffness of the slab since stiffness  $k$  is defined as the ratio of the load  $P$  over the displacement  $d$ . The variation of the slope (stiffness) was correlated against the number of load cycles applied to the specimens. This is shown in Figure 3.11 which gives the data points and linear regression lines for the east and west loading, with the steel and FRP dowels side-by-side. For all cases, it can be shown that the slope increases as the number of load applications increases. Such an increase in slope signifies that for a given level of loading the corresponding vertical displacement is reduced. Normally one would expect vertical displacements to increase as the number of cycles increases and the specimen weakens or experiences damage. In this case, the decreased deflection (and consequently increase in slope) can be attributed to the additional compaction of the soil and not to a reduction in stiffness.

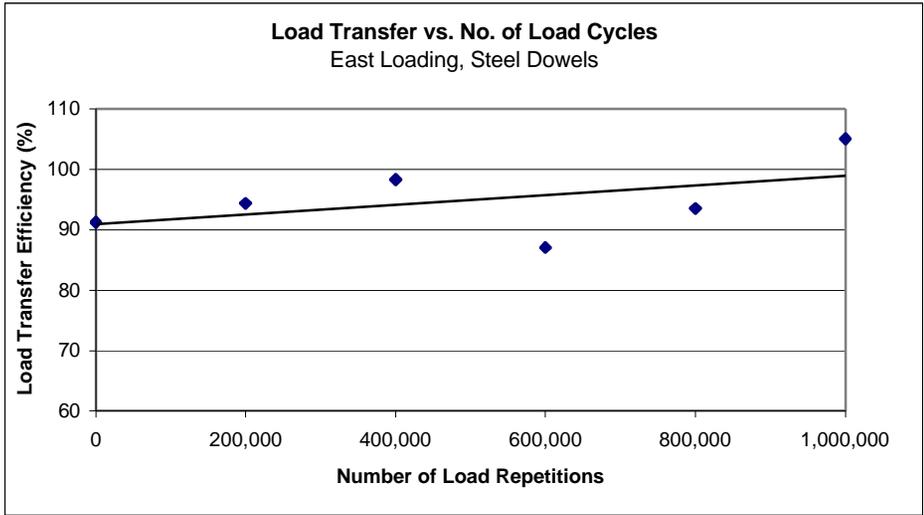
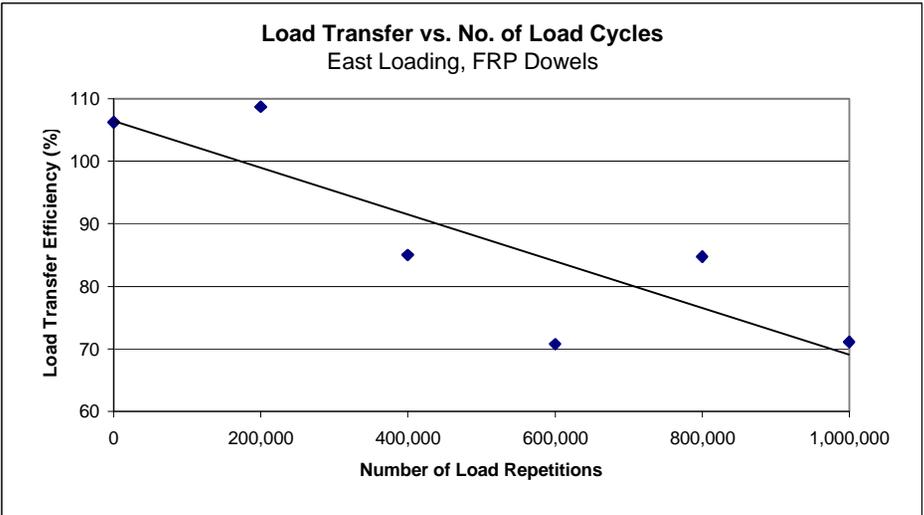
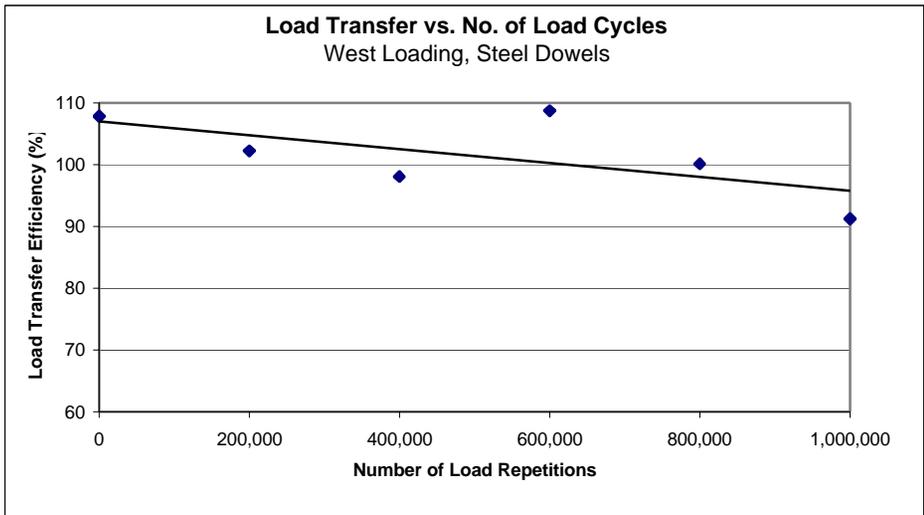
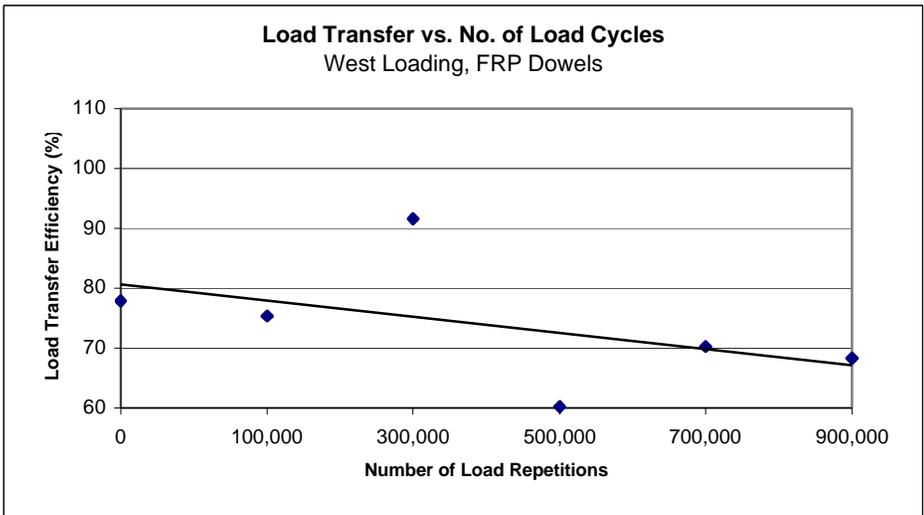
Figure 3.12 Variation of Load Transfer Efficiency with Respect to Number of Load Cycles

The load transfer efficiency (LTE) was calculated using the slopes (stiffness) from the load/displacement data. For this experiment, LTE is defined as the ratio of the loaded to non-loaded slopes from the load/deflection curves. The load deflection curves were developed by loading one side of the joint while measuring the corresponding deflections from the loaded and non-loaded sides of the joint. A value of LTE larger than 100% indicates a “frozen” (or rigid) joint. A value slightly greater than 100% may be attributed to a human error (reading/recording) or improper zeroing of the gages. The variation of the load transfer efficiency with the number of load cycles applied is shown in Figure 3.12.

By examining the graphs in Figure 3.12, it can be seen that, except for the case of east loading with steel dowels, the LTE is generally reduced as more cycles are applied to the pavement. This was to be expected since the joints should weaken or deteriorate over time and under service loads. It can also be noted that the magnitude of the LTE is smaller in the FRP joints, and that the decrease in the LTE over time is more rapid than in the steel joints.

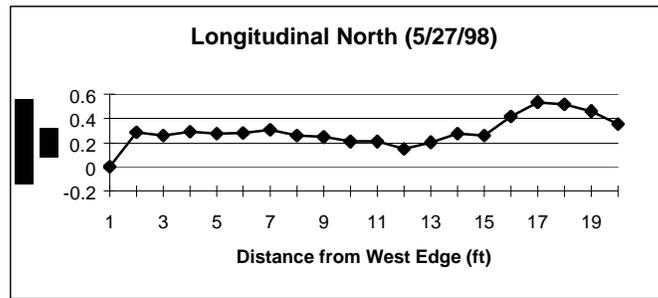
Figure 3.13 North Profiles (Steel)

As indicated in the monitoring plan of Figure 3.8, longitudinal profiles were constructed based on face dipstick measurements made on the exposed outer 0.610 m (2 ft) strips of the pavement slabs. The selection of the frequency at which the measurements were made was based on the requirement of having two sets or readings for each case of room temperature conditions, warm conditions (37.8°C or 100 °F), and cold condition (4.44°C or 40°F). The corrected profiles were plotted and are shown in Figure 3.13 for the north slab, and Figure 3.14 for the south slab.

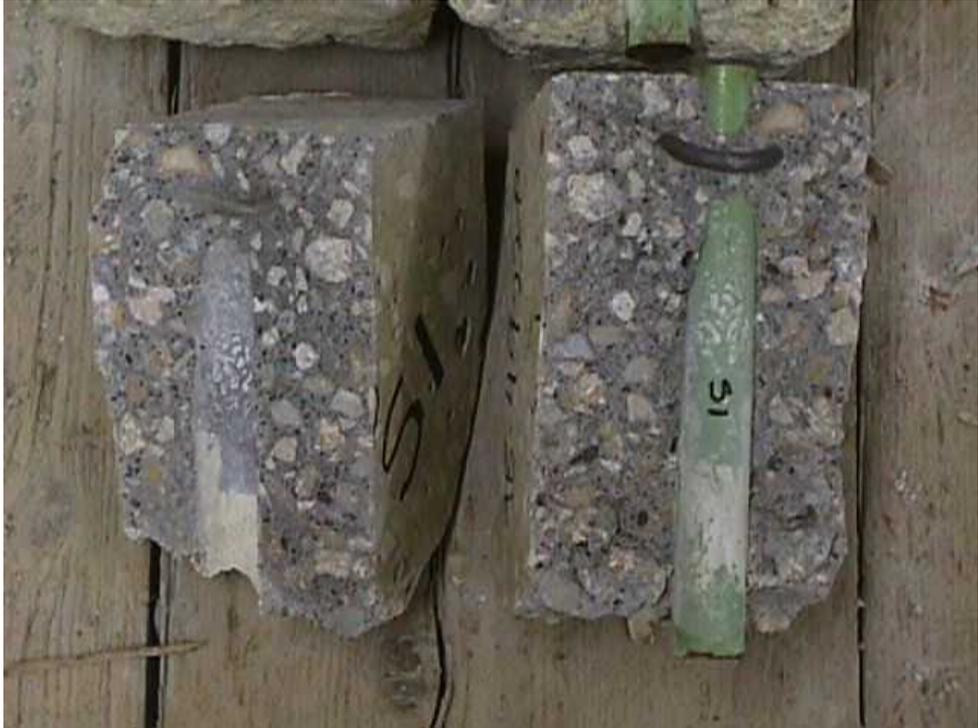
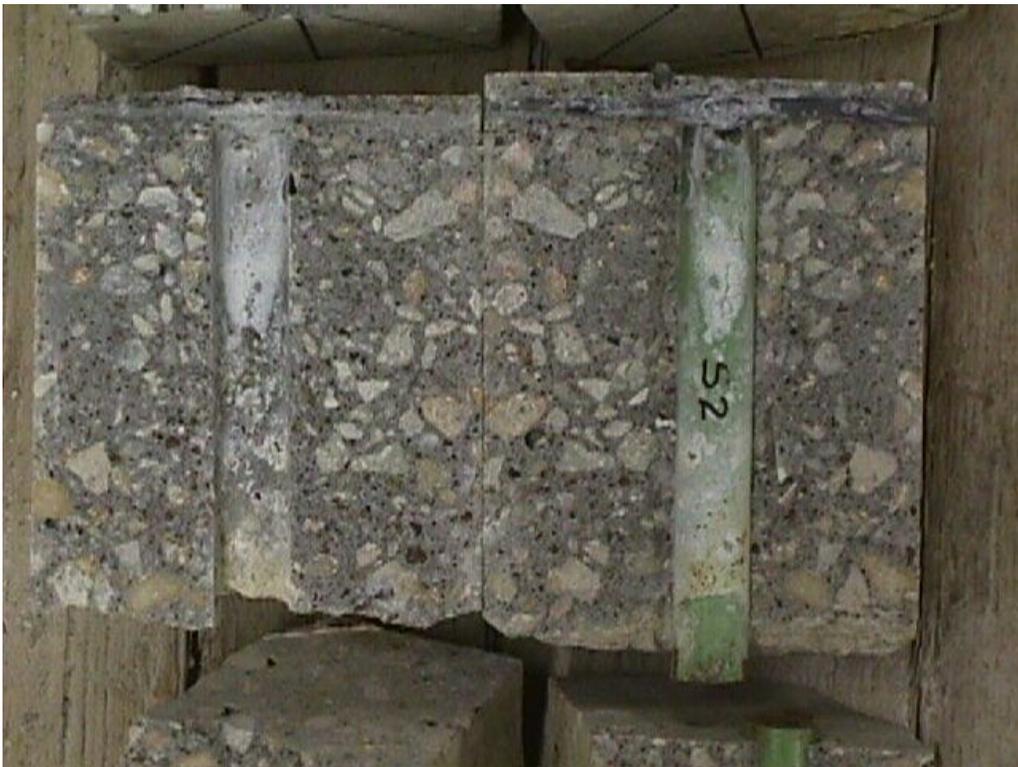
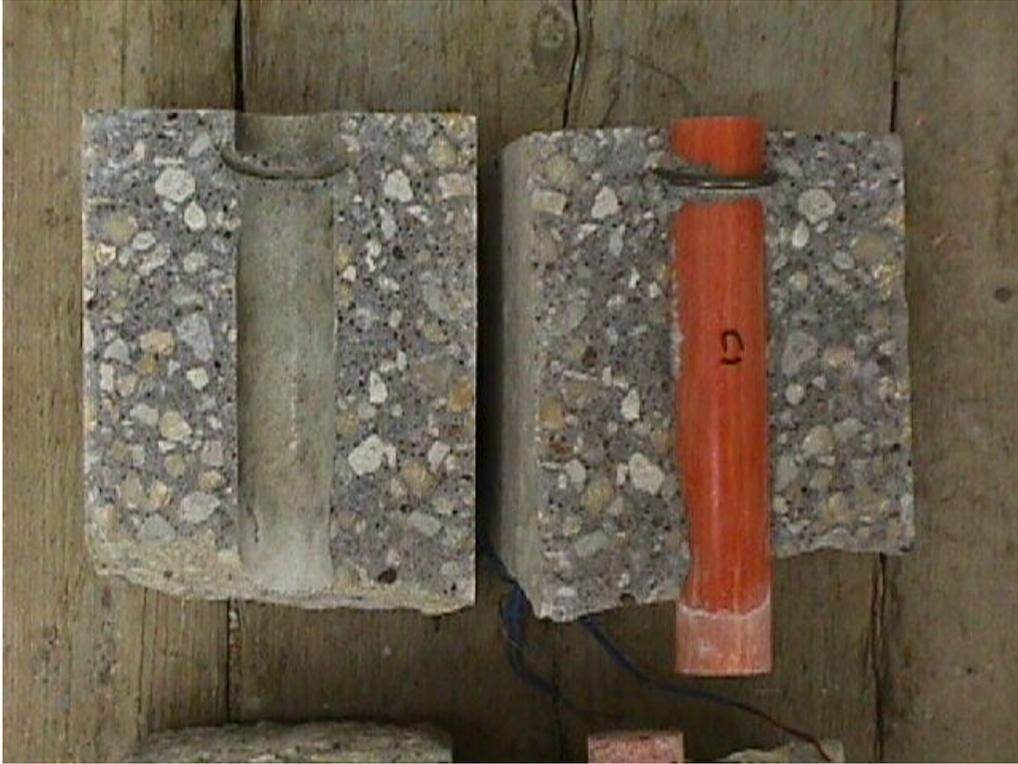
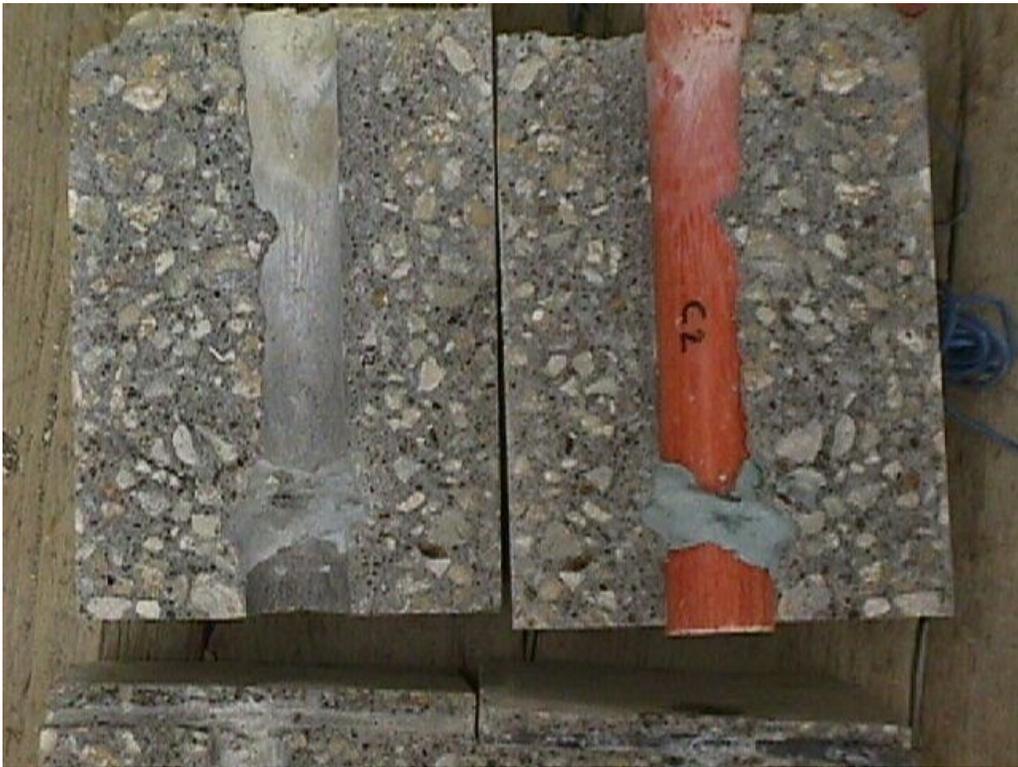
Figure 3.15 (a) and (b) Steel Push-Out Test Specimens

Two dowel bars from each of the steel and fiberglass slabs were examined. The specimens with steel bars were designated S1 and S2, and those with the FRP composite bars C1 and C2. A push-out test was conducted on each of the dowels. It consisted of exposing about 25.4 mm (1 in) of the bar at one end and the other end being flush with the concrete. Then the bars were loaded in a compression machine pushing on the exposed end of the bar and using a ring to support the concrete at the other end. The movement was limited to 3.18 mm (1/8 in.).

As shown in the pictures, by splitting the concrete around the bars, it could be seen that the dowels were in good condition. No abrasions, striations, or chipped coating could be seen. The bars were firmly in place and no annular space was observed.

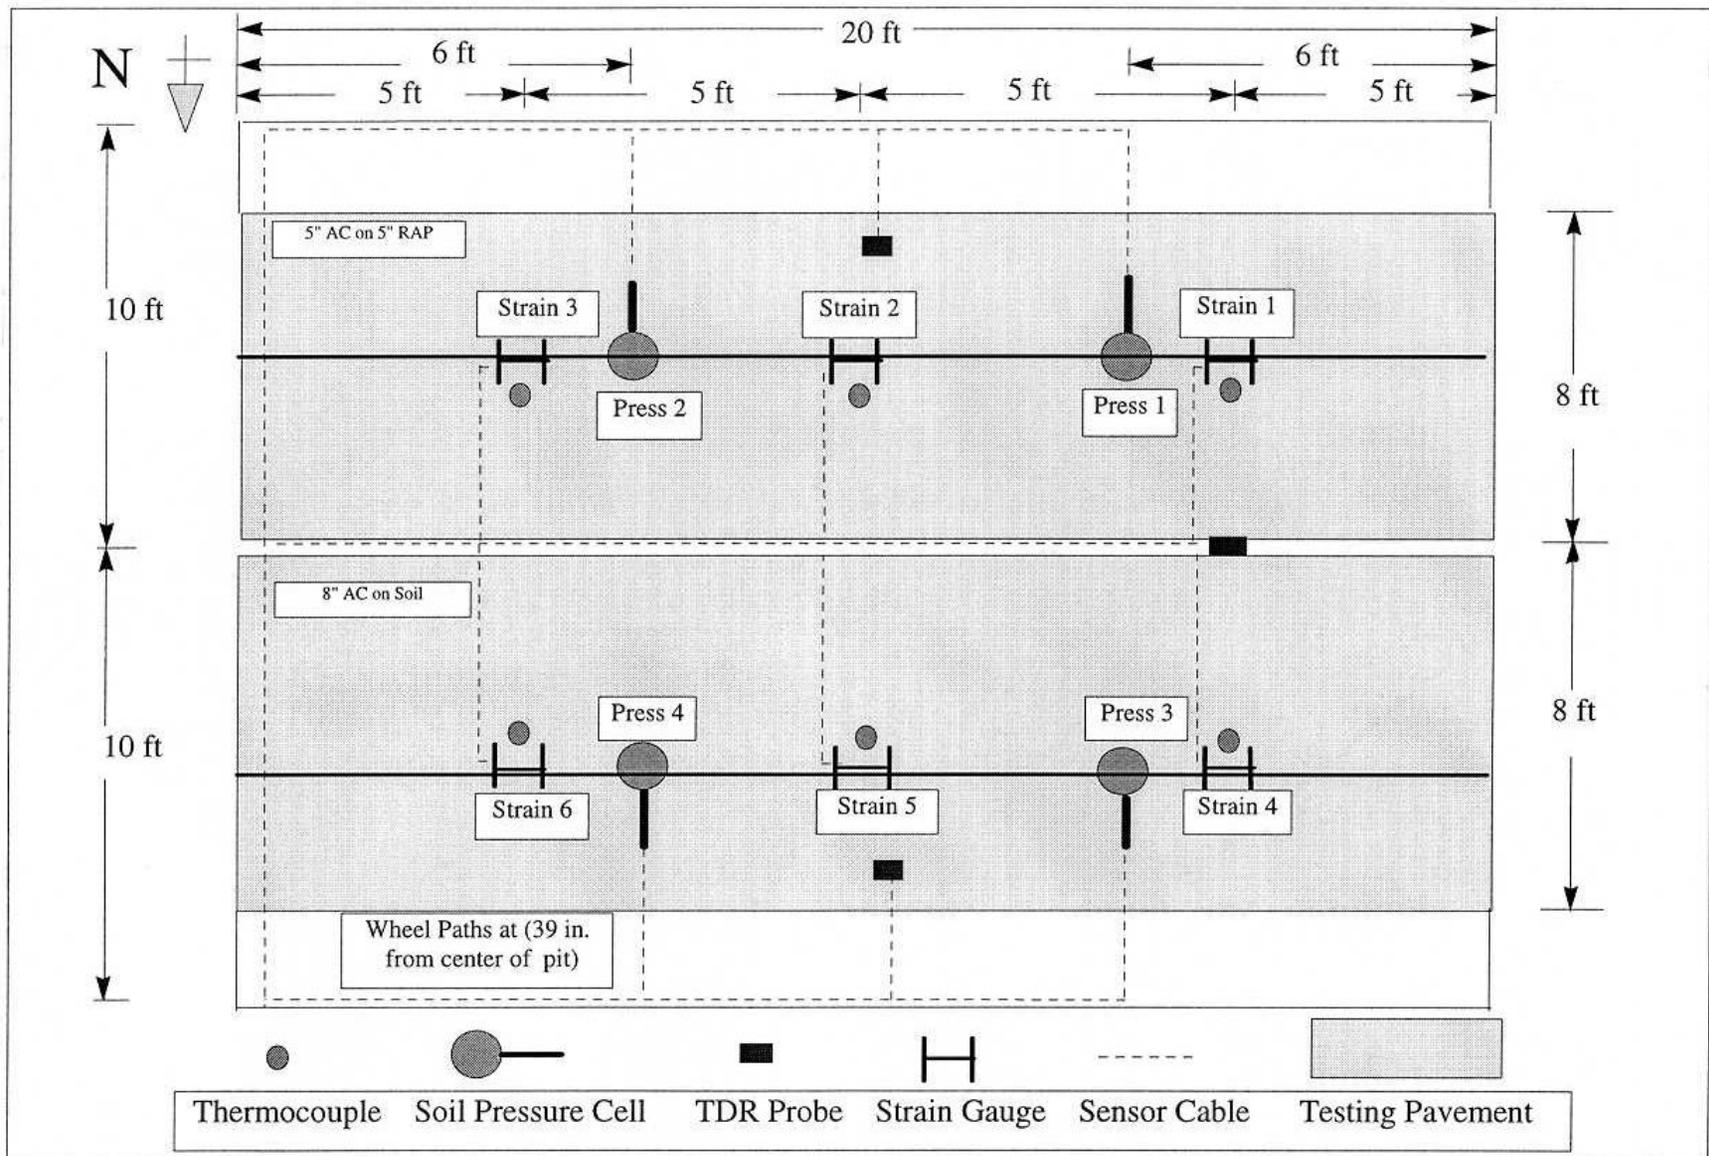
Figure 4.1 Location of Sensors in Nebraska Test (ATL-98-1)

Six strain gauges, Model PAST-2AC (from Dynatest), were placed as indicated in Figure 4.1 along the centerline of each pair of wheels at the quarter-span points. The centerline of the wheel paths for the north and south lanes are symmetrically located at 991 mm (39 in.) from the middle of the pit. Three strain gauges were therefore placed on each wheel path. The gauges (often designated as H-gauges) consist of electrical resistors embedded within a strip of glass-fiber reinforced epoxy supported at each end of the strip on transverse stainless steel anchors forming an H-shape.

In the south lane (reduced pavement thickness over RAP base) the strain gauges were placed at the bottom of the AC layer, right on top of the RAP base layer. This corresponds to about 130 mm (5 inches) below the surface of the pavement. In the north lane (full thickness pavement on subgrade) the strain gauges were placed

below the AC layer, right on top of the subgrade soil, i.e., about 203 mm (8 in.) below the surface of the pavement.

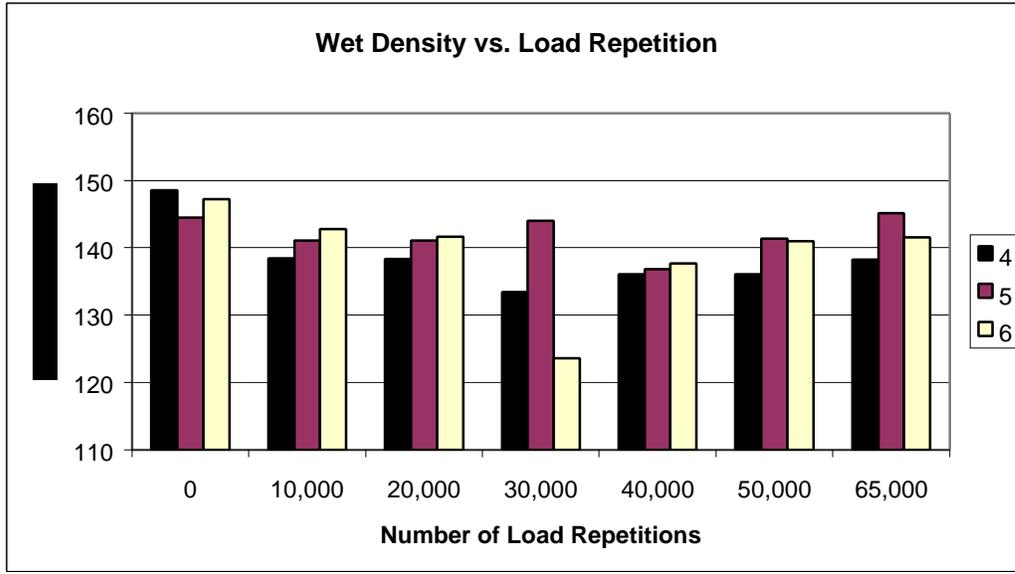
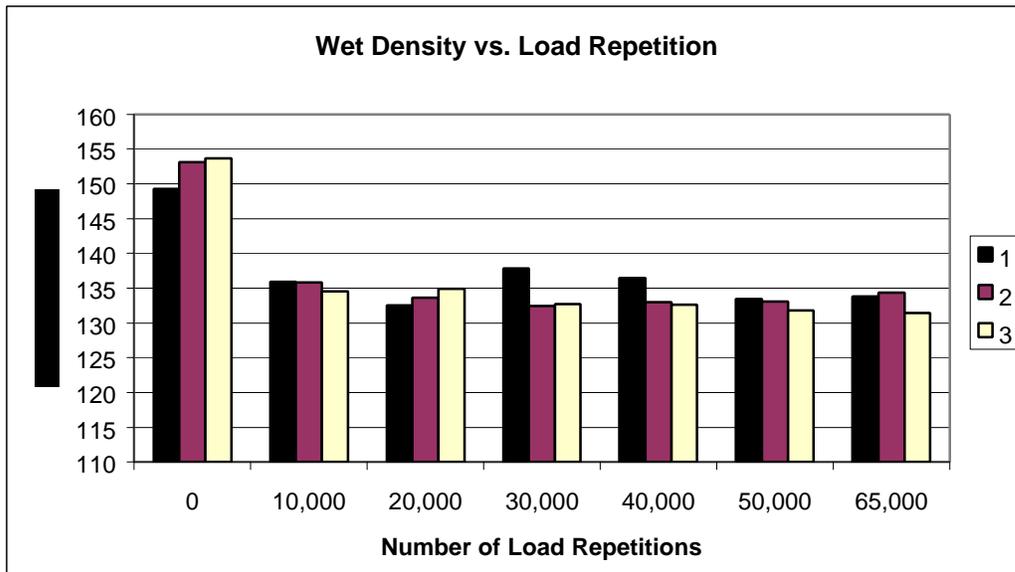
Figure 4.4 Variation of Asphalt Concrete Density with Number of Load Repetitions

At each location, three one-minute readings of the nuclear gauge were taken and averaged. The variation of the asphalt concrete density with the number of load repetitions applied to the pavement sections is depicted in Figure 4.4. It can be observed that the values do not change significantly except from the initial conditions before any load is applied.

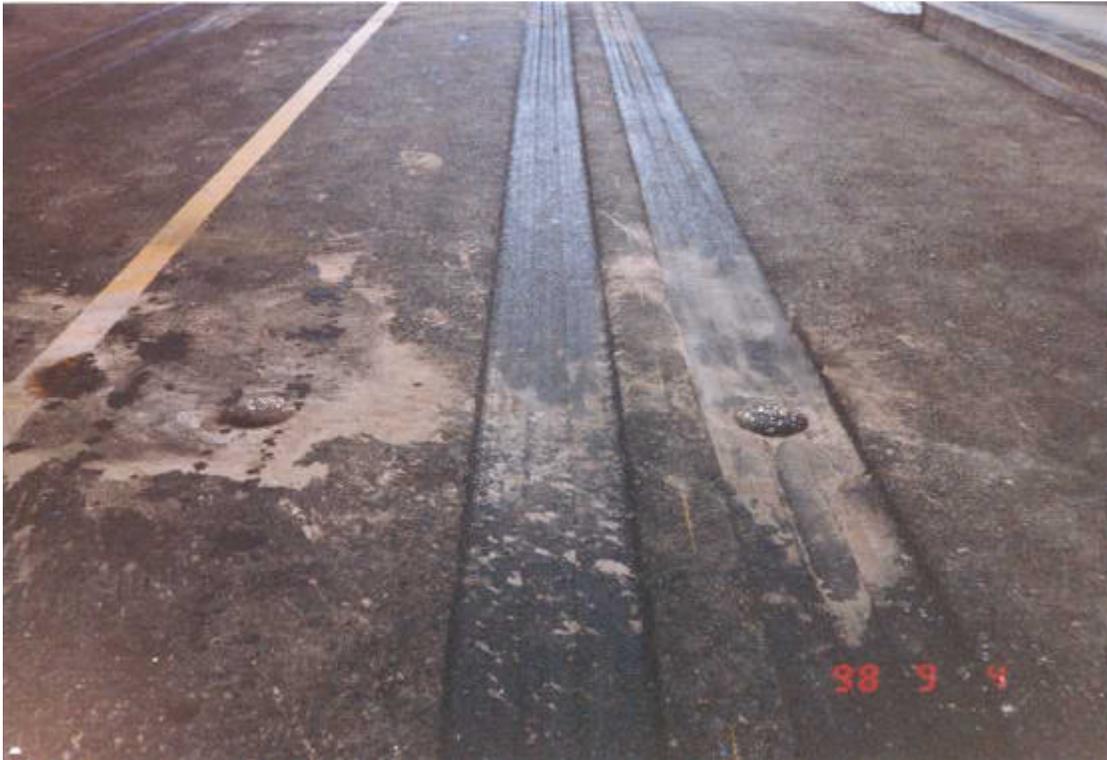
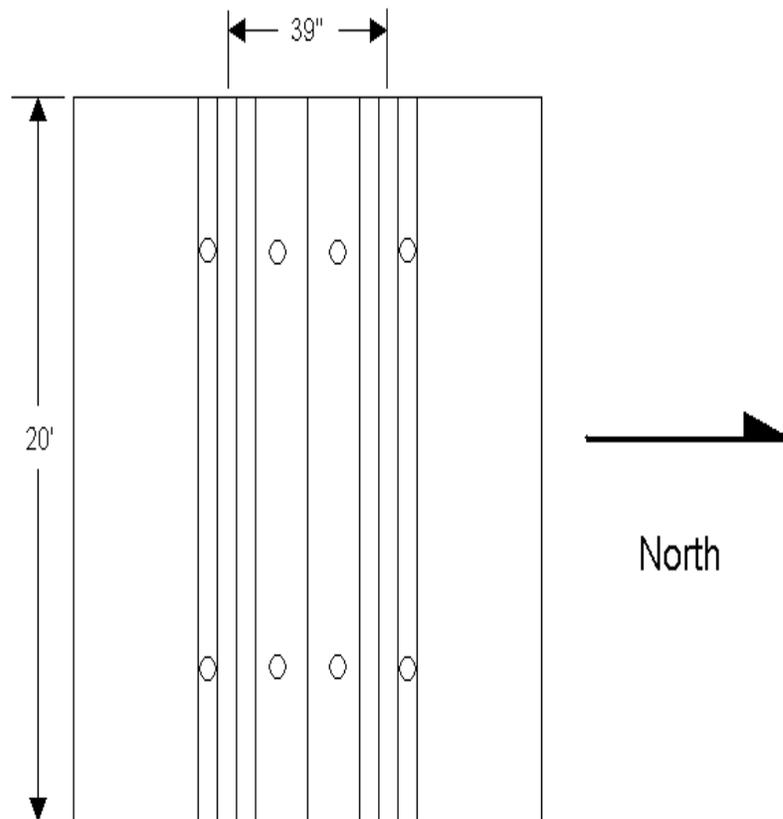
Figure 4.5 Location of Drilled Cores

The visual inspection of the cores show a reduction in the thickness of the asphalt concrete layer between the core taken off the wheel paths and those taken from the wheel paths. These correspond to the degree of rutting observed at the surface of the pavement. This was an indication that the rutting was due to the plastic flow of the AC on the surface of the pavement under the wheel passage rather than compaction or settlement of the soil/RAP base beneath the pavement.

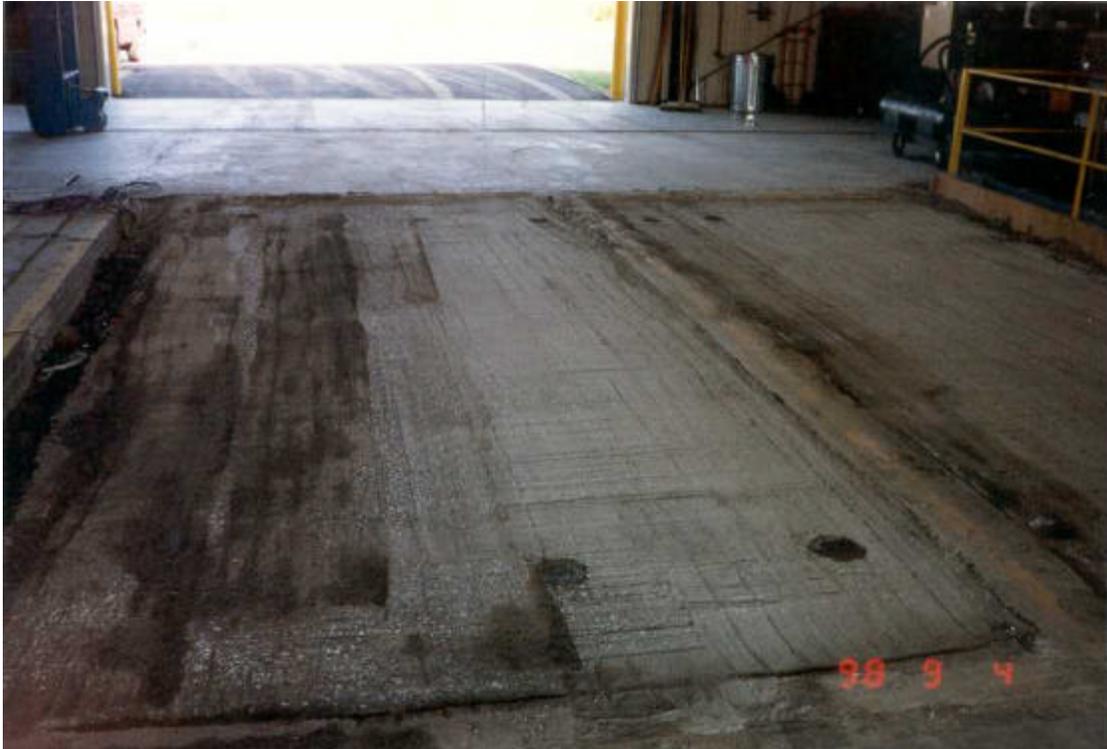
Figure 5.1 Specimen After Milling of Entire Pavement

The pavement structure consists of the two original 2.44 m (8 ft)-wide lanes loaded side-by-side with a single axle up to 67,000 repetitions. The description of these lanes is given in Section 4.1. The repair consisted of milling 50 mm (2 inches) off the surface of the pavement and replacing them with 50 mm (2 inches) of appropriate hot mix asphalt concrete. The soil subgrade is the same as that of the previous experiment (see Section 4.2).

The specimen preparation consisted mainly of performing the repair on the distressed pavement. The repair was done by the same local highway construction company that is also a regular asphalt contractor to KDOT. Milling was done to the whole pavement, i.e. the entire length and width of both sections. This is shown in Figure 5.1. Except for a narrow longitudinal strip between the two slabs, the surface of the pavement was milled to a depth of about 50 mm (2 inches.) The holes caused by the core drilling were filled with the hot mix used for the overlay.

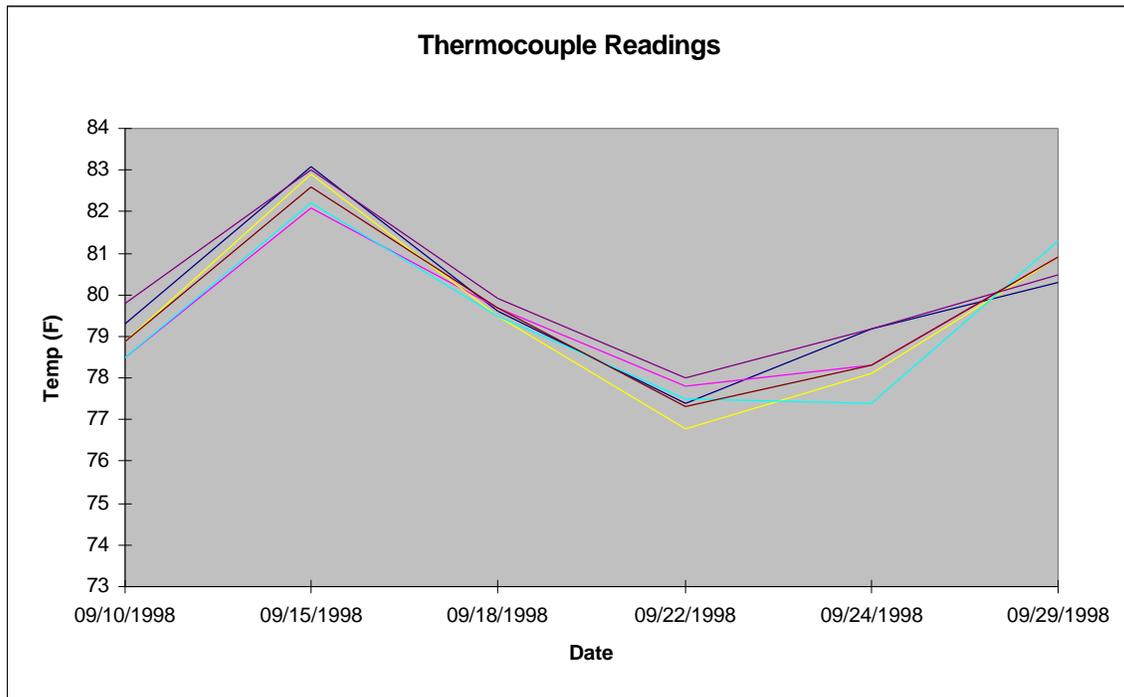
Figure 5.3 Thermocouple Readings for ATL-98-2 Experiment (0-100,000 Repetitions)

Temperatures were recorded towards the end of the application of the specified number of load repetitions, at the time strains were to be recorded. Recorded values are shown in Figure 5.3. It can be noted that surface temperature was mostly below 32°C (90°F) because testing was done in September (as opposed to ATL-98-1 which was done in August). However on the average, temperatures below the slabs were between 25°C and 33°C (77°F and 83°F).

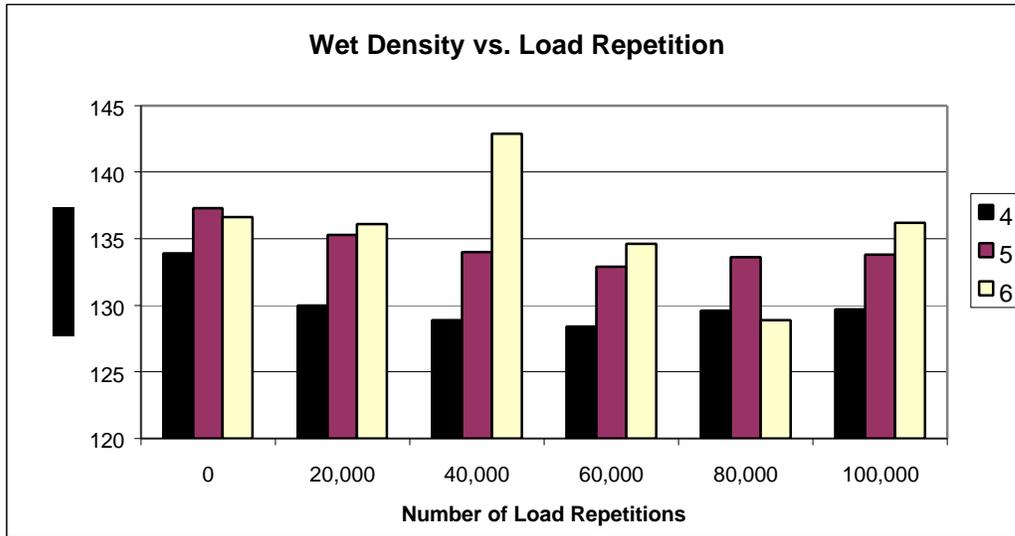
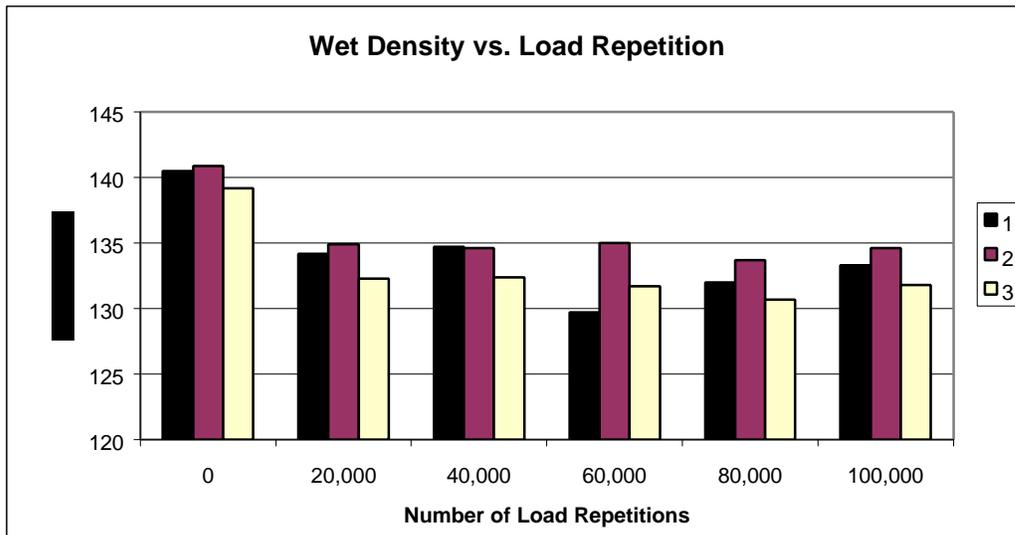
Figure 5.5 Variation of Asphalt Concrete Density with Number of Load Repetitions

At each location, three one-minute readings of the nuclear gauge were taken and averaged. The variation of the asphalt concrete density with the number of load repetition applied to the pavement sections is depicted in Figure 5.5. It can be observed that the values vary relatively more when compared to those in the previous test before the overlay.
