**Construction, Instrumentation, and Testing of Fast-Setting
Hydraulic Cement Concrete in Palmdale, California**

CALIFORNIA DEPARTMENT OF TRANSPORTATION

Jeffery R. Roesler, Clark W. Scheffy, Abdikarim. Ali, and David Bush

Pavement Research Center
Institute of Transportation Studies
University of California Berkeley

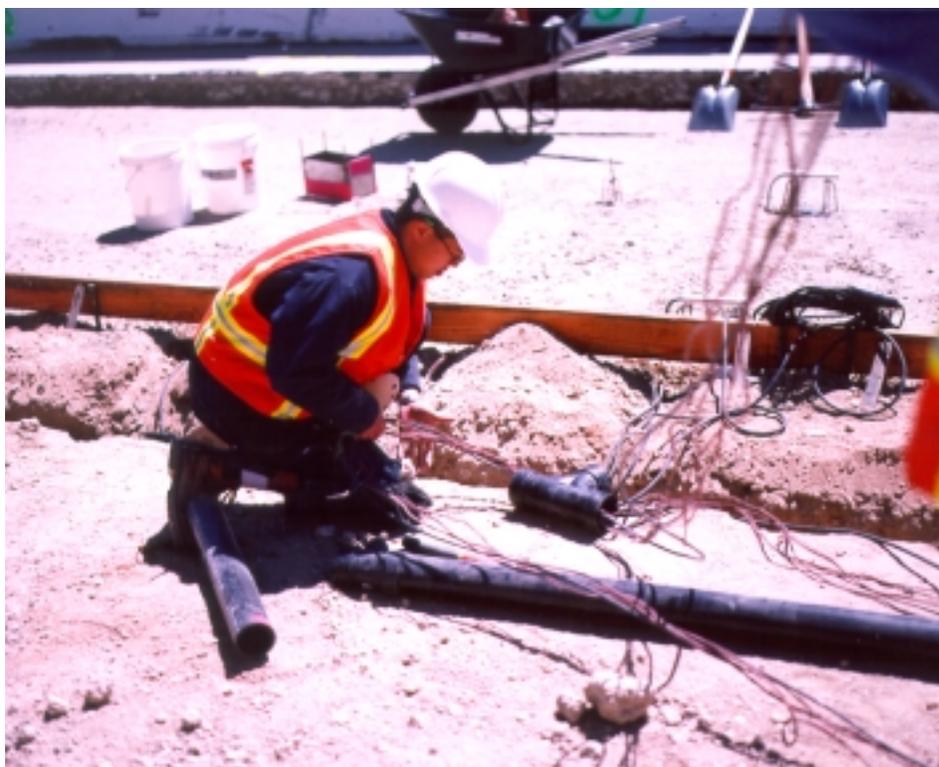
Figure 6.1. South Tangent Instrument Wiring and Piping Laid in Aggregate Base.

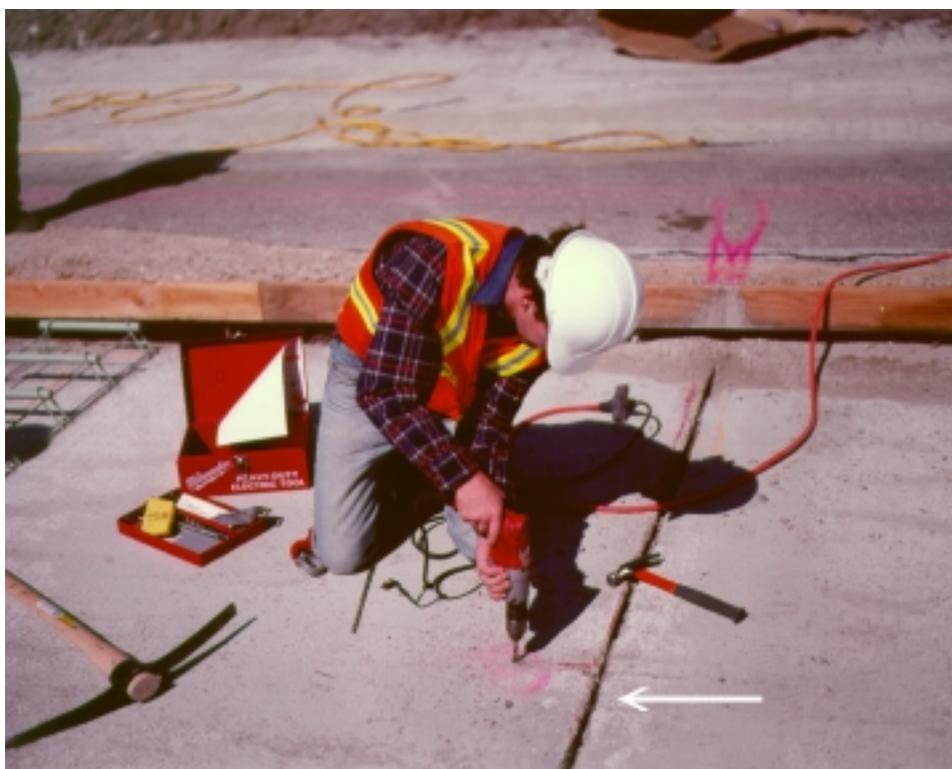
Figure 6.2. Grooves cut in North Tangent CTB for Instrument Leads.

On the North Tangent, which had a cement-treated base (CTB), a saw was used to cut shallow grooves in which to run the gage lead wires, as shown in Figure 6.2. After the wires were placed, fast-setting cement mixed with sand was used to backfill the channels, as shown in Figure 6.3.

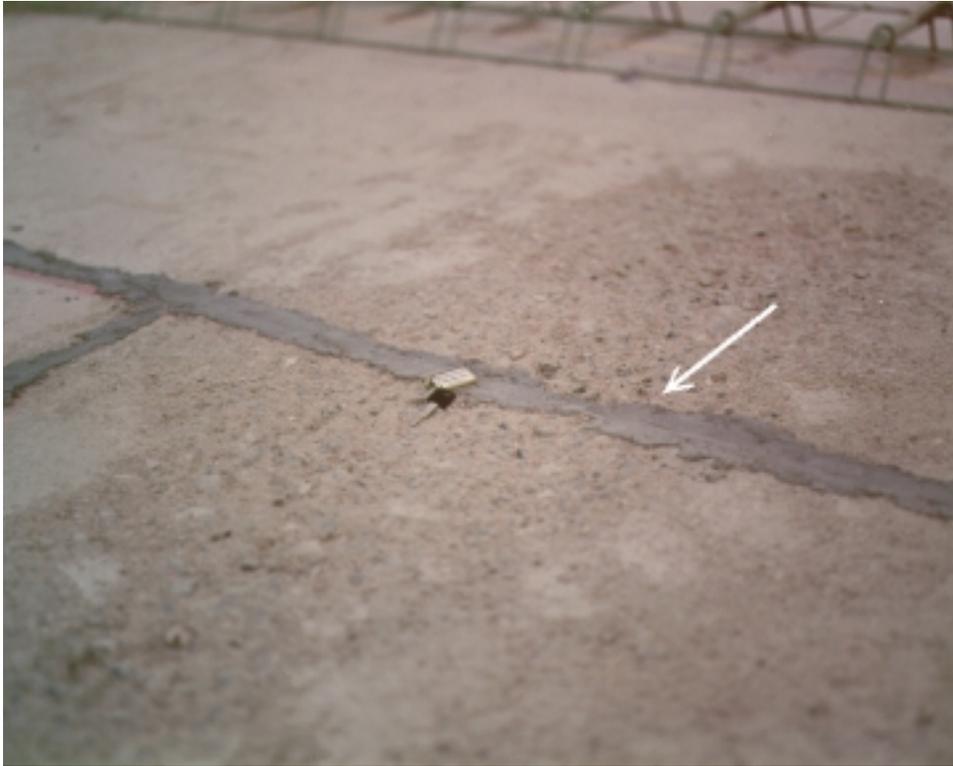
Figure 6.3. Backfilled Instrumentation Lead Channel on North Tangent CTB.

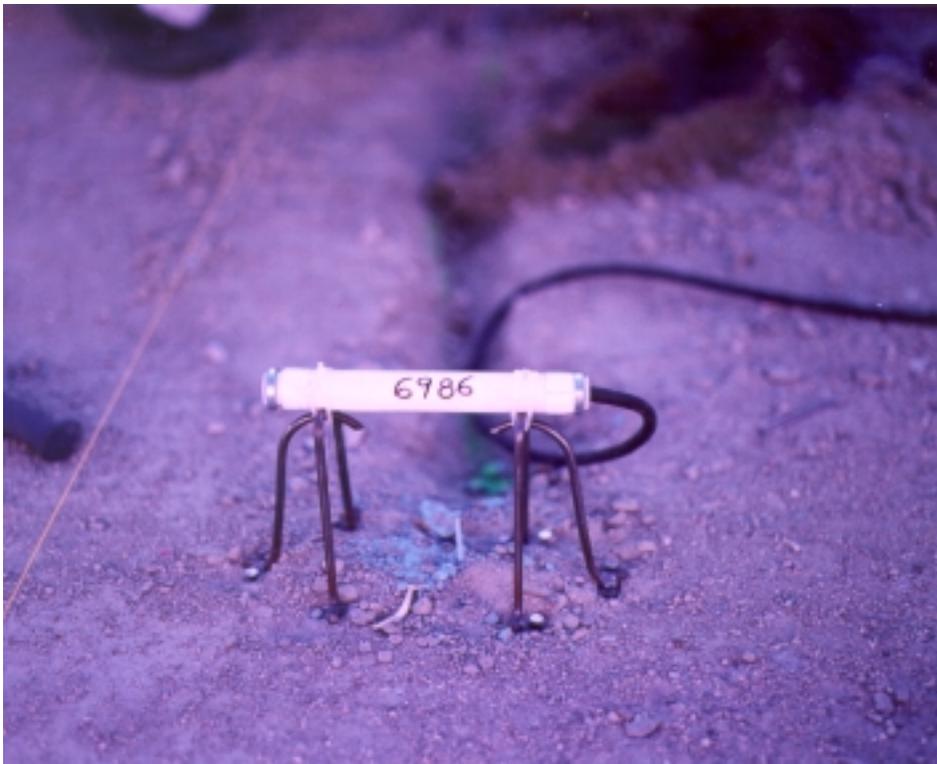
Figure 6.4. Steel Frame with Carlson A-8 Strain Meter Installed on South Tangent.

All strain gages were placed and properly oriented on the base material with small steel frames, as shown in Figures 6.4 and 6.5. Each instrument was attached to its steel frame using a plastic zip tie. Each instrument was attached firmly enough so that it wouldn't become dislodged

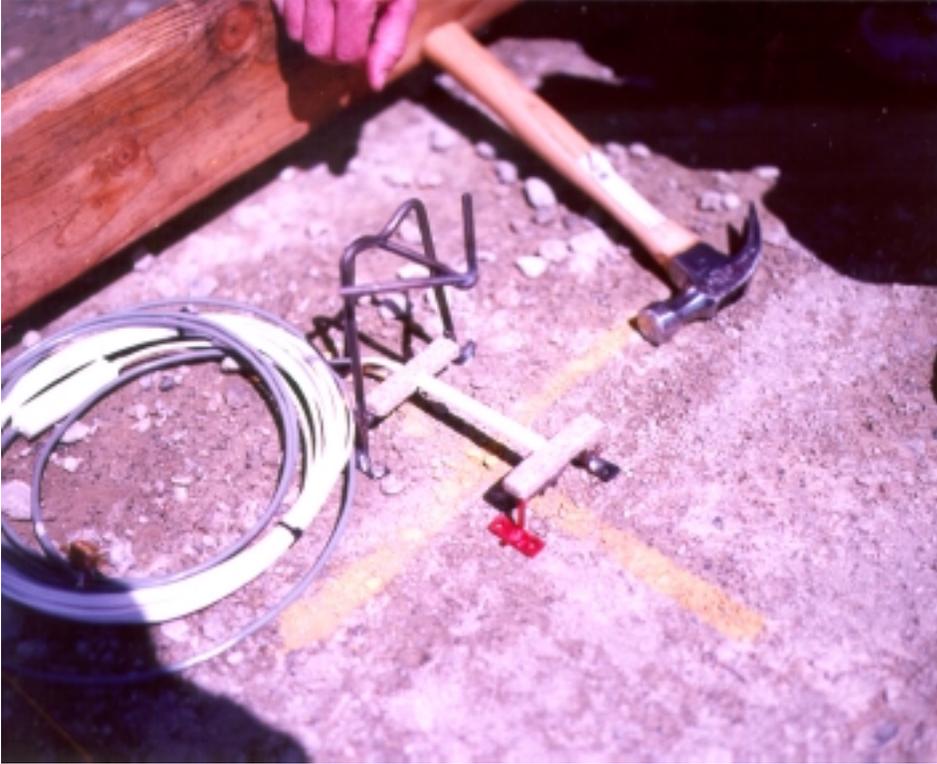
Figure 6.5. Steel Frames for Collocation of Dynatest PAST-2PCC (shown) and Tokyo-Sokki PMR-60-6L (not shown).

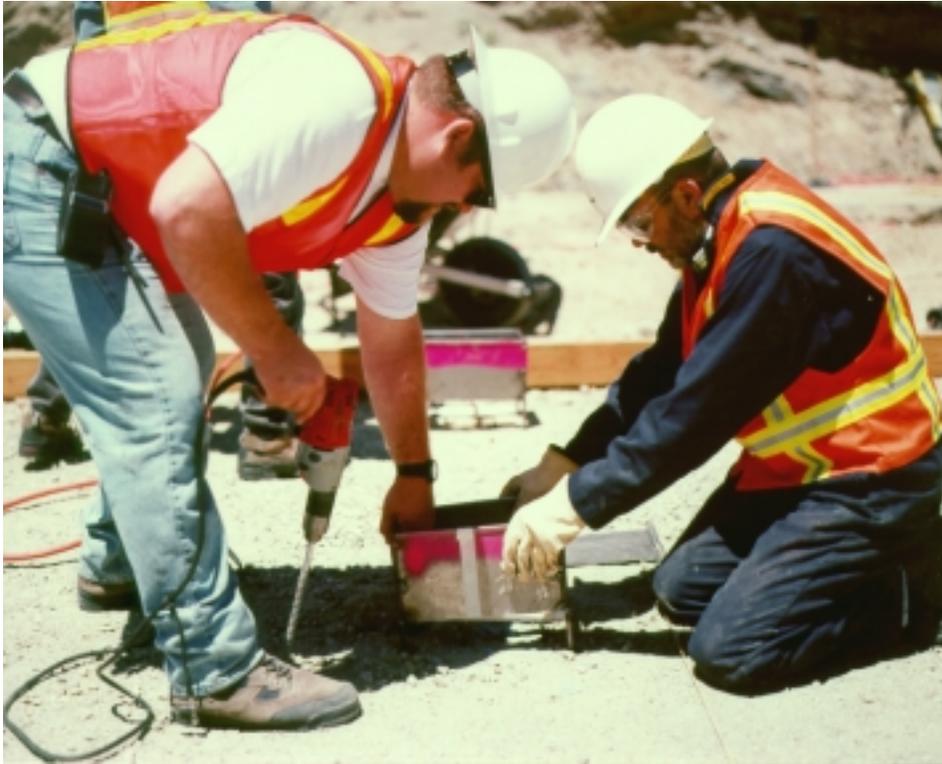
Figure 6.6. Steel Instrument Box Being Installed on South Tangent.

As shown in Figures 6.6 and 6.7, four-part sheet metal boxes with five-centimeter spikes at each corner were placed around all gages except for thermocouples. The sheet metal boxes prevented the flow of concrete from pushing any gages out of their intended location and orientation during paving. The spikes were driven into the base material to further stabilize the boxes. These boxes were then marked with “turkey tails” or wire flags affixed with duct tape so that they would be easily visible to the paving crew, as shown in Figure 6.8.

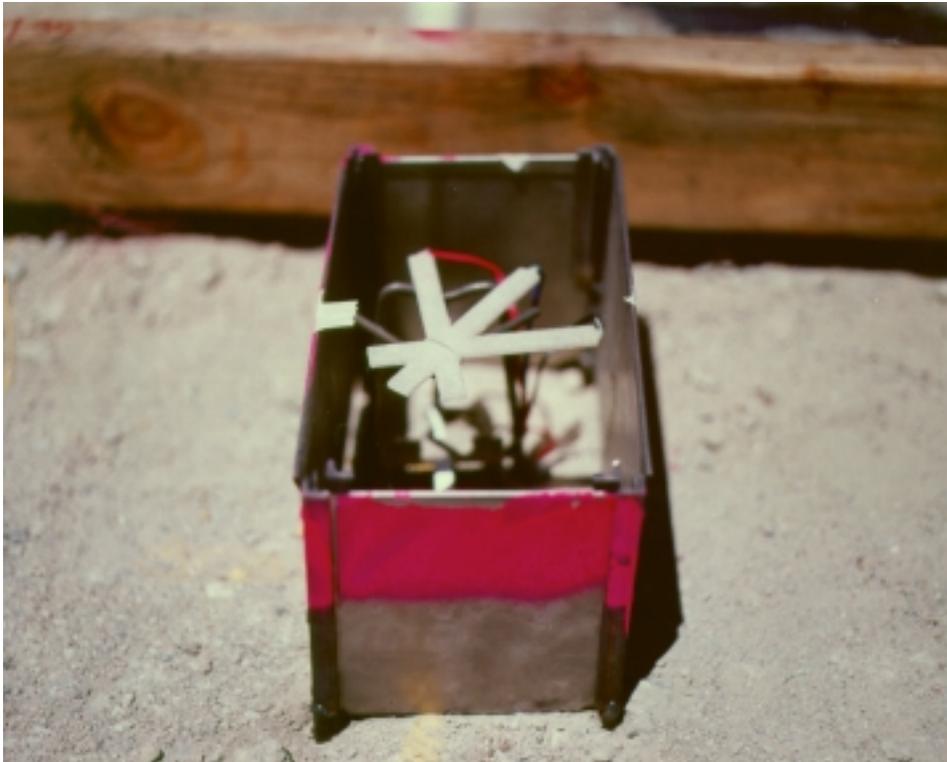
Figure 6.7. Steel Instrument Box Protecting Strain Gages on South Tangent.

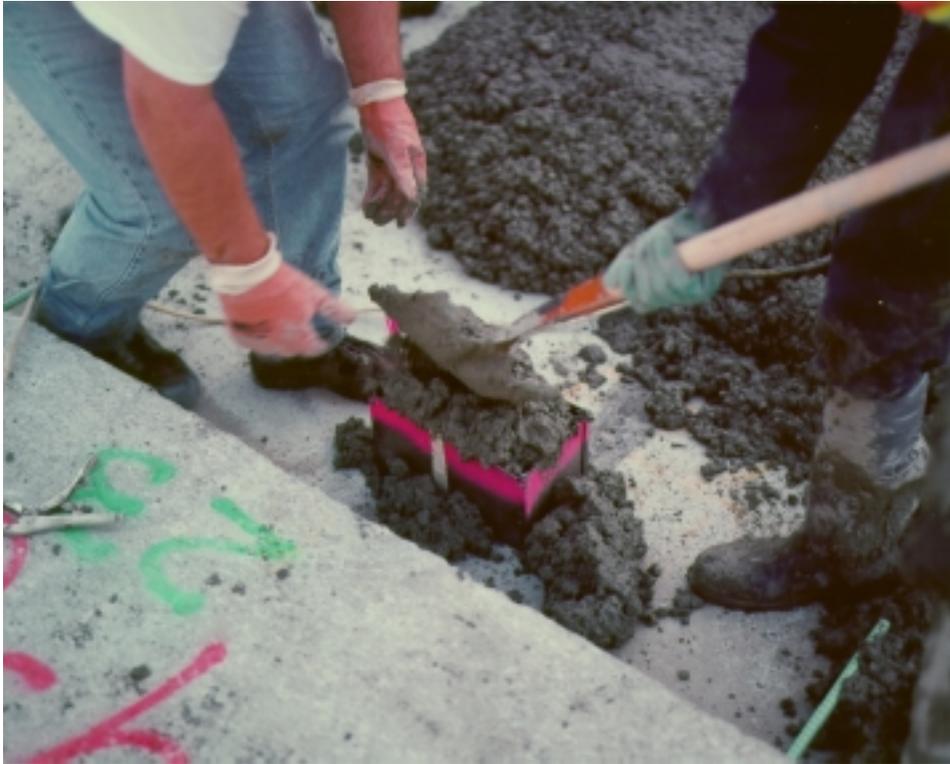
Figure 6.9. Instrument Box Being Filled by Shovel, North Tangent.

When the concrete neared one of the instruments in its box, UCB personnel shoveled concrete into the box, as shown in Figure 6.9. Coffman Specialties personnel consolidated the mix inside the sheet metal box by vibrating all four sides of the box, as shown in Figure 6.10. The Coffman Specialties crew then ran a screed over the concrete surface. Both the wire flags

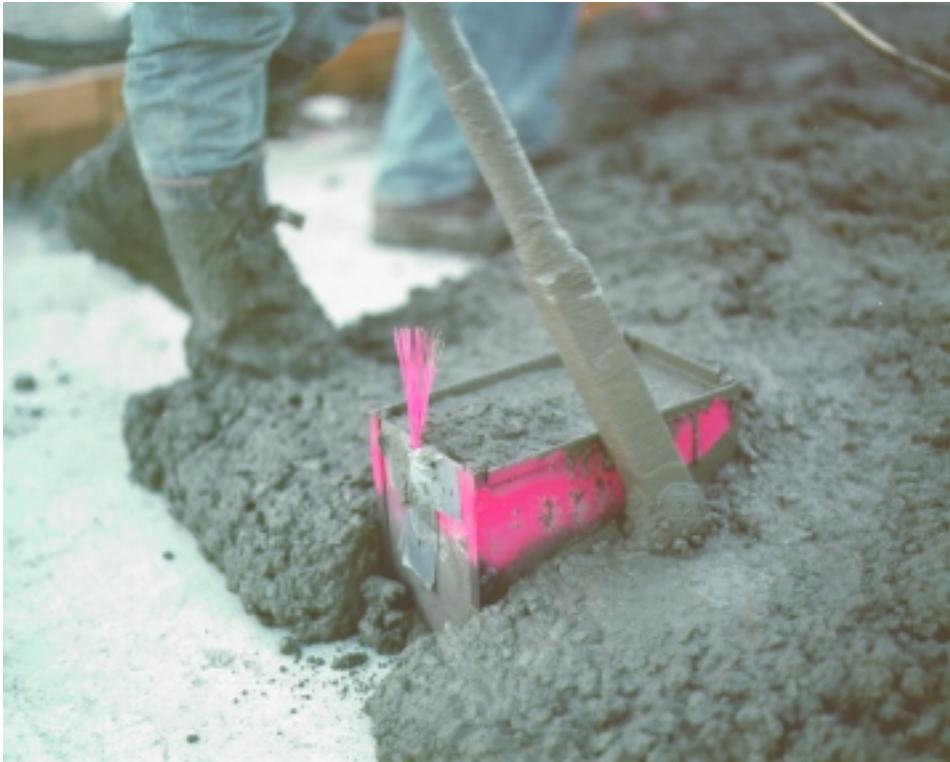
Figure 6.10. Vibrator Being Applied to Instrument Box to Consolidate Concrete.

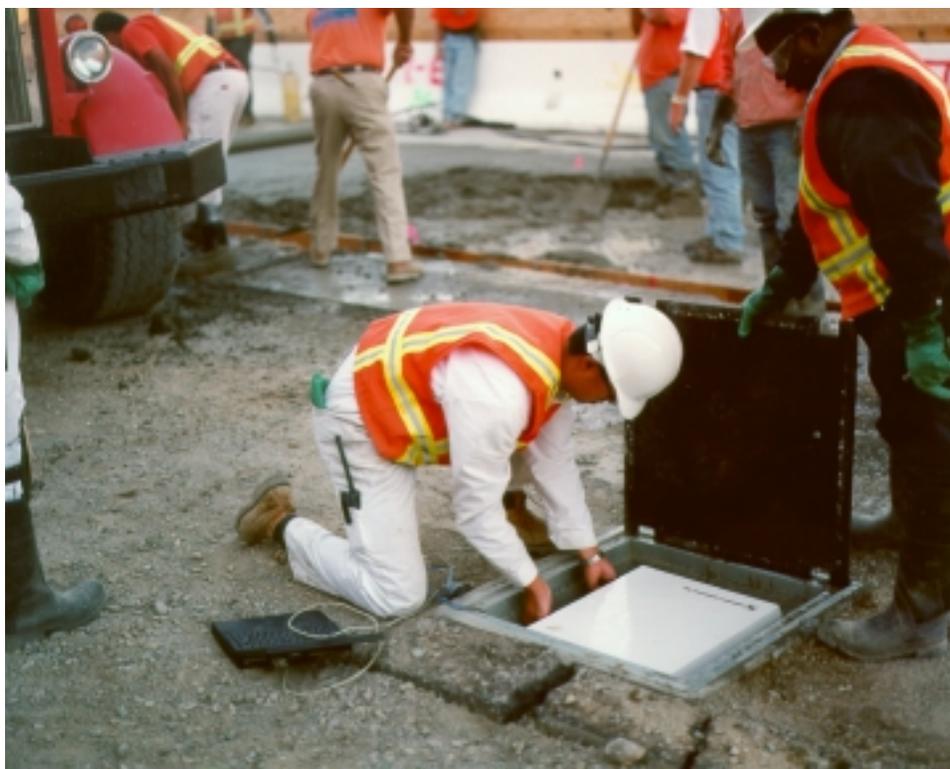
Figure 6.14. CR10X Acquisition System Being Placed on North Tangent.

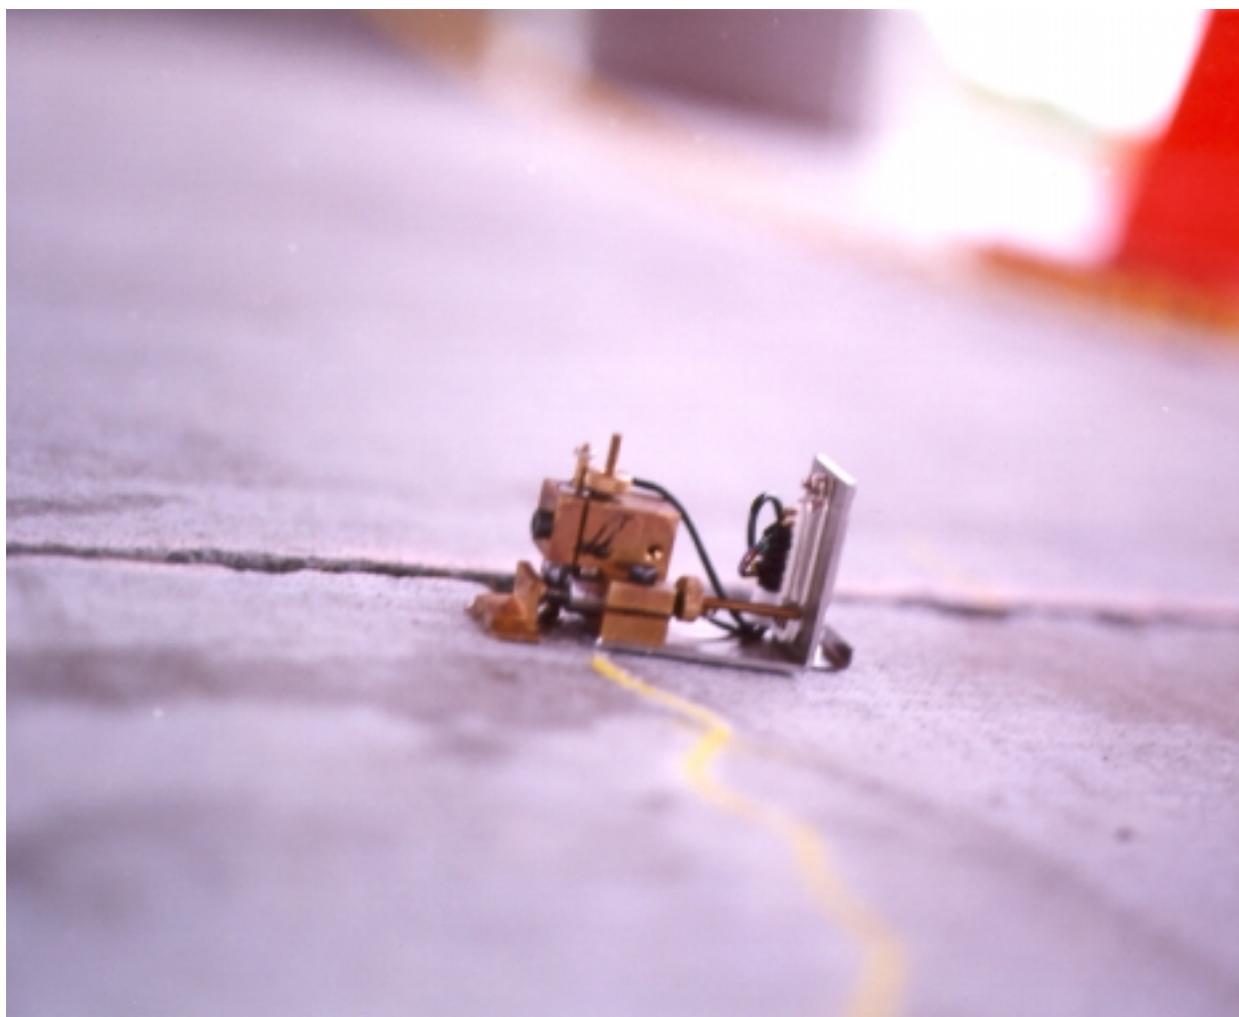
Figure 6.20. Crack Activity Meter (CAM) in Typical Position over a Crack.

The Crack Activity Meter, manufactured by the Council for Scientific and Industrial Research (CSIR), is used to measure the horizontal and vertical displacement of cracks during dynamic loading. The device consists of two Linear Variable Differential Transformers (LVDT), one oriented horizontally and one oriented vertically, as illustrated in Figures 6.19 and 6.20. CAMs will be placed over joints on HVS loaded sections to measure the relative displacement between two adjacent slabs. The CAM data will be used for determination of the load transfer capacity between two slabs.

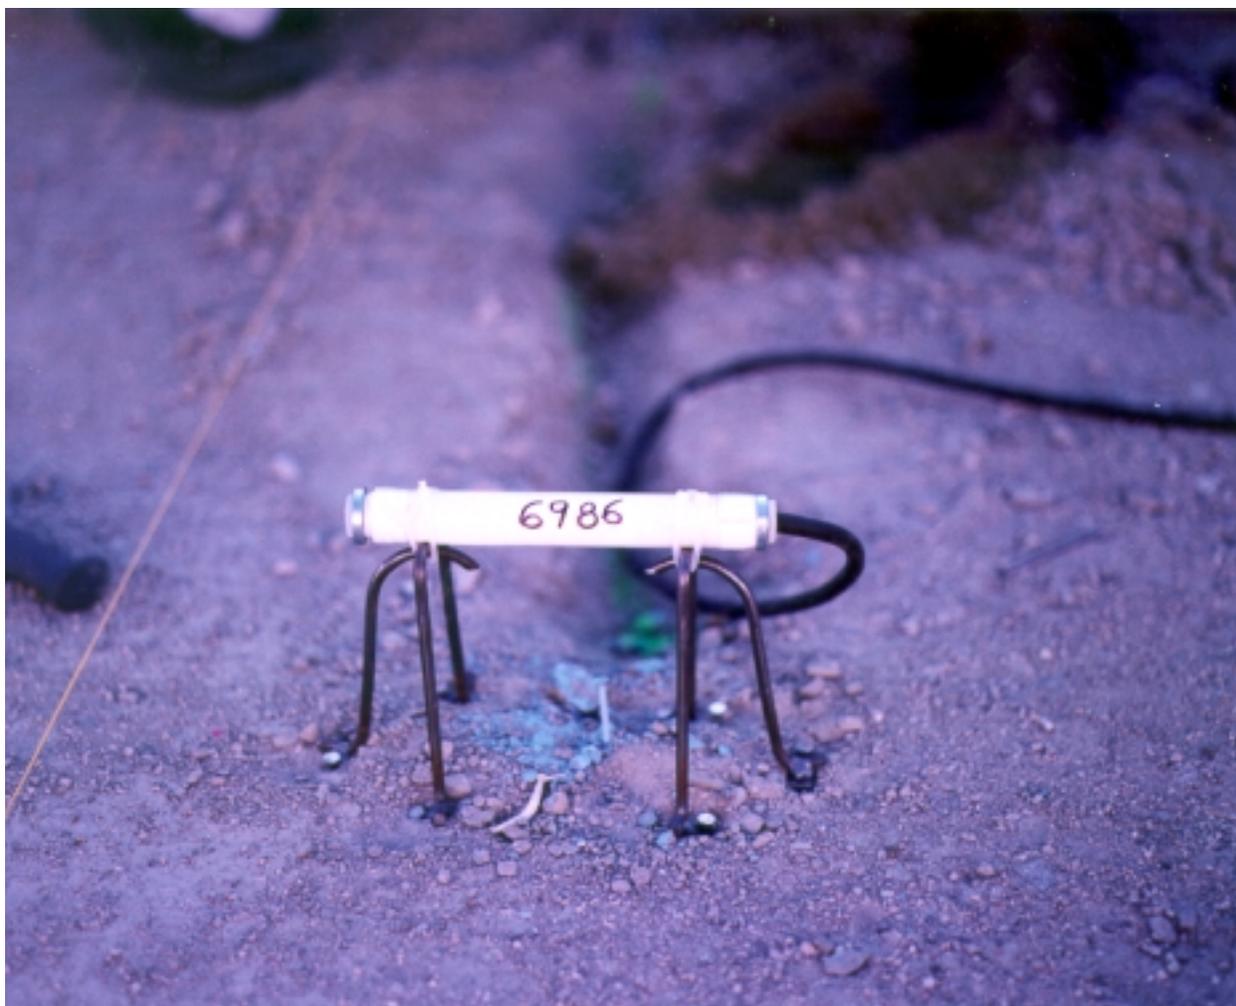
Figure 6.23. Carlson A-8 Strain Meter prior to Placement of Concrete, South Tangent.

The environmental strain gages used were the Carlson A-8 strain meter, manufactured by RST Instruments, Inc. Shown in Figures 6.15 and 6.23, the instrument is tubular in construction and contains two coils of highly elastic steel wire. One coil increases in length and electrical resistance when strained, while the other decreases in length when unloaded or compressed. The gages were placed in the concrete pavement at various critical locations near the surface and bottom of the pavement to measure strains caused by length changes in the pavement due to thermal changes and curing. The Carlson A-8 gages are monitored continuously by the online data acquisition system. A total of 24 Carlson A-8 gages have been embedded in the Palmdale test sections. Appendix A shows the locations of the Carlson A-8 gages on the Palmdale test sections.

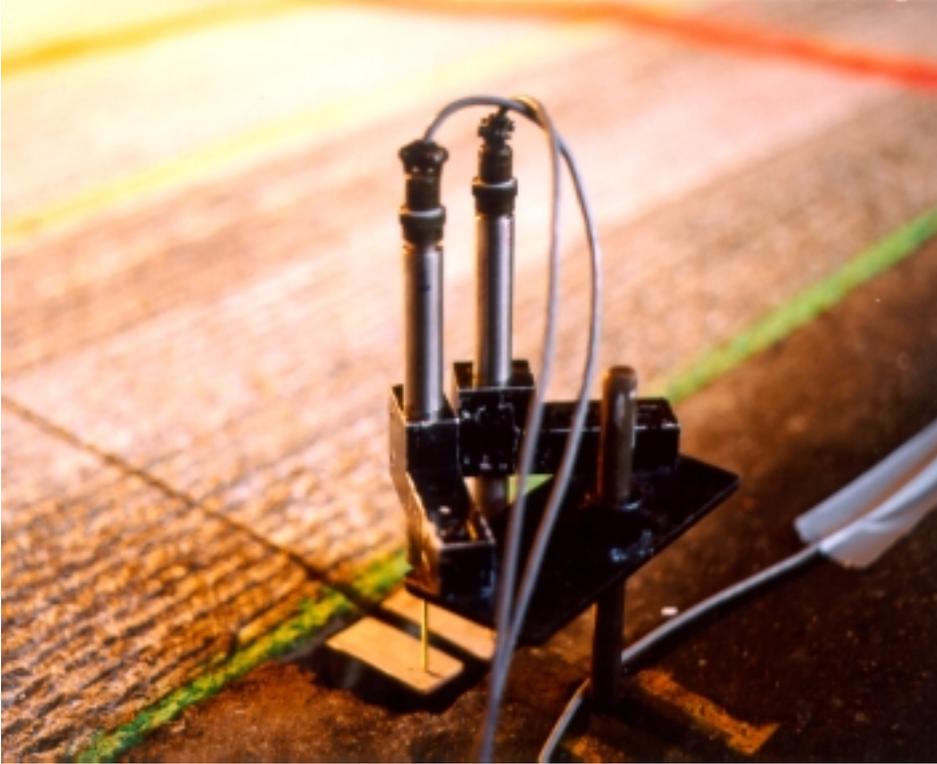
Figure 6.24. Joint Displacement Measuring Device (JDMD) on South Tangent. (*Edge Displacement Measuring Device is essentially identical except that it is placed in the middle of the slab instead of at the joint.*)

The JDMDs, manufactured by the UCB Pavement Research Center, are used to measure vertical and horizontal joint displacement under dynamic loads and temperature changes. For environmental changes, the JDMDs can be used in two separate configurations. The first device can measure the relative vertical and horizontal displacement across a joint. Each device consists of one Linear Variable Displacement Transducer (LVDT) for vertical displacement and one LVDT for horizontal displacement, as shown in Figure 6.24. Section 7C on the North Tangent

uses this type of setup to measure horizontal joint movement and relative deflection between the adjacent slabs.
