# **DIGITAL MAP REQUIREMENTS FOR AUTOMATIC VEHICLE LOCATION**

**Final Report**

**Dr. Joshua Greenfeld**

**New Jersey Institute of Technology**

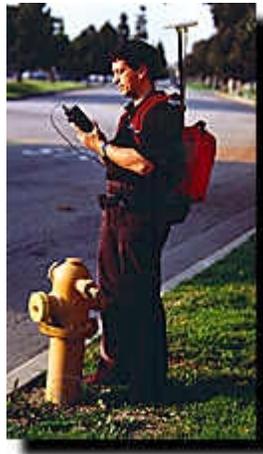
10. GPS battery
11. Operating Temperature: -40° C to +54° C
12. Storage Temperature: -20° C to +45° C
13. Humidity Completely waterproof
14. Dimensions: 12.35" x 4.06" x 2.3"
15. Weight: 3 lbs.

1. Beacon Receiver
2. Backpack
3. Combined GPS/DGPS Beacon Antenna
4. Cabling Battery and Charger

**Figure 1 The Leica MX-8600-RT**

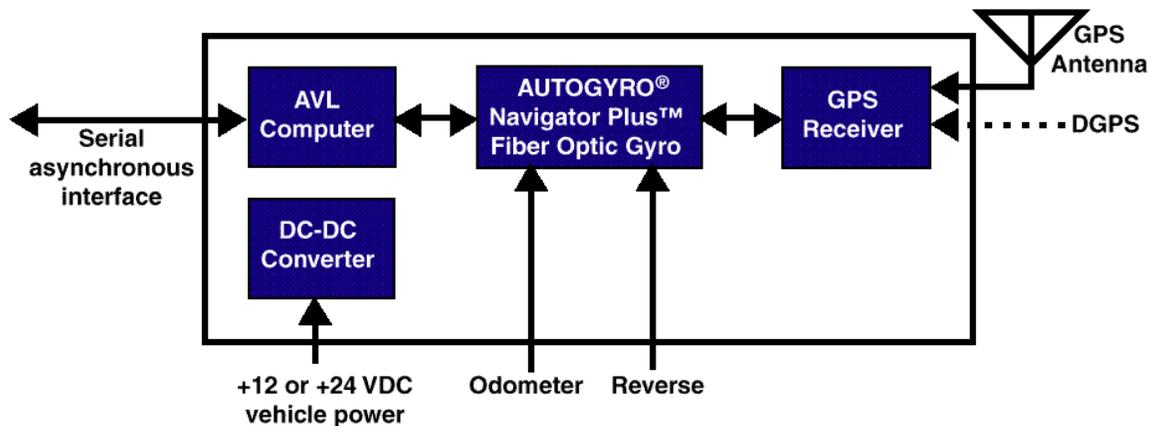
The CPS is a land navigation system for fleet vehicle position location. It was designed to operate under diverse conditions including urban area applications where GPS positioning may fail. The CPS is built around a gyroscope to measure the vehicle azimuth change and the odometer to measure distance traveled. These two parameters constitute the required dead

The simplest approach to AVL is to use the GPS data when it is present, and switch to dead reckoning when the GPS signal is lost. However, GPS is subject to many errors from noise-like small errors to multipath that can sporadically lead to irregular, large and unexpected position errors. To avoid relying on erroneous GPS locations when large errors are present, it is necessary to aid the GPS positioning with a dead reckoned position to act as a data pre-filter. The CPS uses a Kalman filtering method to filter out jumps and inconsistent GPS positioning observations. Simply put, the algorithm estimates the present values of system descriptors (the "state variables") based on the last measurement, the previous values of the state variables, and the estimated accuracy of the state variables and sensor data. Without undertaking a mathematical exposition, one might describe the action of a Kalman filter as corresponding to our intuitive notions of how one should combine measurements:

Figure 2. Continuous Positioning System (CPS) block diagram

The choice of the state variables (such as latitude and longitude) depends on an analysis of the sensor characteristics and error models, as well as the model adopted for the equations of motion of the vehicle.

The dead reckoning sensors provide continuous data, while the GPS solution may be absent for significant periods of time. During the time that GPS data is present, the dead reckoning sensors must be calibrated well enough that vehicle location solution can be "propagated" (projected forward) with acceptable accuracy during times when the GPS signal is lost or distorted.

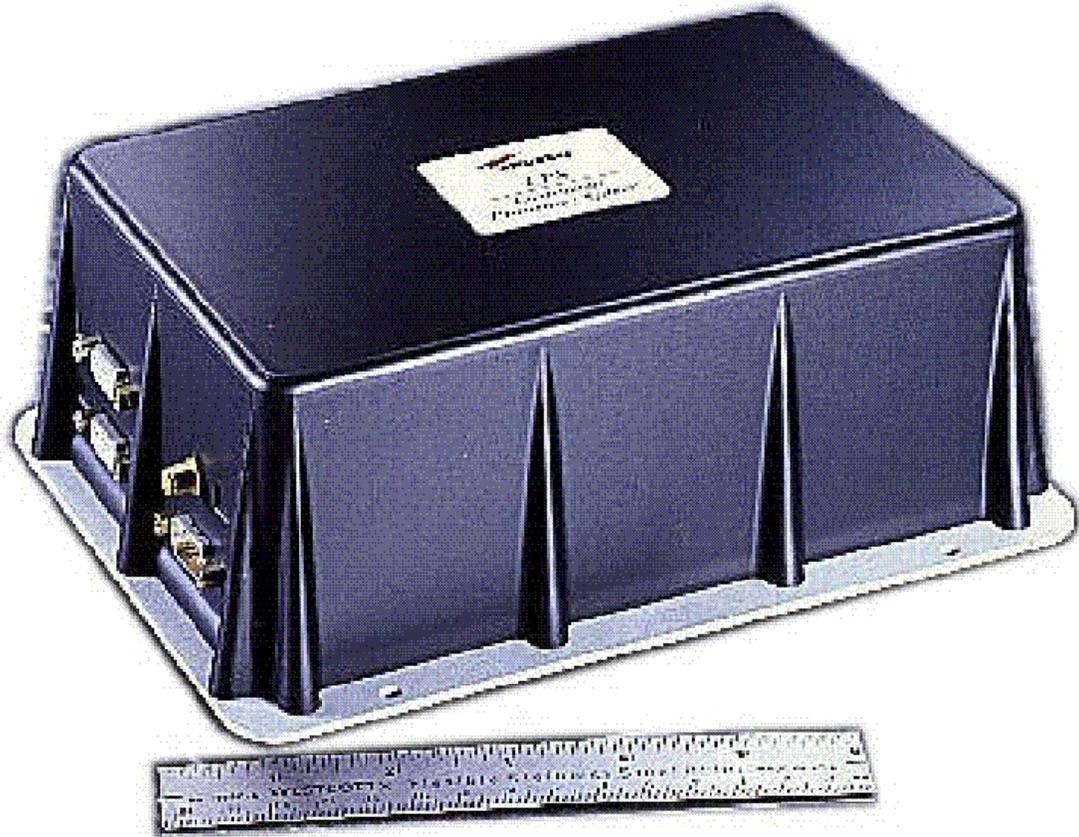
Except for the vehicle speed sensor (odometer) and GPS antenna, the system is housed in a single enclosure that contains the fiber optic gyroscope, GPS receiver, and navigation computer. The system specifications are given in Table 1 and the complete system is shown in Figure 3.

Figure 3. The CPS equipment enclosure

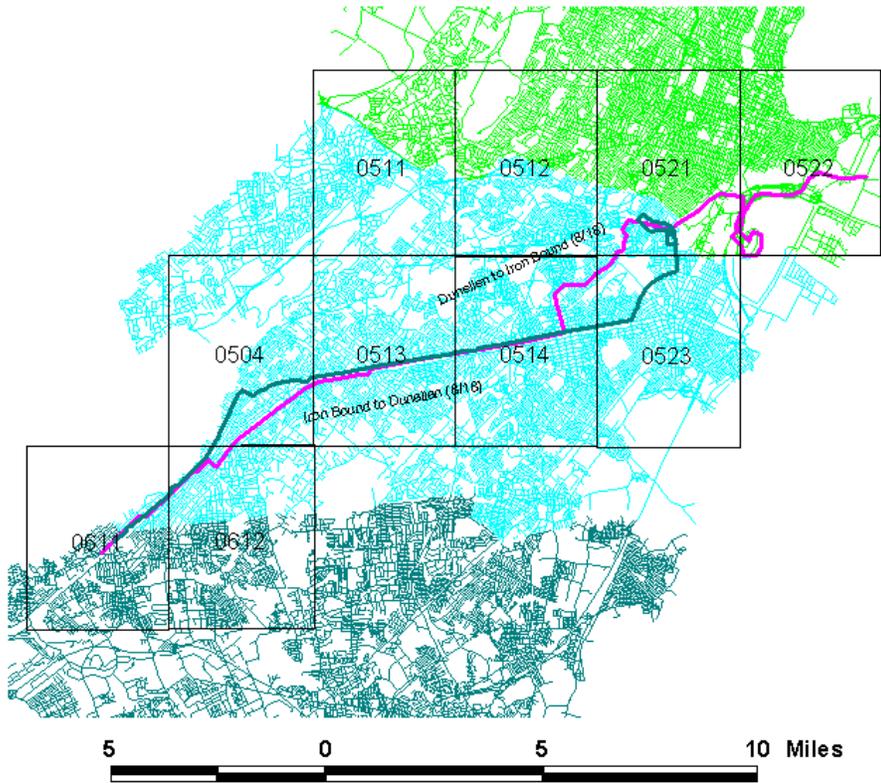
- DOQQ CODE
- ↗ Iron Bound to Dunellen (8/18)
- ↖ Dunellen to Iron Bound (8/18)
- ↗ Essex
- ↖ Middlesex
- ↗ Union

Figure 4. Bus Route of August 18

The selected routes and the dates in which data recording was conducted are shown in table 4 and figures 4, 5 and 6. In figure 5, a single route (PABT to Dunellen) represents Routes 3 and 4 of table 4. The reason for presenting two separate routes (PABT to Cranford and Cranford to Dunellen) in table 4 is because the data for these segments was originally stored in two separate files. An equipment malfunctioning caused the system to stop collecting data in Cranford. The CPS was then reinitialized and the route was completed in Dunellen as planned.

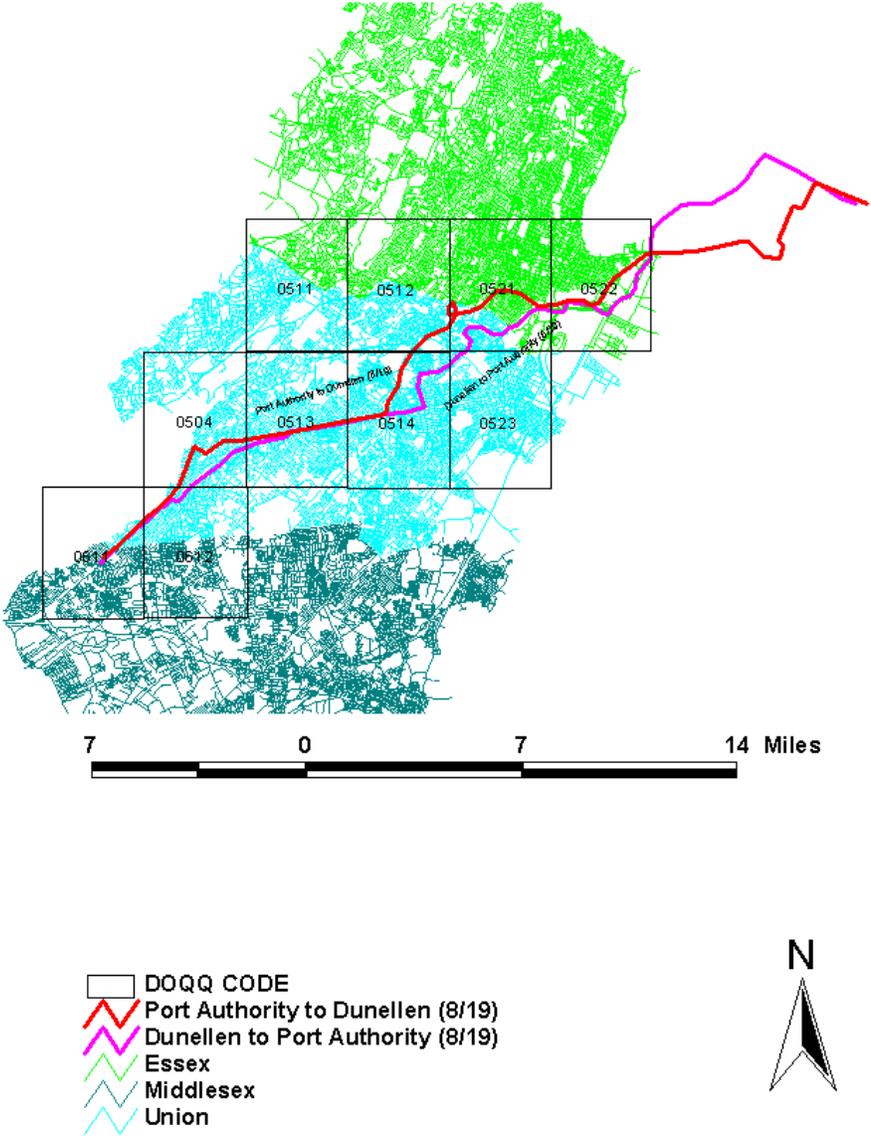
Figure 5. Bus Route of August 19

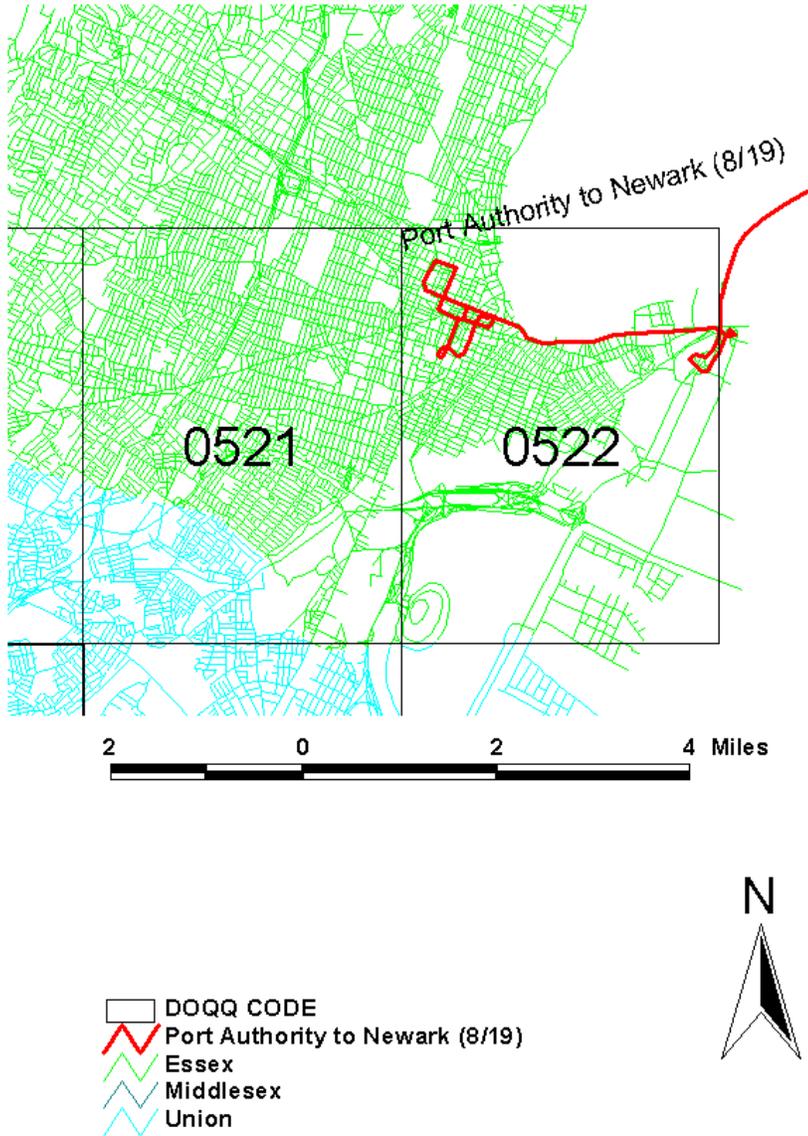
Figure 6. Newark Bus Route of August 19

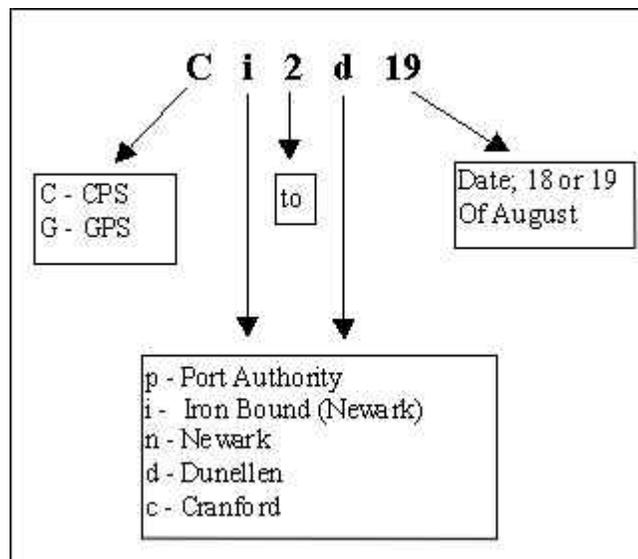
To illustrate this naming convention let's look at an example. The file containing the CPS data for the route from Iron Bound to Dunellen, that was run on August 19, was named "ci2d19".

Figure 7. File name convention for CPS and GPS data

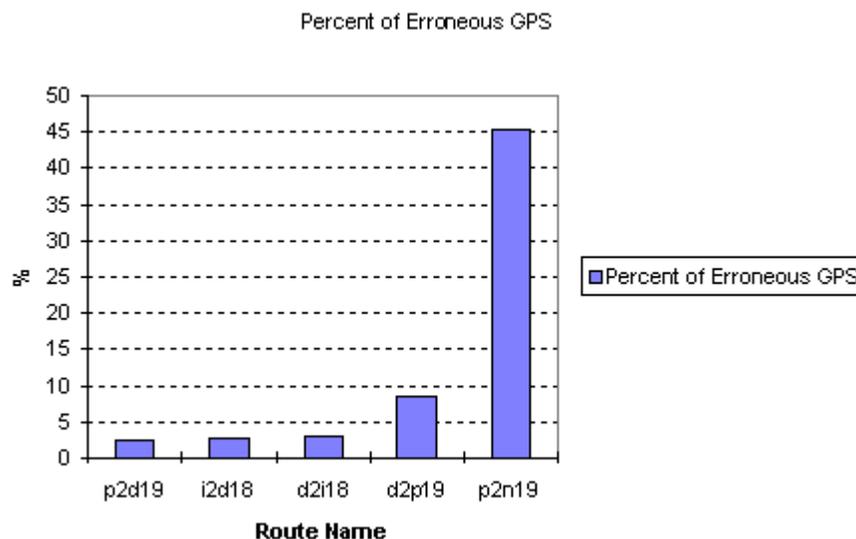
From the above it can be seen that except for the two problematic routes mentioned above, GPS was more than 95% of the time within the reference location. If we exclude the Newark route from these statistics then the overall percent of erroneous GPS positioning drops to 4.29%.

Figure 8. Positional errors of GPS only.

Another route that produced relatively inaccurate results was the one between Dunellen and the PABT, traveled on August 19. The percent of erroneous GPS positioning of route d2p19 was 8.51%. Most of the errors occur on the sections near Dunellen (Rt. 28) and North West to Newark airport (Rt. 22). A possible reason for this failure is poor GPS signal and lack of differential correction. The accuracy of GPS positioning without differential correction is relatively poor due to an intentional degradation of the GPS signal by the US department of defense (DOD). Table 5 and figure 8 summarize these findings.

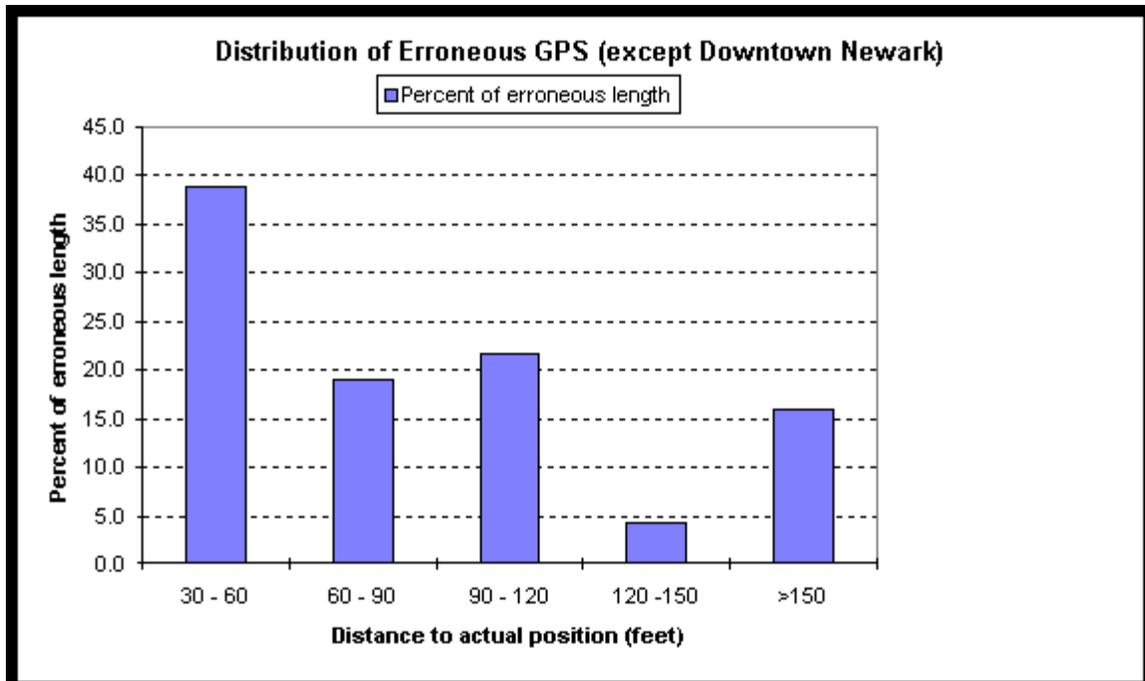
The distribution of the GPS errors excluding the data from the Newark route is shown in figure 9. The figure indicates that almost one half of the errors are less than 100 ft. long. The distribution of GPS data errors follow, in general, familiar statistics pattern in which large errors are less likely to occur than small ones. The seemingly increase in the percentage of errors of 150 feet or more is because it refers to a much wider class interval. If the 30-ft. interval was maintained (i.e. 150-180, 180-210, etc.) one could have seen a decrease in the percent of erroneous length as the distance increases.

Figure 9. The distribution of GPS errors.

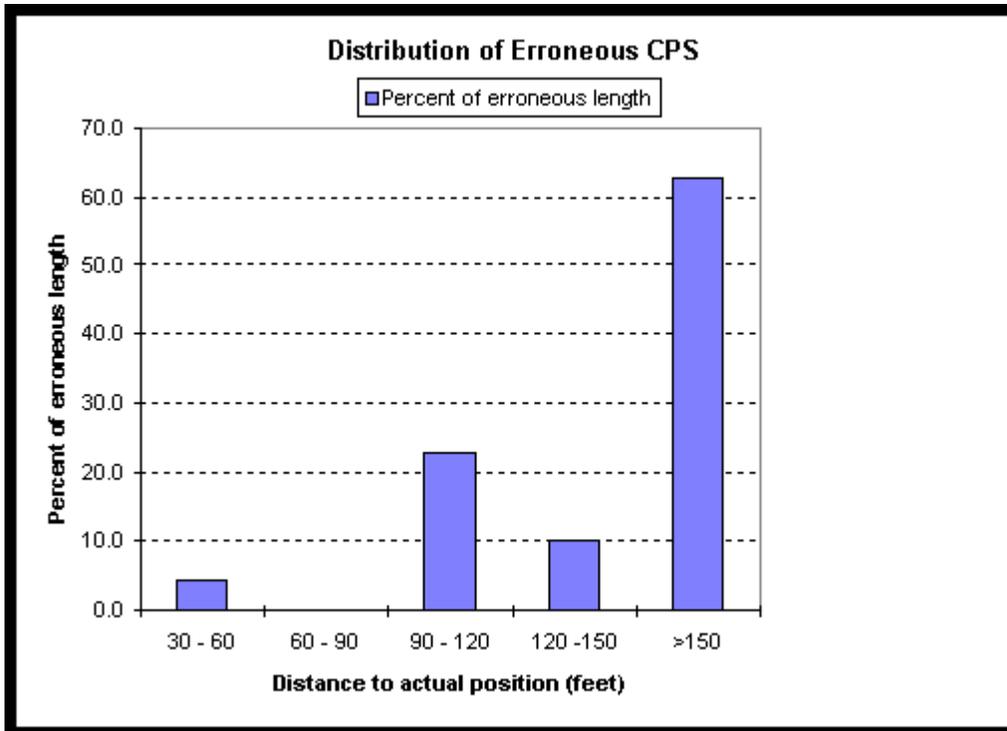
Figure 10. Positional error of CPS only.

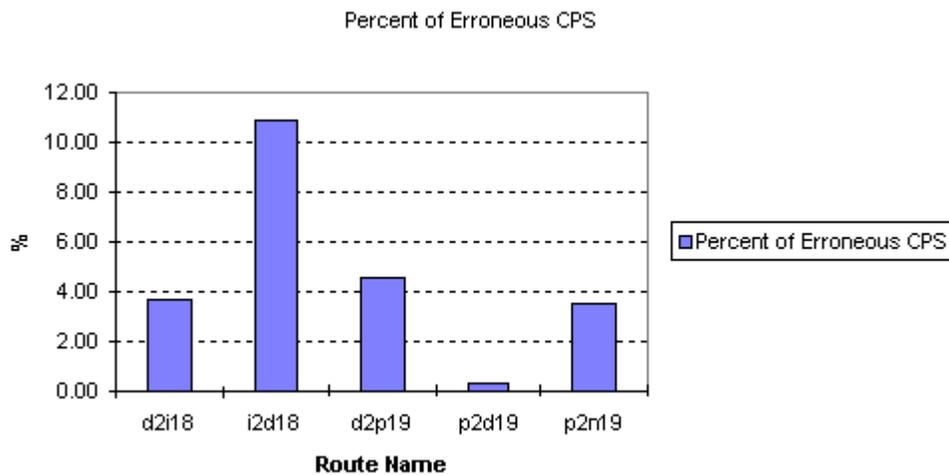
Figure 11. The distribution of CPS errors.

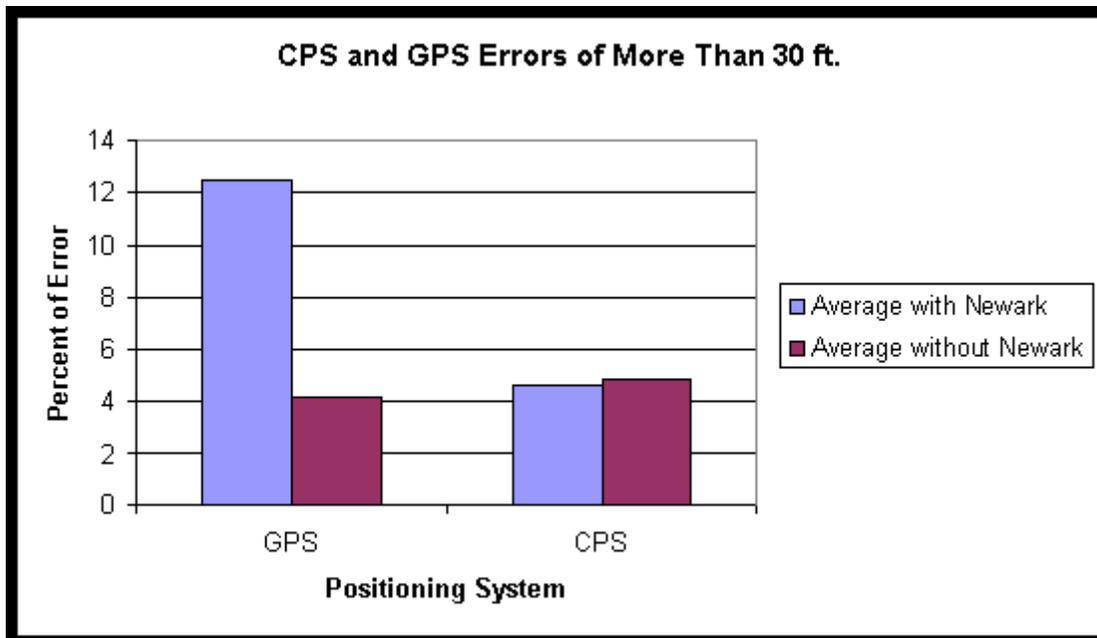
A combined comparison of CPS and GPS accuracies is shown in table 7 and in figure 12. It is interesting to note that if we are to exclude the Newark route, on the average the performance of GPS and CPS is practically the same. Both systems performed at around 95% correctly. However, while the average is the same, there appears to be no correlation between the magnitude of the error of each positioning system in specific routes. In other words, routes that had larger GPS errors (e.g. d2p19) did not necessarily have more CPS errors and visa versa (e.g.

Figure 12. Combined CPS and GPS error

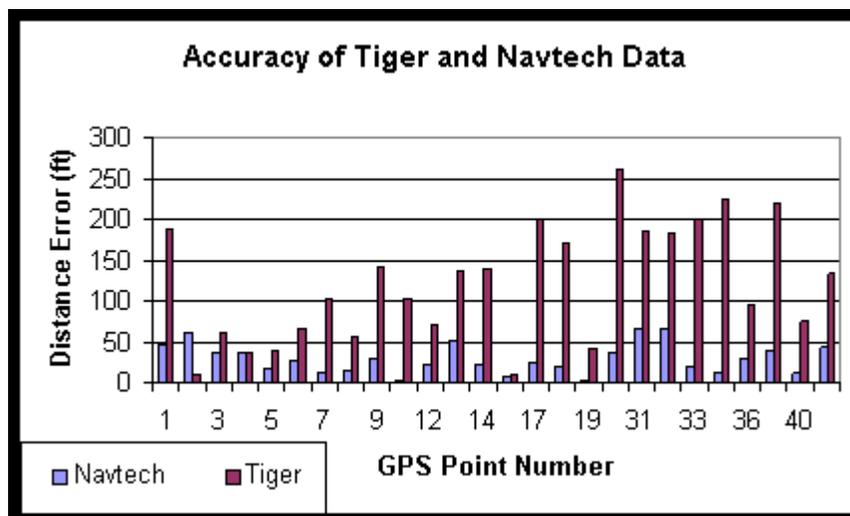
Figure 13. Distances between Navtech and TIGER/Line data sets, and GPS control points.

An apparent (and expected) conclusion from this analysis is that the TIGER/Line data is inadequate for applications where 30-ft. distance error tolerance is required. For more general application where larger error tolerances (such as 200 ft) are acceptable, TIGER/Line data may be considered.

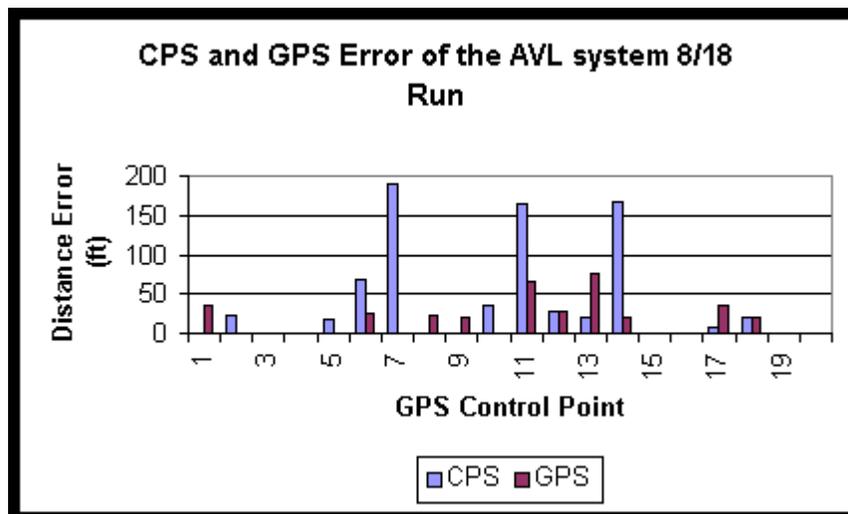
Figure 14. The accuracy of CPS and GPS with respect to GPS control (8/18 run).

The accuracy analysis of the AVL with respect to the GPS control points seems to exhibit better results than those observed during the comparison with the DOQQ. The accuracy improvement can be explained by the fact that the bus actually made a complete stop at these points for a couple of minutes. Thus, the system had more time and additional data to refine its position. The results of this analysis are shown in table 10 and figures 14, 15.

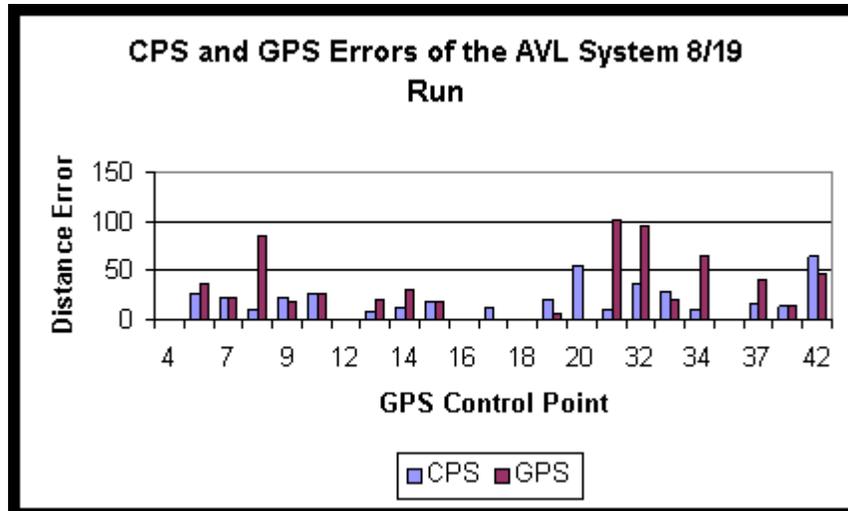
Figure 15. The accuracy of CPS and GPS with respect to GPS control (8/19 run).

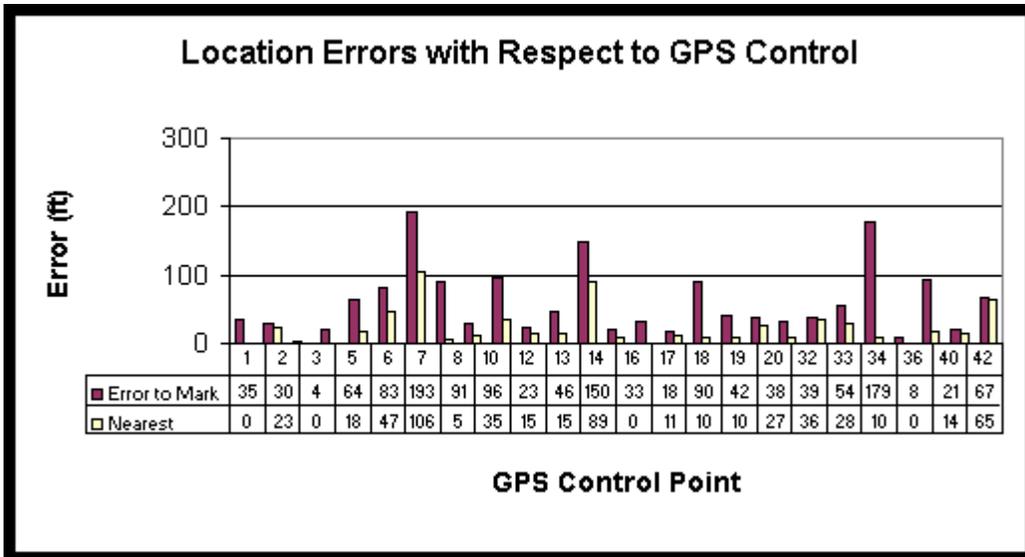
Figure 17 presents the distance or the error between the GPS control point and the Marked point and the nearest CPS point. All of the Marked points have larger distances to the GPS control points compared to the nearest point. What this means is that none of the Marked points was the nearest point to the GPS control. This observation is also evident from figure 16 since the best case scenario is that the nearest point is also the Marked point. In that case both distances to the GPS control are equal. The average error of the Marked points was 59 feet with a standard deviation of  $\pm 50$  feet while the average error of the nearest points was 23 feet with a standard deviation of  $\pm 27$  feet.

Figure 17. Location error the CPS with respect to the GPS control.

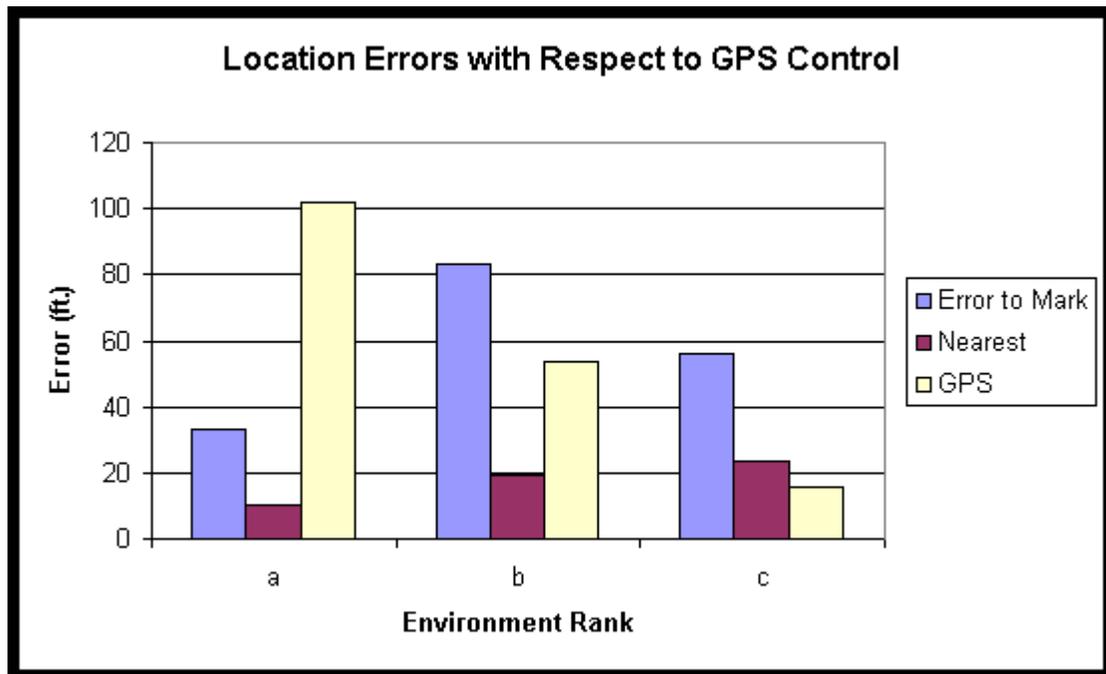
The GPS component of the AVL system showed a definite dependency on the rank of the environment. The point with rank ‘a’ had the largest error while points with rank ‘c’ were found to be within the acceptable error tolerance adopted in this study.

Figure 18. Location error in various operation environments of the AVL system with respect to the GPS control.

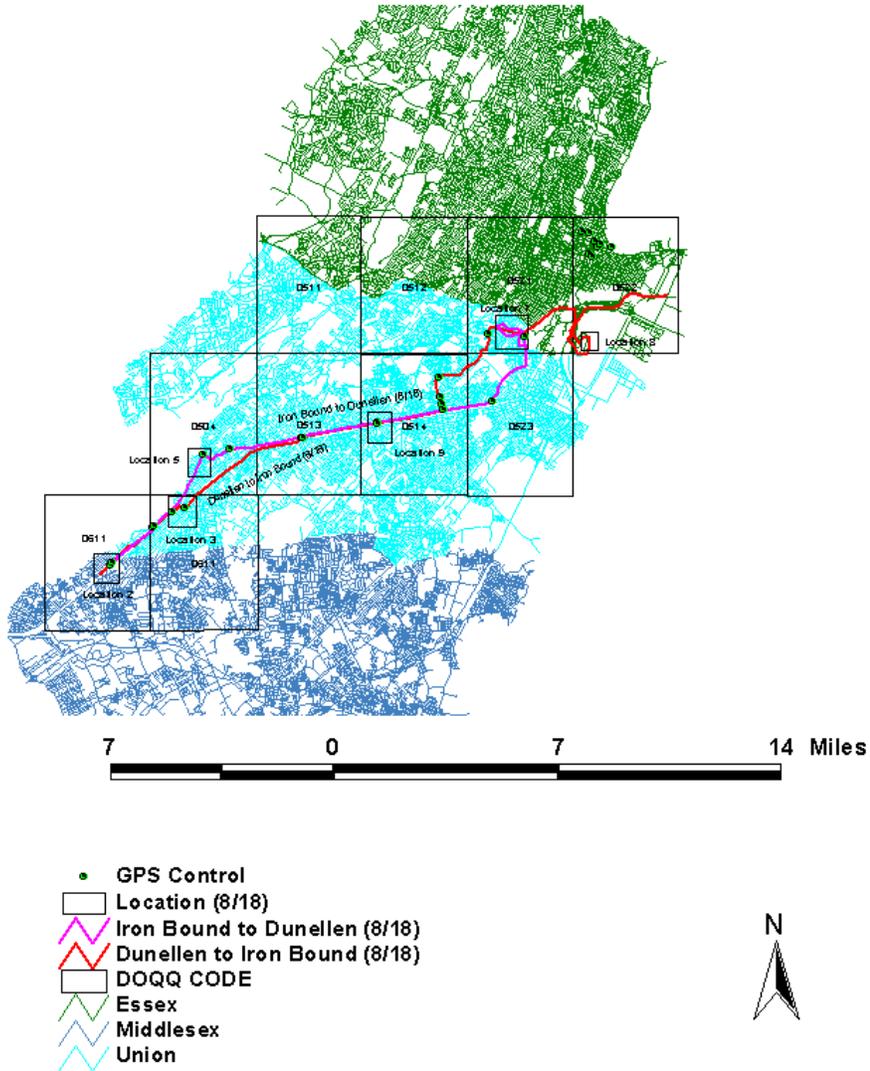
Figure 19. Index of error locations 8/18

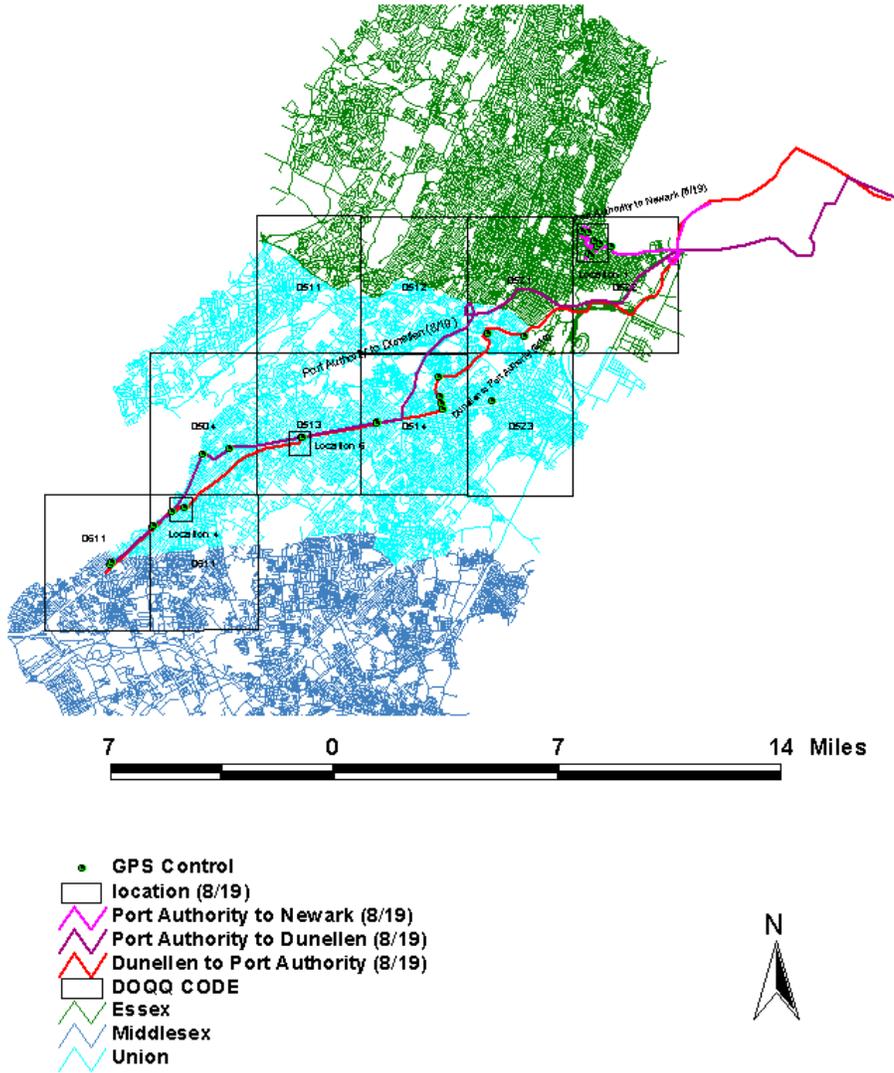
Figure 20. Index of error locations 8/19

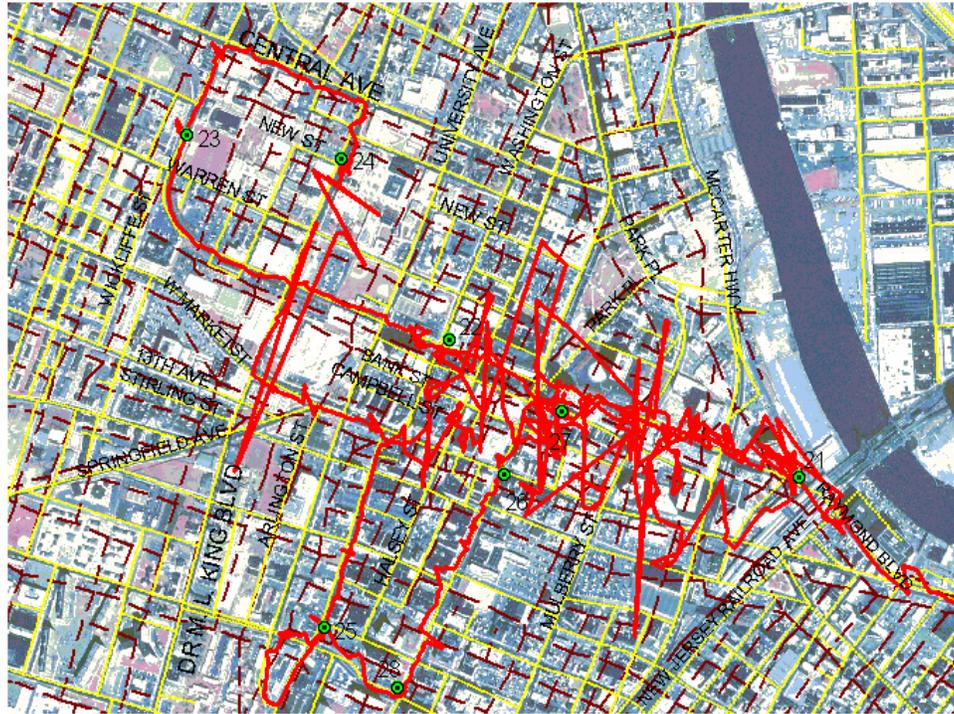
Figure 22. Location 1, GPS

# Location 1 Downtown Newark (GPS)

- Gps Control
- GPS - PABT to Newark 8/19
- Navtech
- Essex (TIGER)

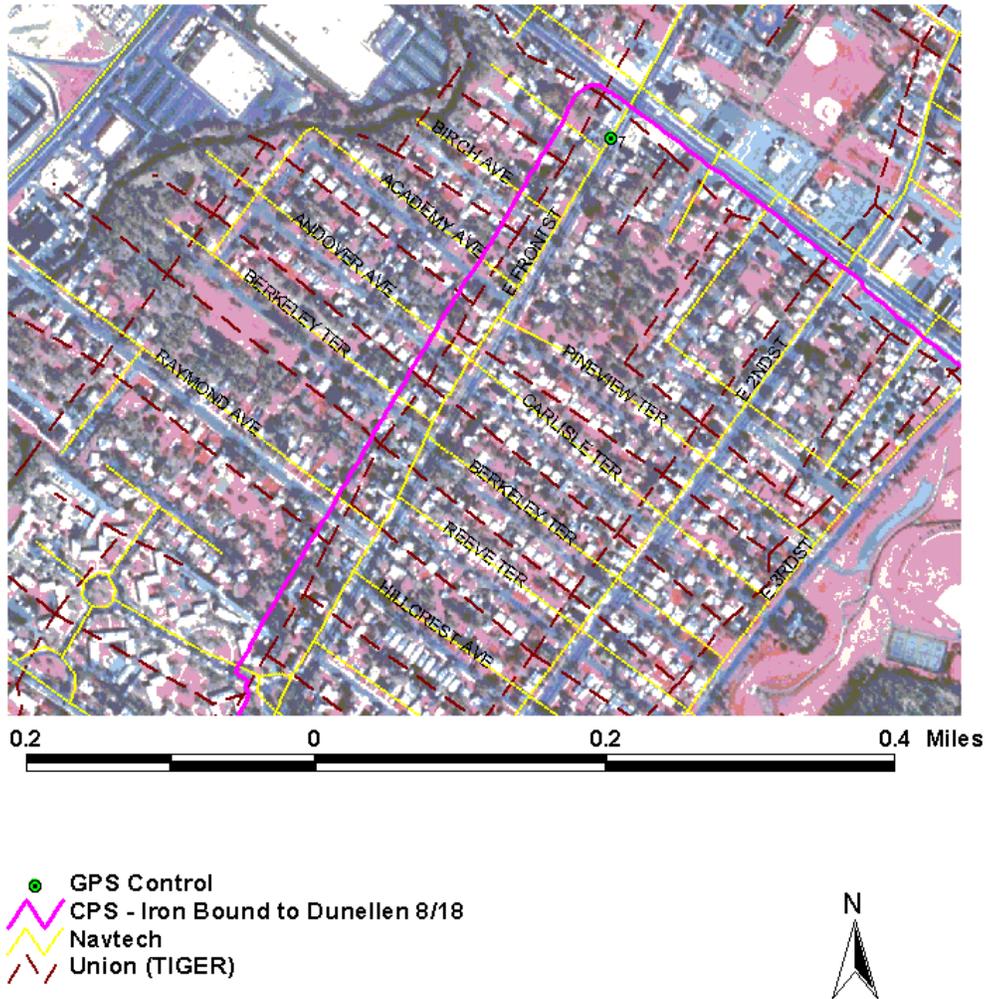
Figure 29. Location 5, CPS

# Location 5 Fanwood (CPS)

Figure 29 - A long section of CPS positioning (Ci2d18) is shift by 60-190 ft. from the reference data.

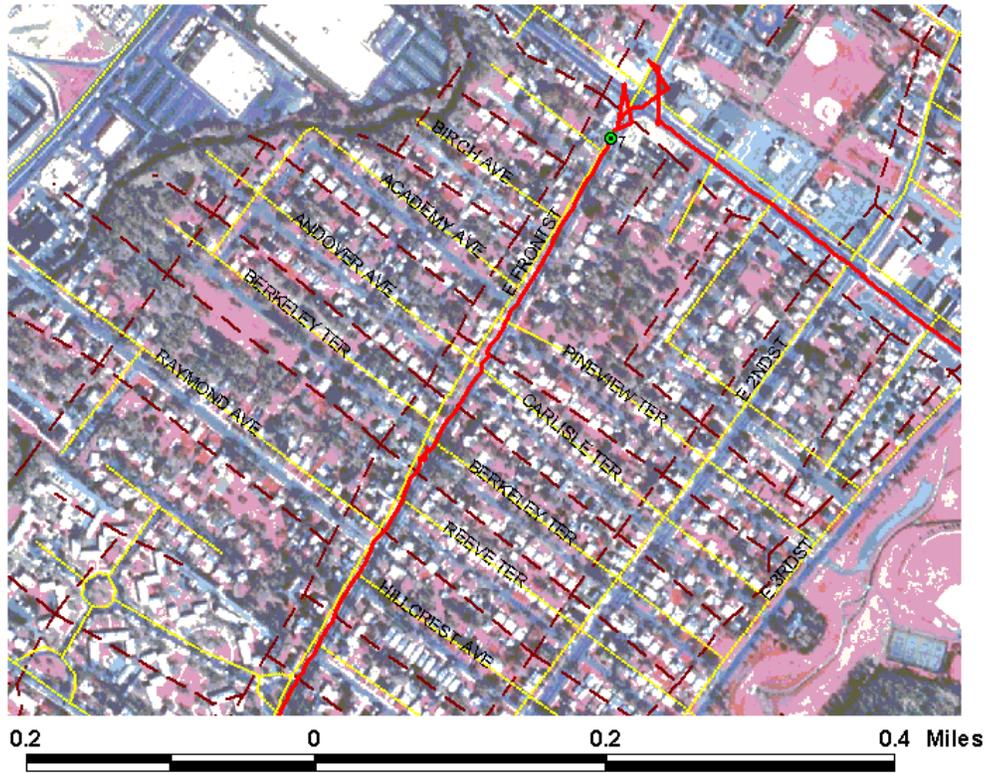
# Location 5 Fanwood (GPS)

- GPS Control
- ↔ GPS - Iron Bound to Dunellen 8/18
- ↔ Navtech
- ↔ Union (TIGER)

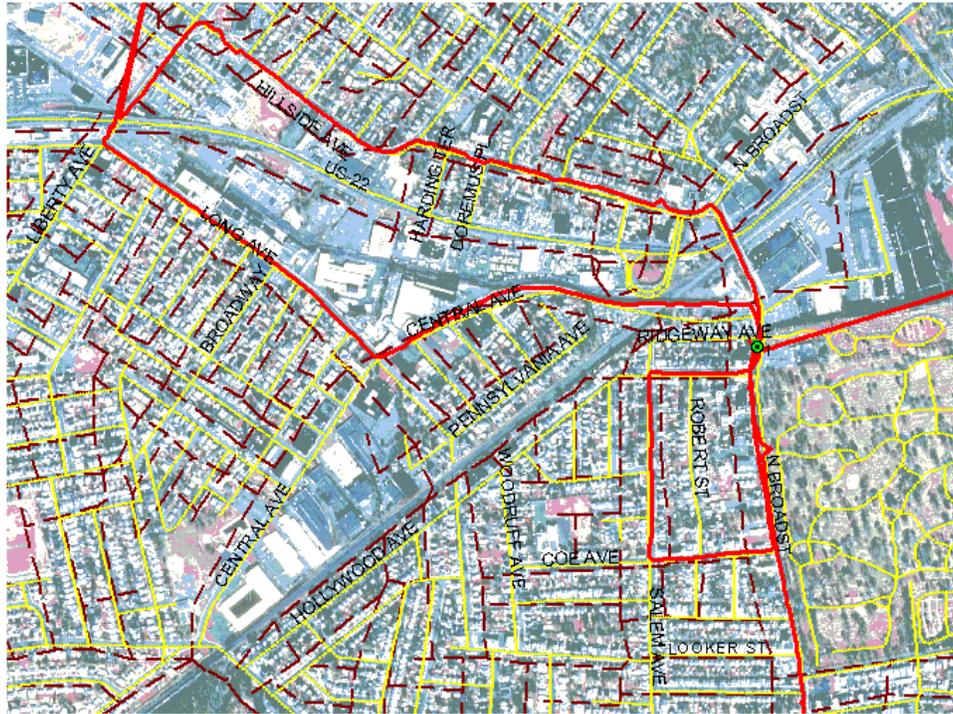
# Location 7 Hillside (GPS)

- GPS Control
- GPS - Iron Bound to Dunellen 8/18
- Navtech
- Union (TIGER)
