# Characterization of the Environment

PUBLICATION NO. FHWA-RD-00-030

AUGUST 2000

16. Abstract  The study on which this report is based sought to compile data on both accelerated and natural exposure of coating and corrosion test panels and then to relate their deterioration to environmental conditions. The report presents data gathered over a 5-year period, incorporating seven different test sites across the United States. Specifically, the report looks at how the local environment affects the performance of eight coating systems and two weathering steels. For coated steel, the report concludes that an absolute humidity of 0.015 moles H <sub>2</sub> O/mole of dry air is the critical level for increasing the likelihood of corrosion. In such environments, a bridge engineer should utilize a zinc-rich coating system to prevent premature failures. Blistering failure is predominant in panels with high initial salt contamination on the substrate. To minimize failure due to blistering, the substrate should be as clean as possible. Cutback is chiefly affected by the high amount of rainfall and salt-fall (marine environments). A zinc-rich coating system is the best method for preventing c

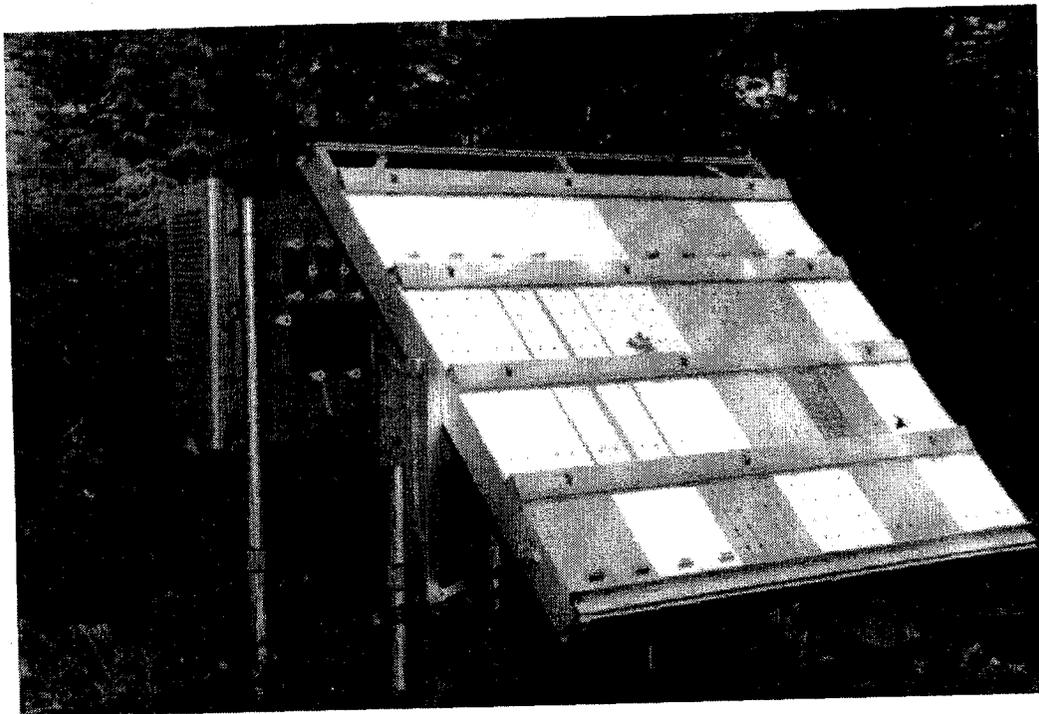
**Figure 1(a). Typical test panel exposure rack.**

Each test site was similarly configured with painted test samples. All sites, with the exception of the Florida and Arizona sites, were outfitted with uncoated steel samples for corrosion rate determinations. Eight coating systems were tested at each location. These panels were prepared and placed on racks that faced South at a 45° angle, in accordance with ASTM D1014. Six panels of each coating system were exposed at the test sites. This included two U-channel panels painted over an SP-10 prepared surface, two flat panels painted over an SP-10 prepared surface, and two flat panels painted over an SP-3 prepared surface. Figure 1(a) shows a typical exposure rack and weathering steel test box. Figure 1(b) shows individual photographs of these test assemblies. Figure 2 describes the panel layout and intentional U-channels and holidays on each panel. The U-channel panel was holiday-free, the second SP-10 surface preparation panel had eight holidays on each face, and the SP-3 surface preparation panel had two holidays on the lower portion of the panel face.

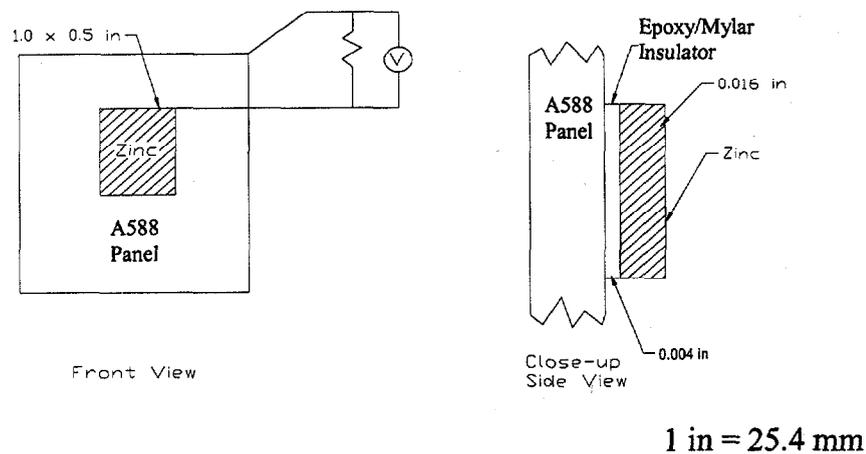
The time-of-wetness was monitored in all four exposure orientations by an apparatus developed by Ocean City Research Corporation personnel. This consisted of a weathering steel (A588) panel with an electrically isolated, centrally located zinc plate. Figure 3 shows a sketch of this apparatus (not to scale). The weathering steel panel was chosen (instead of the gold or platinum devices that were available) since the presence of a corrosion product may affect the time-of-wetness readings. If the surface wetness was not able to generate a corrosion current, then it would not be considered a significant surface wetness for the purposes of this experiment.

**Figure 3. Time-of-wetness gauge.**

Lead wires were attached to the steel panel and zinc plate. A 0.5-mega-ohm shunt resistor shorted the lead wires and the data logger measured the voltage across this resistor. This resistor was chosen due to the low internal resistance of the data logger (2 mega-ohms) and the fact that the logger attempts to read a voltage even at resistances exceeding its internal value. This results in the measurement of finite, unstable values. The 0.5-mega-ohm resistor minimizes the problem of extraneous recorded voltages.

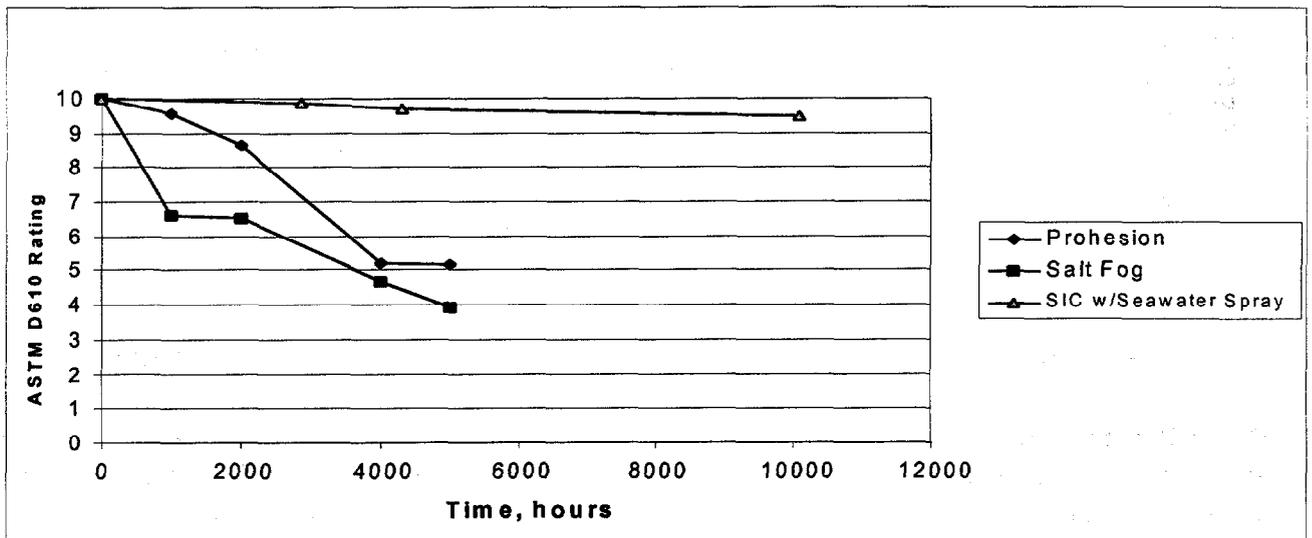
Figure 4 shows the composite rusting (ASTM D610) for all coating systems over an SSPC SP-10 substrate in all accelerated test procedures. This composite rating is an average of rust ratings received by all eight systems. The composite rating is meant to show the overall corrosiveness of the test environment. From this, it can be seen that the accelerated natural exposure test is much less corrosive, from a rusting standpoint, than the salt fog and Prohesion tests. Prohesion and salt fog testing environments were considerably more aggressive, with salt fog showing the most rusting.

**Figure 4. Accelerated testing rust ratings, all systems, SSPC SP-10 substrate.**

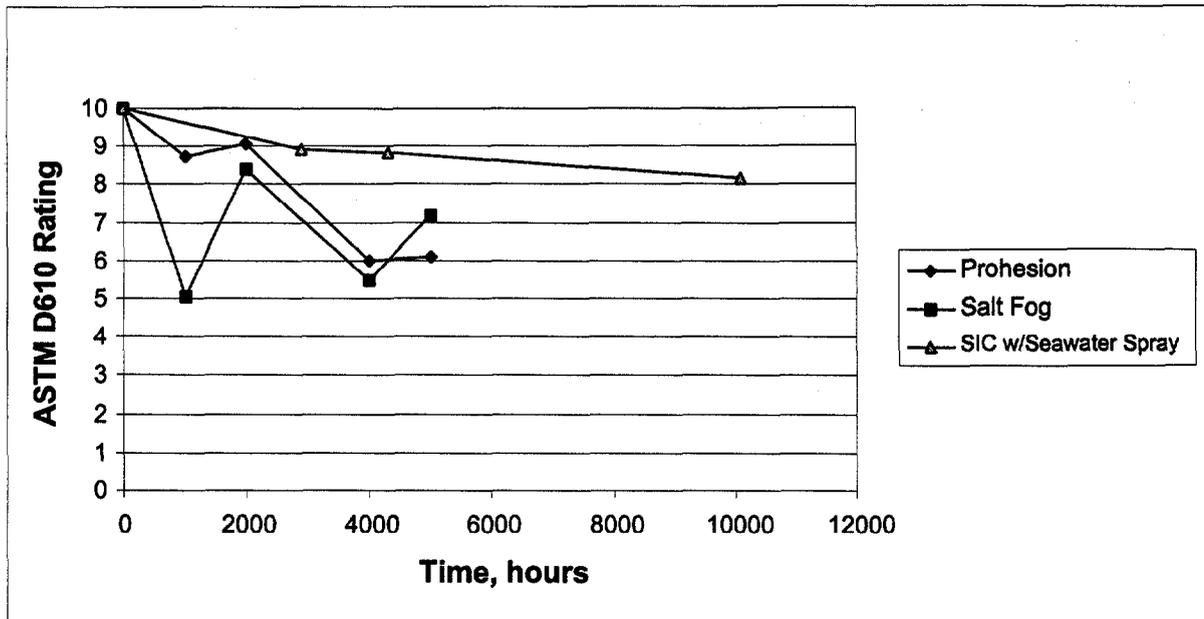
The influence of the substrate is less of a factor in the highly accelerated conditions of the Prohesion and salt fog tests.

Figure 5. Accelerated testing rust ratings, all systems, SSPC SP-3 substrate.

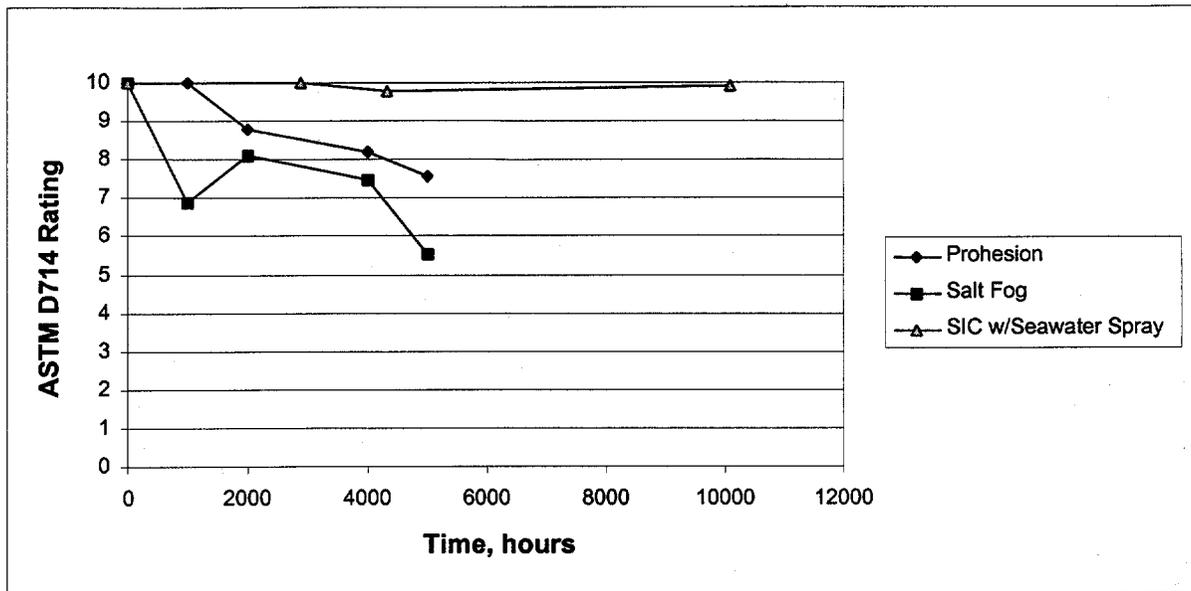
Figure 6 shows the composite blistering (ASTM D714) for all coating systems in all accelerated test procedures over an SSPC SP-10 prepared substrate. From this, it can be seen that when testing over an SSPC SP-10 substrate, salt fog provides the harshest environment, followed by Prohesion, and then accelerated natural exposure, where the average rating is above 9.

**Figure 6. Accelerated testing blister ratings, all systems, SSPC SP-10 substrate.**

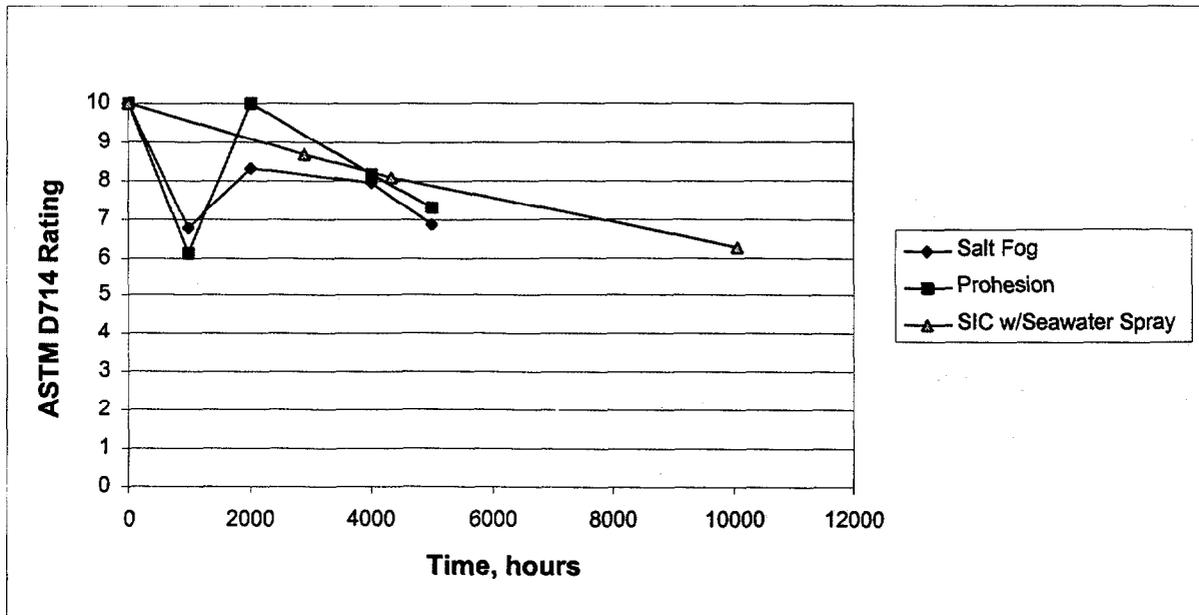
Figure 7 shows the composite blistering (ASTM D714) for all coating systems in all accelerated test procedures. Coating systems were applied over an SSPC SP-3 prepared substrate. From this, it can be seen that the accelerated natural exposure test provided a level of blistering at the end of testing (10,000 h) that was comparable to the level of blistering at the end of Prohesion and salt fog testing (5,000 h). However, it took the accelerated natural exposure test almost twice as long to reach that level of blistering. It is also seen that while the blister ratings for the laboratory tests vary from inspection to inspection, the blistering of the accelerated natural exposure test follows a more linear trend.

**Figure 7. Accelerated testing blister ratings, all systems, SSPC SP-3 substrate.**

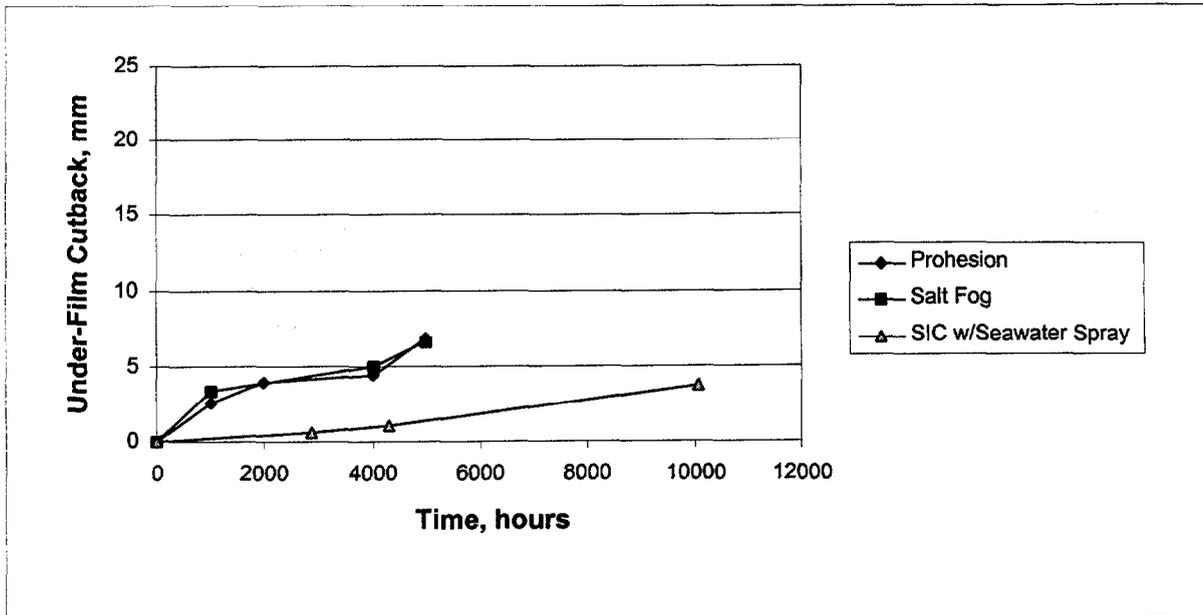
Figure 8 shows the composite under-film cutback for all coating systems in all accelerated test procedures. Coating systems were applied over an SSPC SP-10 prepared substrate. This composite rating is an average of cutback experienced by all eight systems. From this, it can be seen that the Prohesion and salt fog tests have comparable levels of cutback. This is similar to findings by Chong.<sup>(6)</sup> The accelerated natural exposure testing, however, is less aggressive than the two laboratory tests.

**Figure 8. Accelerated testing cutback, all systems, SSPC SP-10 substrate.**

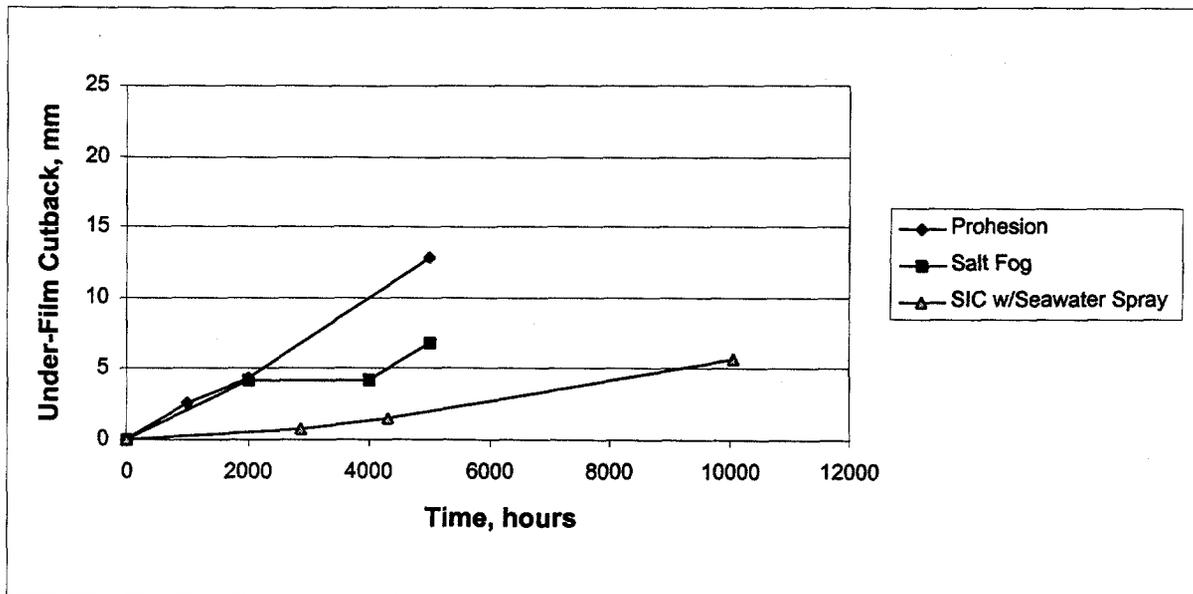
Figure 9 shows the composite under-film cutback for all coating systems in all accelerated test procedures. From this, it can be seen that the Prohesion cabinet provides the highest level of average cutback, indicating that it is a more aggressive environment than the salt fog or the accelerated natural exposure tests, both of which had similar levels of cutback at the end of testing. The total cutback is also more than that experienced over the SSPC SP-10 substrate.

Figure 9. Accelerated testing cutback, all systems, SSPC SP-3 substrate.

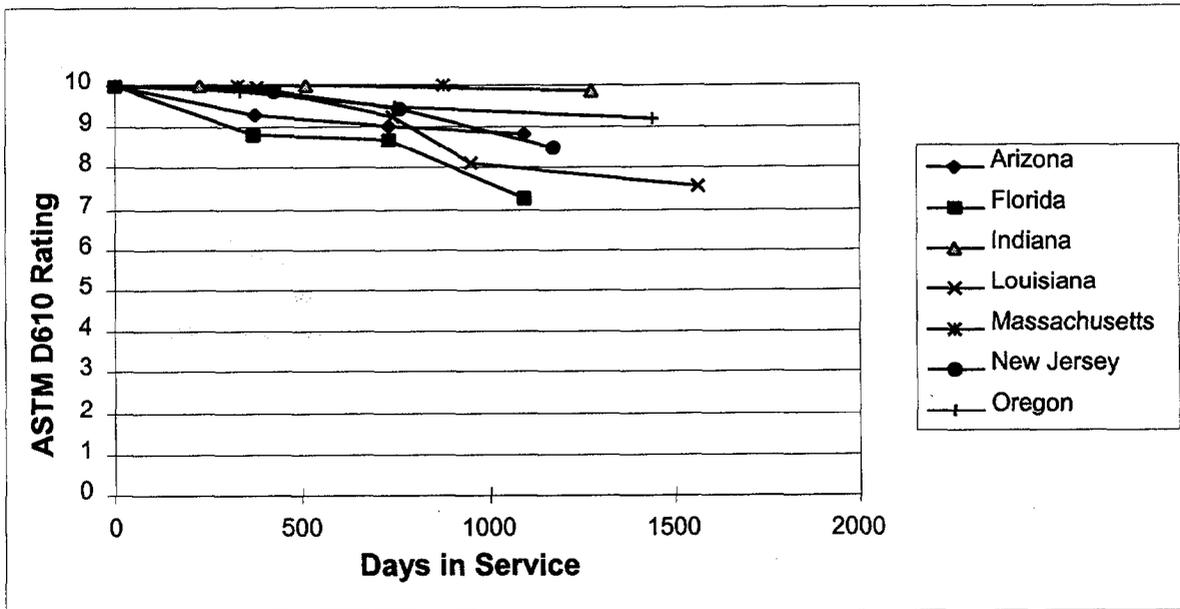
Figure 10 shows the composite rusting (ASTM D610) for all coating systems over an SSPC SP-10 prepared substrate tested at all exposure sites. This composite rating is an average of ratings received by all eight systems. The composite rating is meant to show the overall corrosiveness of the test environment.

**Figure 10. Natural exposure testing rust ratings, all systems, SSPC SP-10 substrate.**

From this data over the differing exposure periods, it can be seen that relatively little, if any, through-film rusting occurred at the Indiana and Massachusetts sites. The Arizona, New Jersey, and Oregon sites have a composite rating between 8.5 and 9.5. The Florida and Louisiana sites appear to be the most aggressive. Both achieved ratings below 8; however, the Florida site had the lowest final rating, which was achieved approximately 400 days prior to the Louisiana site's final reading.

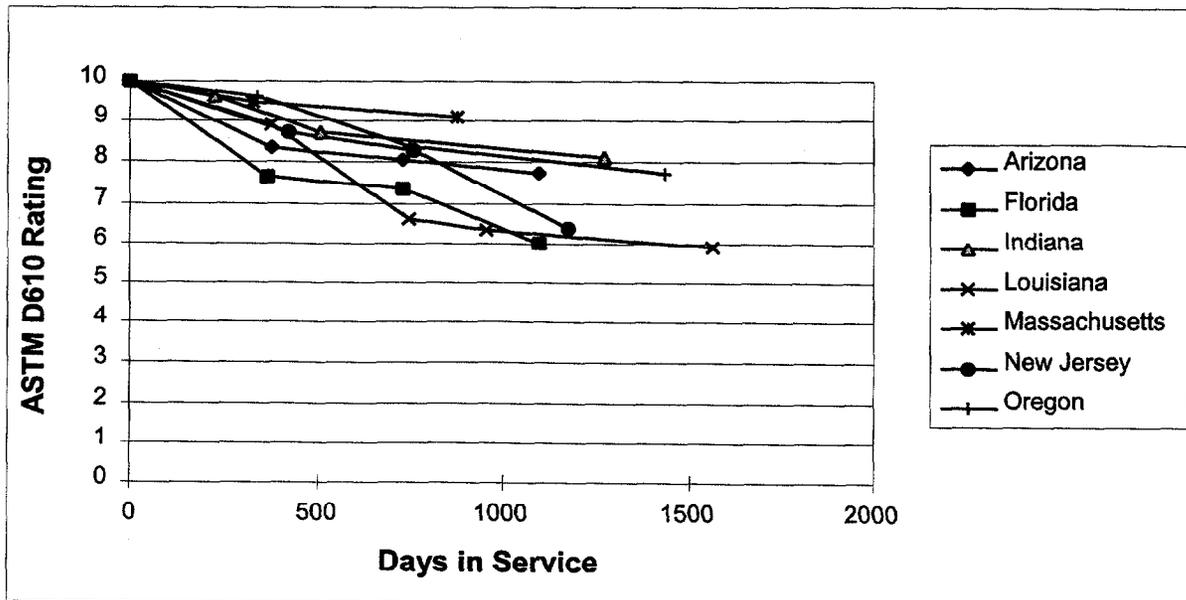
Figure 11 shows the composite rusting (ASTM D610) for all coating systems tested over the SSPC SP-3 substrate at the exposure sites. This composite rating is an average of rust ratings received by all eight systems.

Figure 11. Natural exposure testing rust ratings, all systems, SSPC SP-3 substrate.

From this, it can be seen that over an SSPC SP-3 prepared substrate, rusting was observed at all of the test sites. This rusting was more significant than that observed over the SSPC SP-10 substrate. This rusting ranged from a high rating (above 9) to a low rating (below 6). The order of these sites, from lowest to highest ratings, is: Florida, Louisiana, New Jersey, Arizona, Oregon, Indiana, and Massachusetts. This order is determined using the final rust rating obtained by each location and the slope of the line showing the rating trends.

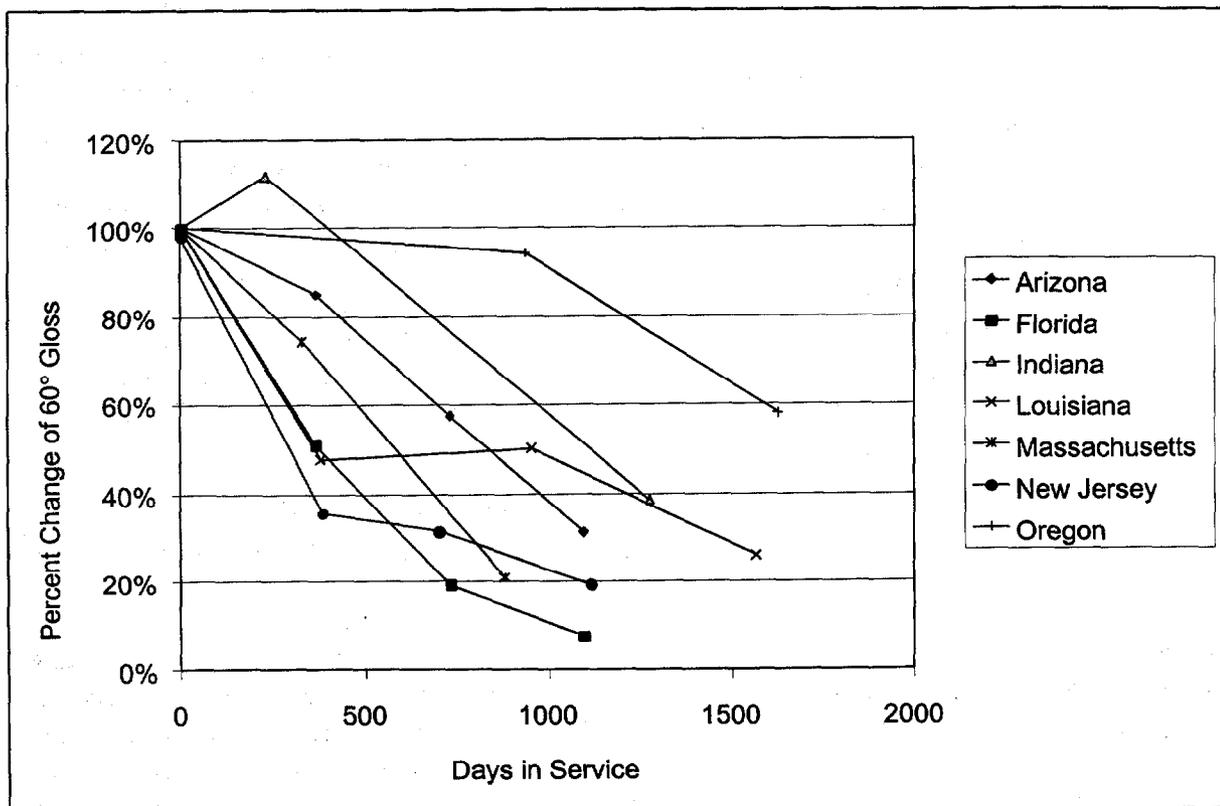
Figure 16 shows the composite gloss for all coating systems tested at all exposure sites. This composite rating is an average of the gloss measurements taken for all eight systems before and during testing. The data show the percent change from the initial readings. The composite rating is meant to show the overall effect that each site has on the change in gloss of a coating system. From this, the sites can be ranked in order from most to least harsh; they are Florida, Massachusetts, Arizona, New Jersey, Louisiana, Indiana, and Oregon. The harshness of the sites is estimated based on the rate of gloss loss (the slope of the curve) and the final gloss measurement.

Figure 16. Change in gloss ratings vs. initial data.

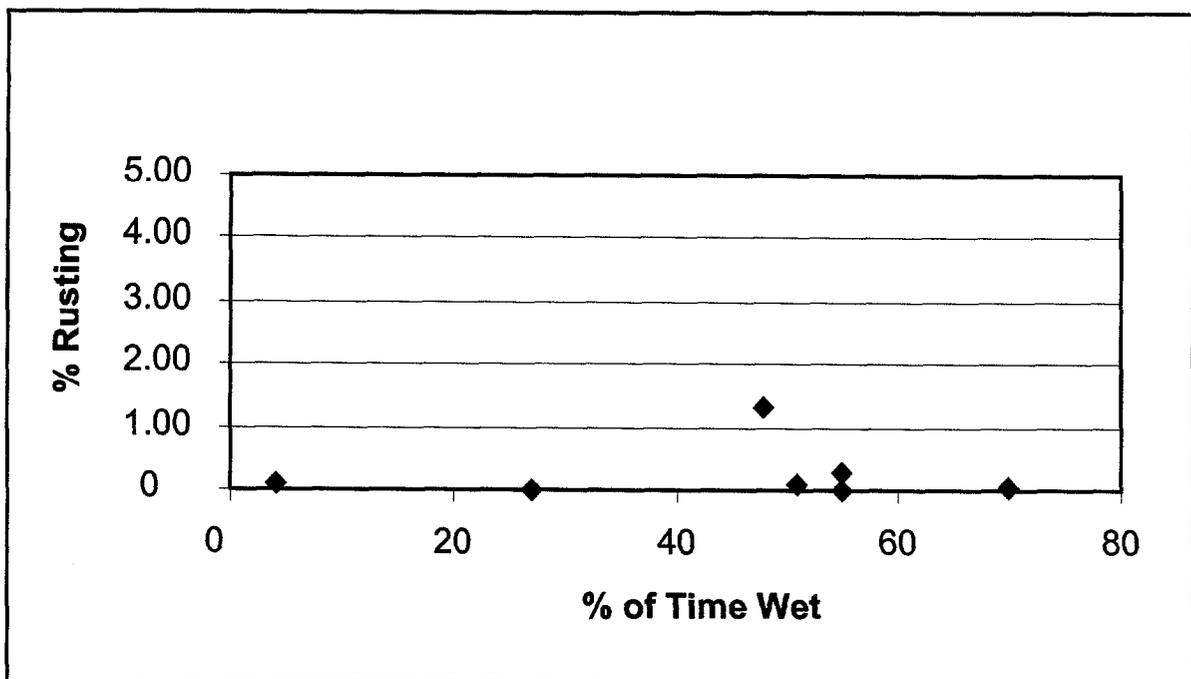
**Figure 17. Percent area rusting vs. time-of-wetness (SP-10).**

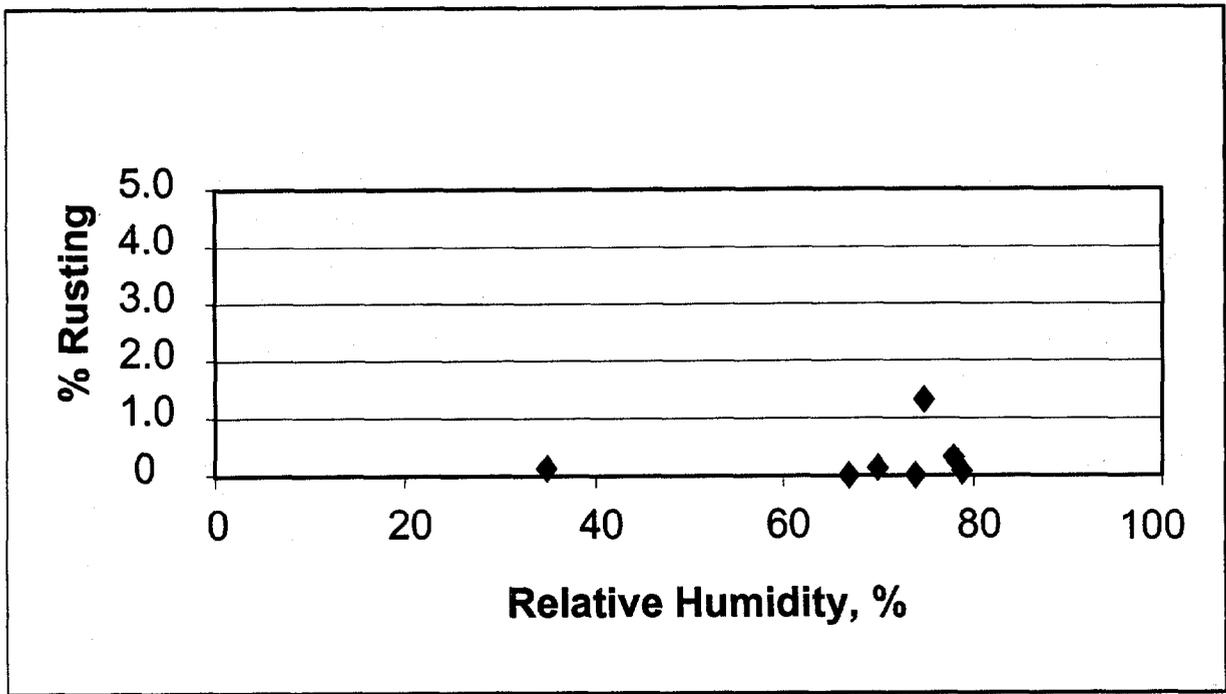
These equations were derived from the regression relationship of rust-through data.  $R^2$  values exceeded 0.99. Through the conversion, the actual differences in site corrosivity are accentuated. There are several possible (single) elements to be considered. The following are plots vs. several single parameters. Figures 17 and 18 show the percent area rusting vs. time-of-wetness and relative humidity. There are no reasonable correlations here.

Figure 18. Percent area rusting vs. relative humidity (SP-10).

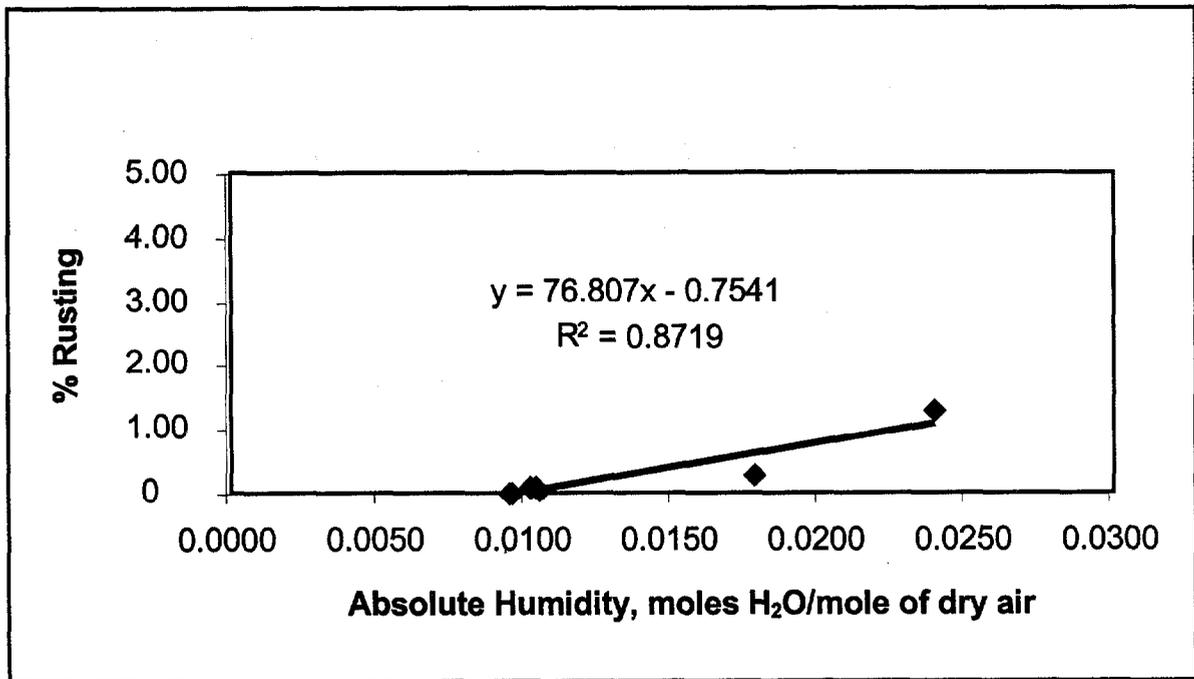
Figure 19 shows the same corrosion data plotted vs. absolute humidity.

Figure 19. Percent area rusting vs. absolute humidity (SP-10).

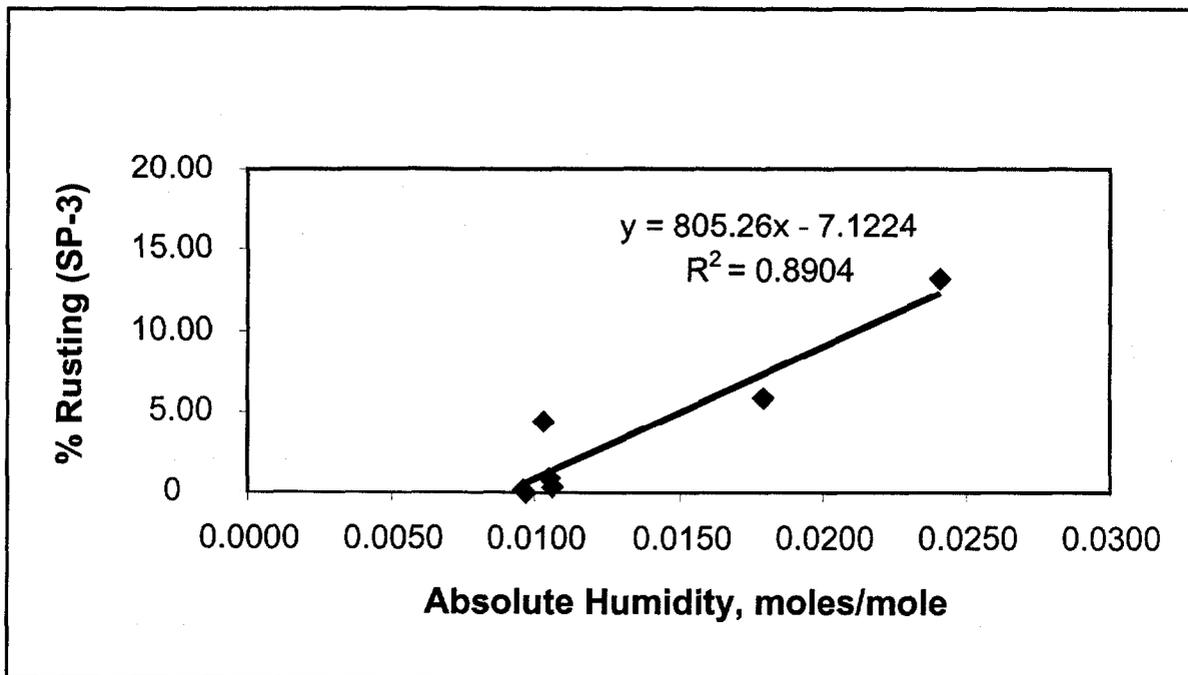
Figure 20 shows the same correlation with the coatings over the SSPC SP-3 surface.

Figure 20. Percent area rusting vs. absolute humidity (SP-3).

Again, a similar reasonable correlation is seen. The fact that both of these parameters correlate well with absolute humidity suggests that they ought to relate well to each other. Figure 21 presents this relationship.

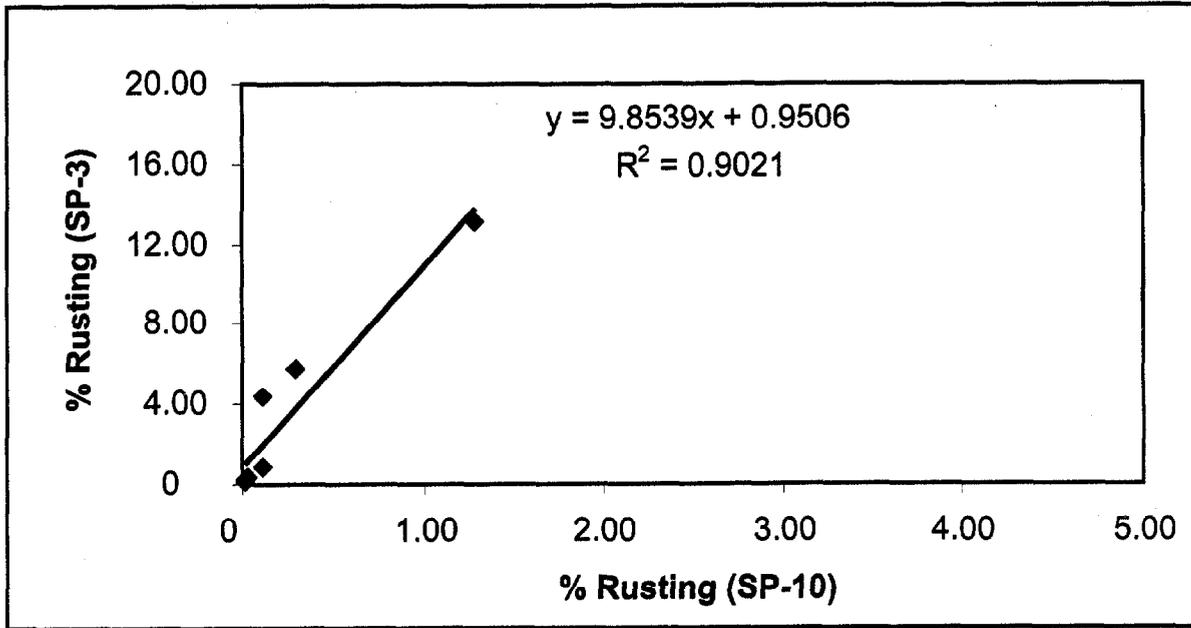
**Figure 21. Percent area rusting, SSPC SP-3 vs. SSPC SP-10 substrate.**

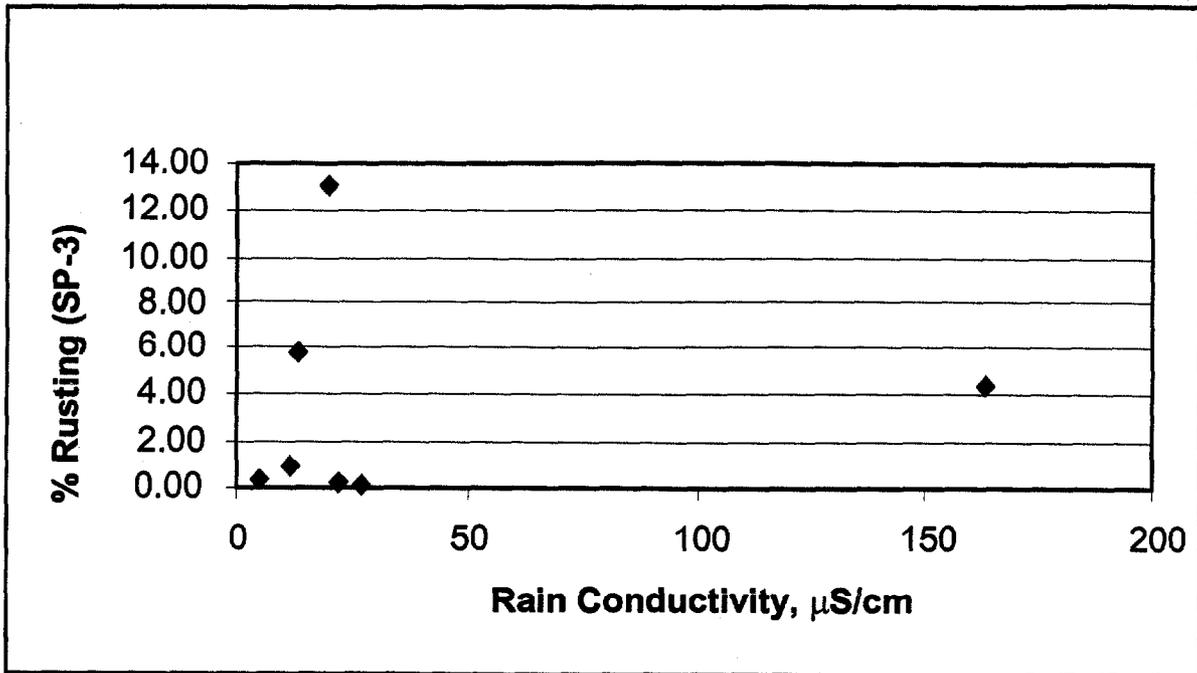
Figure 22 shows the lack of correlation between through-film rusting and the conductivity of the rainfall. This suggests no consistent effect of airborne salts on through-film corrosion within the natural environment.

Figure 22. Percent area rusting vs. rain conductivity (SP-3).

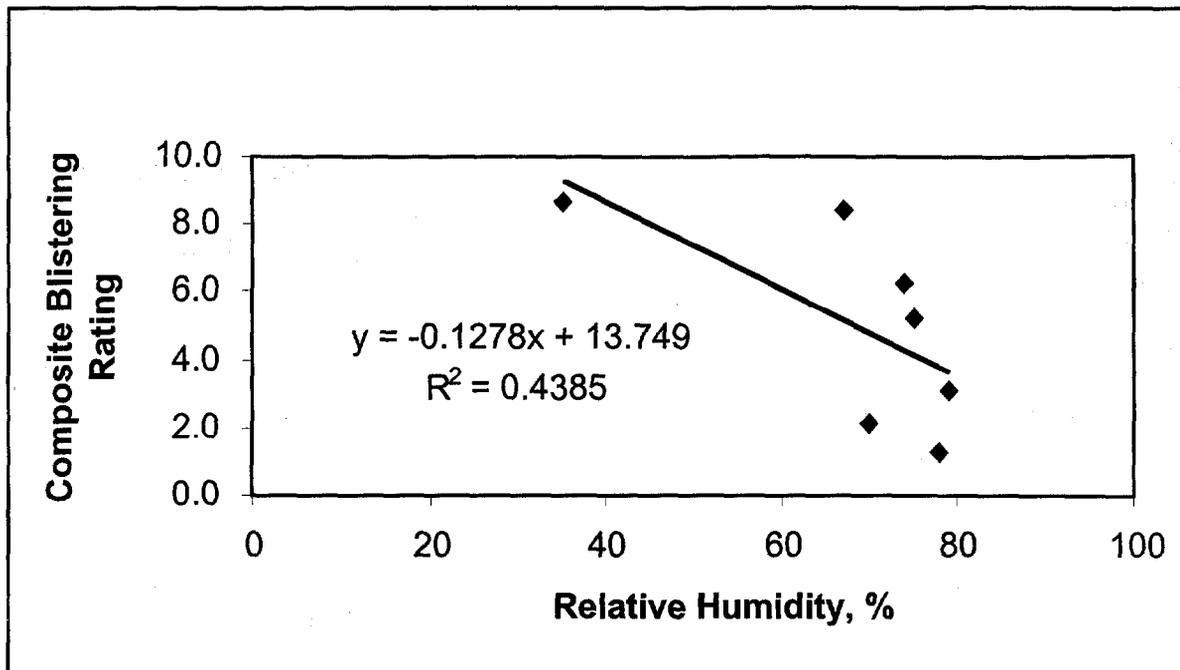
Figure 23 plots the observed blistering vs. the local relative humidity of the test sites.

Figure 23. Blistering vs. relative humidity (SP-3).

This plot does not exhibit a substantial correlation, yet blistering appears to increase with some form of increased wetness. Figure 24 shows the same relationship with respect to rainfall. In this plot, the data are divided by site temperature, where the low-temperature sites had a nominal temperature of 8.9°C vs. 22.6°C at the higher temperature sites. Blistering appears to increase with rainfall and with temperature.

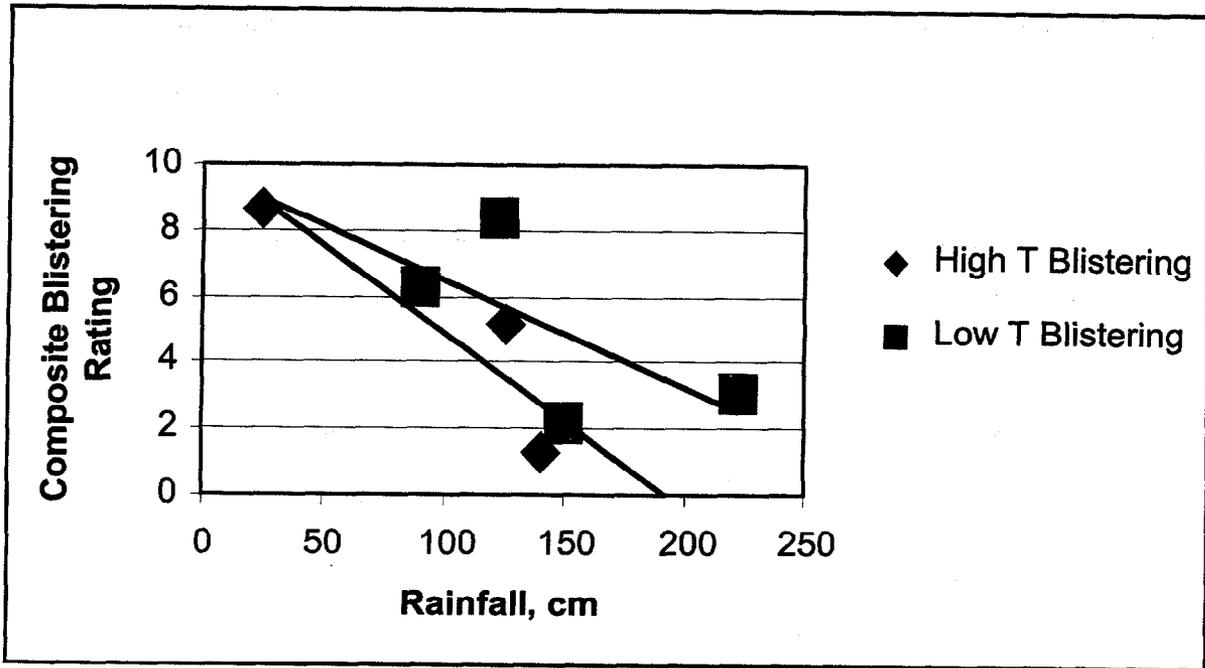
Figure 24. Blistering vs. rainfall and temperature (SP-3).

Looking at this data, there is still some interest due to the lack of significant blistering at the Massachusetts site and the lack of more blistering at the Oregon site. These are the outlier data points. To attempt to address this issue, the blistering data were organized by the severity of the corrosion observed and the time-of-wetness. In this program, time-of-wetness correlated quite well with rainfall. Figure 25 shows this plot.

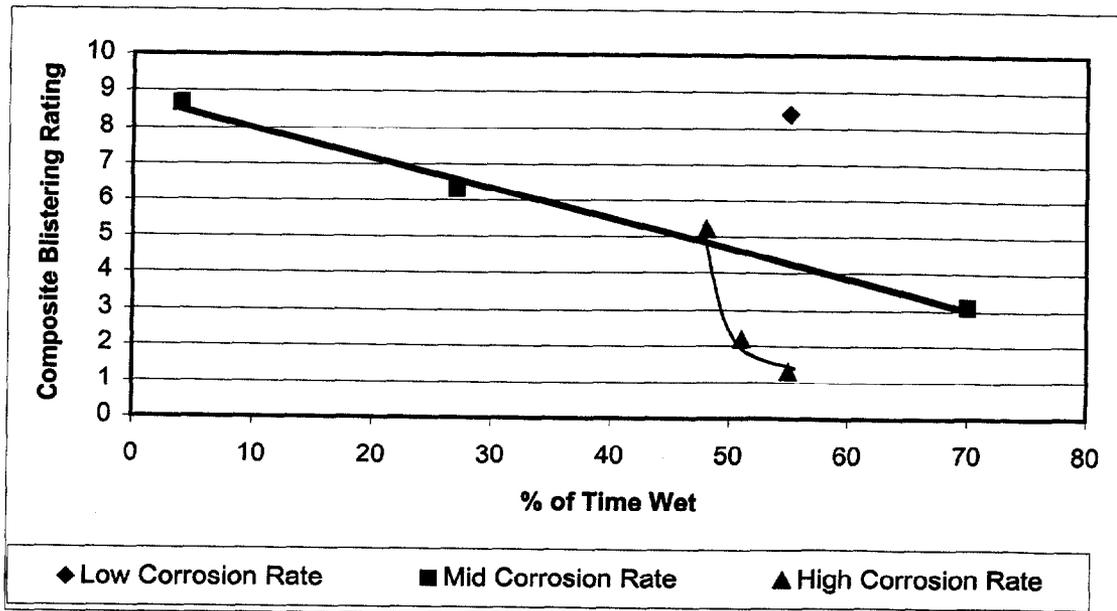
Figure 25. Blistering vs. time-of-wetness and corrosion rate (SP-3).

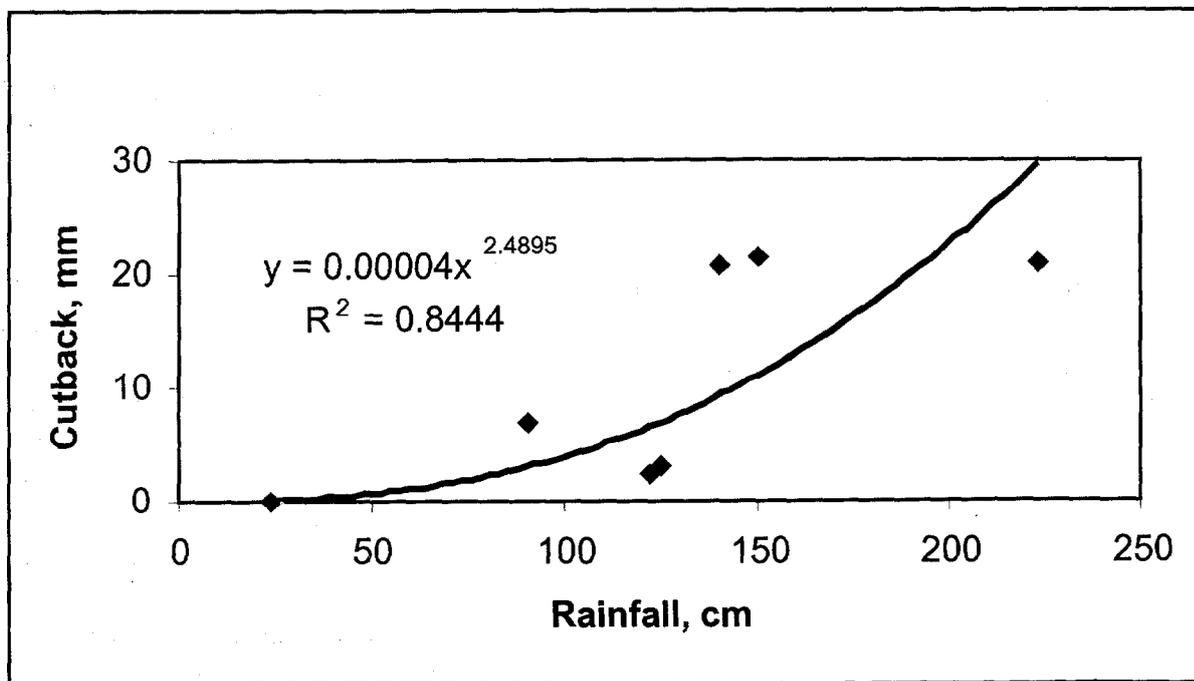
**Coating Cutback:** Cutback of the coatings was similarly analyzed. Figure 26 shows the nominal cutback of the coatings applied over the SSPC SP-3 surface preparation as a function of total rainfall.

Figure 26. Cutback vs. rainfall (SP-3).

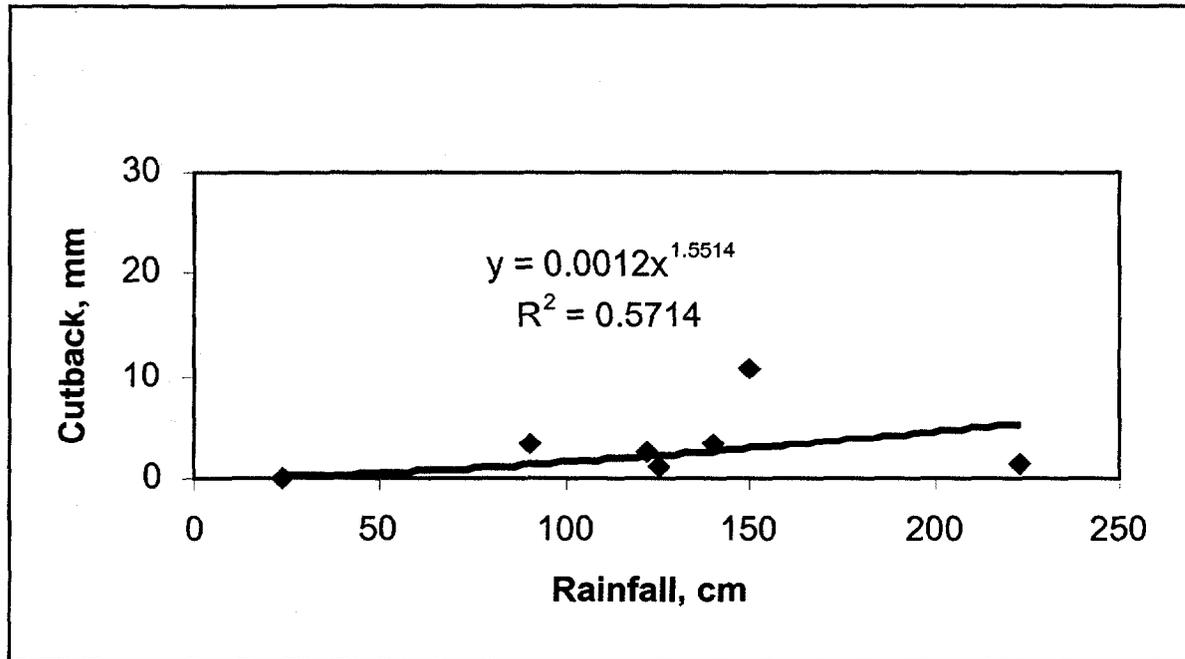
Figure 27 shows the same analysis for the coatings applied to the SSPC SP-10 substrate. It can be seen that the correlation is not as good.

Figure 27. Cutback vs. rainfall (SP-10).

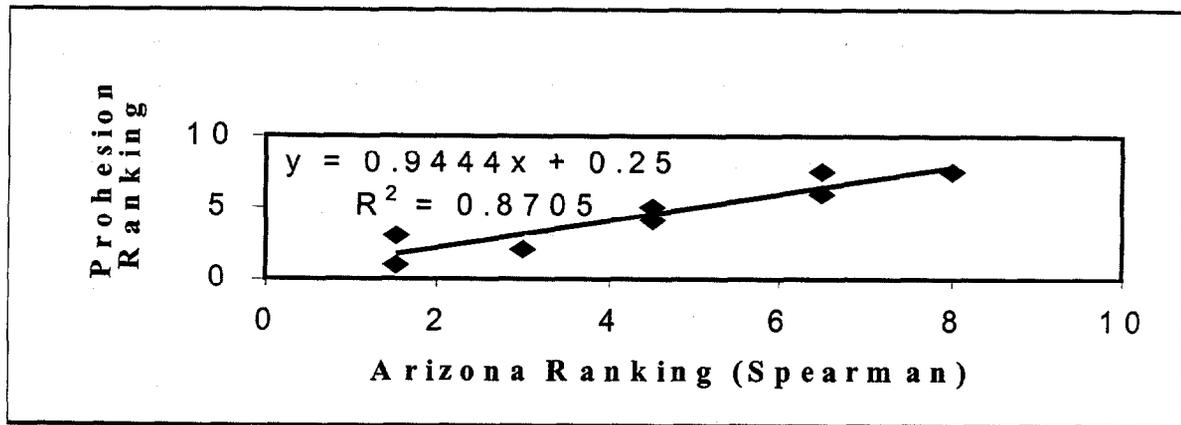
Figures 29 and 30 show the Spearman ranking of the systems in Arizona and Florida vs. the predicted rankings in the Prohesion test.

**Figure 29. Spearman ranking of Prohesion test results vs. Arizona test results.**

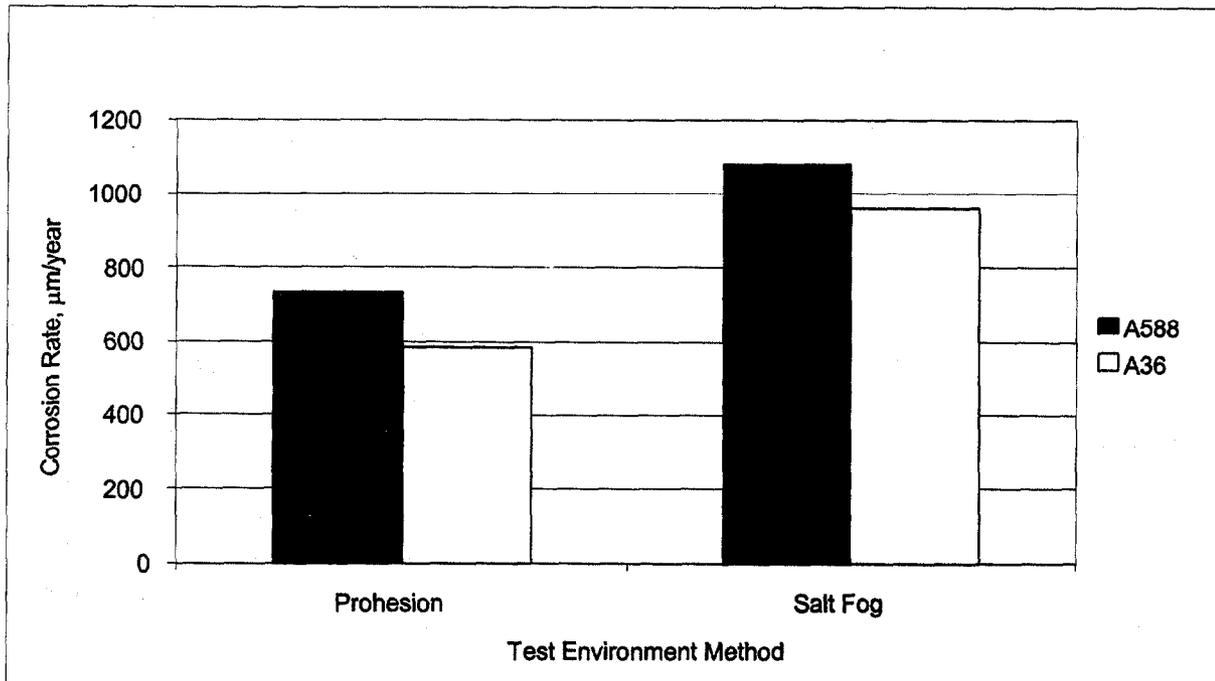
Figure 31 shows the corrosion rate observed in each of these accelerated tests following 1,000 h. From this, it can be seen that the salt fog test provides an environment that is more aggressive to bare steel than the Prohesion test. This graph also shows that the weathering steel (A588) has a higher corrosion rate than the structural steel (A36) in the accelerated tests. The corrosion rates are nominally 10 times higher than might be expected in a natural environment. The lower salt concentration in the Prohesion test, as compared to that in the salt fog test, may reduce corrosion, although the corrosion rate remains high.

Figure 31. Corrosion rate for steel alloys in accelerated tests.

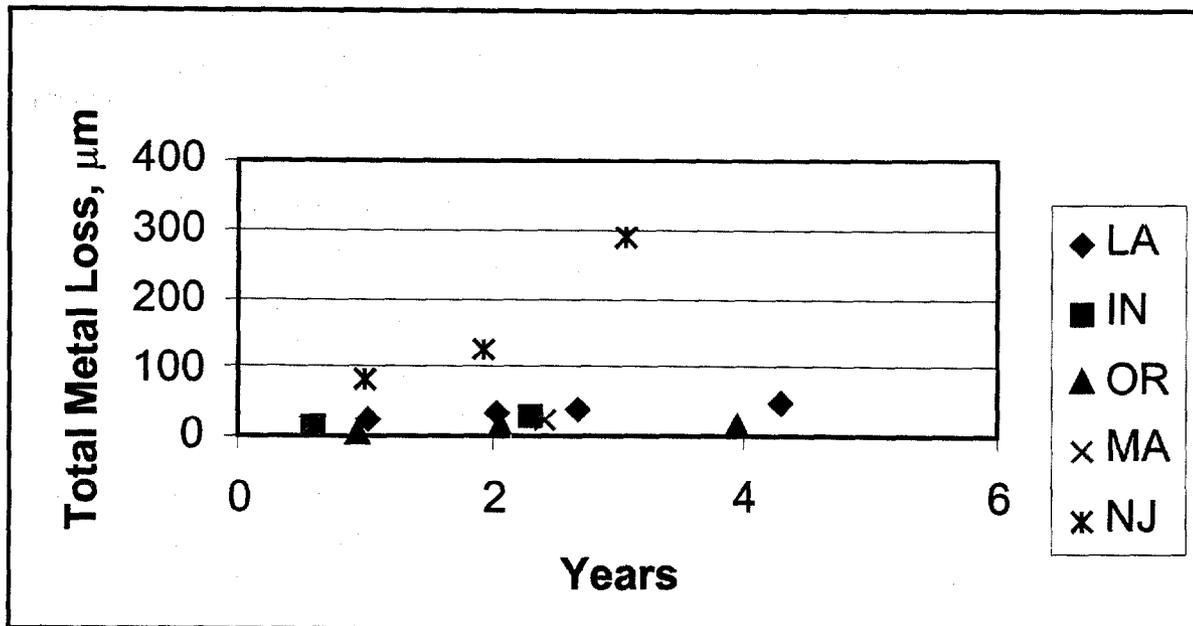
**Effects of the Environment:** To facilitate a discussion on the effects of the environment, the data were further analyzed in a manner consistent with previous studies.<sup>(3,8)</sup> This process looked at the cumulative metal loss vs. time as opposed to the corrosion rate. Figure 32 shows this data. Data are the average for all exposure orientations.

**Figure 32. Total metal loss vs. time, all orientations.**

As has been used in other studies,<sup>(9-10)</sup> these data were regressed to fit the following equation:
