# Characterization of the Environment

PUBLICATION NO. FHWA-RD-00-030

AUGUST 2000

16. Abstract  The study on which this report is based sought to compile data on both accelerated and natural exposure of coating and corrosion test panels and then to relate their deterioration to environmental conditions. The report presents data gathered over a 5-year period, incorporating seven different test sites across the United States. Specifically, the report looks at how the local environment affects the performance of eight coating systems and two weathering steels. For coated steel, the report concludes that an absolute humidity of 0.015 moles H <sub>2</sub> O/mole of dry air is the critical level for increasing the likelihood of corrosion. In such environments, a bridge engineer should utilize a zinc-rich coating system to prevent premature failures. Blistering failure is predominant in panels with high initial salt contamination on the substrate. To minimize failure due to blistering, the substrate should be as clean as possible. Cutback is chiefly affected by the high amount of rainfall and salt-fall (marine environments). A zinc-rich coating system is the best method for preventing c

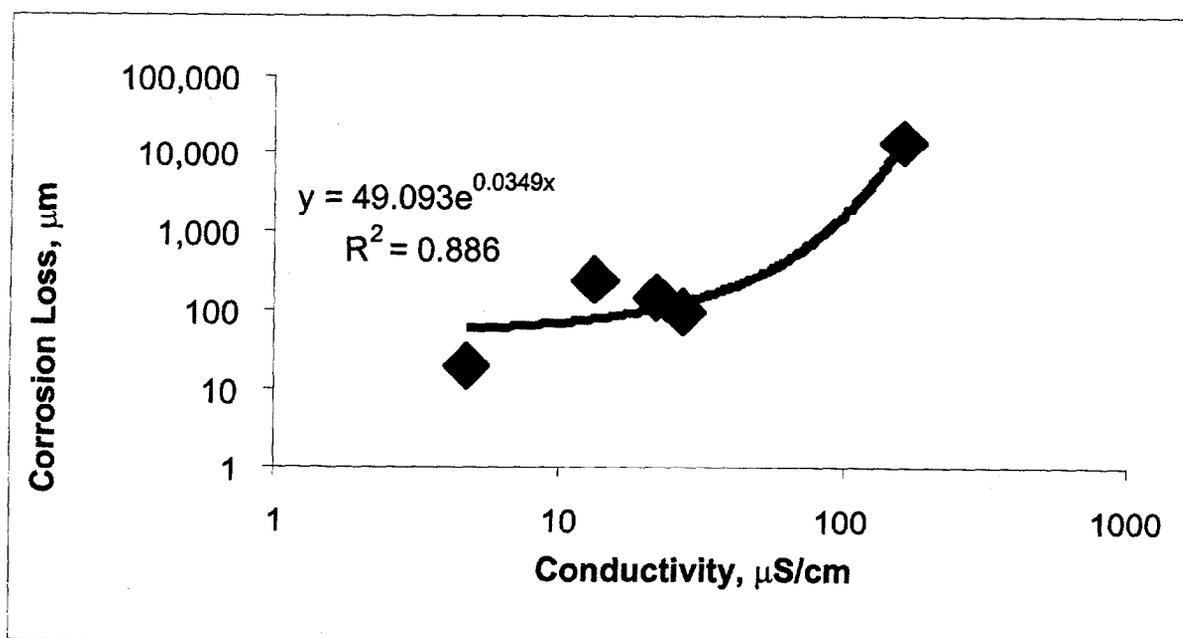
The data do not correlate well with time-of-wetness, which appears to follow rainfall. Assuming that the corrosion rate of the Oregon site appears to settle at the low levels currently observed, the A588 steel corrosion rate may eventually be shown to be a best fit to the local rainfall conductivity. Figure 33 shows the effect on this analysis after removing the first observed corrosion rate at the Oregon test site and calculating a corrosion loss at 100 years.

Figure 33. Corrosion loss vs. conductivity (modified Oregon data point).
