**Air Convection Embankment
Experimental Feature Design
Phase I**

Douglas J. Goering

December 1997

**Report No. INE/TRC 97.06
AK-RD-98-01
AKDOT&PF No. AK-RD-97-02**

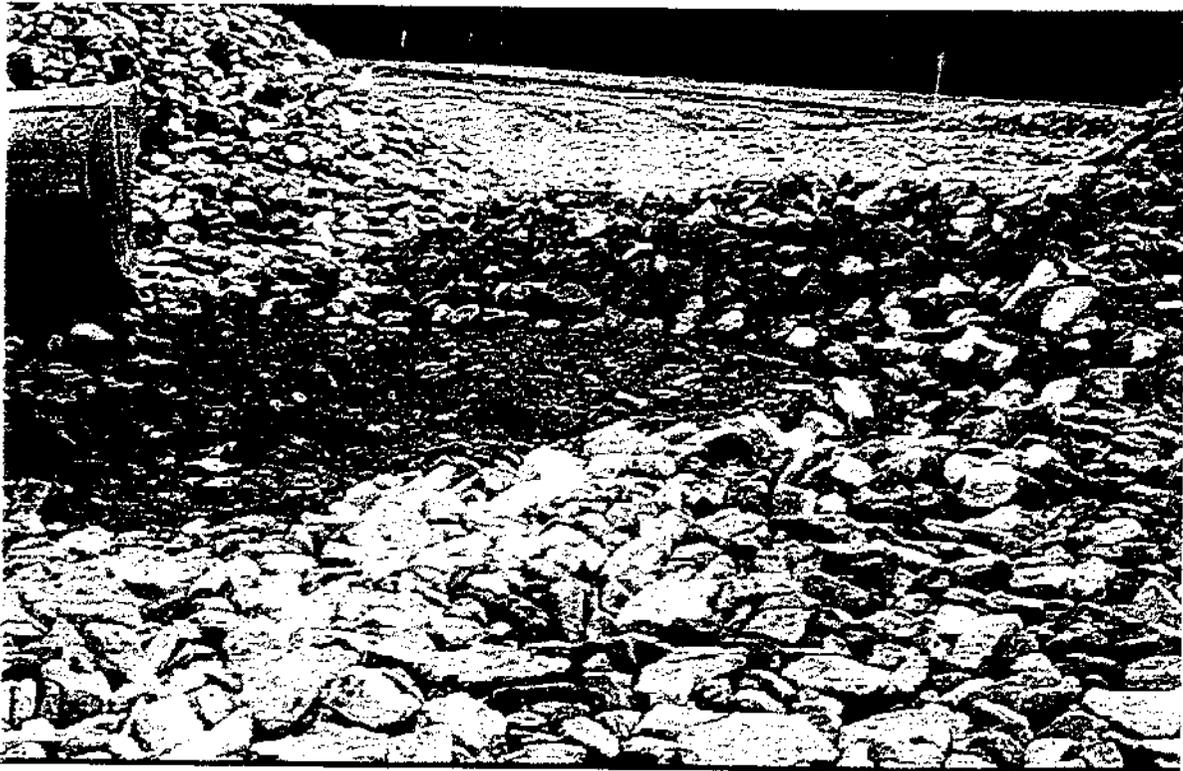
Figure 18. Layer of fines generated during embankment construction.

between the surface rock and the rock lower down. This degradation was not apparent from the surface, but was only noticed when the subsurface layers were probed. The main difficulty was that the action of the loader had caused a uniform layer of fine material to be generated. Figure 18 shows the layer of fines which was found below the surface. It was feared that this layer of fine material would interrupt the convection in the embankment and reduce the cooling effectiveness. In order to improve the situation, the contractor offered to "sift" the rock using a large back hoe. The hoe operator was able to reach from each end of the test section out into the middle of the test section, pick up a bucket of the rock material, shake it to sift the fines to the bottom of the bucket, and then pour the rock back out with the fines remaining at the bottom of the bucket. The fines were then deposited at each end of the test section. This operation appeared to be successful in removing and breaking up the layer of fines which had developed.
