# **BRIDGE MANAGEMENT IN NAMIBIA: EXISTING INITIATIVES AND THE WAY FORWARD**

## **ABSTRACT**

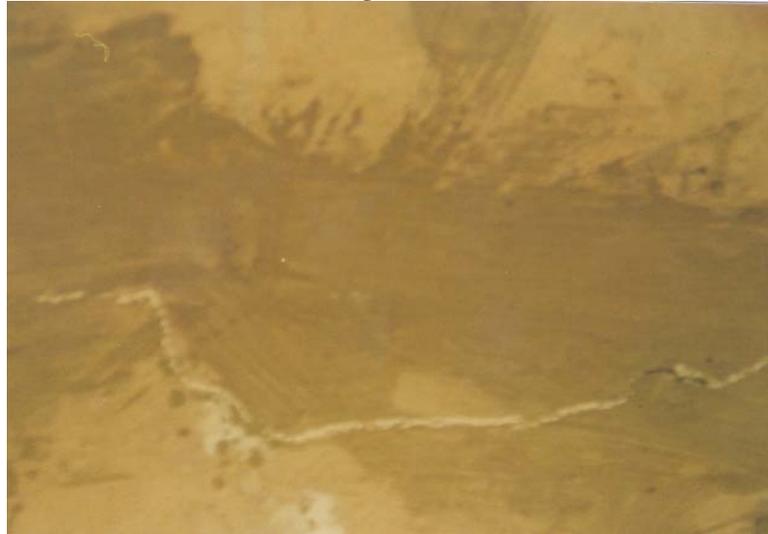
#### **Cracking of the Deck**

Longitudinal members	Torsional cracks up to 0.2 mm
Transverse members	Vertical cracks up to 0.2 mm
Deck slab	Longitudinal cracks up to 0.4 mm
	10-20 mm thermal movement. Creep deflection.

at midspan, the contribution of torsion to the combined stress at midspan for the T-beam is 98% and at the supports is 77.7%. The shear reinforcement provided therefore only catered for direct shear hence the distress in the beams as shown in Figure 4.

It can be concluded that the design did not take into account the effects of skew, which for especially beam and slab decks results in significant torsional moments. For most of the structures with this problem, most of the superstructures especially those on the heavily trafficked routes have been reconstructed as solid slab decks where the degree of deterioration could not allow their strengthening. Those on lightly trafficked routes are to be strengthened.

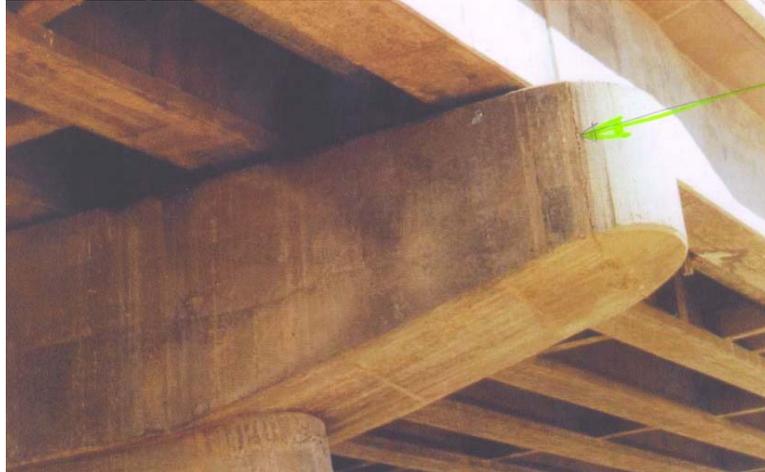
#### **Spalling of Concrete at the End of Prestressed Pier**

Four structures on the coastal belt of Namibia registered the effects of chloride ion penetration into the concrete and carbonation which resulted in the spalling of concrete due to the corrosion of reinforcement. The detailed inspection of the structures included potential mapping of chloride activity levels on the elements supplemented by tests on drilled cores.

Chloride concentrations especially on the pier heads at the end cap and the pier wall interface at ground level were all above 2.0 %. The concentration reduced to lower levels within the 40 mm concrete cover but is higher than the 0.2 % recommended level. This proves the concrete spalling that has occurred on the members as a result of the corrosion of the reinforcement. Figure 5 presents the effects of chloride ion penetration on the members.

Cathodic protection has been used on a number of structures with chloride ion penetration and carbonation problems. The system involves after the repair of the defects, the installation of circuitry that reverses the movement of the ions. An electronic data logging system is also installed for monitoring and to ensure the effectiveness of the protection.
