**EVALUATION OF PATCHING MATERIALS AND PLACEMENT  
TECHNIQUES FOR RIGID PAVEMENTS AND BRIDGE DECKS**

**FINAL REPORT**

**Florida Department of Transportation  
(BB452-WPI 0510861)**

**Department of Civil and Environmental Engineering  
University of Central Florida  
Orlando, FL 32816-2450**

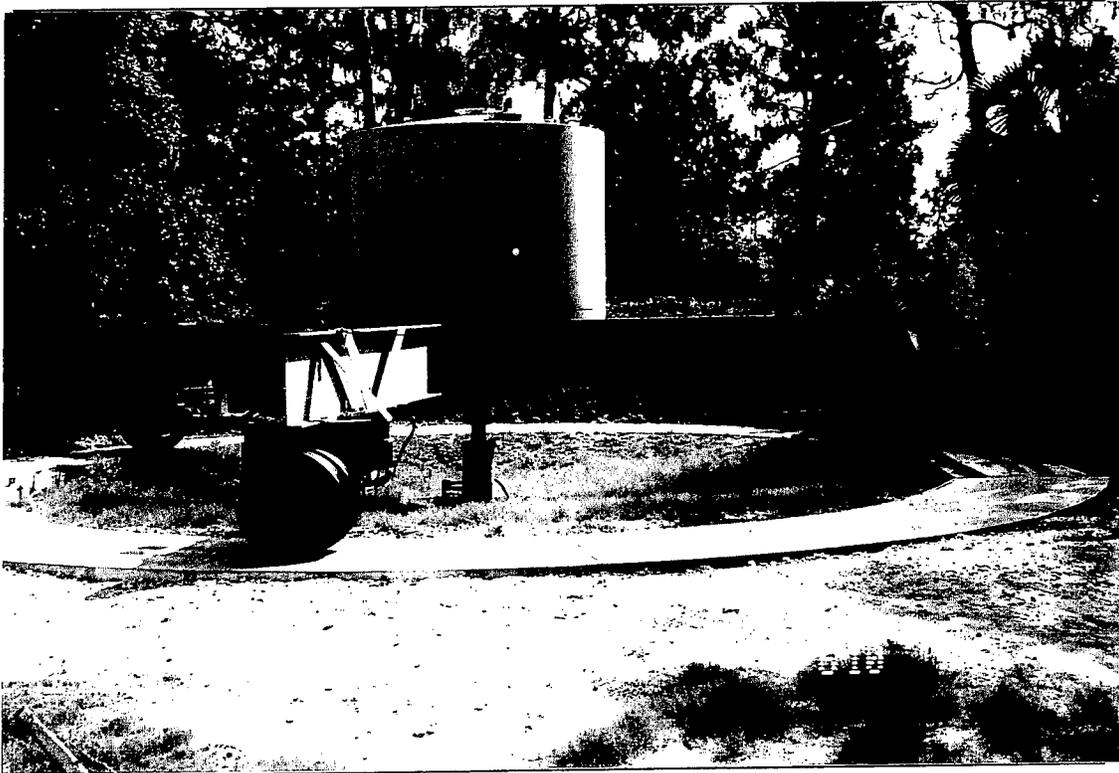
**PHOTOGRAPH 1. University of Central Florida Circular Accelerated Test Track**

The University of Central Florida (UCF) tackled the task of researching for quality patching materials to test the performance for the rehabilitation of potholes and spalls on concrete pavements as a project funded by the Florida Department of Transportation (FDOT). UCF was also responsible for new guidelines in laboratory testing and material placement techniques, so appropriate materials can effectively be used in field application. The performance of the patching materials was tested at UCF and its Circular Accelerated Test Track (CATT) facility (Photograph 1).

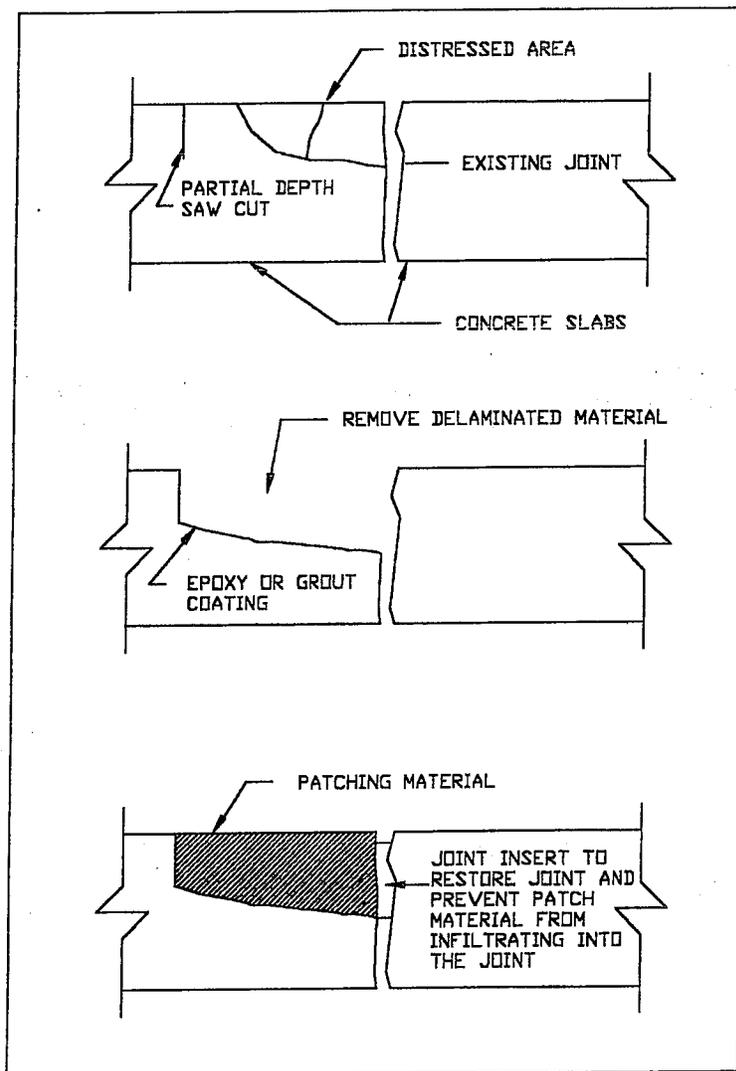
**FIGURE 1. Steps for Partial Depth Spall Patching (Darter, 1985)**

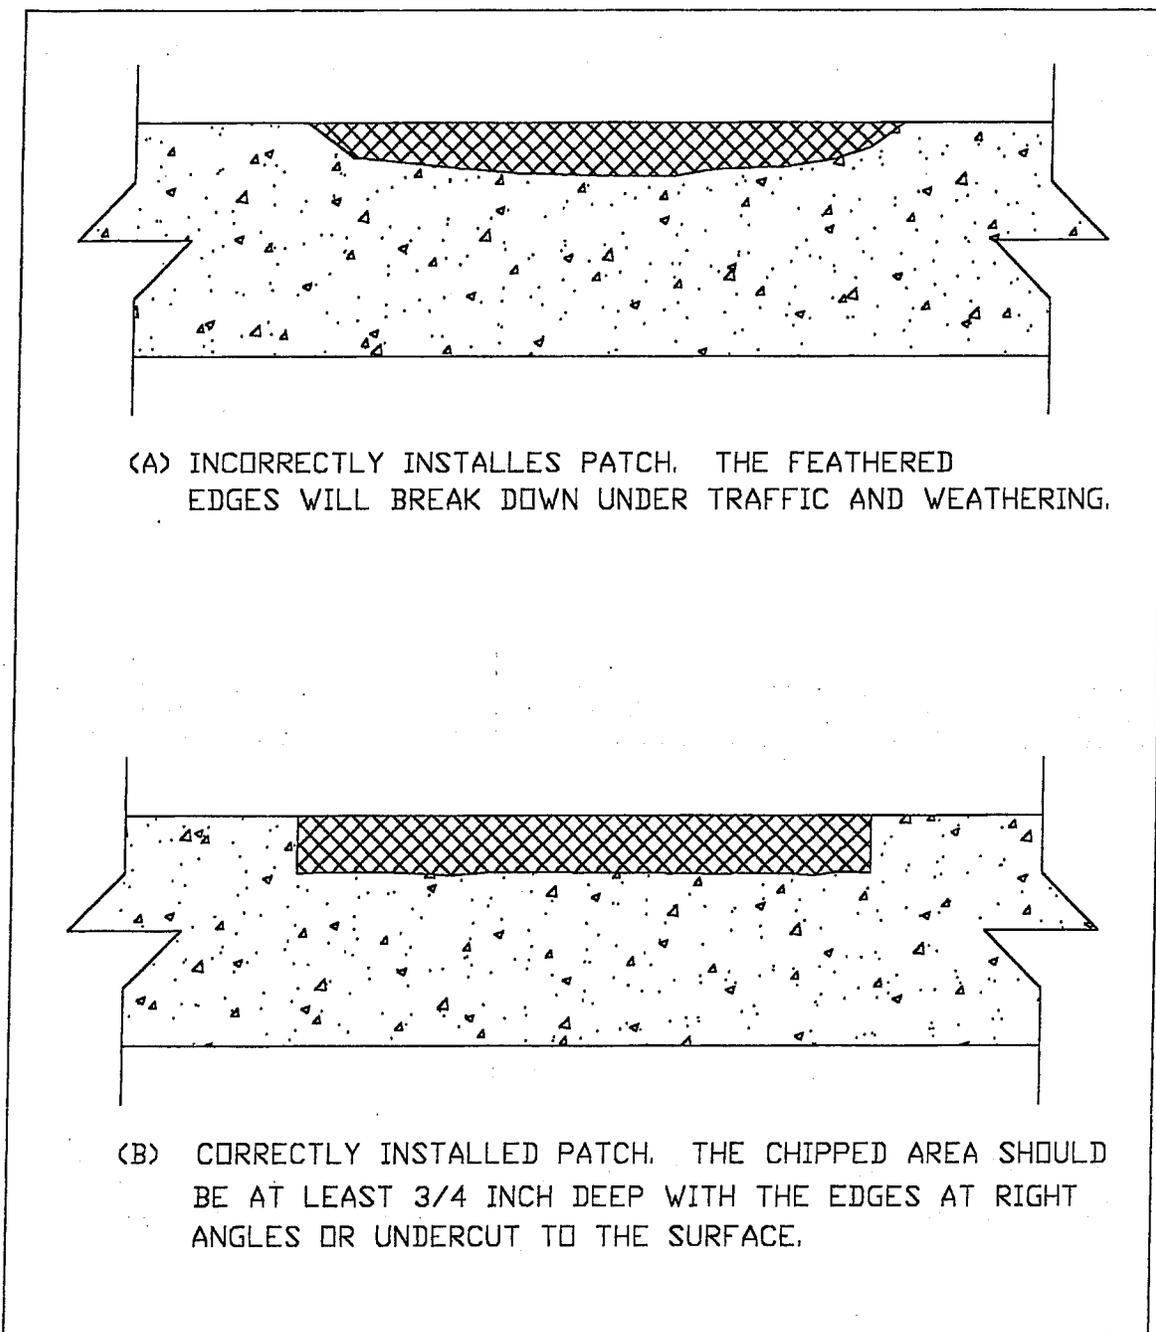
**FIGURE 2. Partial Depth Patching Installation by PCA (Kosmatka, 1985)**

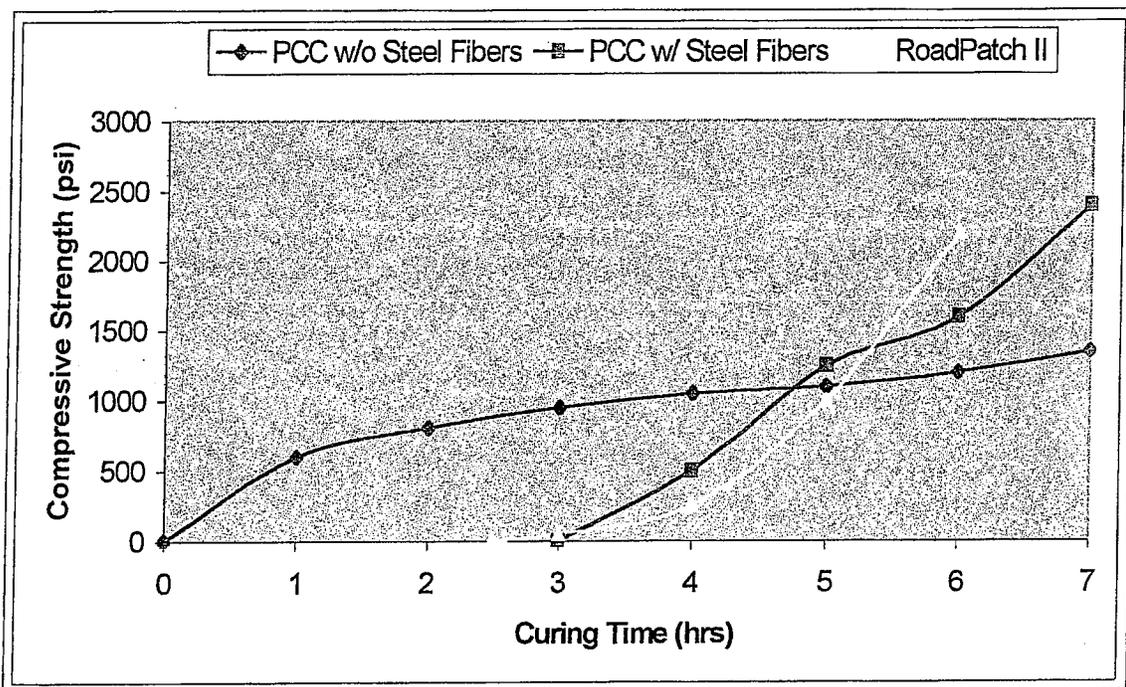
**Figure 3. Laboratory Early Strength-Development Curves (Parker et. al, 1991)**

Above laboratory tests showed that four-hour compressive strength tests of the PCC materials were higher than the proprietary material. However, after 6 hours, the strengths of PCC were lower. During field investigation, the effects of pavement location

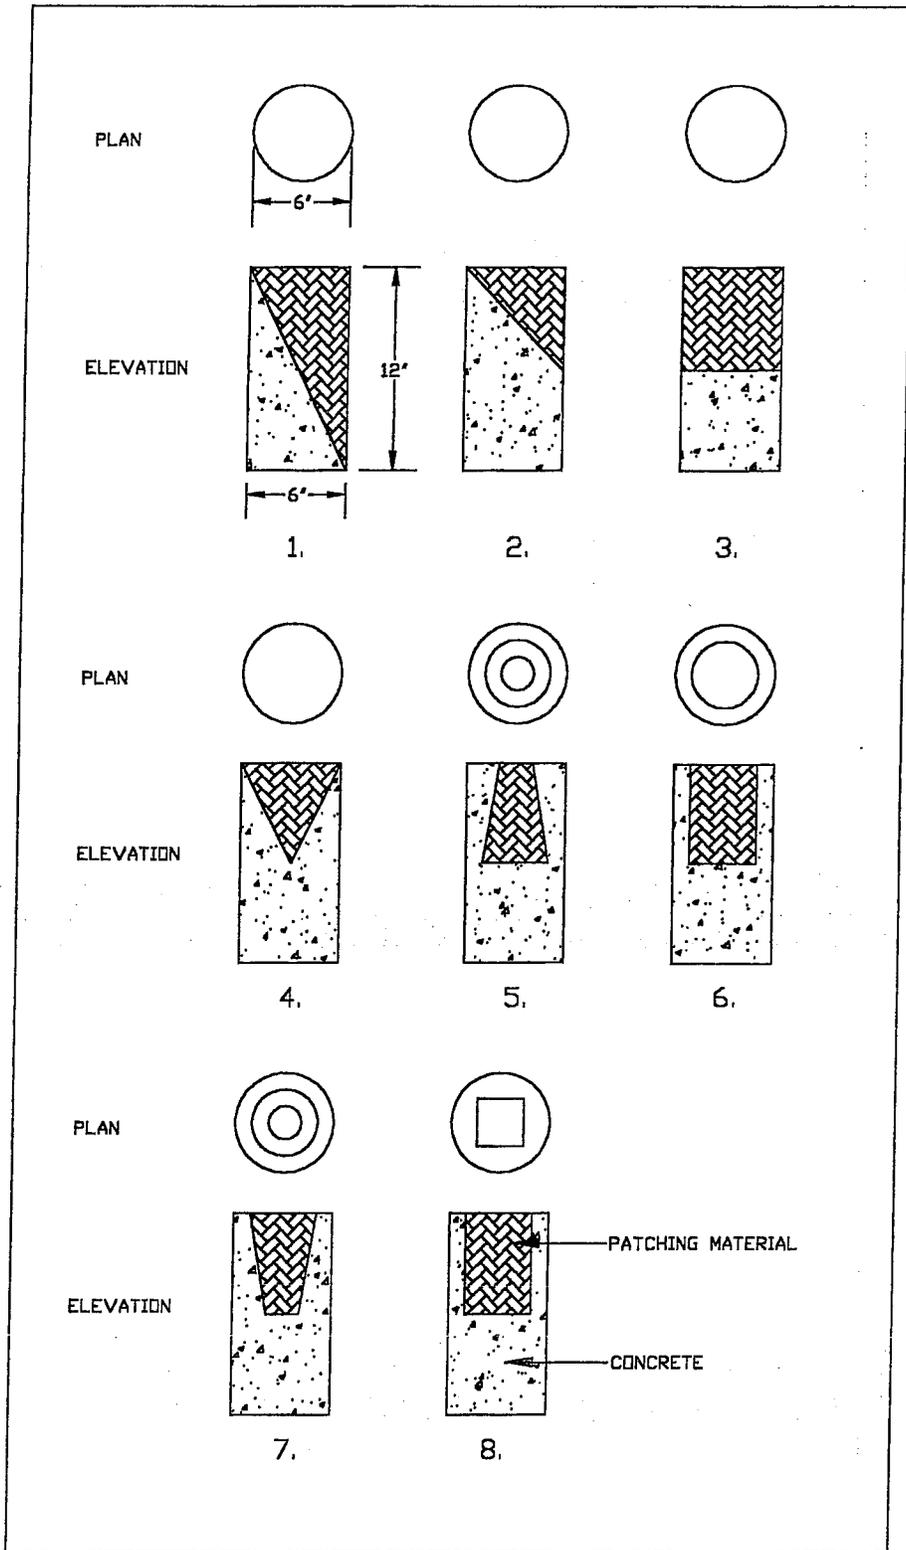
**FIGURE 4. Composite Specimen Patching Configurations**

<b>Compressive Strength Results</b>			
<b>Composite Specimen</b>	<b>Configuration No. (From Figure 4)</b>	<b>Load kN (lbs)</b>	<b>Strength MPa (psi)</b>
<b>Control Section (Type I Cement) 28-day cure</b>	-	874 (196,500)	47.9 (6,950)
	-	912 (205,000)	50.0 (7,250)
	-	867 (195,000)	47.6 (6,897)
<b>D</b>	1	133 (30,000)	7.32 (1,061)
	5	191 (43,000)	10.5 (1,521)
	8	189 (42,500)	10.4 (1,503)
	4	534 (120,000)	29.3 (4,244)
<b>E</b>	6	478(107,500)	26.2 (3,802)
	8	334 (75,000)	18.3 (2,653)
	2	156 (35,000)	8.53 (1,238)
<b>F</b>	6	698 (157,000)	38.3 (5,553)
	1	89 (20,000)	4.88 (707)
<b>G</b>	3	300 (67,500)	16.5 (2,387)
	4	423 (95,000)	23.2 (3,360)
<b>H</b>	6	778 (175,000)	42.7 (6,189)
	7	756 (170,000)	41.5 (6,013)
	-	945 (212,000)	51.7 (7,498)
<b>Control Section (Type II Cement) 1-day cure</b>	-	923 (207,500)	50.6 (7,339)

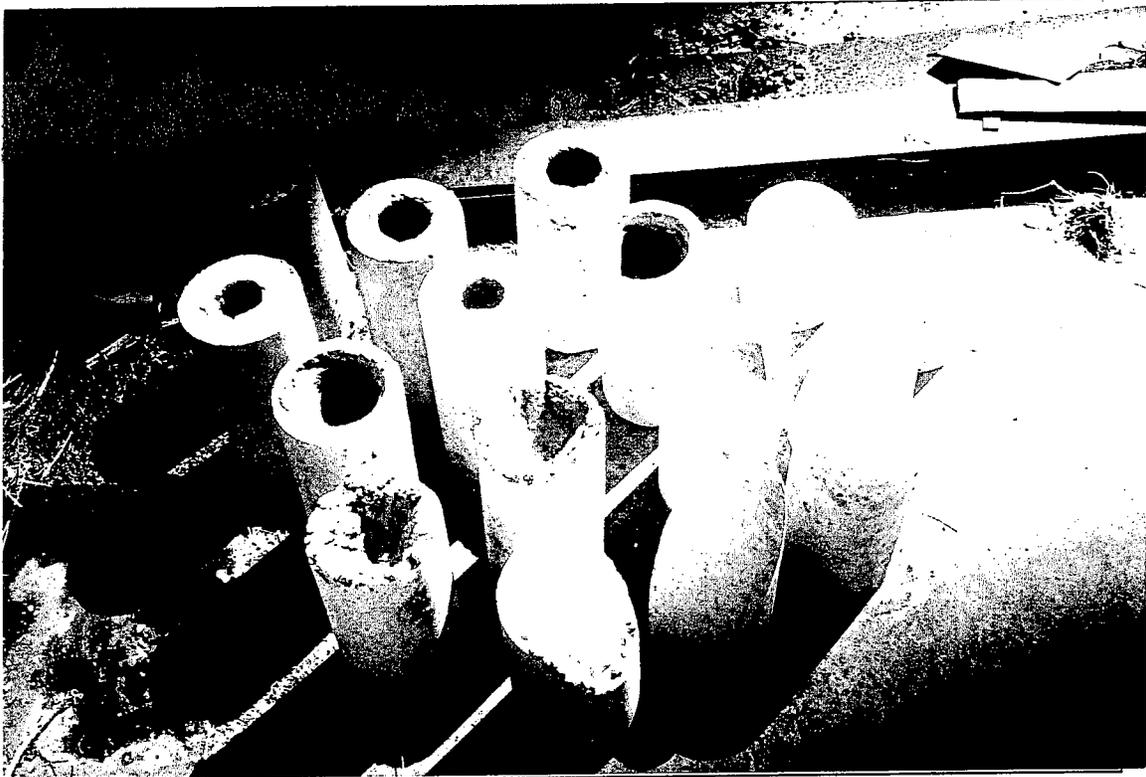
**PHOTOGRAPH 2. Concrete Configurations after 28 Day Cure**

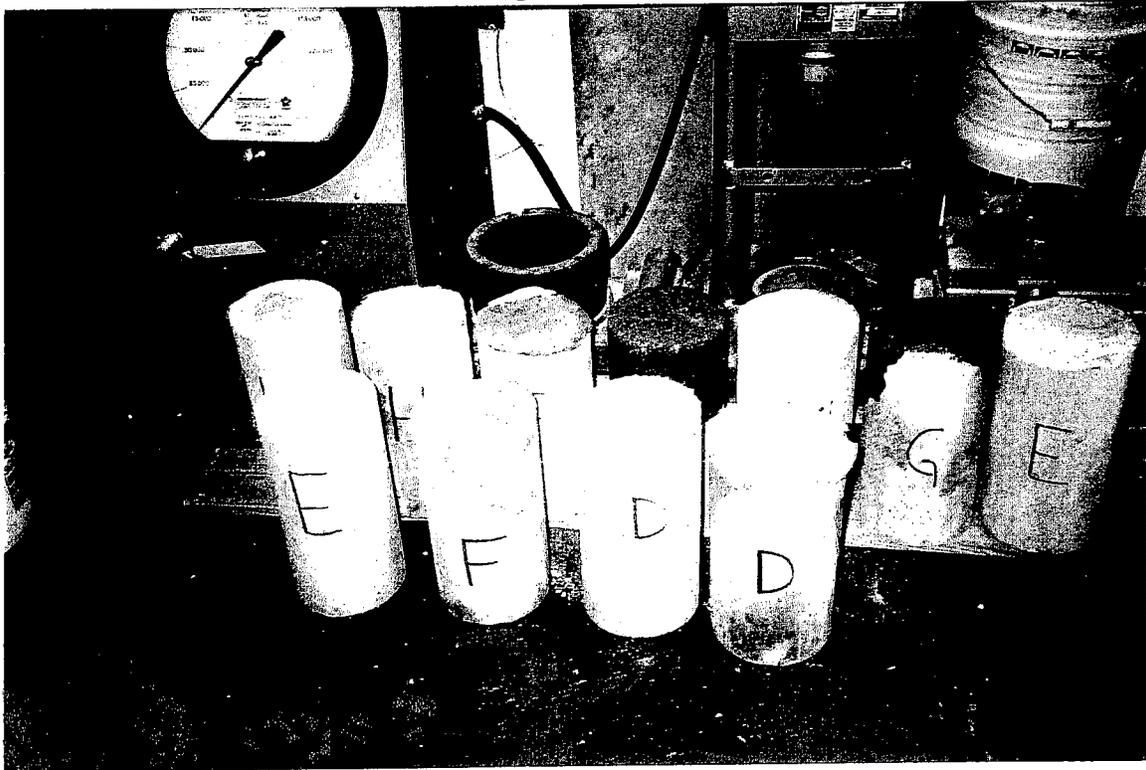
**PHOTOGRAPH 3. Composite Specimens before Compressive Testing**

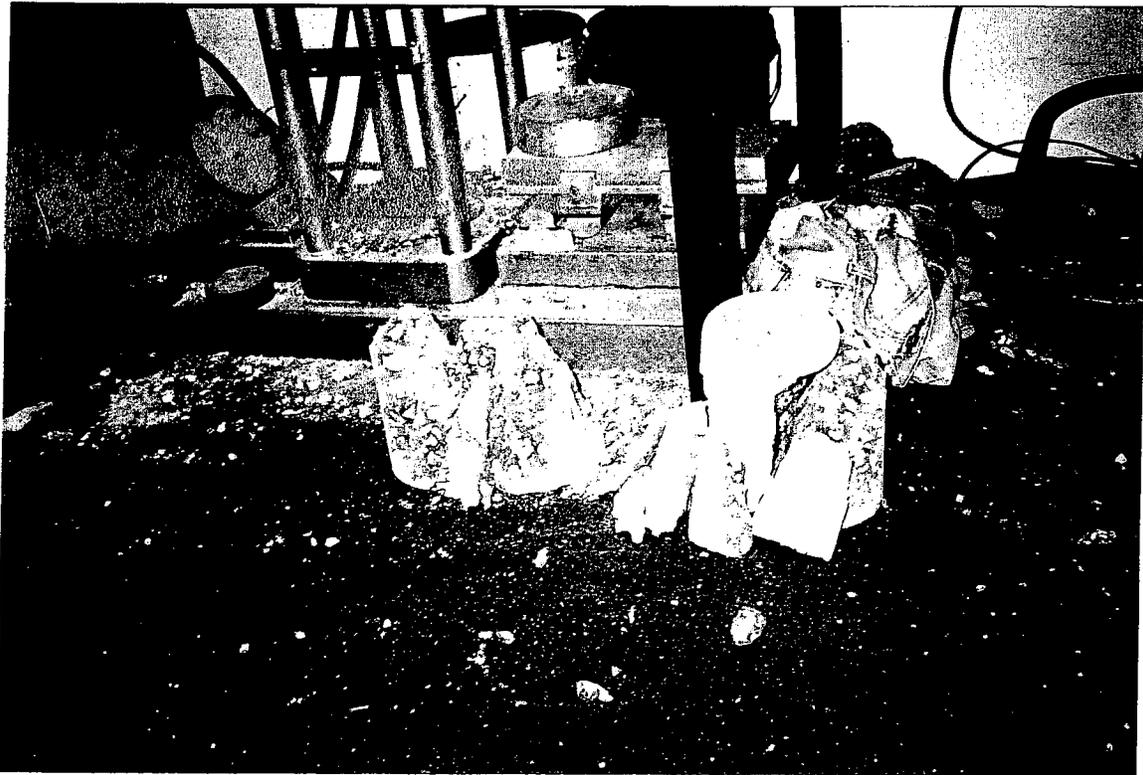
**PHOTOGRAPH 4. 28-Day Failure of Control Sections**

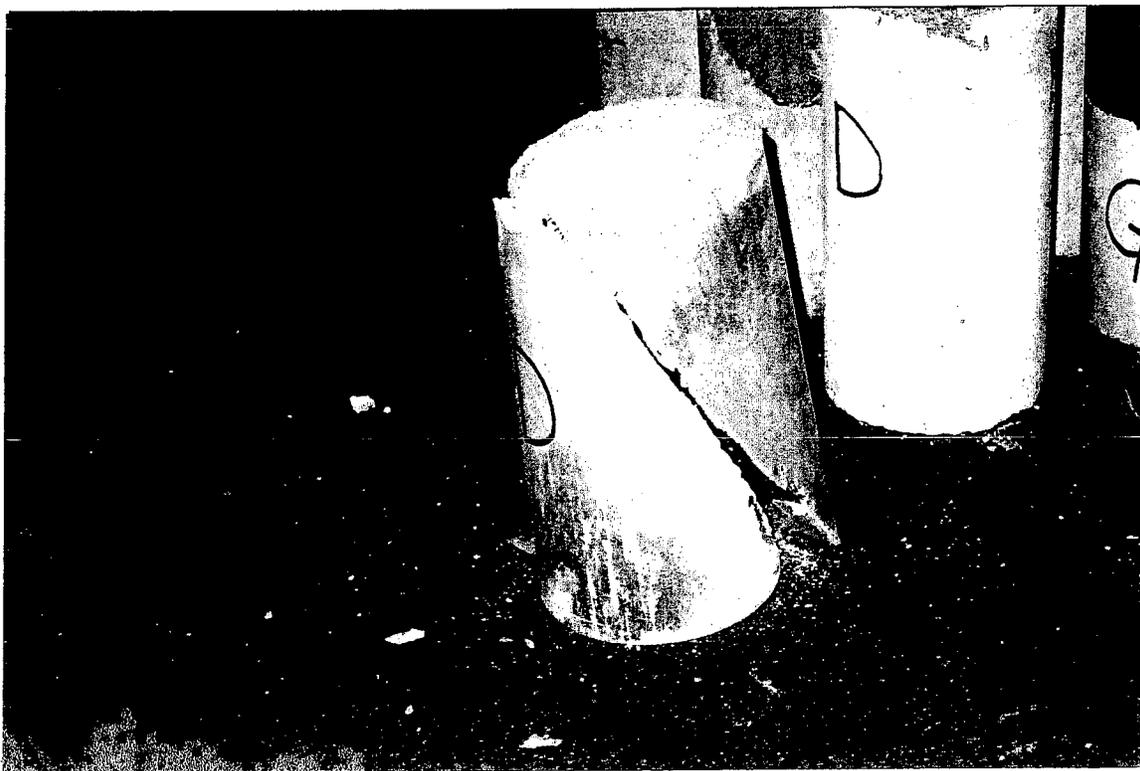
**PHOTOGRAPH 5. Bonding Failure at Interface for PAC 1 and Material D**

obvious that the patching material could sustain a higher load than the PCC, but was still weak in bonding.

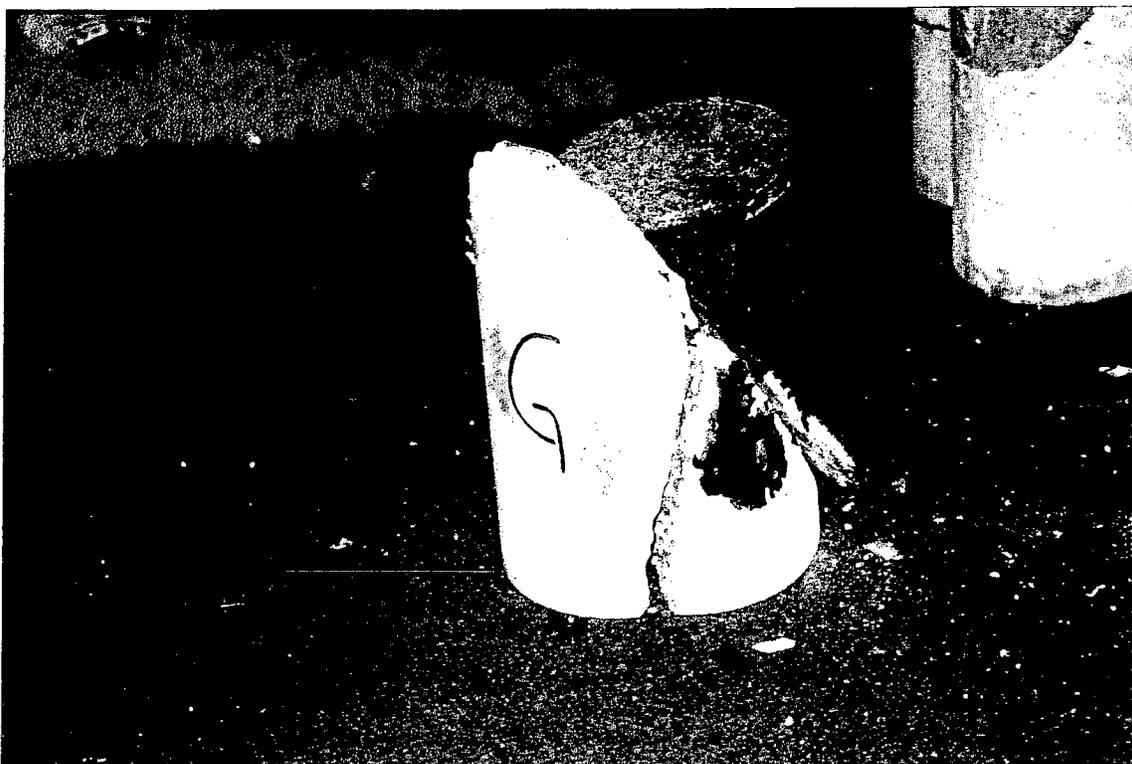
**PHOTOGRAPH 6. Bonding and Fracture Failure for PAC 1 and Material G**

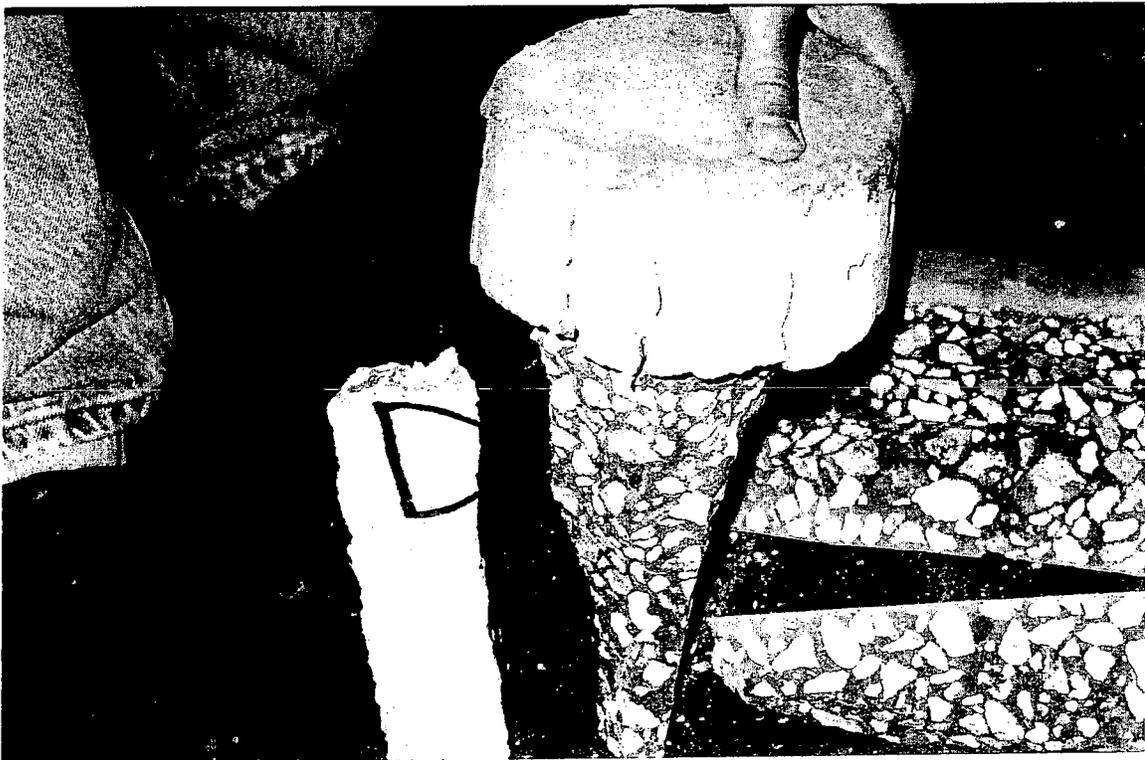
**PHOTOGRAPH 7. Complete Fracture of Concrete below Material D (PAC 5)**

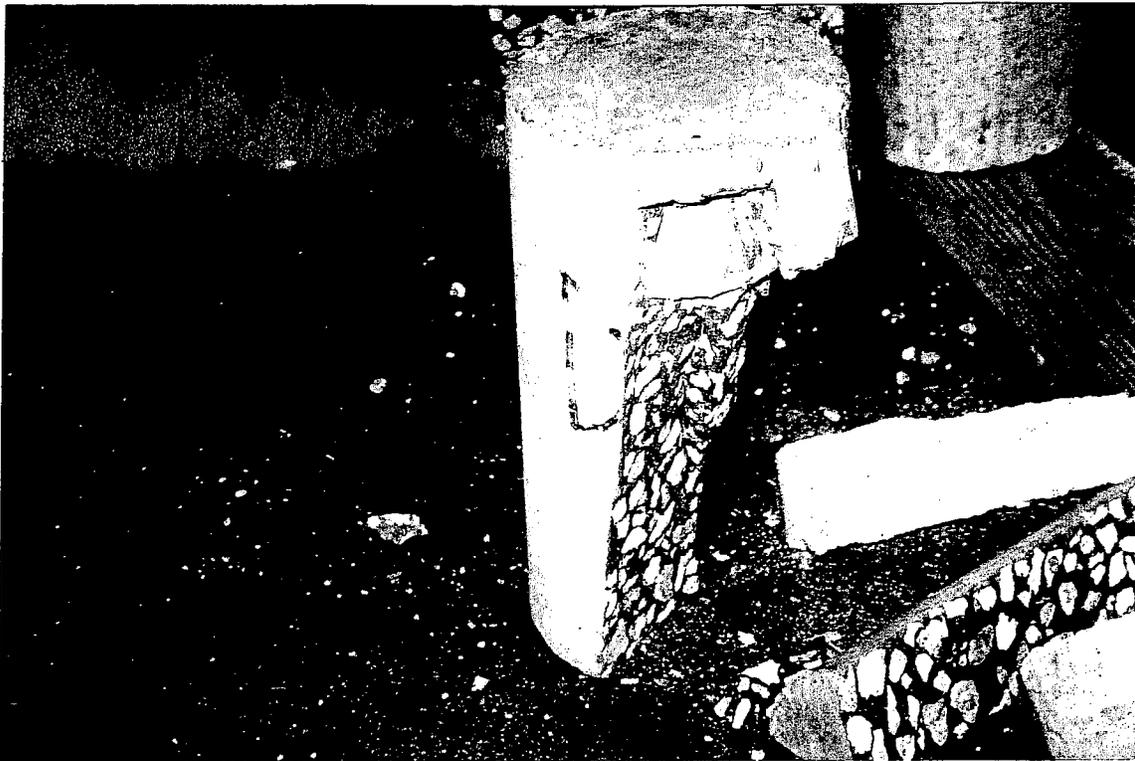
**PHOTOGRAPH 8. PAC 8 Failure Plane with exposed Material**

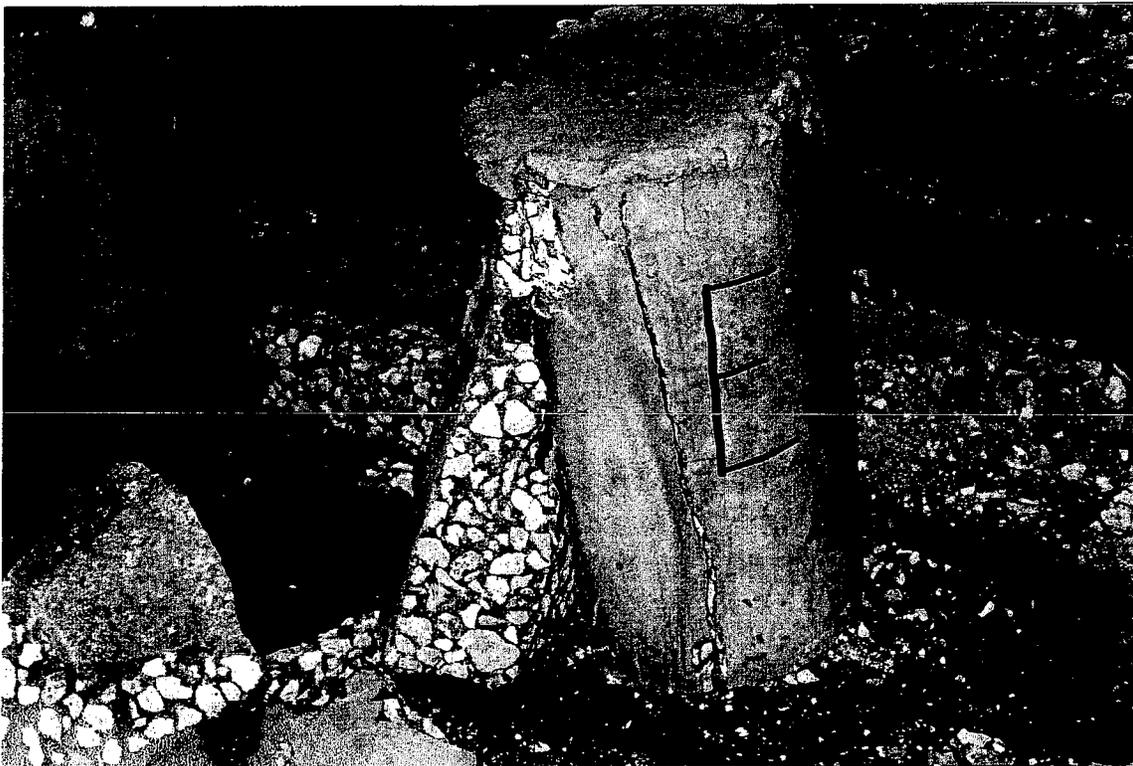
**PHOTOGRAPH 9. Fracture Pattern of Concrete (PAC 4)**

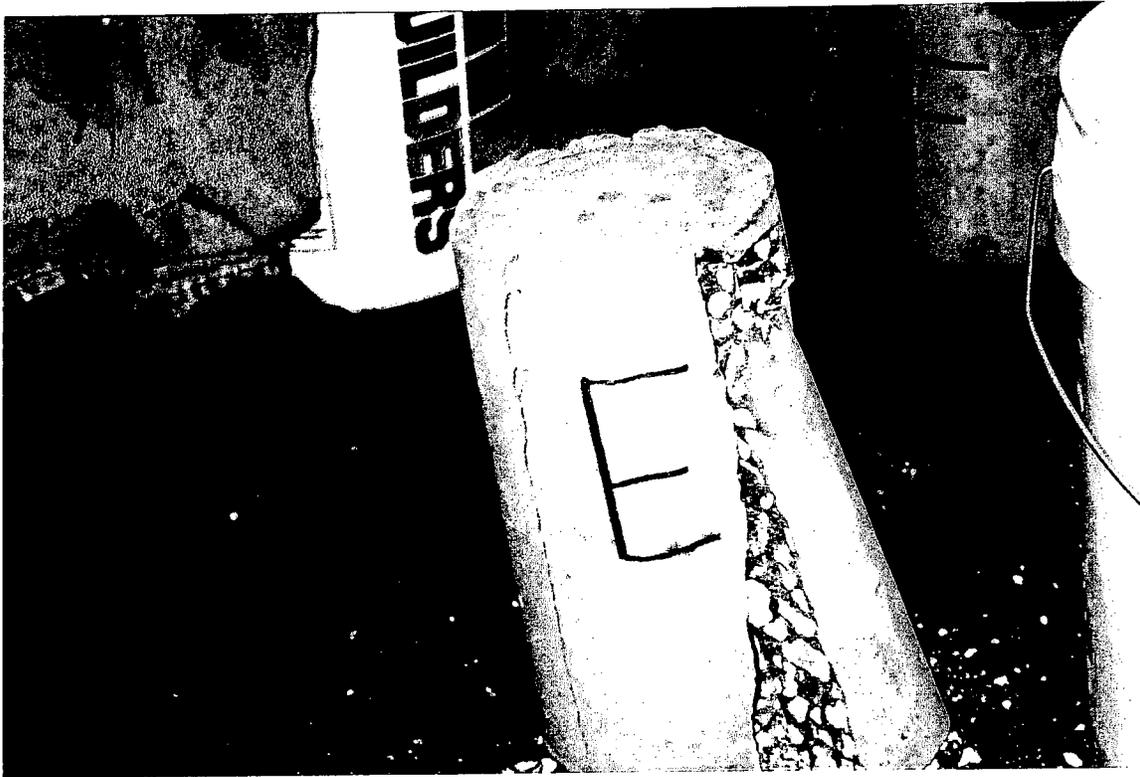
**PHOTOGRAPH 10. Fracture Pattern of Concrete (PAC 6)**

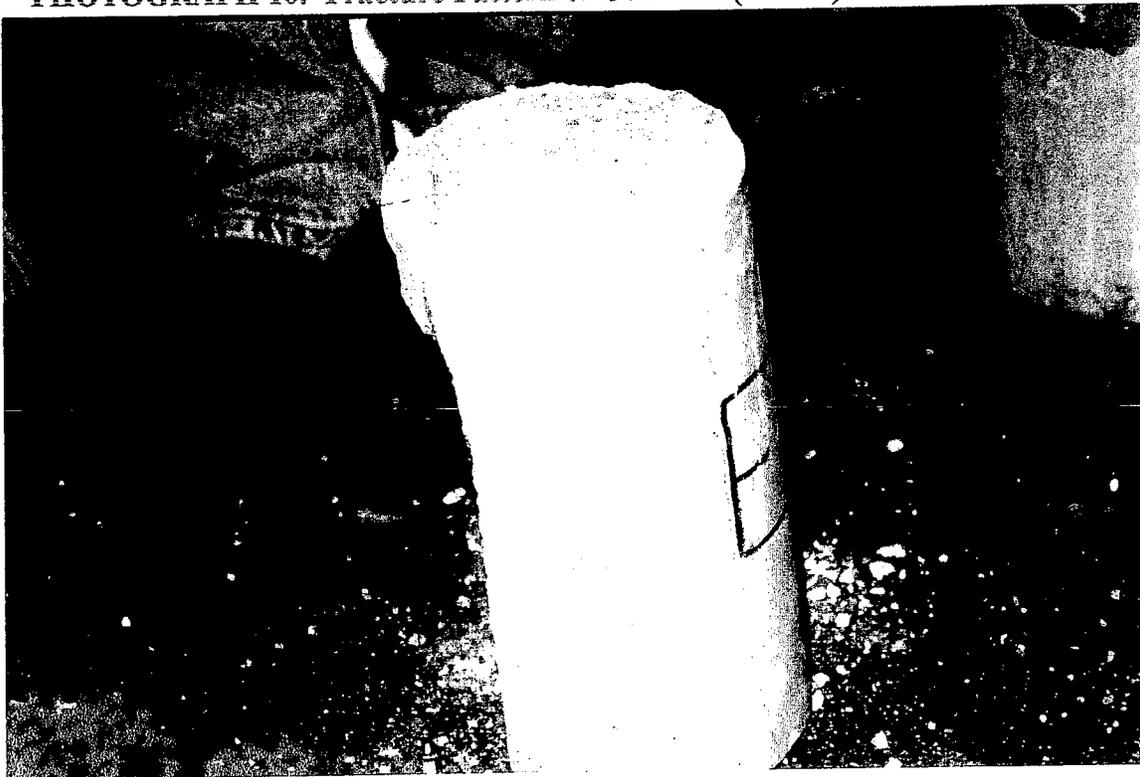
**PHOTOGRAPH 11. Fracture Pattern of Concrete (PAC 8)**

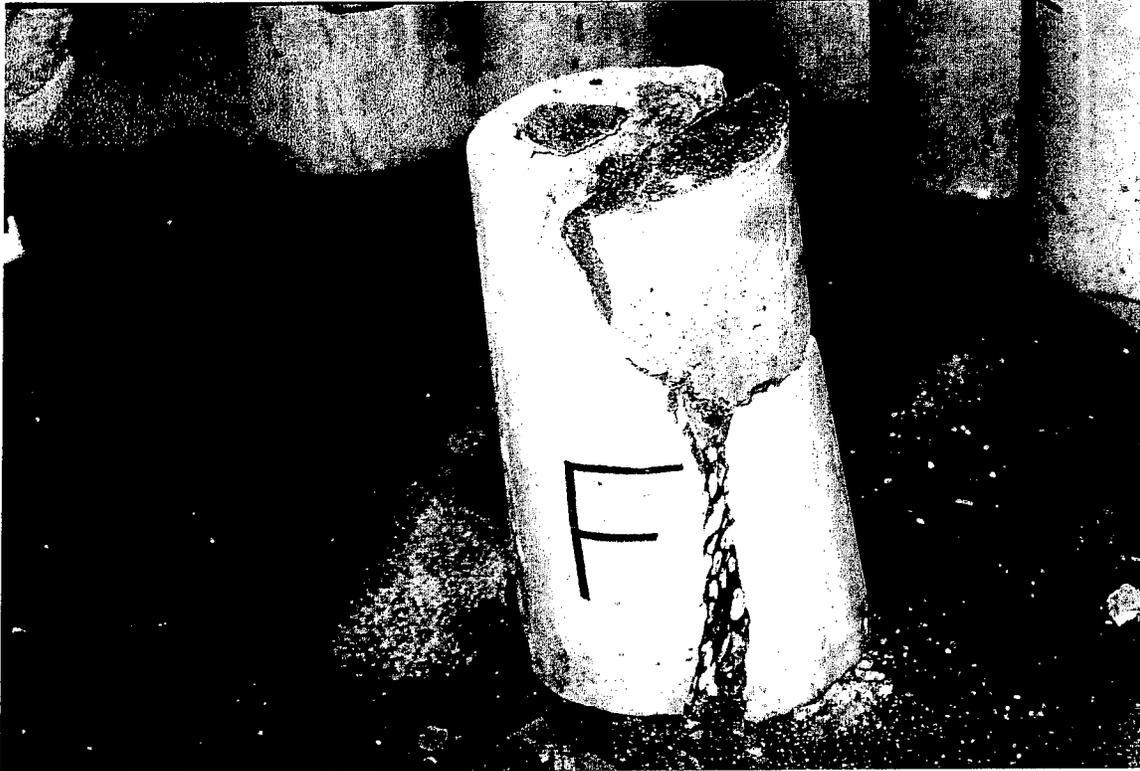
**PHOTOGRAPH 12. Complete Fracture of Material and Concrete (PAC 2)**

PAC 2 and 6 cylinders were cast with material F. The compressive strength was 8.53 MPa (1,238 psi) and 38.3 MPa (5,553 psi) respectively. PAC 2, as seen in Photograph 12 clearly failed in bonding, which resulted in a low compressive strength. Photograph 13 shows that the entire specimen fractured through patching material F and the PCC. This occurrence is evident because of the higher compressive strength of 38.3 MPa (5,553 psi). This material certainly would not be chosen for the accelerated performance test due to its poor bonding characteristics although it had a relatively high compressive strength. Material G was tested with PAC 1 and 3 cylinders. PAC 1 failed in bonding quickly at a very low compressive strength. For PAC 3, the aspect ratio was approximately 1 for the PCC. However, the compressive strength only reached 16.5 MPa (2,387 psi) when the concrete cracked. The strength is expected to be much higher when referring to the figure in Appendix B. Due to this result, it is recommended that more samples be cast and tested in the future. Photograph 14 clearly shows the fractures only occurred on the PCC underneath the patching material. Three composite specimens were cast with material H, in PAC's 4, 6, and 7 cylinders for compressive tests. The compressive strength reached approximately 41.4MPa (6,000 psi) for PAC's 6 and 7, closely achieving the compressive strength of the control sections. However, PAC 4 only sustained a compressive strength of 23.2 MPa (3,360 psi). The lower compressive strength may be attributed to the conical shaped composite specimen, which allowed the higher strength patching material due to the confining pressure to wedge into the lower strength PCC causing failure in the PCC. Photographs 15 and 16 show the interesting fracture patterns of the laboratory samples. The final compressive tests were conducted

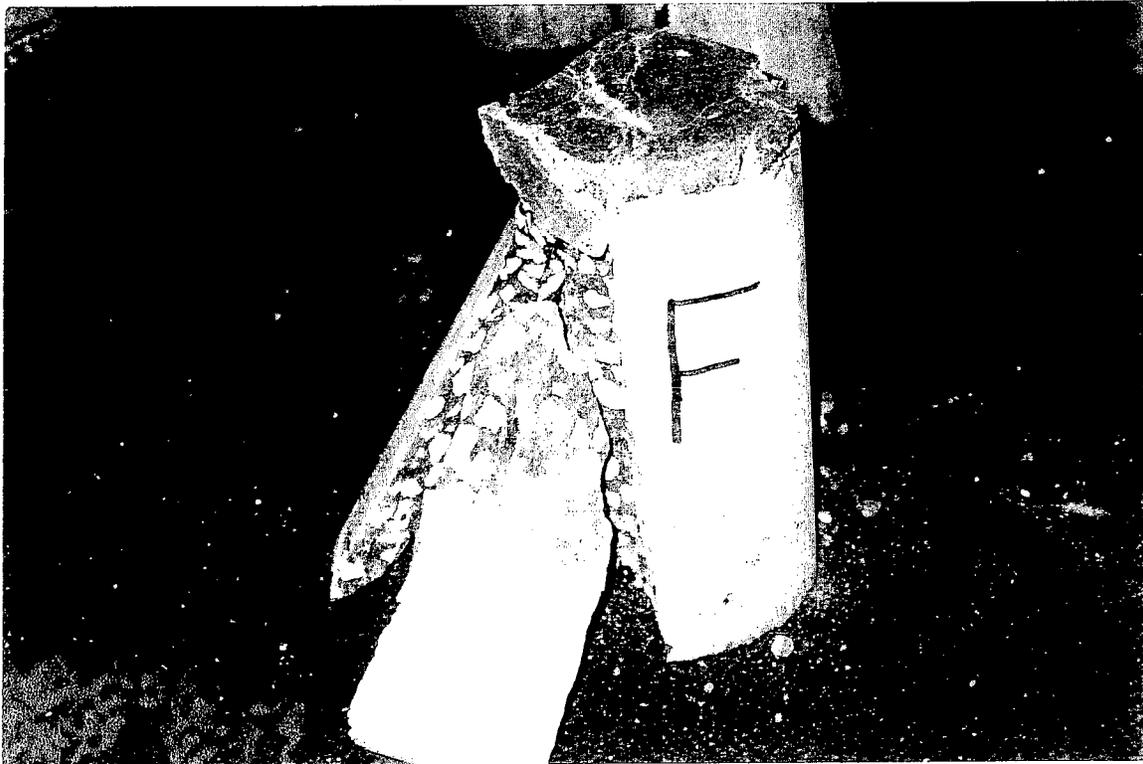
**PHOTOGRAPH 13. Complete Fracture of Material and Concrete (PAC 6)**

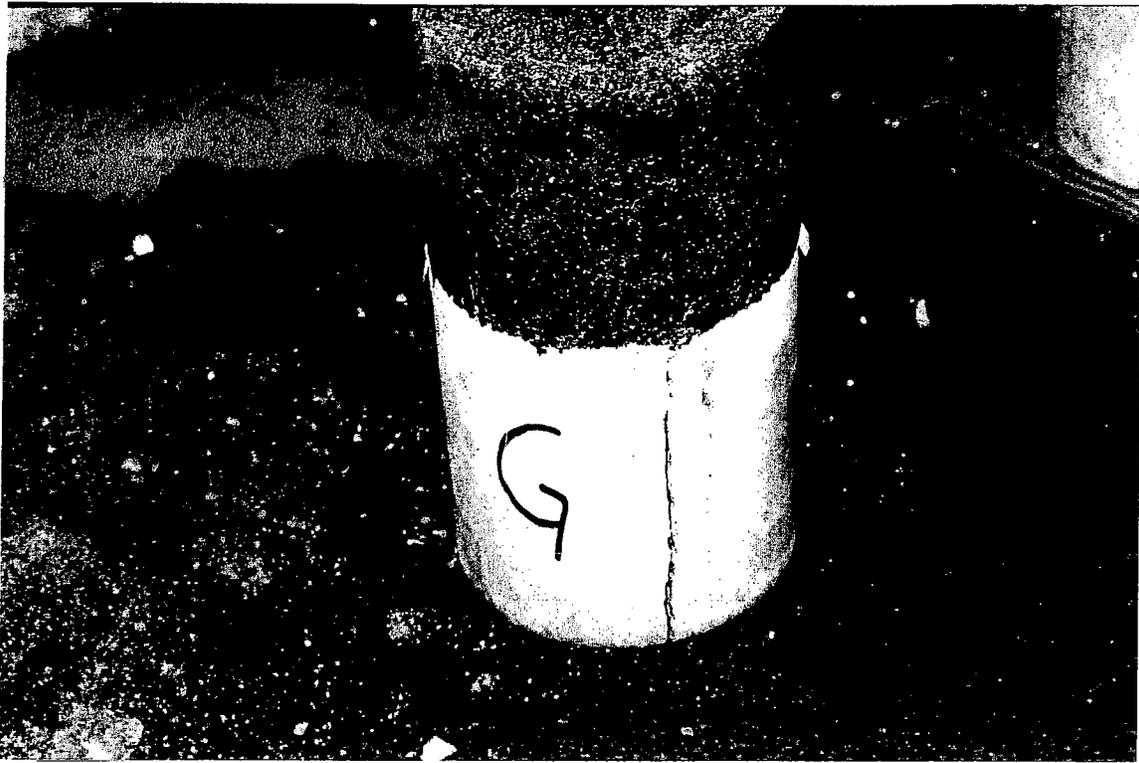
**PHOTOGRAPH 14. Fracture on Concrete below Material (PAC 3)**

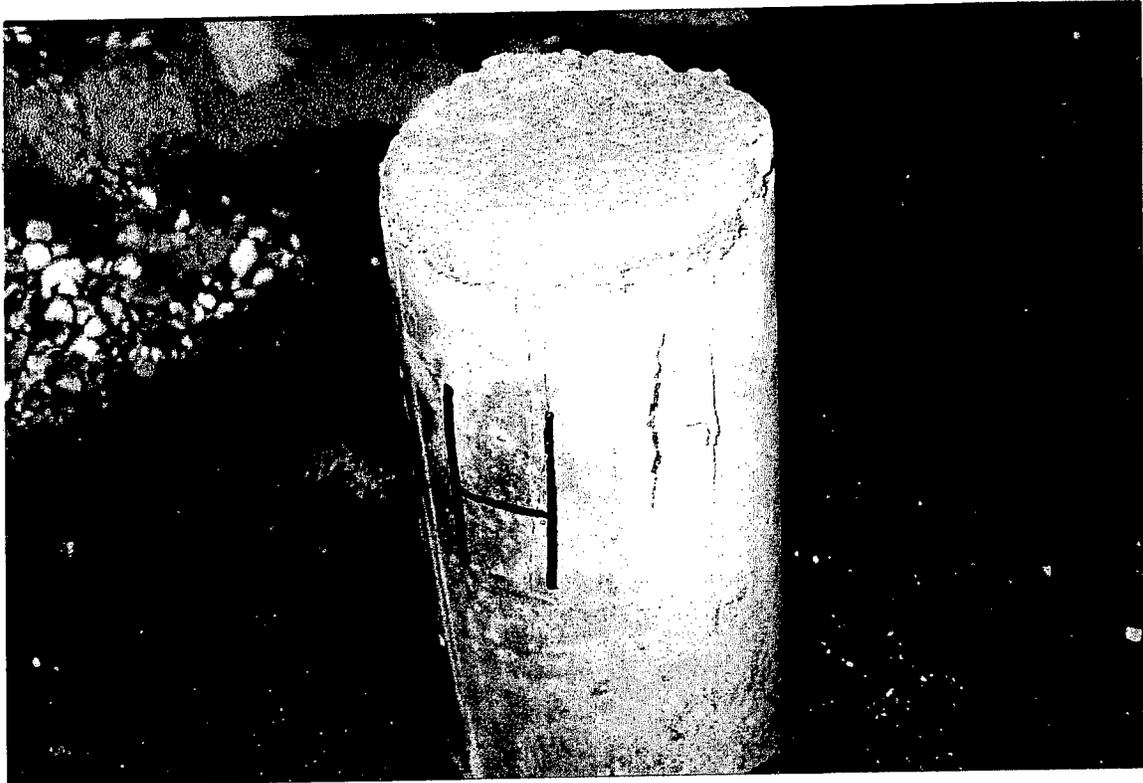
**PHOTOGRAPH 15. Failure of Composite Specimen H (PAC 4)**

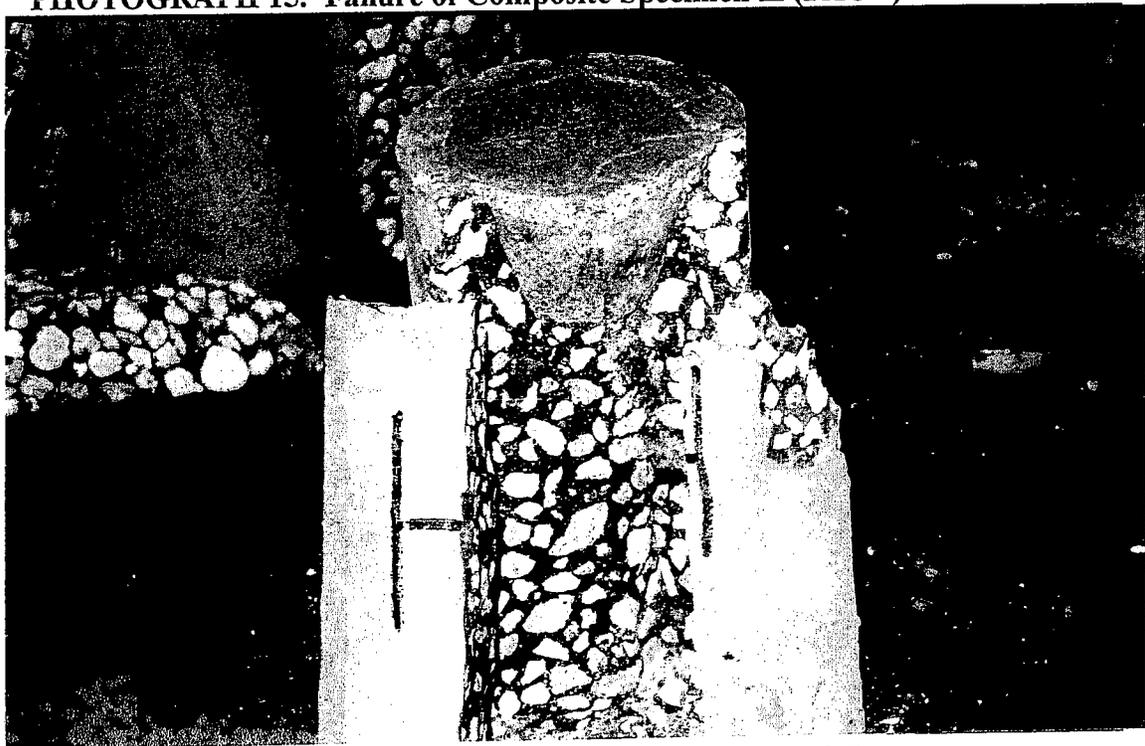
**PHOTOGRAPH 16. Complete Fracture of Concrete (PAC 7)**

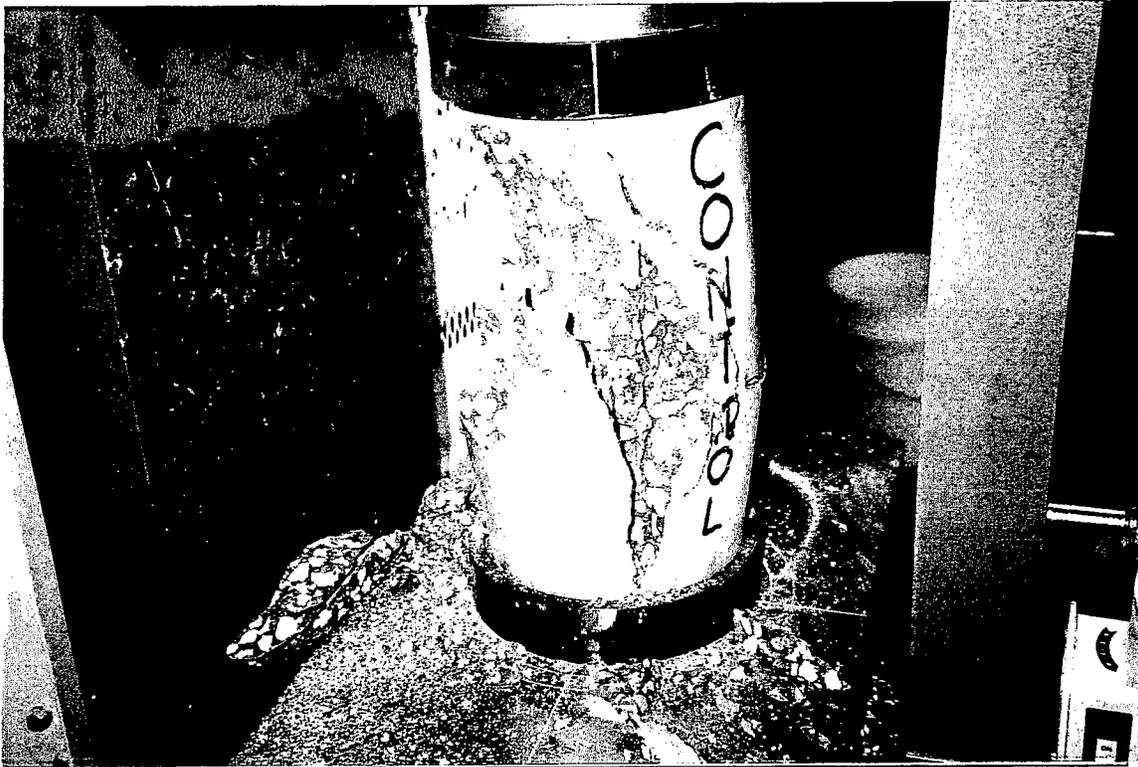
**PHOTOGRAPH 17. Failure of Type II Cement Control Section**

on the fast-set Type II cement mix (Table 5). As previously mentioned the Type II cement mix was used for the control section during the accelerated performance testing. The two cylindrical specimens were allowed to cure for only 24-hours. Yet, the average compressive strength for the Type II cement mix was 51.2 MPa (7,419 psi). As seen in Photograph 17, typical failure of the specimen is shown.

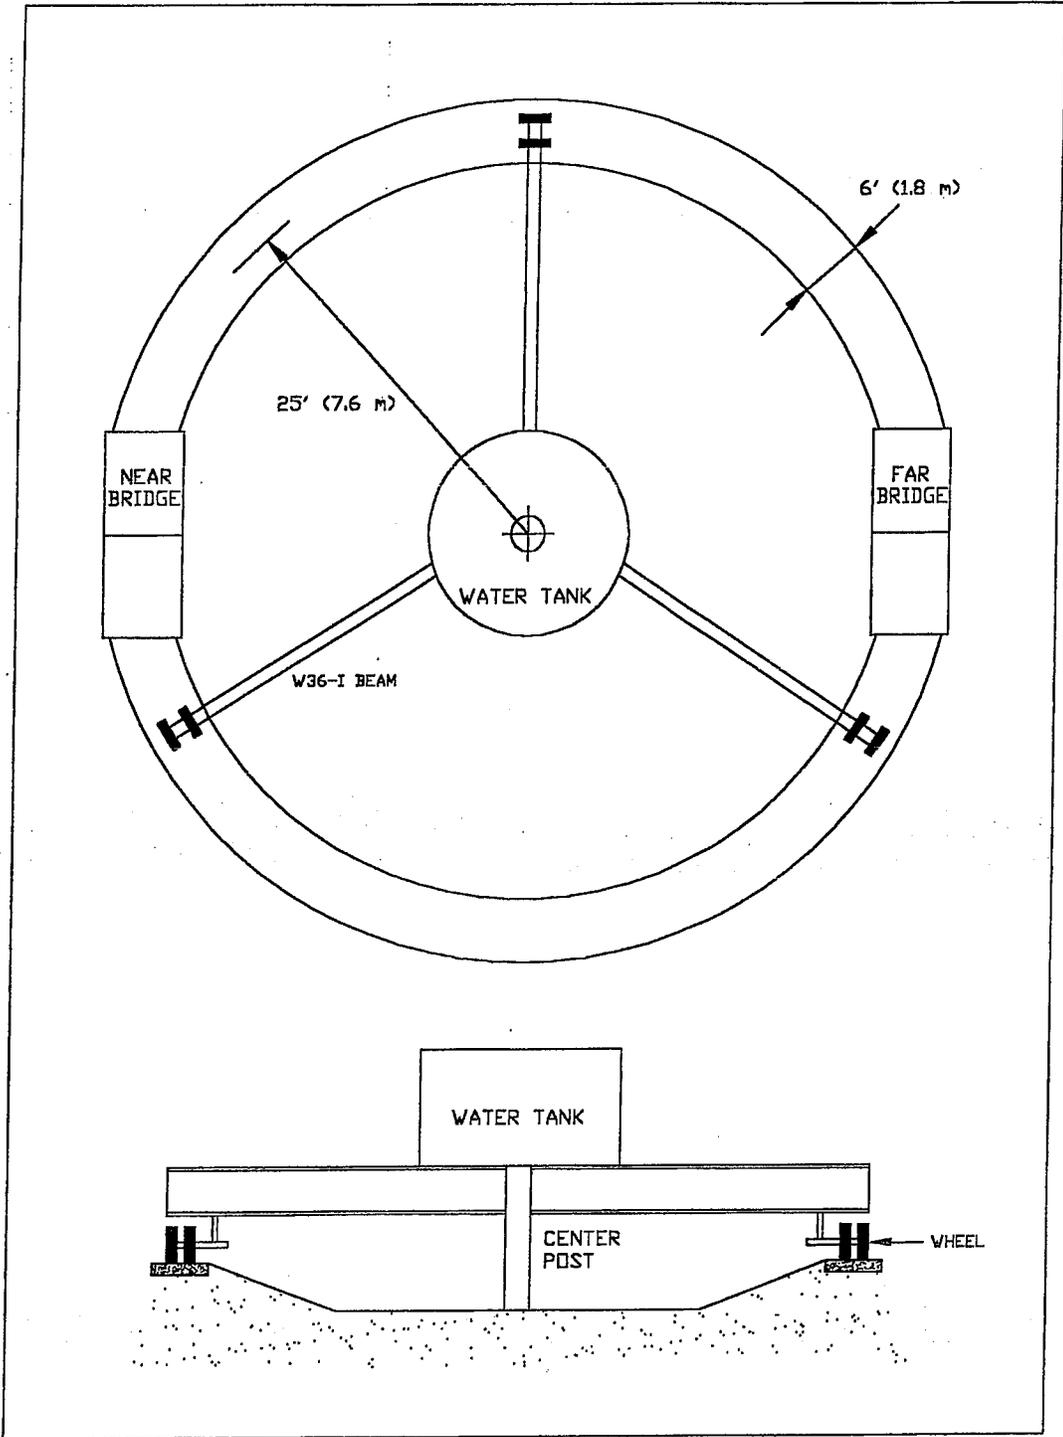
The loading on the dual-wheel assemblies is created by a 28.49 m<sup>3</sup> (7,500 gallon) water tank, 3.7 meters (12 ft) in diameter by 2.4 meters (8 ft) high plus the weight of the structural members. The tank is placed on top of the center support, supported by the I-beams. Depending on the water level in the tank, the total load of the structural weight and filled water tank can vary between 133.5 kN (30,000 lbs) and 356 kN (80,000 lbs). This load is evenly distributed to the three dual-wheel assemblies. This facility, which was illustrated in Photograph 1, has been used to test large-scale bridge expansion joints, experimental pavements, and patching materials since 1990.

FIGURE 5. UCF Circular Accelerated Test Track
