**EVALUATION OF PATCHING MATERIALS AND PLACEMENT  
TECHNIQUES FOR RIGID PAVEMENTS AND BRIDGE DECKS**

**FINAL REPORT**

**Florida Department of Transportation  
(BB452-WPI 0510861)**

**Department of Civil and Environmental Engineering  
University of Central Florida  
Orlando, FL 32816-2450**

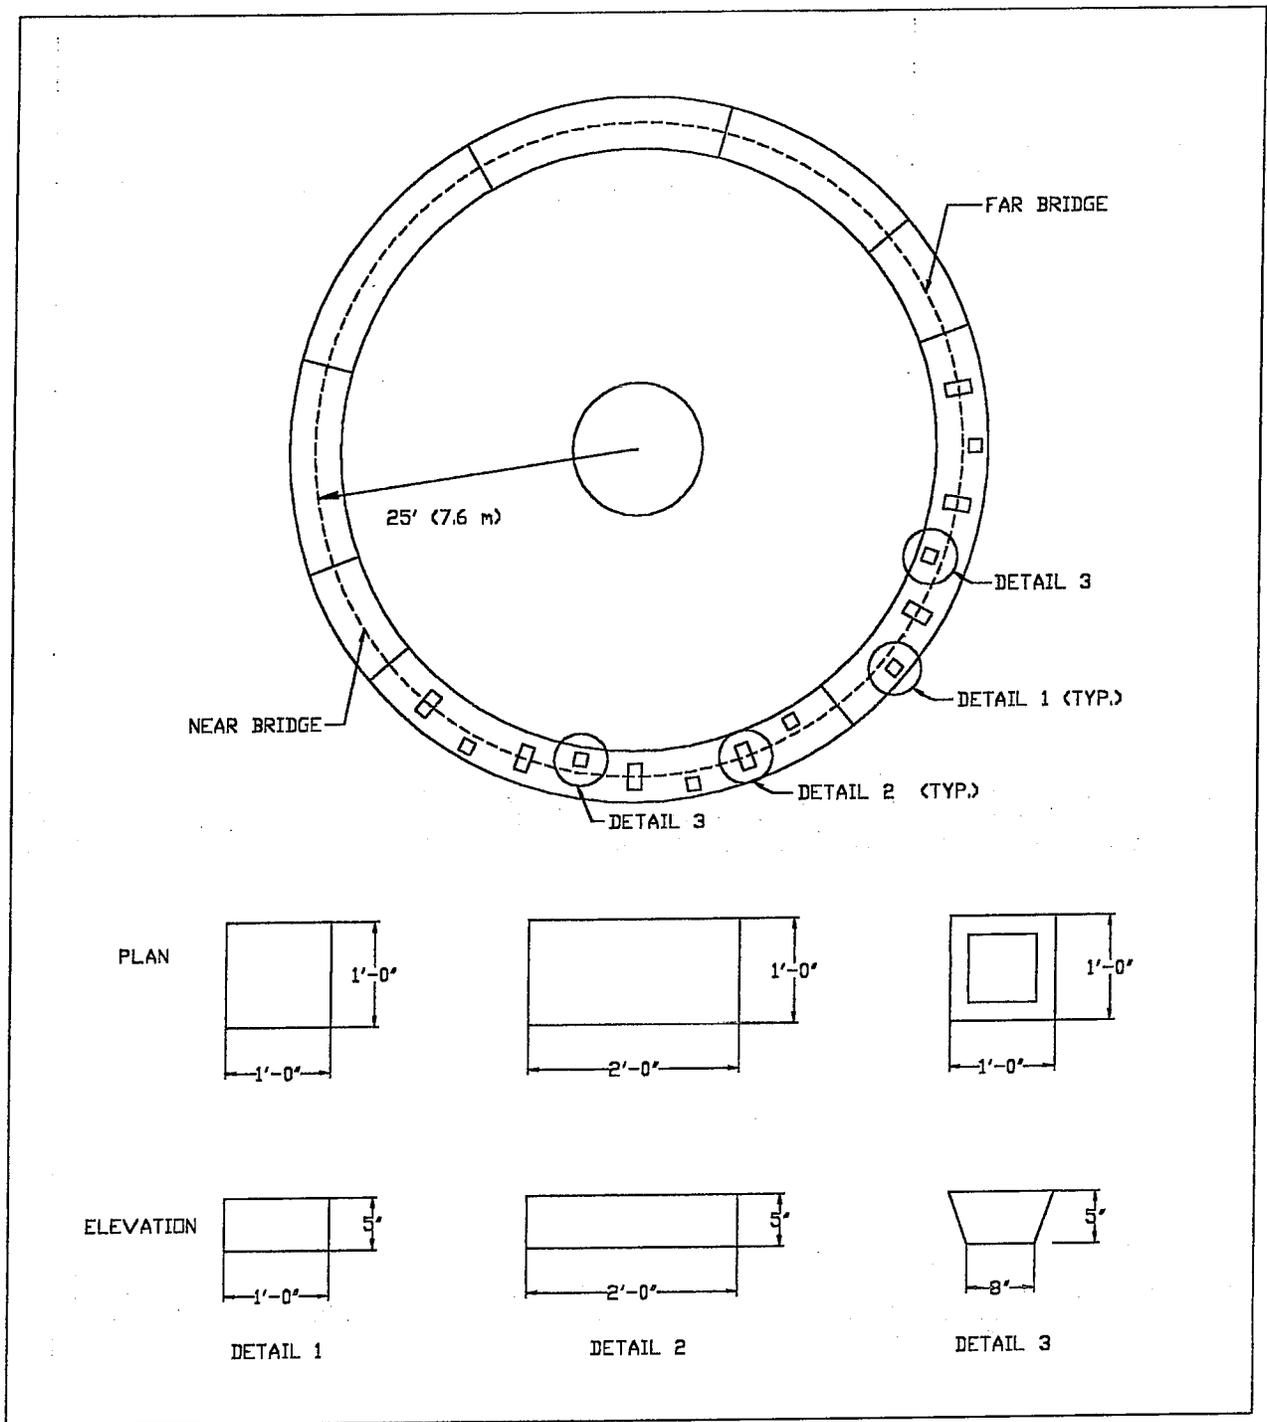
FIGURE 6. Pothole Layout

Figure 6 illustrates the locations of fourteen (14) potholes and two (2) spalls at the pavement joints. three different pothole sizes were created. Seven (7) at the size of 30.4 x 30.4 x 12.7cm (1 x 1 x 0.4 ft) (Detail 1), seven (7) at the size of 60.96 x 30.48 x 12.7cm (2 x 1 x 0.4ft) (Detail 2), and two (2) feathered edged at the size of 30.48 x 30.48 x 12.7cm (1 x 1 x 0.4ft) (Detail 3). Each patching material was placed in two of the pothole molds as seen in Detail 1 and Detail 2 in Figure 6. The purpose of placing the same material in two different potholes was that one pothole is placed under a single tire that may cause the edge of the patching to detach, while the other pothole is under the dual tires that may cause a higher displacement of patching. The placement of the patching materials onto the pre-formed potholes was not an easy task for this project. Leveling the materials with the track surface became somewhat difficult with the cementitious materials and the control section due to the large size of the aggregate involved. This was the reason that the patchings with cementious materials caused uneven levels with the concrete track surface. If the size of the aggregate can be reduced in these materials, then patching will be easier.

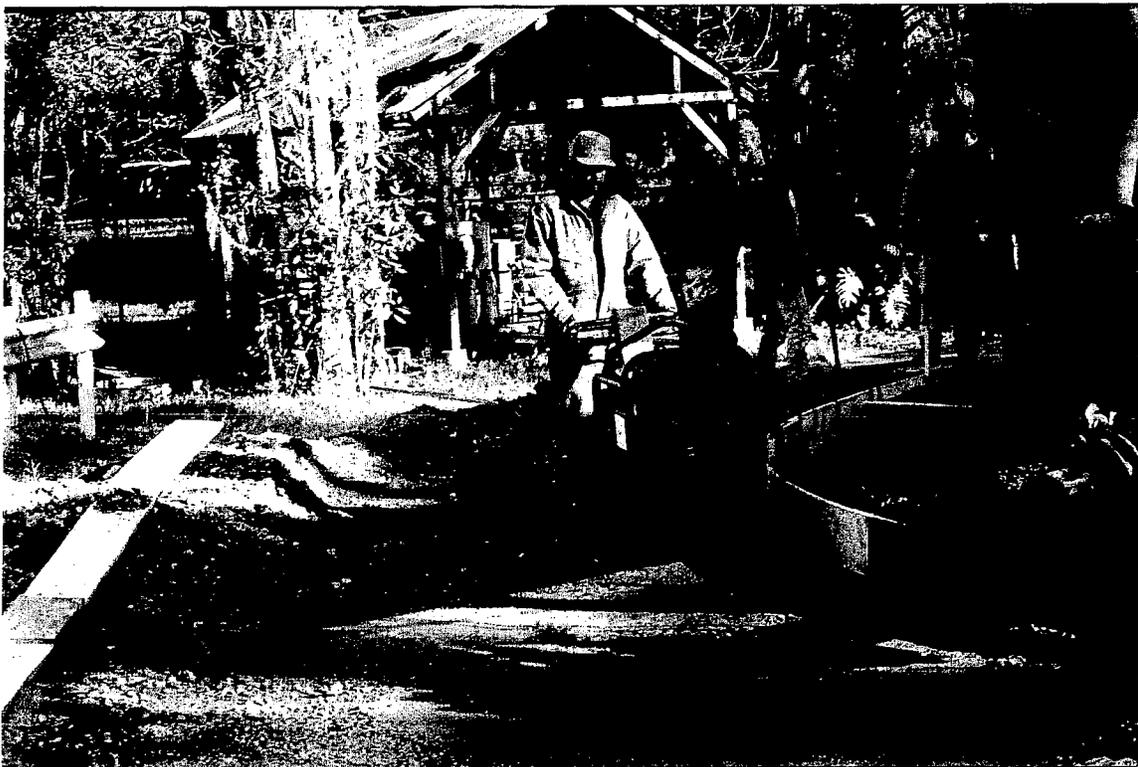
The base materials were parts of virgin and recycled aggregate, constructed in a previous project (Duxbury, 1997). It was decided that the existing base materials would be sufficient for the new test track. However, after removing the HMA, the top portion of aggregates were disturbed by the backhoe, thus further compaction was needed for the existing aggregate base. Hunter Concrete Contractor used a 454 kg (1000 lb) vibrating compactor (Photograph 19) to compact the virgin and recycled aggregate bases. Once the material was compacted, the placement of the new concrete slab followed.

**PHOTOGRAPH 19. Compaction of Base Material**

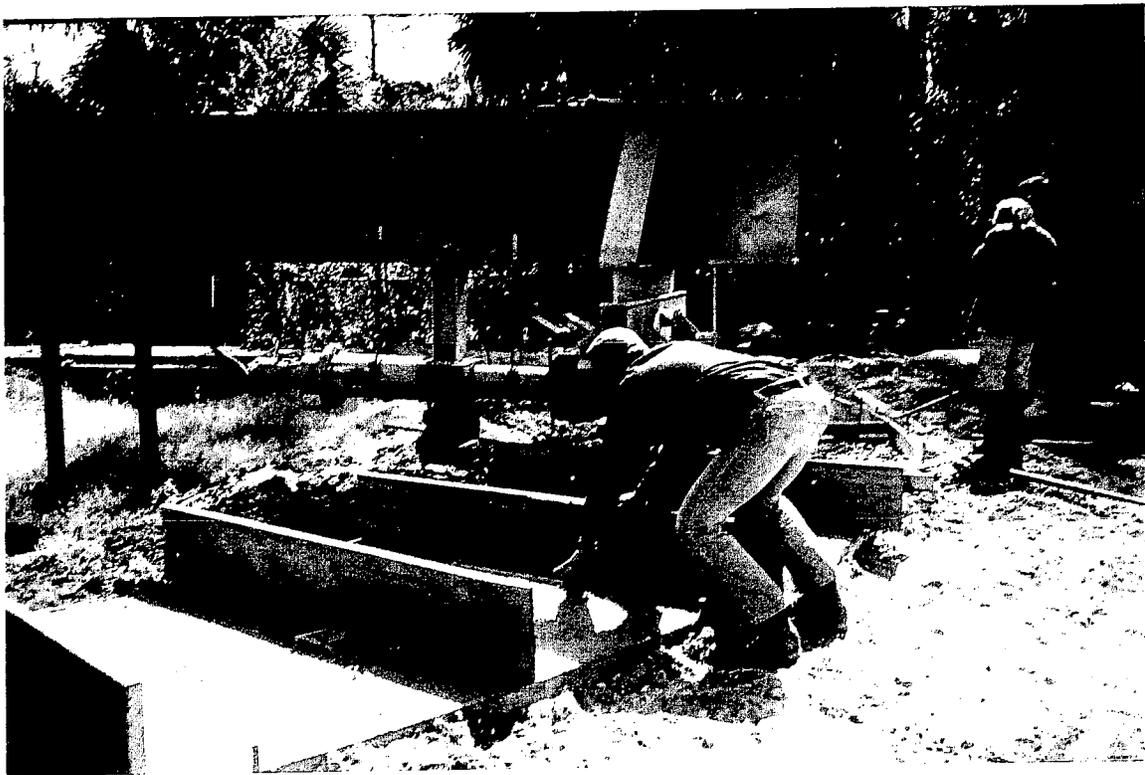
To construct the different configurations of potholes, 2.54 cm x 15.24 cm (1 in x 6 in) pressure treated lumber was used to form the molds. The molds were constructed prior to the pour of the concrete on the test track. The box and rectangular molds were then toe-nailed to 5.1 cm x 25.4 cm (2 in x 10 in) lumber panels that spanned the 1.83 m (6 ft) width of the test track. This was done to stabilize the molds when the concrete was poured (Photograph 20). Two joint spalls were created on opposing sides under the different wheel paths. The concrete pavement was chipped with hammer and chisel to create the spalls. The spalls were approximately 11" x 5" x 1.5" in size (Photograph 24).

**PHOTOGRAPH 20. Pothole Construction during Concrete Pour**

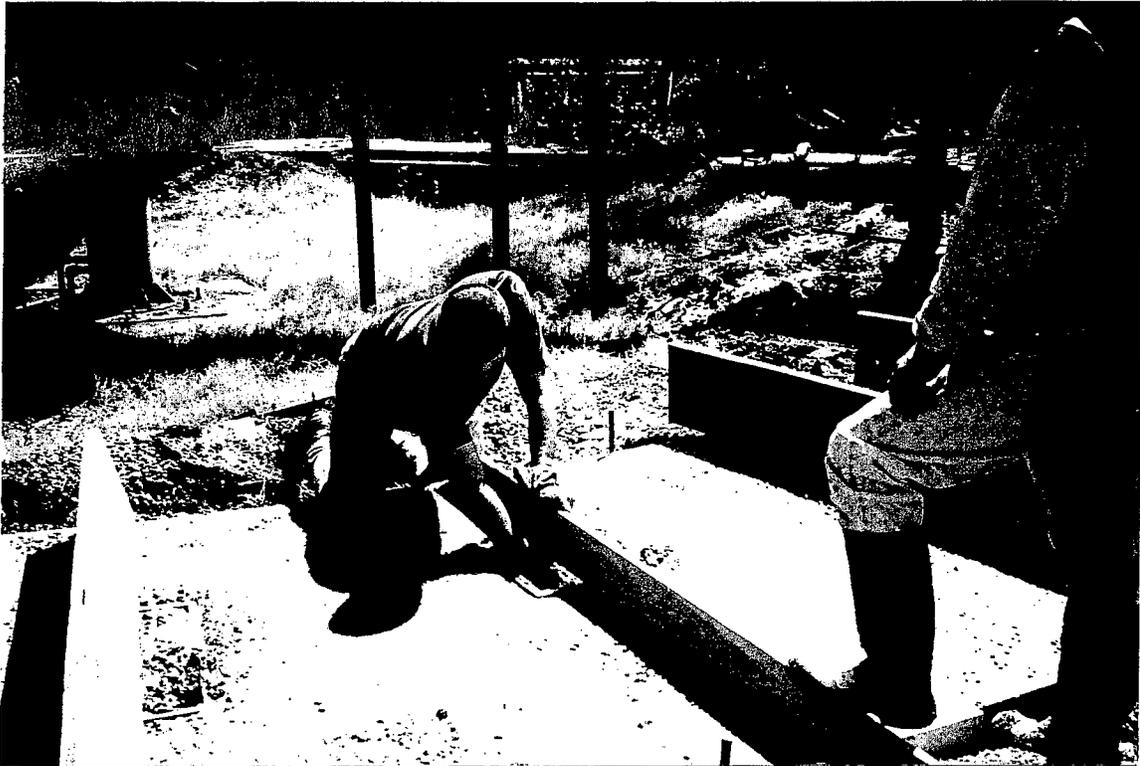
**PHOTOGRAPH 21. Concrete Being Removed from Pothole Molds**

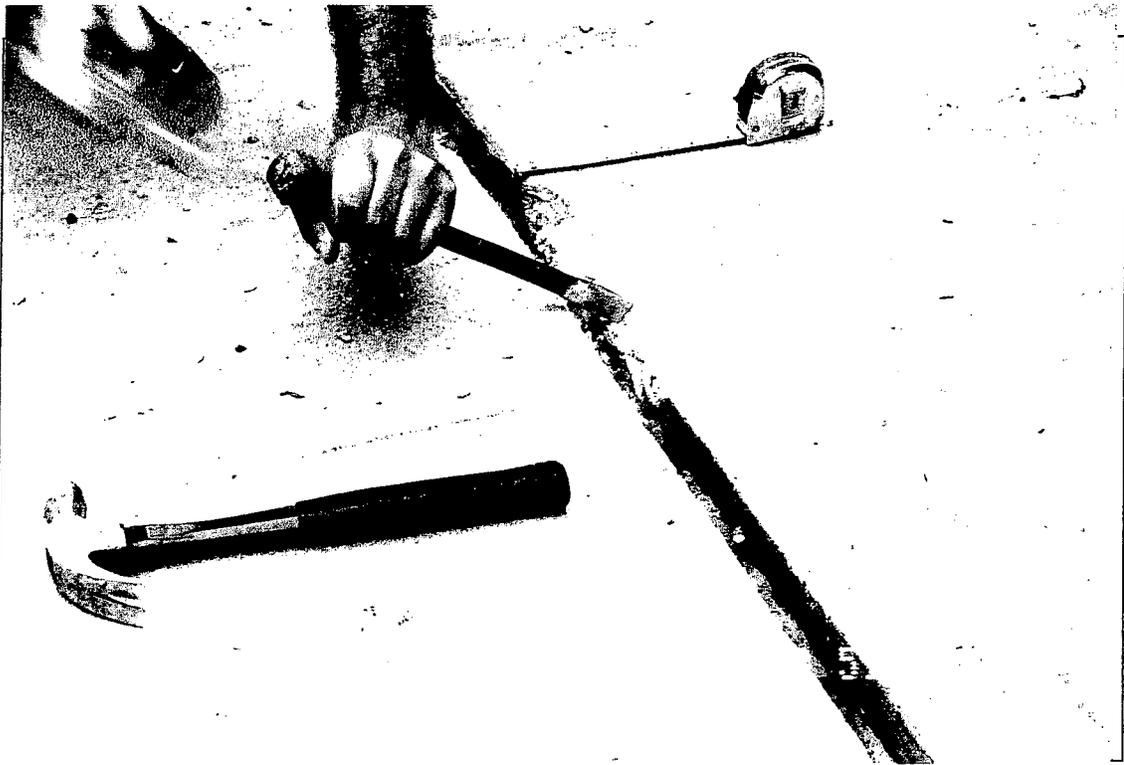
**PHOTOGRAPH 24. Chipping to Create Joint Spall**

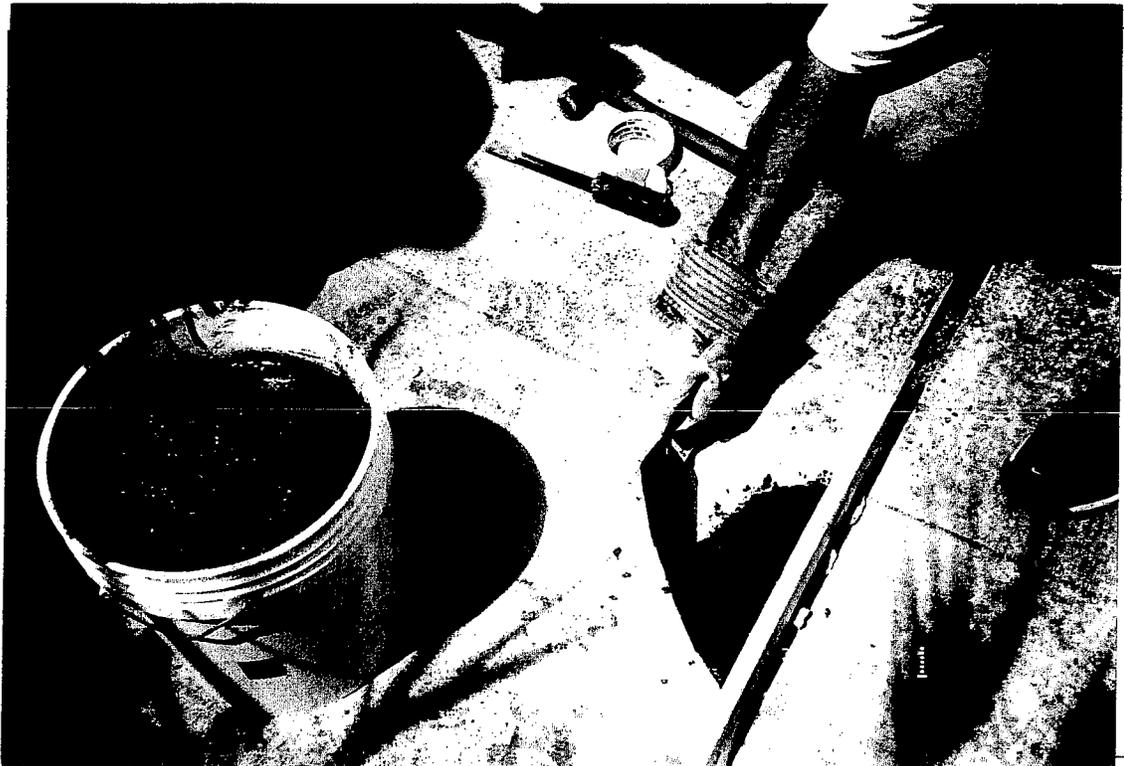
**PHOTOGRAPH 25. Spall Patching Placement**

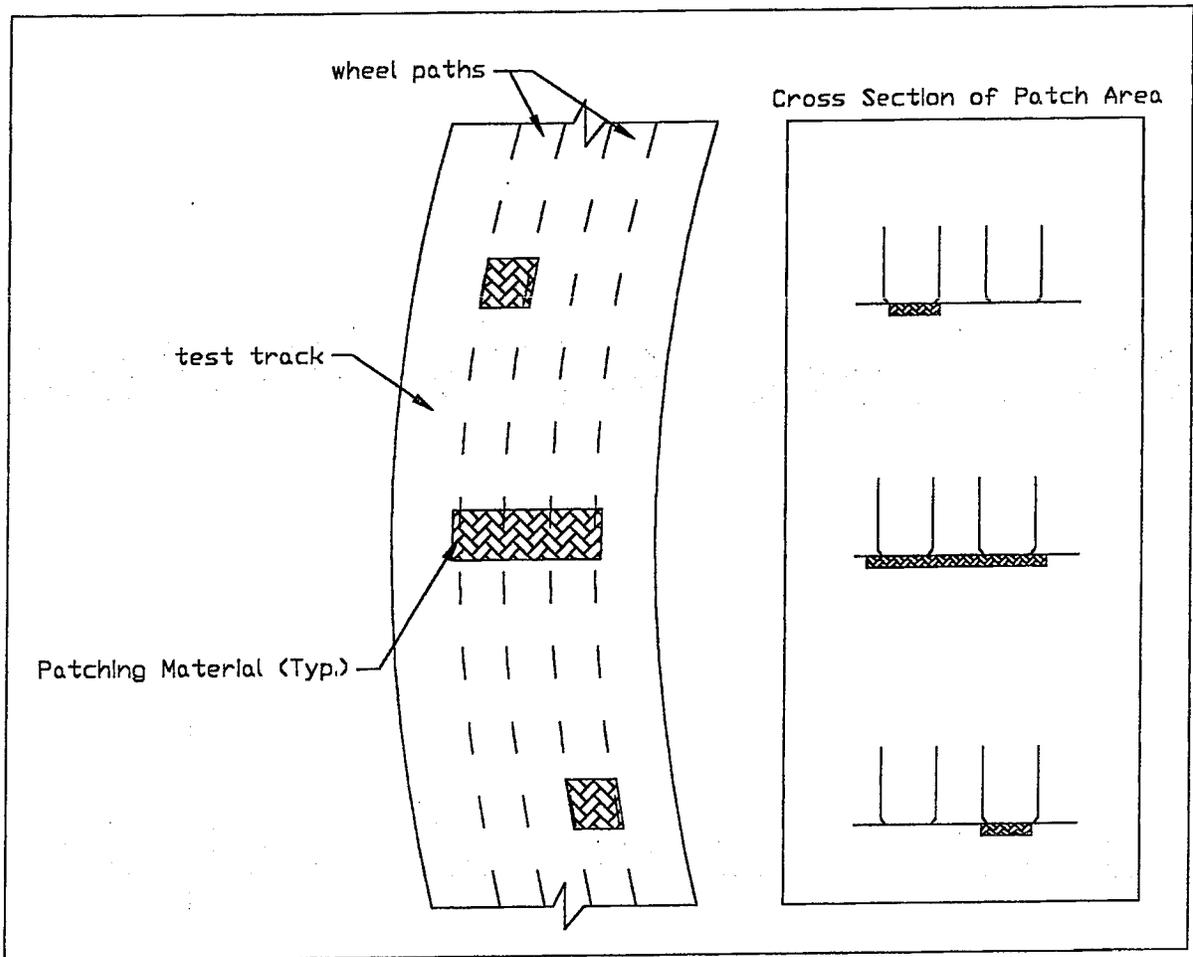
**FIGURE 7. Typical Location of Patching Materials on Test Track**

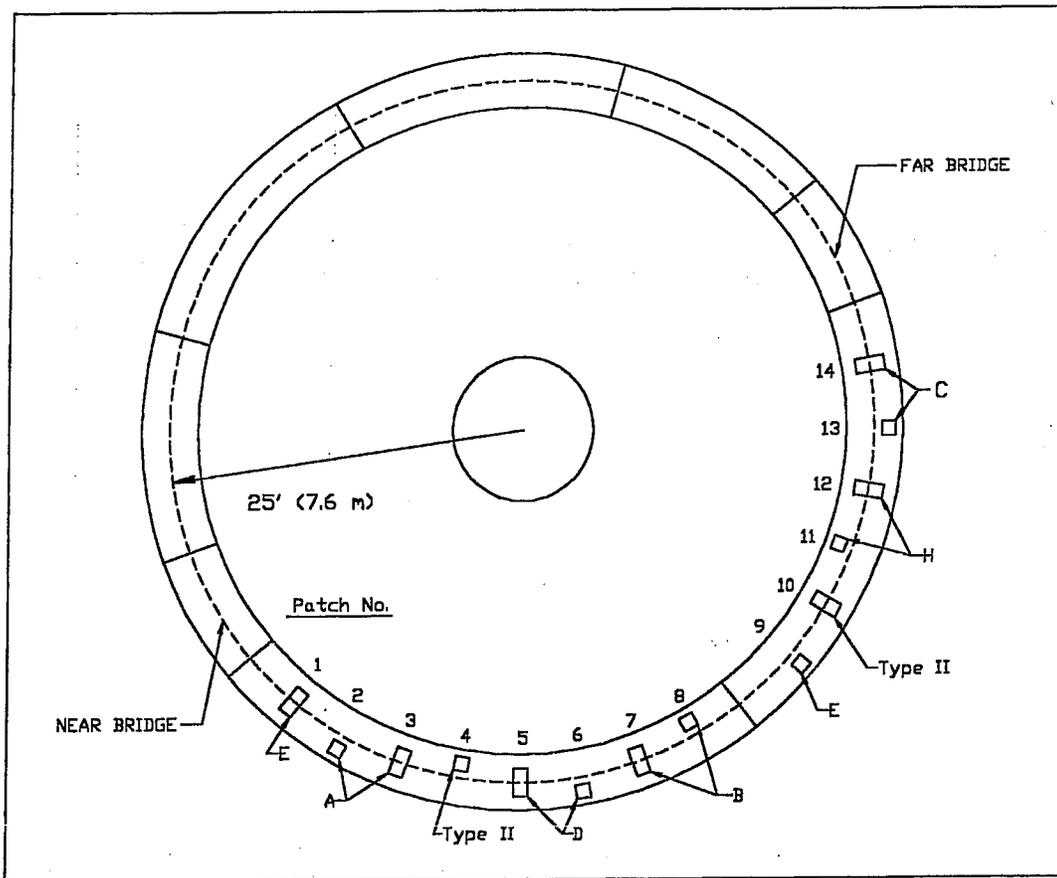
Material Type	Property	Mixing Procedure	Workability	Aggregate Additives	Curing Time
A	Polymer	moderate	moderate	pre-packaged	2-4 HRS
B	Cementitious	easy	moderate	3/8" clean	2 HR
C	Cementitious	easy	moderate	3/8" clean	4 HR
D	Elastomeric	easy	easy	pre-packaged	4 HR
E	Elastomeric	moderate	moderate	pre-packaged	4 HR
H	Cementitious	easy	moderate	3/8" clean	2 HR
Control Section	Type II (PCC)	hard	difficult	57 stone	24 HR

**FIGURE 8. Placement and Characteristics of Selected Patching Materials**

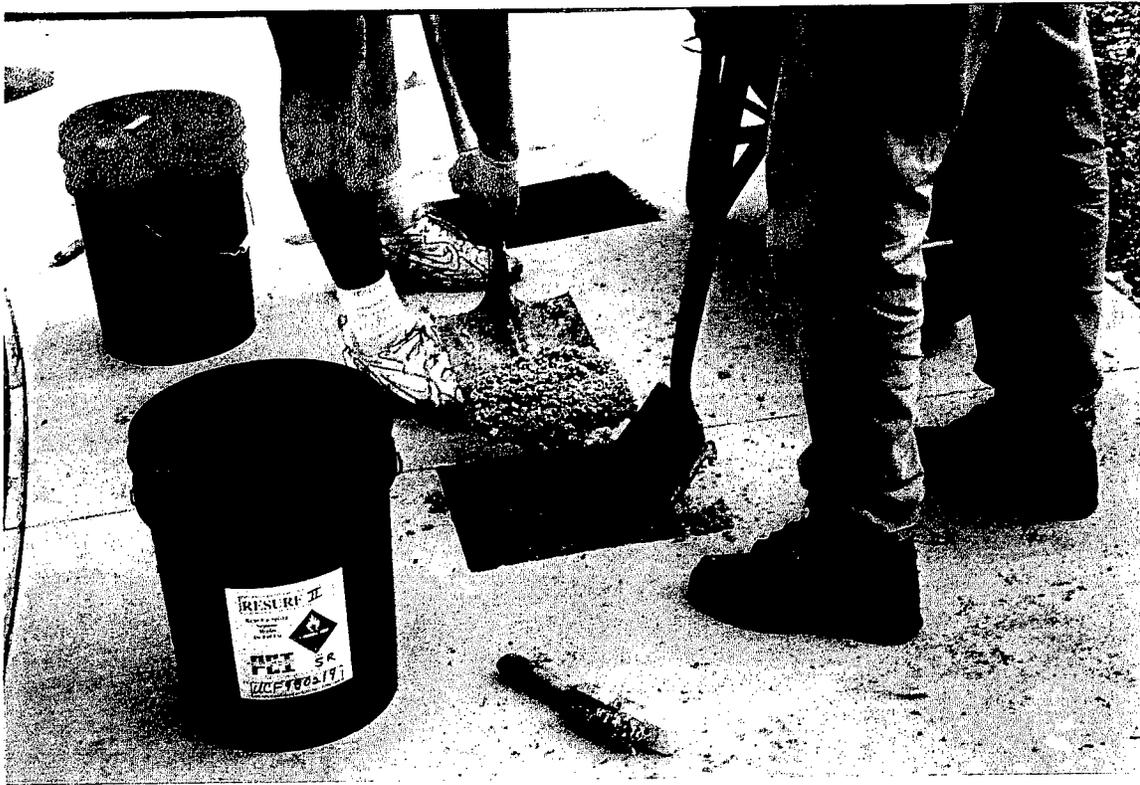
**PHOTOGRAPH 26. Placement of Material A into Pothole**

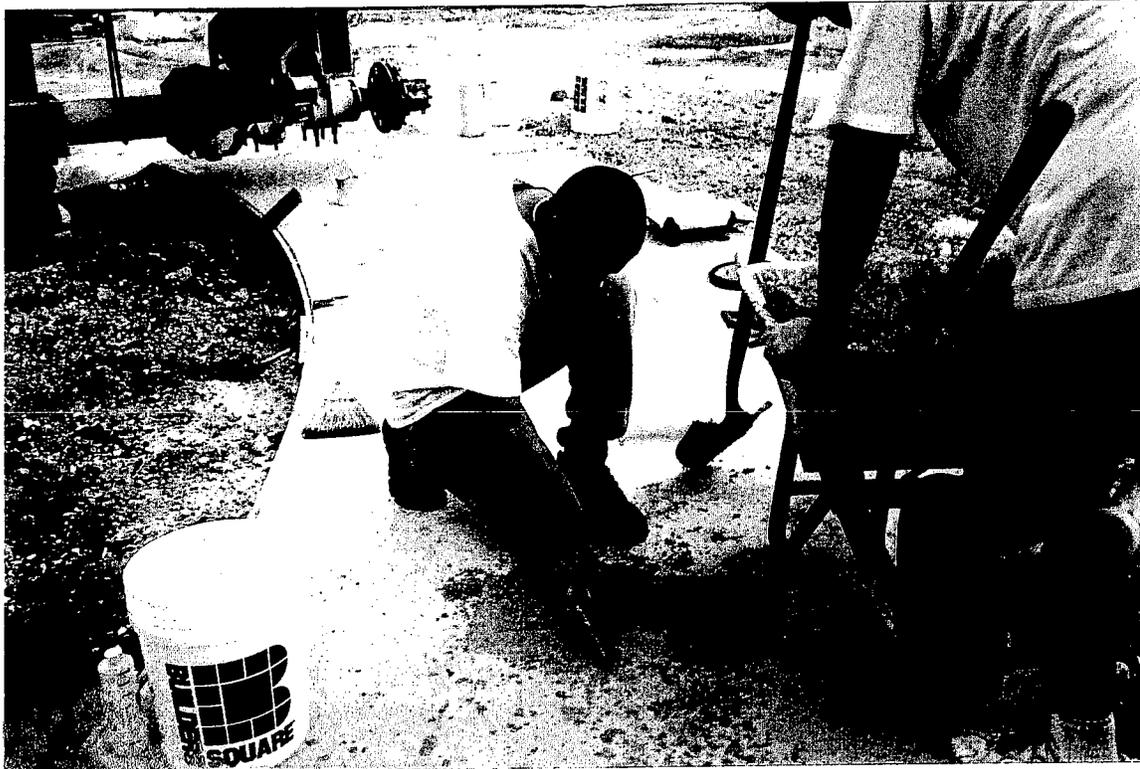
**PHOTOGRAPH 27. Leveling Material A with Trowel**

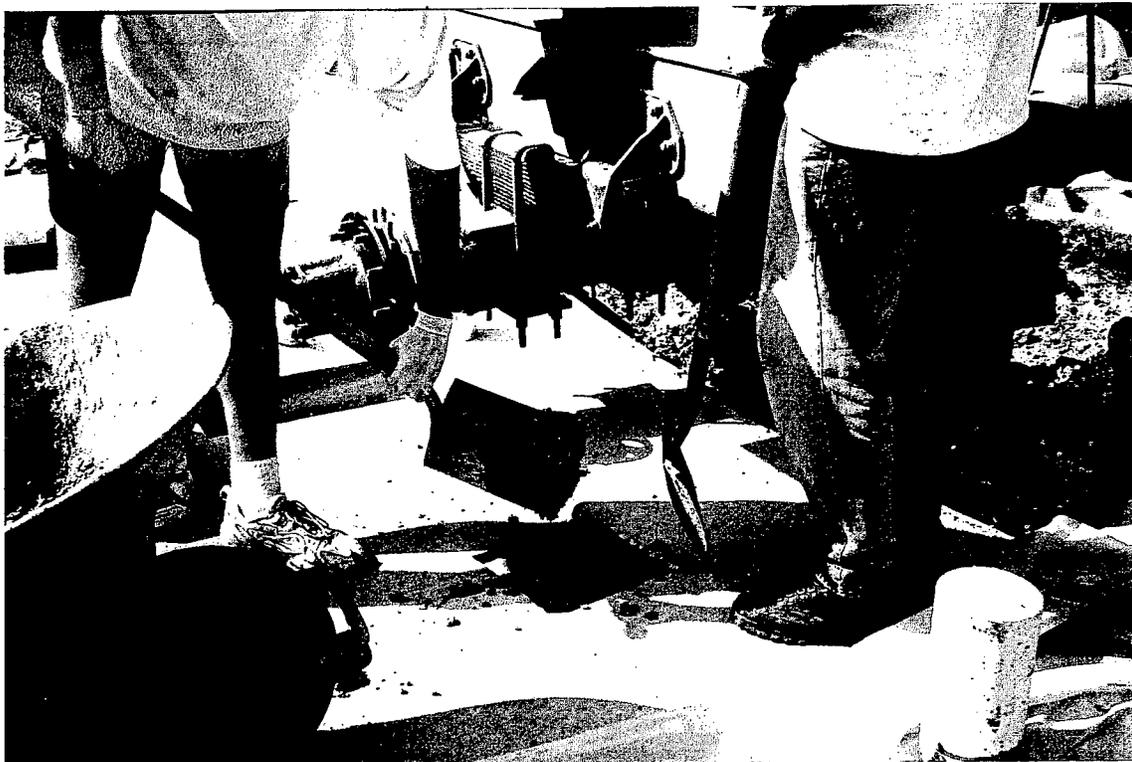
**PHOTOGRAPH 28. Placement of Material B**

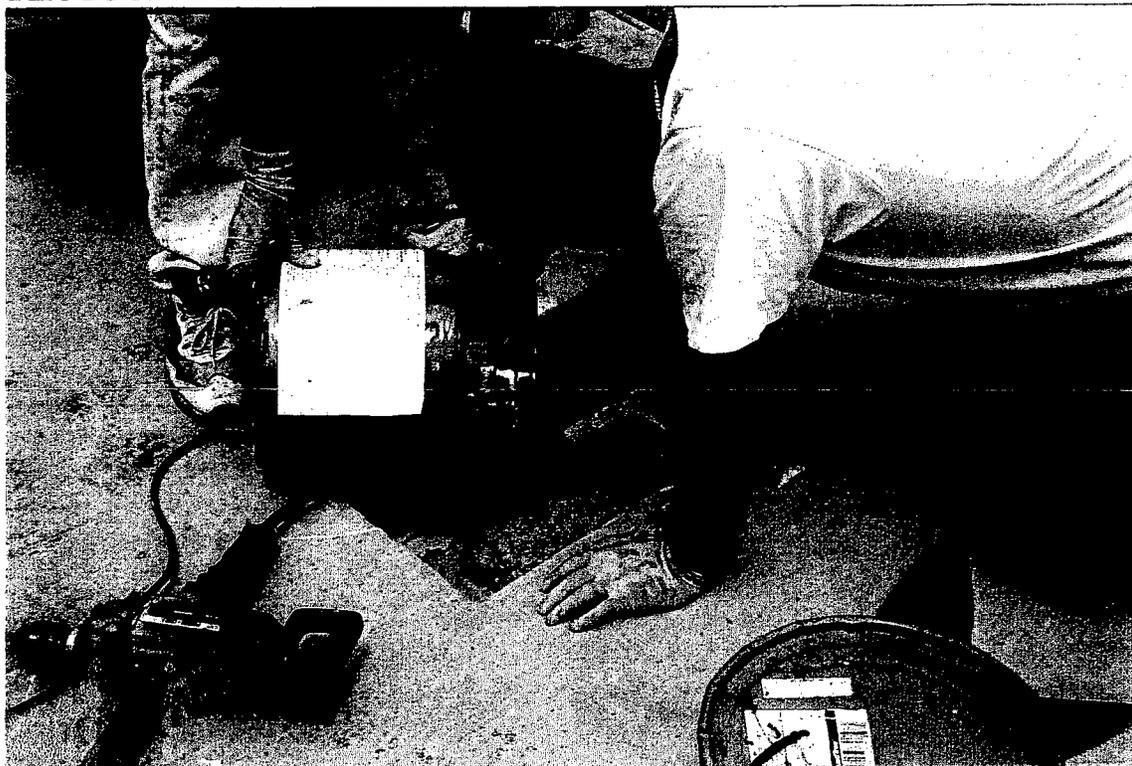
**PHOTOGRAPH 29. Placing Material E with Bonding Agent Adhered to Sides**

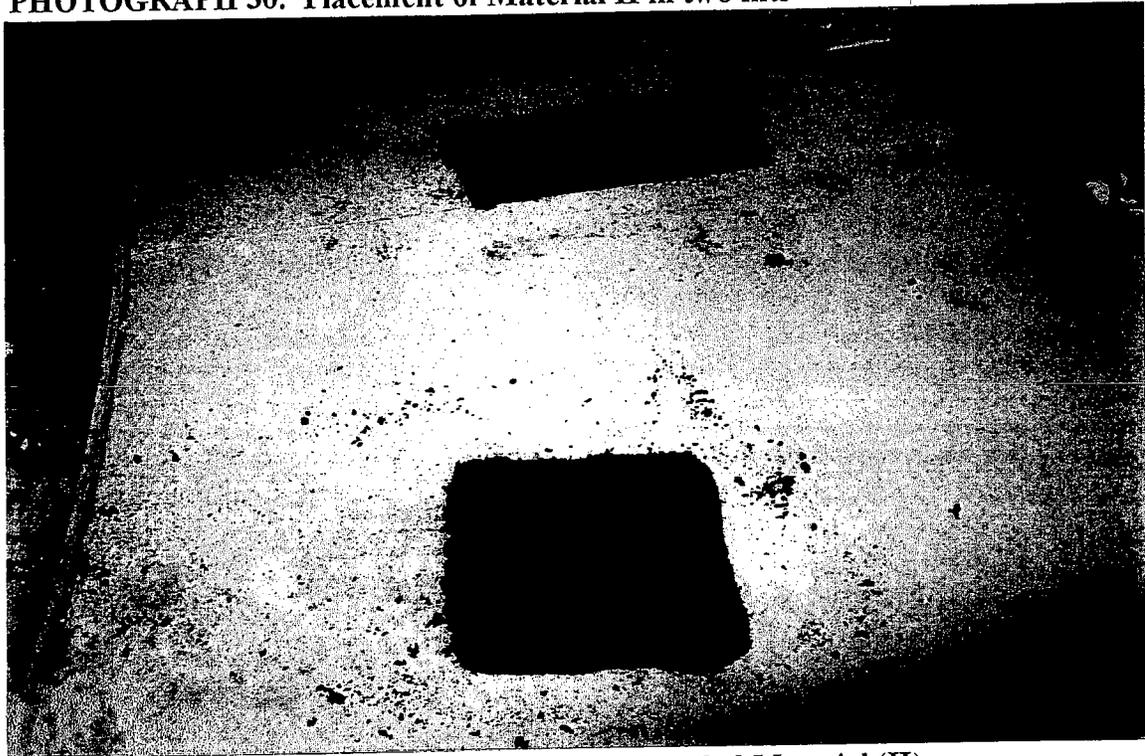
**PHOTOGRAPH 31. Sample of Finished and Leveled Material (H)**

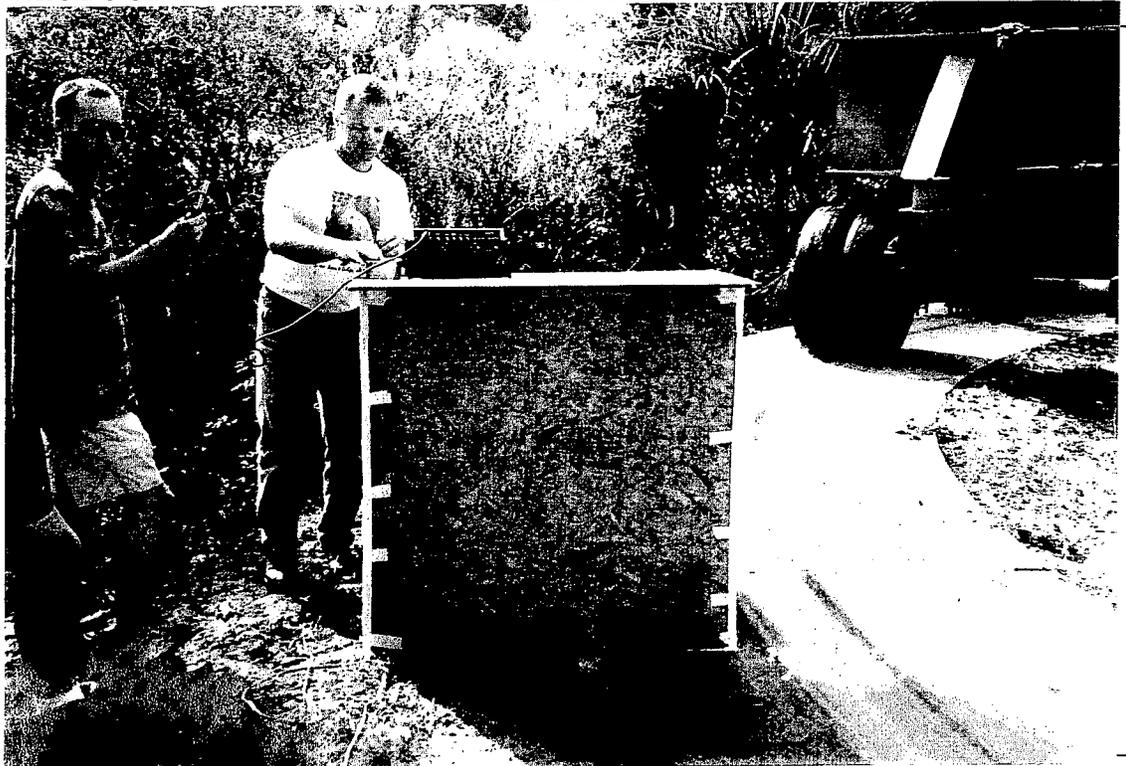
**PHOTOGRAPH 33. Conduction of Joint Noise Tests**

An Octave Band Real-Time Analyzer was used to measure the decibel levels while the wheels passed across the joint (Photographs 33 and 34). A microphone was placed on the test track to record the decibel levels. The collected data could be compared with and without material being placed in the joint (Photograph 35).

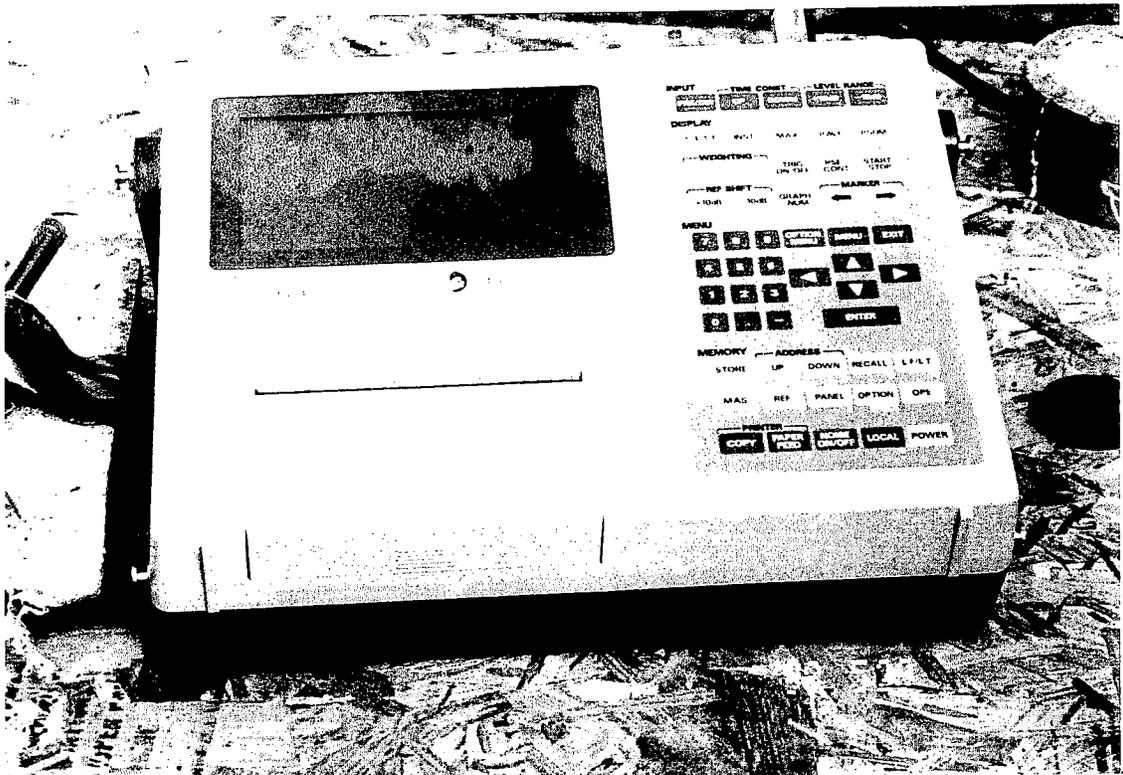
PHOTOGRAPH 34. Rion SA-27 Octave Band Real Time Analyzer

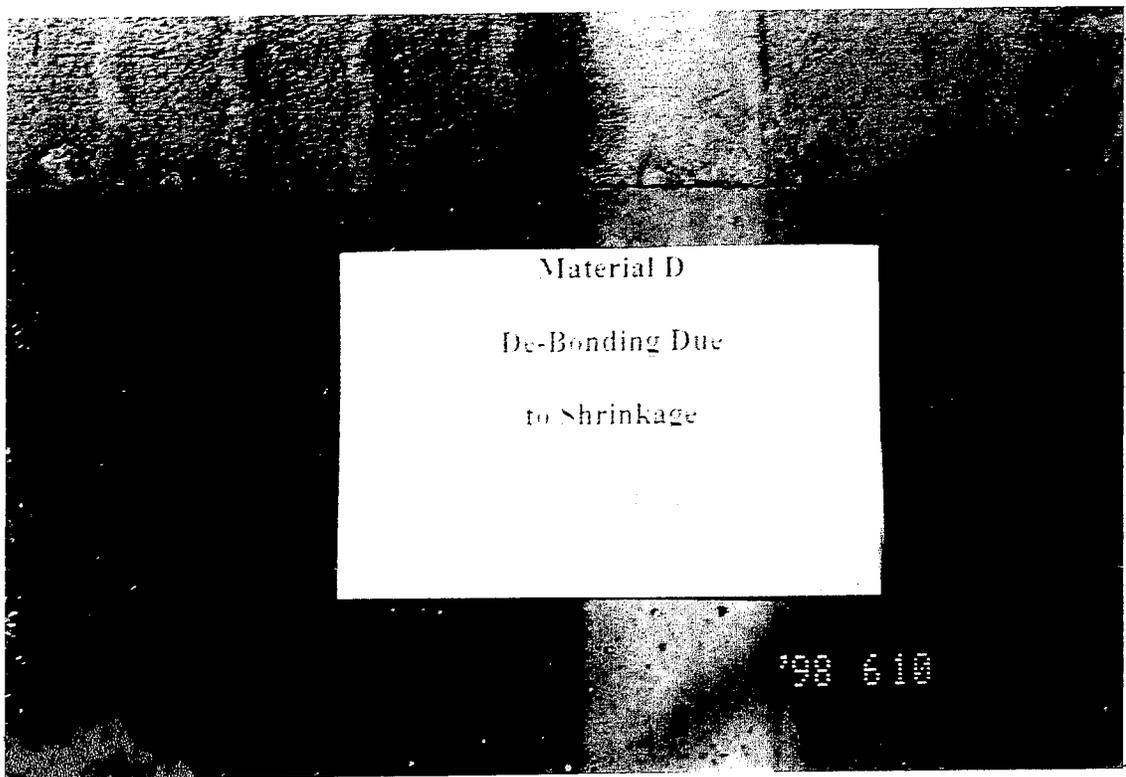
PHOTOGRAPH 36. Cracks along Interface Due to Shrinkage (Patch No. 5)

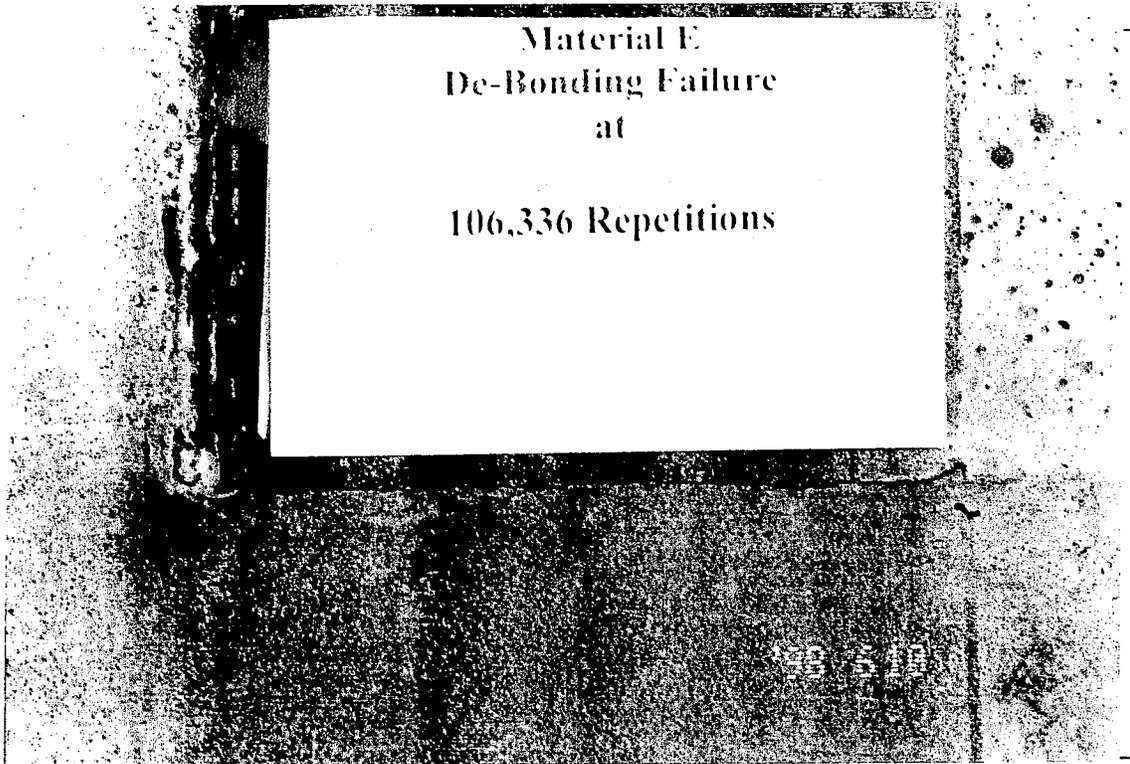
**PHOTOGRAPH 37. Material E at 122 Hours and 106,336 Repetitions (Patch No. 9)**

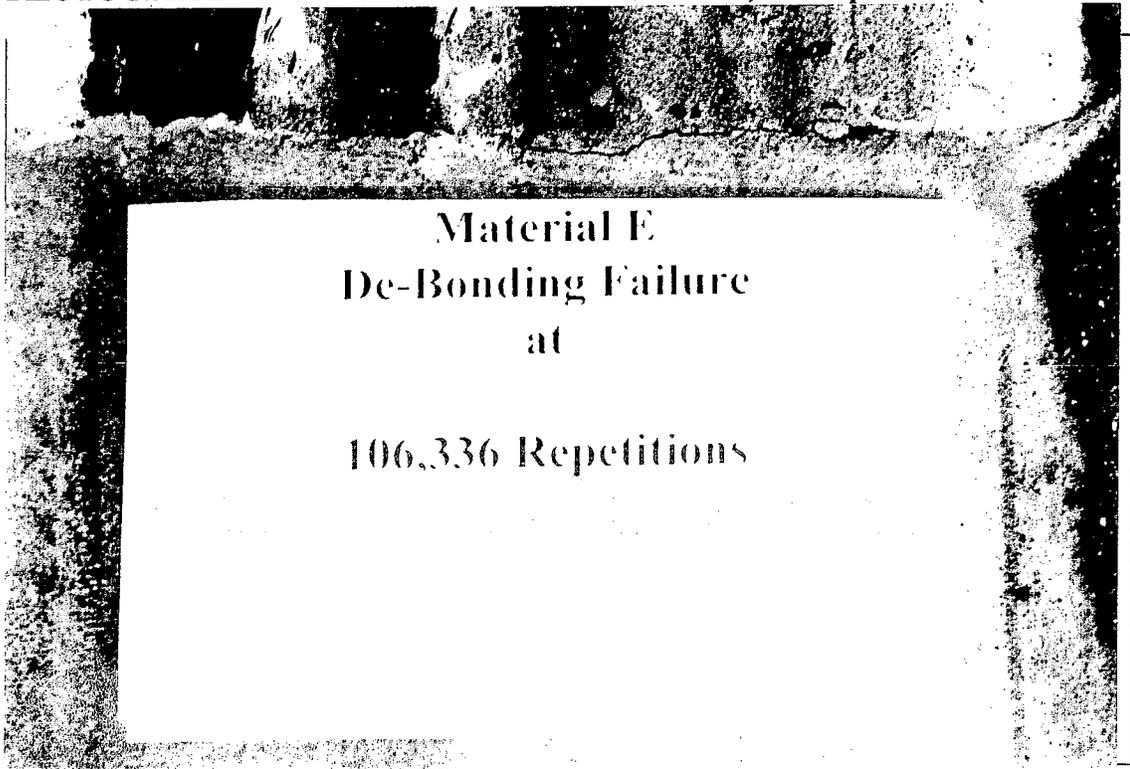
**PHOTOGRAPH 38. Material E at 122 Hours and 106,336 Repetitions (Patch No. 1)**

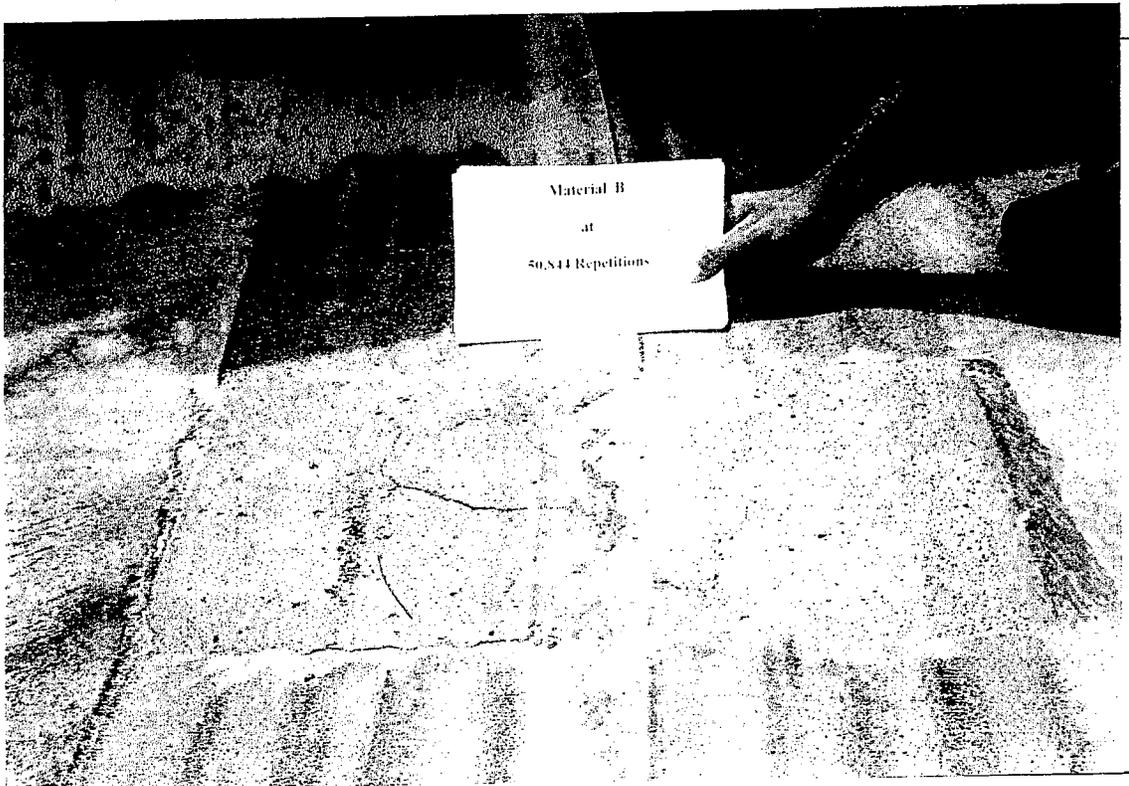
shrinkage/expansion cracks along Material B's surface is present. This was due to excessive addition of water while mixing the cementitious material. This factor is evident, because the other pothole with Material B present has no cracks or other failures associated with bad mixing procedures (Photograph 40).

**PHOTOGRAPH 39. Shrinkage Crack Due to Excessive Water in Mix (Patch No. 7)**

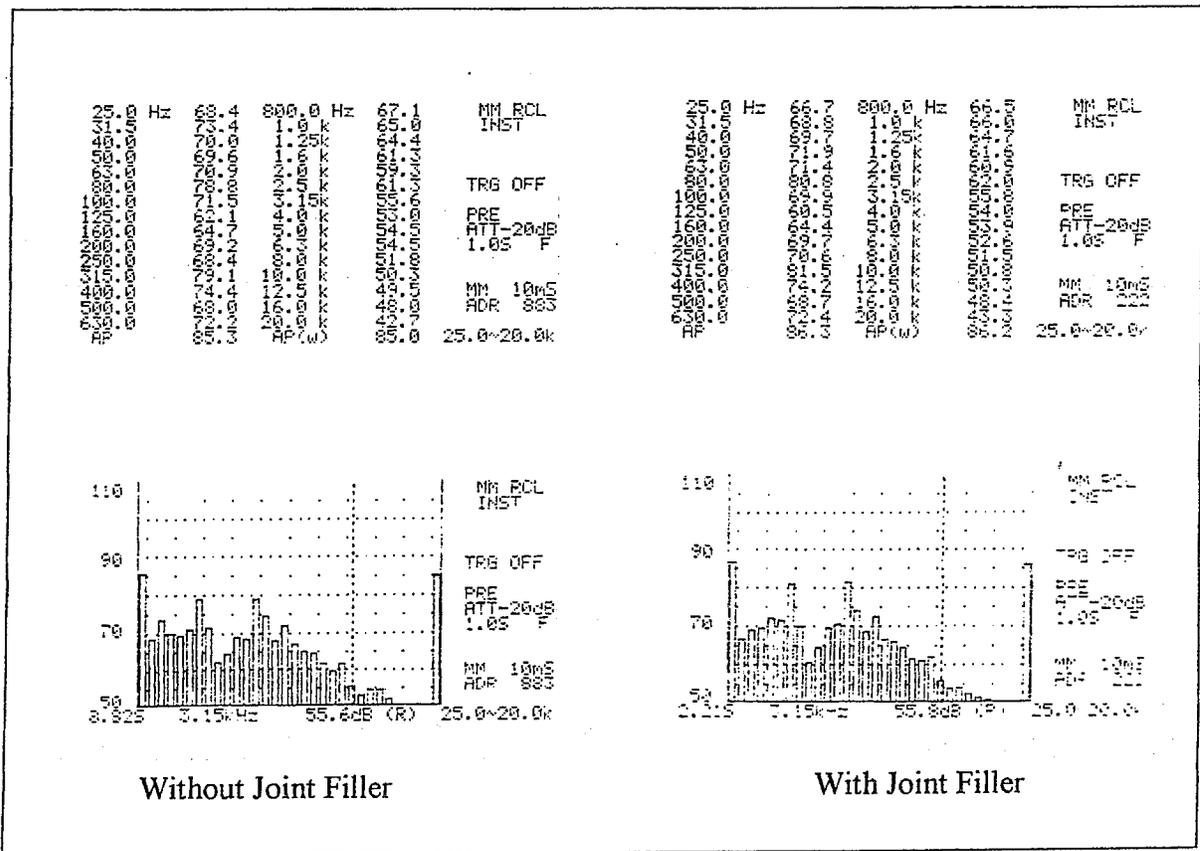
been contributed by the noise of the test track powered engine and the relatively slow speed of the wheel passes. In order to obtain variable data, the engine noise must be isolated by an insulated structure as recommended by a transportation noise research professor. The design and construction of this insulated structure may require some funding and period of time. A small project of this research can be done in the near future.

FIGURE 9. Joint Noise Decibel Recordings

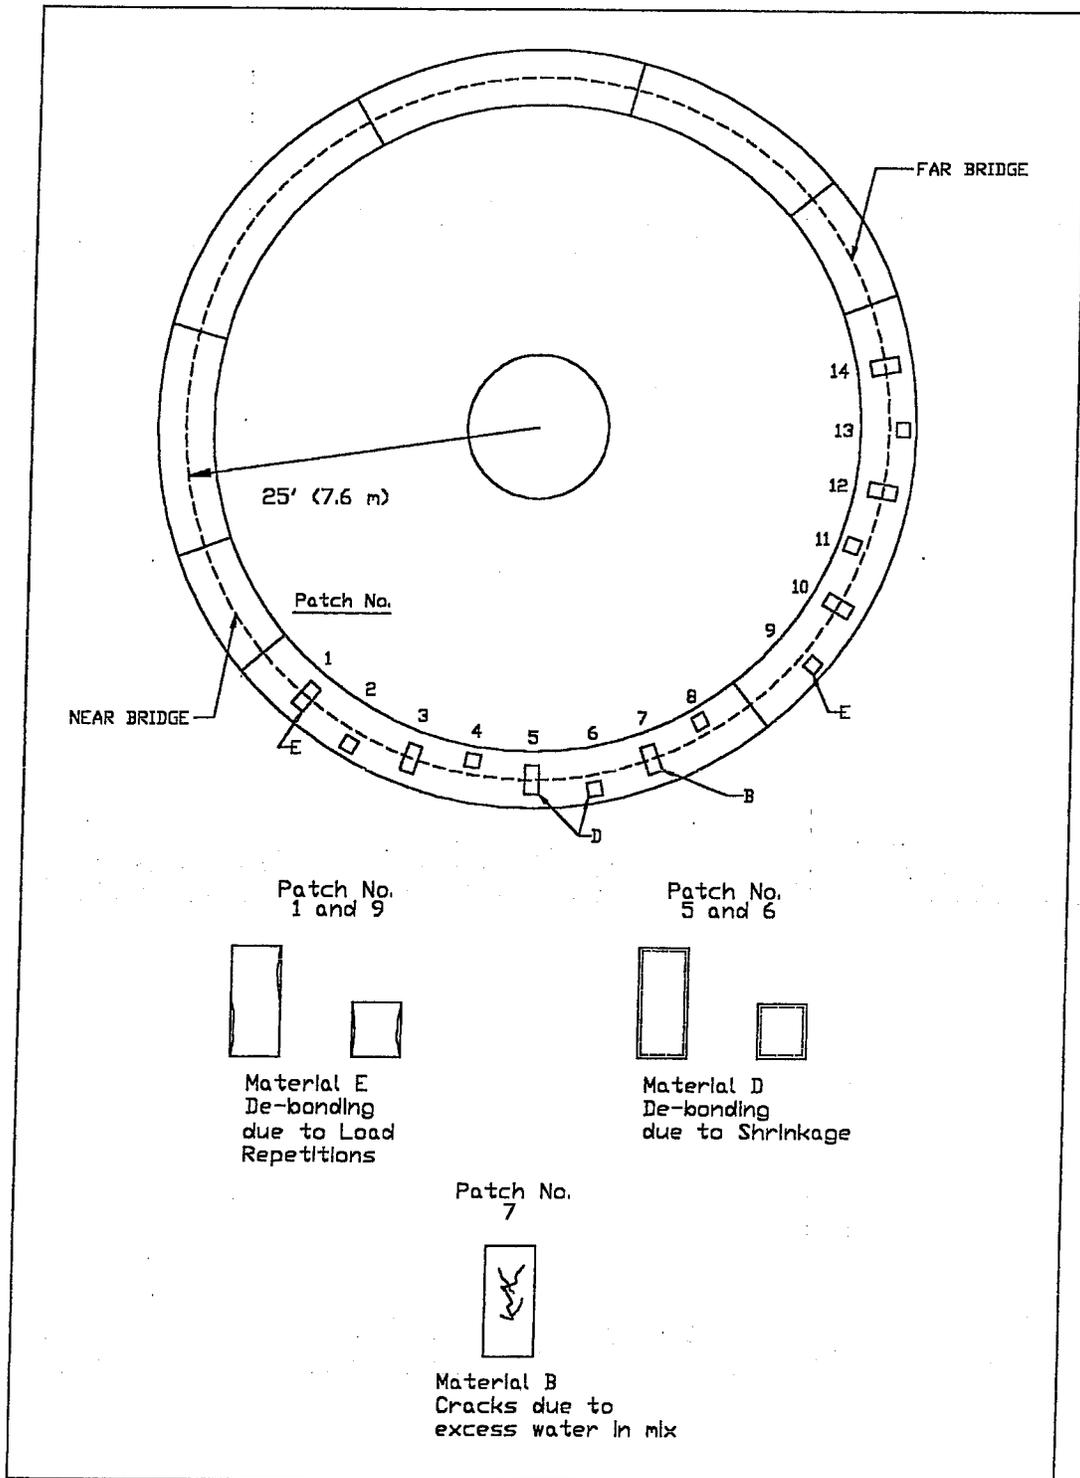
<b>C</b>	Little wear Little debonding Little exposure of coarse aggregate at edges
<b>D</b>	Debonding Exposure of fiber reinforcement
<b>E</b>	Debonding Some exposure of voids and coarse aggregate
<b>H</b>	Little debonding Little exposure of voids and coarse aggregate
<b>Control Section</b>	Little wear Chipping at edges Some exposure of coarse aggregate at edges
<b>Spalls</b>	
<b>Spall #1</b>	<b>Distress Description After 420,000 Repetitions</b>
<b>Material G</b>	Little Wear Little chipping at edge
<b>Spall #2</b>	<b>Distress Description After 400,000 Repetitions</b>
<b>Material B</b>	Some exposure of fine aggregate

**FIGURE 10. Distress Location of Patching Materials**

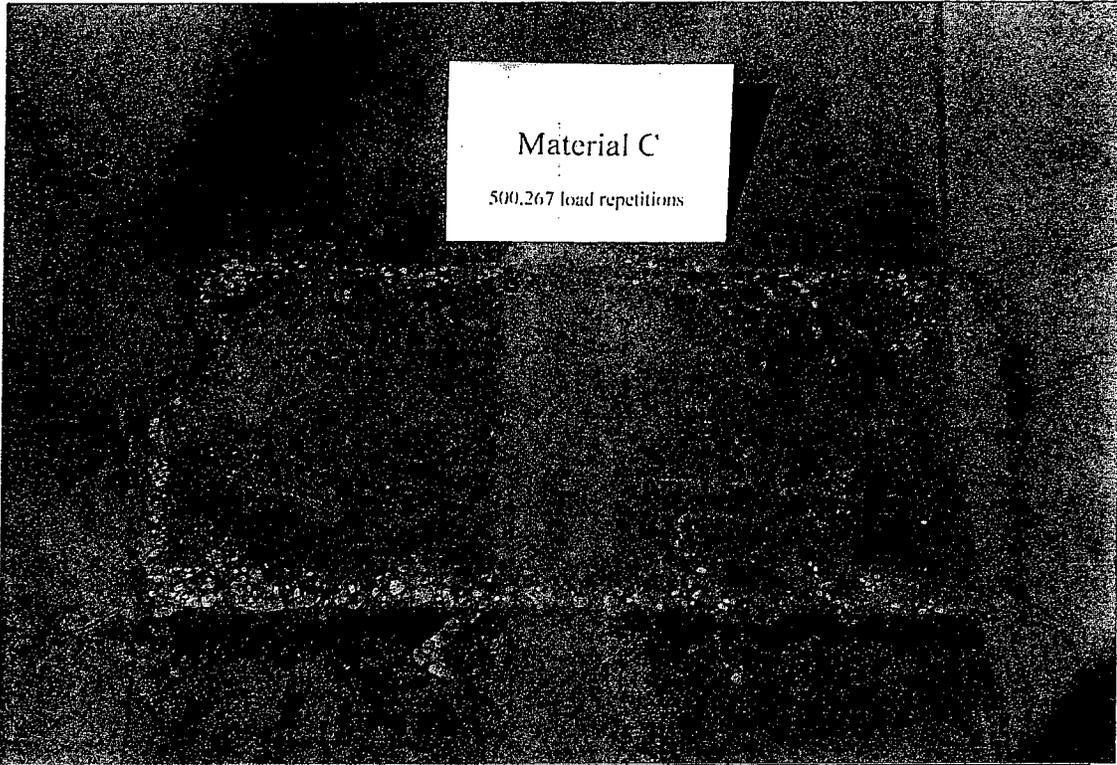
**PHOTOGRAPH 46. Material C at 500,267 Repetitions (Patch No. 14)**
