**EVALUATION OF PATCHING MATERIALS AND PLACEMENT  
TECHNIQUES FOR RIGID PAVEMENTS AND BRIDGE DECKS**

**FINAL REPORT**

**Florida Department of Transportation  
(BB452-WPI 0510861)**

**Department of Civil and Environmental Engineering  
University of Central Florida  
Orlando, FL 32816-2450**

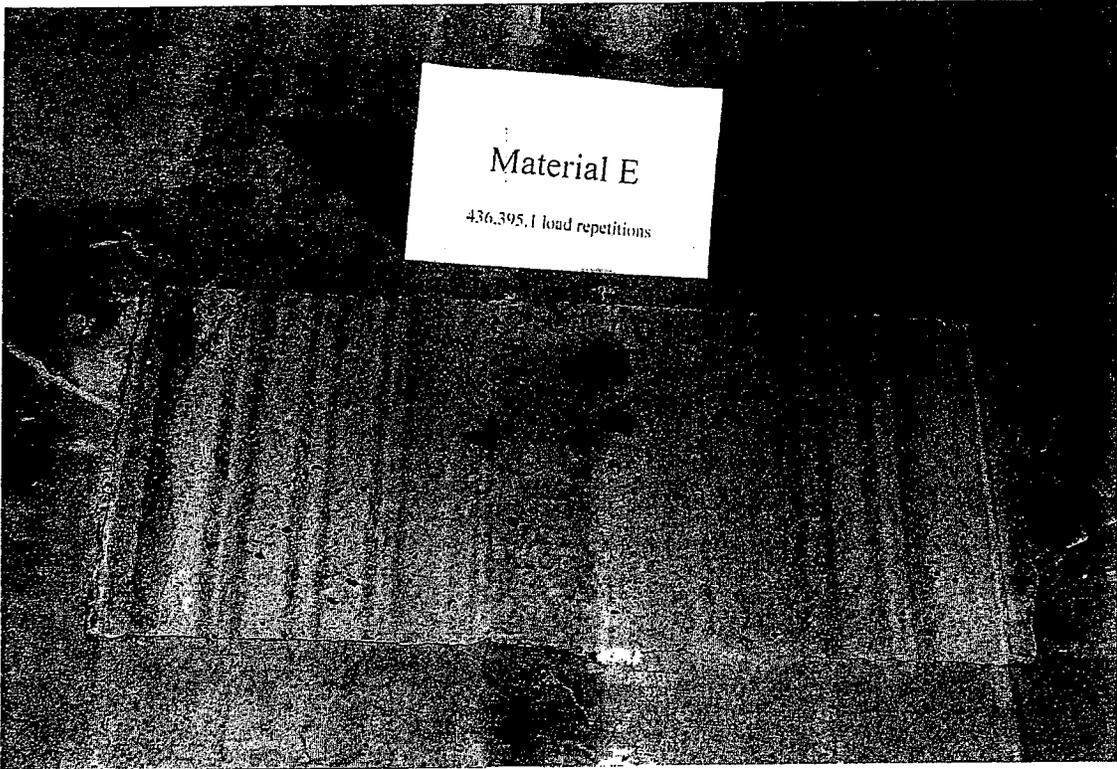
**PHOTOGRAPH 50. Material E at 436,395 Repetitions (Patch No. 1)**

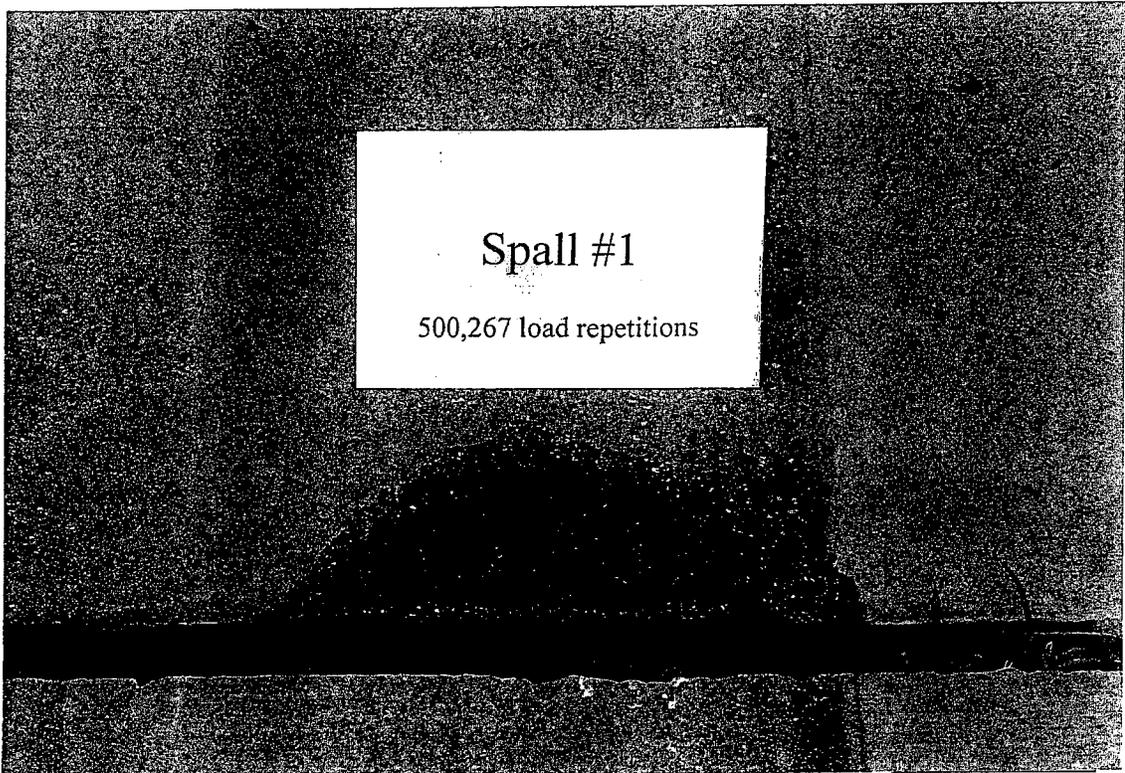
**PHOTOGRAPH 56. Spall #1 at 500,267 Repetitions**

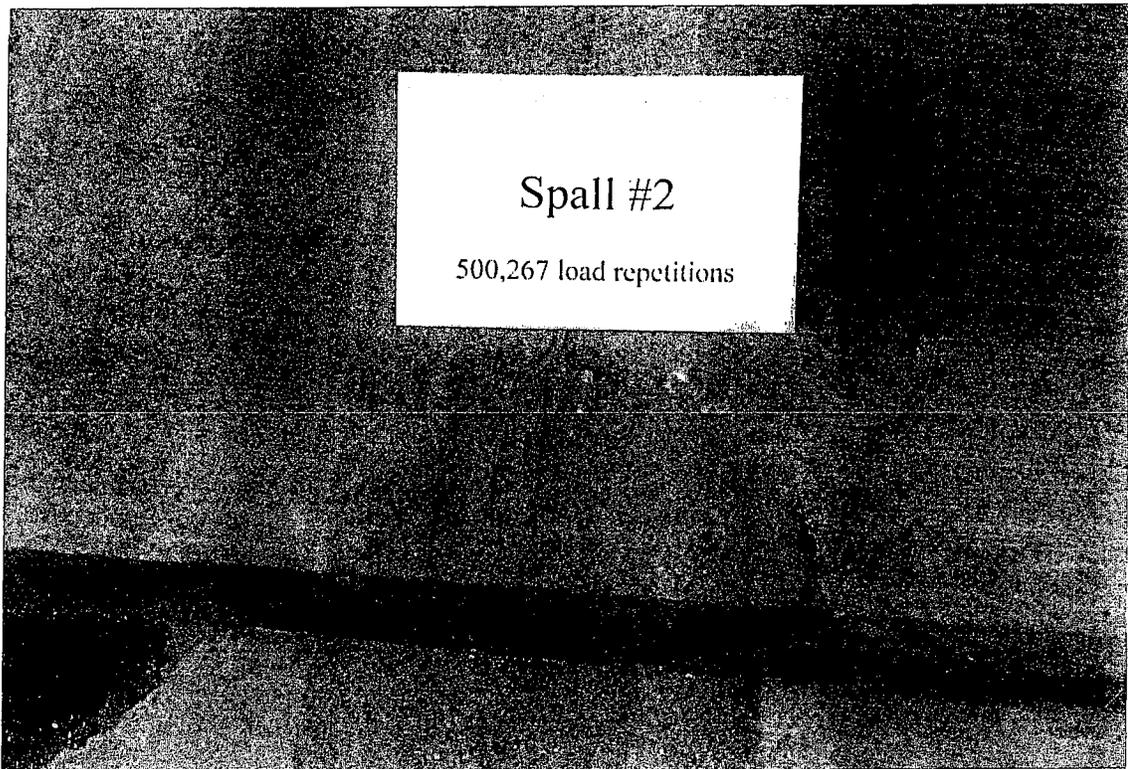
**PHOTOGRAPH 57. Spall #2 at 500,267 Repetitions**
