U.S. Department
of Transportation
**Federal Transit
Administration**

Advanced Technology Transit Bus

Final Test Report for the ATTB Prototypes

September 1999

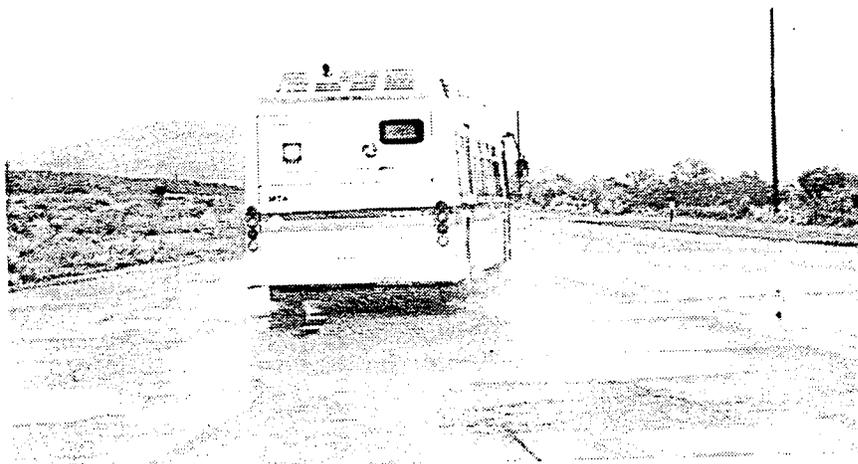
FIGURE 3.4. ATTB TESTING IN RAIN AT PHOENIX

Inclement weather conditions were encountered during testing at Phoenix (see Figure 3.4) and Altoona, and during the Operational and Road testing (reported on later). Windshield wiper operation during rain and snow conditions was deemed satisfactory. Operator comments, observations and reliability data collected documented compliance with the requirements of Table 3.4.

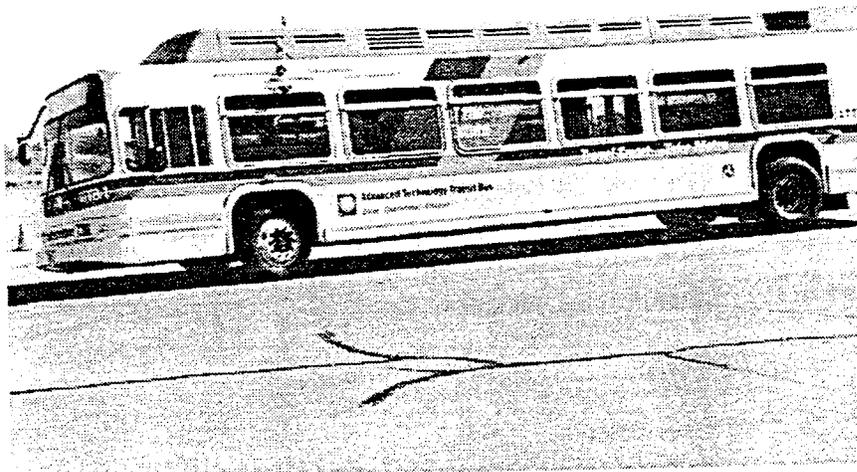
FIGURE 6.5-2. ATTB-1 PERFORMING U-TURN

A course was laid out as shown in Figure 6.5-1 on the 10-acre FaAA skid pad. At GVWR the ATTB was driven in both directions into the course performing a U-Turn maneuver at speeds of 10, 20 and 30 mph. Table 6.5 lists the results of this test and video was recorded to further document this test. Figure 6.5-2 shows ATTB-1 on one of U-Turn test runs.
