FINAL REPORT

LOAD RESPONSE INSTRUMENTATION OF SHRP PAVEMENTS -
THE UNIVERSITY OF CINCINNATI

Andrew Bodocsi, Ph.D., P.E.
and
Mark T. Bowers, Ph.D., P.E.

May 2001
University of Cincinnati
Cincinnati, Ohio

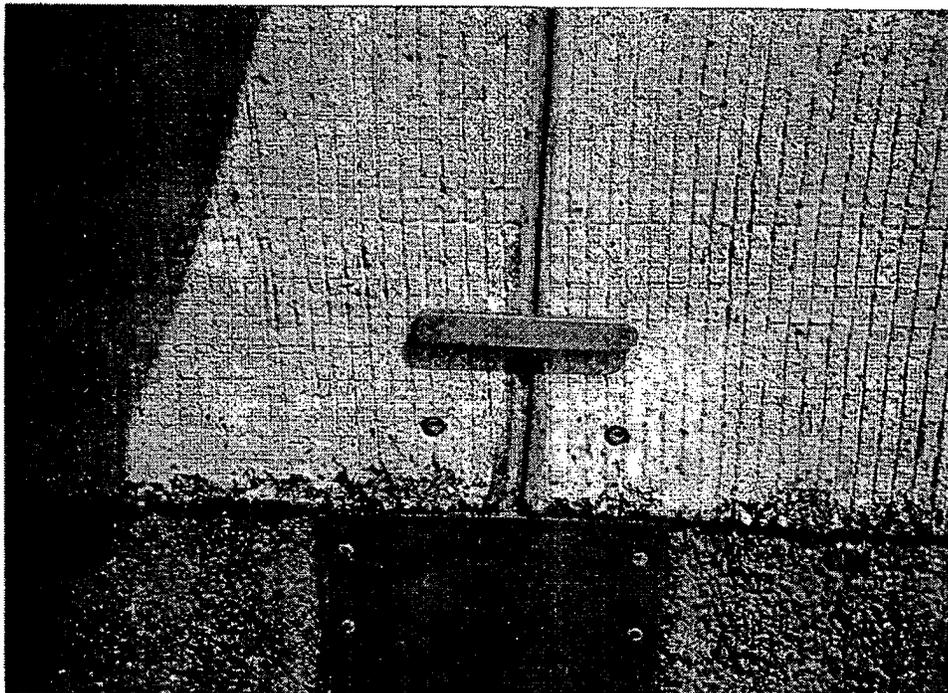
The hand-held micrometer could be adjusted to fit its 45 degree conical probes perfectly into the conical depressions of the brass plugs. The micrometer had a stainless steel body with a stainless steel sliding bar, each equipped with the aforementioned stainless steel conical probe. The micrometer had a range of six inches plus

Fig. 18. Brass Plugs and Invar Calibration Bar

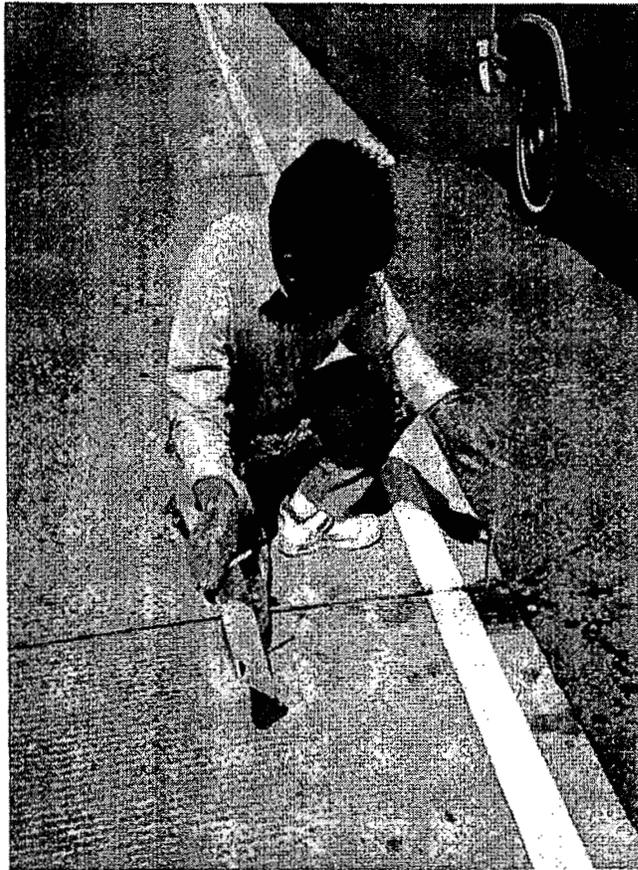
On each occasion that joint movement measurements were made, the temperature of the air and pavement were taken at frequent intervals. The temperature of the pavement was measured in a one inch diameter by five inches deep hole which was filled with oil. After waiting for the oil to assume the temperature of the pavement, the temperature readings were initiated. A regular laboratory-type glass thermometer was used (see Figure 19). For joint movement readings which did not coincide with a temperature reading, interpolation of temperatures was used. The air temperature was measured in the shade, approximately one foot above the pavement. Figures 11 through 16 give a graphic representation of the variation in temperatures, both pavement and air, during the days when joint measurements were made.

Fig. 19. Pavement Temperature Measurements
