RESEARCH INVESTIGATION RI97-021

**PRECAST I-GIRDER CRACKING: CAUSES AND DESIGN DETAILS**

PREPARED FOR THE  
MISSOURI DEPARTMENT OF TRANSPORTATION

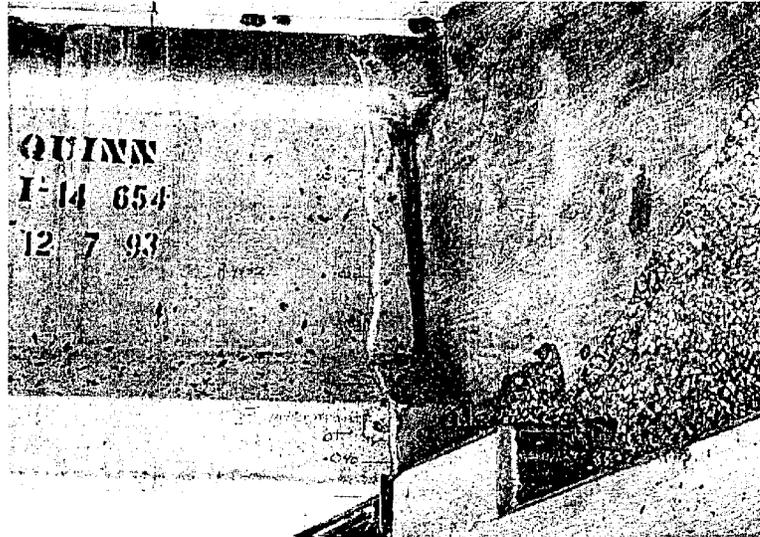
**Figure 1.1 Vertical Crack in the Girder-end at the Diaphragm**

The cracks observed in the girders were of three main types: vertical cracks (Figures 1.1 through 1.3), diagonal shear cracks (Figure 1.3), and reverse diagonal cracks (in a direction perpendicular to typical shear cracks, Figure 1.4). The vertical cracks are accompanied in some cases with damage to the diaphragm (Figures 1.1 and 1.2), suggesting that the girders are pulling out from the diaphragm (or in some instances

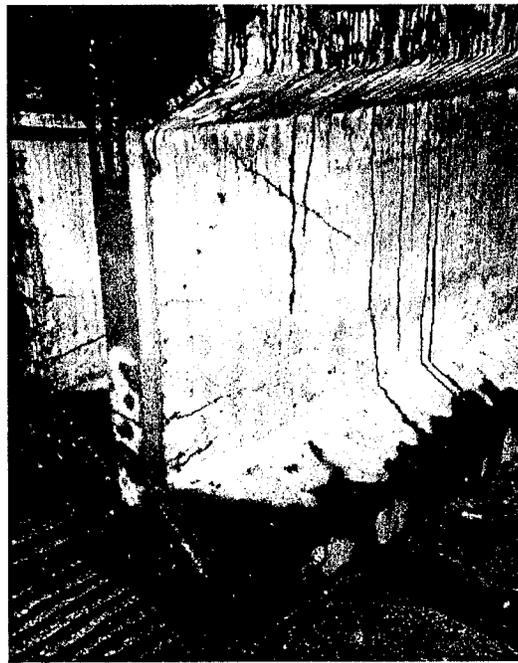
**a:** girder embedded in a diaphragm

**b:** just fabricated girder stored at the precasting yard

**Figure 1.4 Web Cracking in the “Reverse Shear Direction”**

pushing into the diaphragm). Reverse diagonal cracking was also observed in girders after casting, but before placement on the bridge, suggesting that they may be due to early-age behavior of the girder. Other types of early-age cracking in the girder included horizontal cracks in the girder web near the junction between the bottom flange and the web (Figure 1.4b). This type of cracking may not be readily visible after construction of the bridge, as the girder-ends are embedded in the diaphragm.

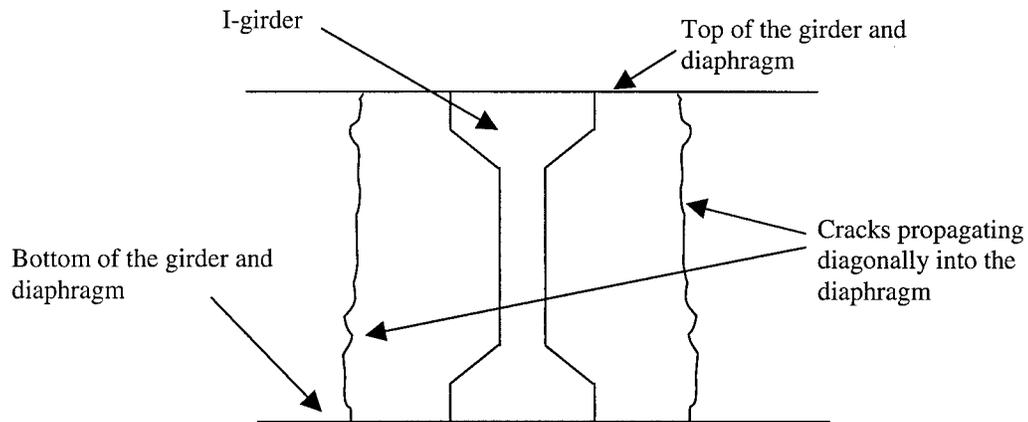
**Figure 1.5 Typical Failure of the Continuity Connection**

Salmons’ specimens modeled a girder-diaphragm interface; some modeled only the girder-diaphragm interface while others modeled the girder-diaphragm-deck interface. Both types of specimens exhibited the type of cracking illustrated in Figures 1.5 and 1.6 at failure. Figure 1.5 illustrates a cross-sectional view of the I-girder and diaphragm interface, while Figure 1.6 illustrates this same section in plan view. This is precisely the type of cracking that has been exhibited at several of the PC I-girder bridges in this study. Additionally, this type of cracking configuration could pose a long-term durability concern if it were to result in the propagation of a crack parallel to the bent line on the surface of the deck.

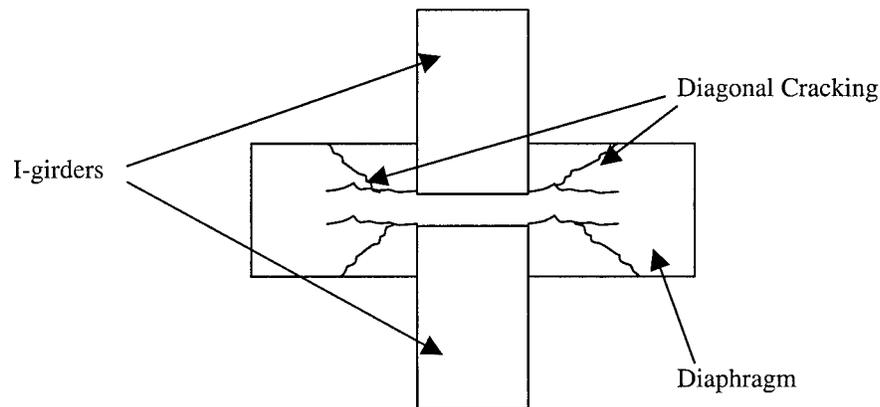
**Figure 1.6 Plan View of the Same Typical Failure**

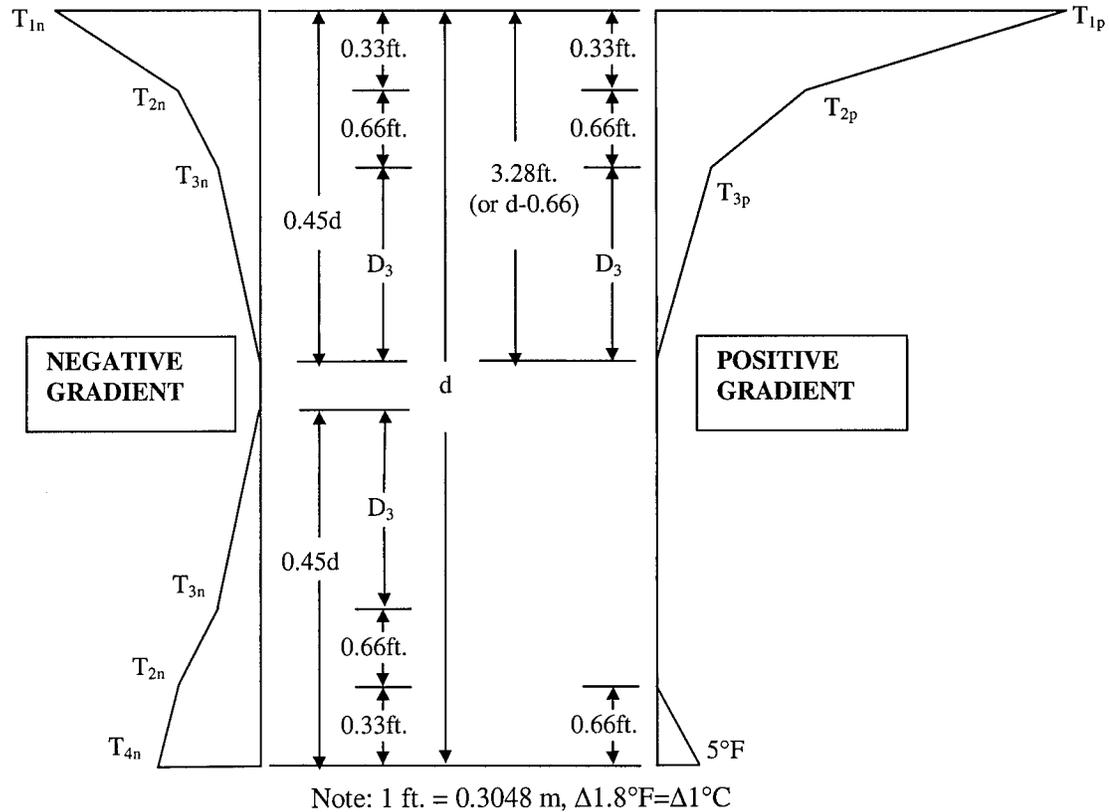
**Figure 1.7 AASHTO Recommended Thermal Gradients (1989)**

It should be noted that the AASHTO (1989) thermal gradient is the “benchmark” gradient for this study to which the measured gradient will be compared. These gradients were used due to the fact that this gradient is a published and recommended thermal gradient for design of bridges in the U.S. Additionally, as will be discussed Section 7, these gradients have been validated for the climatic conditions in the State of Missouri.

It may be noted that the AASHTO recommended positive gradient is a function of the depth of the bridge. (Recall Figure 1.7.) For both bridges, there is good correlation between the measured and recommended gradients, although it may be noted in Figure 7.5 that the AASHTO gradient is slightly unconservative compared to the temperatures measured in the field.

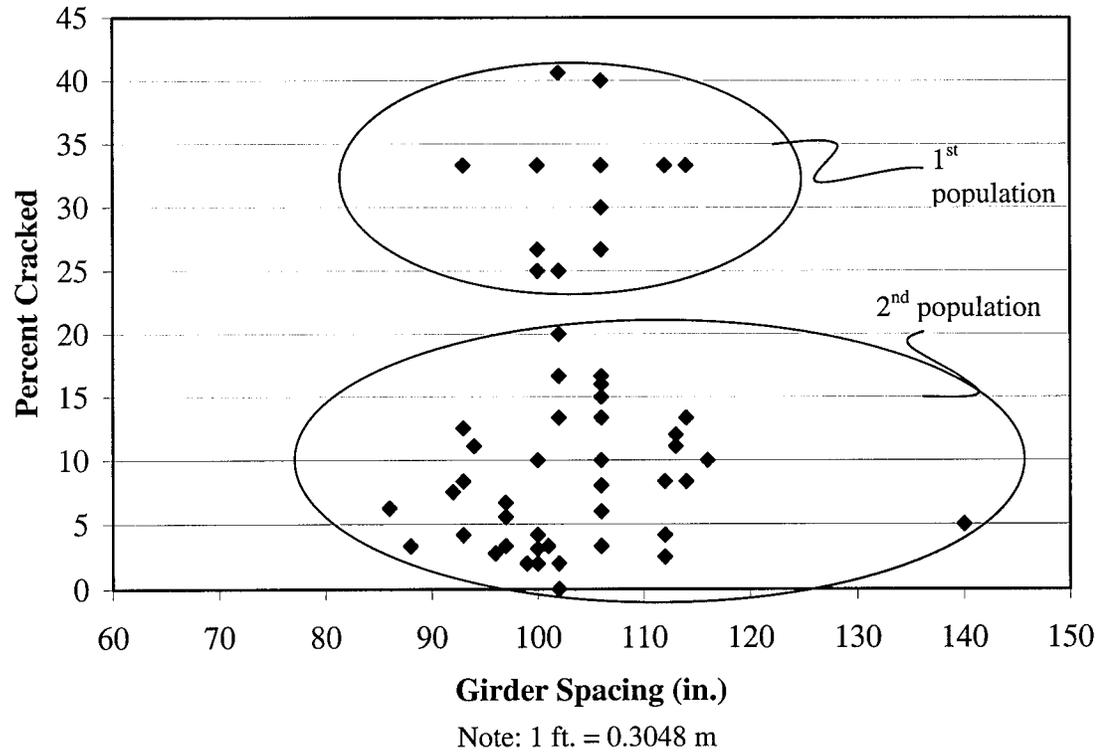
**Figure 3.1 Percentage of Girder Ends Cracked vs. Girder Spacing**

Figure 3.1 seems to illustrate the two populations the most clearly, with the data split approximately between the 20 and 25 percent lines. The researchers were not able to prove or disprove this assumption due to the fact that the means of crack inspection was not reported in the preliminary database provided by MoDOT.

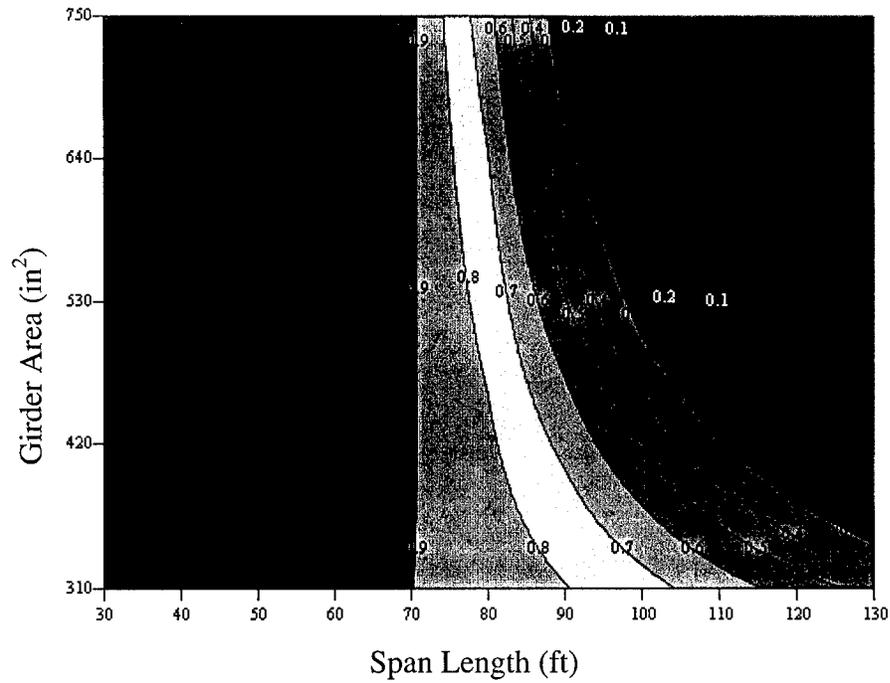
Figure 3.2 Contour Plot for Chert Aggregate and Non-interstate Highways

Recall that ‘aggzone’ equal to zero represents the presence of chert aggregate and ‘aggzone’ equal to one represents the presence of non-chert aggregate. Additionally, ‘rt1’ equal to zero represents a non-interstate highway and ‘rt1’ equal to one represents an interstate highway. The contour plots provided in Figures 3.2 through 3.5 were created for these four possible combinations of variables, respectively, and illustrate the probability of cracking as a function of girder area and span length.

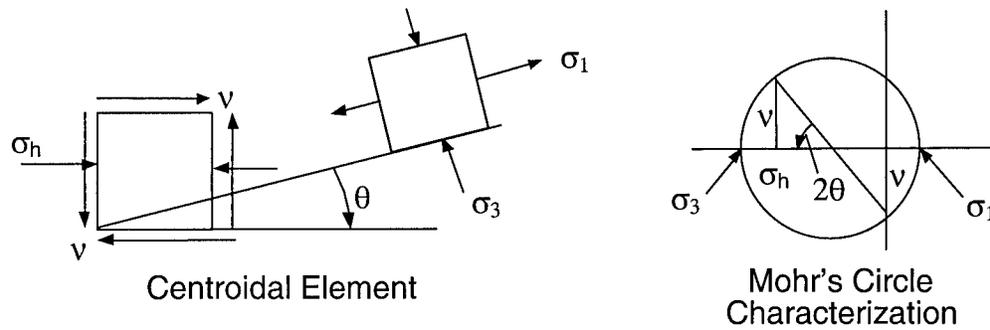
**Figure 4.4 Element at Girder Centroid and Mohr's Circle Characterization of This Stress State**

Figure 4.4 shows the stress state of the element and its Mohr's circle representation.

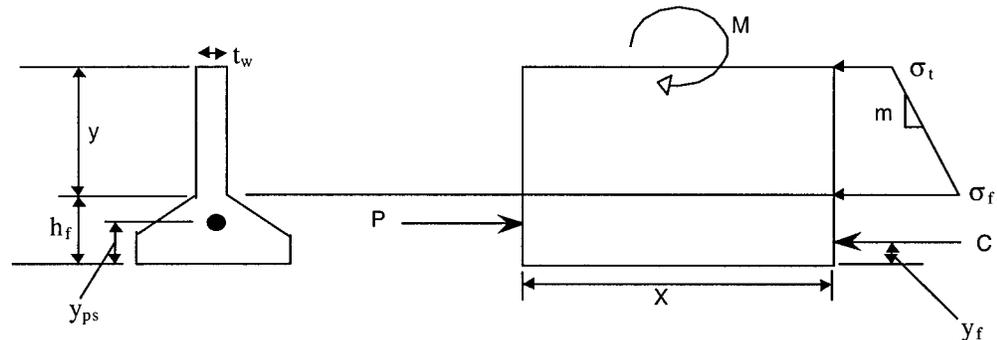
**Figure 5.2 Modified Gergely - Sozen Model**

available, it was possible to evaluate the Gergely - Sozen recommendation for girder length to be considered.

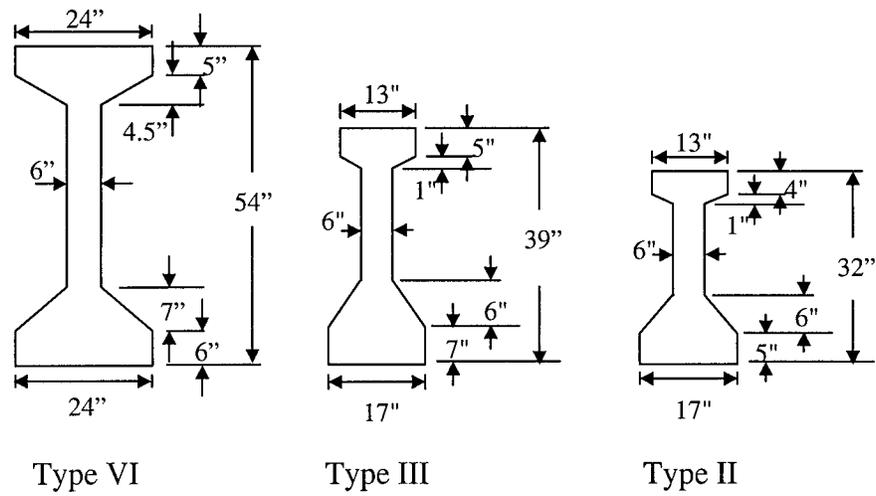
**Figure 5.5 Dimensions of MoDOT Girder Types Used in the Finite Element Models**

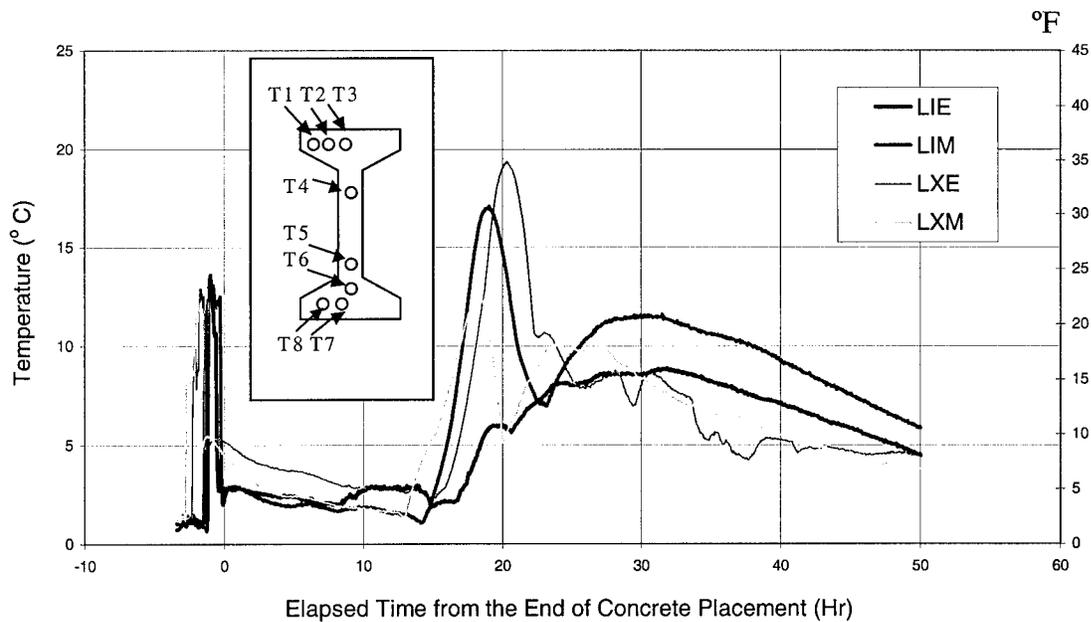
NOTE: (Data from UMC for HPC Girders (Eatherton, 1999, and Gopalaratnam and Eatherton 2001)). Inset legend: L: Long girder, I: Interior girder, X: Exterior girder, E: Cross-section near end, M: Cross-section at midspan.  $\Delta 1 \text{ }^\circ\text{F} = \Delta 1.8 \text{ }^\circ\text{C}$

Figure 5.7 shows the experimentally measured temperature difference for four HPC girder cross-sections. The values plotted are the absolute maximum difference in temperature among eight thermocouples (locations shown in the inset to the figure) at each of two cross sections in the two (of the four) instrumented girders: one cross-section at midspan, and one at the end. Figure 5.8 shows the temperature development and the maximum difference observed between the top and bottom thermocouples of the NSC girders using data collected by MoDOT (Chojnacki, 1999). Thermal gradients measured experimentally from the NSC girders were extrapolated linearly to the total depth of the girder. This was necessary because of differences in the location of temperature measurements between the HPC and NSC girders (see insets in Figures 5.7 and 5.8).

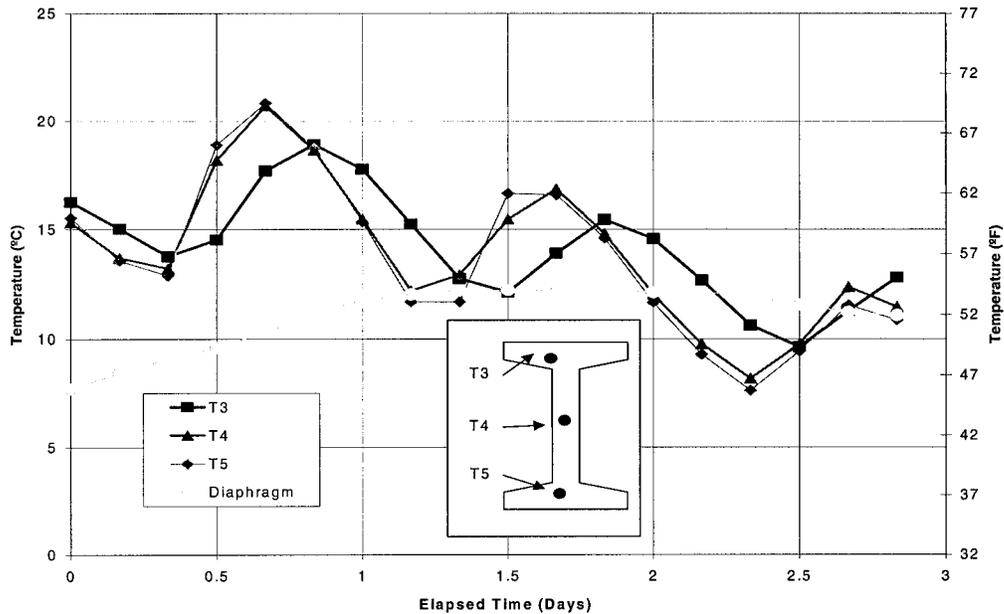
**Figure 6.1 Daily Temperature Variations at Various Locations in the Girder and The Diaphragm During a 3-Day Cooling Period in Spring**

shortening of the girder. In bridges that are constructed during the summer, when temperatures are near their highest, the girders are likely to have their longest lengths. If, during this time, the girder-ends are built into the diaphragm, they will be restrained from shortening during cooling. This will cause tensile stresses to develop in the end regions.

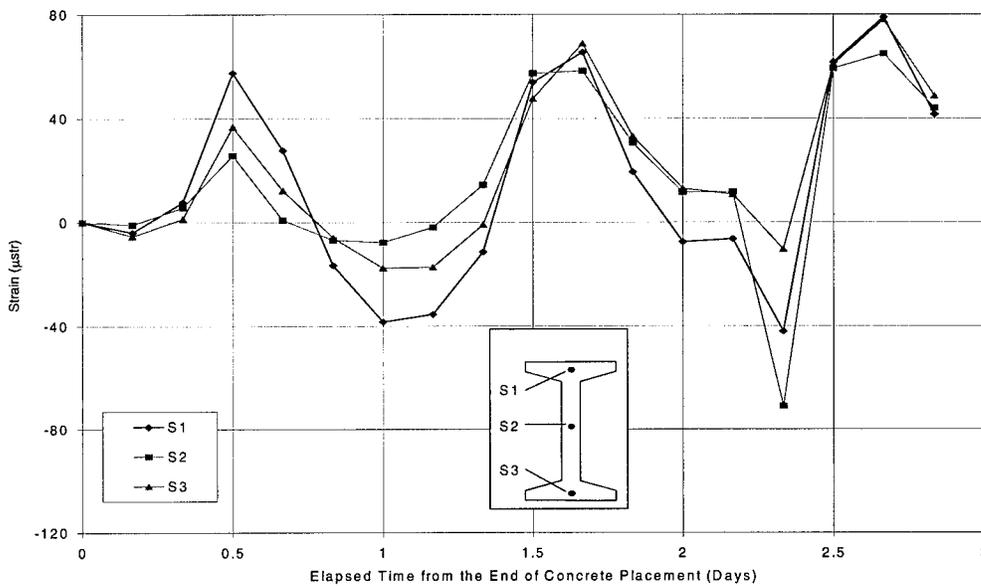
**Figure 6.2 Variations in Girder Strains During the Period Corresponding to Figure 6.1**

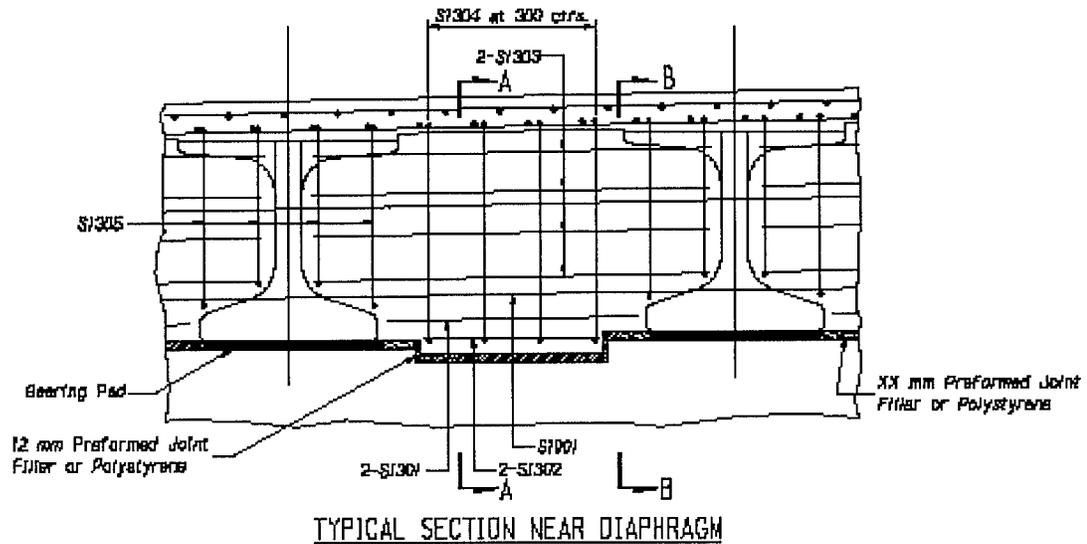
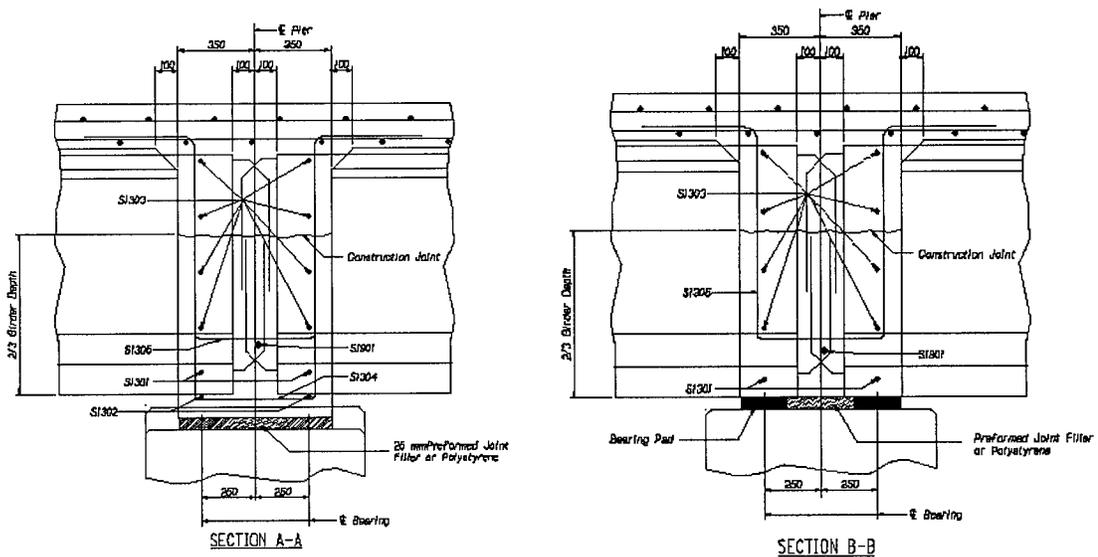
Note (1) polystyrene pad separating diaphragm from bent beam, (2) construction joint at  $\frac{2}{3}$  of the diaphragm height, and (3) sawed-off top flange at girder-ends.

State	Design detail comments
Alabama	<ul style="list-style-type: none"> <li>• Discontinued use of diaphragms</li> <li>• Uses open expansion joints over bents</li> <li>• Does not use deicing salts</li> </ul>
Florida	<ul style="list-style-type: none"> <li>• Discontinued use of diaphragms</li> <li>• Pour slab continuous with preformed crack over bents</li> <li>• Does not use deicing salts</li> </ul>
Georgia	<ul style="list-style-type: none"> <li>• Discontinued use of diaphragms</li> <li>• Pour slab continuous with preformed crack over bents</li> <li>• Does not use deicing salts</li> </ul>
Illinois	<ul style="list-style-type: none"> <li>• Place bond breaker between sides of girder and diaphragm</li> <li>• Leave gap between diaphragm and bent cap</li> </ul>
Nebraska	<ul style="list-style-type: none"> <li>• Uses expansion material to isolate diaphragm from bent cap</li> <li>• Places construction joint in diaphragm at 2/3 height</li> <li>• Top flanges of girders sawed-off within diaphragm</li> </ul>

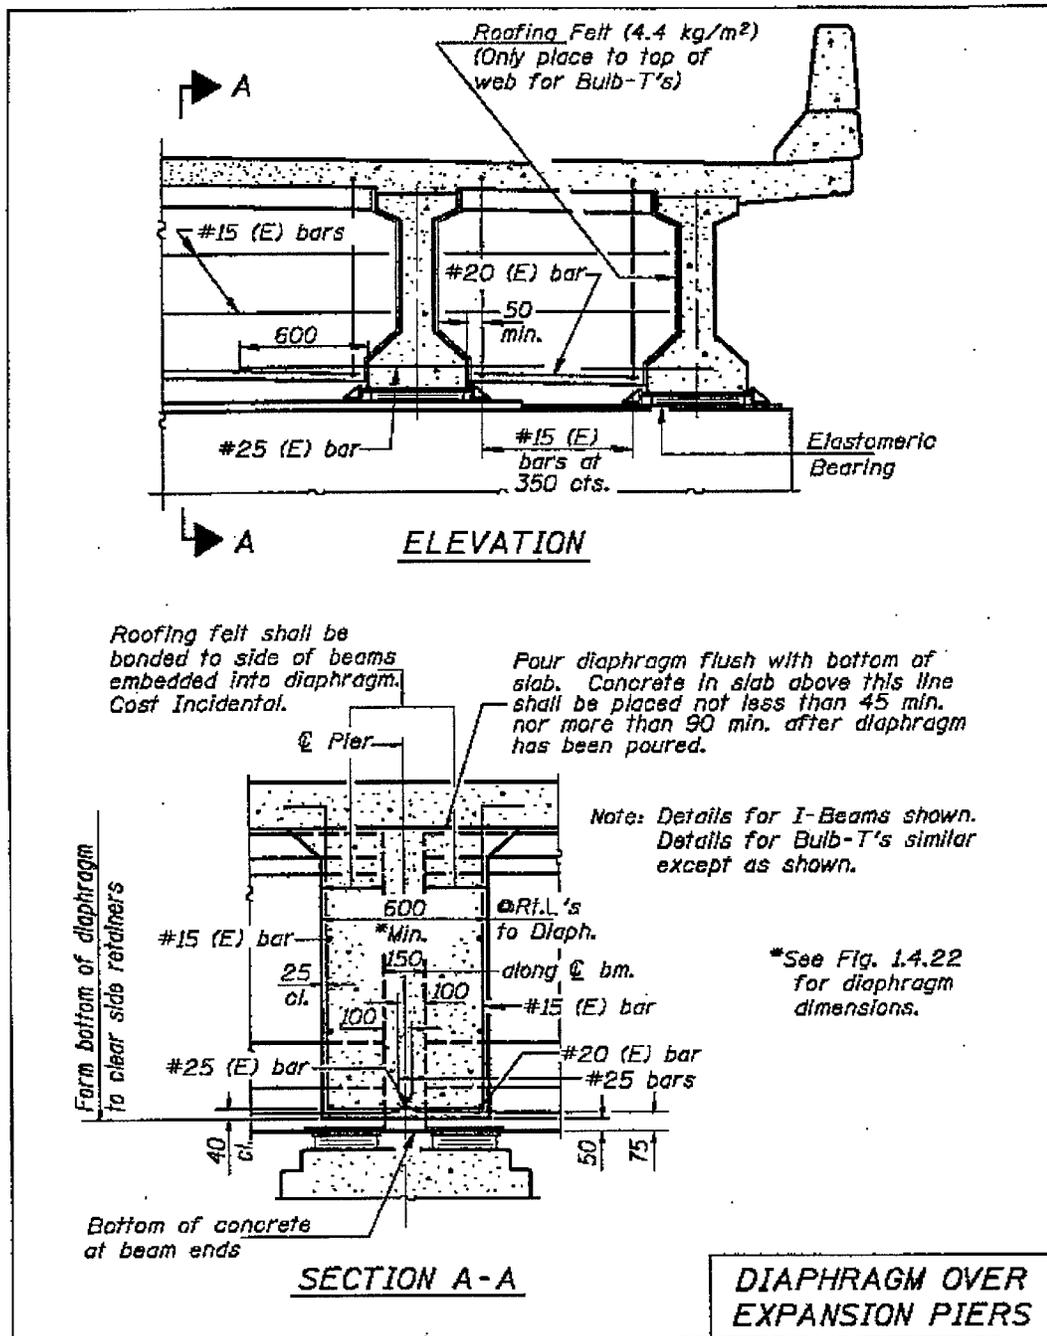
NOTE: 1) Open space between diaphragm and bent beam, and 2) Use of roofing felt as bond breaker on sides of girders

**6.3.4 Florida and Georgia.** Florida and Georgia Departments of Transportation too have encountered cracking due to thermal gradients, creep and shrinkage in prestressed I-girder bridges made continuous at the bents (Conway, 1999). The solution implemented was to eliminate the diaphragm, but continue to pour the slab continuously over the whole bridge. In order to allow for the movement that occurs in the slab with such a design, a crack is preformed in the deck over the bents by placing a thin layer of expansion material through the thickness of the slab. This design may not be adequate in Missouri, however, due to use of deicing salts and snowplows unlike in these southern states.

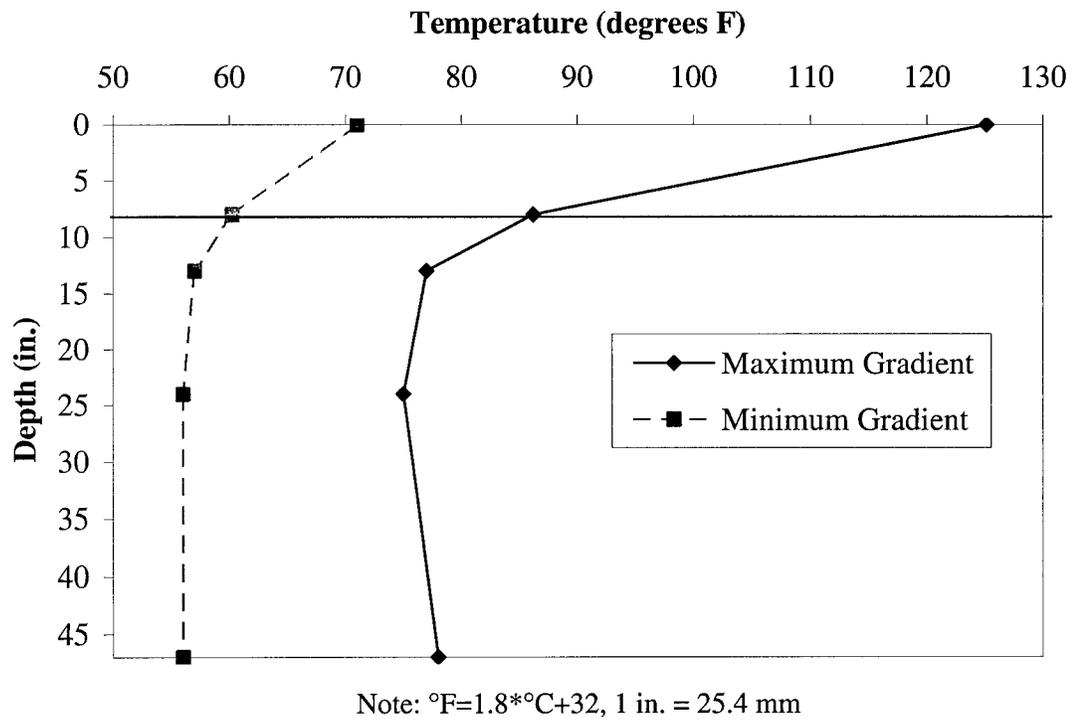
Figure 7.3 Maximum and Minimum Temperature Profiles, Bridge A4565

In Figure 7.3, the maximum and minimum profiles, corresponding to a difference between the temperatures at the top and bottom of the deck, are 39°F (21.7°C) and 11°F (6.1°C), respectively. For Figure 7.4, these values are 28°F (15.6°C) and 7°F (3.9°C). Again, these two figures illustrate the trend of a relatively large gradient through the deck, with a smaller gradient occurring through the depth of the girders.

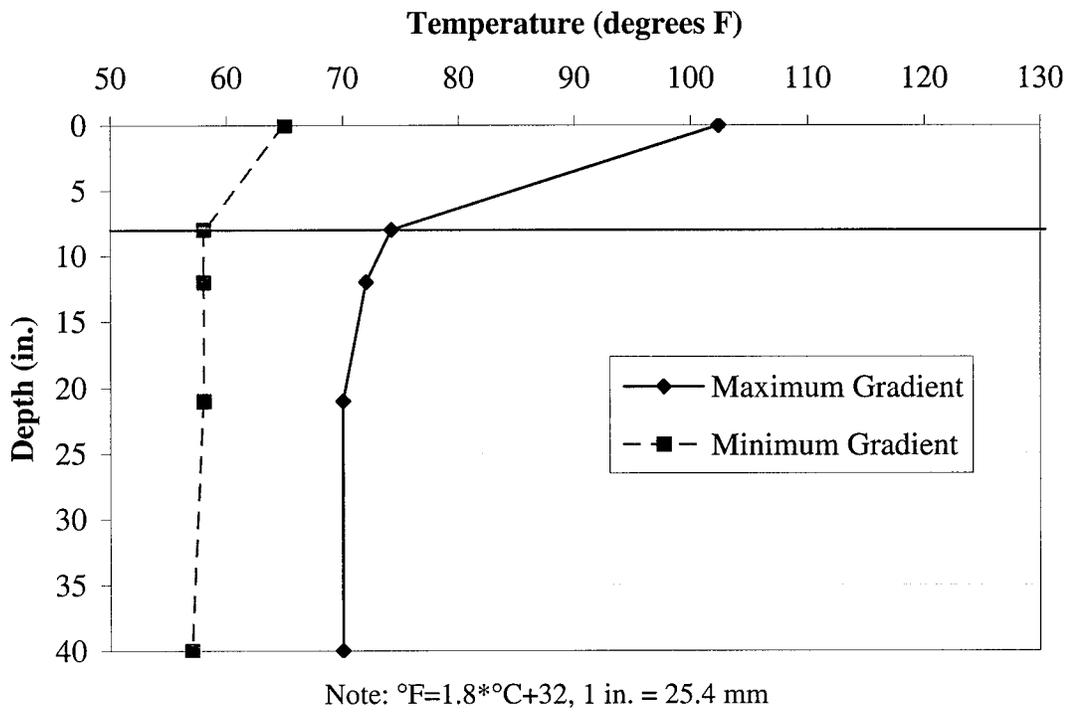
Figure 7.4 Maximum and Minimum Temperature Profiles, Bridge A5736

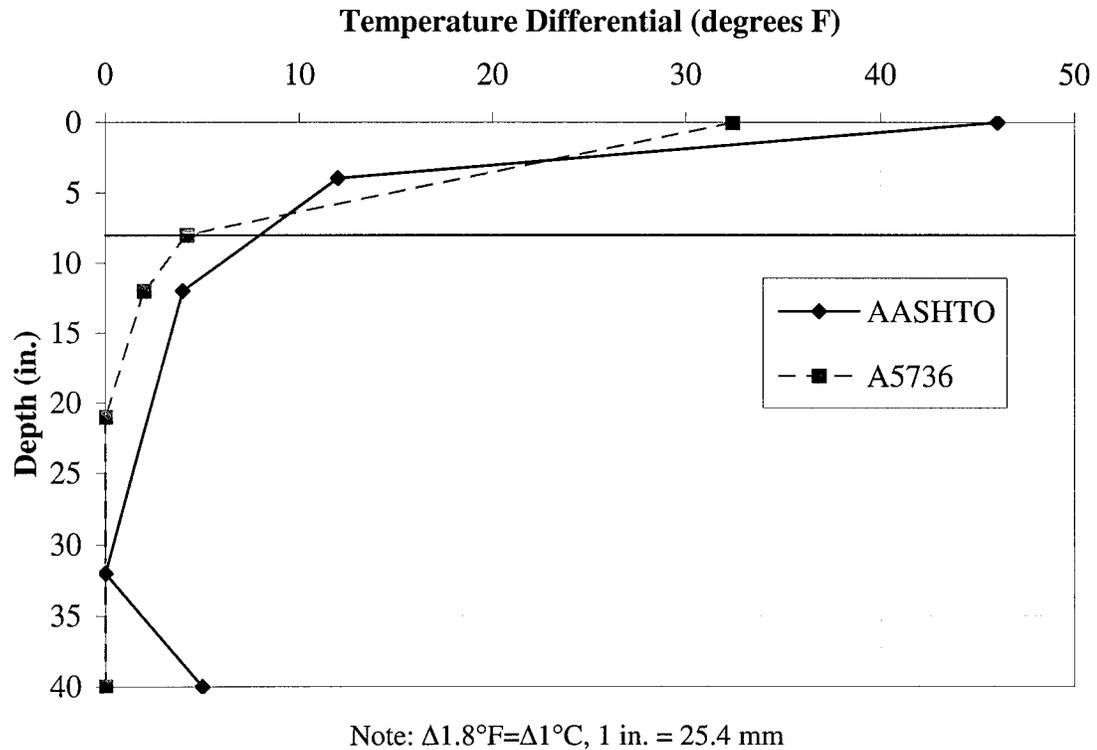
**Figure 7.6 Comparison of AASHTO Positive and Bridge A5736 Gradients**

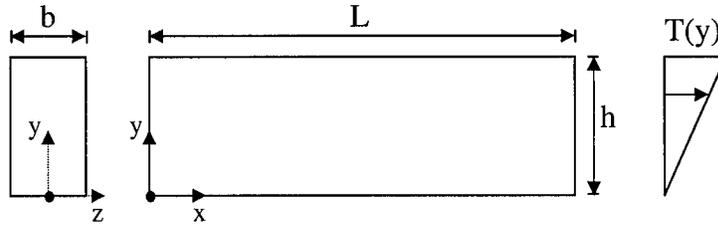
**Figure 8.1 Cross Section and Side View of Rectangular Member**

The following conditions assume a cross section and side view of the member as outlined in Figure 8.1. Additionally, the temperature distribution is one-dimensional, that is, it varied only with depth, “y”. It may also be noted that a positive stress denotes tension, while a negative stress denotes compression.

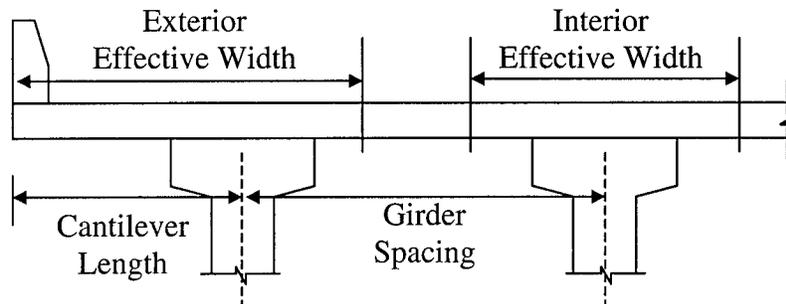
**Figure 8.11 Effective Flange Width Detail**

The exterior effective flange width shall be the smaller of the value calculated from Equation 8.7 and the interior effective flange width.

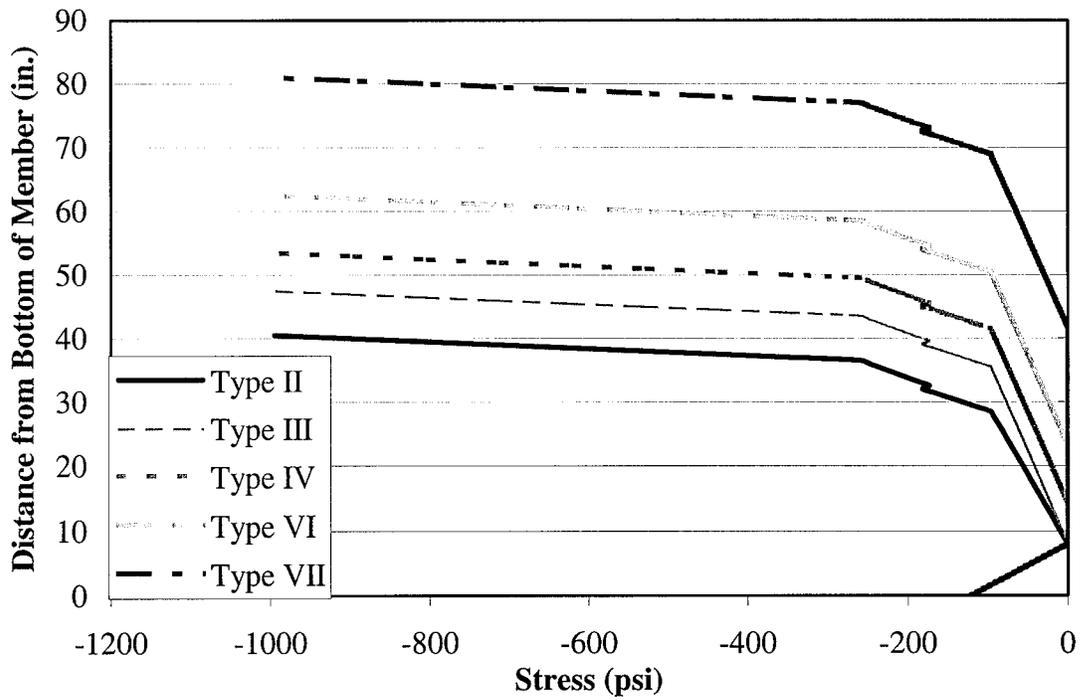
Figure 8.17 Thermal Stresses – Fully Restrained – Positive Gradient

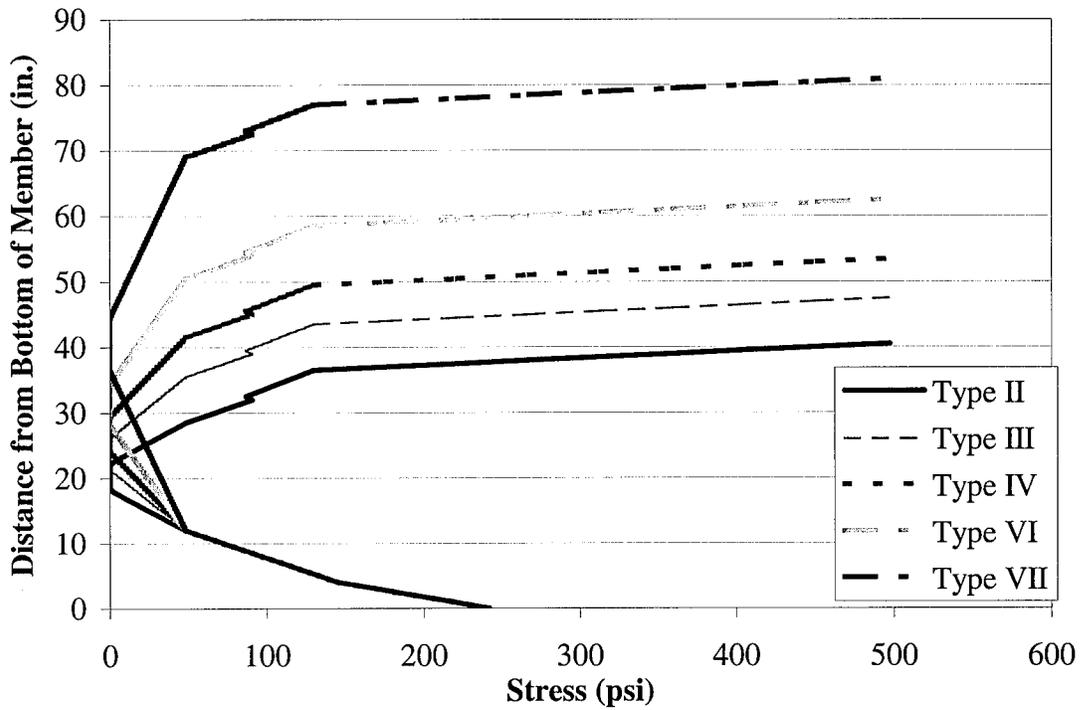
Figure 8.18 Thermal Stresses – Fully Restrained – Negative Gradient

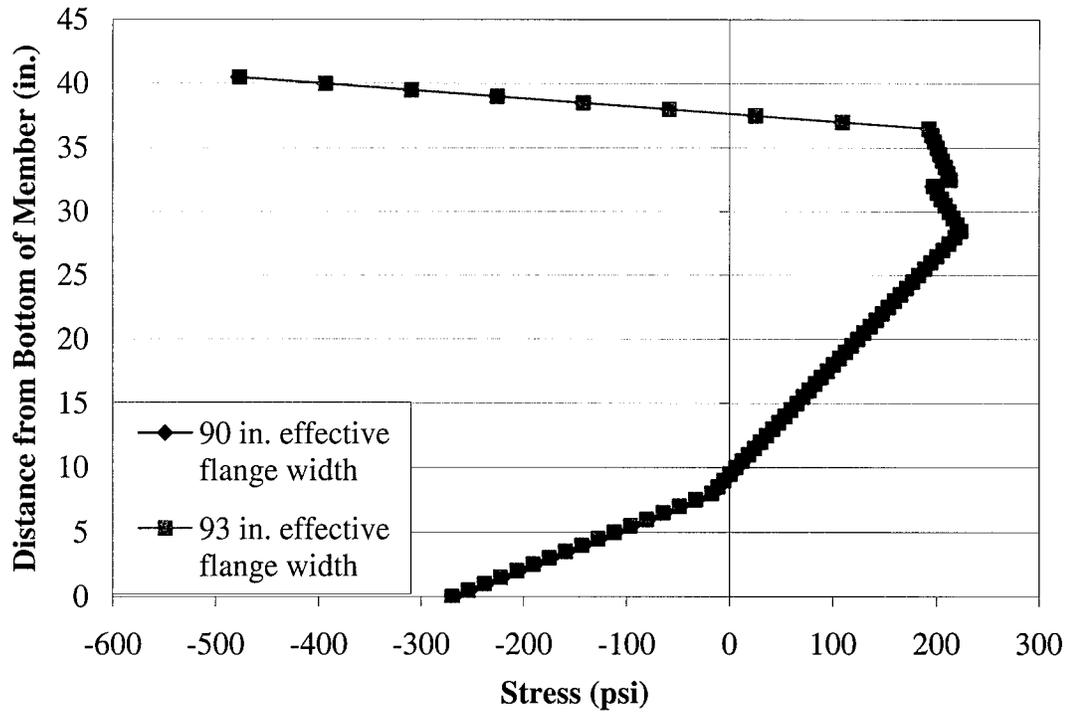
Figure 8.19 Thermal Stresses – Positive Gradient –Girder Type II

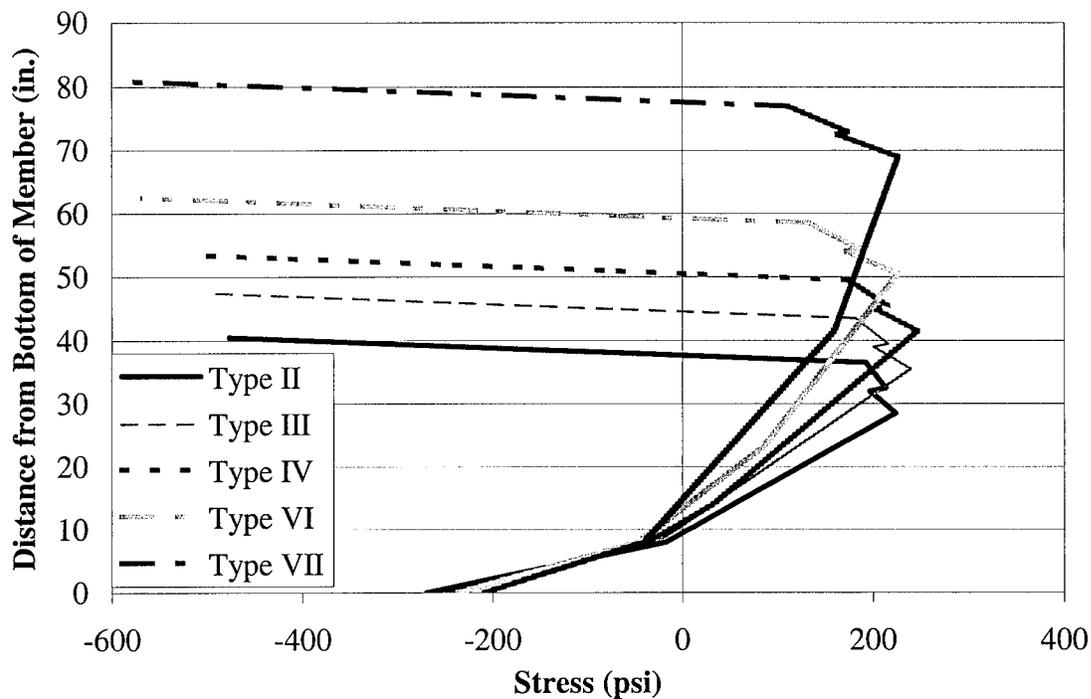
**Figure 8.21 Thermal Stresses – Unrestrained – Positive Gradient**

Based on the fact that the results for the three effective flange width values are virtually identical, the results reported henceforth will be for a 93-in. (2.36-m.) effective flange width. It may also be noted that each girder type was analyzed using an effective flange width of 93 inches (2.36 meters). Figures 8.21 and 8.22 illustrate the thermal stresses for each of the five girder types for the unrestrained condition for the positive and negative thermal gradients, respectively. Additionally, Figures 8.23 through 8.27 illustrate the results for both the positive and negative gradients, and both boundary conditions, by girder type.

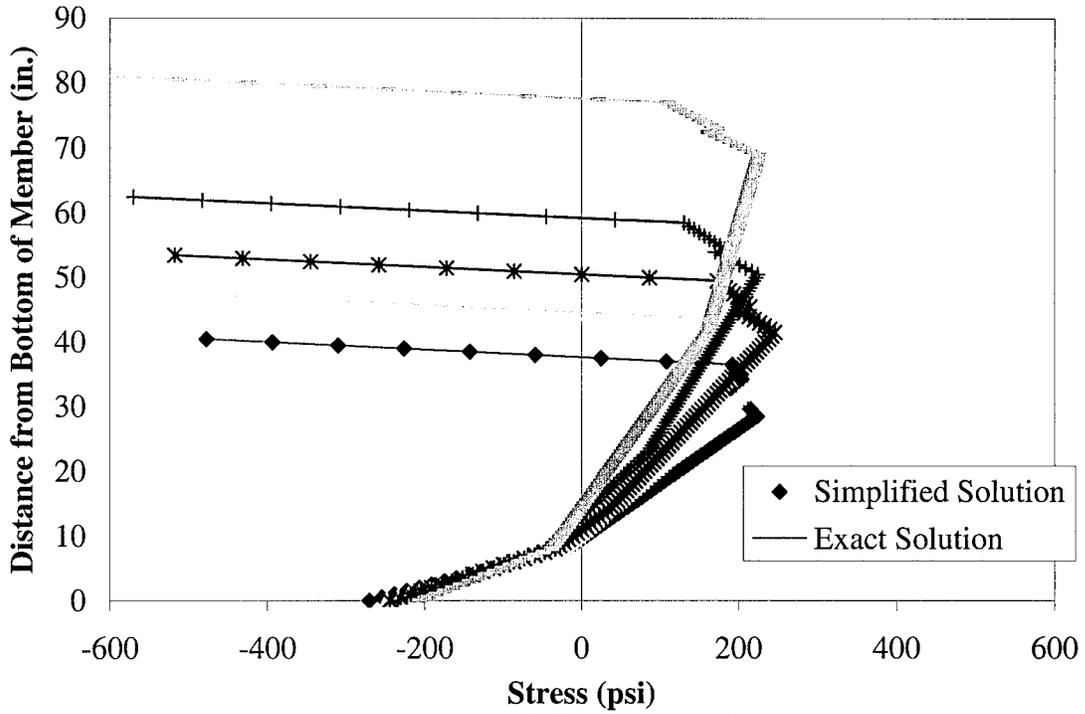
Figure 8.30 Comparison of Results for the Positive Gradient

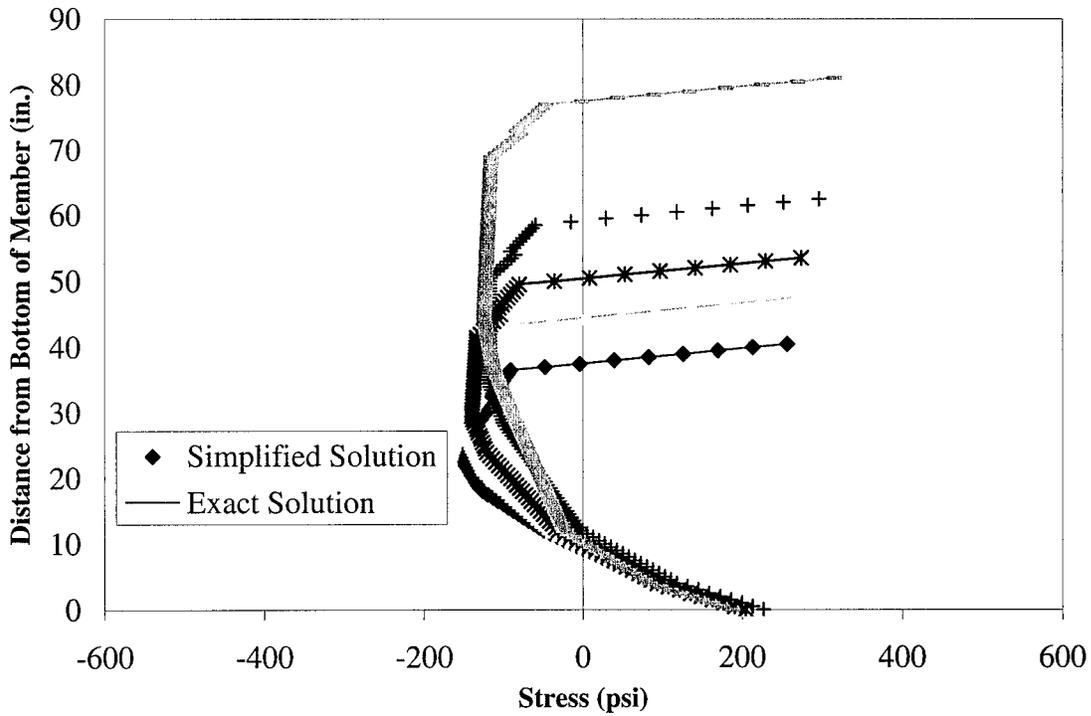
Figure 8.31 Comparison of Results for the Negative Gradient

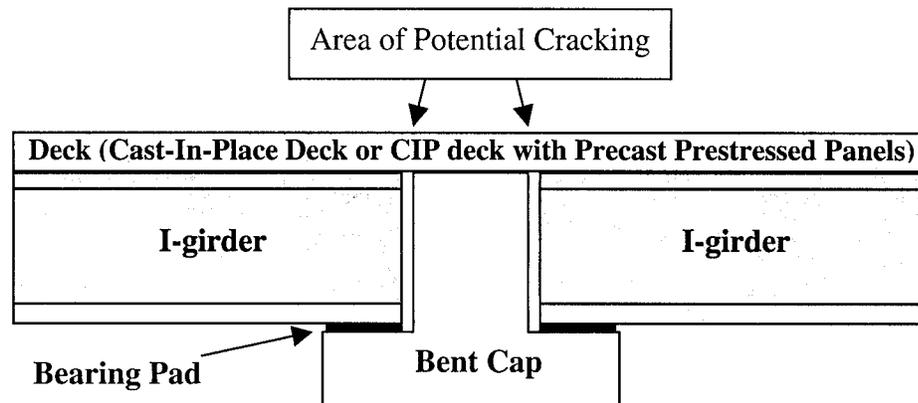
**Figure 10.1 Simple Span Girders with Continuous Deck**

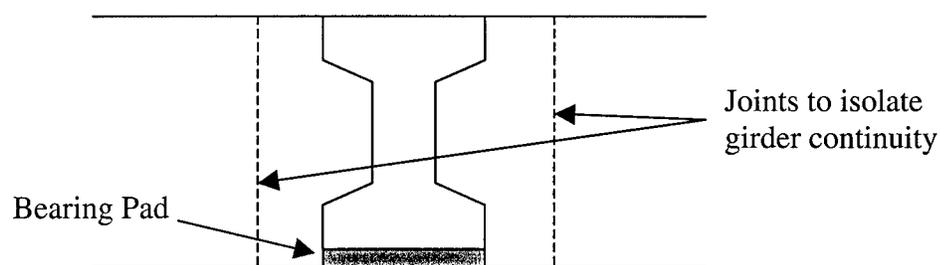
**Figure 10.2 Joint Placement to Isolate Girder Continuity**

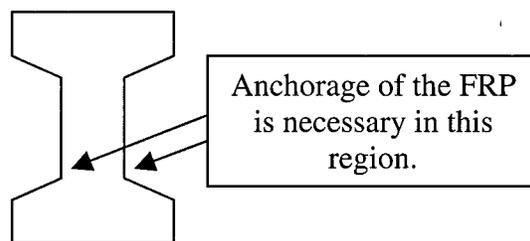
**Figure 10.3 Anchorage Region**

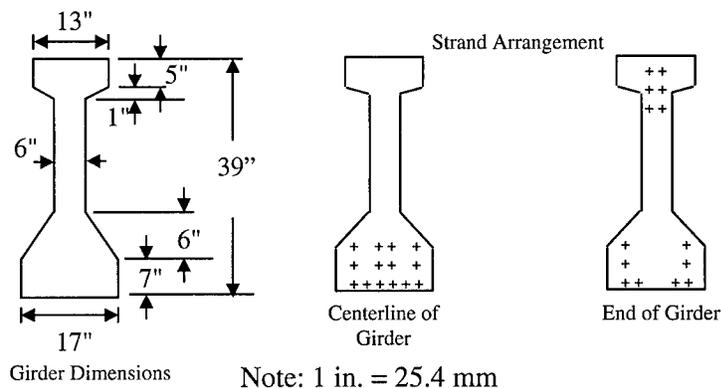
**Figure I.1 Type III Girder Cross Section and Strand Arrangement**

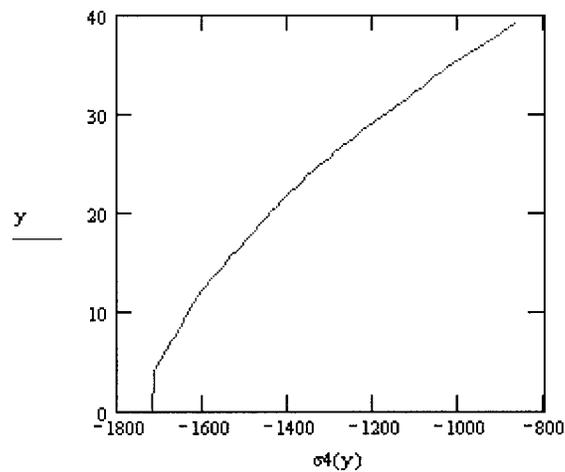
**Figure I.6 Stresses Due to Loading and Negative Thermal Gradient, Unrestrained**

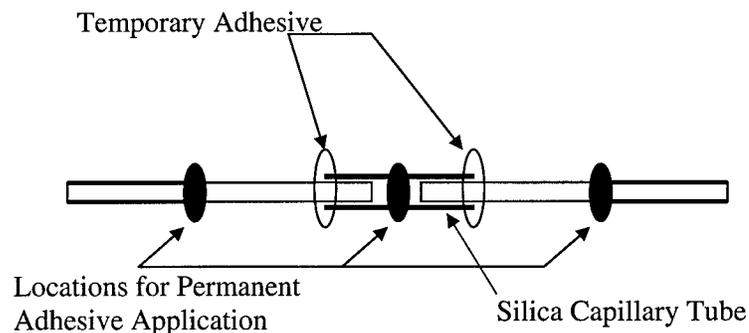
**Figure J.1 Extensometer EFPI Strain Gage**

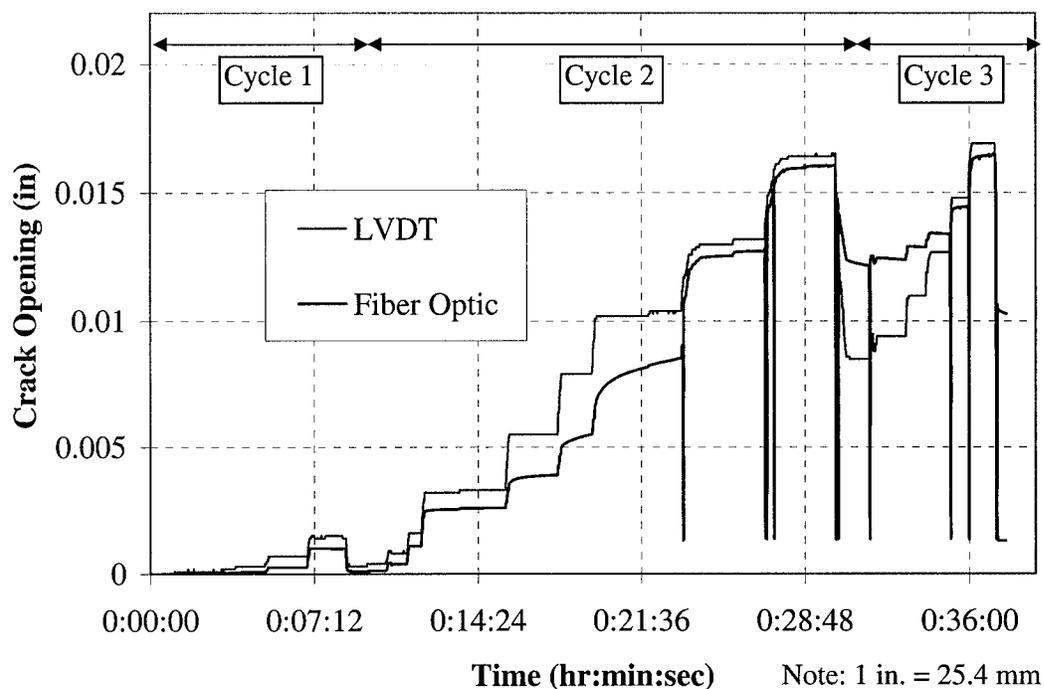
**Figure J.4 Crack Opening Versus Time**
