**Pedestrian Crosswalk Safety:  
Evaluating In-Pavement, Flashing Warning Lights**

**FINAL REPORT**

Peter Boyce, Ph.D. and John Van Derlofske, Ph.D.  
Lighting Research Center  
Rensselaer Polytechnic Institute

March 2002

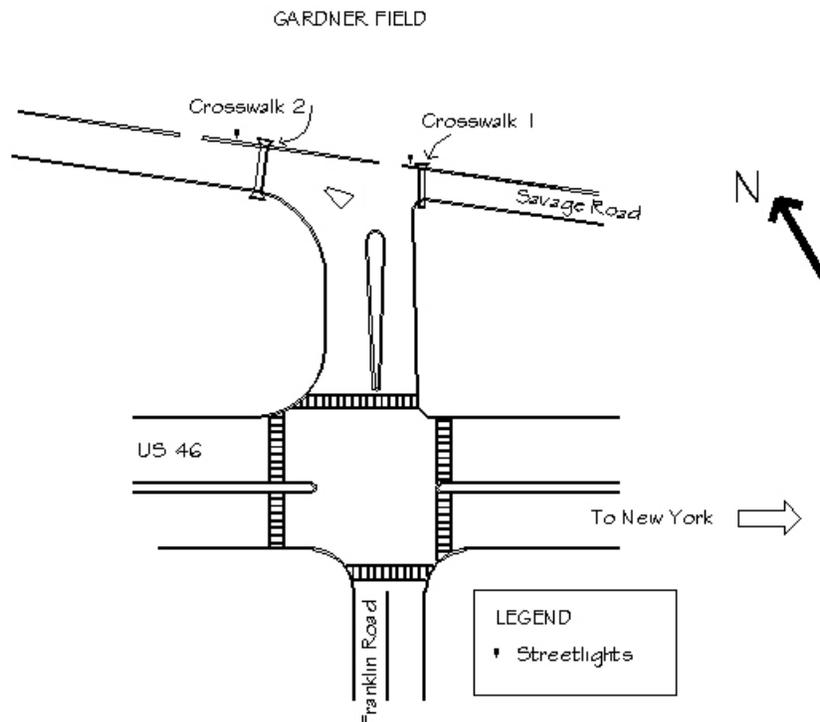
The Department of Transportation of the State of New Jersey identified a site for the evaluation in Denville, New Jersey. Figure 1 shows a plan of the site. The site is adjacent to a major traffic-signal-controlled intersection between US Route 46, a four-lane, divided highway, and Franklin Road, a two-lane road. There are crosswalks across US Route 46 and across Franklin Road but these are linked to the traffic signals via pedestrian operated push-buttons. The actual site of the evaluation is the T-junction between Franklin Road and Savage Road. At this junction, Franklin Road, which forms the stem of the T, has a large median, there being three lanes for travel in a southwesterly direction and one lane for travel in a northeasterly direction. As for Savage Road, which forms the cross of the T, there are two lanes for travel in the northwesterly direction for the part to the southeast of Franklin Road, and one lane each for travel in the southeasterly and northwesterly directions on the part of the road to the northwest of Franklin Road. To the North of Savage Road is Gardner Field, an extensive recreational area containing baseball diamonds, tennis courts, soccer and football fields, and a children's playground. Access to the parking lot of Gardner Field is off Savage Road, just to the west of crosswalk 2. Egress from the parking lot is actually into the junction adjacent to crosswalk 1. To the South of Savage Road, the area between Savage Road and US 46 to the southeast of Franklin Road is open grassland. The area between Savage Road and US 46 to the northwest of Franklin Road is dense scrubland.

Figure 1. A plan of the evaluation site.

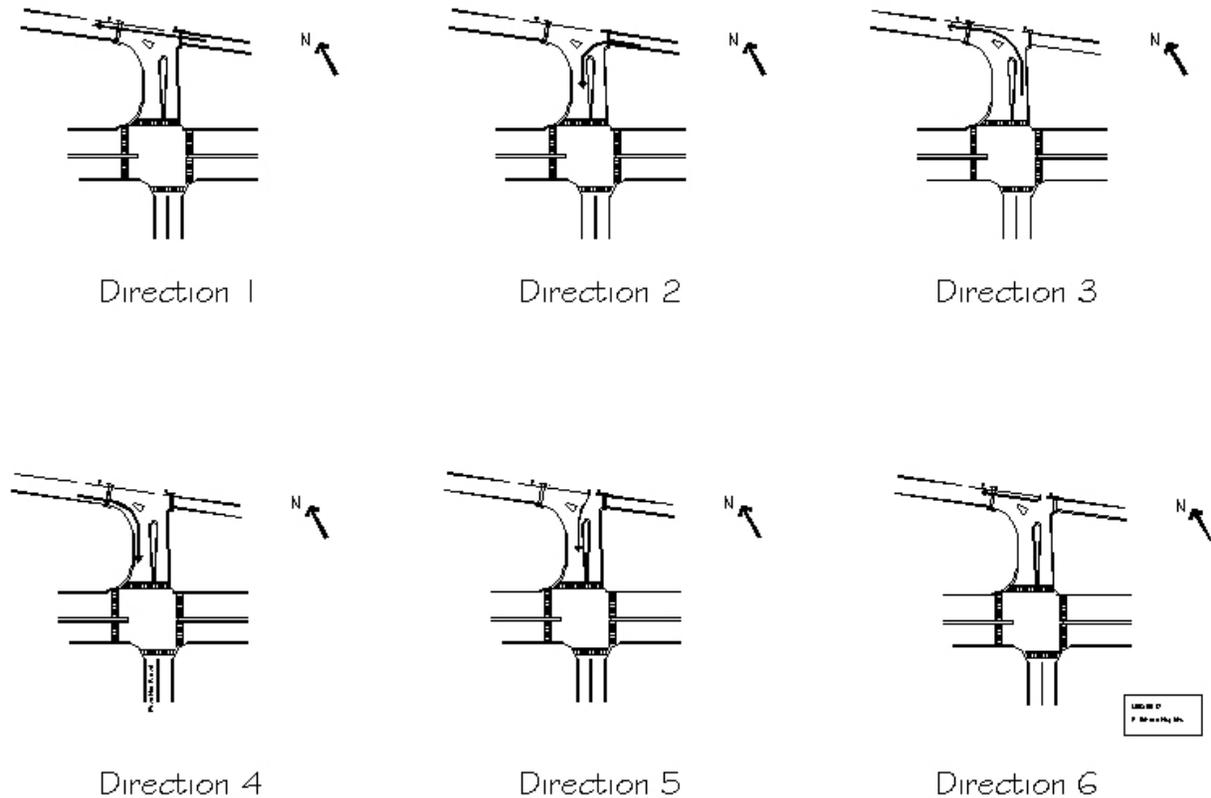
This complicated pattern of lanes means there are six possible routes for drivers to pass through the junction between Franklin Road and Savage Road. They are shown in

Figure 2. A triangular island is placed in the middle of the junction to guide drivers turning from Savage Road into Franklin Road. For pedestrians, the crosswalks being evaluated cross Savage Road from either side of Franklin Road. There is no crosswalk across Franklin Road until the intersection between Franklin Road and US Route 46.

Figure 2. The six directions of traffic flow through the evaluation site.

Finally, the interviewees were asked if they had any comments about the crosswalks. The comments made are listed in Table 8. There are a number of points made in these comments that are themselves worth commenting on. There are two points that are repeated in Evaluation 2. The first is the difficulty of seeing up Savage Road from one side of Crosswalk 2 because of the overhanging trees and shrubs on the adjacent land (Figure 12). The other is the difficulty produced by having to look out for vehicles coming from several different directions. This was emphasized by one pedestrian who, quite rationally, choose to always use Crosswalk 1 because then it was necessary to look out for traffic from only two lanes, both in the same direction. For Crosswalk 2, it is necessary to look out for vehicles in 4 lanes in four different directions (See Figure 2).

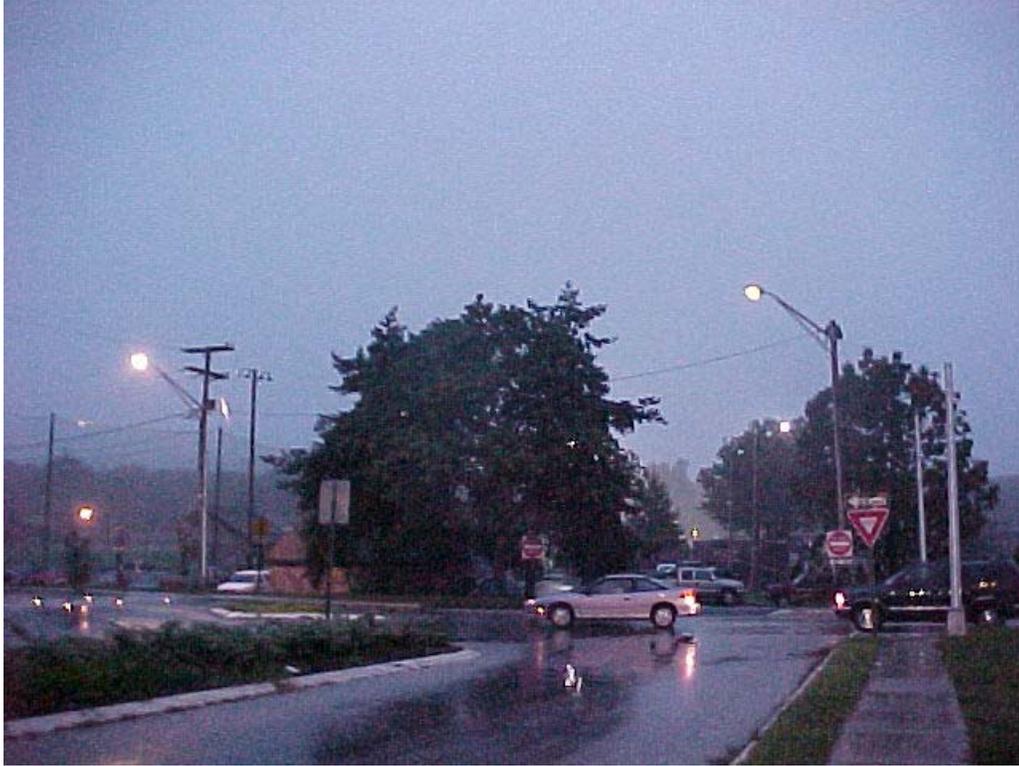
Throughout the series of evaluations the lighting of the junction of Franklin Road and Savage Road has been provided by two drop-lens cobrahead luminaires, each one containing a 250 W high-pressure sodium discharge lamp (Figure 3). Each luminaire is mounted on an extension arm fixed to a wooden utility pole. The two poles are located close to the two crosswalks.

Figure 3. The cobrahead luminaires used to light the evaluation site at night.

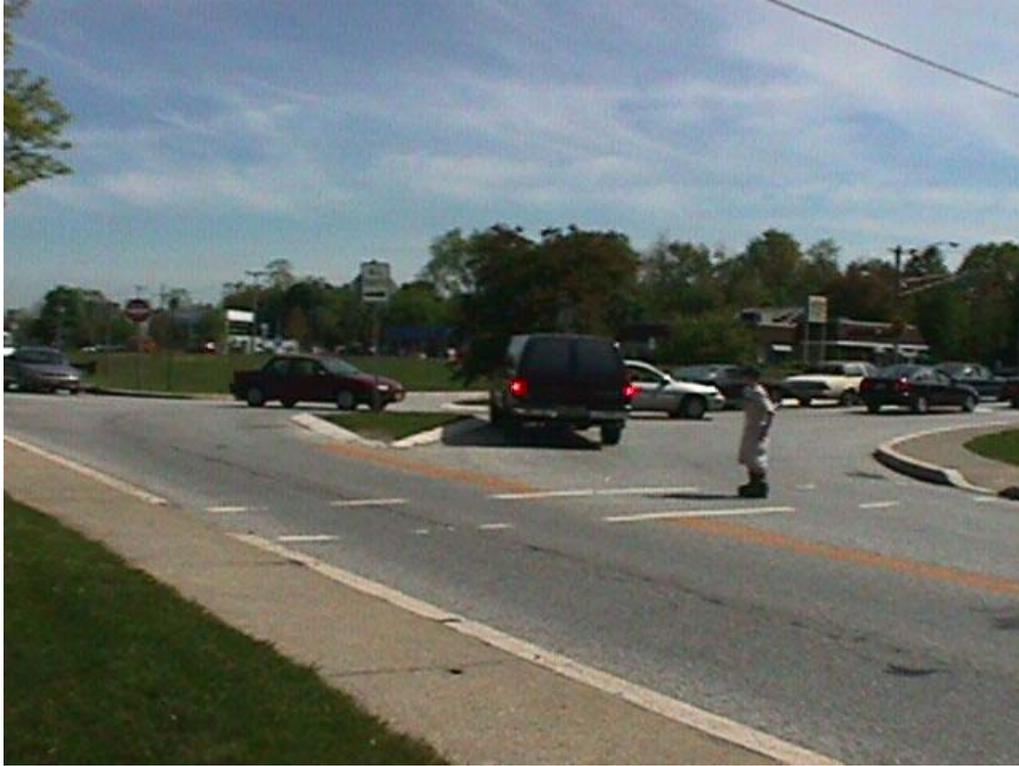
The first evaluation was made on Saturday, 12th June 1999. At this time, there was only one marked crosswalk at the site, that being crosswalk 2 on the northwest side of the junction of Franklin Road and Savage Road. This crosswalk was linked to a sidewalk on the northwest side of Franklin Road. There was no sidewalk on the southeast side of Franklin Road so there was no marked crosswalk 1 at this point. Figure 4 shows the marking of crosswalk 2 from the sidewalk on Savage Road on the day of the evaluation. It is clear that the original marking of crosswalk 2 consisted of two parallel lines across the road, although by the time of the evaluation, the lines had been badly eroded by traffic.

Figure 4. Crosswalk 2 at the time of the first evaluation.

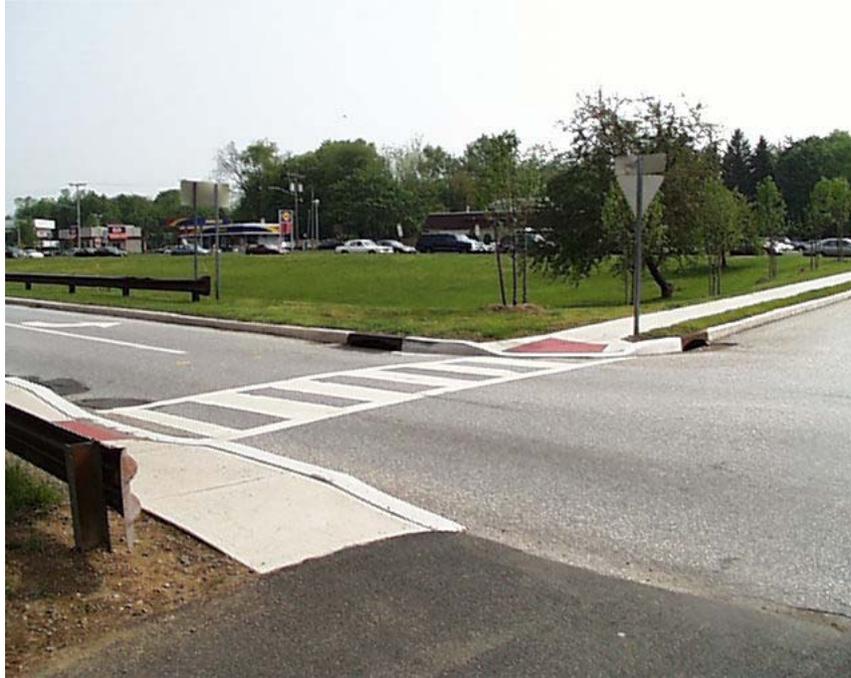
The second evaluation took place on Saturday, 13th May 2000. By this time, a sidewalk had been constructed on the southeastern side of Franklin Road and a new crosswalk across Savage Road (crosswalk 1), complete with ADA ramps, had been finished. Both crosswalks had been newly striped in a grating pattern. Specifically, the striping consisted of alternate 2-ft-wide bars of white paint and 2-ft-wide pieces of asphalt, arranged to form a grating pattern, the upper and lower boundaries of the grating being closed by a continuous white paint line of 9" thickness. The overall width of both crosswalks was 7 ft. Figure 5 shows a view of crosswalk 1 at this stage and Figure 6 does the same for crosswalk 2.

Figure 5. Crosswalk 1 at the time of the second evaluation.

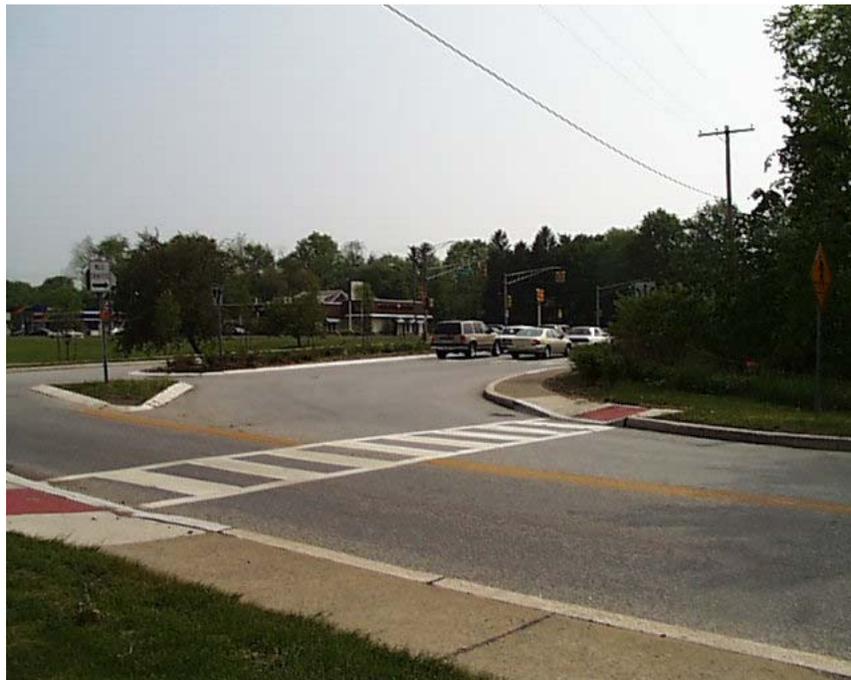
Figure 6. Crosswalk 2 at the time of the second evaluation.

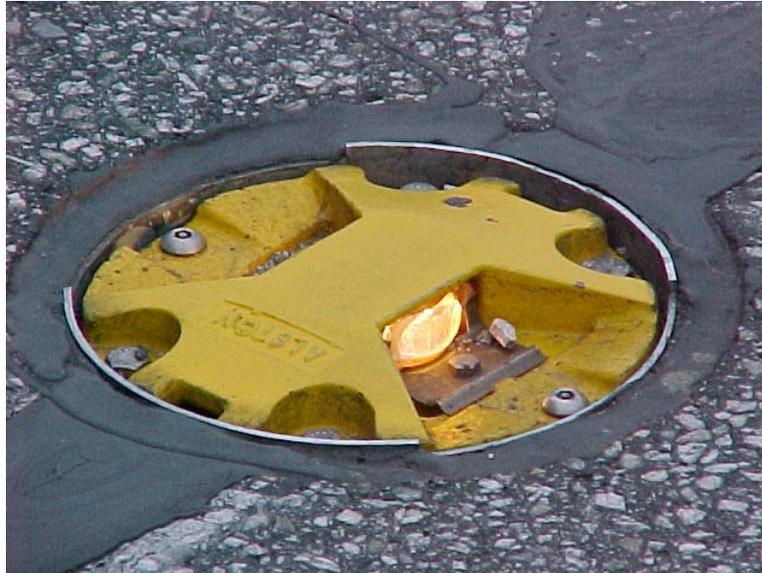
pavement flashing warning lights (Model ZA230) were purchased from Traffic Safety Corporation of Sacramento, California and installed by the New Jersey Department of Transportation. Figure 7 shows a close-up of one of the in-pavement flashing warning light units as installed.

Figure 7. One of the in-pavement flashing warning lights, installed.

The unit was originally designed for use on airport runways. Consequently, it is of rugged construction and designed to be set low enough in the pavement (projecting less than 0.50 inches above grade) that it will not be damaged by snowploughs. The light source used in the unit is a 45 W tungsten halogen lamp. The light output of the unit is predominantly in two directions, through apertures set at 180° to each other. The unit is installed so that these directions are along the main axis of the road. In Denville, only the direction towards approaching traffic emits light (the other direction is sealed). The light distribution from the unit is determined by the clear lens in the aperture of the unit. The effect of the lens is to direct a high luminous intensity beam along the road in the direction of approaching drivers. The color of the flashing warning lights was white. Four ZA 230 units were installed on crosswalk 1 and six units on crosswalk 2, as shown in Figure 8. Figures 9 and 10 show the installations at crosswalks 1 and 2 respectively.

As originally installed, the in-pavement flashing warning light installation consisted of ten in-pavement light units. During the one year of operation New Jersey Department of Transportation has had to carry out maintenance on five of these units. Two of the units had to be replaced after suffering damage from a snowplow. Another three suffered electrical failure of some sort, probably a failure of the filament of the halogen lamp in the unit, caused by vibration produced by the high traffic flows over the units. This cause of failure has to be an assumption because the maintenance procedure is to extract the failed unit from the pavement, replace it with a spare unit, send the failed unit back to the manufacturer in California, who makes any necessary repair and returns the unit to NJDOT where it becomes a spare unit. Nonetheless, the fact that five out of the ten units initially installed have required maintenance during the first year suggests that the units are not suitable for use where they will be exposed to high traffic flows.

A close examination of the units after one year in the pavement showed a large reduction in light output from new. There were two reasons for this reduction. The first was the presence of small debris in the incline leading to the lens of each unit. The second, and more important, cause was the deposit of a black film, probably rubber, over a large part of the lens through which light is emitted in each unit. Both these causes of decline in light output were easily removed using a brush and glass cleaner respectively.

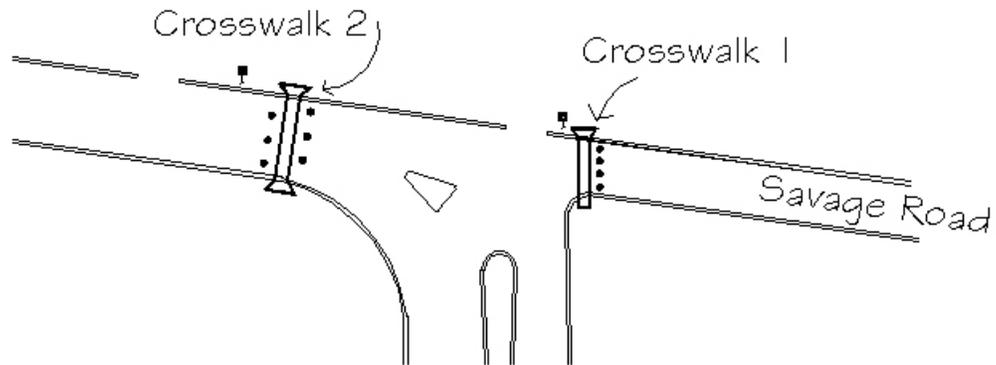
Figure 8. A plan showing the arrangement of the in-pavement flashing warning lights installed on the two crosswalks.

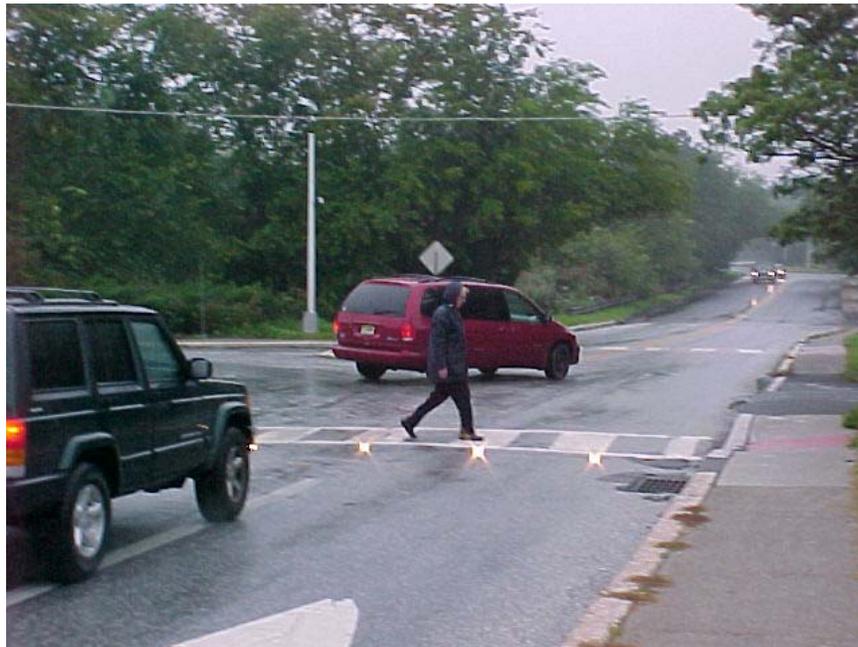
Figure 9. Crosswalk 1 with the in-pavement flashing warning lights installed and operating, at the time of the third evaluation.

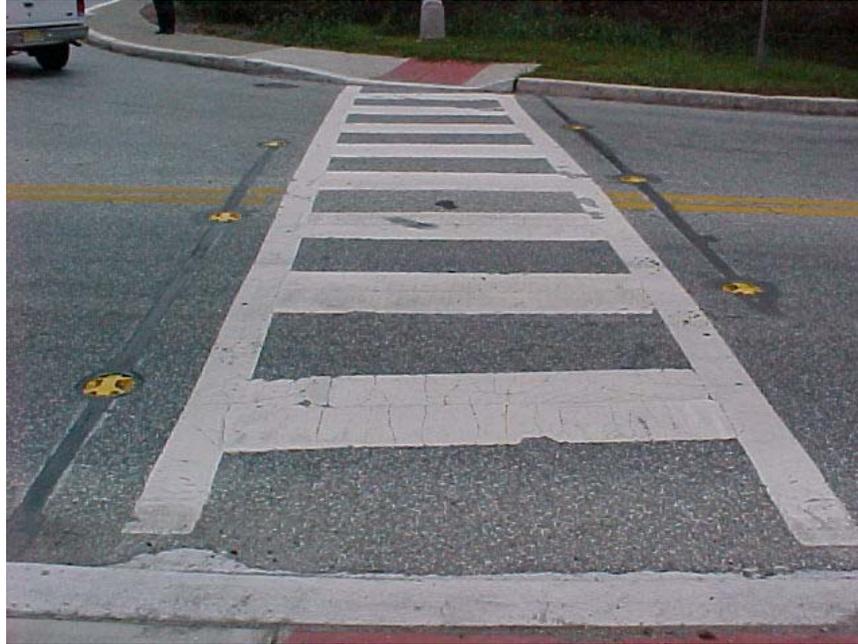
Figure 10. Crosswalk 2 with the in-pavement flashing warning lights installed, at the time of the third evaluation.

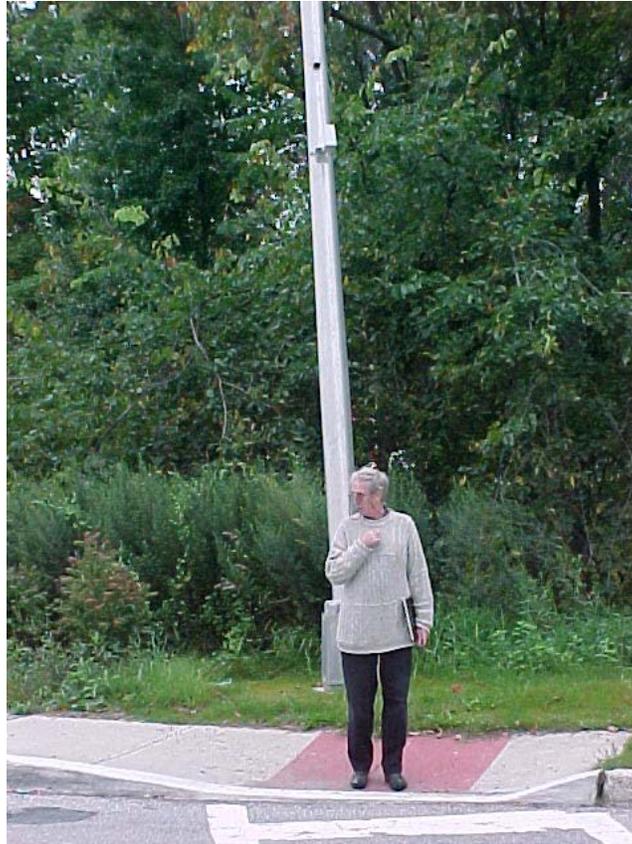
The activation of the in-pavement flashing warning light units was by four microwave detectors (Model AD1400) also purchased from Traffic Safety Corporation. One of these detectors was mounted on a pole at either end of both crosswalks. Figure 11 shows the location of one of the AD1400 detectors relative to the pedestrian. These devices detect the presence of a pedestrian in the detection area. The pedestrian has to be in the detection area for a minimum time before the flashing warning lights are activated. This time delay from detection to activation is necessary so that pedestrians passing through the detection area but continuing along the sidewalk do not trigger the flashing warning lights. The sensitivity of the detector, the detection area and the delay time are all adjustable on site.

Figure 11. One of the four microwave detectors used to activate the in-pavement flashing warning lights. The detector is in the small box on the pole behind and above the pedestrian.

The pole-mounted activating system has adjustments of coverage area, sensitivity and time delay. These adjustments are used to ensure that the in-pavement flashing warning lights are only operated when a pedestrian is waiting to cross and are not activated by a pedestrian walking along the sidewalk past the crosswalk, nor by passing traffic. At the time of Evaluation 3, i.e., one week after commissioning, it was observed that the in-pavement units were sometimes activated when there was no pedestrian present. Examination of the activation of the in-pavement flashing warning lights for several hours during Evaluation 5 revealed the pattern of activation shown in Table 9.

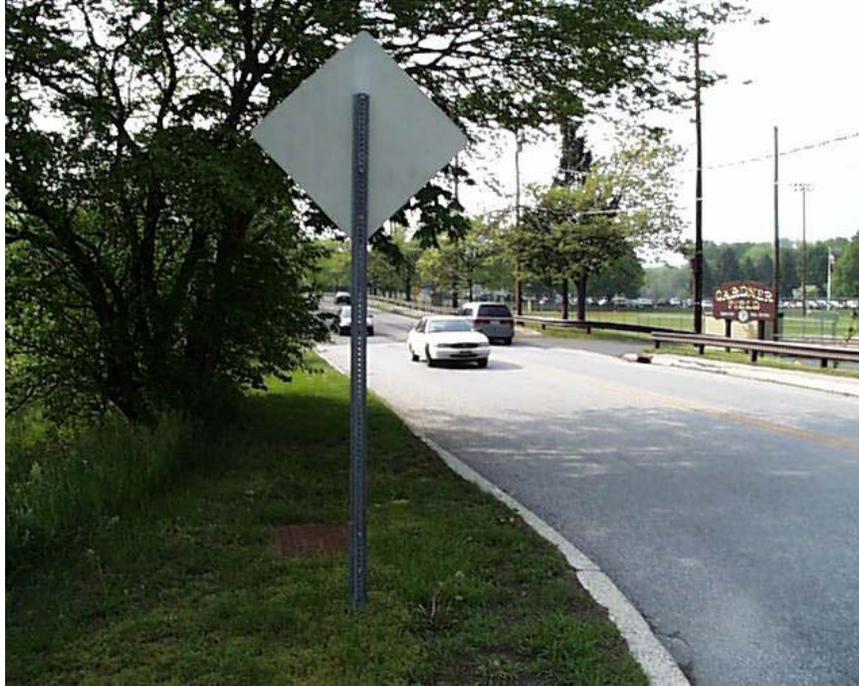
Figure 12. View up Savage Road to the northwest, from the Franklin Road side of Crosswalk 2, obscured by shrubs.

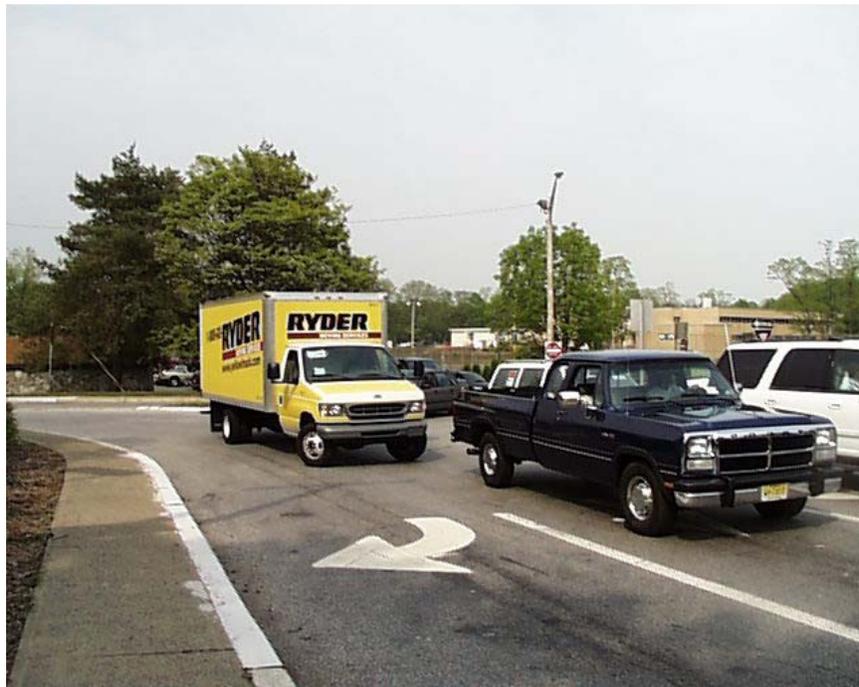
While making the evaluations on site, the authors had an opportunity to observe drivers' behaviors. Two aspects of that behavior are of relevance here. The first is that traffic backing up from the traffic signals on US Route 46 sometimes produced partial blockages of different lanes between the two crosswalks. The most common blockages occurred for directions 2 and 3 because of vehicles coming from directions 2 and 4 (Figure 13). Occasionally, this situation was exacerbated by a vehicle coming out of Gardner Field and blocking direction 1. The importance of such blocking for the use of the crosswalks is that the vehicles obscure the drivers' view of the crosswalk and the pedestrians' view of the traffic. This means it is sometimes not possible for a driver traveling in direction 1 to see if a pedestrian is waiting to cross from one side of the two crosswalks, or even if a pedestrian has already started to cross, until the pedestrian emerges from behind a vehicle. Striping does not do anything to help in this situation but the in-pavement flashing warning lights would, if drivers were confident that their operation meant a pedestrian was using the crosswalk.

Figure 13. Blockage of some directions of travel in the area of the crosswalk by traffic backing up from the traffic signals at US Route 46 and Franklin Road.
