Report No. CDOT-DTD-R-2002-10

Final Report

**EVALUATION OF SLOPE
STABILIZATION METHODS**

(US 40 BERTHOUD PASS)

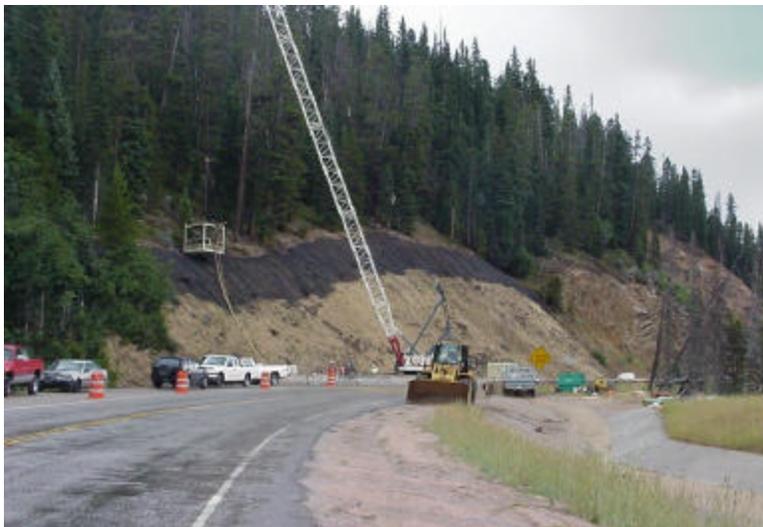
Figure 1. Lifting materials to the top of the slope.

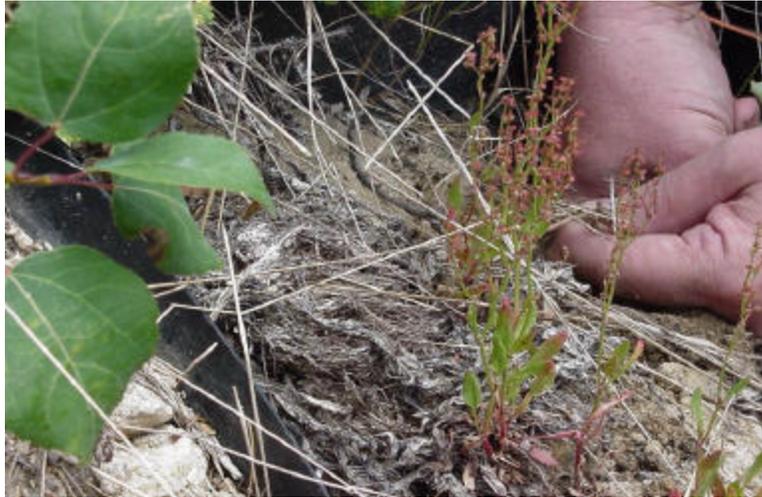
Figure 2. The number of plants in a sample area of each zone were carefully counted.

In late 2000, five years after the completion of construction, the slopes were evaluated for the amount of plant material growing within the erosion control blanket and cellular confinement test areas. Plants in each test area were counted based on culms (stems and shoots – one individual grass plant may contain 10-15 culms) within a 1-meter square transect.

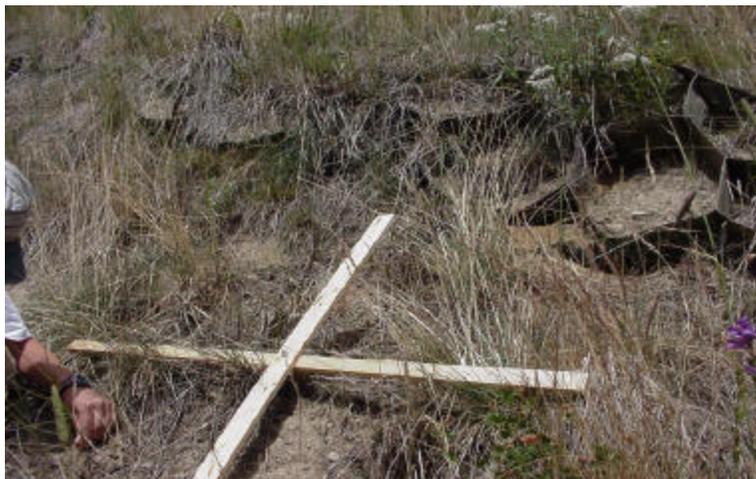
Figure 3. A frame marks the area to be counted.

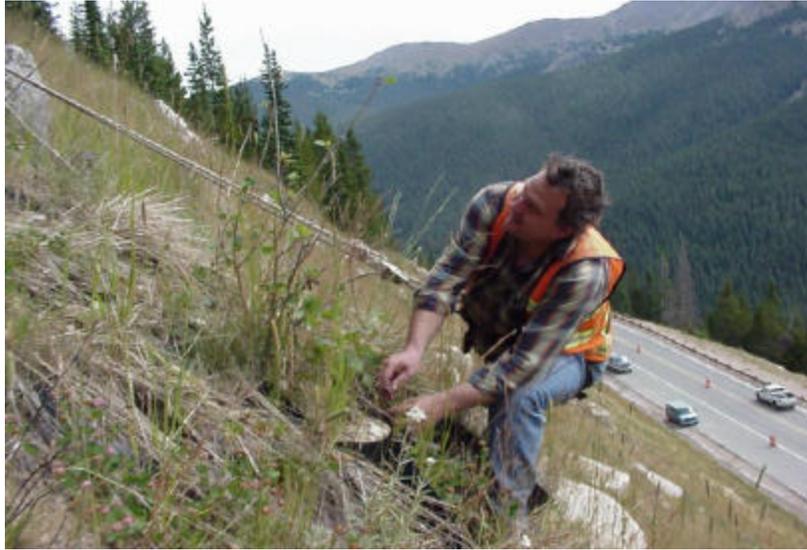
- Zone one – cellular confinement methods (Table 1, p. 5), with a control section adjacent to the test sections.

Figure 4. The steep slope in zone 1 necessitated safety ropes.

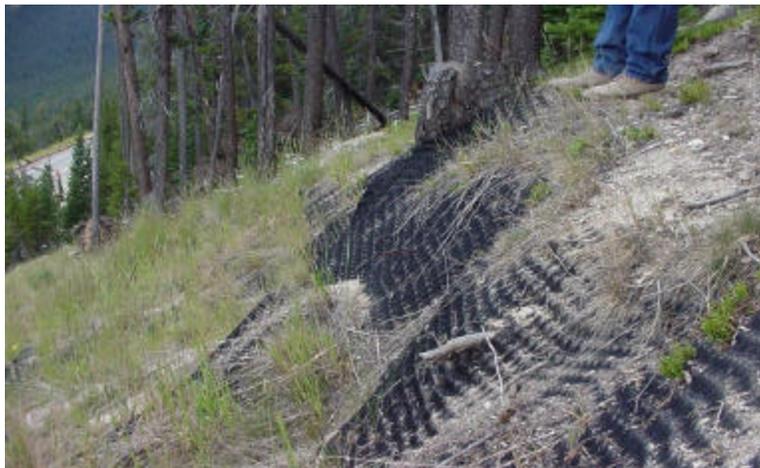
Figure 5. Pyramat near the top of zone 2 in August of 2000.

4. The Pyramat blanket in zone 2 did not conform to irregularities in the slope as well as the other products. This is the only zone where the plant count was lower than the count in the control section.

1. The cellular erosion control products and soil retention blankets tested for this study all performed well under harsh conditions. All of them should be installed over relatively smooth surfaces to allow them to conform closely to the surface; large rocks should be removed and hollows filled before they are installed.
2. It would be worthwhile to continue to monitor the plant densities and soil fertility at the site to see if they are able to sustain themselves without repeated re-seeding and re-fertilization.
