PHASE I CULTURAL RESOURCE SURVEY OF A
PROPOSED NEW ALIGNMENT OF ROUTE 460
TOWN OF GRUNDY, BUCHANAN COUNTY, VIRGINIA

A PHASE I CULTURAL RESOURCE SURVEY OF A
PROPOSED NEW ALIGNMENT OF ROUTE 460
TOWN OF GRUNDY, BUCHANAN COUNTY, VIRGINIA
PROJECT: 6460-013-113, PE100

Prepared for
Virginia Department of Transportation

October 1993

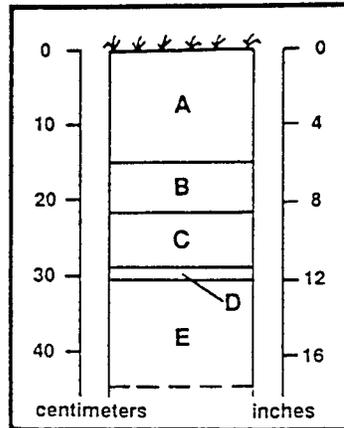
Stratigraphy of the site consisted of a layer of dark brown (10YR3/3) sandy clay loam 16 cm (6.3 in.) thick over dark brown (10YR3/3) sandy clay loam with large pieces of gravel fill 7 cm (7.4 in.) thick. These two layers sealed a 2 cm (.8 in.) thick layer of yellowish brown (10YR5/8) sand. These first three

layers consisted of topsoil and fill. All artifacts recovered from this shovel test were from Layers 1 and 2. Beneath the sand layer a very dark brown (10YR2/2) fine sandy clay loam 14 cm (5.5 in.) thick was encountered. This was determined to be a natural layer that had been sealed by the fill. Below this was subsoil, a dark yellowish brown (10YR4/6) sandy clay (Figure 6). The profile of this shovel test indicated that the area was disturbed and that the artifacts recovered from the location were of indeterminable provenience.

- A - Dark Brown (10YR3/3) Sandy Clay Loam
- B - Dark Brown (10YR3/3) Sandy Clay Loam with Large Pieces of Gravel Fill
- C - Yellowish Brown (10YR5/8) Sand
- D - Very Dark Brown (10YR2/2) Fine Sandy Clay Loam
- E - Dark Yellowish Brown (10YR4/6) Sandy Clay (Subsoil)

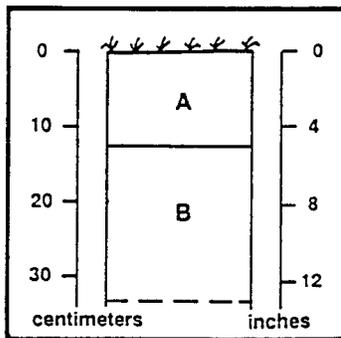
- A - Very Dark Brown (10YR2/2) Sandy Loam*
- B - Mottled Brown (10YR5/3) and Brownish Yellow (10YR6/6) Sandy Clay with Large Pieces of Bedrock*

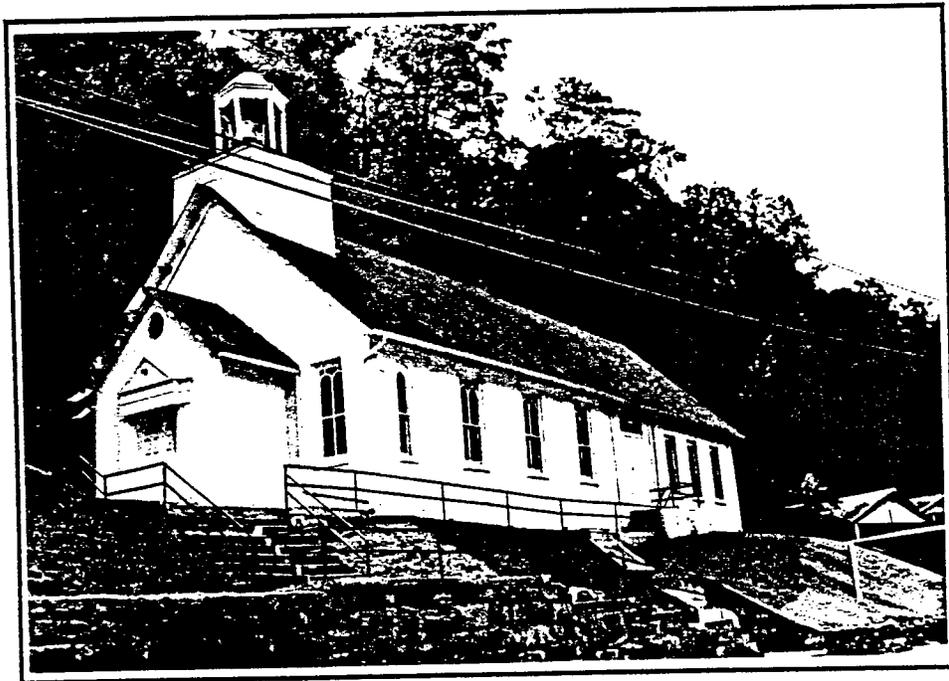
Description: Grundy Bible Church, the only previously identified structure is a one-story, three-bay linear brick church resting on a small steep hill fronting Main Street. Its gable roof has replaced composition shingles and extended eaves. The one-bay, gable roof vestibule has wood double-doors flanked by a plain pedimented frontispiece. The church retains its original belfry with replaced aluminum siding. The windows show an influence of Gothic Revival style decorated with a stone sill. A rear four-bay, brick extension has been added. There are no associated cemetery or outbuildings.

Figure 11. Structure 229-10, Grundy Bible Church, north and east elevations.

Significance: Not eligible for nomination to the National Register of Historic Places under Criterion A or C.

Recommendations: No further work is required.

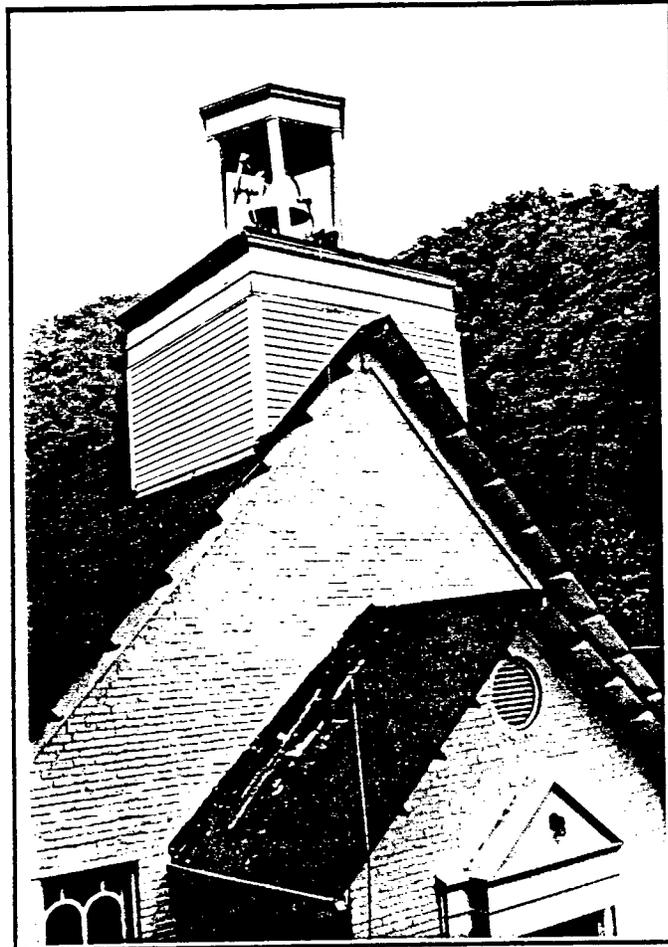
Figure 12. Structure 229-10, Grundy Bible Church, belfry, east elevation.

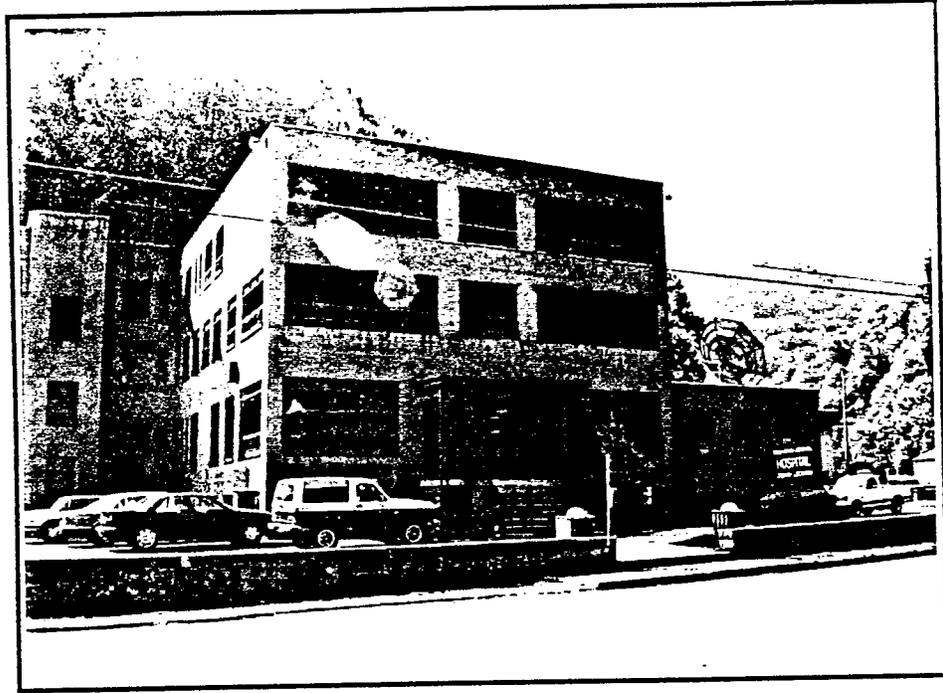
Description: The Buchanan General Hospital is a large, commercial structure that has witnessed many changes. A frame Presbyterian schoolhouse was originally built on the site around 1920. It was destroyed by fire and replaced with a hospital in 1930. This new hospital served the county until 1980 when a newer one was built at a different location. At that time extensive remodeling took place producing the current structure housing the Home Health Office. The three-story, squared, symmetrical three-bay, brick building has a flat roof with a small corbeled parapet. The window fenestration also has been severely altered due to the remodeling. The commercial windows have metal frames and single tinted glazing, and are either singular or in a row divided with one, two, or four mullions. Only the front elevation shows the fabric of the earlier 1930 building with its centered entrance porch. This porch has a replaced door, but retains the flat and broad portico with paired, square columns. The porch is raised to the first floor with a brick foundation and eight concrete steps finished with a cast-iron railing. Two new three-story wings identical in design were added during the 1980 remodeling. There are no outbuildings associated with this commercial structure. The landscaping consists of a low, rough-faced ashlar wall fronting Riverside Drive, with the remaining area covered with asphalt.

Figure 13. Structure 229-12, Buchanan General Hospital, north to northwest elevation.

Significance: Not eligible for nomination to the National Register of Historic Places under Criterion A or C.

Recommendations: No further work is required.

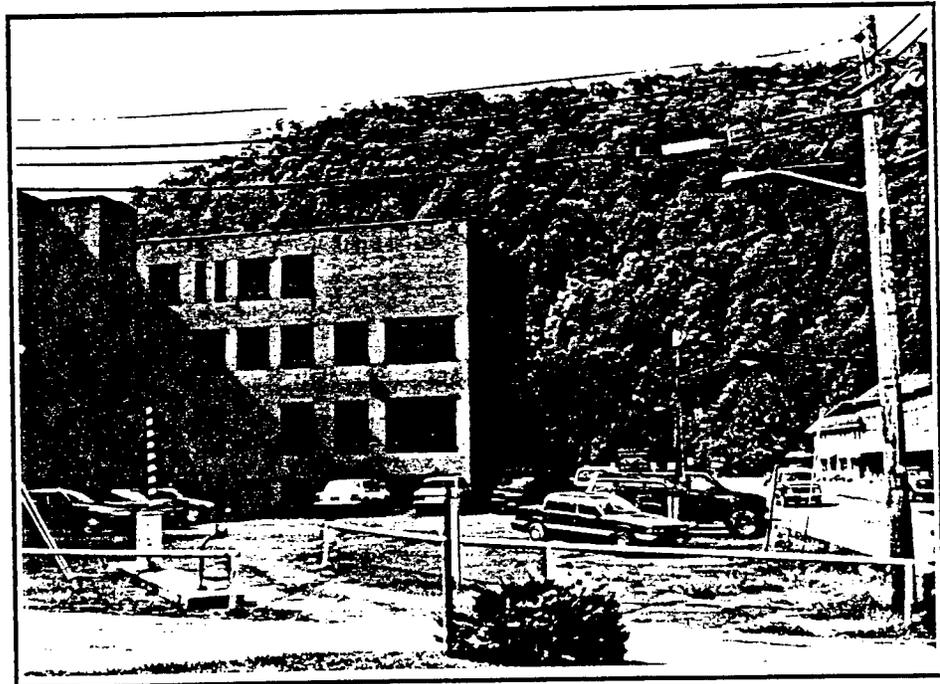
Figure 14. Structure 229-12, Buchanan General Hospital, north elevation.

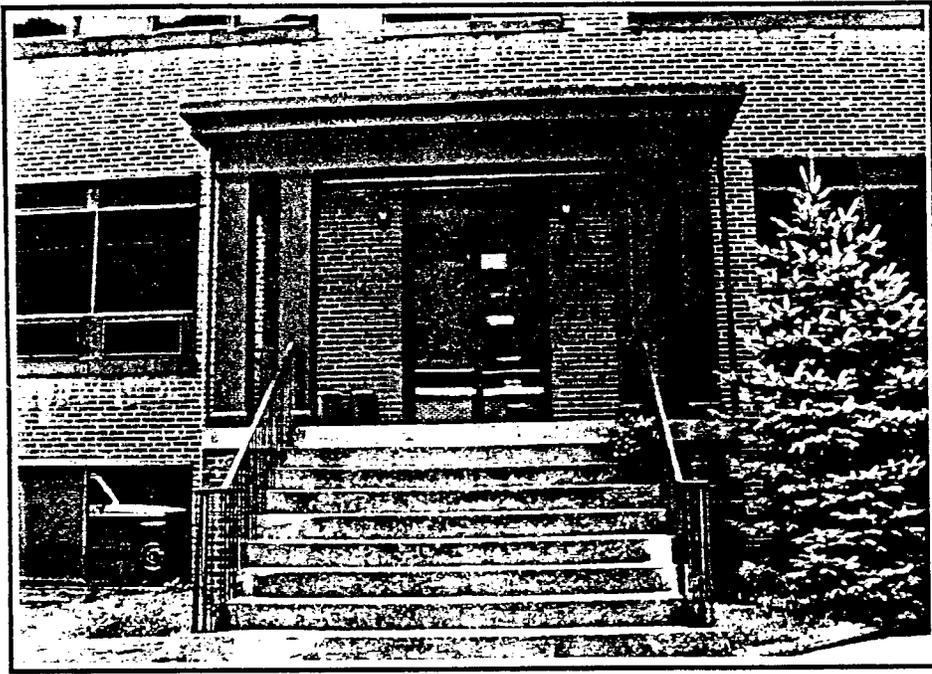
Figure 15. Structure 229-12, Buchanan General Hospital, porch detail.

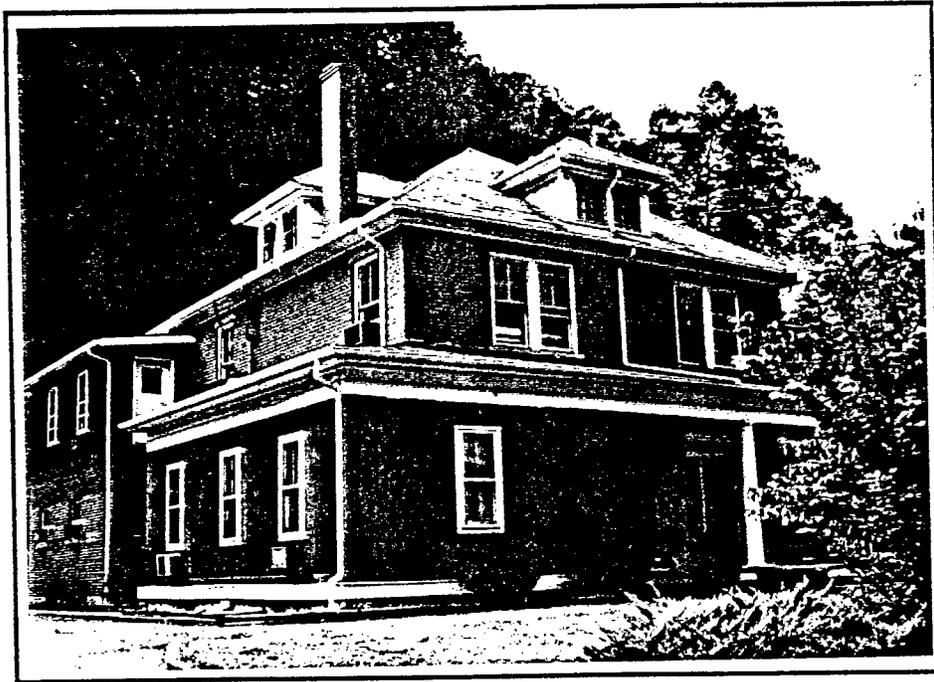
Figure 16. Structure 229-13, Watkins Building, north to northeast elevation.

Significance: Not eligible for nomination to the National Register of Historic Places under Criterion A or C.

Recommendations: No further work is required.

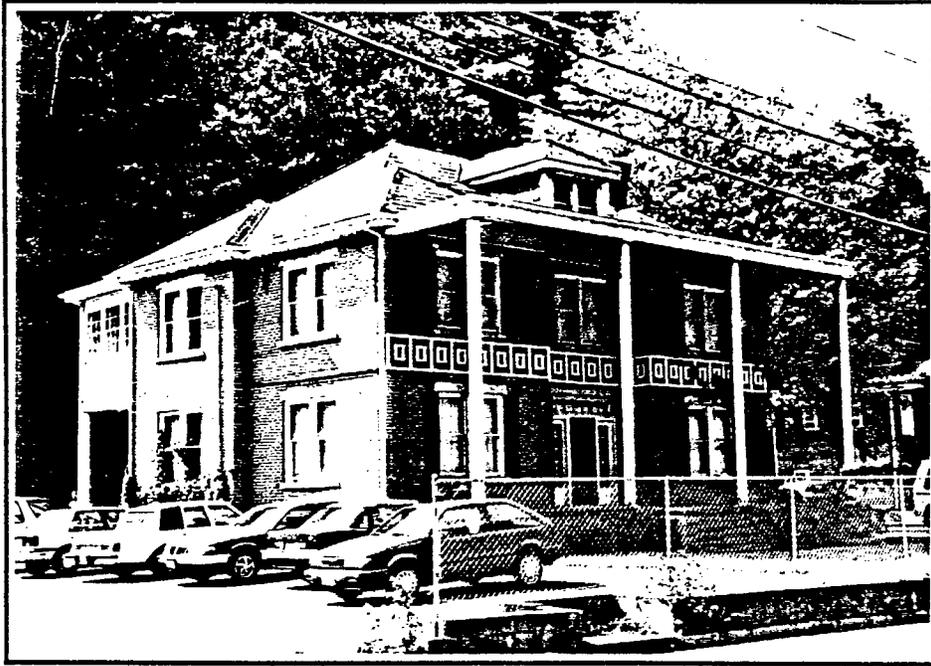
Description: Structure 229-14 is an American Foursquare similar to the adjacent Watkins Building, but probably built slightly later and with more elaborate fenestration and detail. This double-pile, two-story, symmetrical three-bay, brick domestic structure is owned and used for storage by the adjacent bank. It rests on a raised, coursed, rough-faced ashlar foundation with full basement. The shallow pitched hipped roof is clad with pressed tin with one large dormer on the front elevation. The three-bay front elevation has a slightly indented two-story, centered entrance section giving the flanking bays small hipped roofs. The original single front door is decorated with a fully glazed transom and ten-light sidelights. The door and paired one-over-one double hung windows on the front elevation are decorated with large, smooth stone-faced lintels and smaller sills, while the windows on the sides are decorated with rough-faced ashlar. A replaced two-story, three-bay, aluminum clad flat-roofed porch supported by aluminum clad fluted columns rest on the existing raised concrete deck supported with ashlar piers infilled with brick. An open squared, continuous aluminum decorative band was probably added at the same time to the front elevation masking the location where the original front porch was attached. A full width, two-story, earlier frame addition is attached to the rear elevation. There are no outbuildings associated with this domestic structure. The landscaping includes a front lawn and concrete sidewalk connecting to the ashlar wall projecting from the front porch, similar to the Watkins Building.

Figure 17. Structure 229-14, domestic structure, north to northeast elevation.

Significance: Not eligible for nomination to the National Register of Historic Places under Criterion A or C.

Recommendations: No further work is required.

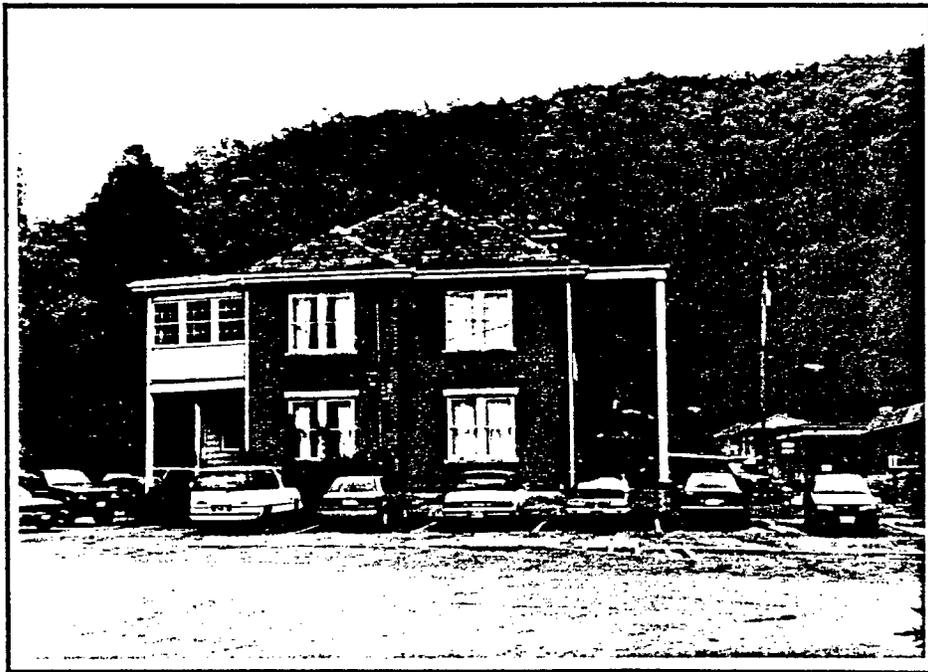
Figure 18. Structure 229-14, east elevation.

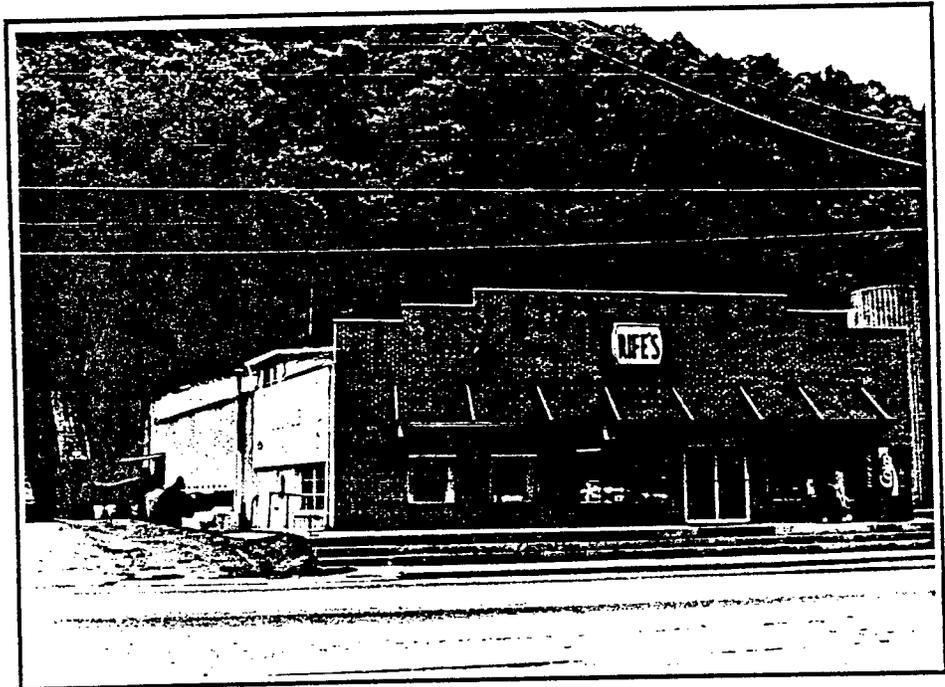
Figure 19. Structure 229-15, Rife's Wholesale, north elevation.

Significance: Not eligible for nomination to the National Register of Historic Places under Criterion A or C.

Recommendations: No further work is required.

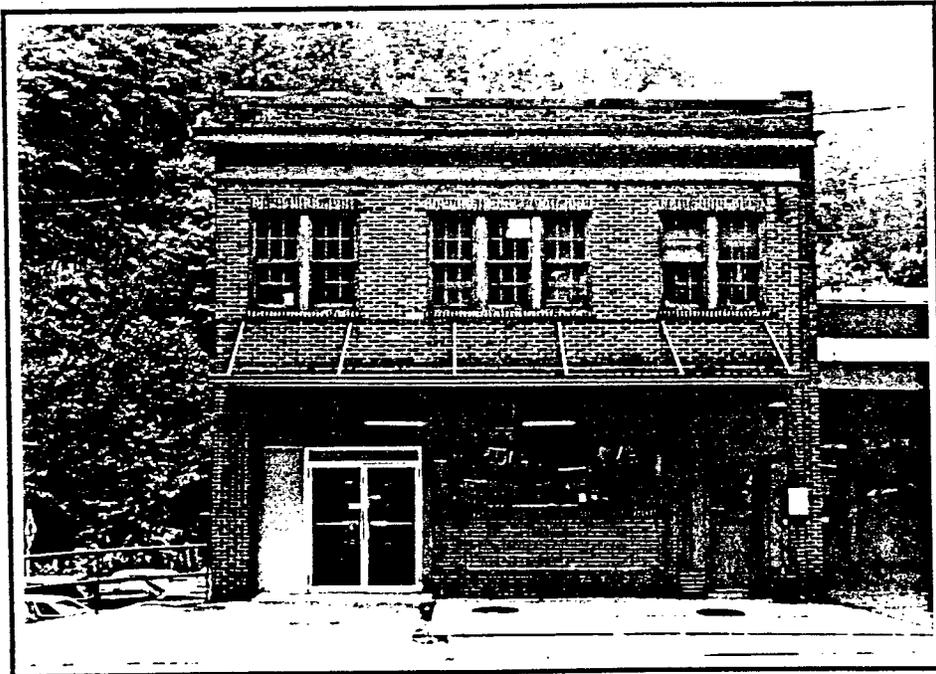
Figure 20. Structure 229-16, Mountaineer Publishing Co., south elevation.

Significance: Not eligible for nomination to the National Register of Historic Places under Criterion A or C.

Recommendations: No further work is required.

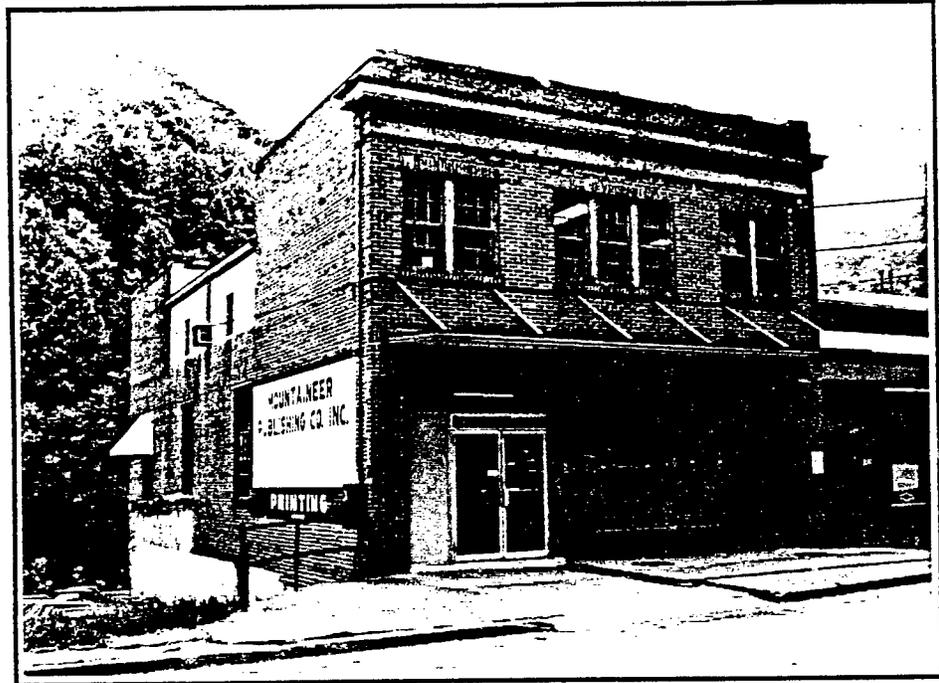
Figure 21. Structure 229-16, southeast elevation.

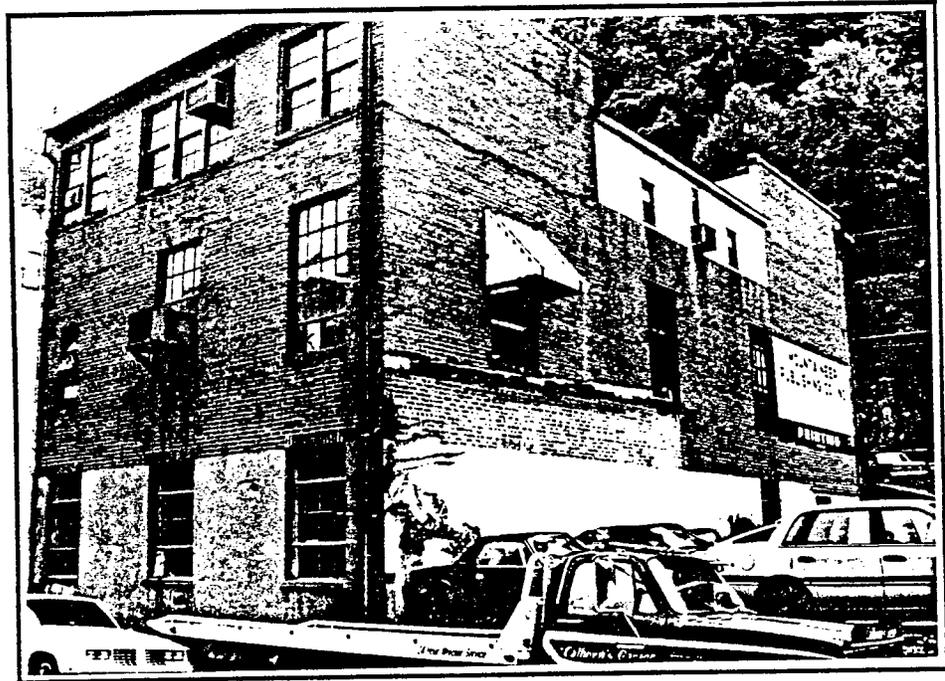
Figure 22. Structure 229-16, east and south elevations.

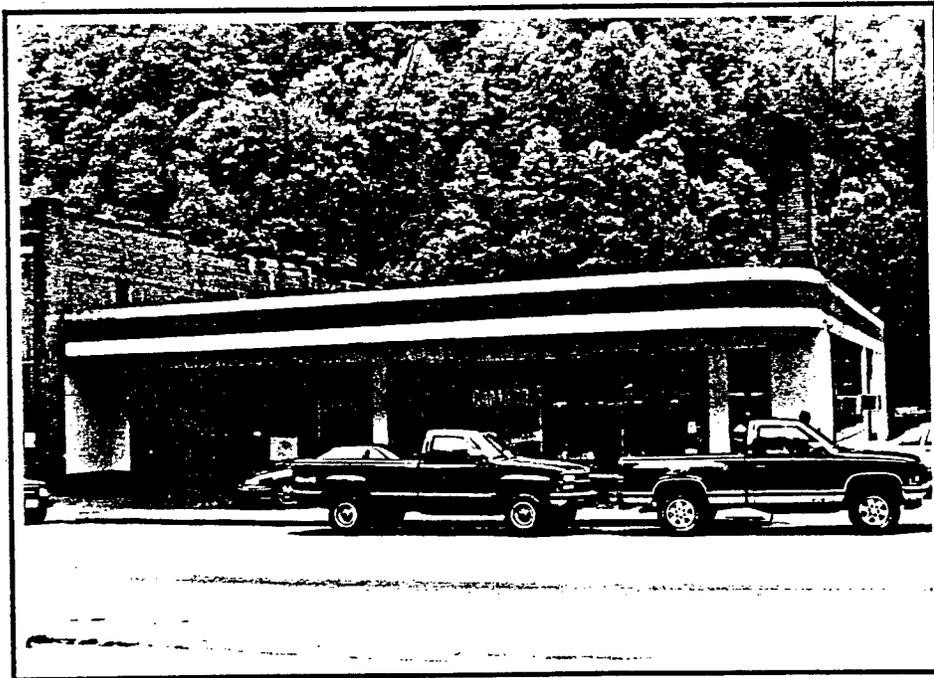
Figure 23. Structure 229-17, Rife Chevrolet, south elevation.

Significance: Not eligible for nomination to the National Register of Historic Places under Criterion A or C.

Recommendations: No further work is required.

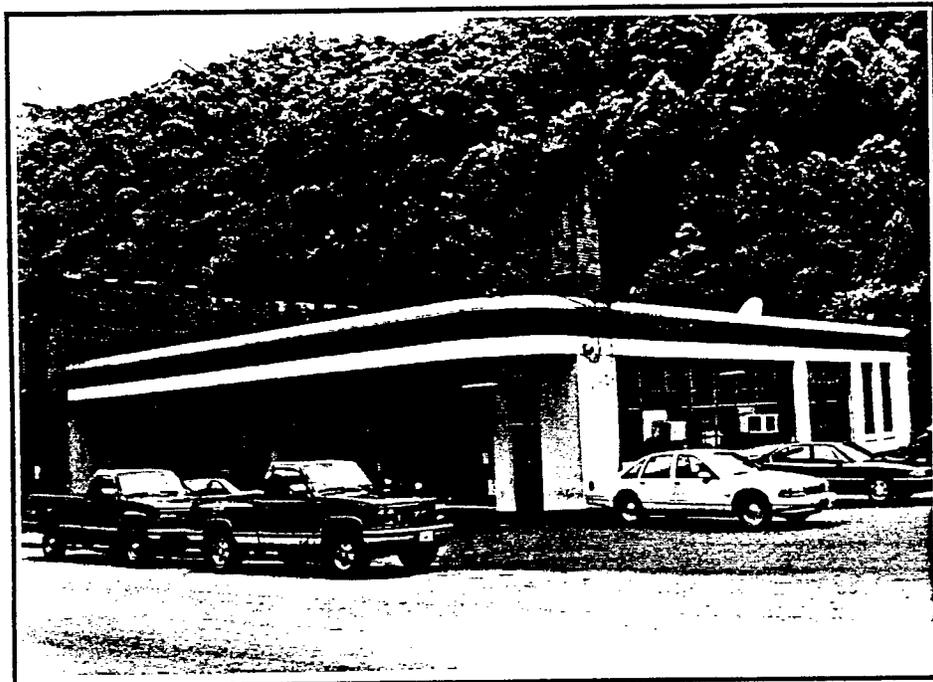
Figure 24. Structure 229-17, southeast elevation.

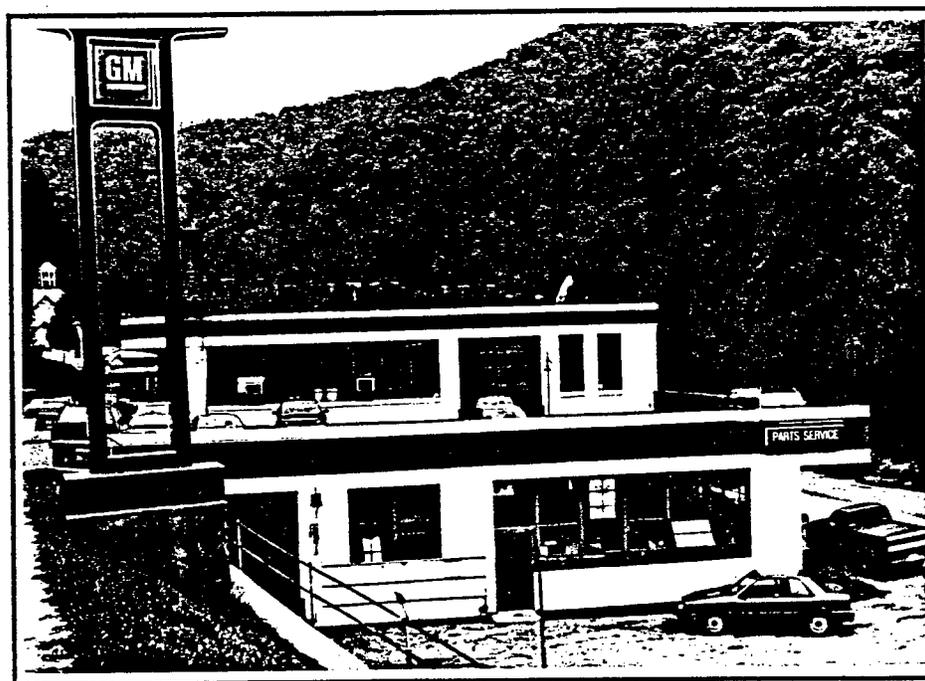
Figure 25. Structure 229-17, east elevation.

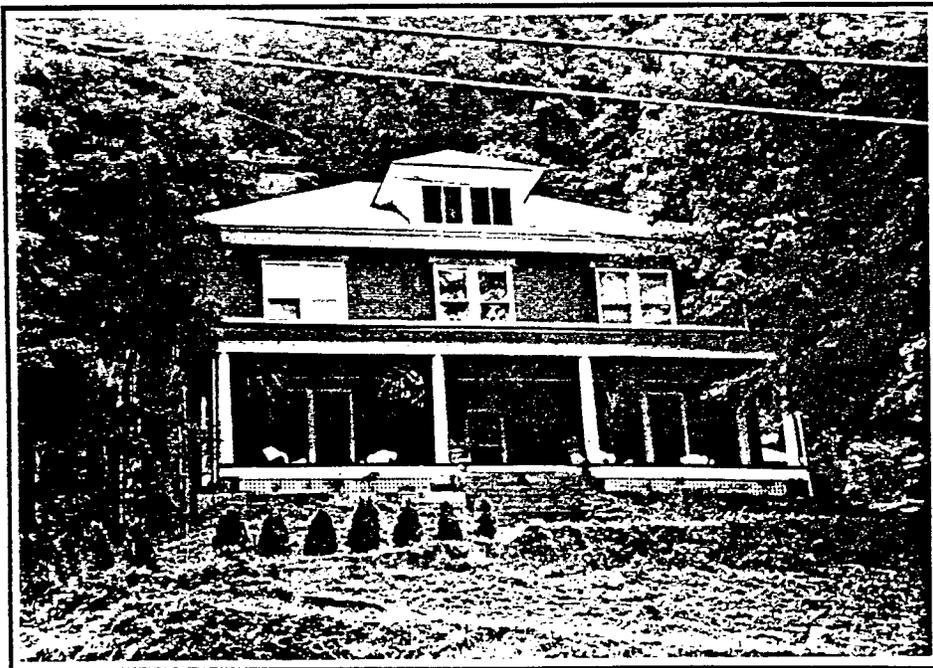
Figure 26. Structure 229-18, domestic structure, northwest elevation.

Significance: Not eligible for nomination to the National Register of Historic Places under Criterion A or C.

Recommendations: No further work is required.

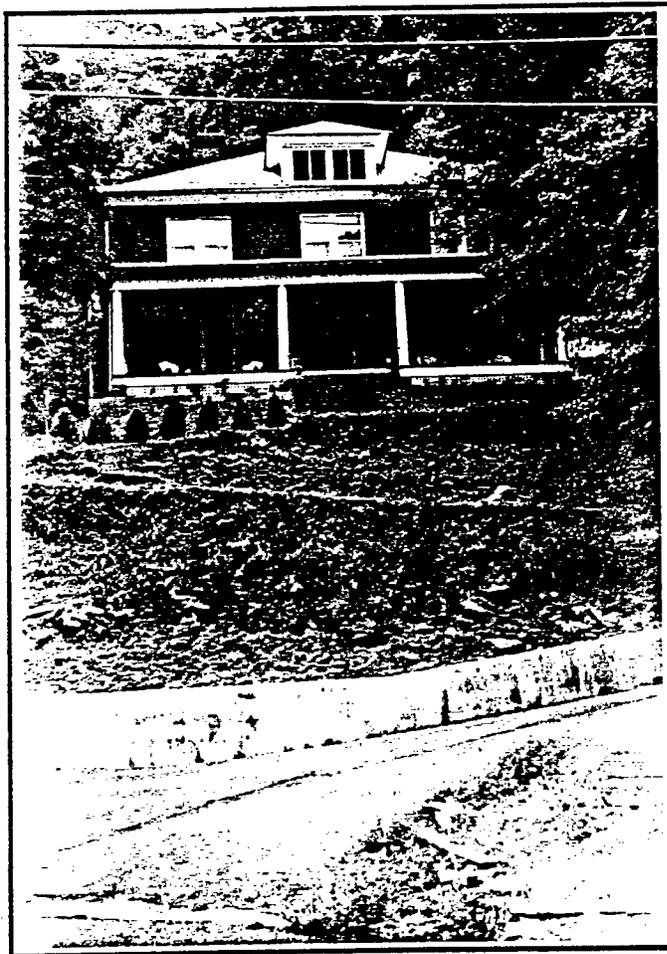
Figure 27. Structure 229-18, northwest elevation.

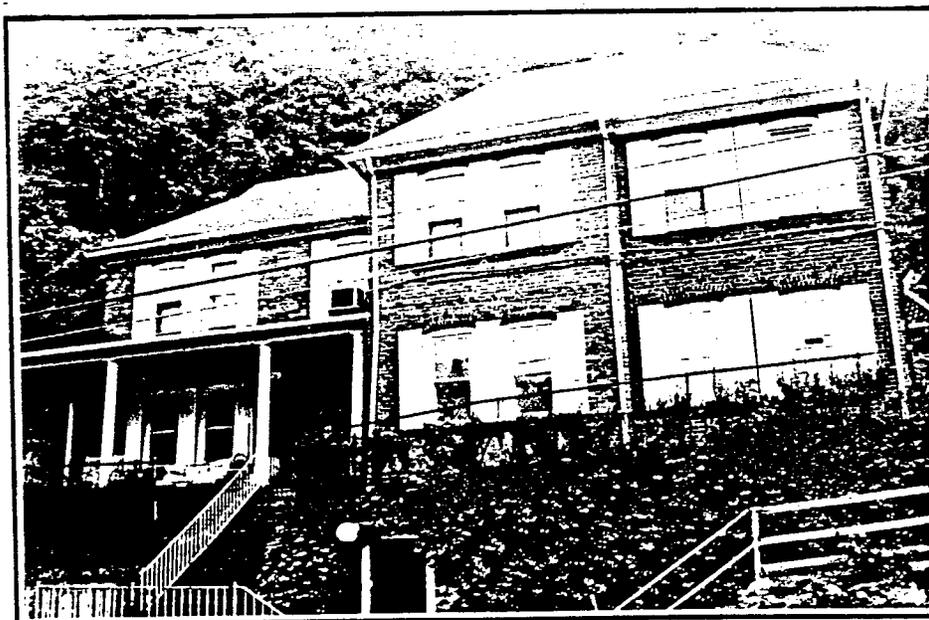
Description: Structure 229-19 is an intact ell-shaped, two-story, three-bay, brick structure uniquely made from locally produced brick. Its hipped roof has replaced composition shingles and extended eaves. The house rests on a raised basement, with one internal end chimney on the west elevation. The paired one-over-one double hung windows are decorated with brick segmental arches and stone sills. It has a five-bay, hipped-roofed, wraparound porch with a small wooden cornice and long tapering Tuscan columns resting on wood decking supported by brick piers infilled with decorative lattice. A two-story, one-bay brick extension was added to the west elevation in 1924, according to the present owner. The original pyramidal hipped-roof design was then changed to its present form of an elongated hipped roof. This domestic structure sits on a steep slope with a coursed, rough-faced ashlar retaining wall and smaller stone garden retaining wall with a series of steps and landing leading down directly to Main Street. The landscaping is well executed and maintained.

Figure 28. Structure 229-19, northwest elevation.

Significance: Not eligible for nomination to the National Register of Historic Places under Criterion A or C.

Recommendations: No further work is required.

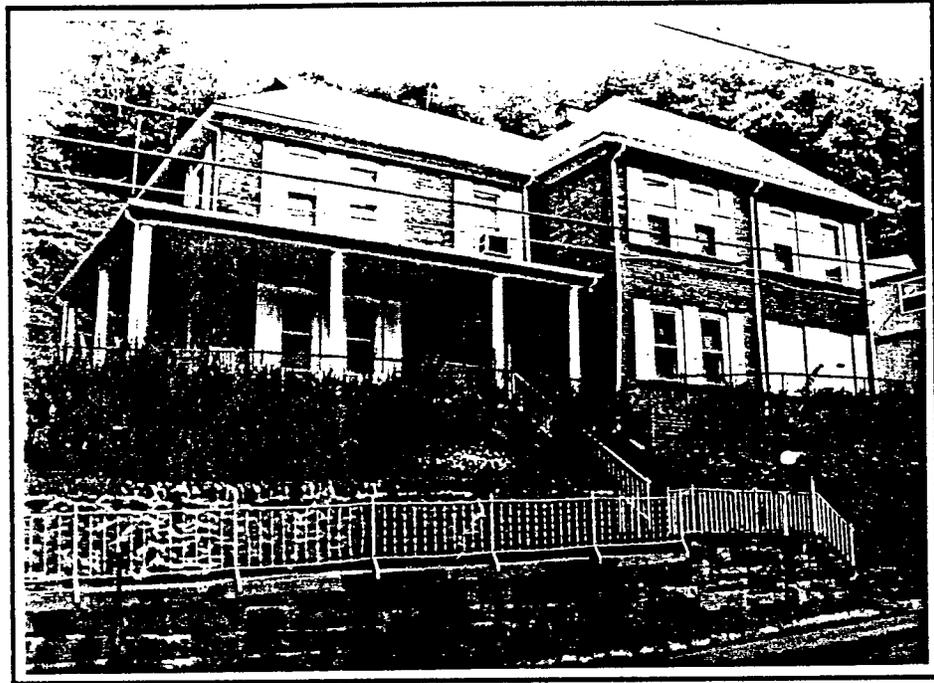
Figure 29. Structure 229-19, northwest elevation.
