Field Evaluation of a New Aluminum Alloy as a Sacrificial Anode for Steel Embedded in Concrete

PUBLICATION NO. FHWA-RD-98-058

APRIL 1998

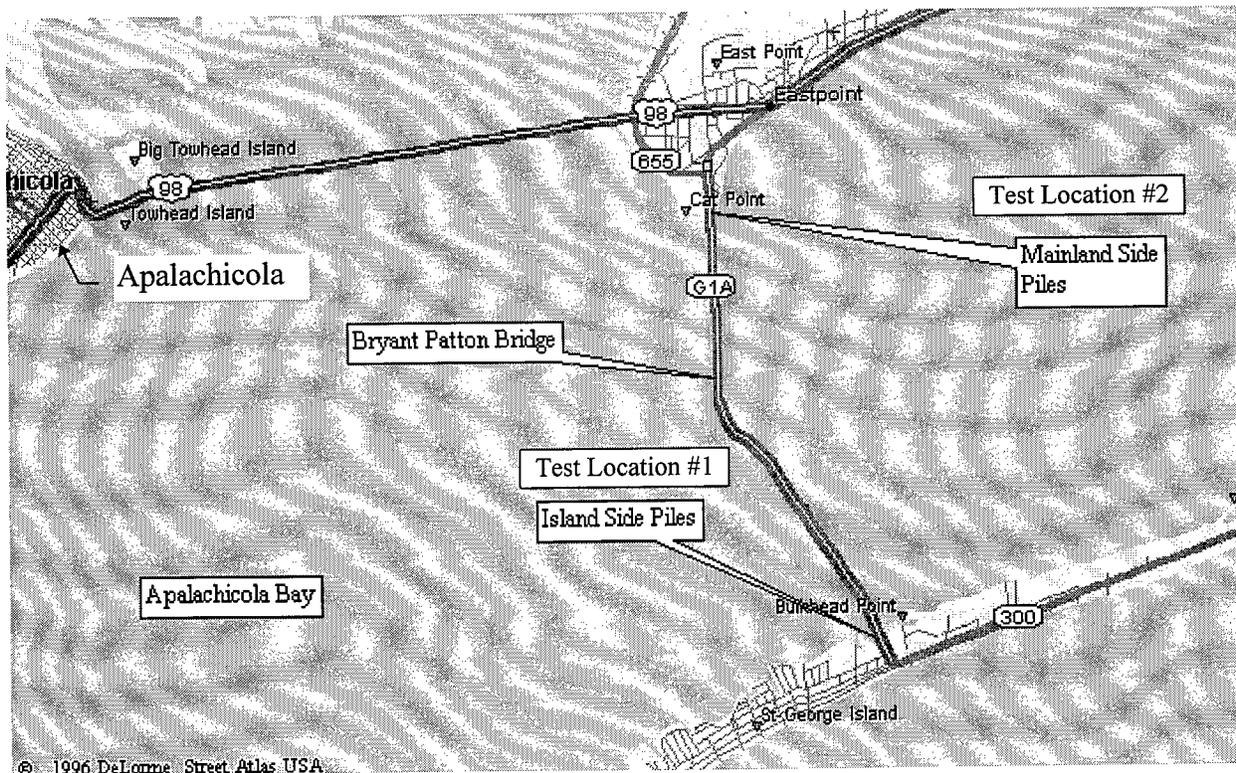
Figure 1. Location of the Bryant Patton Bridge and the piles used to test the sacrificial anodes.

The anode was applied with Florida DOT's assistance to selected prestressed concrete piles of the Bryant Patton Bridge, located between Eastpoint and St. George Island in Florida. This location is on the Gulf of Mexico coast between Tallahassee and Panama City. Figure 1 shows the location of the bridge and the test piles.

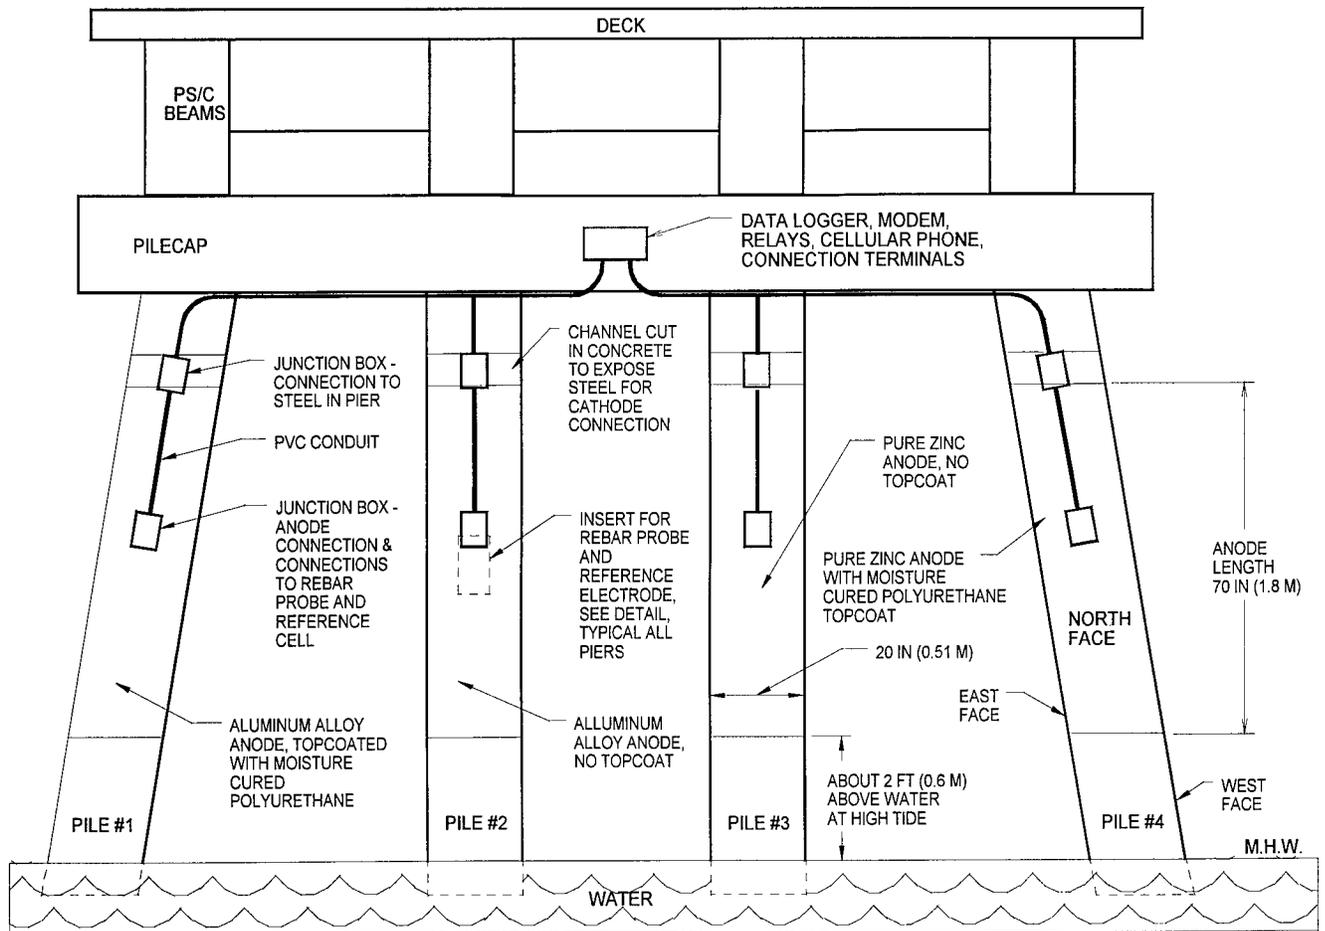
Figure 2. General layout of island-side piles (test location #1).
(view south toward St. George Island)

Two of the piles at test location #1 were coated with the aluminum alloy. In addition, two piles at this bent were coated with zinc for comparative purposes. Piles #1-1 and #1-2 were coated with the aluminum alloy and piles #1-3 and #1-4 were coated with pure zinc. Piles #2-5 and #2-6 on the bent at test location #2 were coated with the aluminum alloy, and pile #2-7 was coated with pure zinc. The zinc used for piles #1-3, #1-4, and #2-7 was 100 percent pure zinc supplied as 1/8-in- (0.3175-cm-) diameter wire. The nominal composition of the aluminum alloy was 80 percent aluminum, 20 percent zinc, 0.2 percent indium, and it was manufactured in the Sumitomo Metal Mining Co. laboratory for this project. Note that pile #2-7 also had a zinc anode mesh compression jacket applied at the base by Florida DOT.

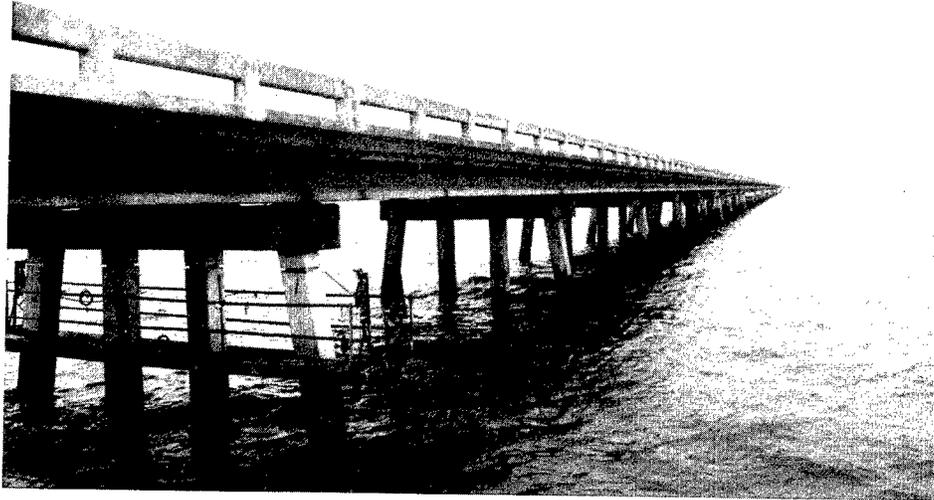
Figure 4. General view of Bryant Patton Bridge from St. George Island - view toward north.
(island-side piles are on the left)

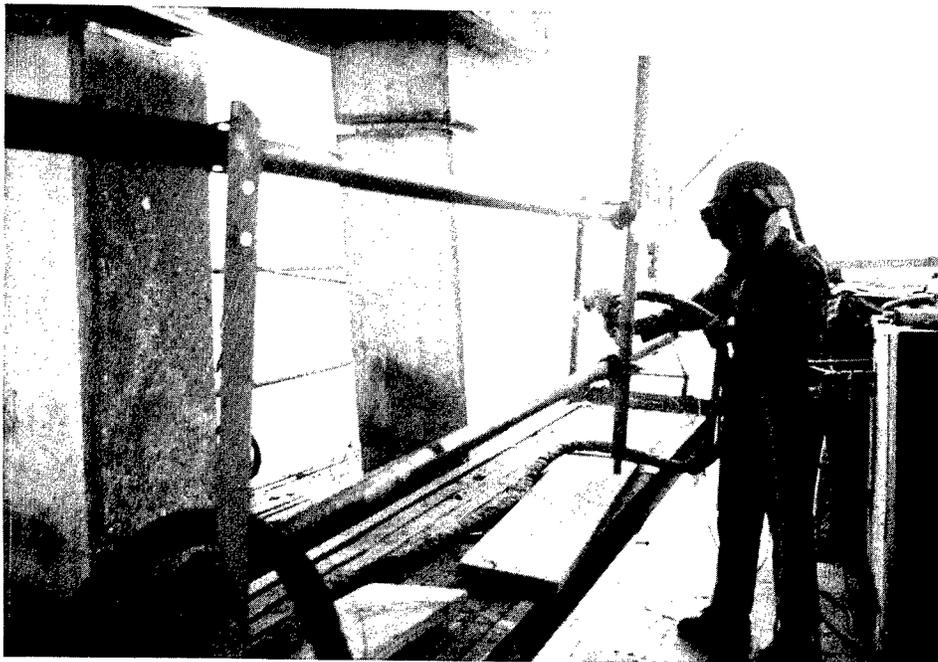
Figure 5. Application of aluminum alloy using arc-spray equipment (test location #1).

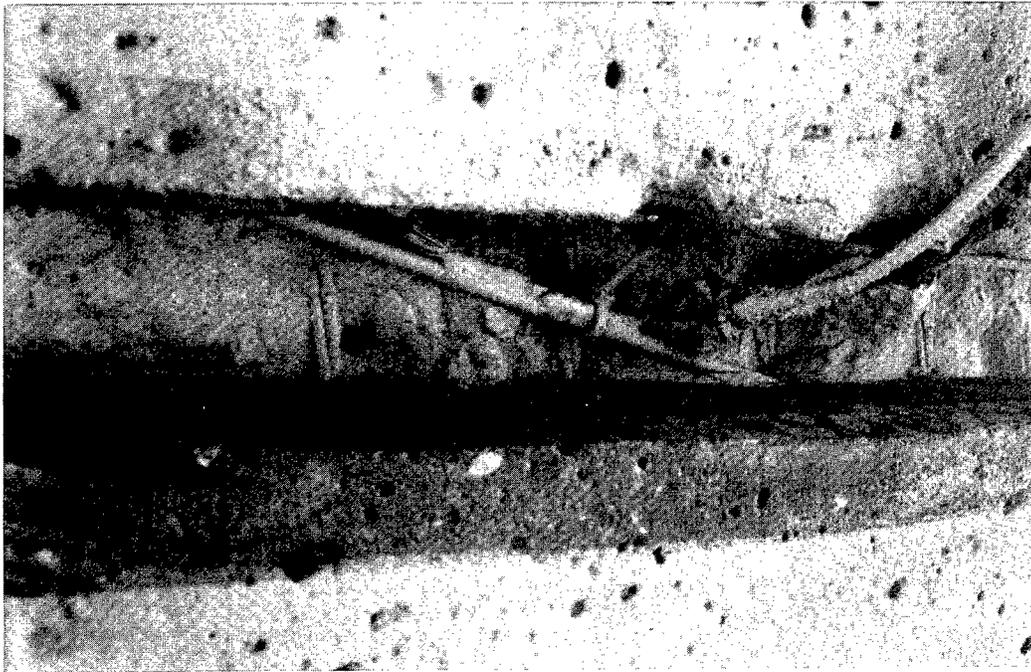
Figure 6. View of cathode connection at piles 1 to 4.

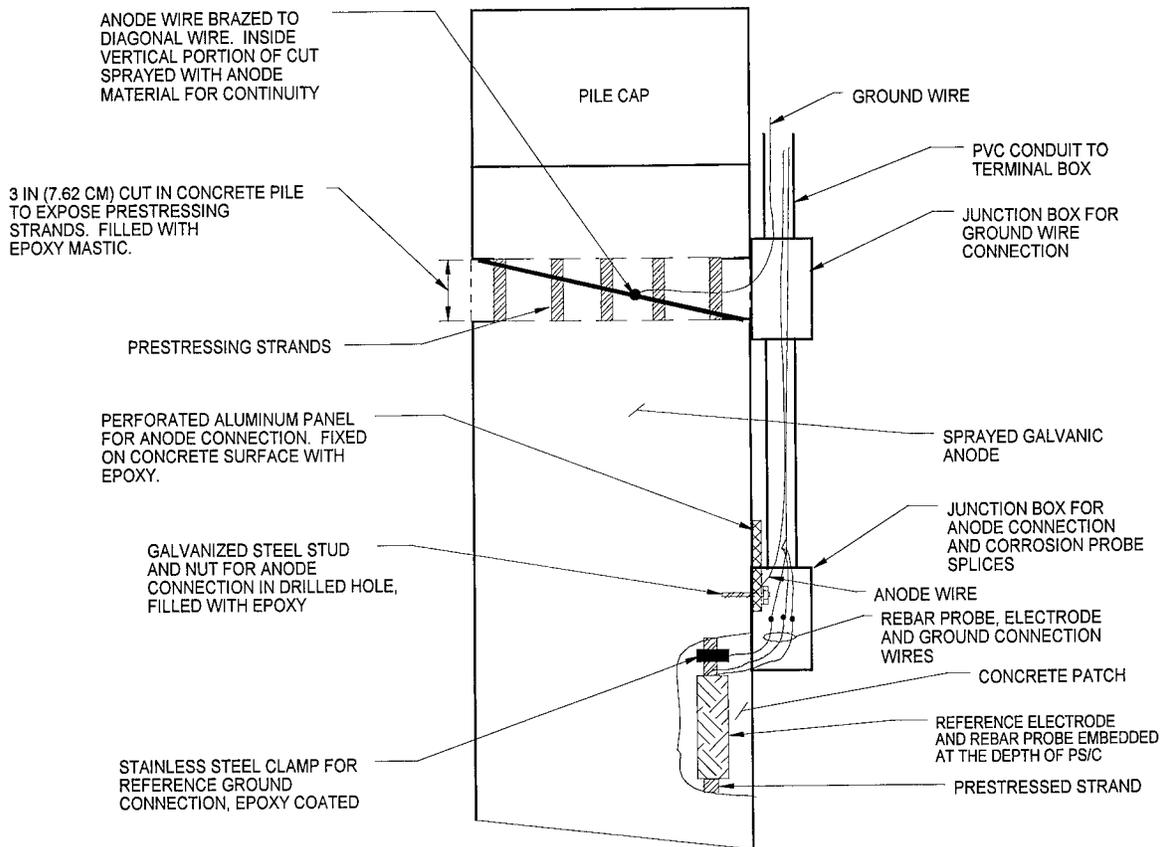
Figure 7. Schematic diagram of connections to piles.

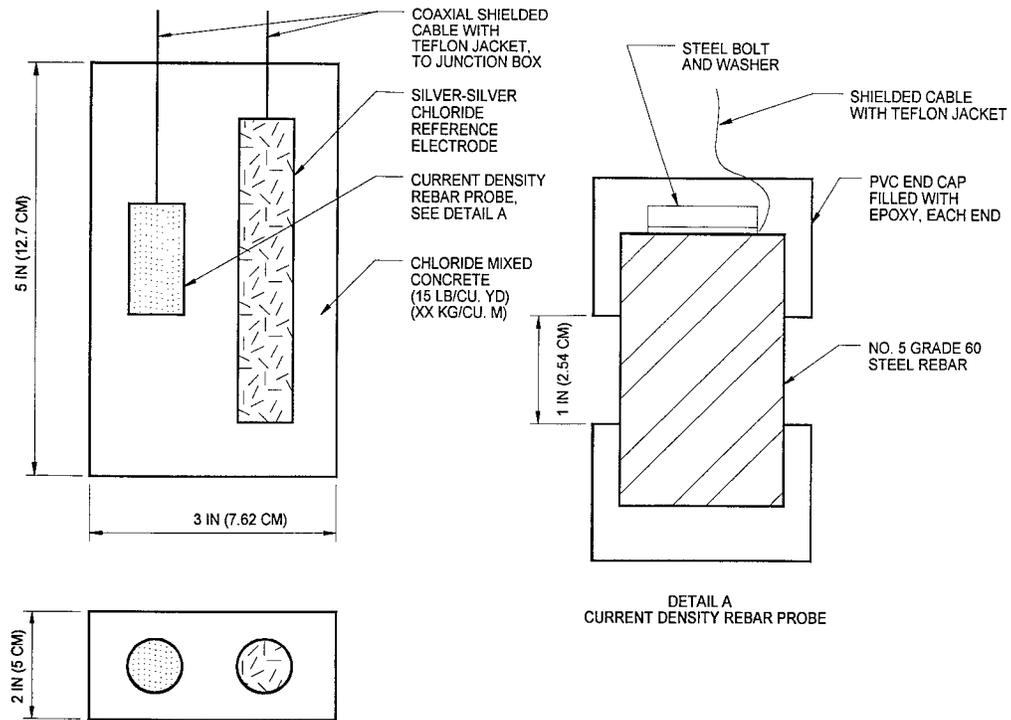
Figure 8. Details of reference electrode and rebar probe construction.

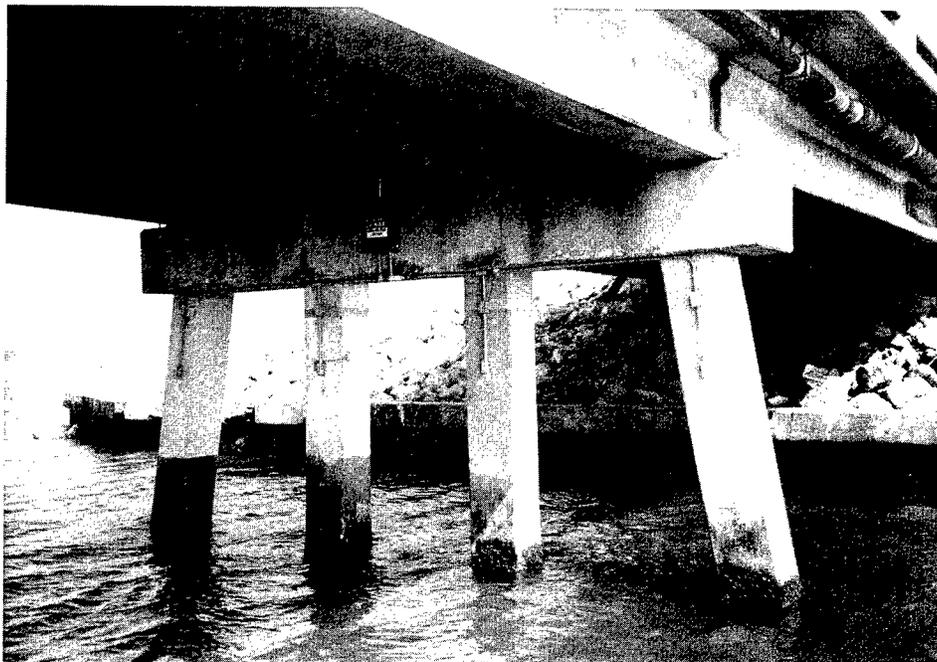
Figure 9. Completed island-side piles 1 yr after installation (test location #1).
(the data acquisition unit is the gray box mounted on the pile cap)

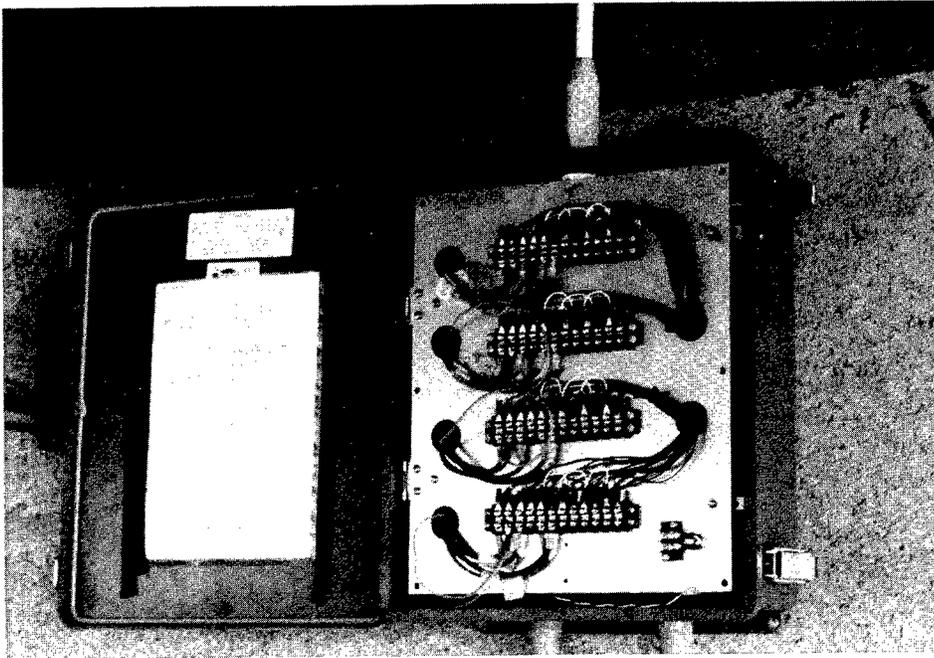
Figure 10. Terminal board inside data acquisition unit.

measurement of depolarization potentials. The DAU could be addressed through a cellular phone system mounted on the pile cap (see figure 2). Thus the data could be monitored and downloaded for analysis from Corpro's office. Figure 9 shows the completed installation (1 yr after installation) and figure 10 shows the interior of the DAU.

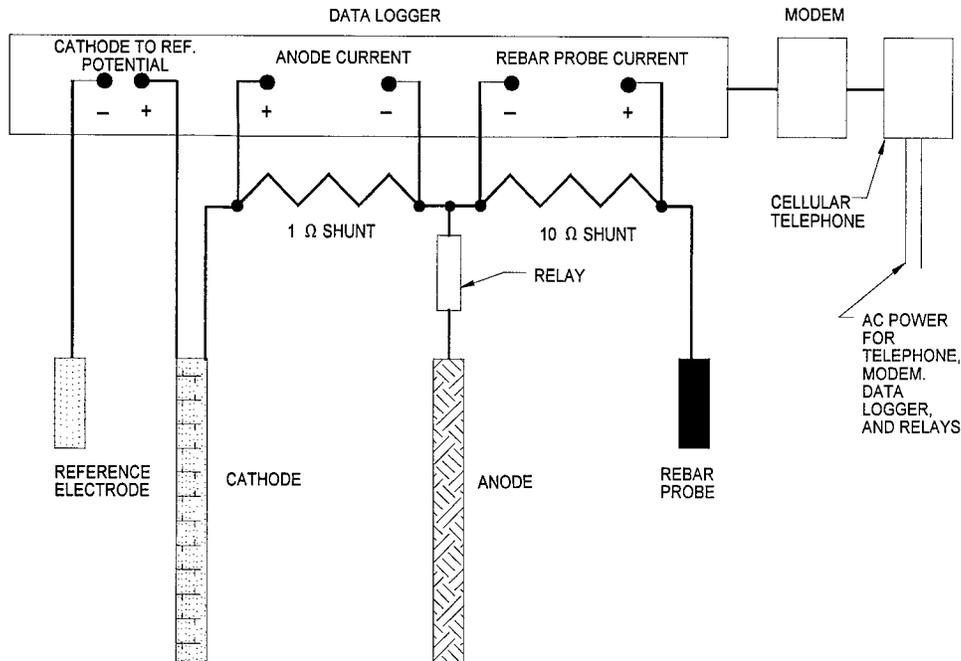
Figure 11. Schematic of data acquisition system.

The remote monitoring system was designed to permit measurement of anode-to-cathode current, anode-to-rebar probe current, and cathode potential. The system also was designed to allow the anode-to-cathode current to be interrupted remotely so that depolarization data could be taken. Figure 11 shows a schematic diagram of the data monitoring system.

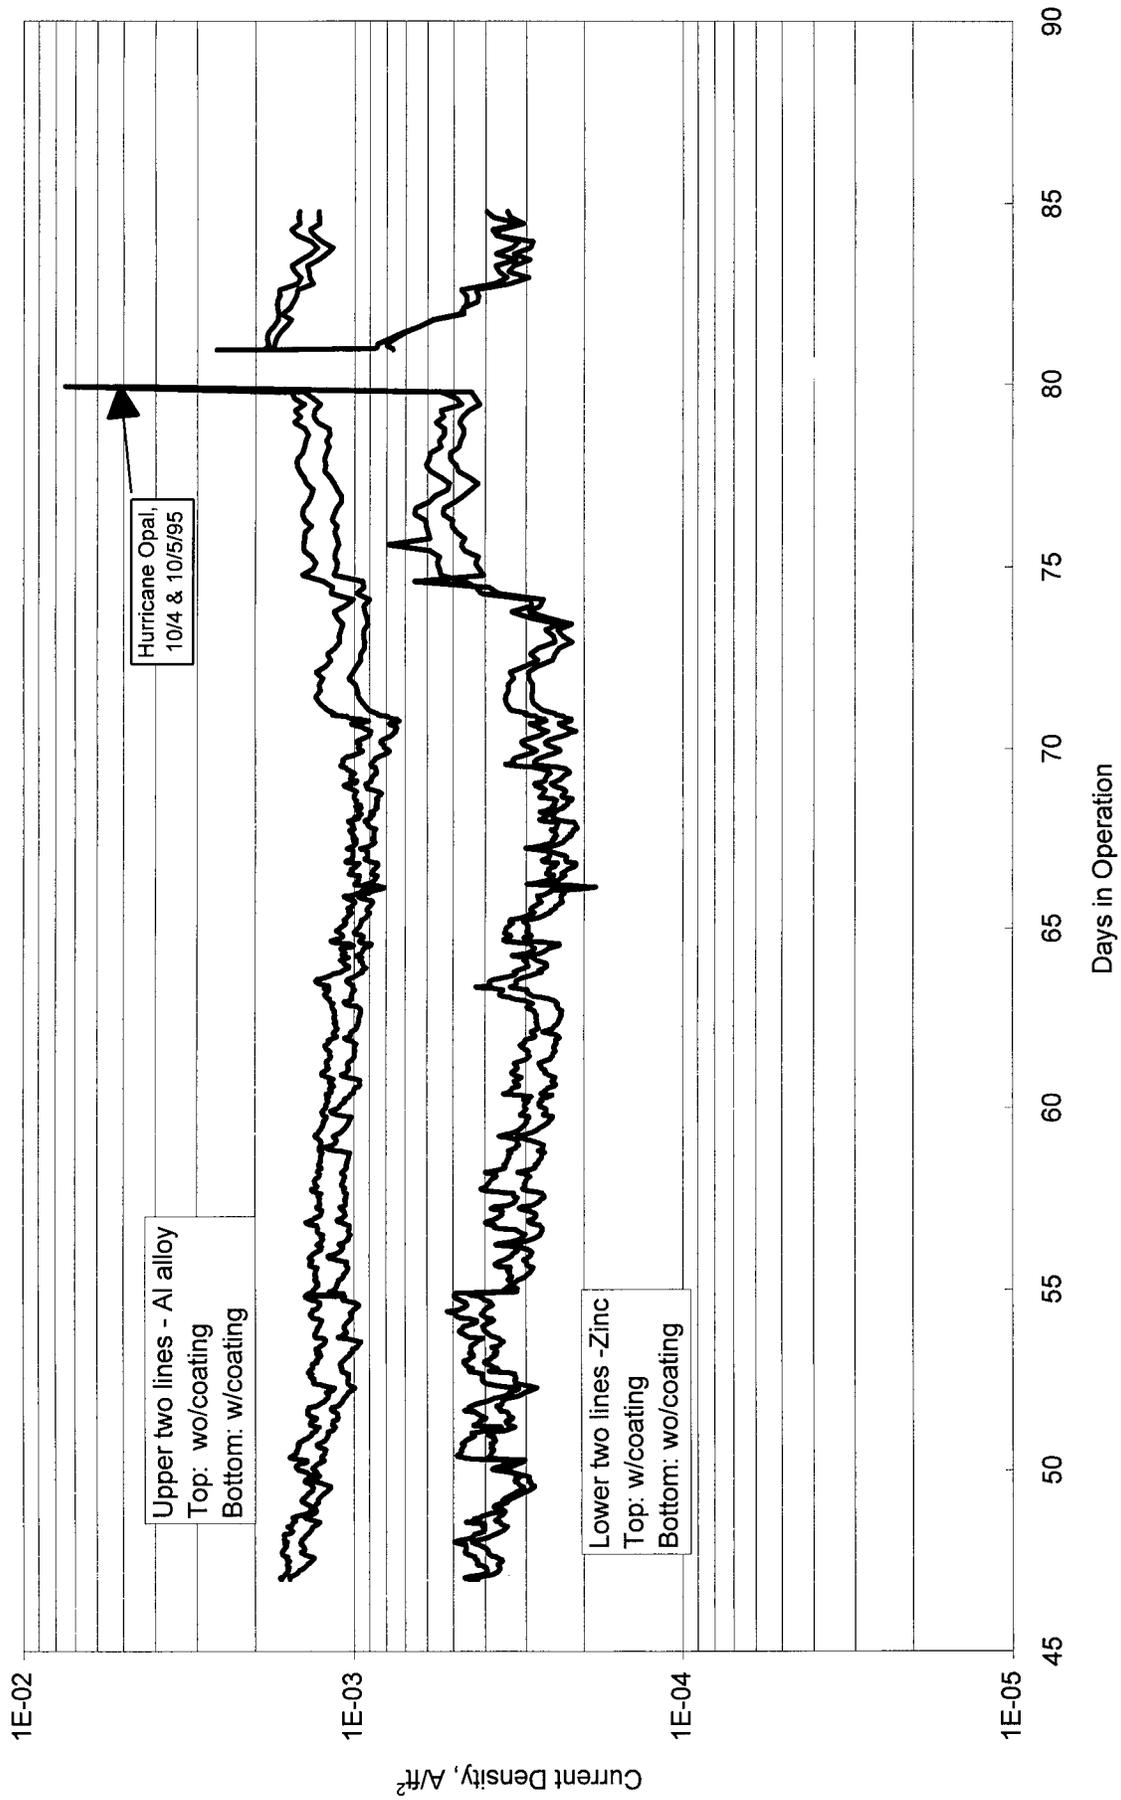
Figure 12. Sacrificial anode current density on steel, 8/30/95 to 10/9/95.

Table 3 summarizes the data derived from the data logger for the 2-yr test period. Figure 12 shows a representative anode current pattern (based on the steel surface area), this chart having been obtained at the beginning of the test, from the 43rd to the 85th day of operation (the period ending 10/9/95). The coated and uncoated anodes performed similarly throughout the whole 2-yr test period, so no differentiation is made between the coated and uncoated piles in this report.

The data logger was not active until after the system had been active for about a month and a half, but a gradual decline in current is seen for both anodes until about the 73rd day when the current started to rise, particularly that from the zinc anode. On about the 80th day, the current of all the anodes peaked. This corresponds to the date Hurricane Opal struck the Florida coast. There is a gap of about 24 h at the time of the hurricane, possibly caused by a power outage. After the hurricane, the current declined slowly, because of retained moisture in the concrete from the storm. The initial current rise before the hurricane was probably caused by moisture from rough seas and rain. Prior to the hurricane, the current density on the steel (steel surface area per pier = 23 ft²) from the aluminum alloy anodes was about 1 mA/ft² (10.76 mA/m²) and about 0.3 mA/ft² (3.23 mA/m²) from the zinc anodes. Note the fluctuation in current with time, resulting from temperature and humidity changes of the environment from hour to hour and day to day.

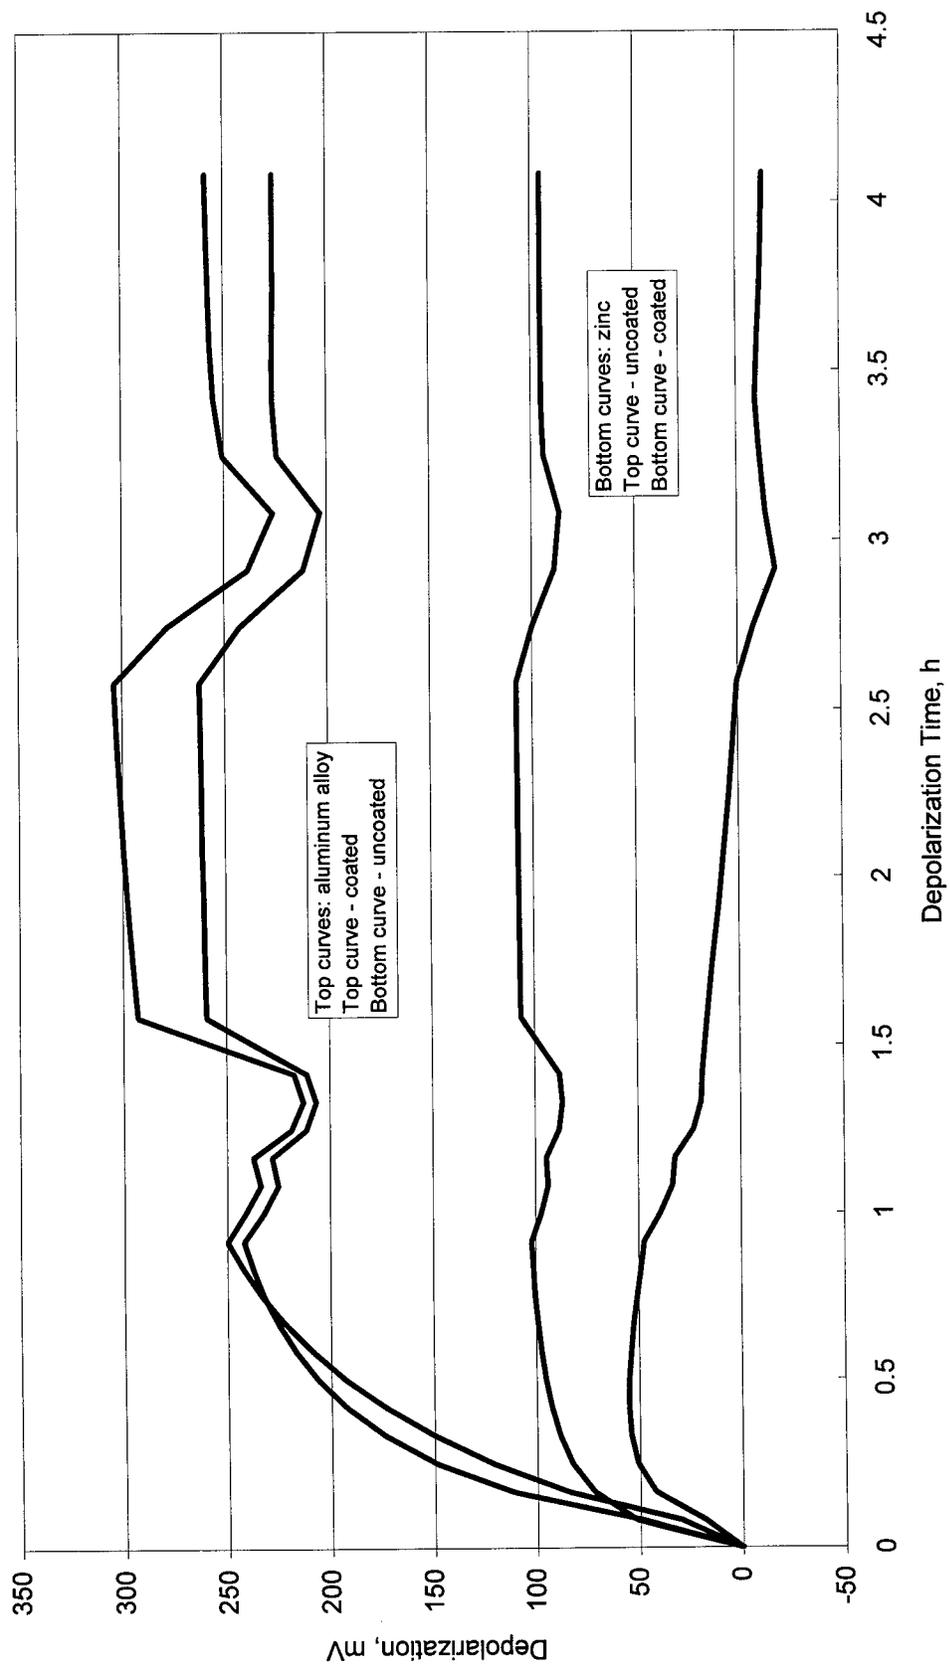
Figure 13. Depolarization curves, 10/24/95.

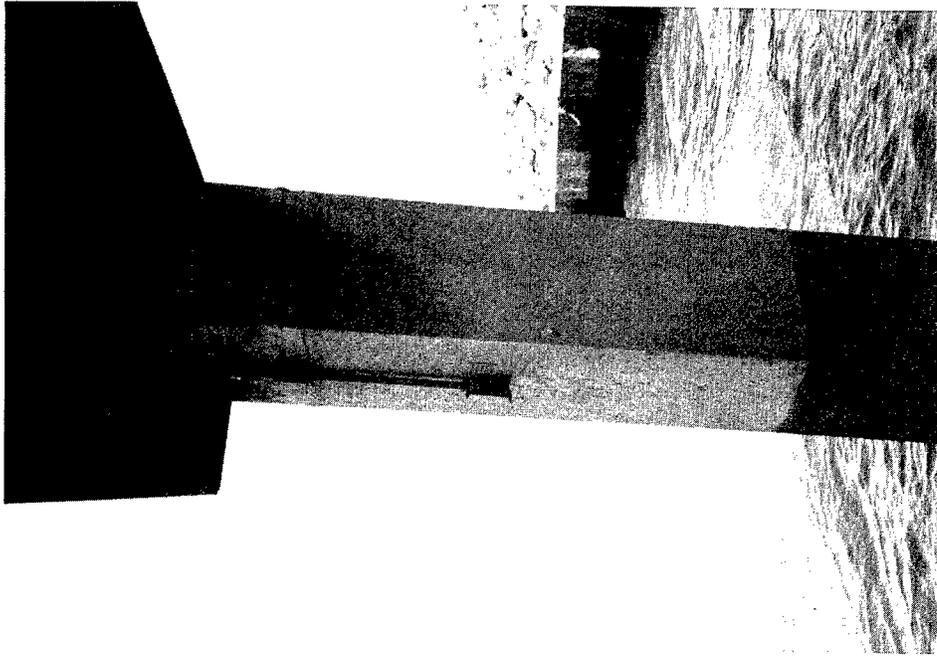
Figure 15. View of north and west faces of pile #1-1, May 1996.
(note loss of anode material below center junction box on north
face)

Despite the good current values observed on piles #1-1 and #1-2, the depolarization values remained disappointingly low from April 1996 on. The inspection trip in May 1996 revealed the reason for this, which was the disbonding of the aluminum alloy anode from the face of the concrete patch where the reference electrode was placed. This anode was placed over relatively

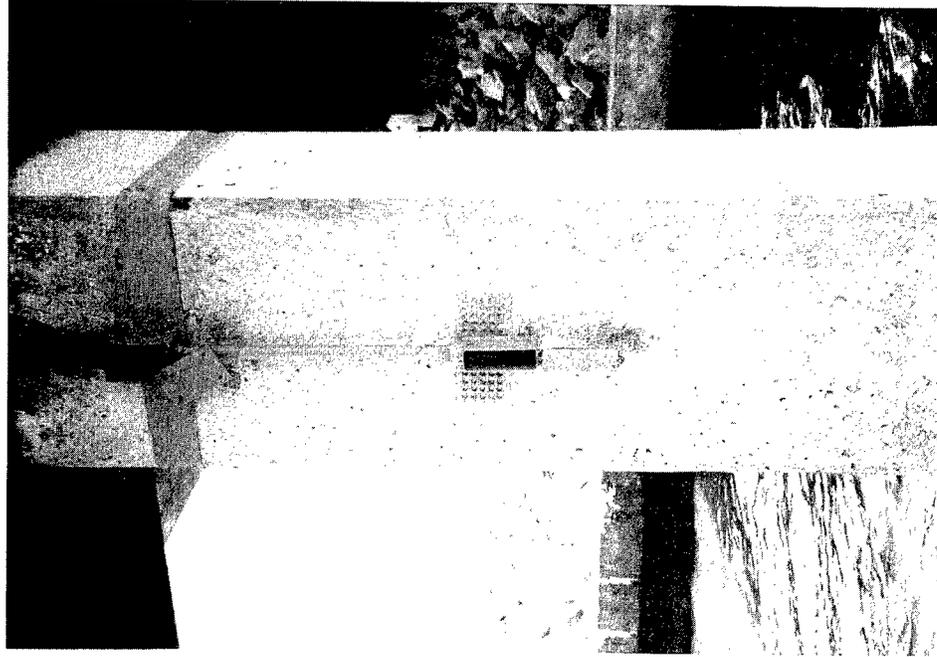
Figure 16. View of north and west faces of pile #1-2, May 1996.
(note anode material loss below center junction box on north face)

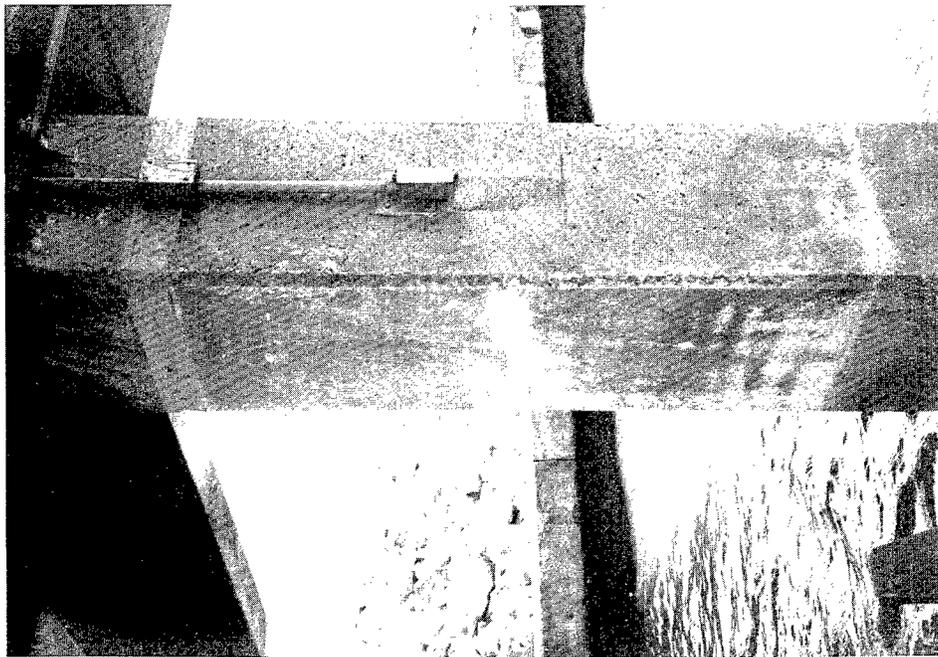
Figure 17. Pile #1-3, north and east faces, May 1996. (note white corrosion products on surface, particularly near base)

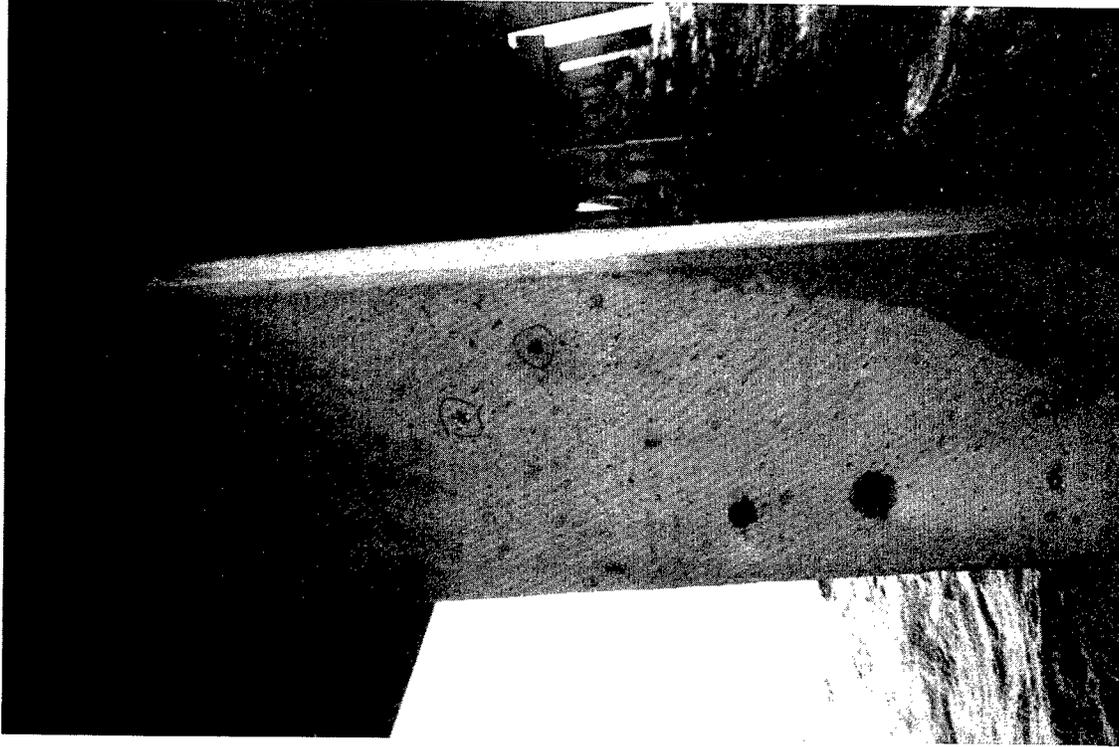
Figure 21. View of south face of pile #2-5, June 1997.
(Note porosity of concrete and small delaminated area)

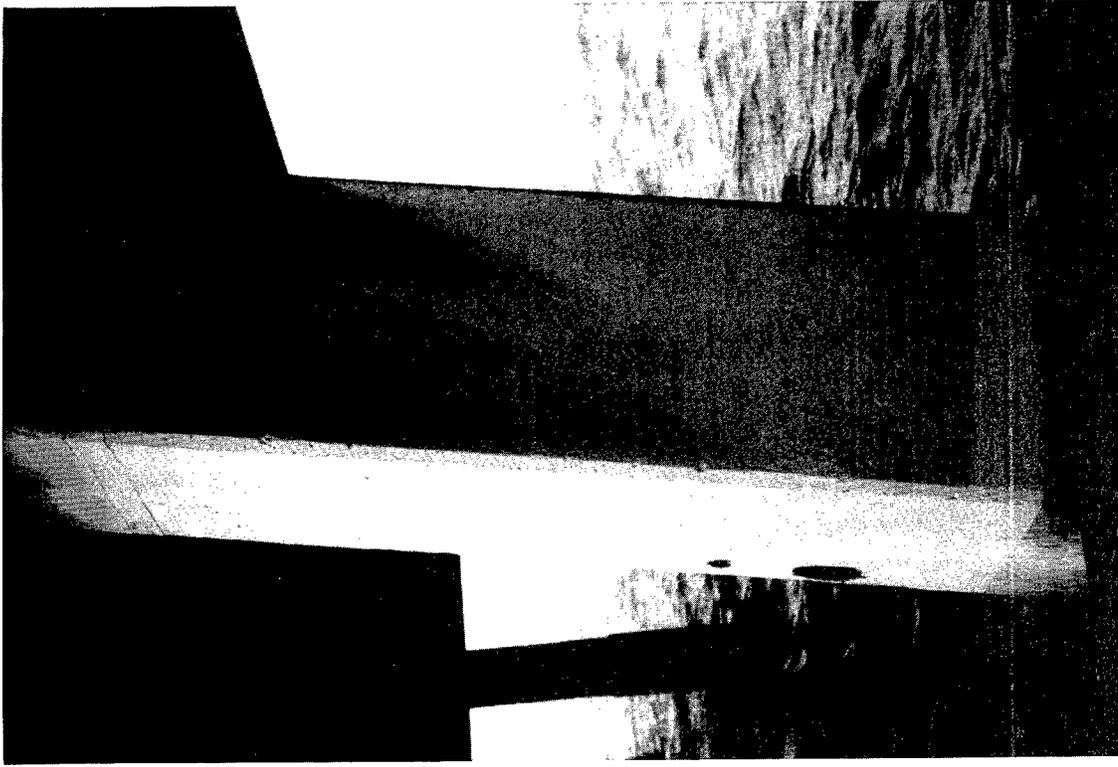
Figure 23. View of north and west faces of pile #2-6, June 1997.
(Note localized areas of disbondment at aggregate and adhesion
doliies)

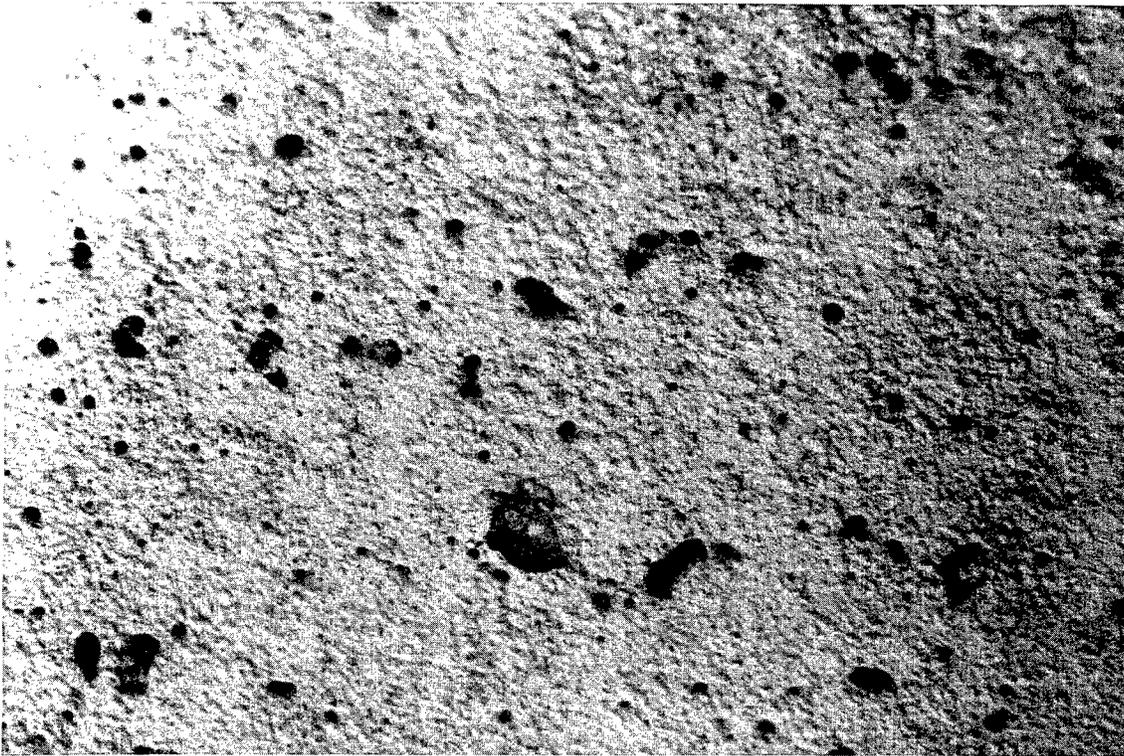
Figure 24. View of north face of pile #2-6, June 1997.
(Close up of disbonding at aggregate)

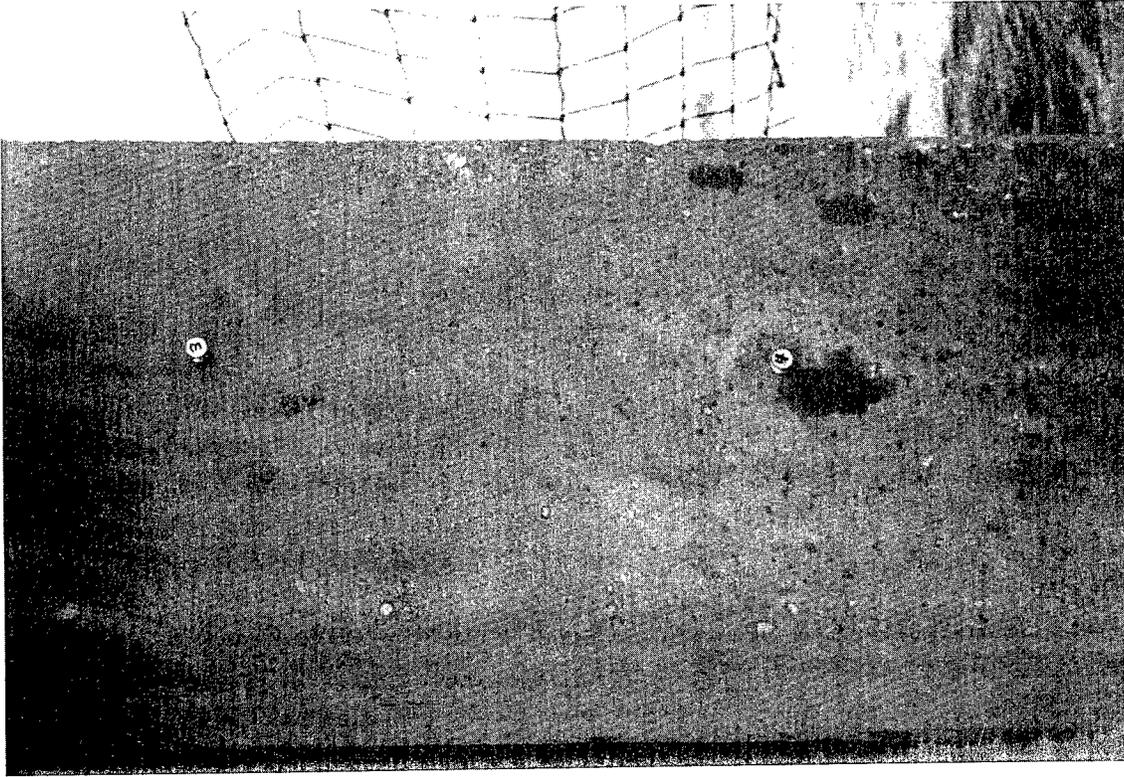
Figure 27. View of south and east faces of pile #2-7, June 1997. (South face, note localized disbondment at aggregate, junction box is for FL DOT splash zone anode test)

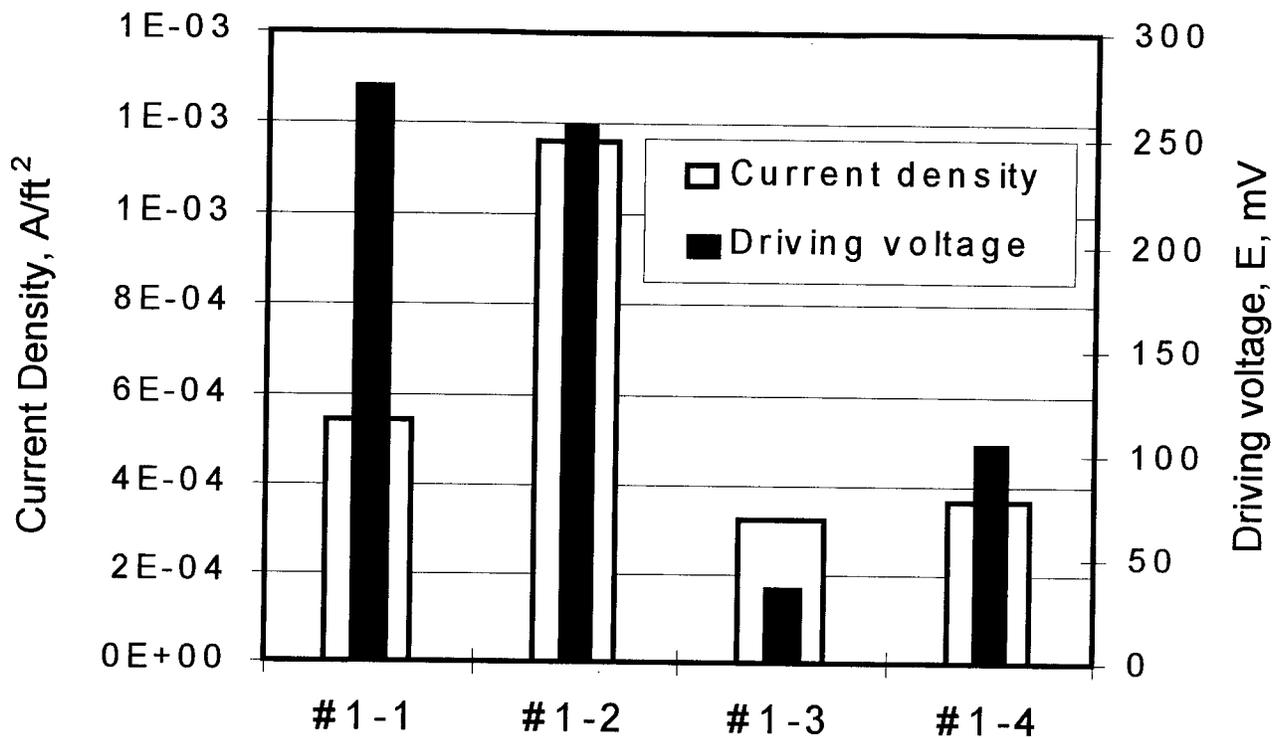
Figure 28. Galvanic anode current density (on steel) and driving voltage, June 10, 1997.

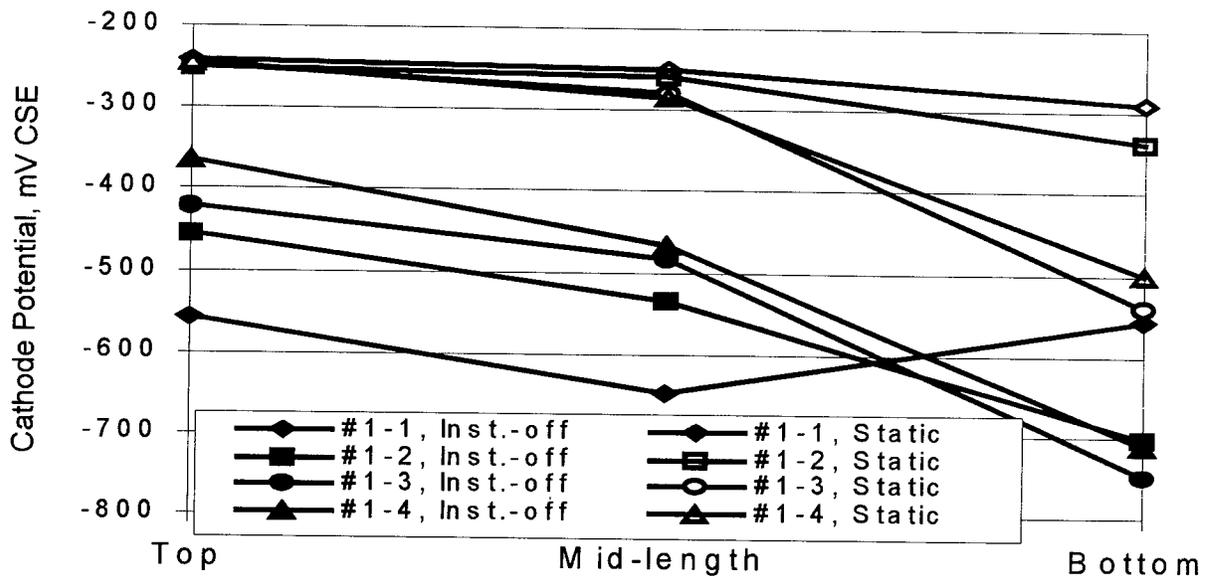
Figure 29. Comparison of instant-off and static cathode potentials with position on pile, June 11, 1997.

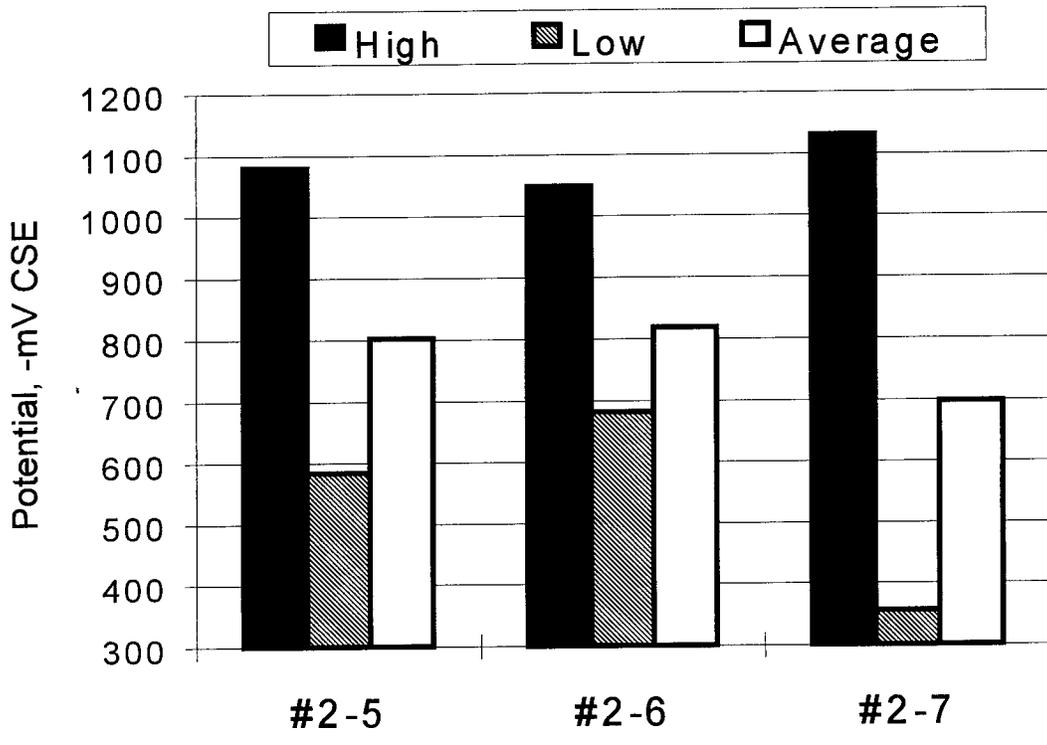
Figure 38. Mixed anode-cathode potentials, piles on mainland side, June 10 to 11, 1997.

Mixed anode-cathode potentials were taken on the mainland-side (test location #2) pile bent. The potentials were taken in the same manner as those at test location #1, but at random locations. The test points were located about mid-length of the anode, and data were taken on each face. Figure 38 presents the high, low, and average potential at each pile. There is a large variation in potentials, although the zinc anode (pile #2-7) does have a wider range and lower average. The active potentials were measured at locations where the concrete was obviously wet and the more noble potentials were measured in drier locations.
