Field Evaluation of a New Aluminum Alloy as a Sacrificial Anode for Steel Embedded in Concrete

PUBLICATION NO. FHWA-RD-98-058

APRIL 1998

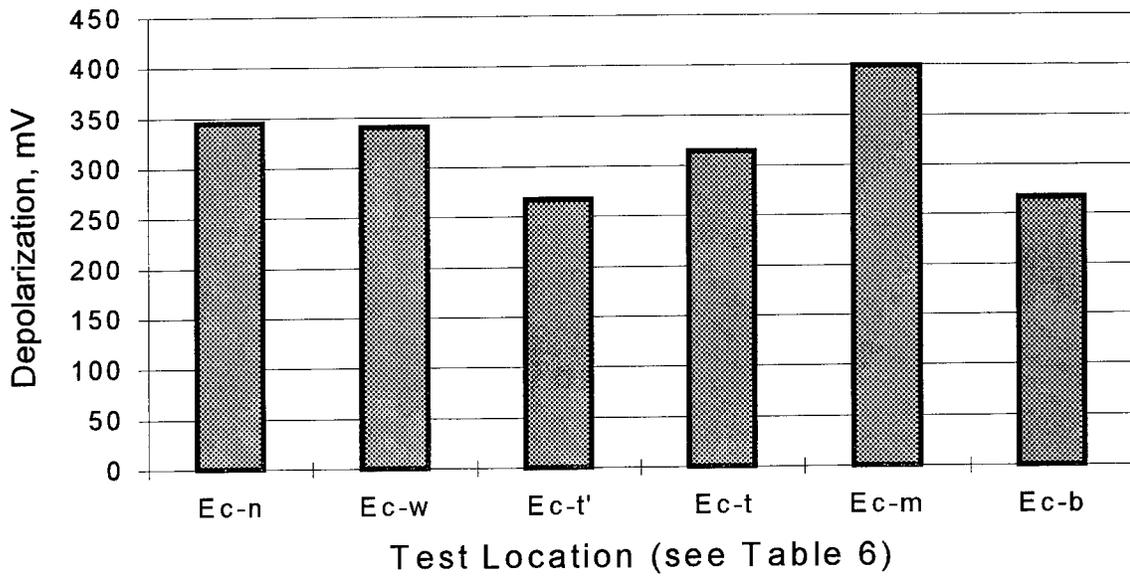
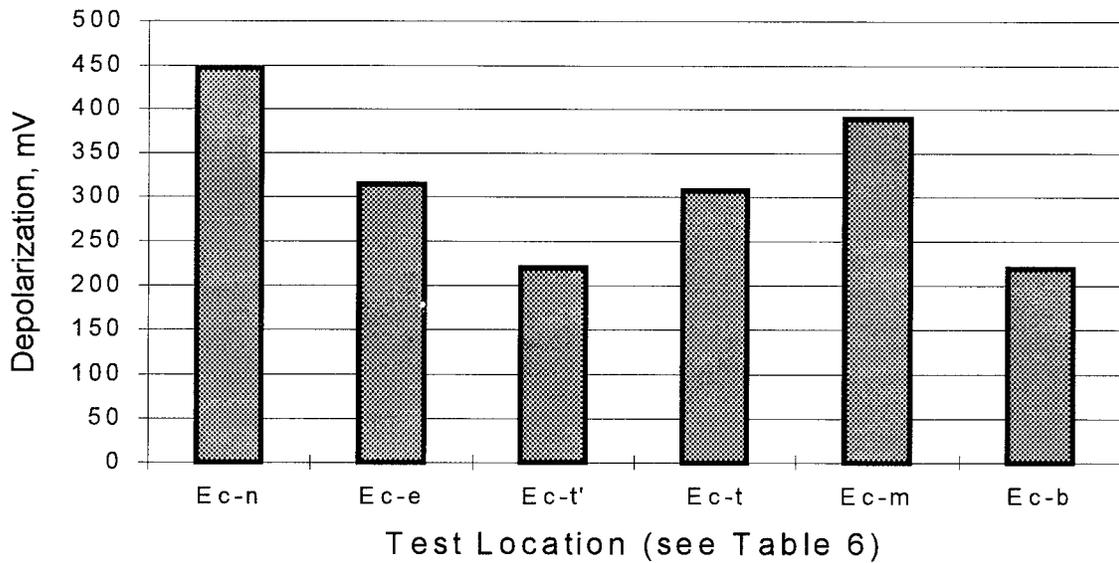
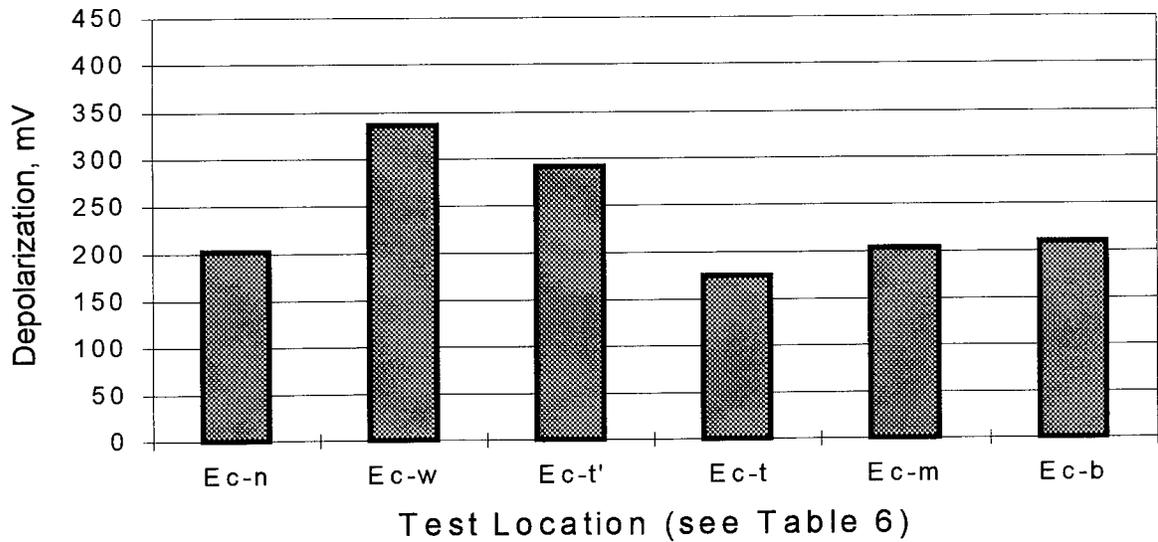
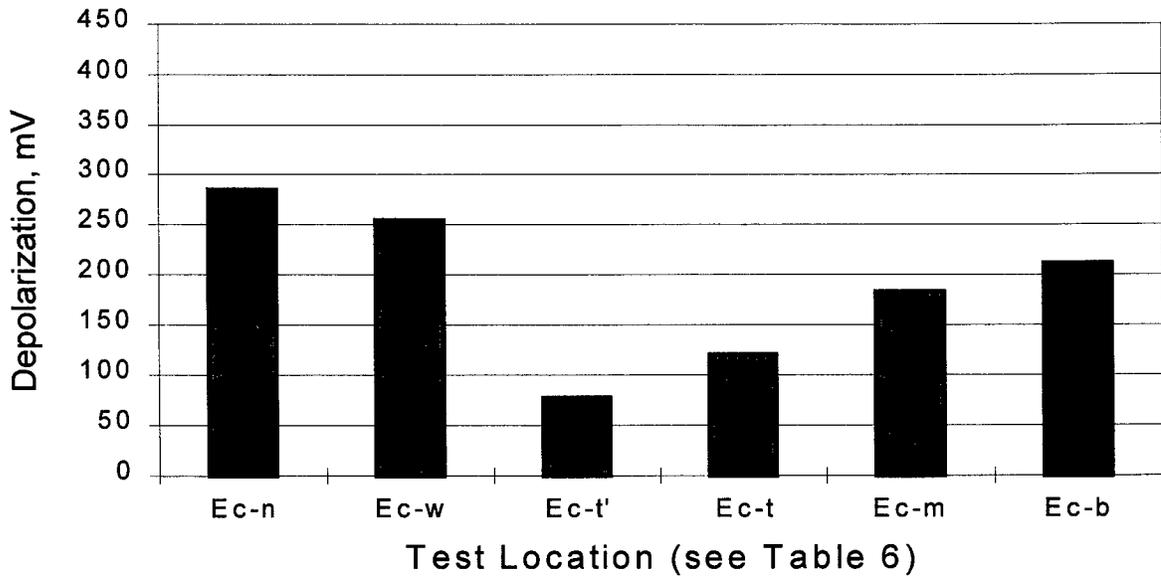
Figure 40. Cathode depolarization on pile surface, final data, pile #1-1

Figure 42. Cathode depolarization on pile surface, final data, pile #1-2.

Figure 44. Cathode depolarization on pile surface, final data, pile #1-3.

Figure 46. Cathode depolarization on pile surface, final data, pile #1-4.

Figures 40, 42, 44, and 46 show the depolarization data obtained directly on the concrete surfaces of the piles using a surface reference electrode. Depolarization values for the cathodes on the aluminum alloy-coated piles ranged from 219 to 447 mV and those for the zinc-coated piles ranged from 77 to 336 mV. The depolarization values for the aluminum alloy-coated piles are generally higher than those for the zinc-coated piles. The values of depolarization tended to increase toward the bottom of the anode, as might be expected, although the bottom reading on piles #1-1 and #1-2 did not follow this trend.

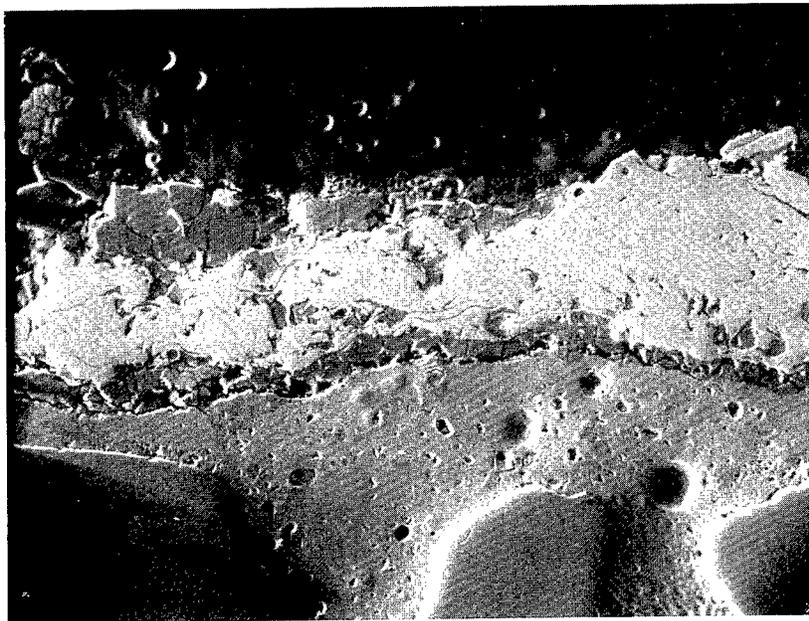
Figure 47. SEM image of a cross-section through the concrete core from pile #1-1 south face, 100X. (aluminum alloy anode had been active for 2 yr, concrete is at the bottom)

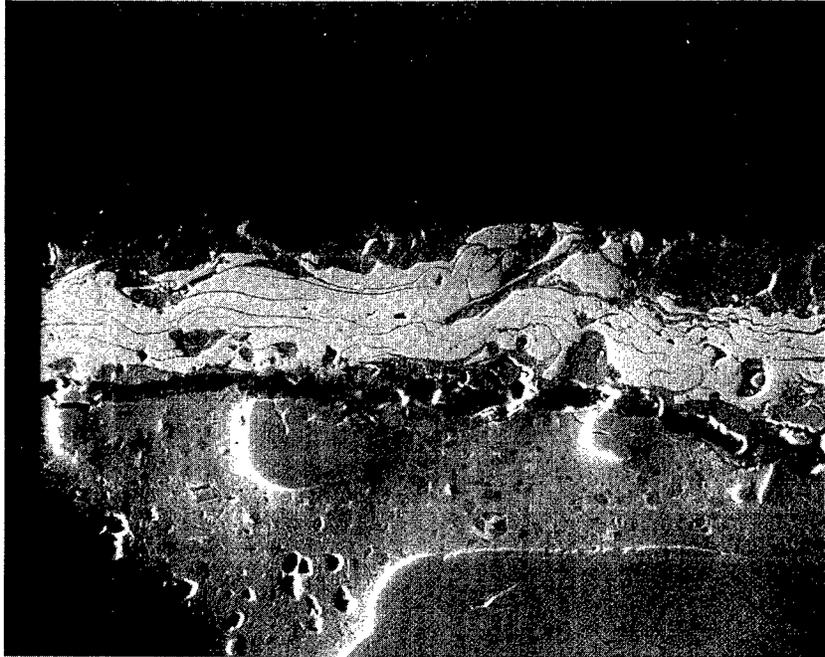
Figure 48. SEM image of a cross-section through the concrete core from pile #1-2 south face, 100X. (aluminum alloy anode had been active for 2 yr, concrete is at the bottom of the photograph)

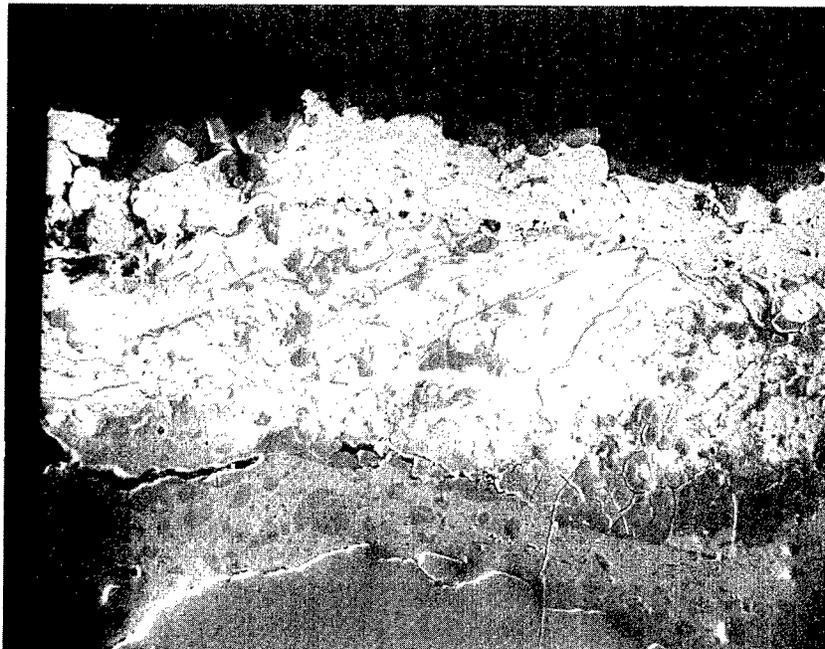
Figure 49. SEM image of a cross-section through the concrete core from pile #1-2 north face, 100X. (aluminum alloy anode had been active for 1 yr, concrete is at the bottom of the photograph)

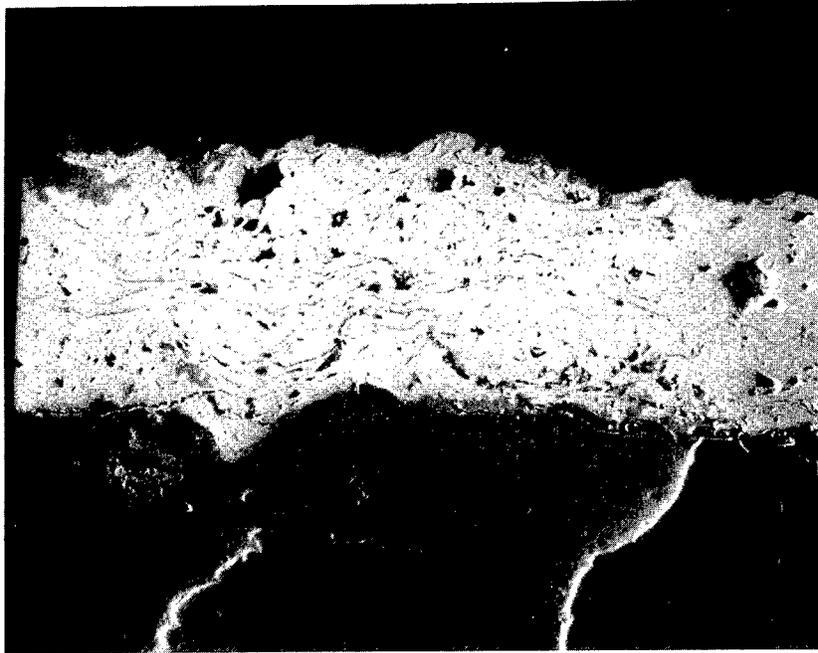
Figure 50. SEM image of a cross-section through the concrete core from pile #1-3 west face, 100X. (zinc anode had been active for 2 yr, concrete is at the bottom of the photograph)
