# Performance of Two Rubber-Modified Asphalt-Concrete Overlays: A Three-Year Progress Report

**SPECIAL REPORT 107**

Interim Report on Research Project 214-1  
Conducted in Cooperation With  
The U.S. Department of Transportation  
Federal Highway Administration

Special Report 107  
December 1992

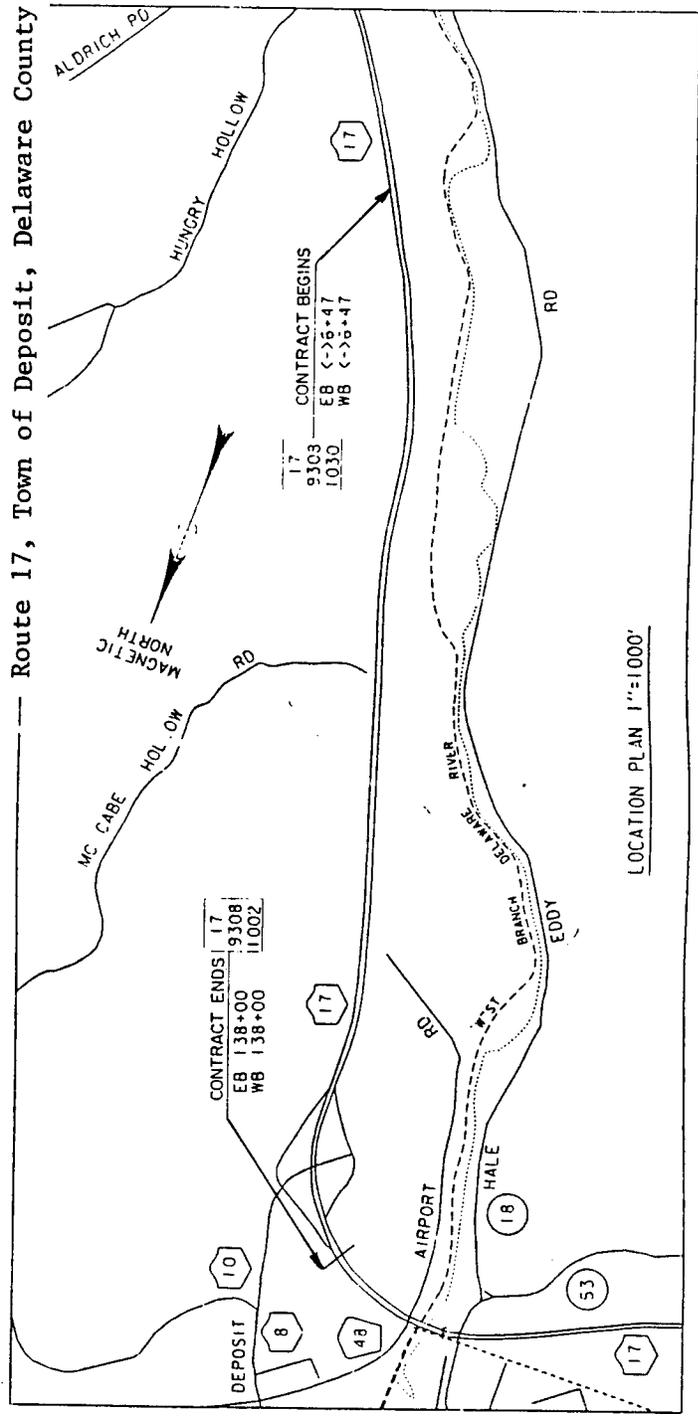
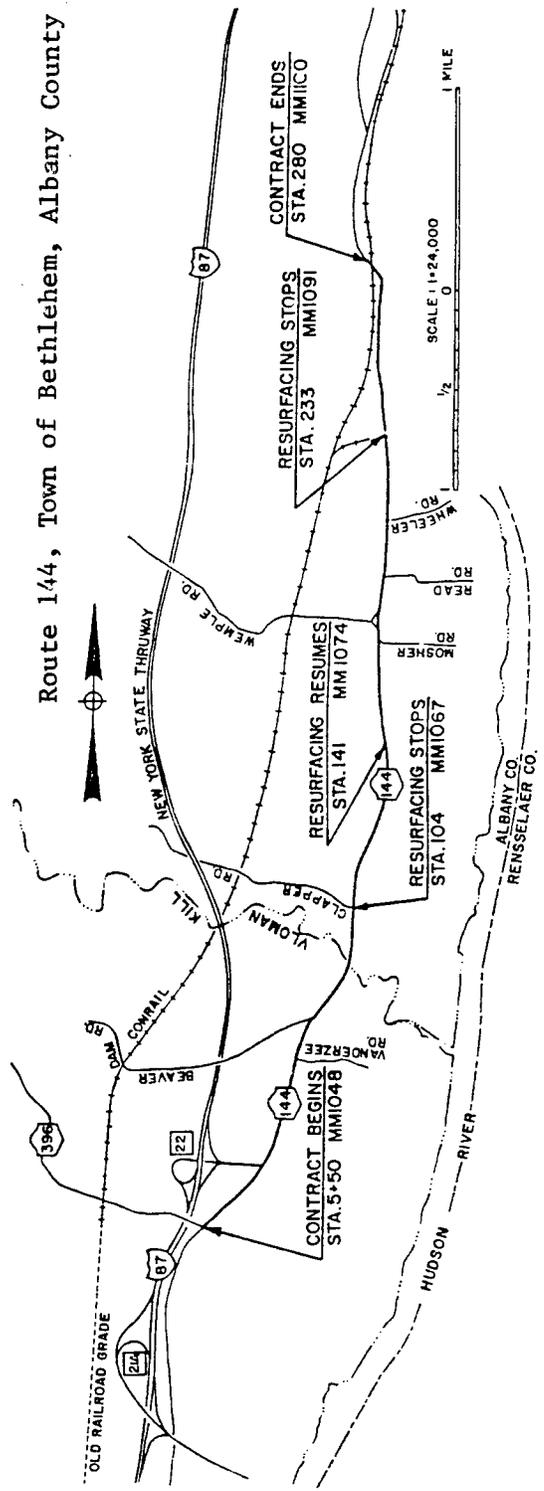
Figure 1. Locations of RUMAC pavements.

1. The Rte 17 site is in the Town of Deposit, Delaware County (Fig. 1), with an AADT of 5200 and 15-percent trucks. This was a "crack-and-seat" project on an existing concrete pavement, consisting of 5½ in. of new asphalt concrete pavement as an overlay. The first 2½ in. course was for truing-and-leveling, the next 1½ in. was a binder course, and the final 1½ in. was either a mix incorporating rubber as a percentage of total weight of the mix, or a conventional top-course. Each of the mix segments was about 2000 ft long and the paving sequence progressed as follows: 1-percent, 3-percent, Plus-Ride (also 3-percent), 2-percent, and conventional.

2. The Rte 144 site is in the Town of Bethlehem, Albany County (Fig. 1), and is similar in traffic pattern. It also has an AADT of 5200 with a slightly higher truck count of 16 percent. The contract was an asphalt concrete resurfacing project consisting of a 1½-in. overlay, again incorporating a percentage of rubber or a conventional top course mix, over an existing 1½ in. asphalt cement concrete overlay, which in turn was over an original 9-in. concrete pavement. Because of contract limitations, paving took place in two sections 1.75-miles apart. The mix segments are about 1000 ft long in each section. Section 1 was paved in this order: 1-percent, 2-percent, 3-percent, Plus-Ride, and conventional, with Section 2 in random order -- conventional, 2-percent, Plus-Ride, 1-percent, and 3-percent. Typical closeups of each mix are shown in Figure 2.

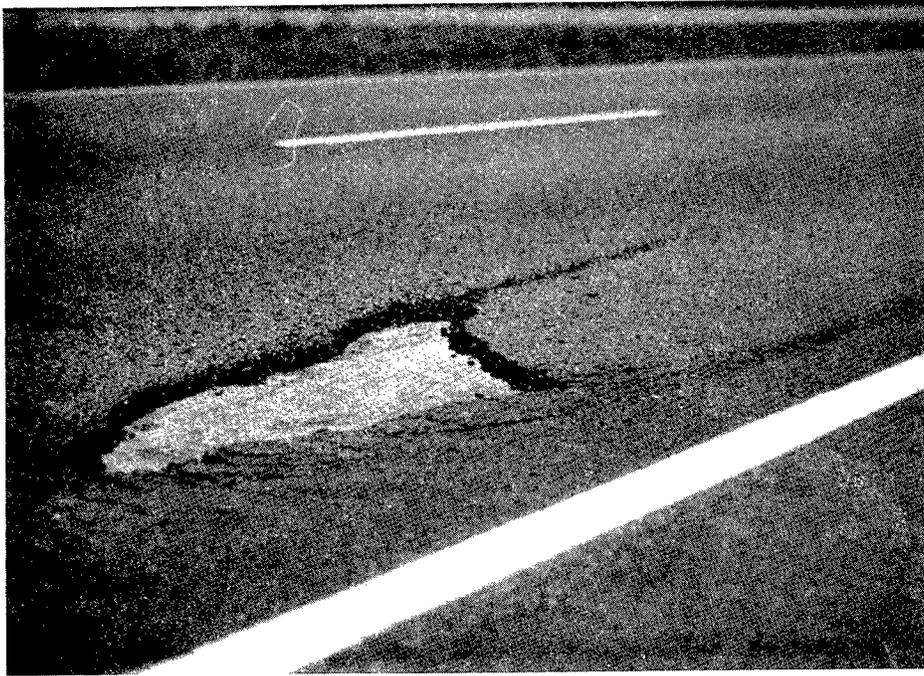
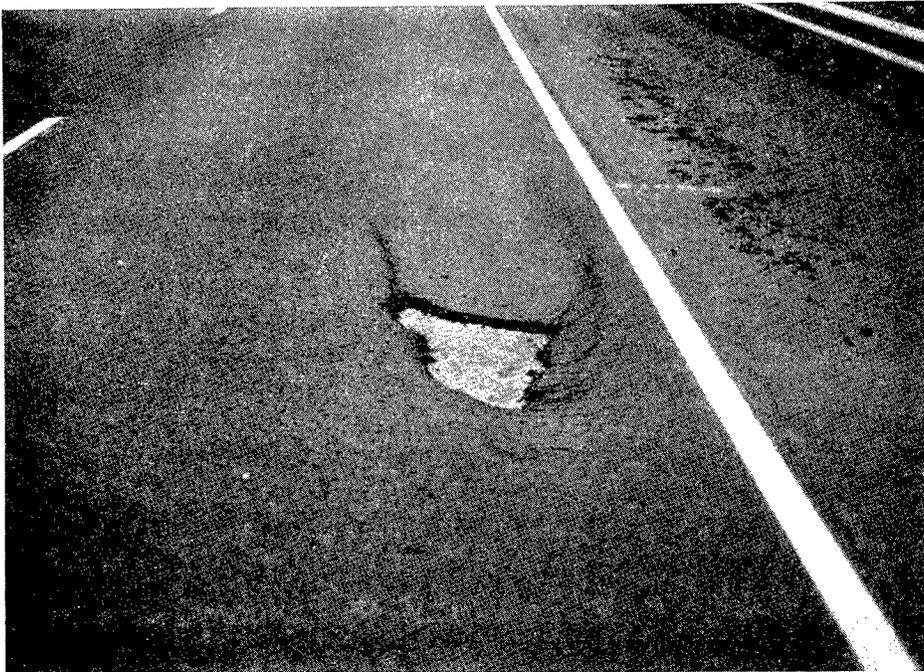
The area of surface course debonding (raveling) from the underlying pavements is documented in Table 1. Raveling is facilitated by water intrusion through cracks and other surface distress areas. Water is prevented from draining in these RUMAC sections because the shoulder mixes are denser. Water ponds at the pavement edges (usually the lowest point on the pavement) and ravels thus appear mostly in the outer wheelpath. Raveling initially occurs as alligator or slippage (shear) cracks (Fig. 3). Occurrence of shear failures in the RUMAC pavement sections is inexplicable, because historically they take place in transition (stop/go/turn) traffic areas. In the case of these sections, they appear randomly. As the percentage of rubber increases, severity of this particular distress also increases.

Figure 3. Typical raveled areas resulting from shear failure on Route 17.

In July 1992 notification was sent to both Regional Materials Engineers to eliminate the 3-percent area in Section 1 on Rte 144 and the 3-percent area on Rte 17 due to uncontrollable raveling. Removal and replacement of these two distressed sections by whatever means convenient was suggested to them. It should be noted that in 1991 each site's problem areas were properly cut back to sound pavement and patched with conventional mix to no avail.

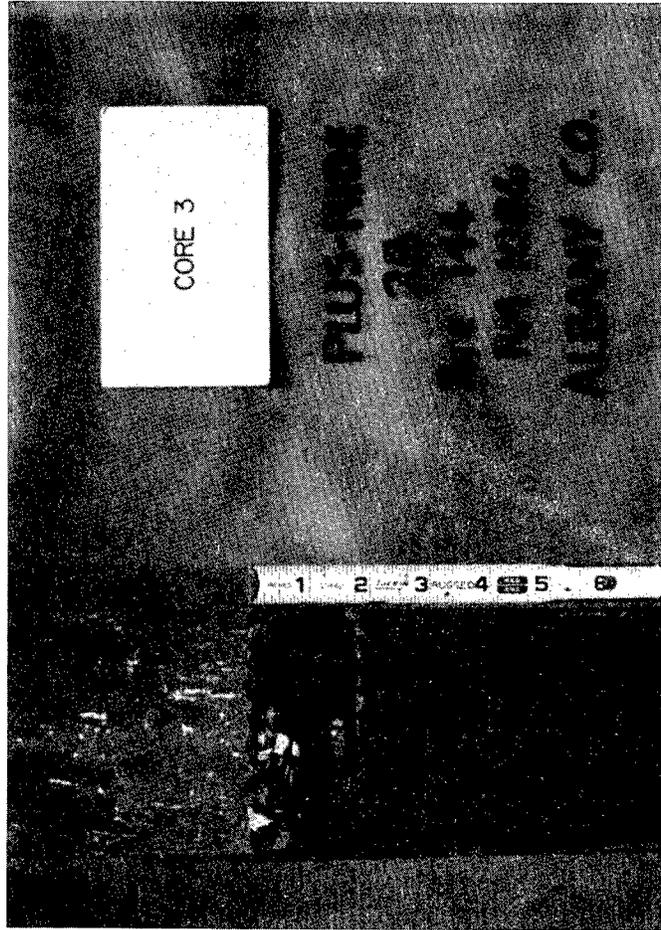
Figure 4. Typical raveling repair by patching on Route 144 before removal of Plus-Ride section (left), and appearance of core from raveled area (below).

In consultation with the Regional Materials Engineer, it was determined from pavement cores extracted in Fall 1990 from Plus-Ride Section 2 on Rte 144 that this mix was more permeable than the underlying pavement, leading to premature deterioration. In October 1991, after numerous complaints from the motoring public and inability of maintenance forces responsible for this section of highway to keep up with steady eroding of pavement due to raveling (Fig. 4), the Plus-Ride course in Section 2 on Rte 144 was removed and replaced with a conventional mix. During its removal, because of the presence of standing water after a relatively dry period, it was apparent that the failure was caused by the Plus-Ride mix's permeability in contrast to the shoulder or underlying mixes.

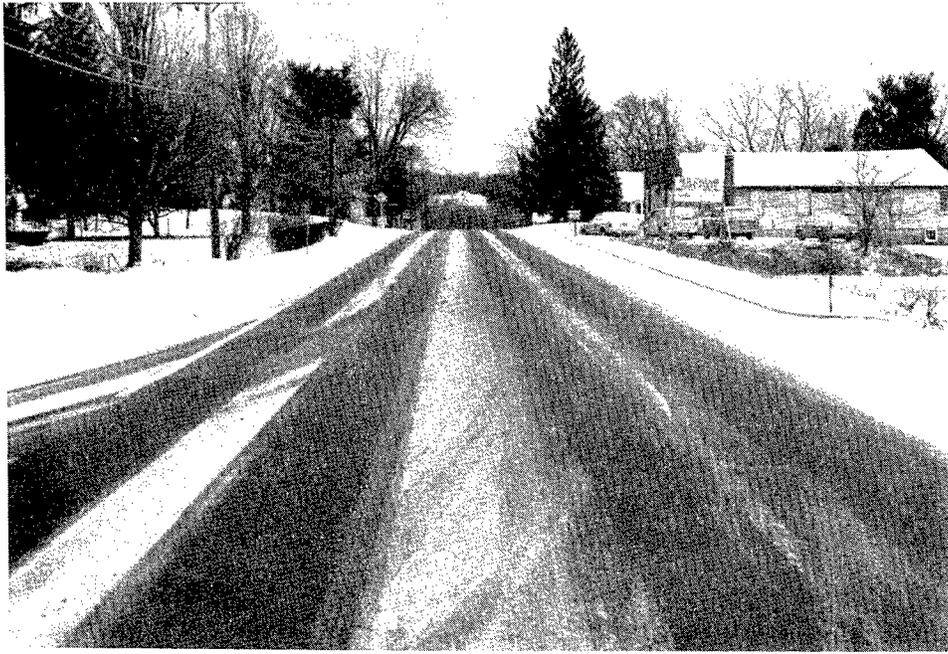
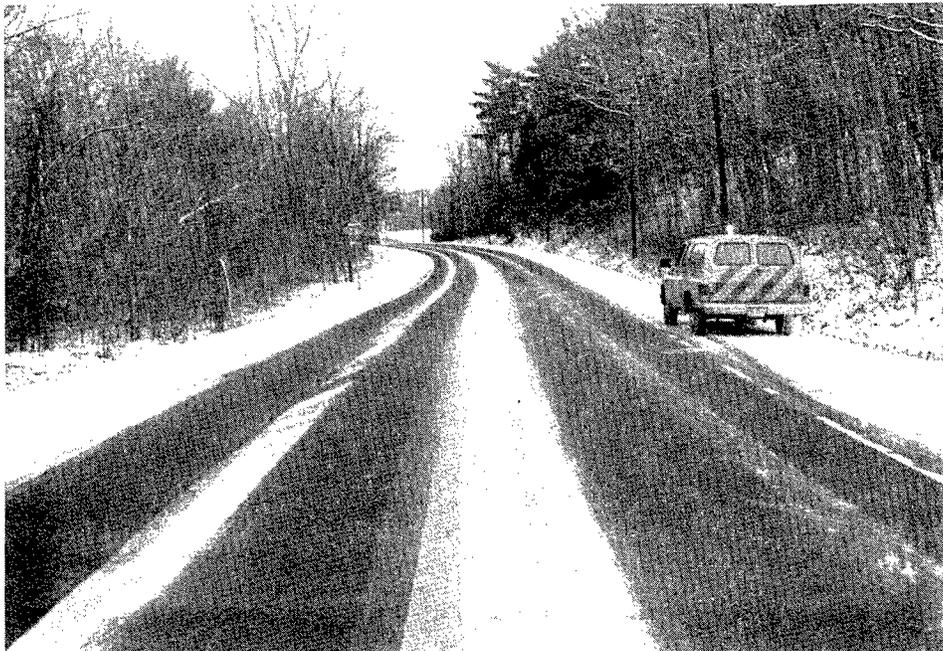
Figure 5. Appearance of Route 144 pavement after snowfall is shown in upper view with Plus-Ride in foreground and conventional mix in background, and lower view with conventional mix in foreground and 2-percent crumb rubber in background.

None of the 23 operator reports noted any shedding or prevention of icing on the RUMAC pavements. Similarly, ice-shedding capabilities were not observed by researchers during winter field inspections on Rte 144. In one field observation during inclement weather (air and windchill temperatures of about 10 and -10 F, respectively) consisting of light granular snow quickly turning to ice upon contact with pavement and the action of traffic, with a hazardous driving condition warning issued by the U.S. Weather Bureau, there was no apparent difference in performance (ice/pavement debonding) between RUMAC and conventional pavements (Fig. 5).

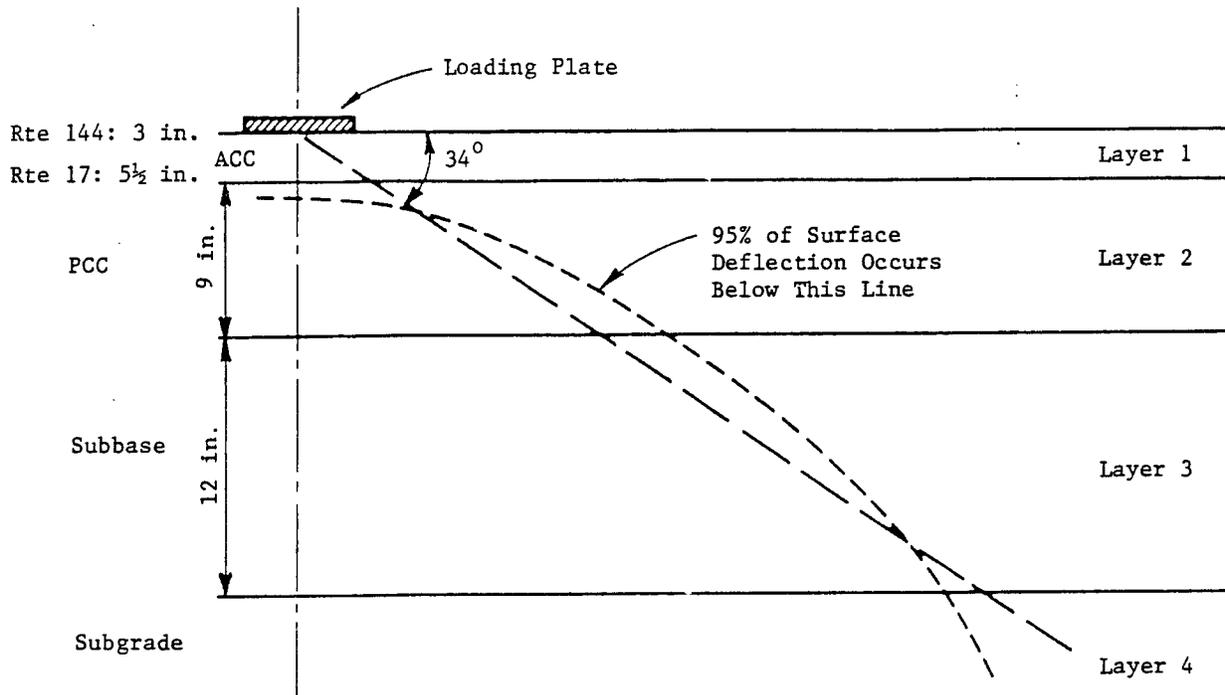
Figure 6. Pavement system, showing line of 95-percent deflection.

By computing deflections in the pavement system, a typical 95 percent-of-surface deflection curve can be drawn (Fig. 6). It should be noted that the depth beneath which 95 percent of the surface deflection occurs gradually moves downward with increasing radial distance from the loading plate. The actual shape and position of this curve is a function of the moduli and thickness of the pavement layers. The outer sensors are used to characterize deeper layers and the center ones to represent composite effects of the pavement system. To estimate sensor spacing for the layers, a 34-deg line is used. It has been determined that this line gives a good estimation of the 95-percent surface deflection curve (5).

Three sensors were used to represent response of three subsystems -- entire pavement layers, the subbase and subgrade combined, and the subgrade. As just discussed, a 34-deg line was used to estimate spacing for layers. Center deflection ( $R = 0$ ) was used for all the layers. The other two sensors were determined using  $R = \text{depth to the top of the layer} \div \tan(34 \text{ deg})$ . For Rte 17, sensor spacings of 0, 20, and 50 in. were used. For Rte 144, sensor spacing was determined to be 0, 20, and 32 in. Deflection data are plotted for Rtes 17 and 144 in Figures 7 and 8. By examining magnitude of deflection in mils, relative weakness and changes with time at each individual test station can be identified, and the layer(s) responsible for any weaknesses can be determined.

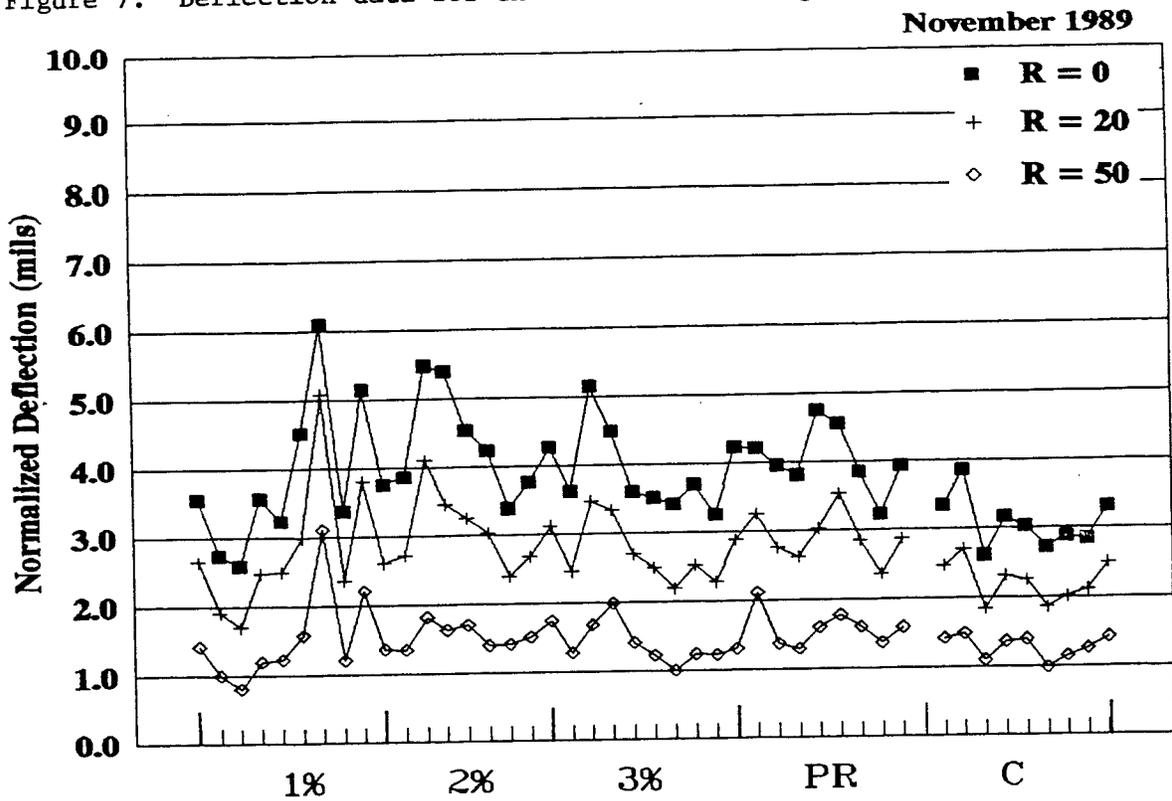
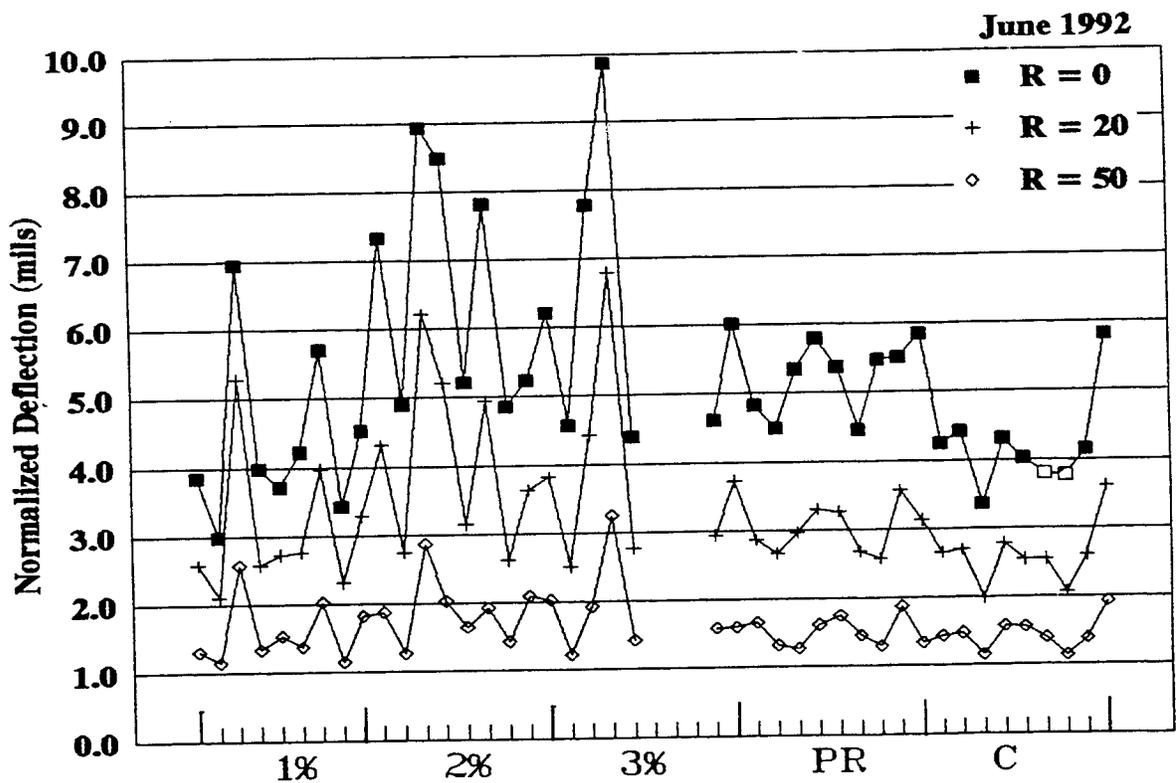
Figure 7. Deflection data for the Route 17 driving lane.

It should be noted that FWD testing on Rte 17 was incomplete. In Figure 7 for 1989 no test was recorded for one Plus-Ride section, and for 1992 three tests were not performed on the 3-percent due to raveling. In Figure 8, the Plus-Ride data reported for 1992 are for the only remaining section.

1. From Figure 7, it can be noted that center deflections increased between 1989 and 1992; thus on the whole all the overlays have deteriorated.
2. By comparing deflection at R = 20 in Figure 7, the subbase under Plus-Ride and conventional section remains essentially the same, since deflections were both about 3 mils. However, one point under the 1- and 3-percent sections and two points under the 2-percent section appear to be weaker in the 1992 data, with a relatively high deflection increase at R = 20, while deflections at R = 50 remain about the same.

3. It can be observed in the 1992 plot that subbase condition under Plus-Ride and the control mix is better than under the other three sections, since deflections at R = 20 are smaller and more uniform than the other three. Some of this variation in the 1-, 2-, and 3-percent sections can be attributed to the subgrade since they exhibit the same pattern.

4. Comparing 1989 and 1992 deflection readings at R = 50, the subgrade (where deflections registered around 3 mils) remained fairly constant except for one area in each of the 1-, 2- and 3-percent sections.

5. From the 1992 plot in Figure 7, the best overall condition is found in the conventional section with the smallest deflection, and the weakest in the 2- and 3- percent with the highest deflections.

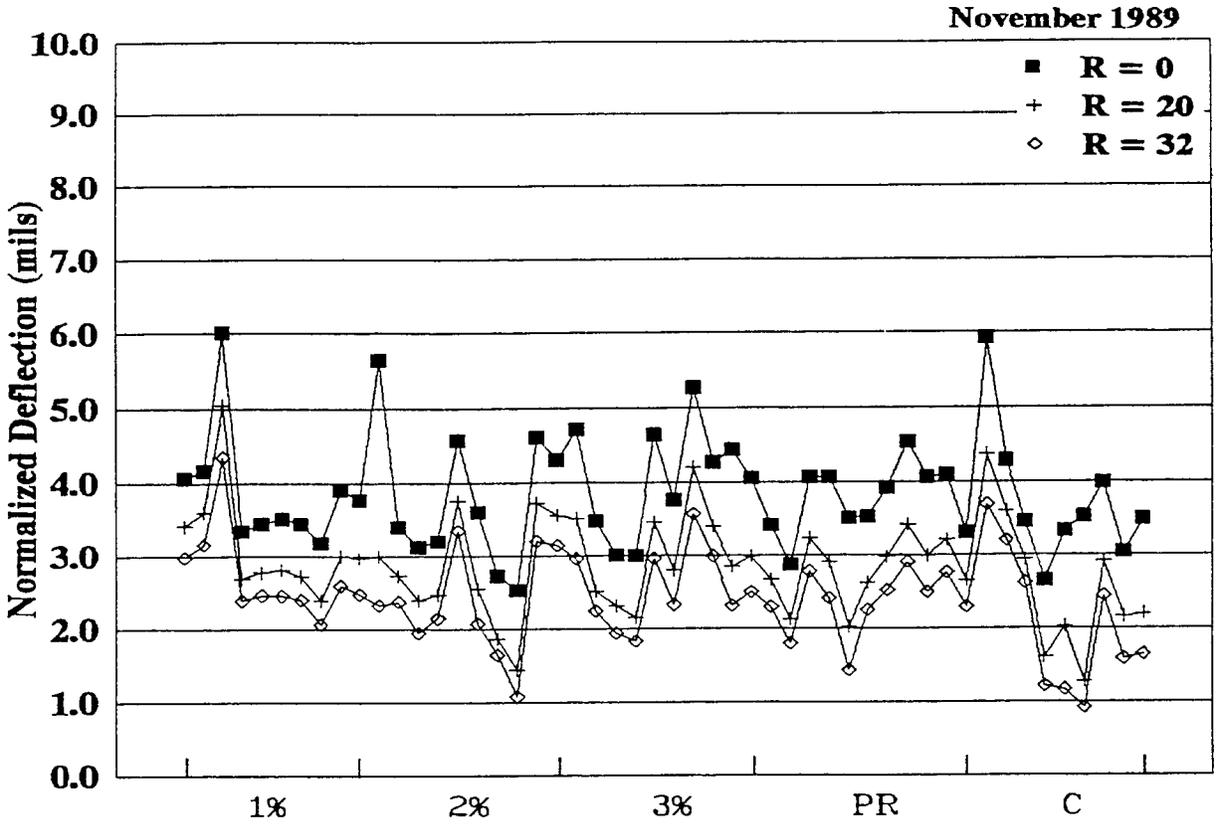
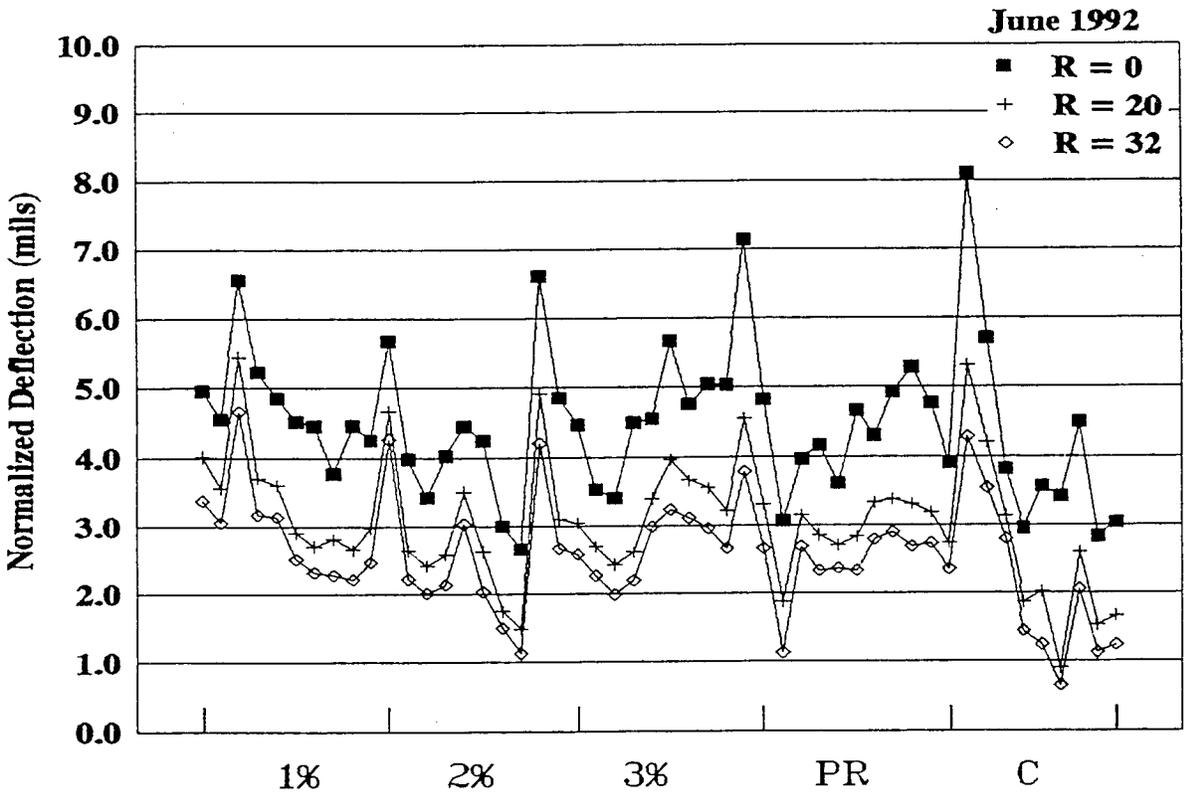
Figure 8. Deflection data for the Route 144 northbound lane.

1. From Figure 8, most of the conventional section's subbase and subgrade is registering the lowest deflections (R = 20 and R = 32), while the other sections are performing adequately.
2. Each section has at least one station exhibiting relatively high deflection readings at all three sensors, with the 3- percent the worst. Since all three sensors exhibit the same high reading, the weakness is most likely attributable to the subgrade.
3. With deflection readings at R = 32 increasing between 1989 and 1992, the subgrade has deteriorated in terms of strength. The subbase has essentially remained the same.
4. Examining the 1992 deflection data, overall the conventional section is performing best in all layers because it exhibits lowest deflections.
