# Crash Tests of Work Zone Traffic Control Devices

**RESEARCH REPORT 147**

Final Report on Research Project 102-13

Research Report 147  
February 1990

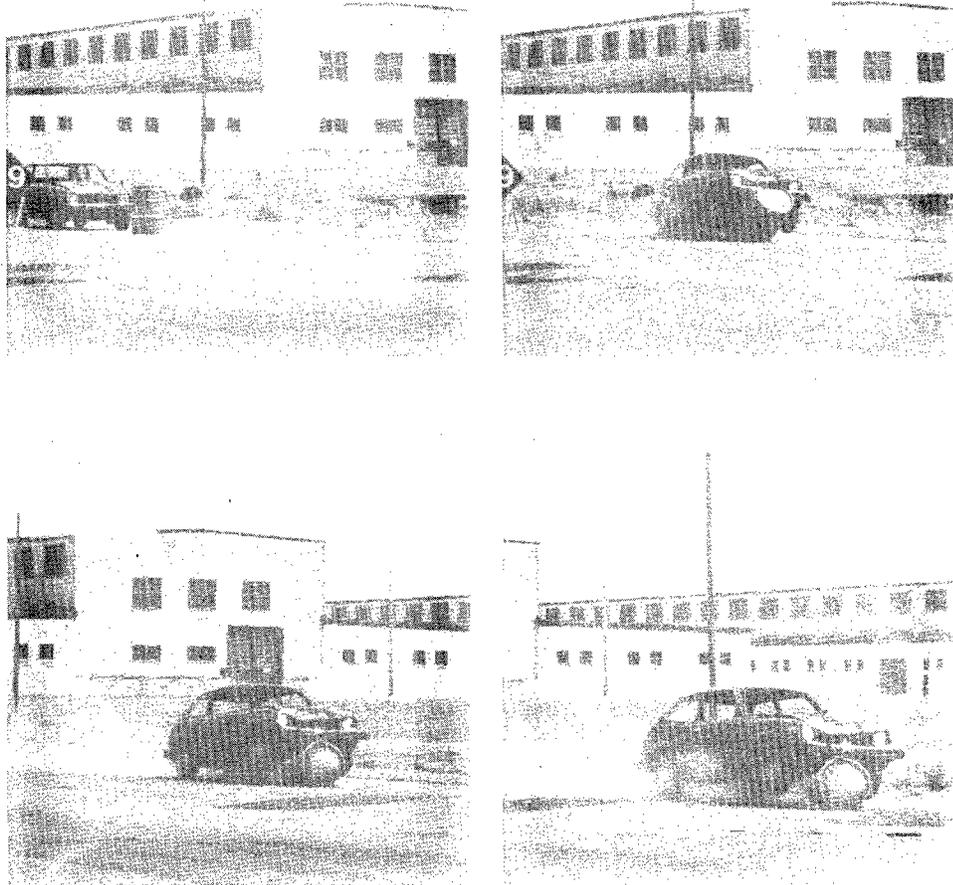
**Figure 1. An 1800-lb car impacting a 55-gal steel drum at 60 mph resulted in loss of vehicle control.**

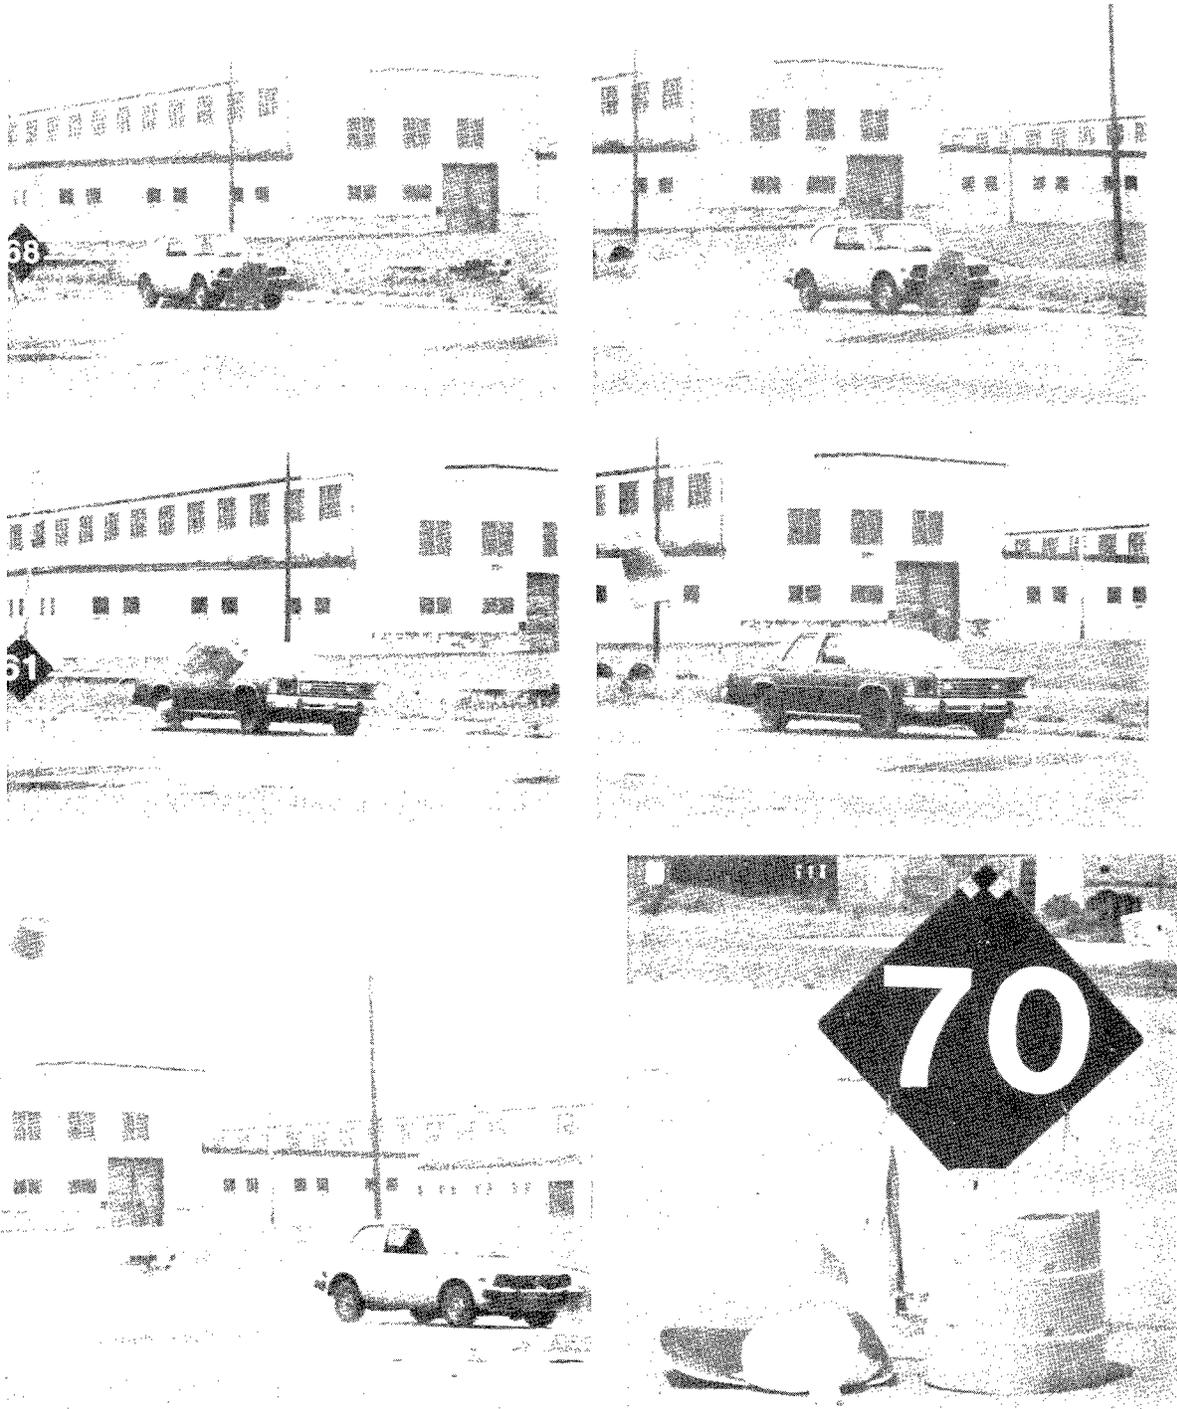
**Figure 2. Typical impacts with plastic drums ballasted with 50-lb sandbags resulted in drums staying with the front of the car (top), being pushed aside in a brushing impact (center), and two-piece drum being thrown high into the air (bottom).**

Plastic drums with sandbag ballast placed at ground level generally provided excellent performance. However, open-top drums with internal ballast and two-piece drums split mid-height both resulted in debris that could threaten other traffic.

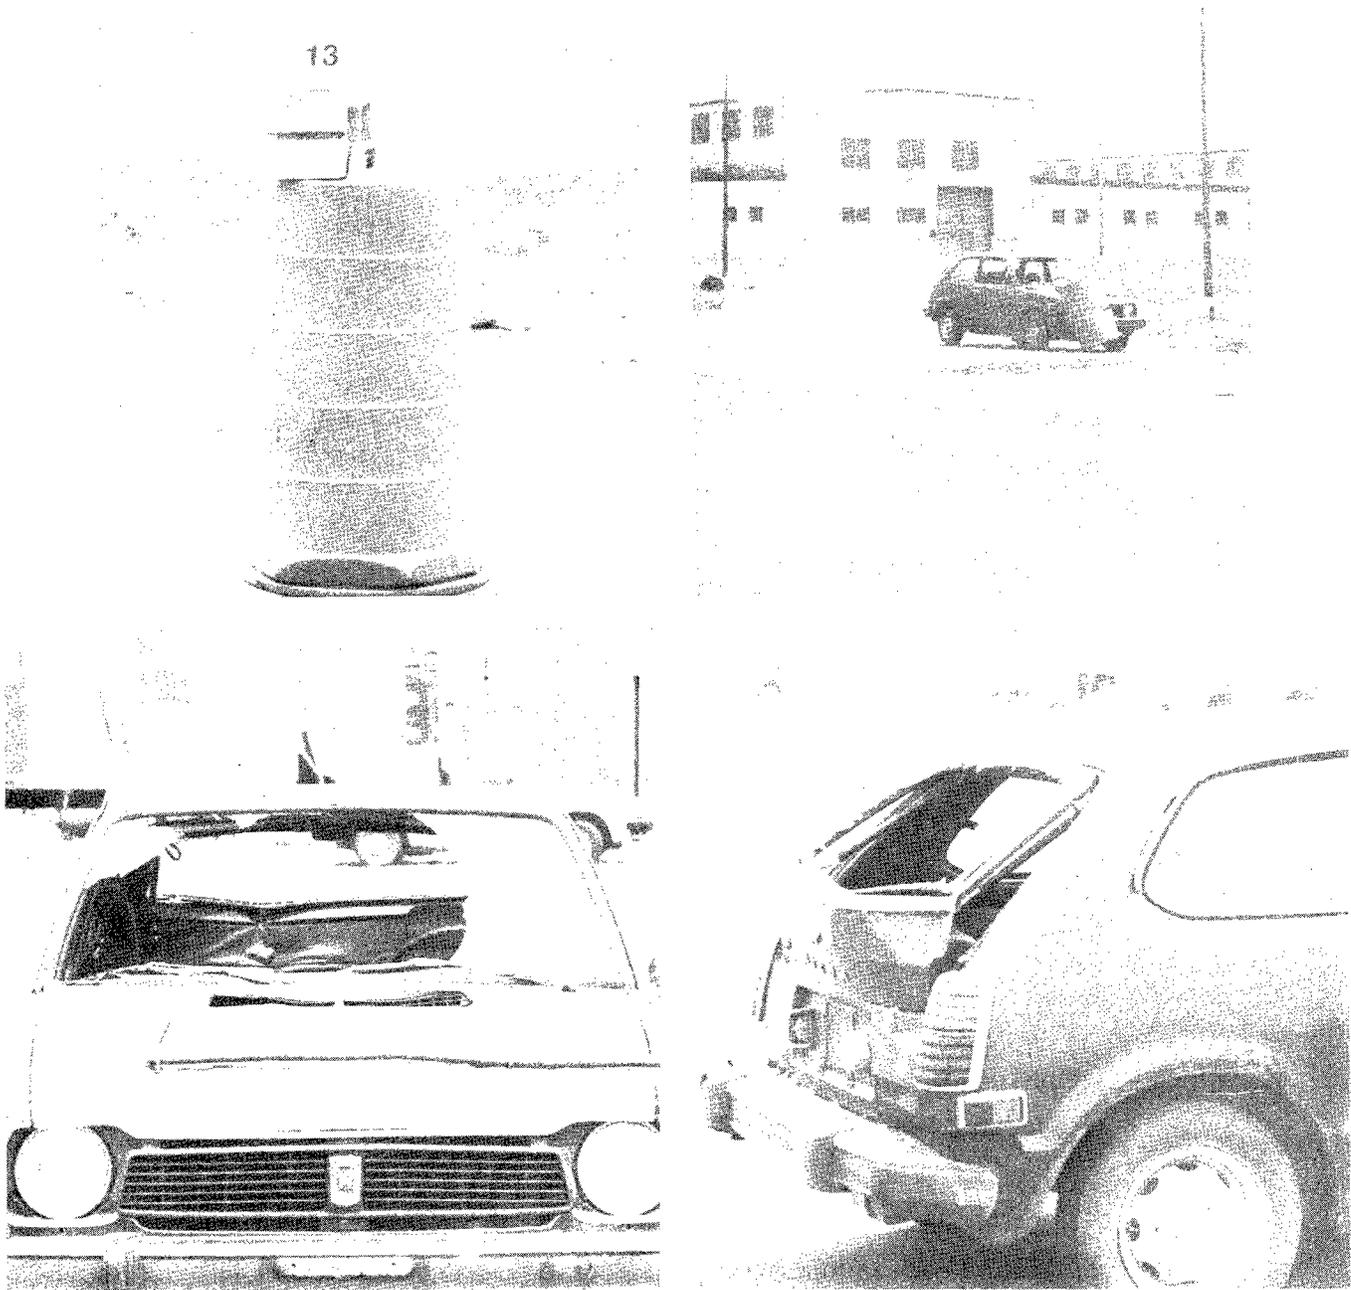
**Figure 3. A 42-lb concrete-block ballast placed on a drum resulted in unacceptable intrusion into the passenger compartment.**

In addition to unacceptable behavior in terms of the primary evaluation criteria, all three open-top drums and the drum with a sandbag on top were destroyed by the impacts (this last drum had been impacted in four previous

tests). Added resistance of the heavier ballast and inability of internal ballast to separate from the drum resulted in severe impact forces. In previous tests with standard ballasts, most drums withstood similar impacts with only minor damage.

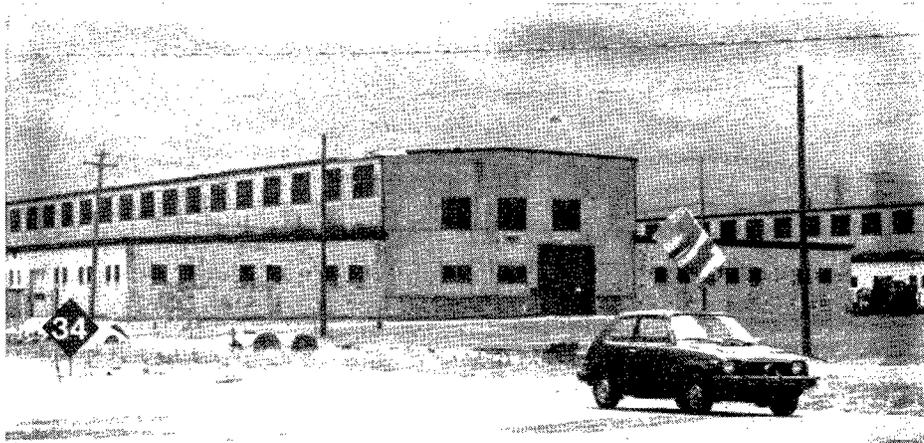
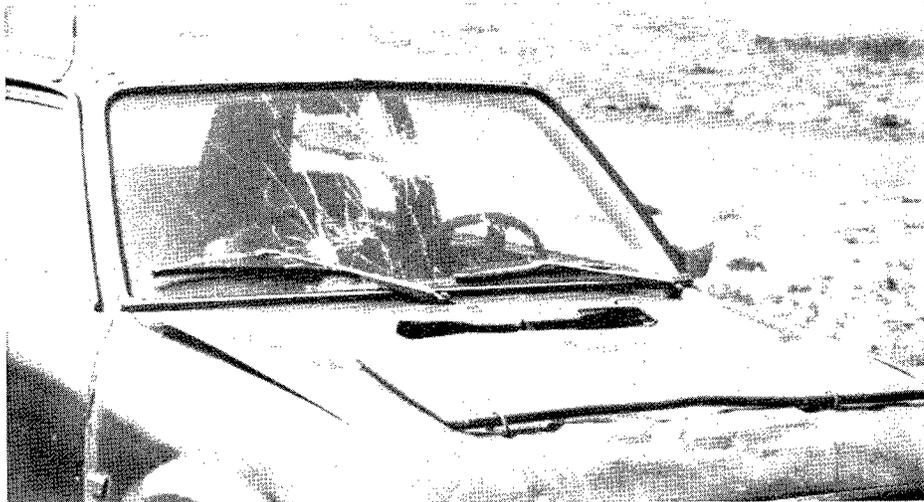
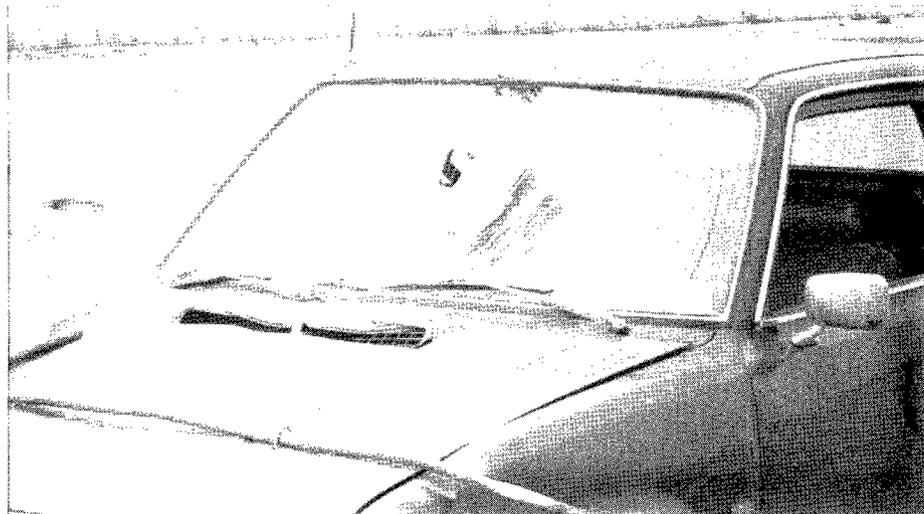
**Figure 4. Attaching warning lights to channelizing drums resulted in lights being thrown on impact and drums flying over the vehicle (top), with varying degrees of windshield damage (center and bottom).**

Of 19 tests of plastic drums with Type A warning lights attached (Fig. 4), only five met the primary evaluation criteria. Lights were attached to the drums by various methods. The primary problem was that the lights -- weighing about 6 lb including lantern batteries -- separated on impact and flew through the work zone, creating hazards to workers or other vehicle windshields. In two 60-mph tests, batteries traveled about 250 ft from impact, and in several others over 150 ft from impact.

Of 12 different drum models tested, only one had specific instructions on the drum for light attachment, calling for use of a retainer with the bolt. In an attempt to avoid light detachment, seven additional tests were conducted with 1-in. OD washers installed behind the bolt heads to prevent their pulling through the plastic. In three tests with 4500-lb cars -- two at 60 mph and one at 30 mph -- the lights remained attached to the drums, and the drums stayed with the front of the car on impact, thus providing acceptable results. None of the four tests with 1800-lb cars at 60 mph were acceptable. In one, the bolt and washer pulled through the plastic and the light impacted the windshield. In the second, the top of the drum broke apart, throwing the light into the work zone. In the third, the light unit remained attached but the battery compartment ruptured, throwing the batteries into the work zone. In the fourth, the light remained attached but the increased weight of the light on the top of the drum, combined with the low frontal profile of the small car, resulted in the drum flying over the car rather than staying in front, presenting a potential threat to other traffic and workers. Drums with warning lights attached thus behaved unacceptably in several cases, with lights thrown into the work area and drums flying over the vehicle on impact. Efforts to prevent this problem by adding washers to the attachment bolt were only partially successful.

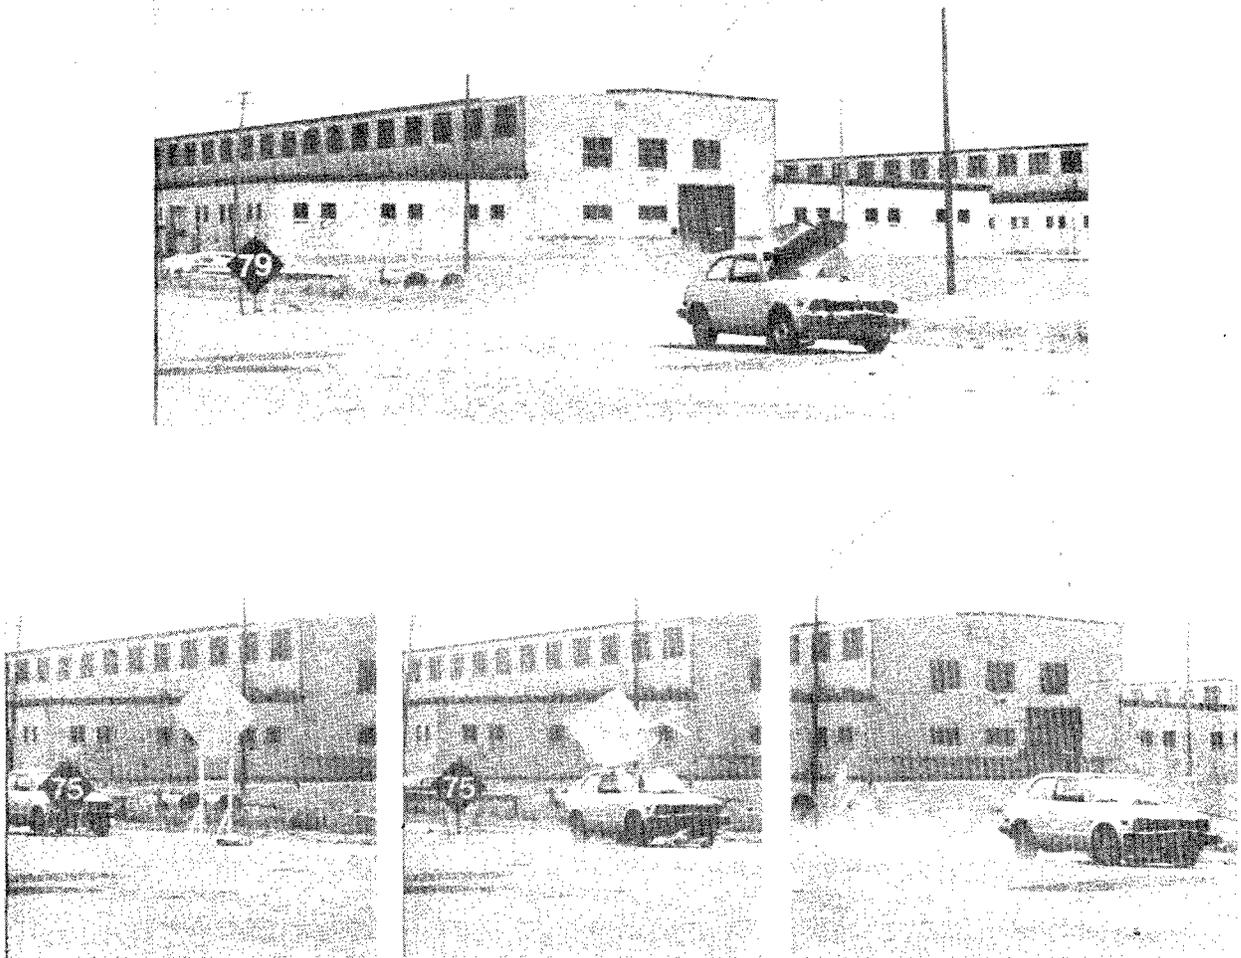
**Figure 5. A portable low-mounted sign resulted in windshield penetration and debris (top). A tall portable sign resulted in unacceptable debris, although the panel cleared the car (bottom).**

A commercial metal tripod with a 4-ft diamond sign panel mounted 4 ft above the pavement tested at 55 mph resulted in the panel being pulled down into the windshield on impact. The vertical support did not fracture or release on impact, but instead deformed against the front of the car. The panel broke free after striking the hood and windshield and was thrown over the car, presenting a hazard to workers and other traffic. Except for one leg that broke free but remained on the pavement, no harmful debris resulted from the support. If equipped with a flexible rather than rigid panel, this support might perform acceptably.

Performance problems thus were observed in all but one test on signs and supports. Impact debris from the supports was thrown into the work zone in all but two tests, and in several others low-mounted sign panels impacted and broke windshields or were thrown through the work zone.

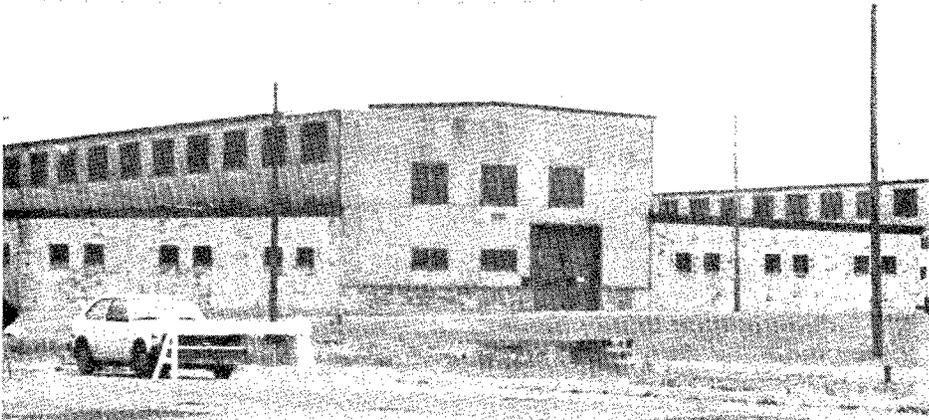
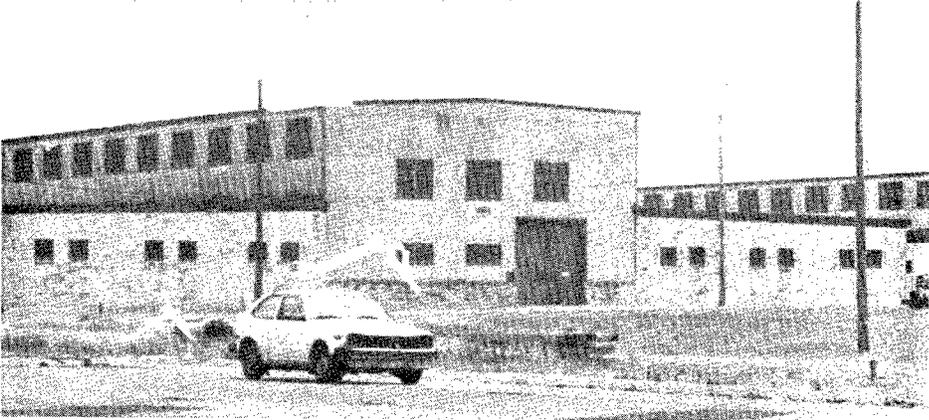
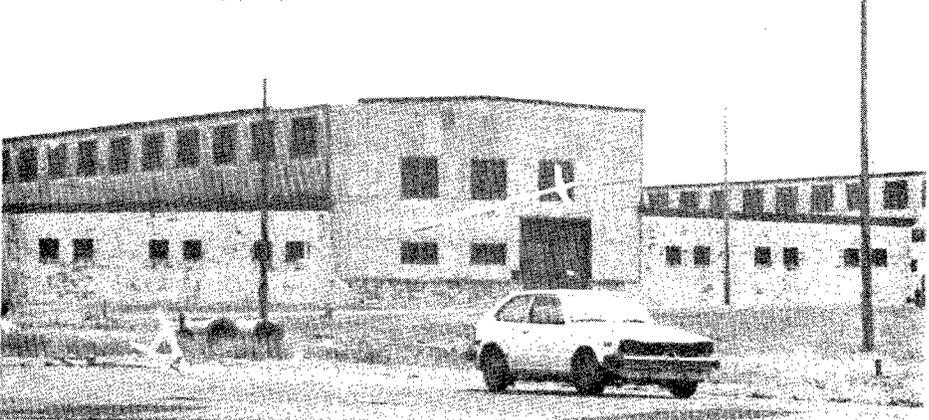
**Figure 6. Collision with a Type I barricade resulted in unacceptable debris.**

Four tests on Type I barricades resulted in debris thrown into the work zone, threatening workers and other traffic (Fig. 6). In three 60-mph tests, debris was thrown from 102 to 172 ft, and in the single 30-mph test debris was thrown 70 ft. Considering that these barricades weighed from 18 to 32 lb and included various steel and wood members, this debris appeared to present a significant hazard if it were to strike a worker or the windshield of another vehicle. In each case, debris was thrown high in the air, presenting a substantial risk that such contact would occur.

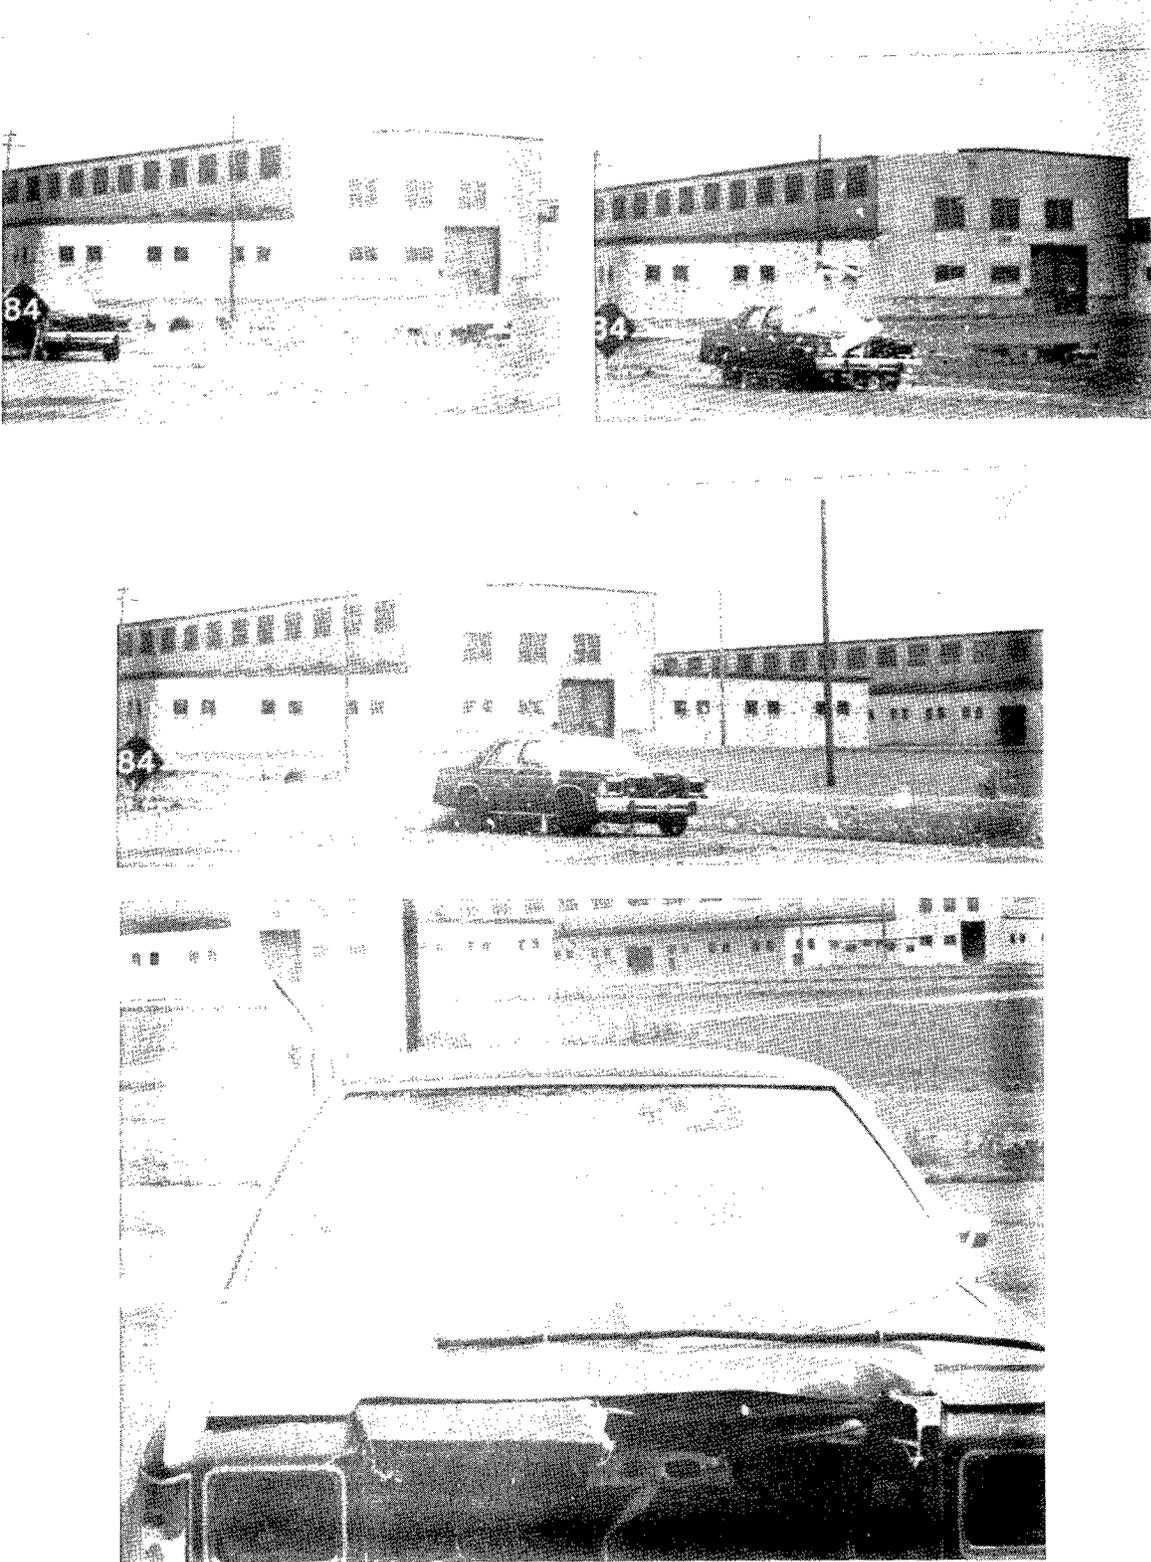
Figure 7. A 60-mph impact with a PVC Type III barricade resulted in a shattered windshield.

Three tests of PVC plastic Type III barricades resulted in their shattering, with debris thrown up to 207 ft from impact at 60 mph. Resulting debris was light in weight, and did not appear to represent a significant hazard to workers or other traffic. All three tests resulted in broken windshields on the test vehicles. In two of the three tests, a warning light was attached to the top barricade rail and contributed to windshield damage. In the third (at 60 mph) the windshield of the large sedan was shattered by impact with the top barricade rail (Fig. 7). All three tests with PVC barricades were thus considered unsatisfactory because of windshield damage. These barricades were

all constructed using heavy grade pipe (D 2655) and a lighter grade might prevent this damage.
