REPORT NO.
UCB/EERC-97/13
DECEMBER 1997

FATIGUE LIFE EVALUATION OF CHANGEABLE MESSAGE SIGN STRUCTURES

VOLUME 2: RETROFITTED SPECIMENS

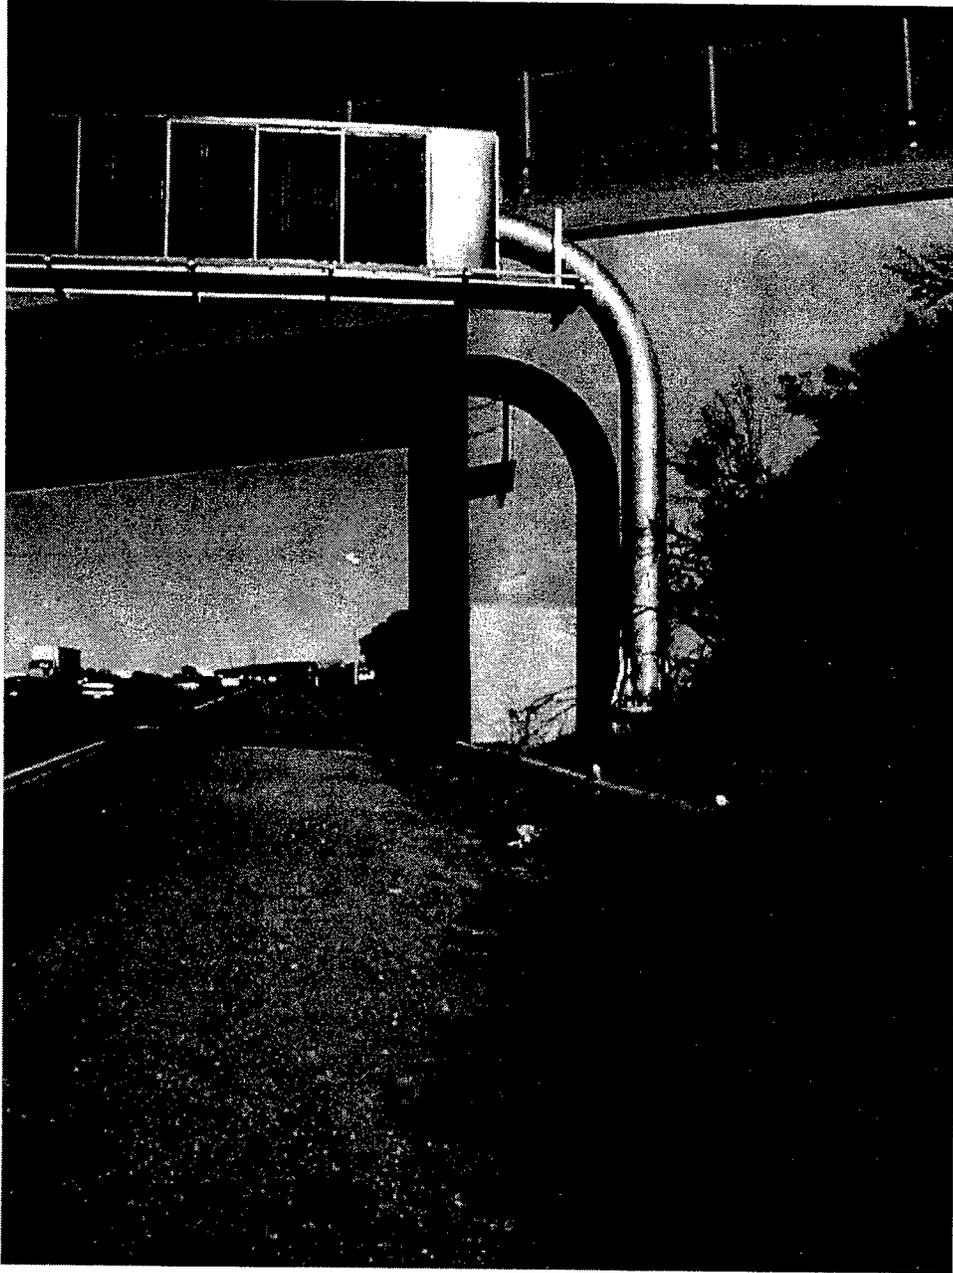
Figure 1.1: Photograph of gusset retrofitted CMS structure on Interstate 80

Changeable Message Sign (CMS) structures are widely used in California by the California Department of Transportation (Caltrans) for communicating information on road conditions to the driving public. Figure 1.1 shows a newly installed gusset-retrofitted CMS structure on Interstate 80, near Rodeo California. In the field, the CMS structures are subjected to variable environmental and wind-vibration conditions. They are designed by Caltrans using the AASHTO Standard Specifications for Structural Supports for Highway Signs, Luminaries, and Traffic Signals (AASHTO, 1994).

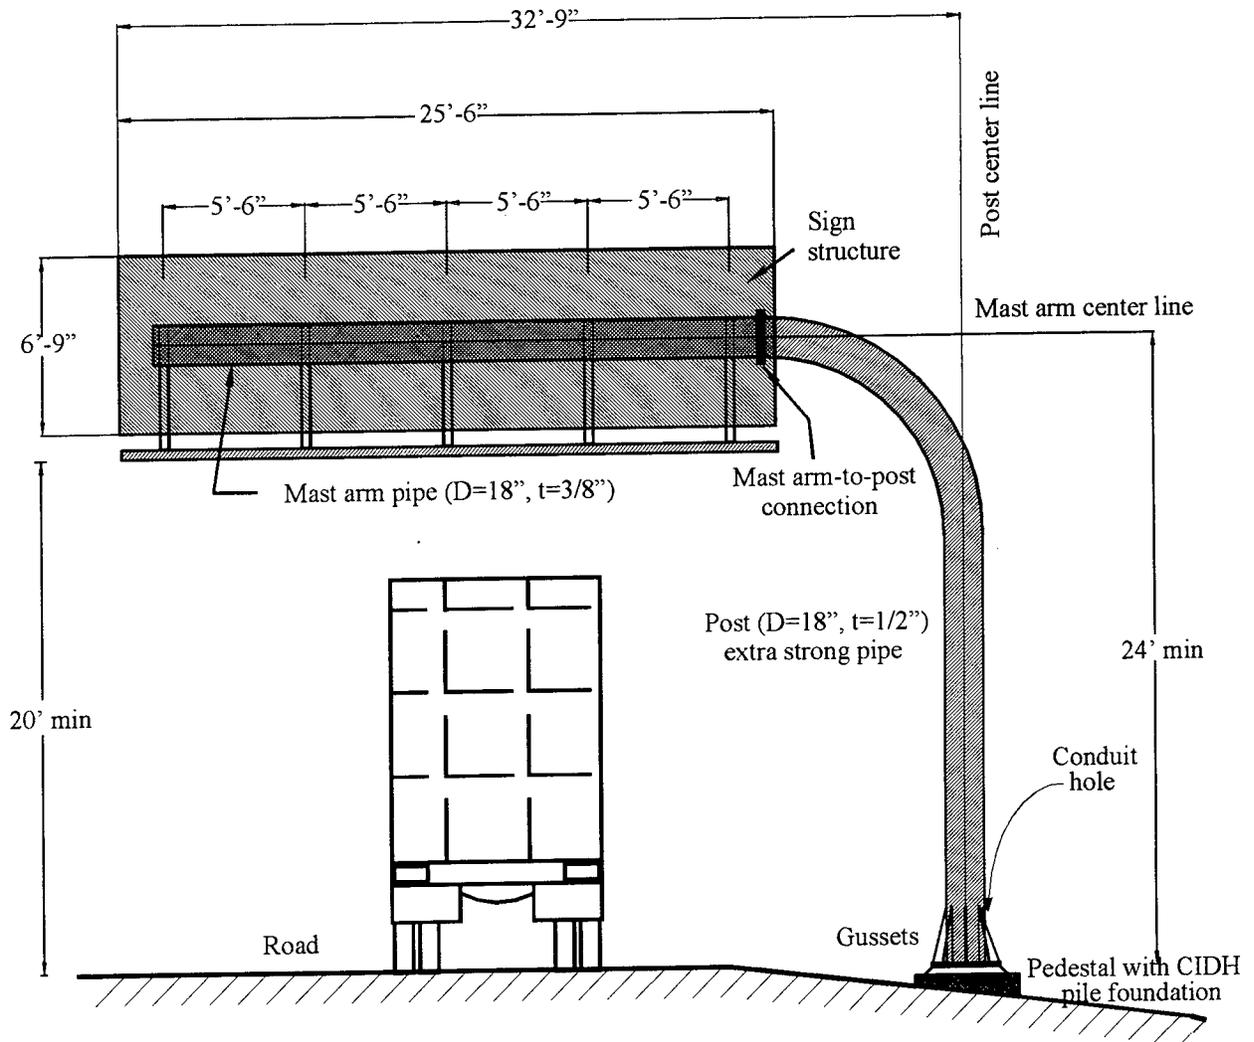
Figure 1.2: Steel-gusset retrofitted Model 500 CMS structure

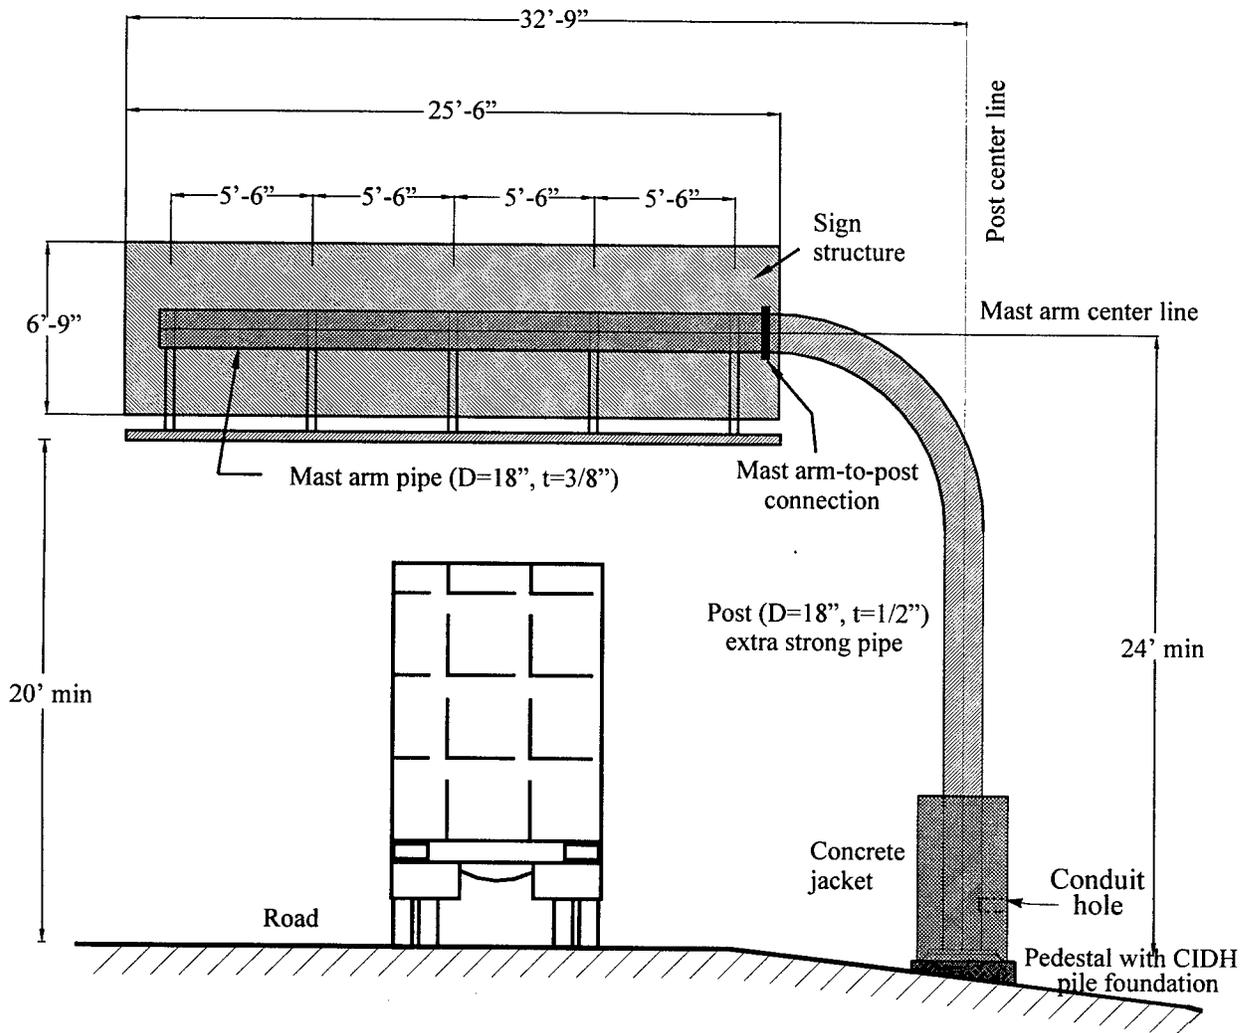
Figure 1.3: Concrete-jacket retrofitted Model 500 CMS structure

The concrete jacket retrofit detail consisted of adding a reinforced concrete shell to the steel post. The jacket had a outside diameter of 42 in. (1.1 m) and was 6 ft (1.8 m) tall. The jacket was attached to the existing foundation by drilling and bonding a total of 16 #7 vertical reinforcement bars. The transverse reinforcement in the jacket consisted of #4 hoops with a 15 in. (381 mm) lap placed at 4 in. (102 mm) spacing. Trim reinforcement was added around the conduit hole. Figure 1.3 shows the dimensions of a concrete jacket retrofitted Model 500 CMS structure. The lower 15 ft (4.6 m) of a concrete jacket retrofitted CMS was tested at EERC; refer to Chapter 5 for details.

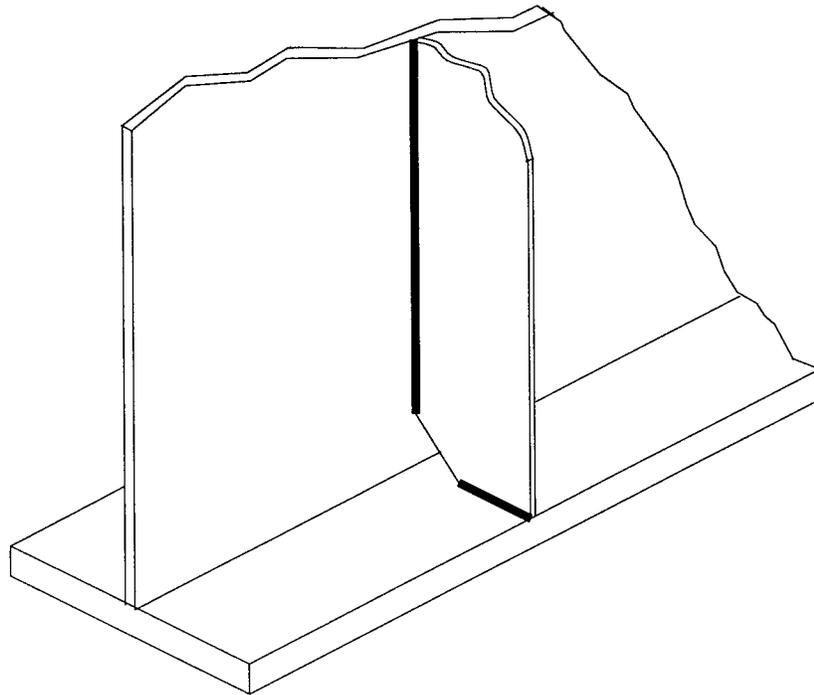
Figure 2.1: Gusset welded connection details (adapted from Daniels and Herbein, 1980)

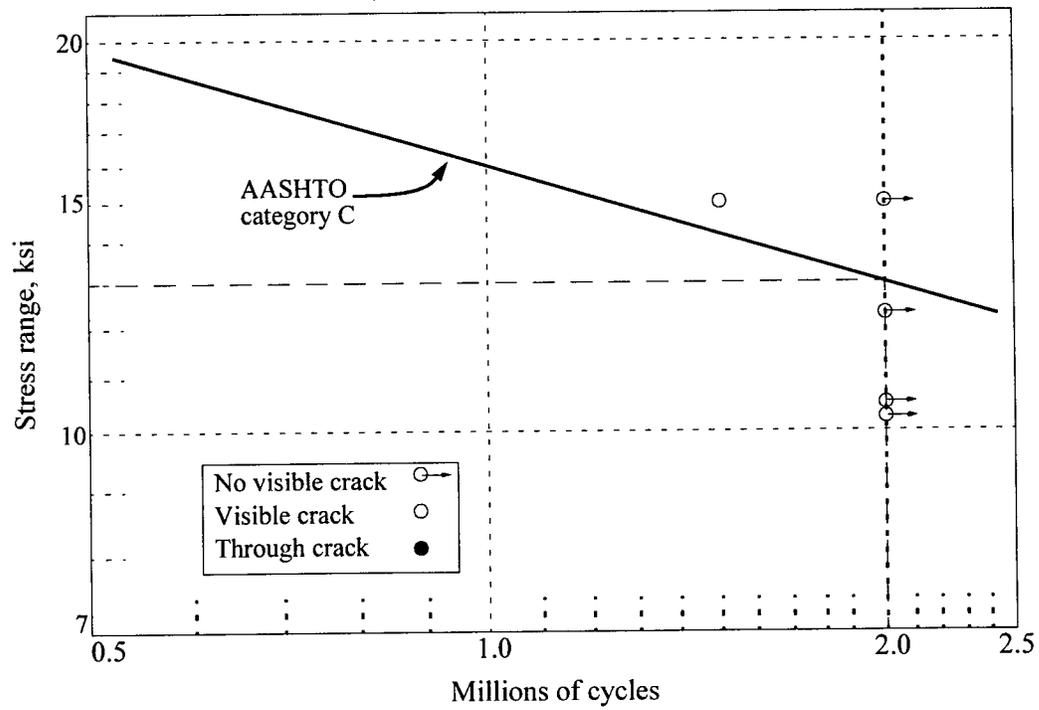
Figure 2.2: S-N curve for a gusseted connection (adapted from Daniels and Herbein, 1980)

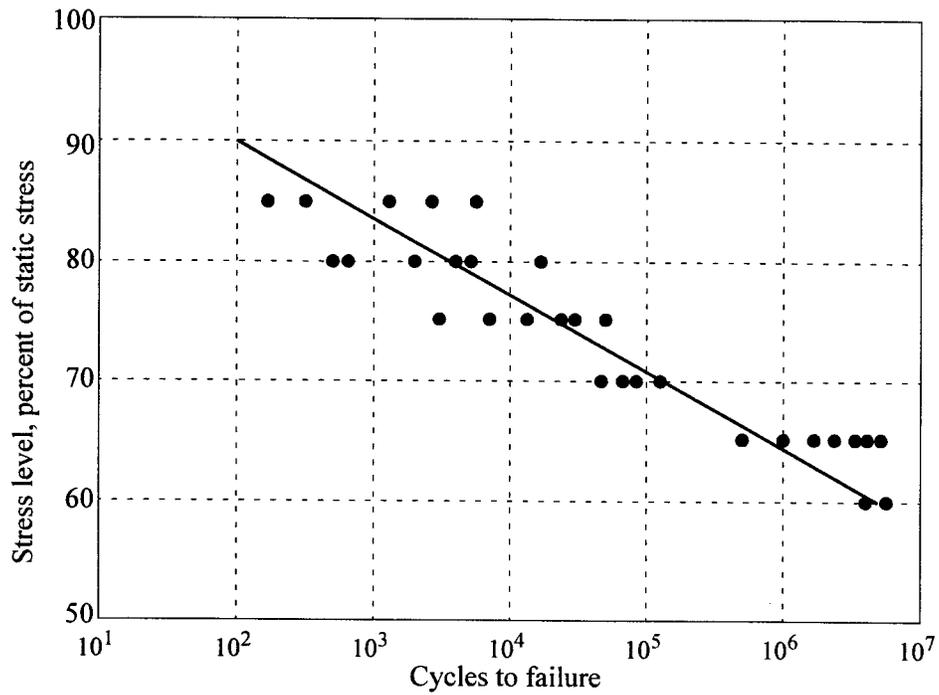
Figure 2.3: S-N curve for plain concrete (adapted from Bury and Domone, 1974)

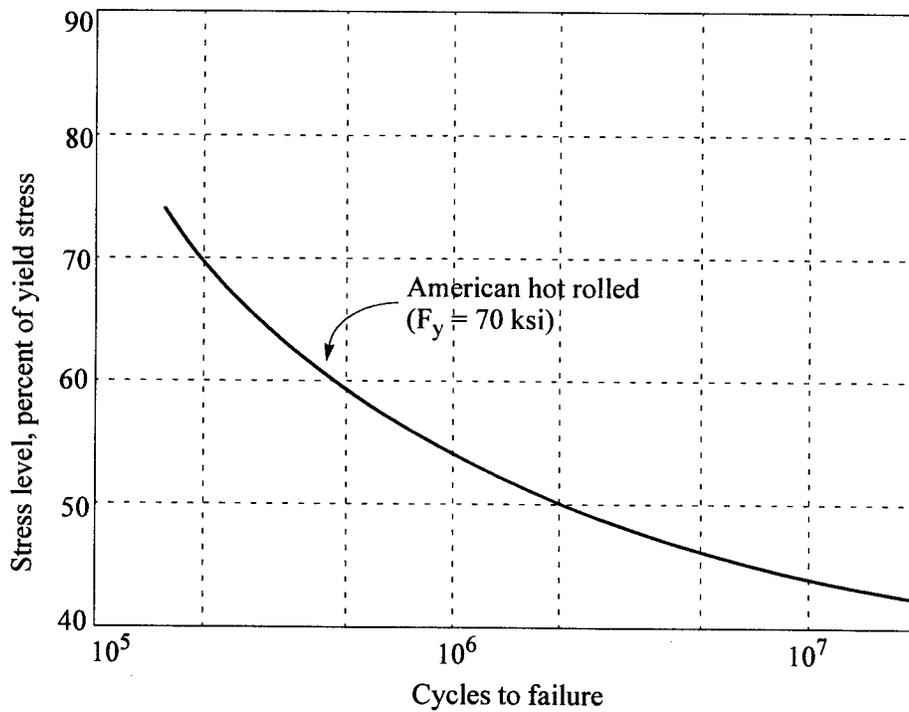
Figure 2.4: S-N curve for various reinforcing bars (adapted from Bury and Domone, 1974)

The fatigue strength of reinforcing bars under either uniaxial loading or flexural loading in reinforced concrete beams has been studied by several authors (e.g., Bury and Domone, 1974). The findings indicate that the fatigue life of reinforcing bars depends on minimum stress level, bar size, geometry of deformation, yield strength, prior bending of the bar, and welding. As is typical for metals, the fatigue life of reinforcing steel is determined by the stress range and not the absolute values of minimum and maximum applied stresses. Figure 2.4 shows a typical S-N curve of reinforcing steel bars.

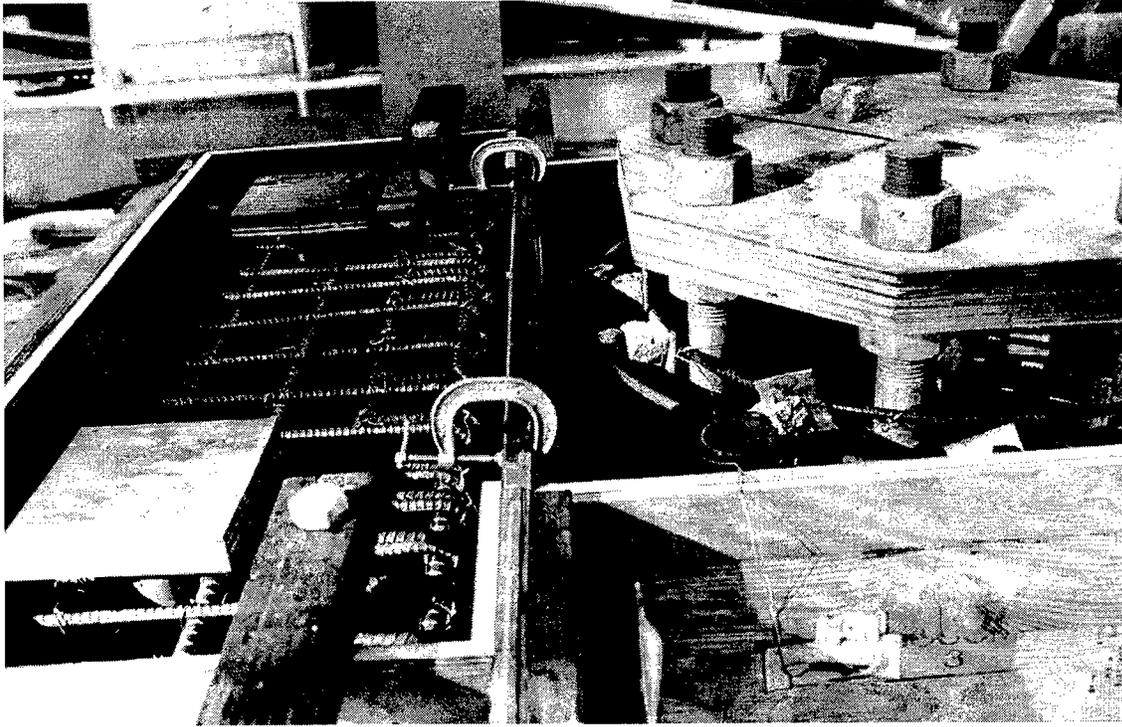
Figure 3.1: Foundation details for Specimen CIP1

A reinforced concrete foundation blocks were cast and anchored to the strong floor in the Structures Research Laboratory at EERC. The concrete foundation simulated the CIDH pile typically used as the foundation for 18 in. (46 mm) diameter CMS structures. As shown in Figure 3.1, specially fabricated anchor bolts, identical to bolts used in the field, were embedded in the foundation. The test specimens were attached to the foundation using these anchor bolts. Each specimen was leveled using nuts placed underneath the base plate. The anchor bolts at the base plate were initially snug tightened and then tightened further using the turn-of-the-nut method (AISC, 1995). The gap between the base plate and the foundation was then grouted with mortar cement.

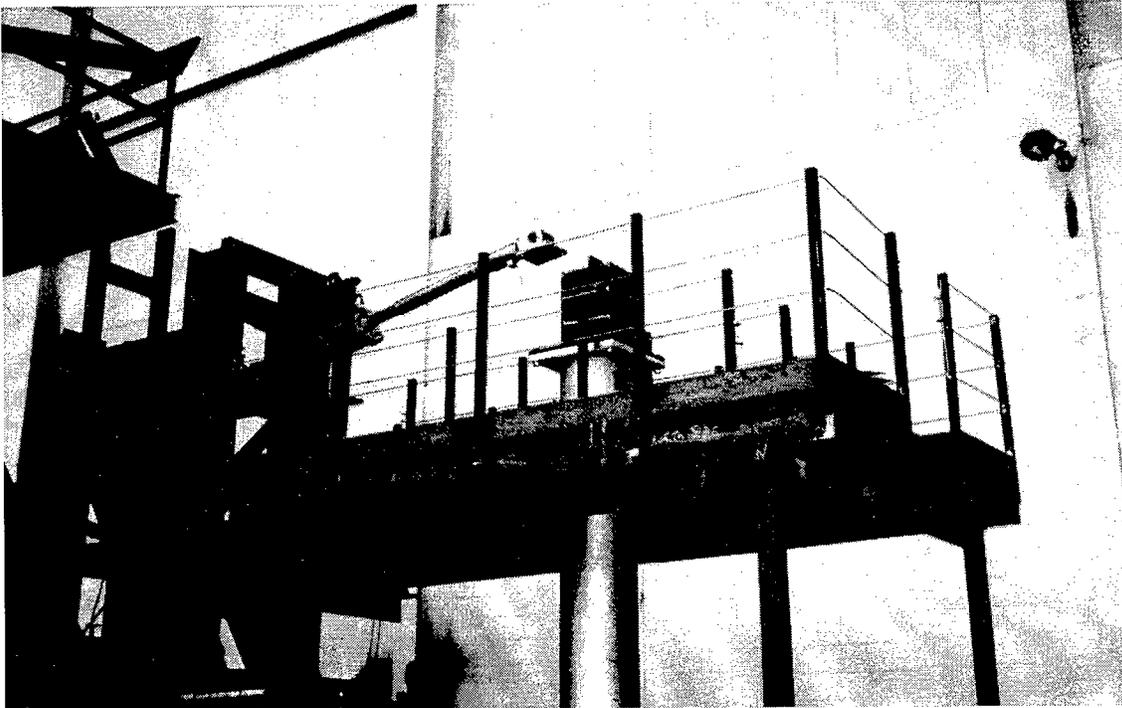
Figure 3.2: Test setup for Specimen GR1

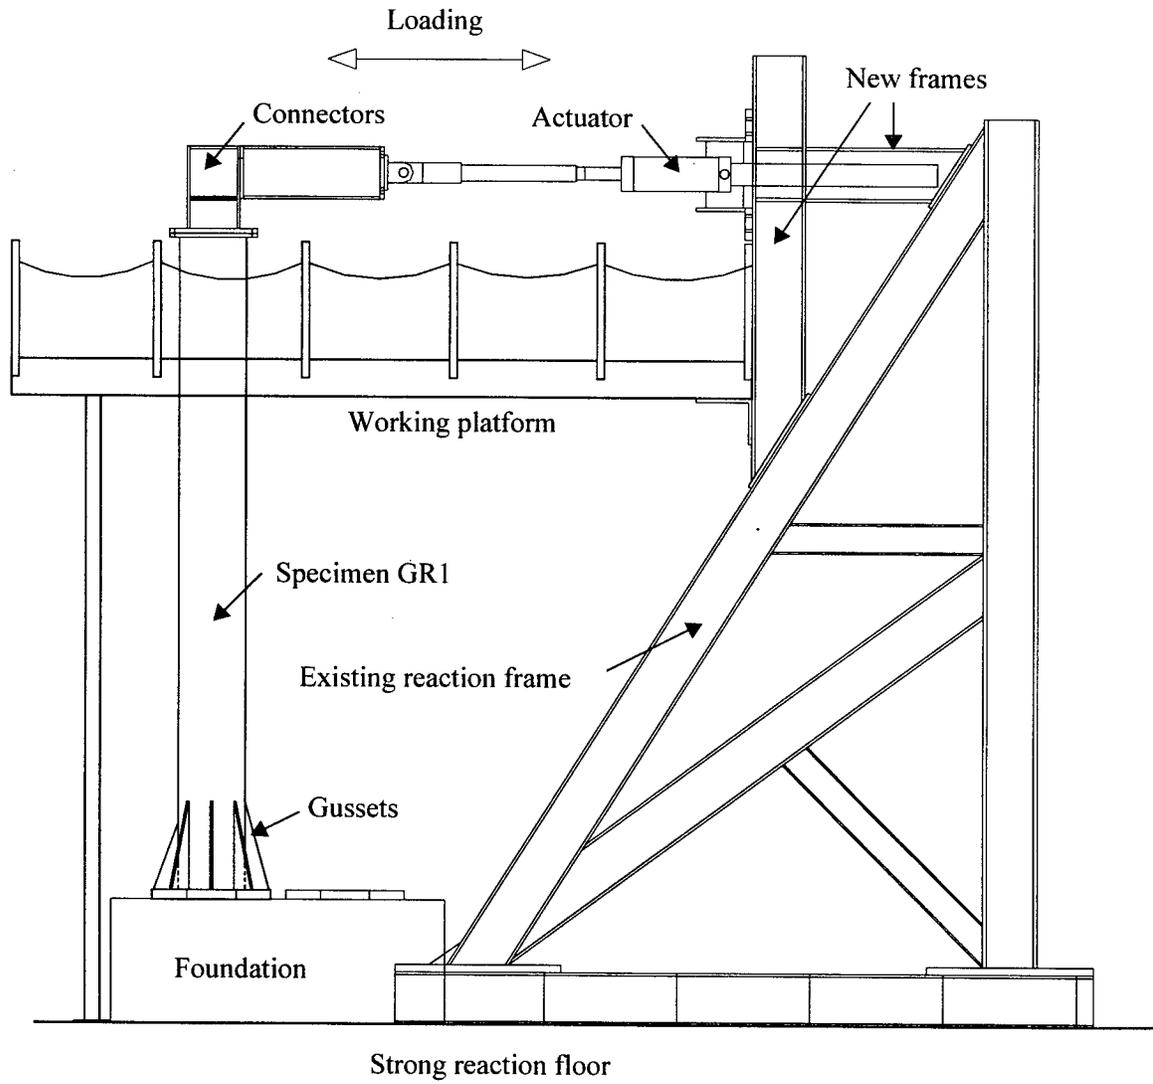
Figure 3.3: Main components of the test setup for Specimen GR1

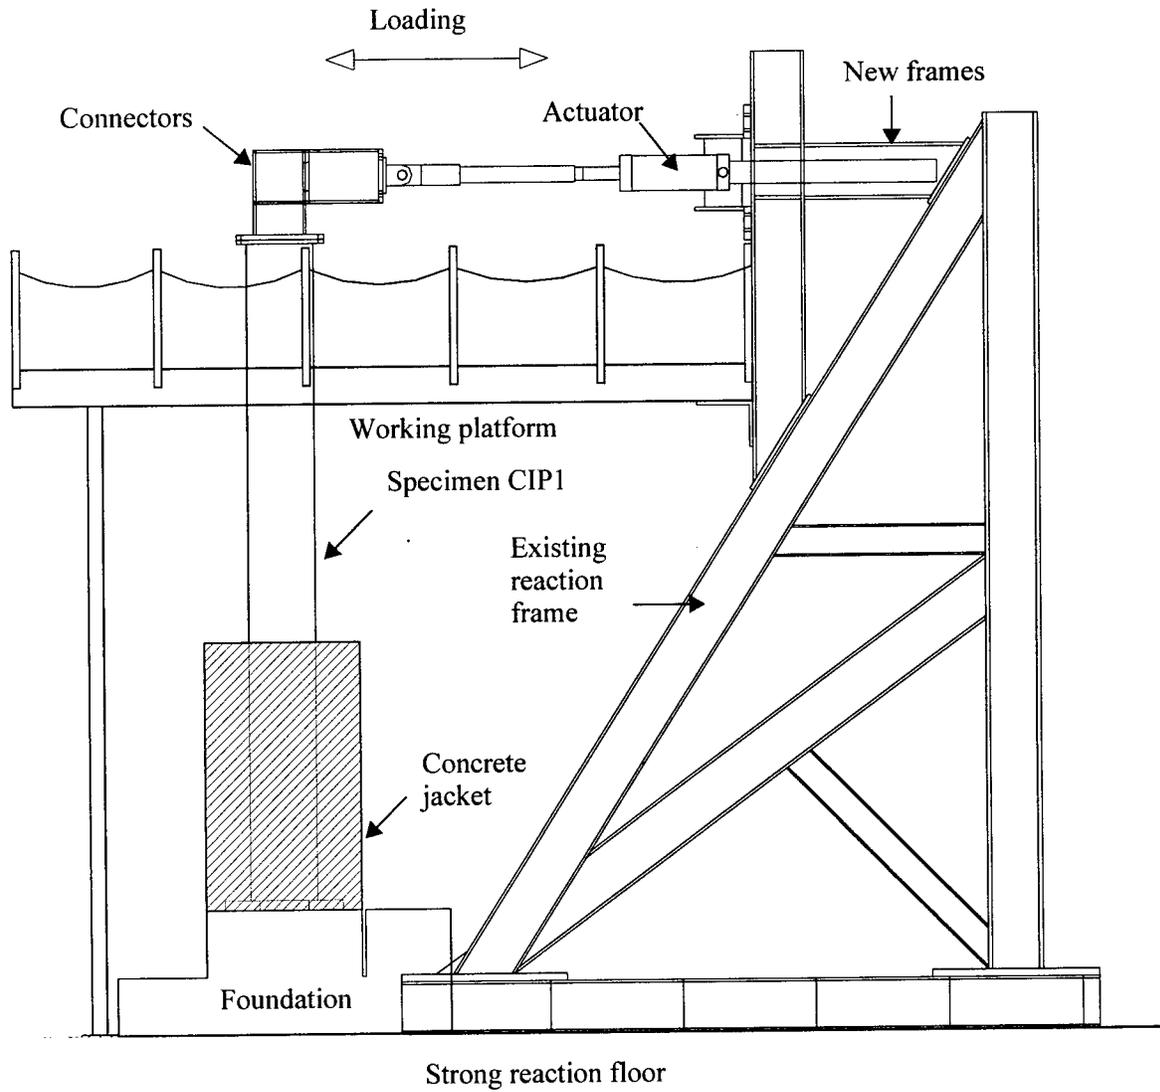
Figure 3.4: Main components of the test setup for Specimen CIP1

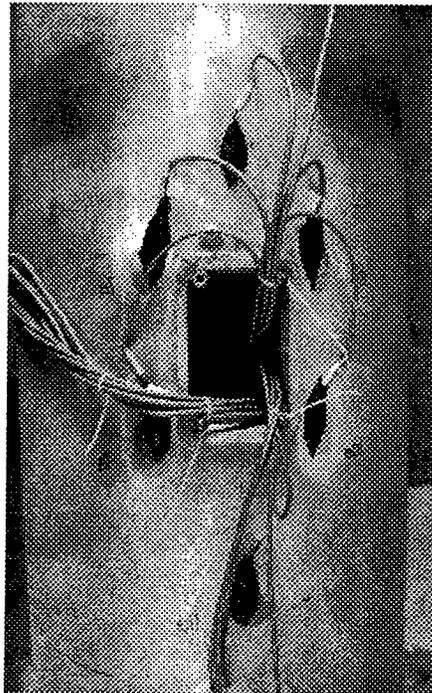
Figure 3.5: Instrumentation of Specimen CIP1

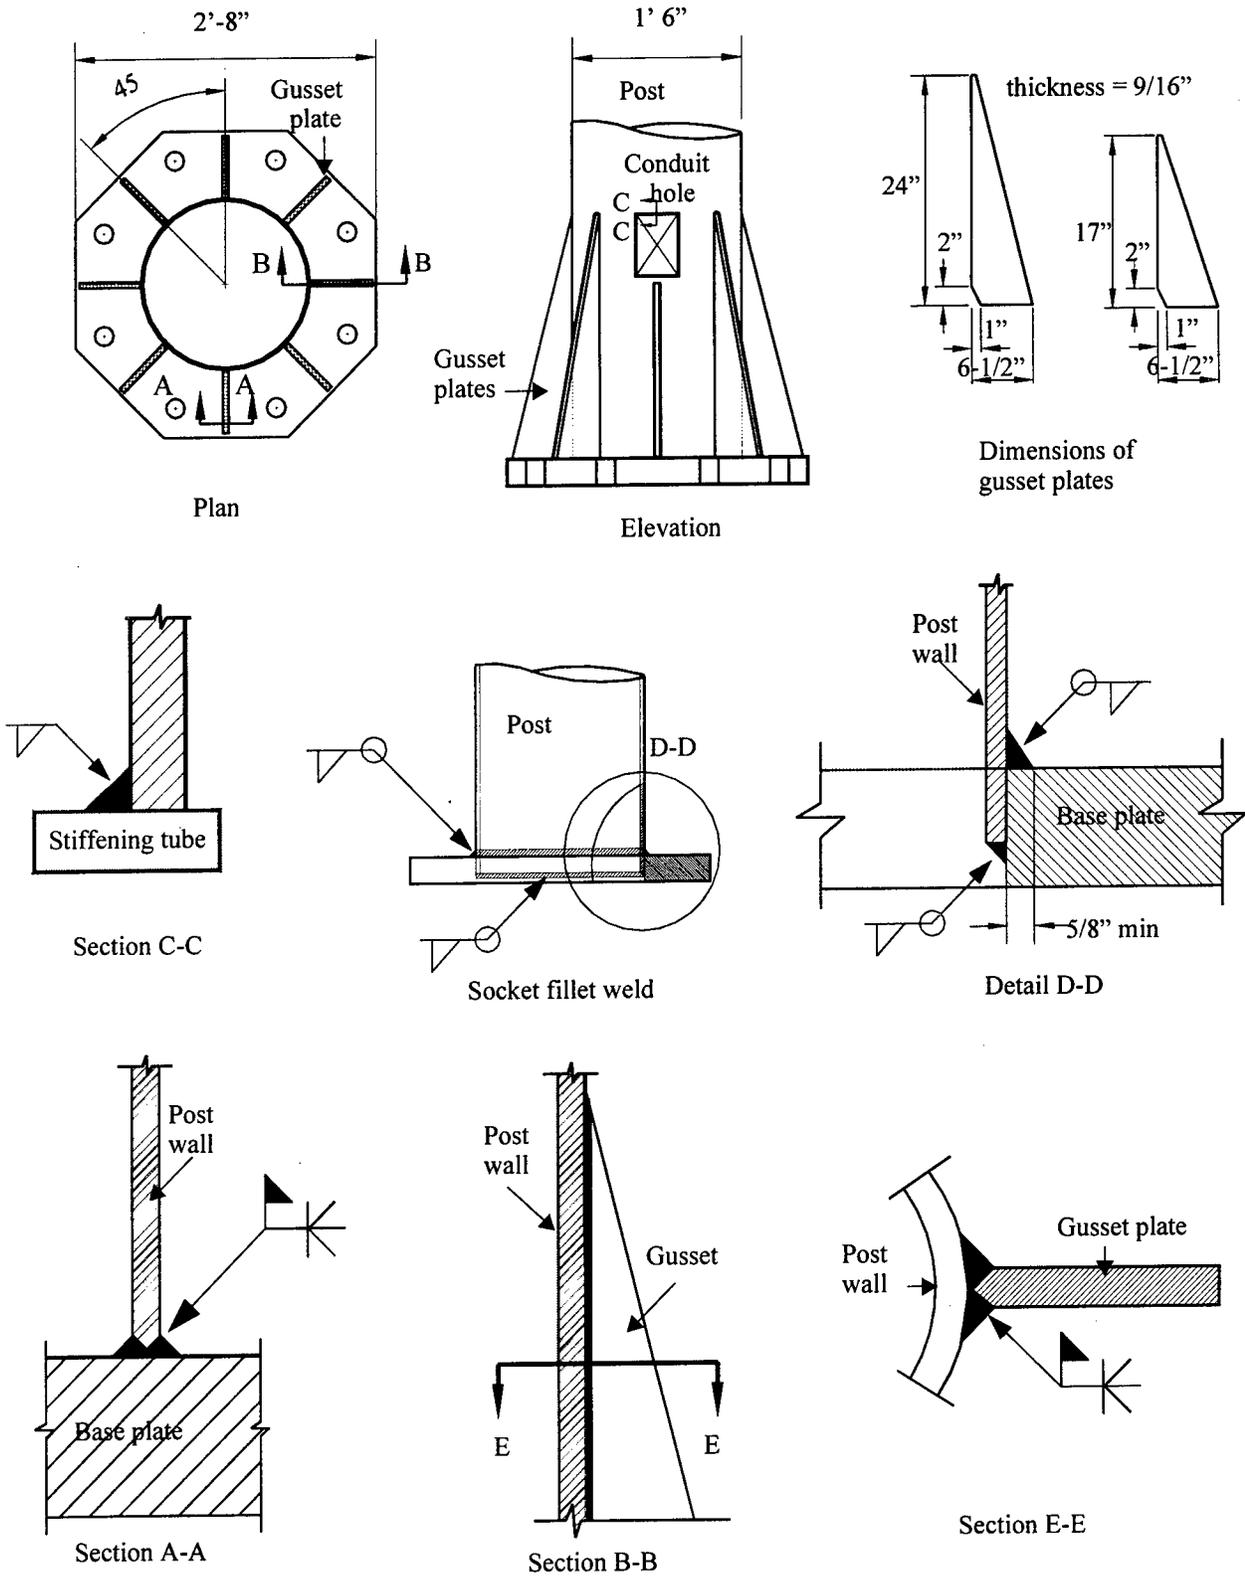
Figure 4.1: Dimensions and connection details for gusset-retrofit Specimen GR1

The test specimen was fabricated by cutting a CMS post with an outside diameter of 18 in. (457 mm) and a wall thickness of 1/2 in. (13 mm) to a length of 14 ft. 4 in. (4.4 m) to accommodate the framing built for testing of other CMS components (Gilani, et al., 1997). The post was socket fillet welded at its base (see Figure 4.1) to a 2-3/4 in. (70 mm) thick octagonal steel plate. The specimen was connected to the foundation using eight 2-1/4 in. (57 mm) diameter anchor bolts following Caltrans guidelines. The upper nuts were first snug tightened, then further tightened by the turn-of-the-nut method (AISC, 1995). A

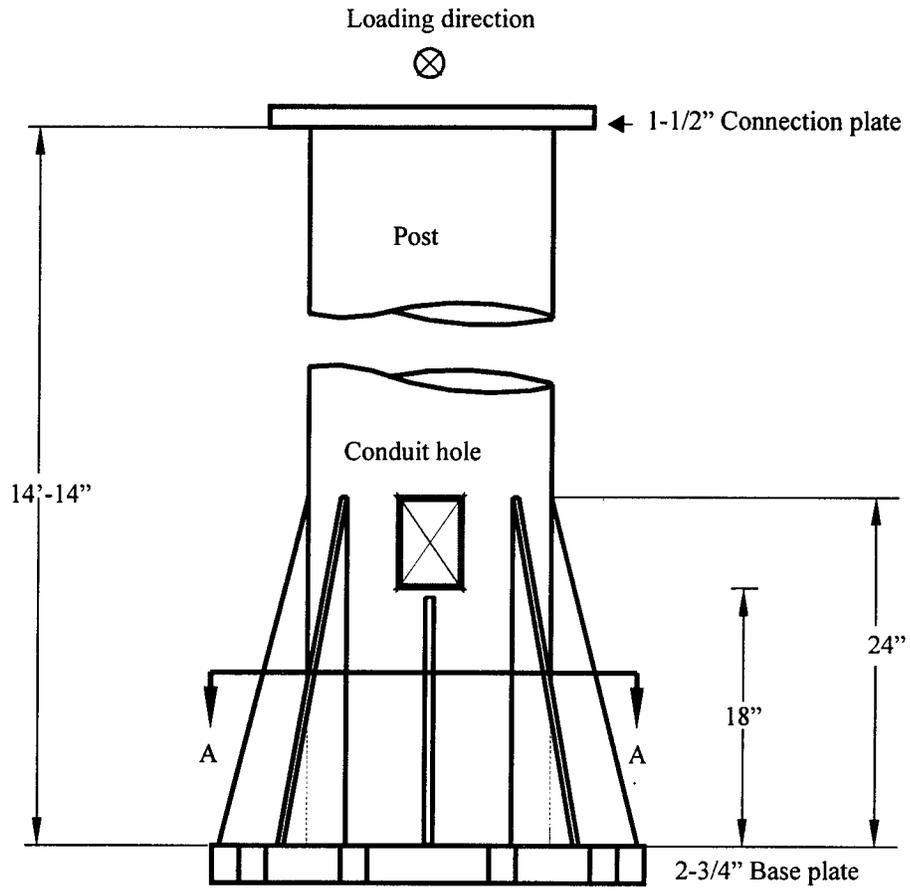
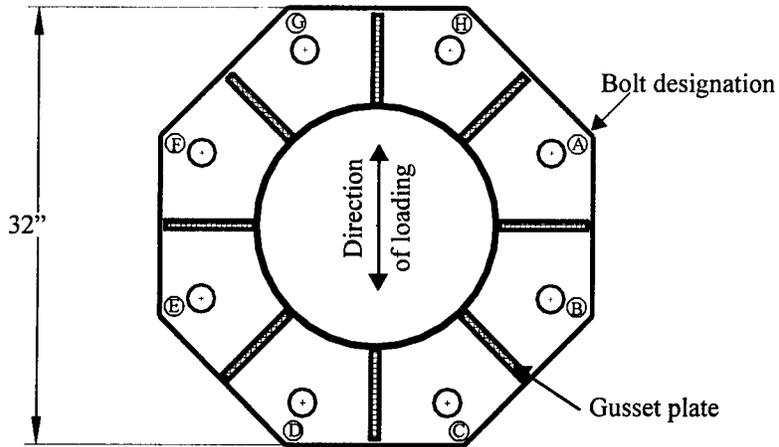
(a) Elevation

(b) Section A-A (Plan)

Figure 4.2: Schematics of setup for Specimen GR1

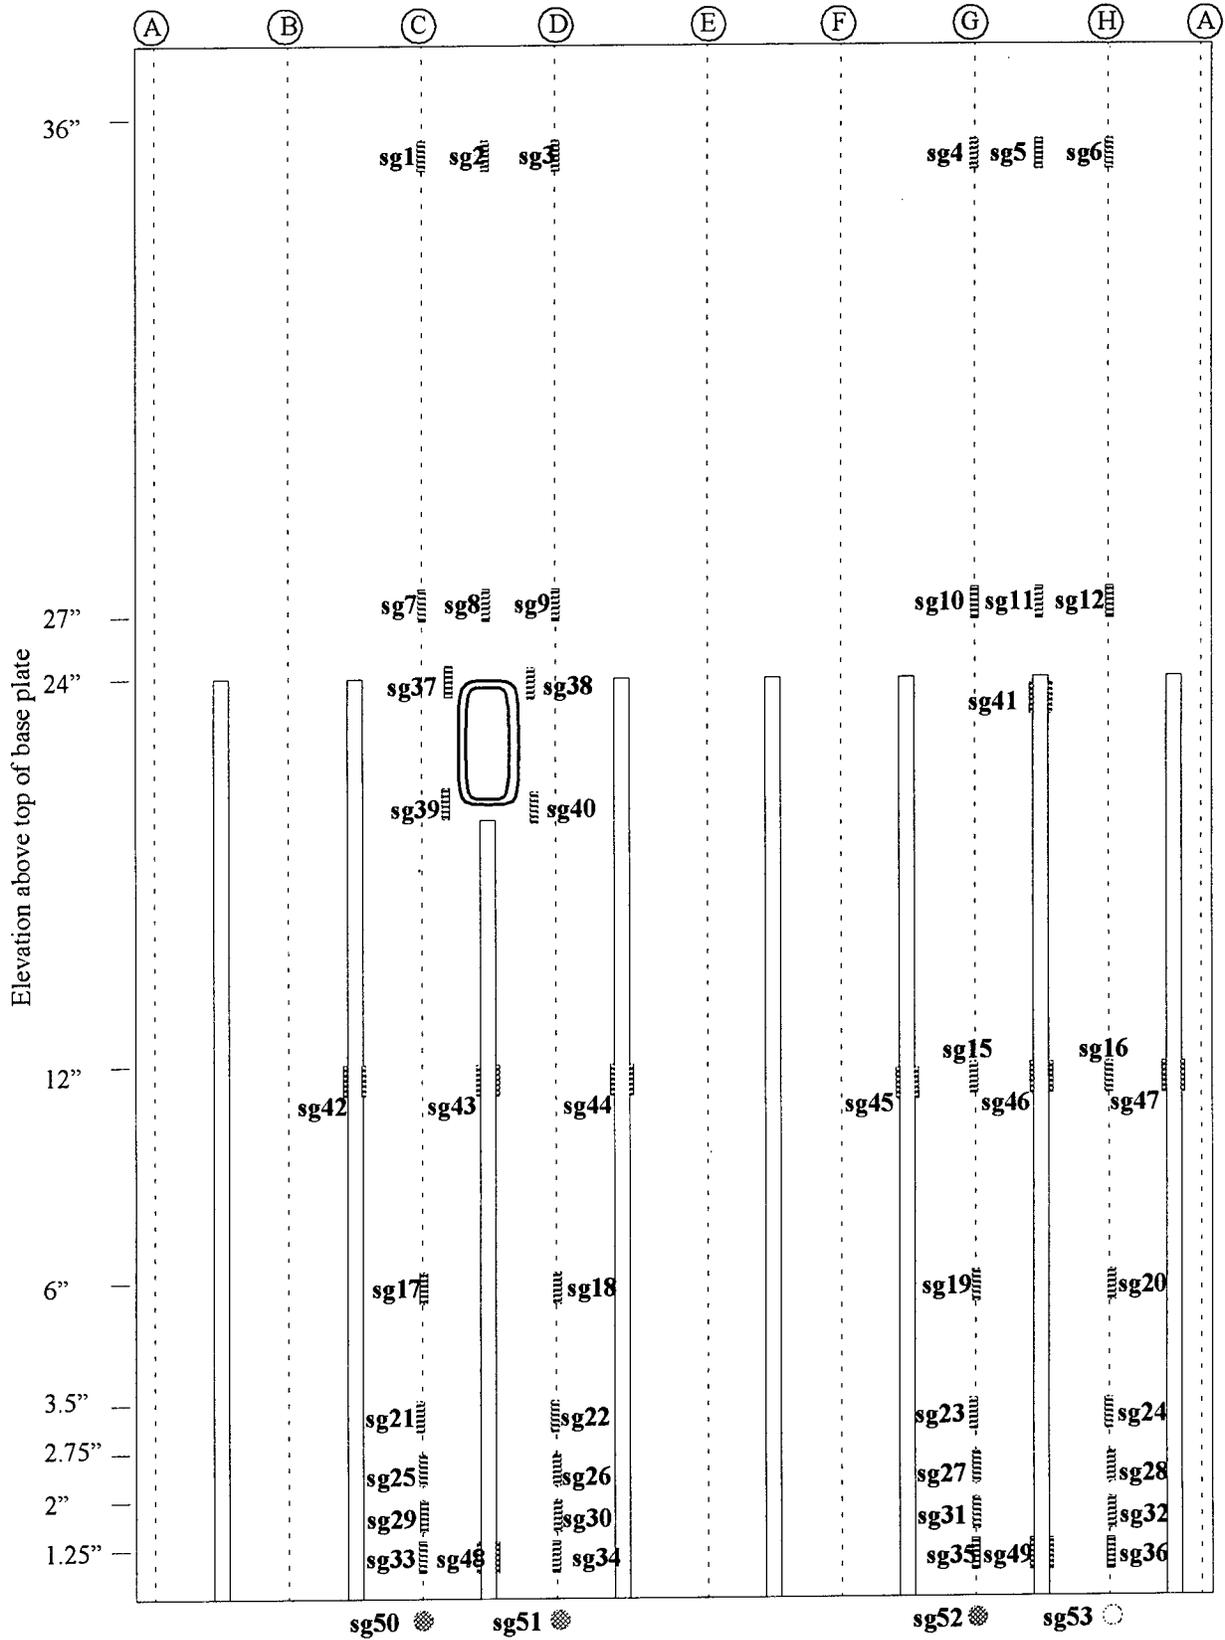
Figure 4.3: Instrumentation for Specimen GR1

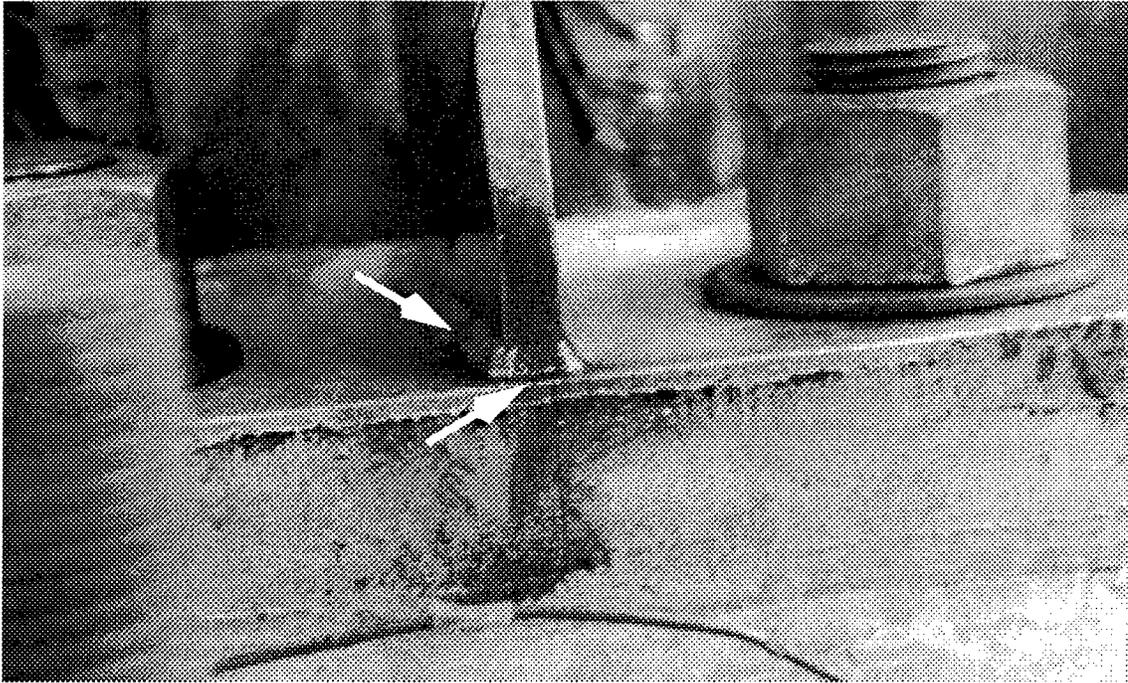
Figure 4.4: Cracking of gusset-to-base plate weld for Specimen GR1

Several cracks were identified during cyclic testing, including cracks in the gusset-to-base plate welded connections, the gusset-to-post welded connection, the gusset-to-base plate welded connections, the post-to-base plate welded connections, the gusset parent metal, and in the post initiating at the upper and lower corners of the conduit hole. Figures 4.4 and 4.5 identify the cracks observed at the gusset-to-base plate connection and at the conduit hole at the end of the testing.

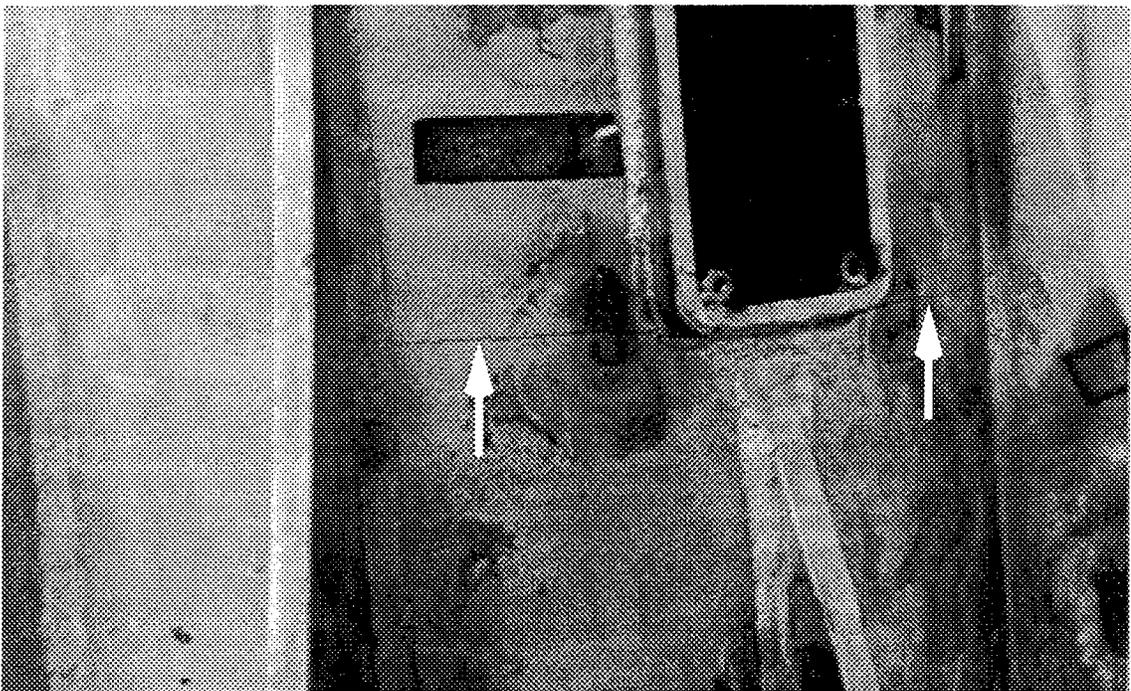
Figure 4.5: Crack propagation at the conduit hole for Specimen GR1

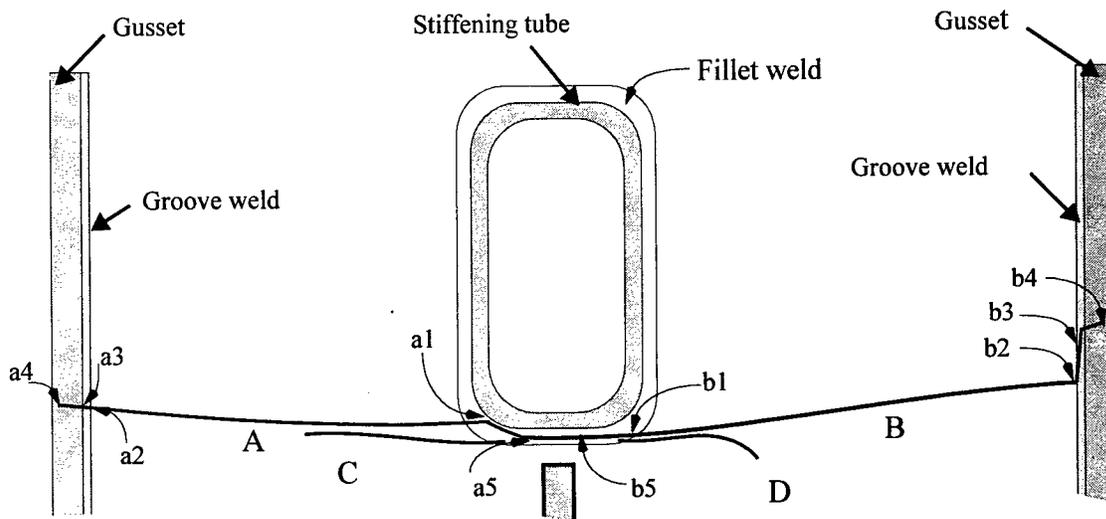
Figure 4.6: Crack pattern around the conduit hole for Specimen GR1

Figure 4.6 shows the crack pattern around the conduit hole. In particular, two horizontal cracks initiating at the lower left (a1) and right (b1) corners of the conduit hole (designated as cracks A and B, respectively) propagated substantially as the cycles accumulated. These cracks reached the gusset-to-post welded connections (a2 and b2) at approximately 985,000 cycles.

Crack A, starting at the lower left corner of the conduit hole (a1), propagated horizontally toward the gusset-plate groove weld (a2), passed through this weld (a3) at 1,020,000 cycles, and then propagated into the gusset parent metal (a4) at 1,055,000 cycles. Crack B, starting at the lower right corner of the conduit hole (b1), propagated to the gusset-plate groove weld (b2), through the gusset plate-to-post weld (b3) at 1,020,000 cycles, and then into the gusset parent metal (b4) at 1,055,000 cycles. Both cracks continued to propagate into the gusset parent metal. In addition, due to the propagation of crack A to the right (a5) and crack B to the left (b5) at the conduit hole, these cracks met below the bottom edge of the conduit hole at approximately 860,000 cycles.

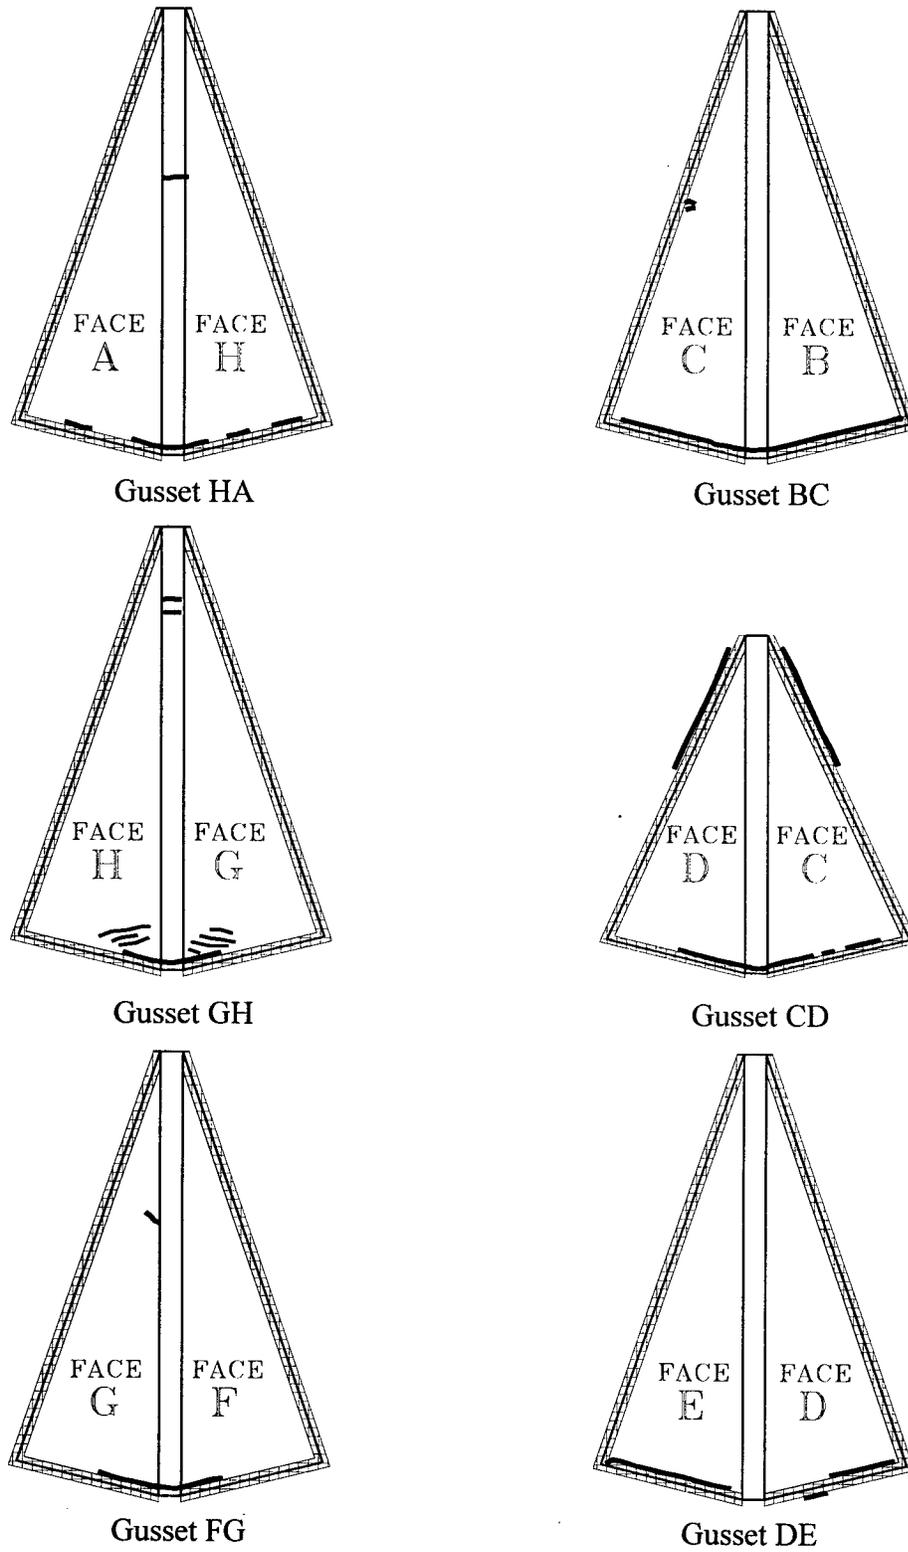
Figure 4.7: Cracking (solid heavy line) in the gusset plates (shown in exploded view) of Specimen GR1

Figure 4.7 shows the locations of the cracks (solid heavy line) in, and adjacent to, the gusset plates at the conclusion of the cyclic test. Most of the cracks developed in the gusset plate-to-base plate welded connections. Cracks also developed at the gusset plate-to-post connection in gusset CD (tension side) below the conduit hole.
