REPORT NO.
UCB/EERC-97/13
DECEMBER 1997

FATIGUE LIFE EVALUATION OF CHANGEABLE MESSAGE SIGN STRUCTURES

VOLUME 2: RETROFITTED SPECIMENS

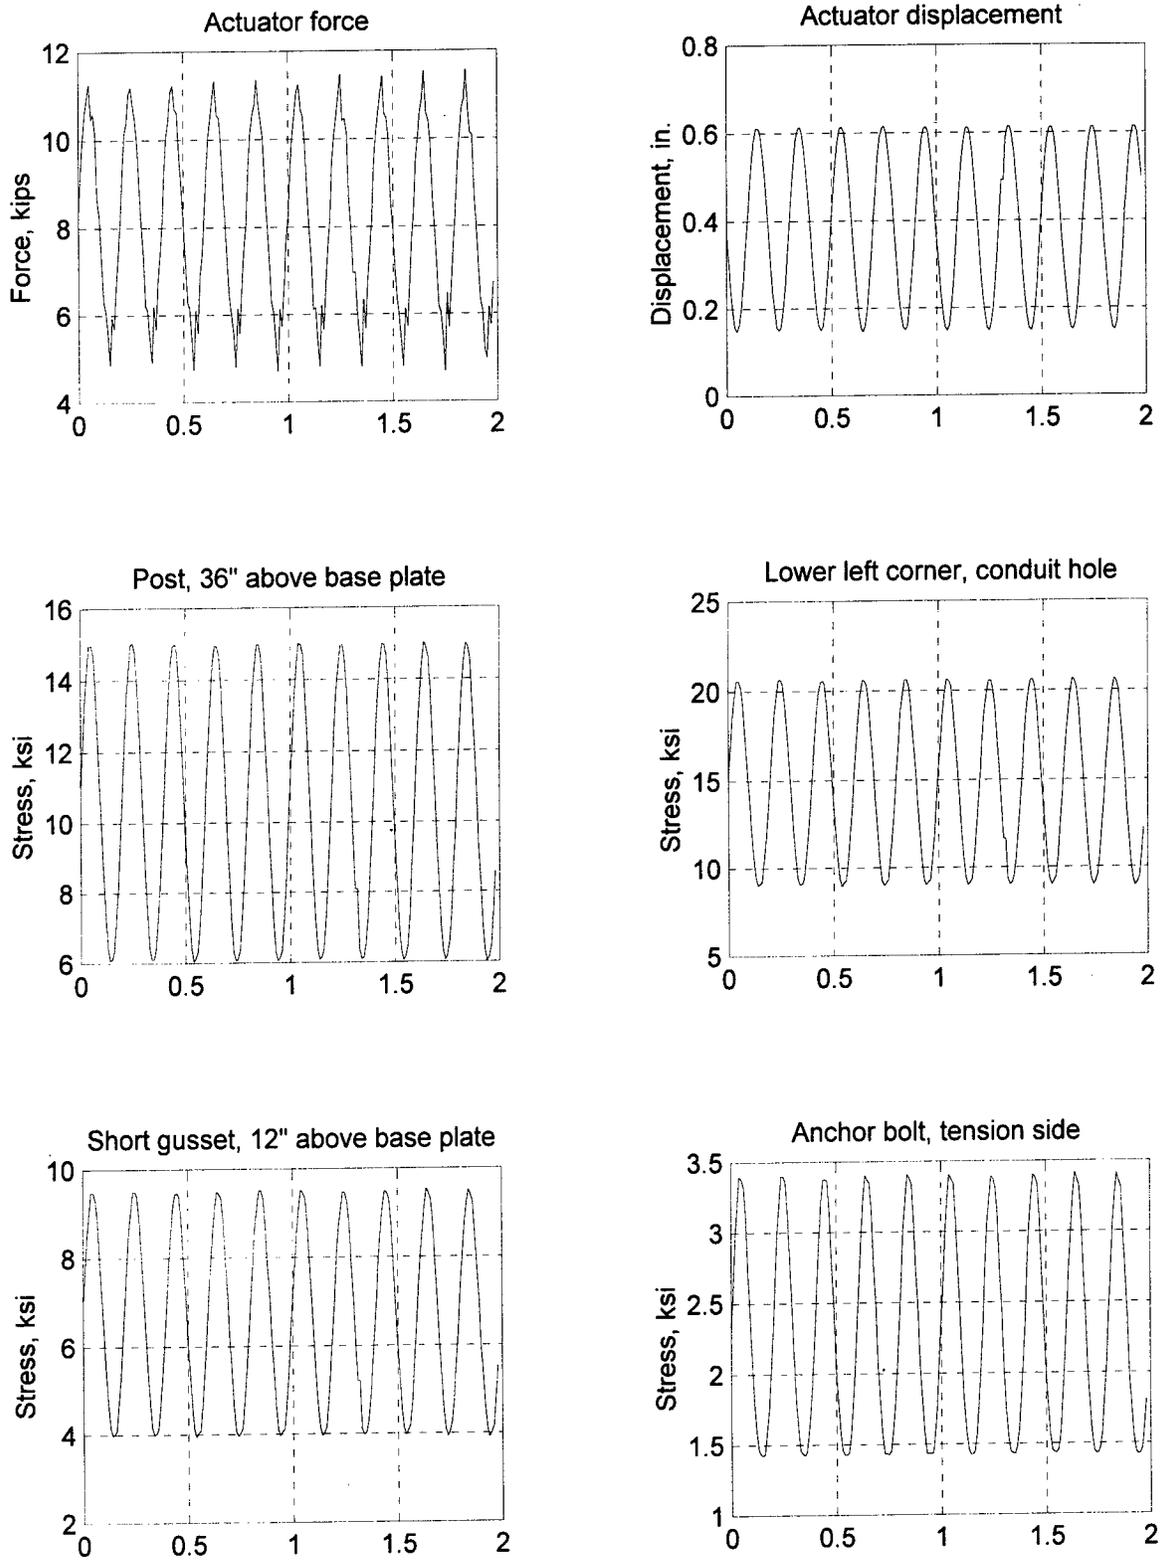
Figure 4.8: Typical response histories for Specimen GR1

Typical test data is shown in Figure 4.8. The data in these plots were collected at a cycle count of 10,000 cycles and are representative of the response of Specimen GR1 prior to substantial cracking. The stresses were obtained by multiplying the strain gage values by Young's modulus for steel, assumed to be 30,000 ksi (207 GPa). The plots show the response histories of the actuator force and displacement, the post stresses 36 in. (914 mm) above the base plate (sg2), the stresses at the lower left corner of the conduit hole (sg39), the stresses at the gusset plate CD (sg43), and the stresses at the anchor bolts in the tension side (sg52).

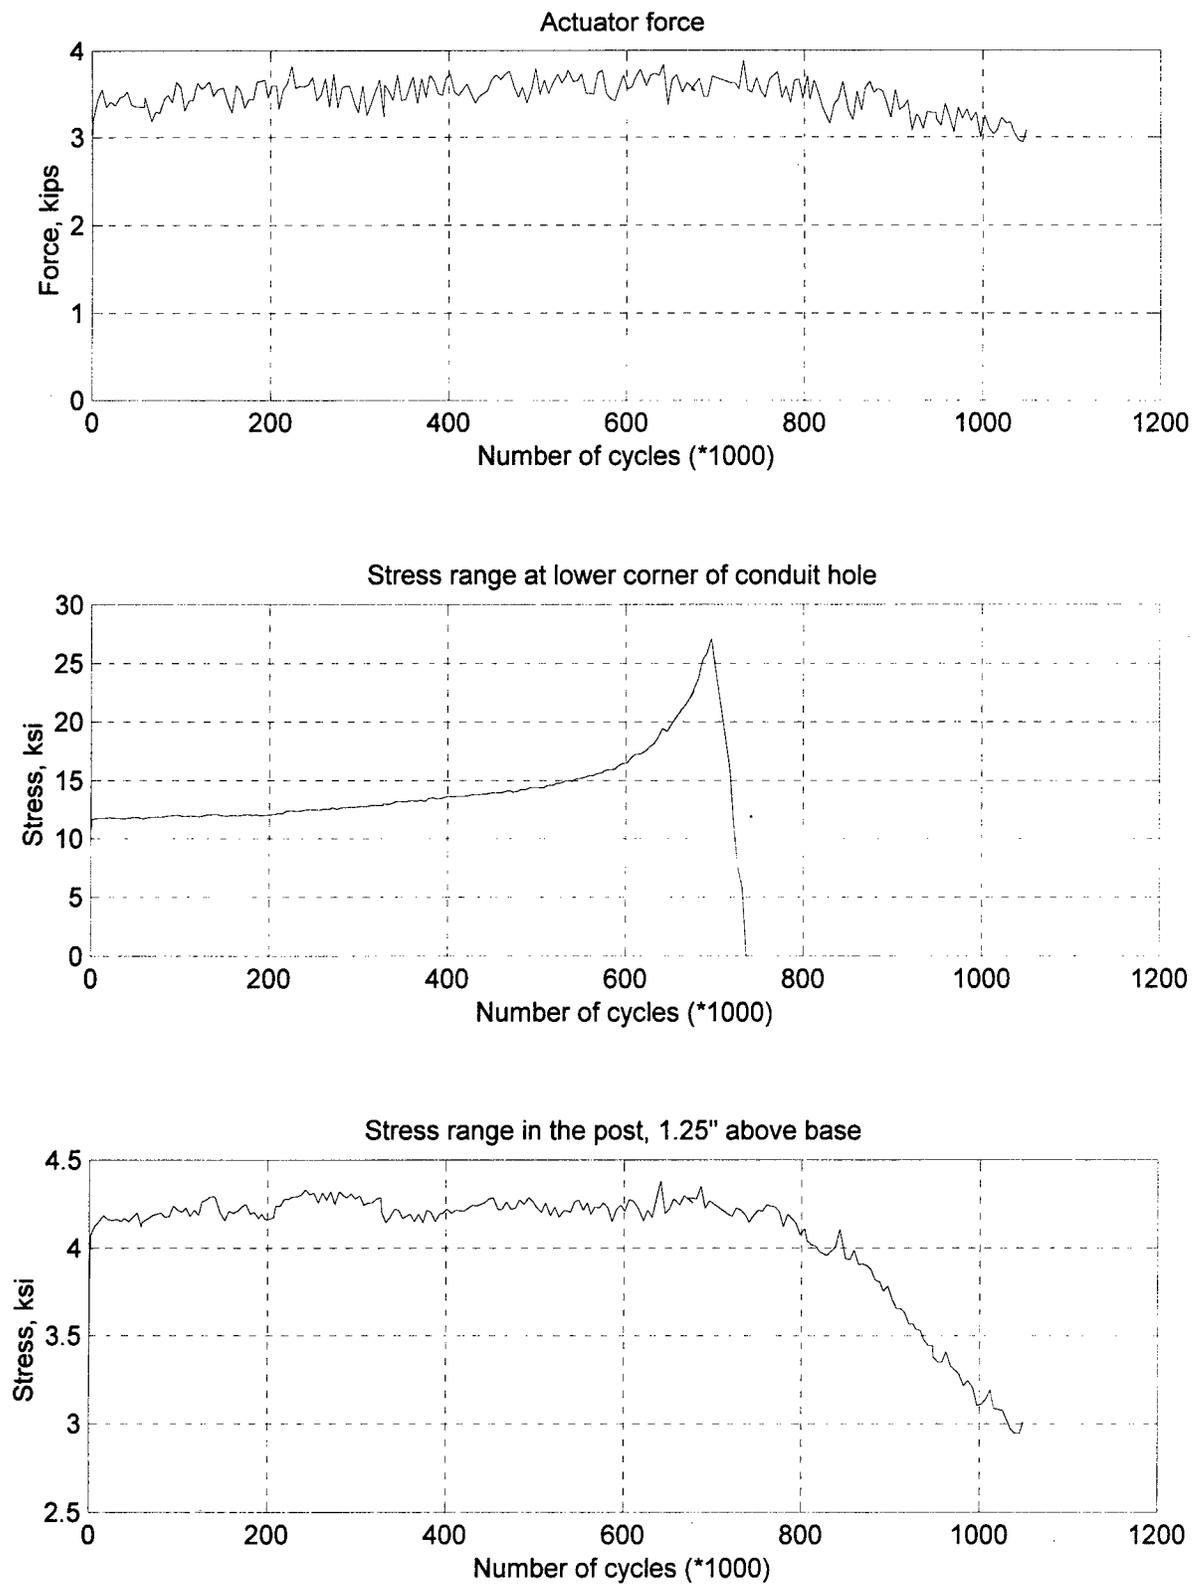
Figure 4.9: Response maxima for Specimen GR1

The minimum and maximum responses were computed for each data channel and for all 212 tests. Figure 4.9 shows the response maxima of the actuator force history, the stress range at the lower corner of the conduit hole (sg 39), and the stress range in the post at 1.25 in. (32 mm) above the base plate on the tension side (sg33). The actuator force is relatively constant up to approximately 800,000 cycles, and starts to decrease noticeably thereafter. A similar trend is noted for the post stresses 1.25 in. (32 mm) above the base plate. The post stresses at the lower end of the conduit hole increase substantially after approximately 300,000 cycles due to stress redistribution in the post following cracking adjacent to the conduit hole. After approximately 700,000 cycles, cracks propagated to the gage, and the strain readings dropped to zero.

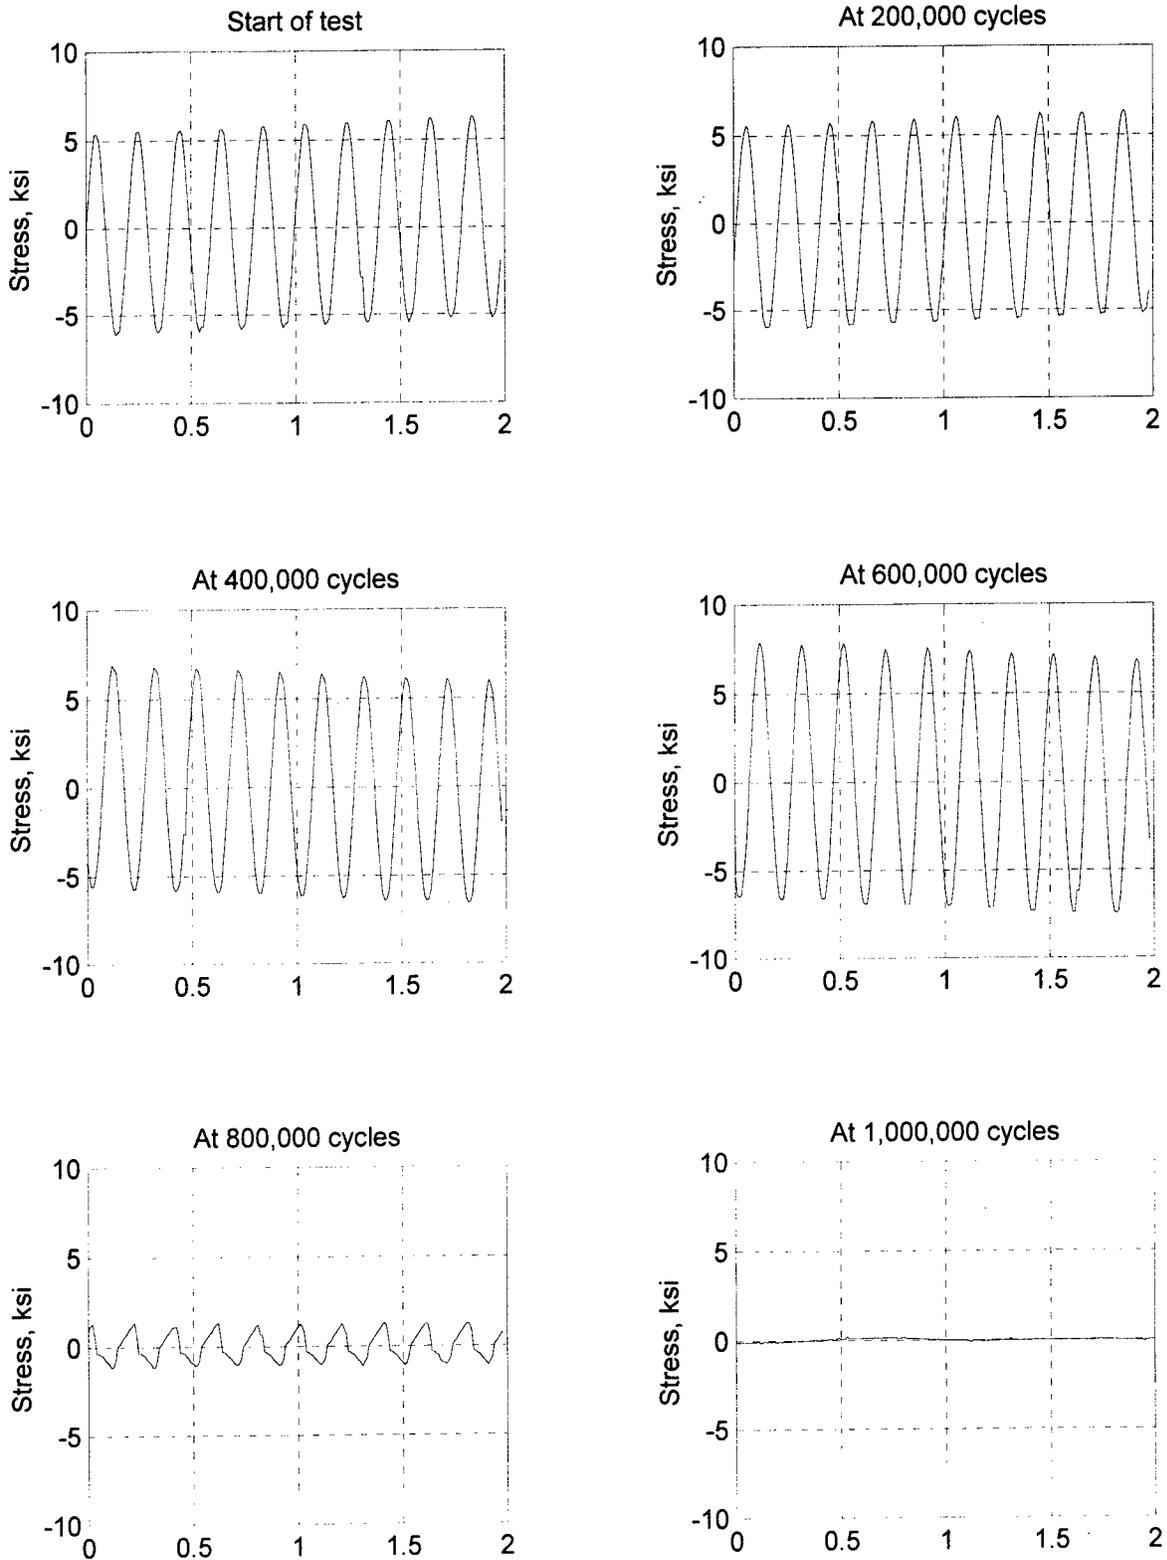
Figure 4.10: Response history (mean value removed) at the bottom left corner of conduit hole for Specimen GR1

Figure 4.10 shows the average stress (strain) response, near the lower corner of the conduit hole, at 200,000 cycle increments of loading. The data shown was corrected to remove the drift in the transducer response history. Up to 600,000 cycles, the data is essentially symmetric and sinusoidal. At 800,000 cycles, the stress response has lost both its symmetry and its sinusoidal shape, and the stresses are significantly smaller indicating the presence of adjacent cracks. At 1,000,000 cycles, the stresses are negligible due to cracking at the sensor location.

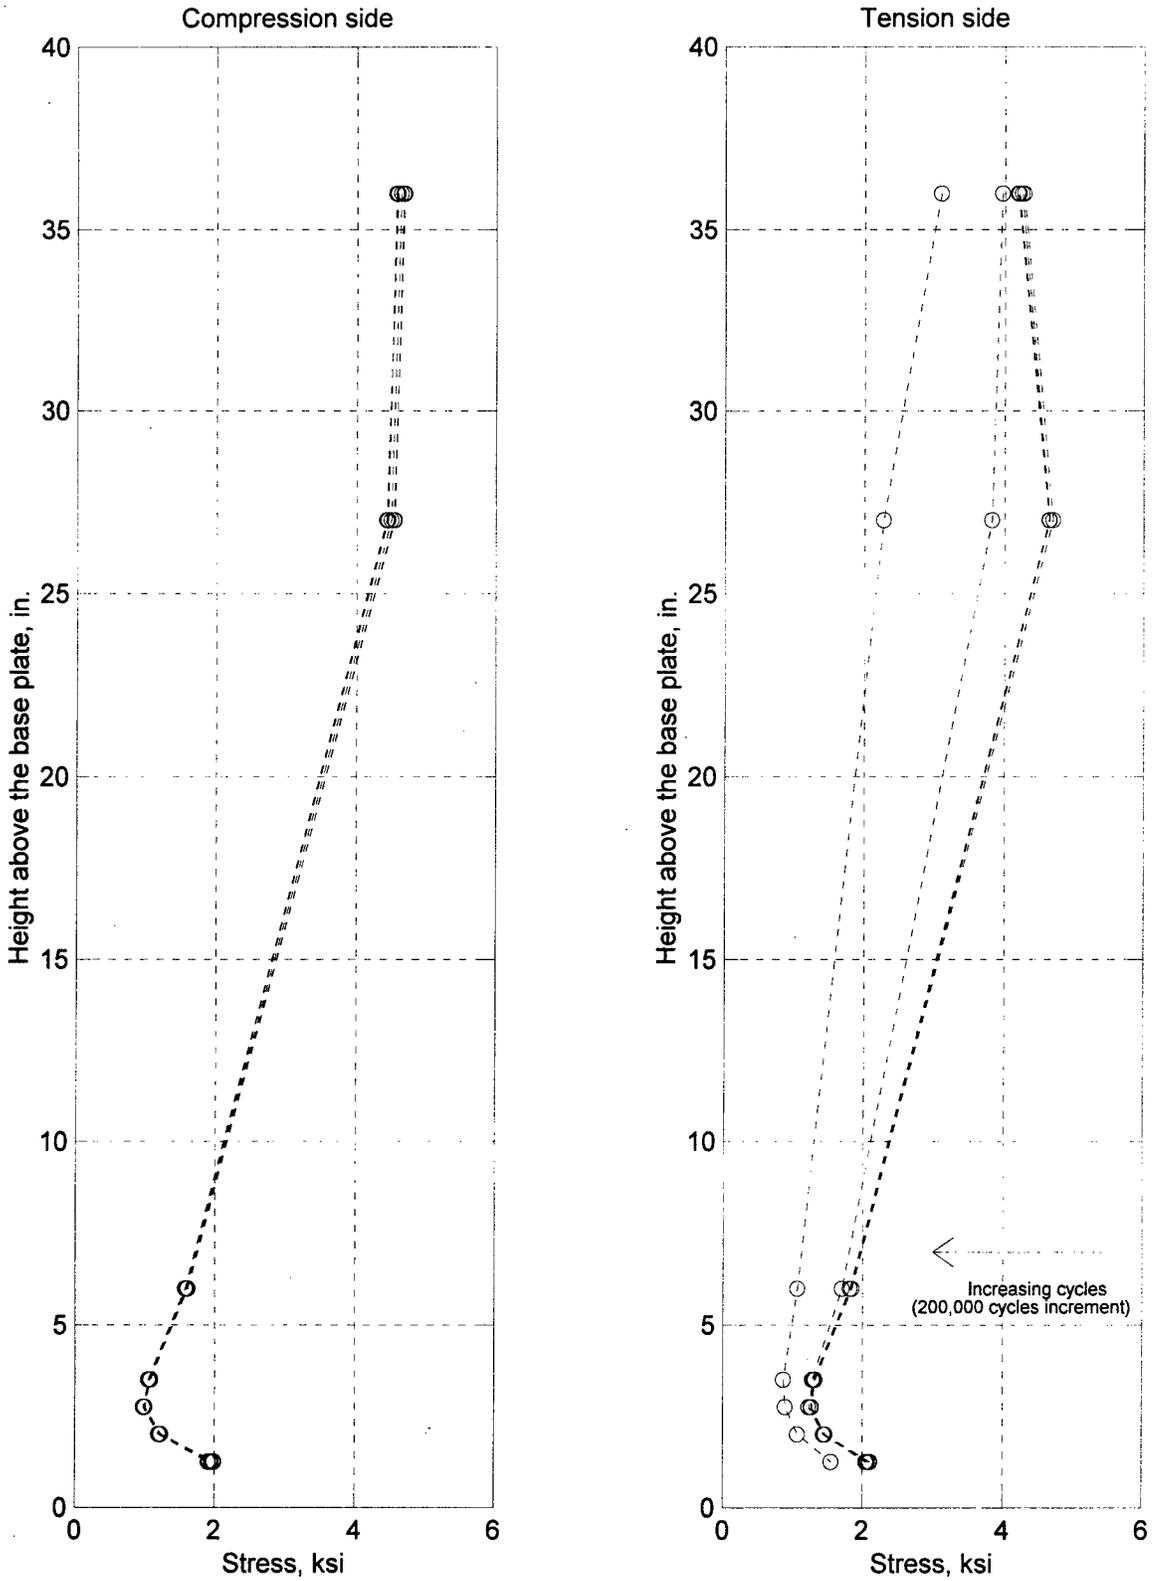
Figure 4.11: Stress distribution (mean value removed) along the post for Specimen GR1

Figure 4.11 shows the stress profile on the tension and compression faces of the post. The stresses are plotted for every 200,000 cycles. The stress distribution on the compression side does not change with the number of test cycles. However, on the tension side, the stress distribution varies with the number of cycles. Up to 600,000 cycles, the stress distribution is stable, but varies thereafter as the cracks around the conduit hole grow substantially. The highest stresses in the tension side occur 27 in. (686 mm) above the base and above the gusset plate. Below this height, the stresses in the post are dramatically reduced due to

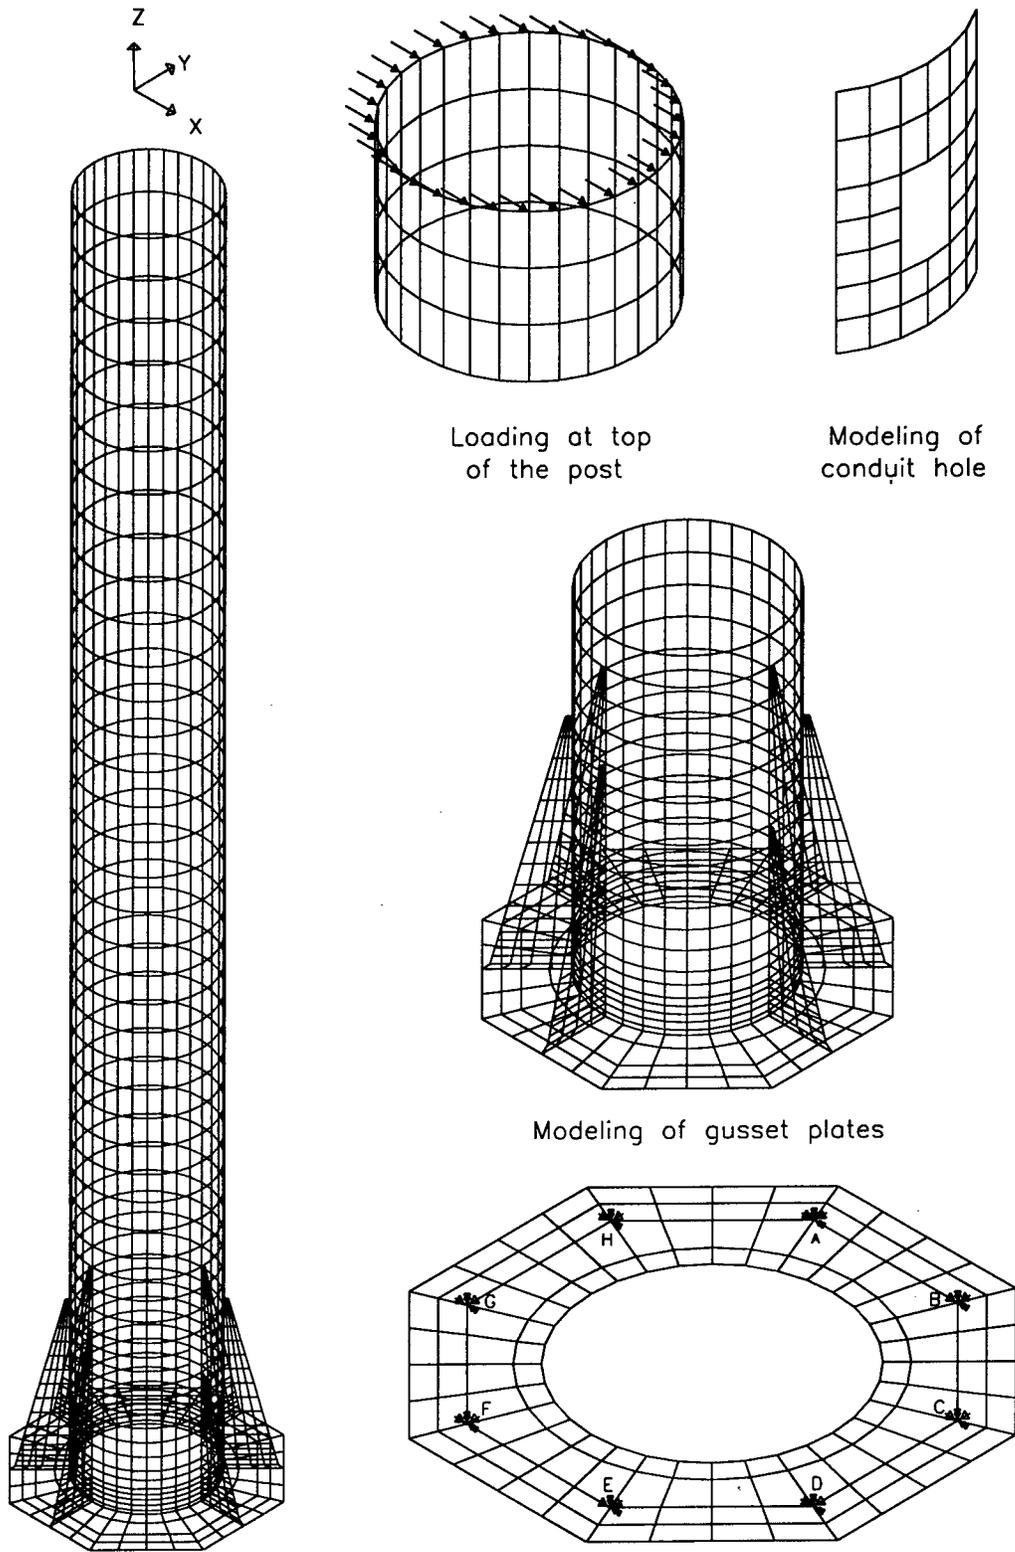
Restraints at the base

Figure 4.12: Analytical model of Specimen GR1

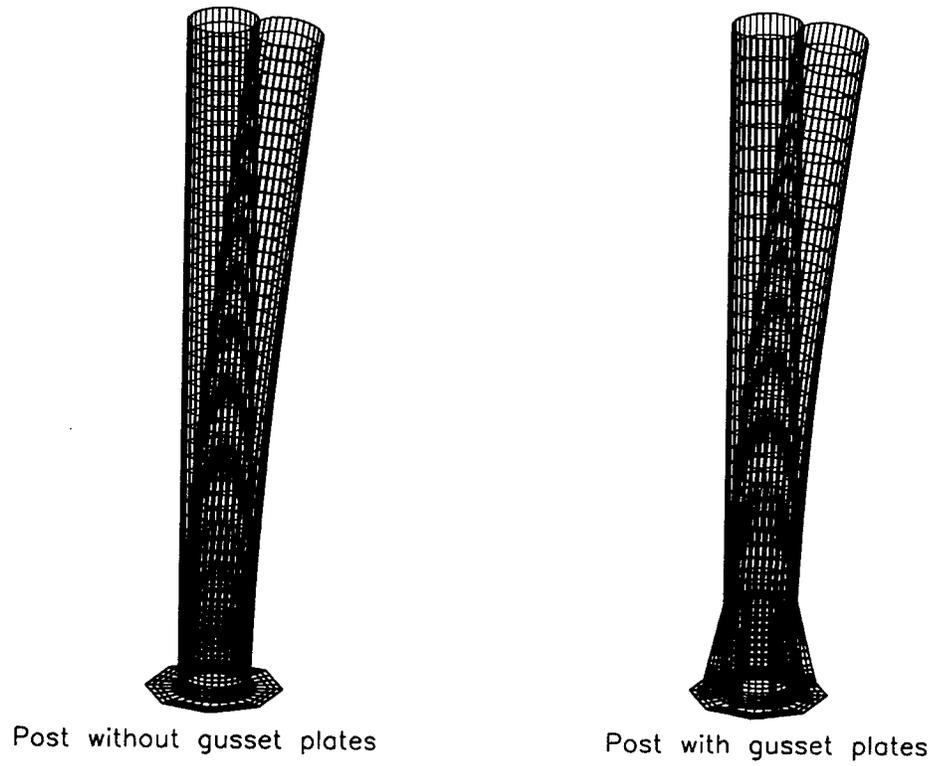
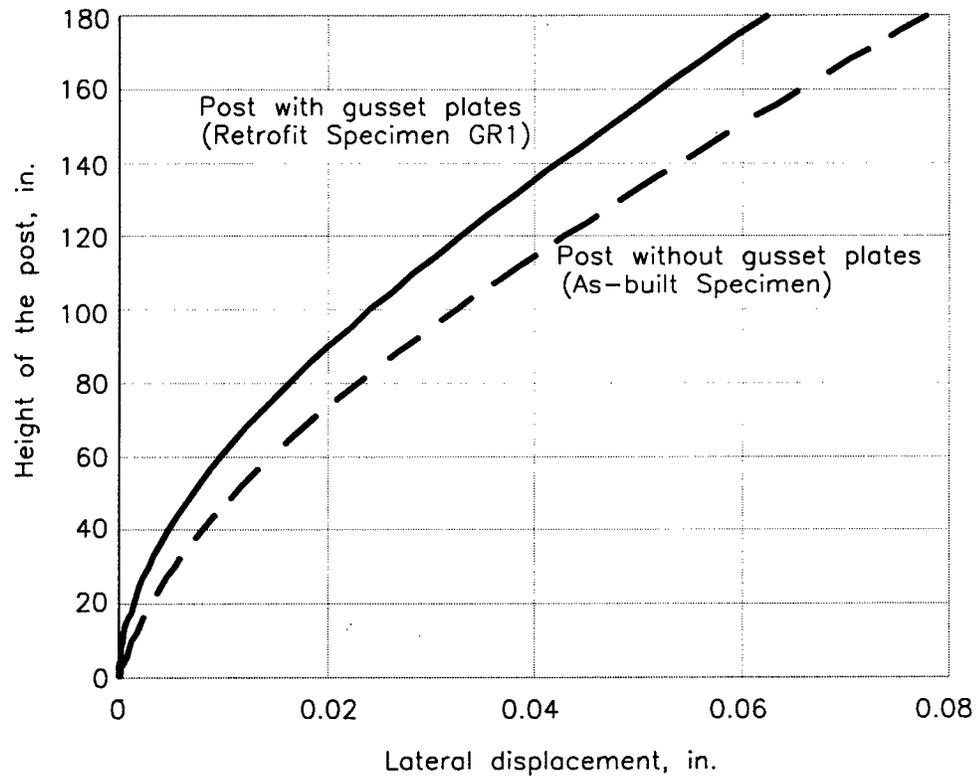
Figure 4.13: Deformed configuration due to a unit load applied at the top of Specimen GR1

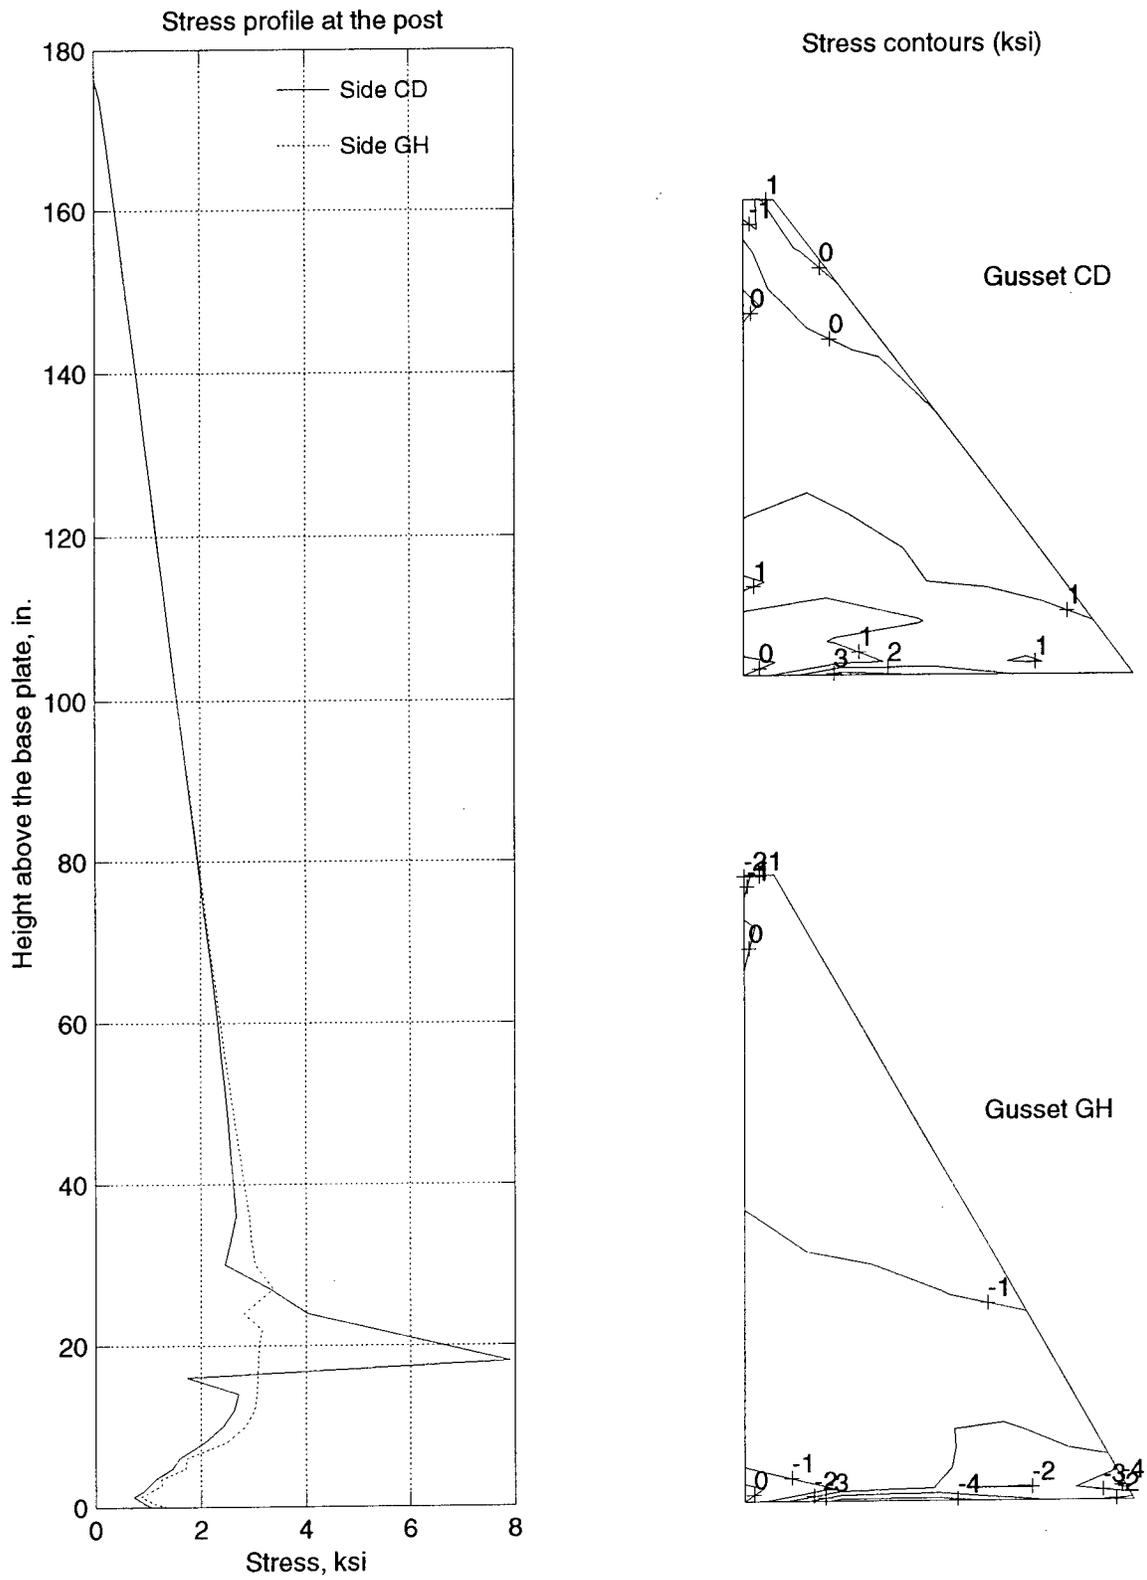
Figure 4.14: Computed stresses for Specimen GR1

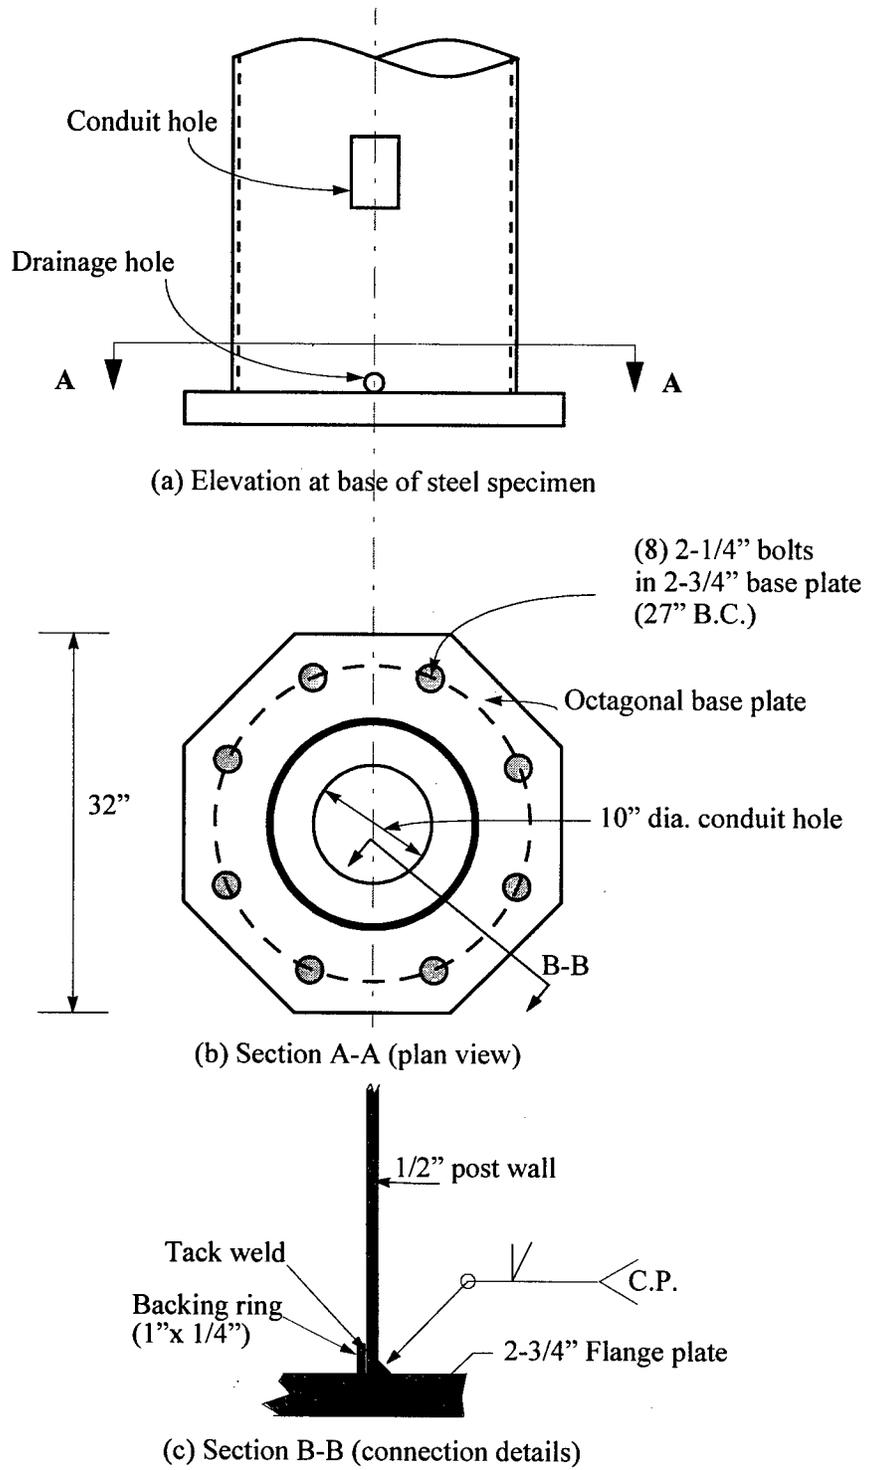
Figure 5.1: Connection details for the steel post of Specimen CIP1

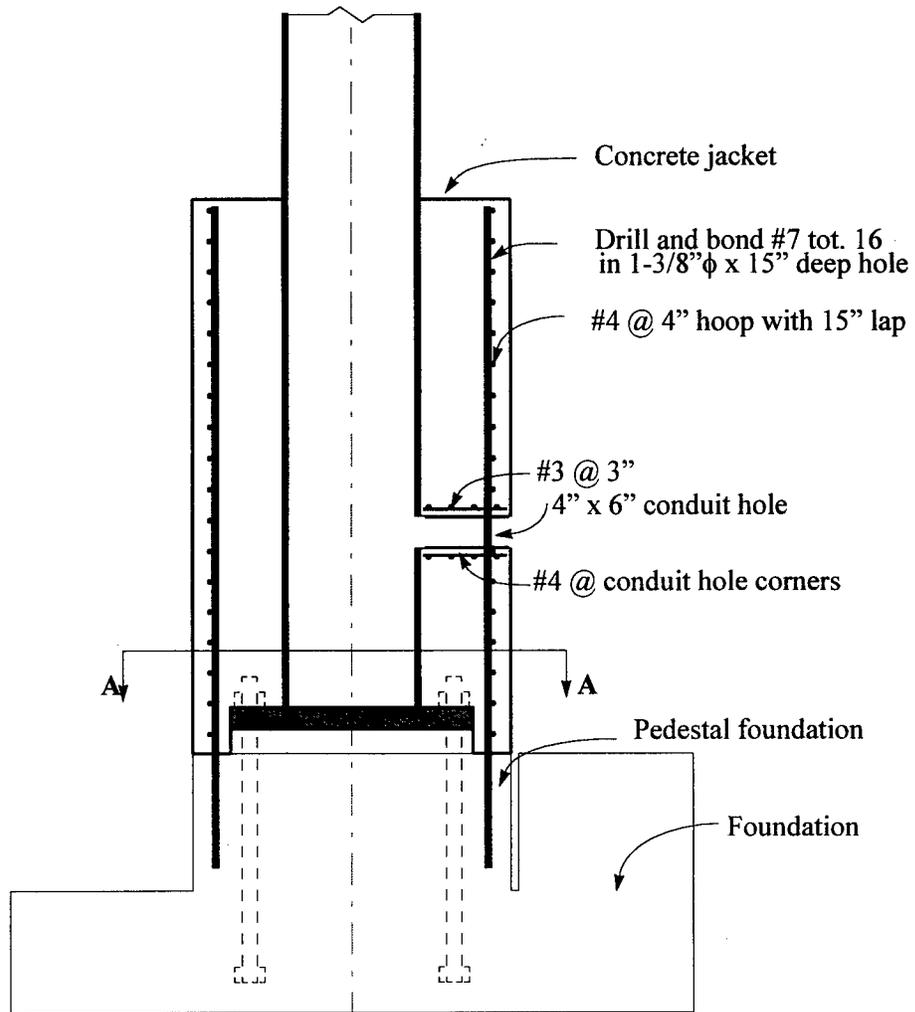
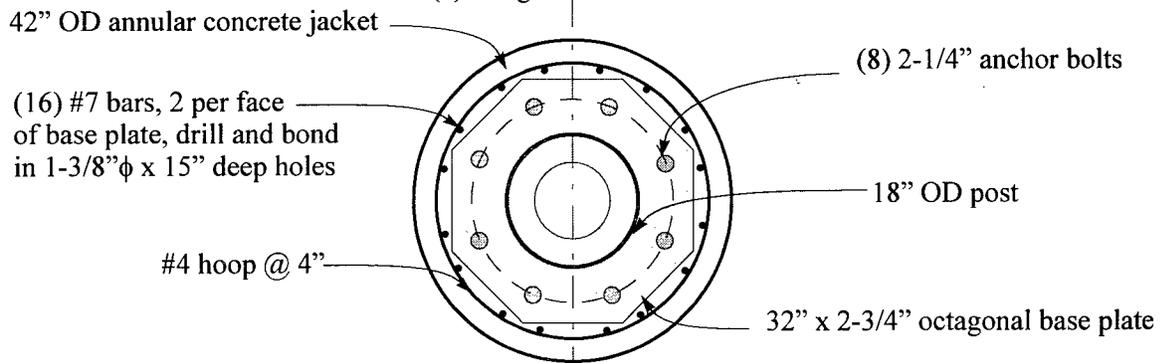
(a) Longitudinal Section

(b) Section A-A (plan view)

Figure 5.2: Retrofit details for Specimen CIP1

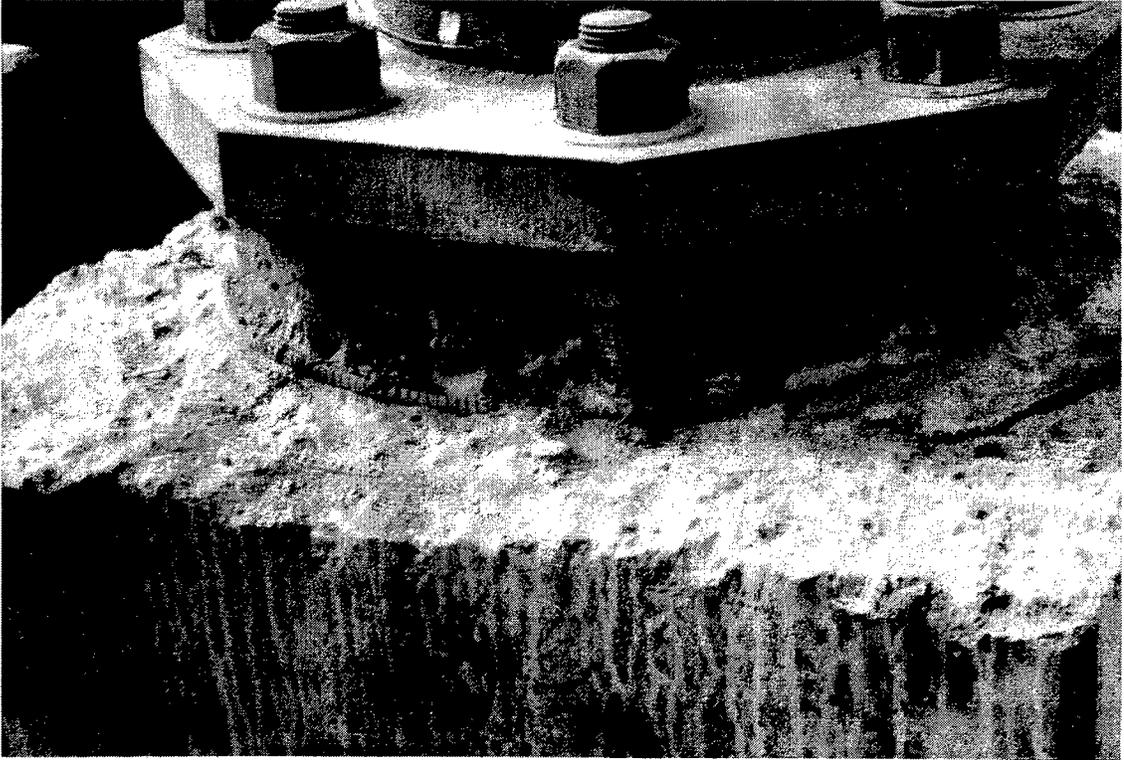
Figure 5.3: Removing the cover concrete and exposing top reinforcement

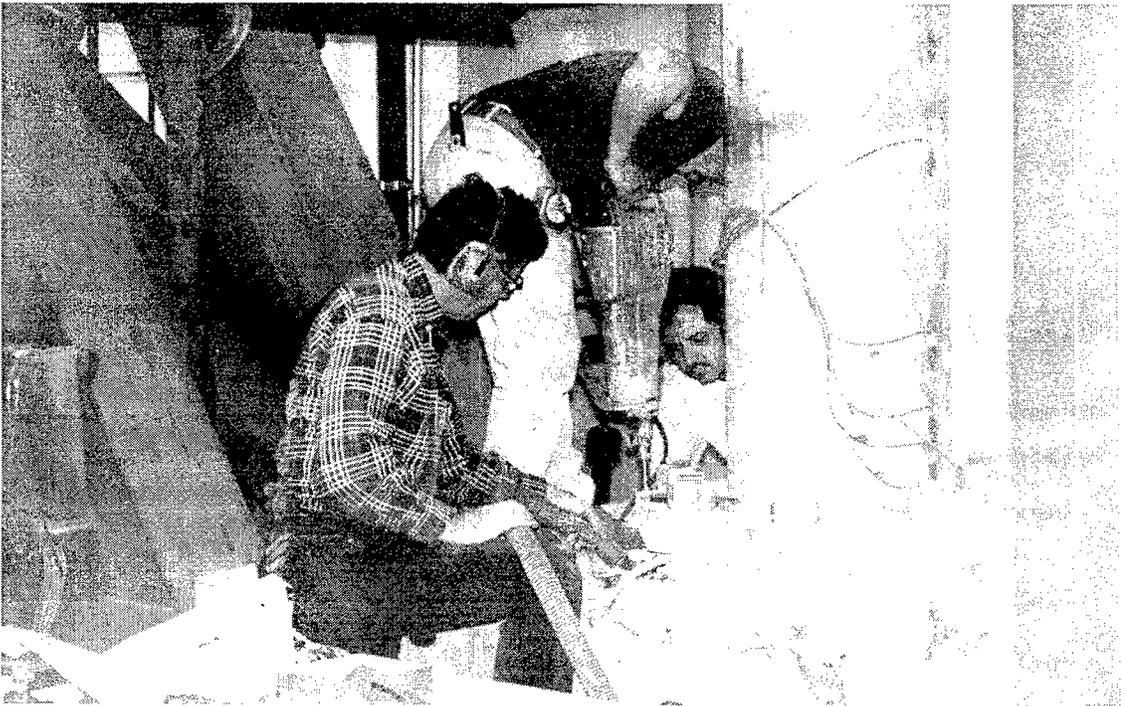
Figure 5.4: Drilling the existing foundation

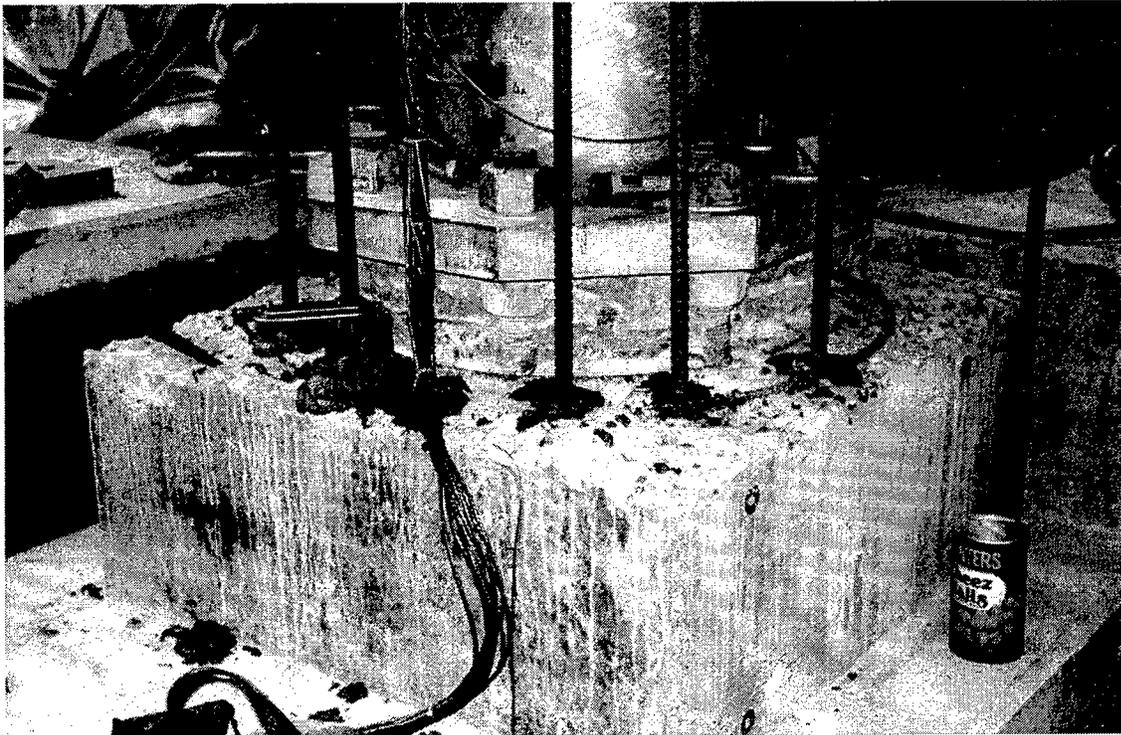
Figure 5.5: Grouting the longitudinal reinforcement

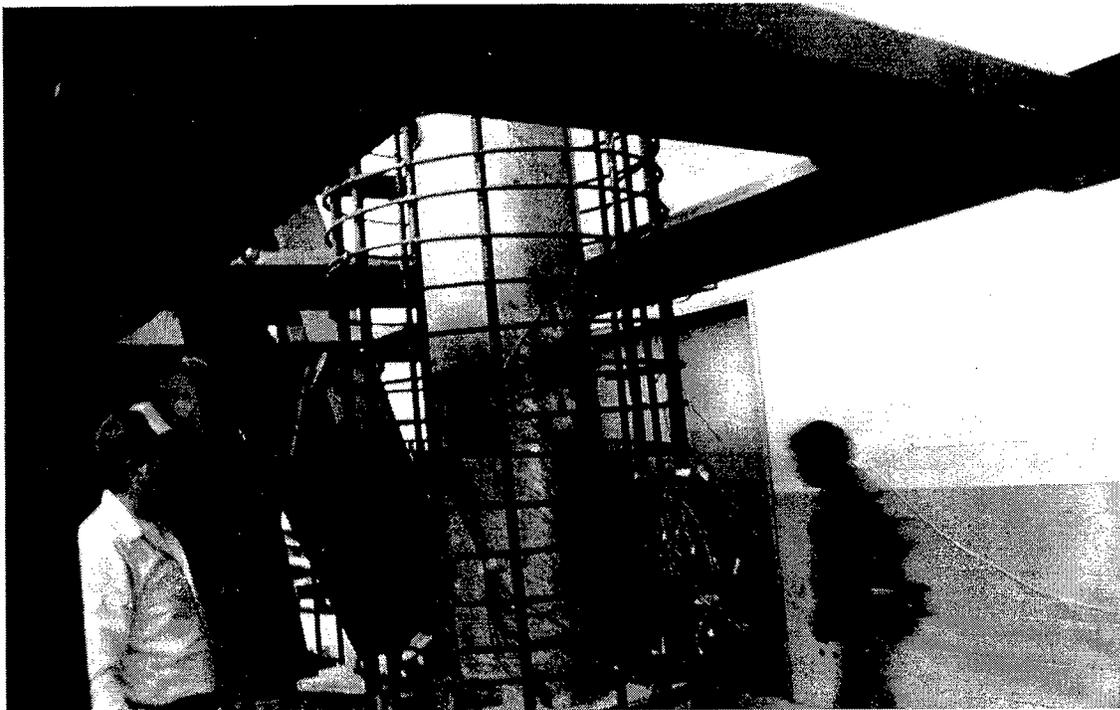
Figure 5.6: Placing the transverse hoops

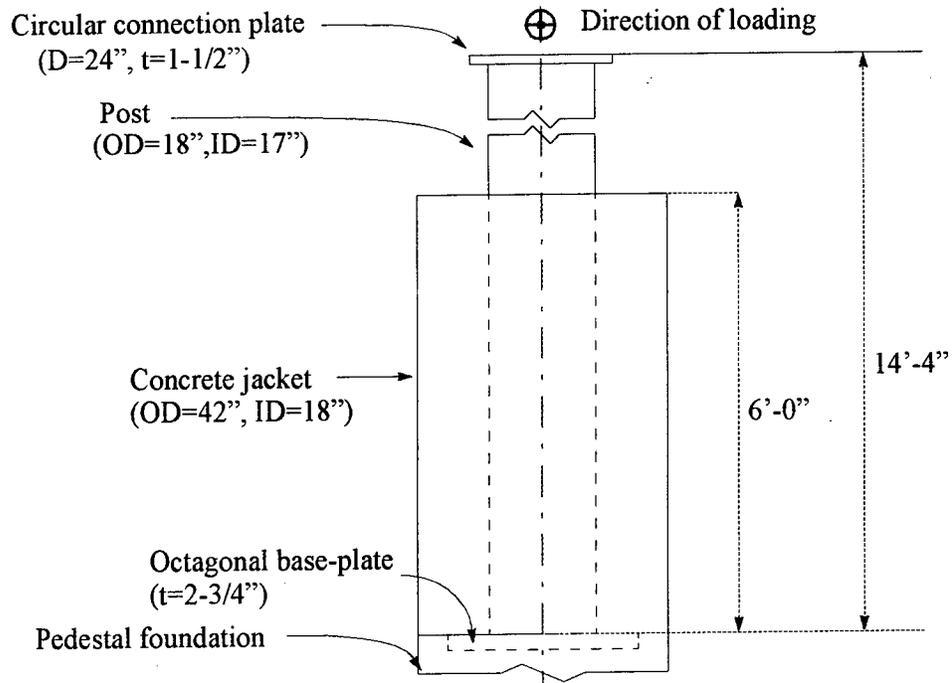
Figure 5.9: Test setup for Specimen CIP1

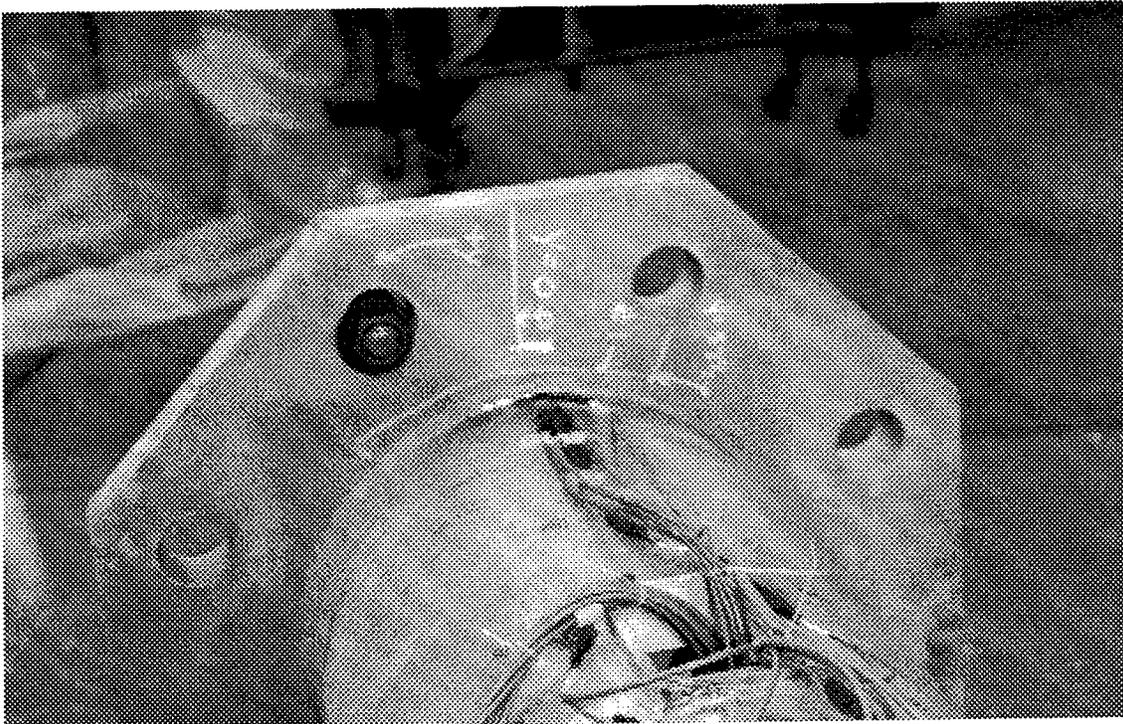
Figure 5.10: Location of flaws on the tension side of the post detected by ultrasonic testing

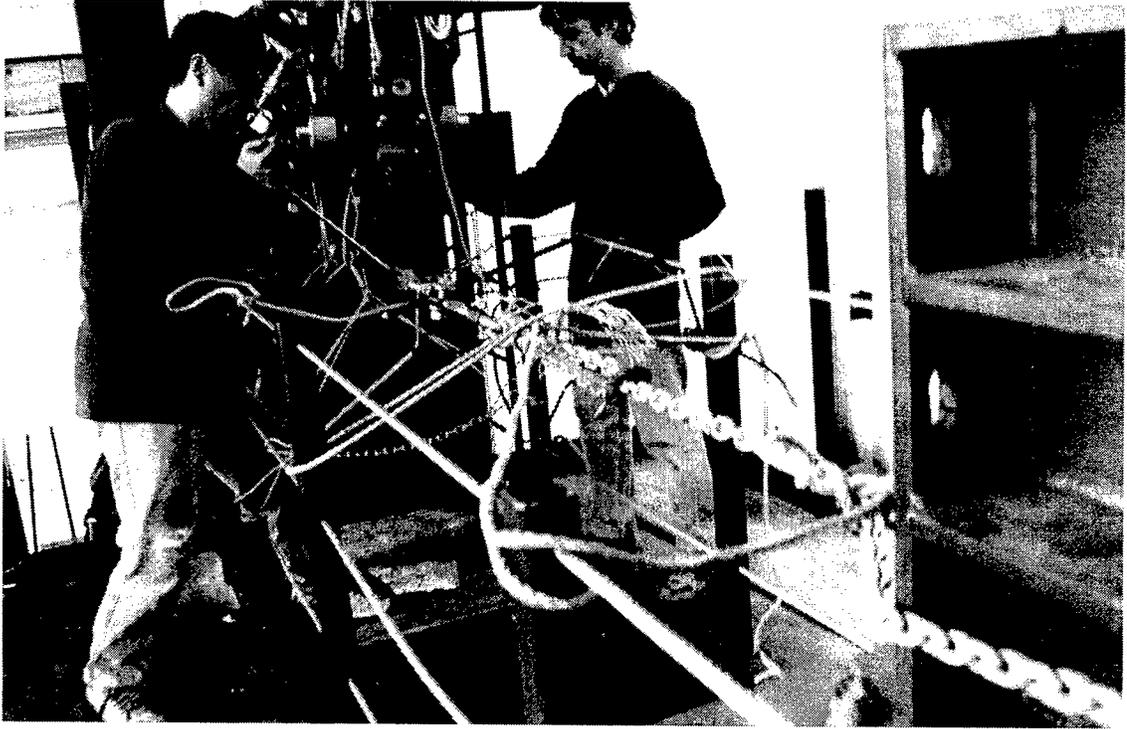
Figure 5.11: Test setup for the pull-back tests

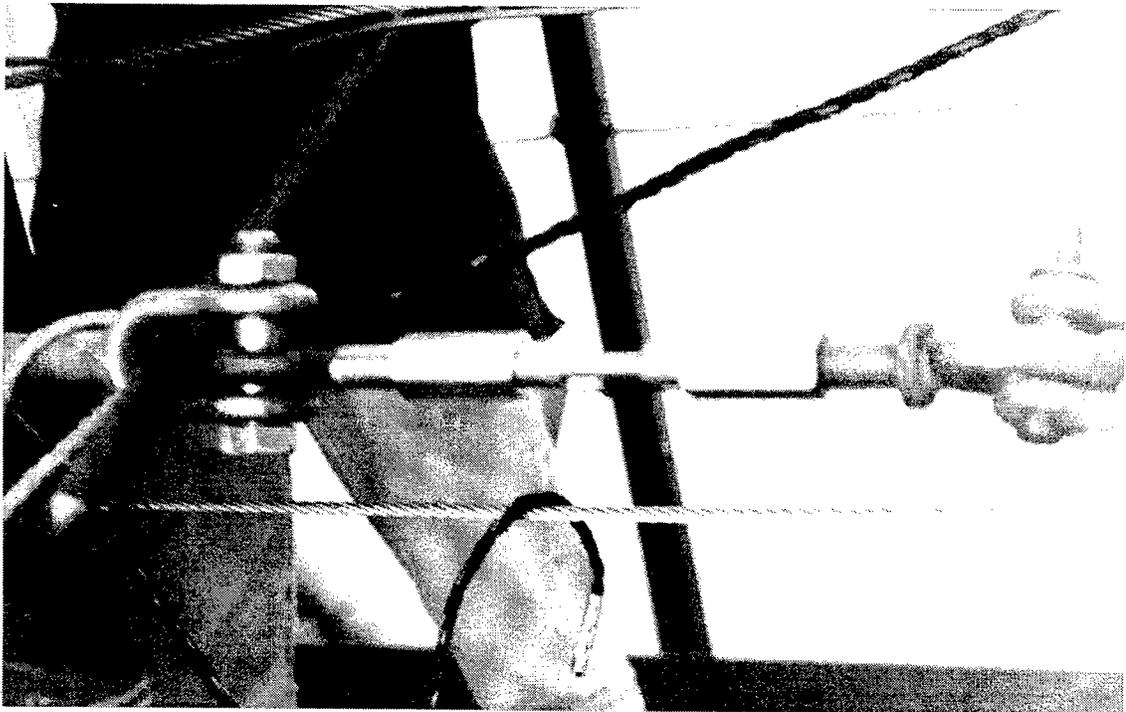
Figure 5.12: Machined bolt used for the sudden release of applied load
