REPORT NO.
UCB/EERC-97/13
DECEMBER 1997

FATIGUE LIFE EVALUATION OF CHANGEABLE MESSAGE SIGN STRUCTURES

VOLUME 2: RETROFITTED SPECIMENS

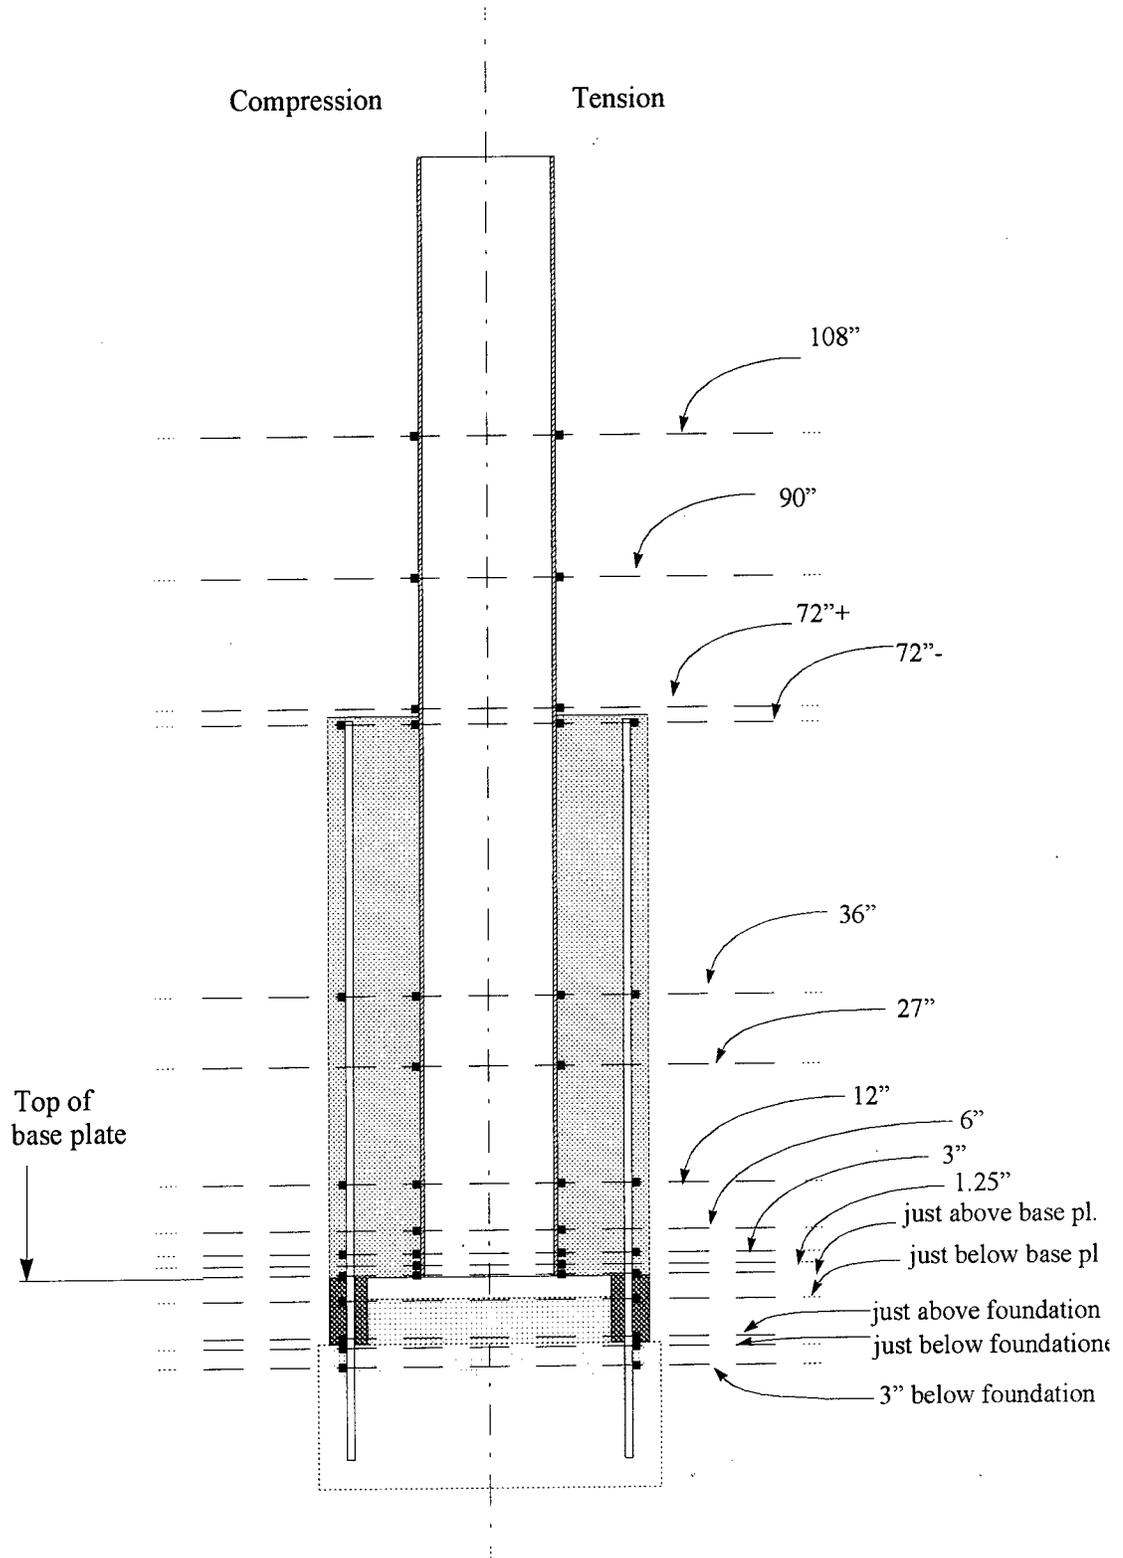
Figure 5.13: Schematic view of longitudinal strain gages on the post and jacket reinforcement

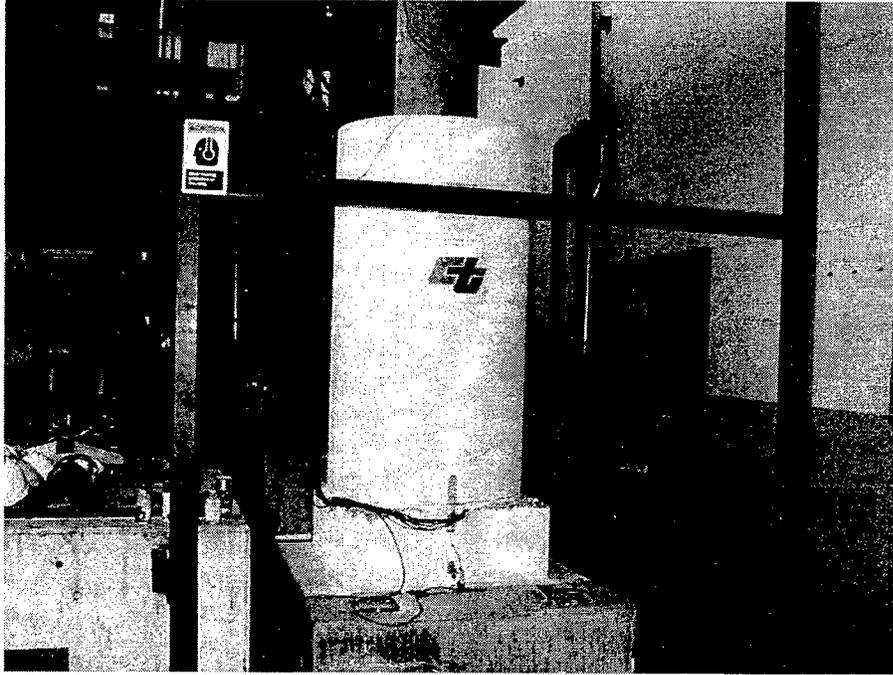
Figure 5.14: Photograph of Specimen CIP1 prior to cyclic testing

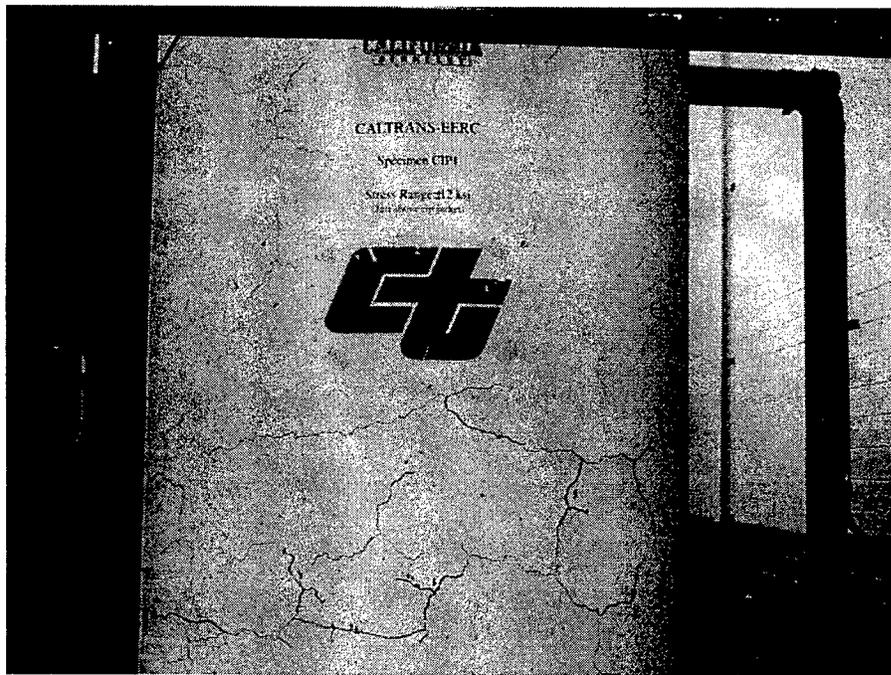
Figure 5.15: Photograph of Specimen CIP1 at the conclusion of the cyclic testing

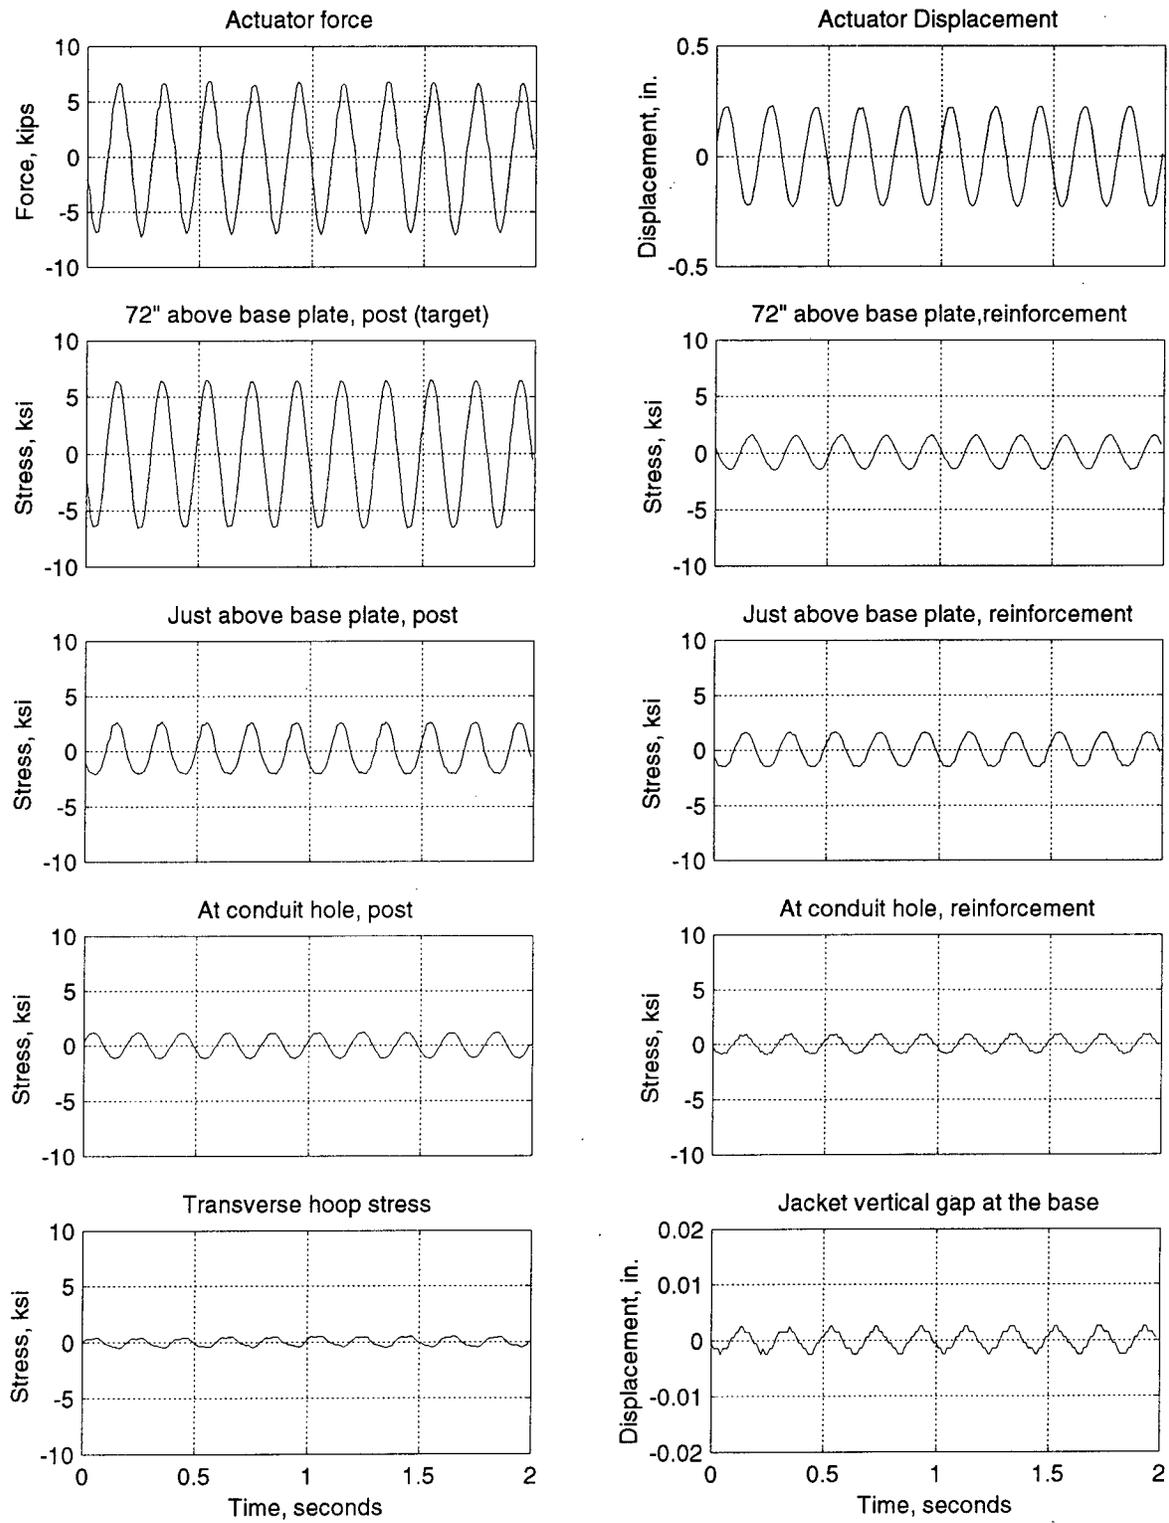
Figure 5.16: Typical response histories for Specimen CIP1

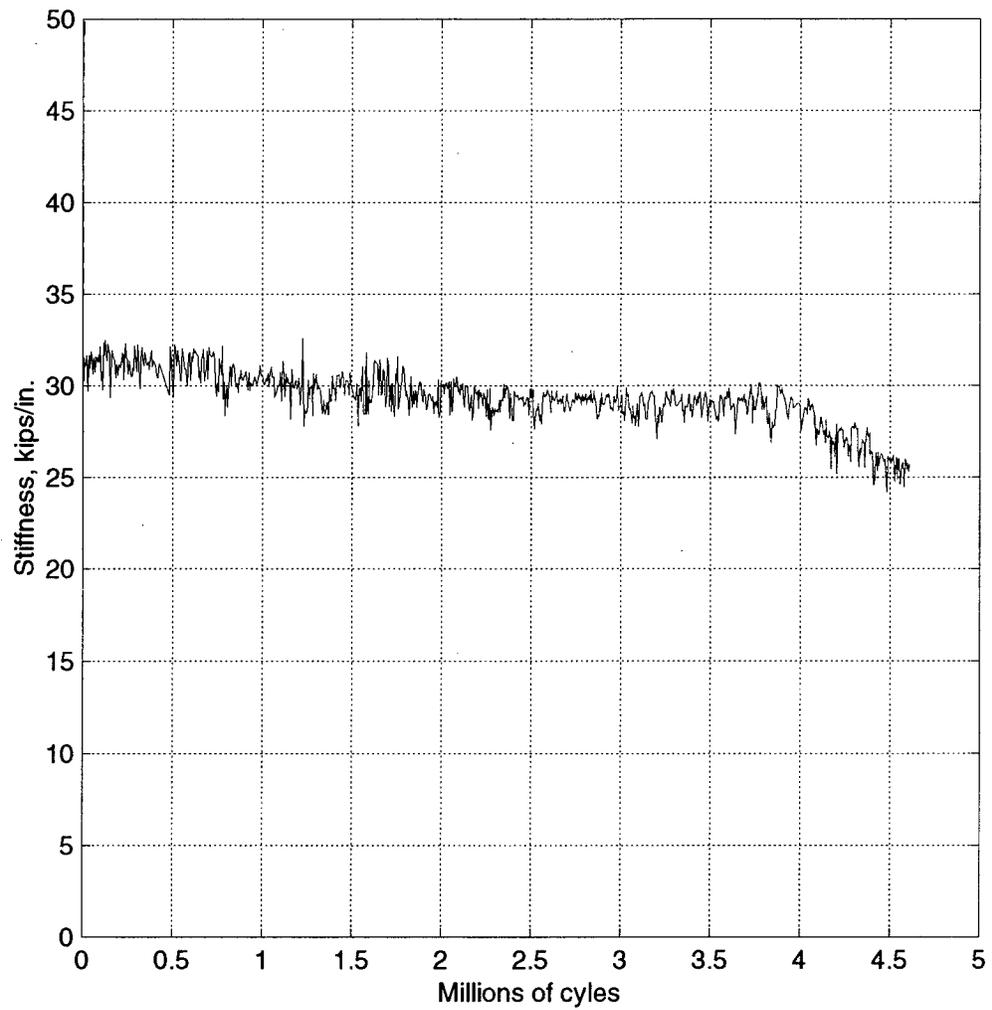
Figure 5.17: Lateral stiffness history for Specimen CIP1

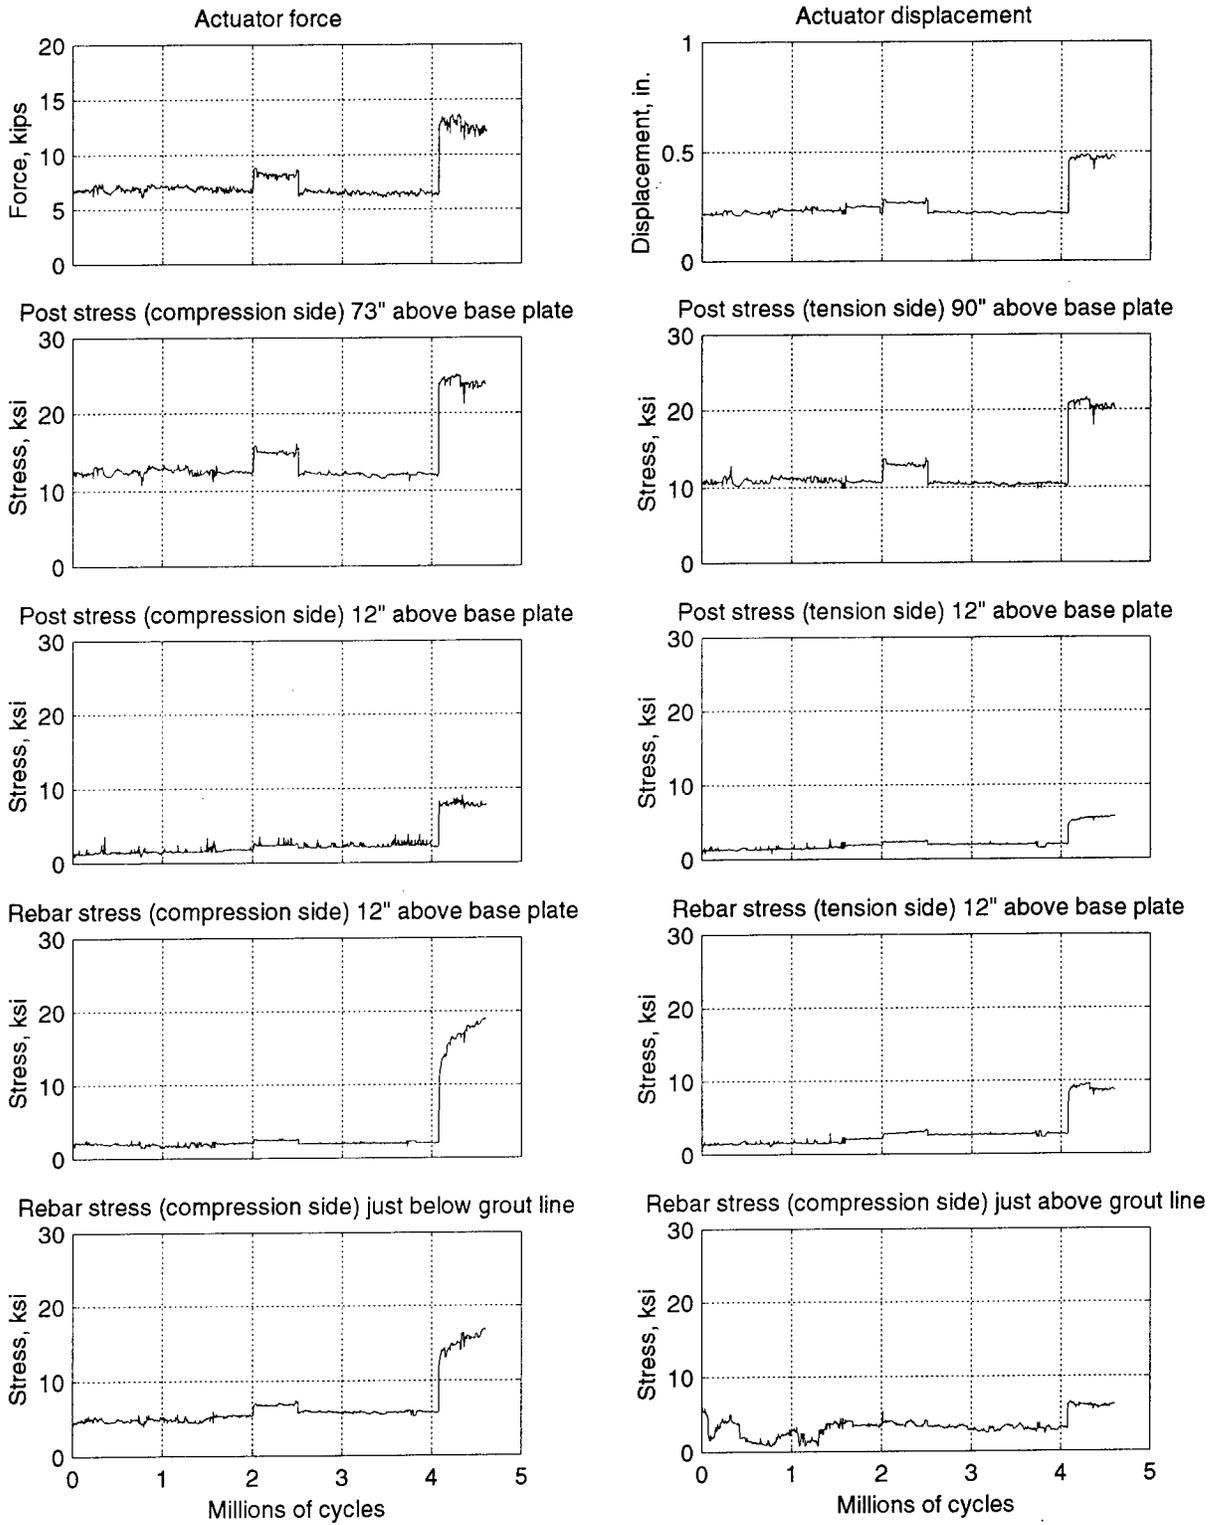
Figure 5.18: Response maxima for Specimen CIP1

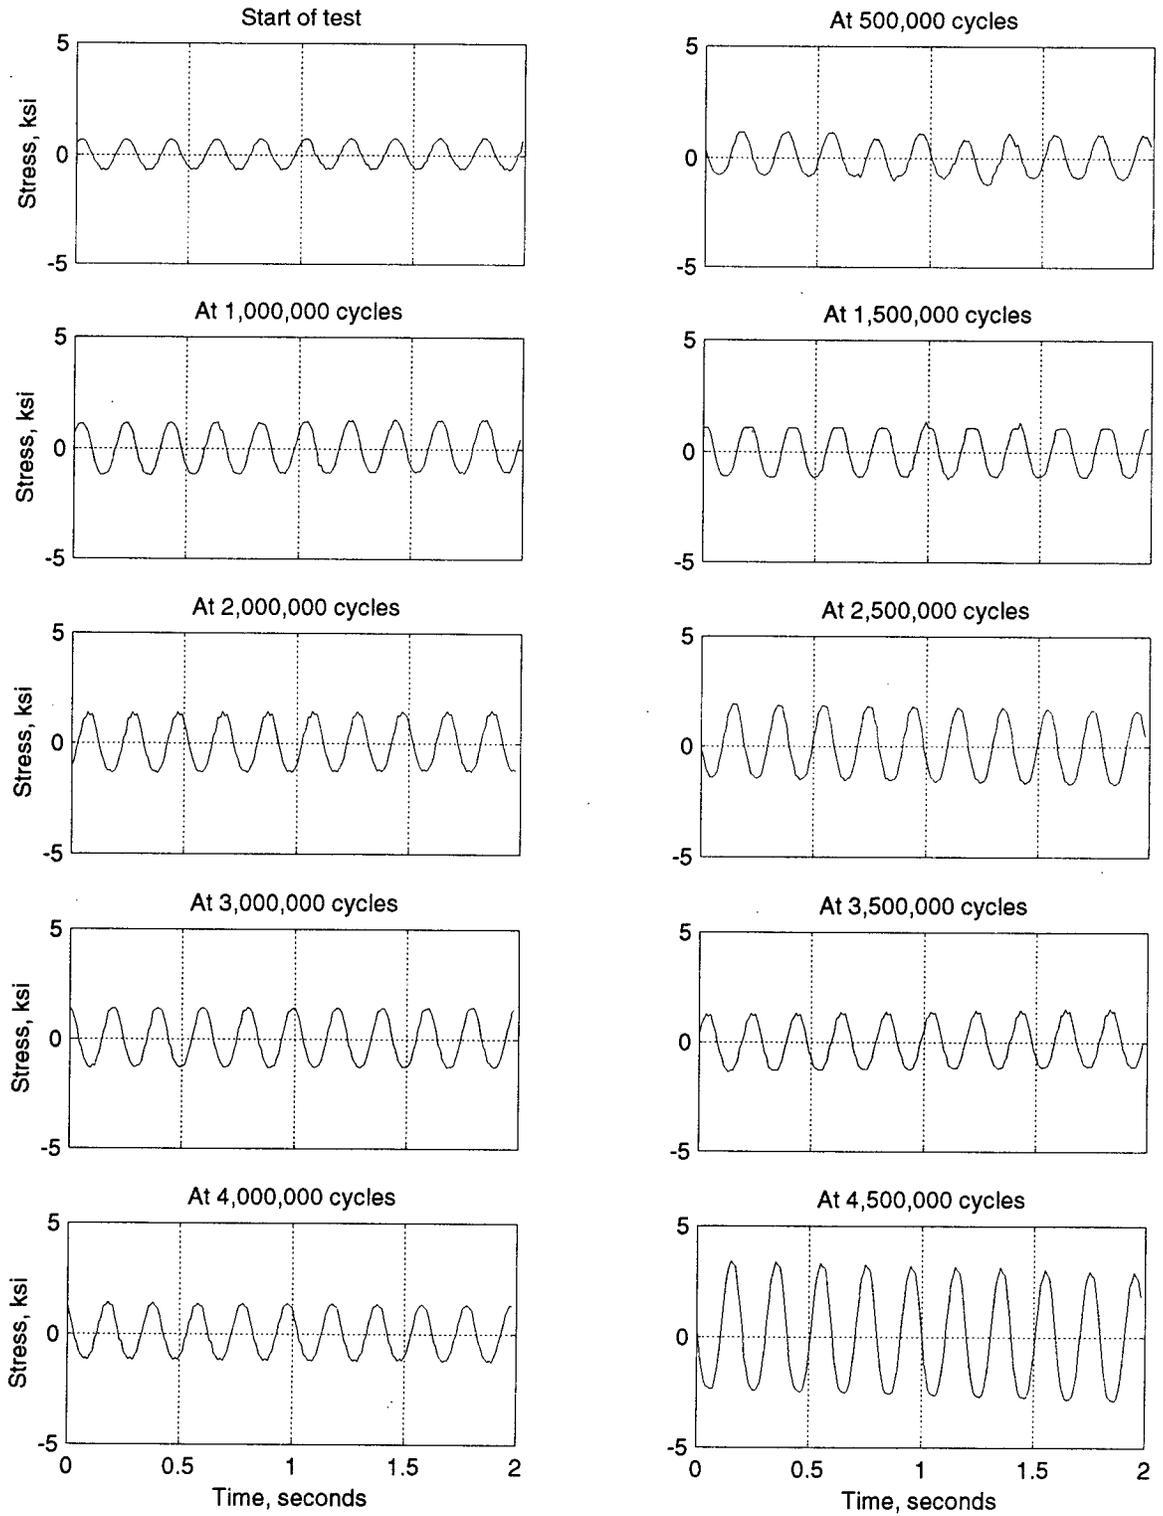
Figure 5.19: Post stress history at 3 in. above the base plate (sg3) for Specimen CIP1

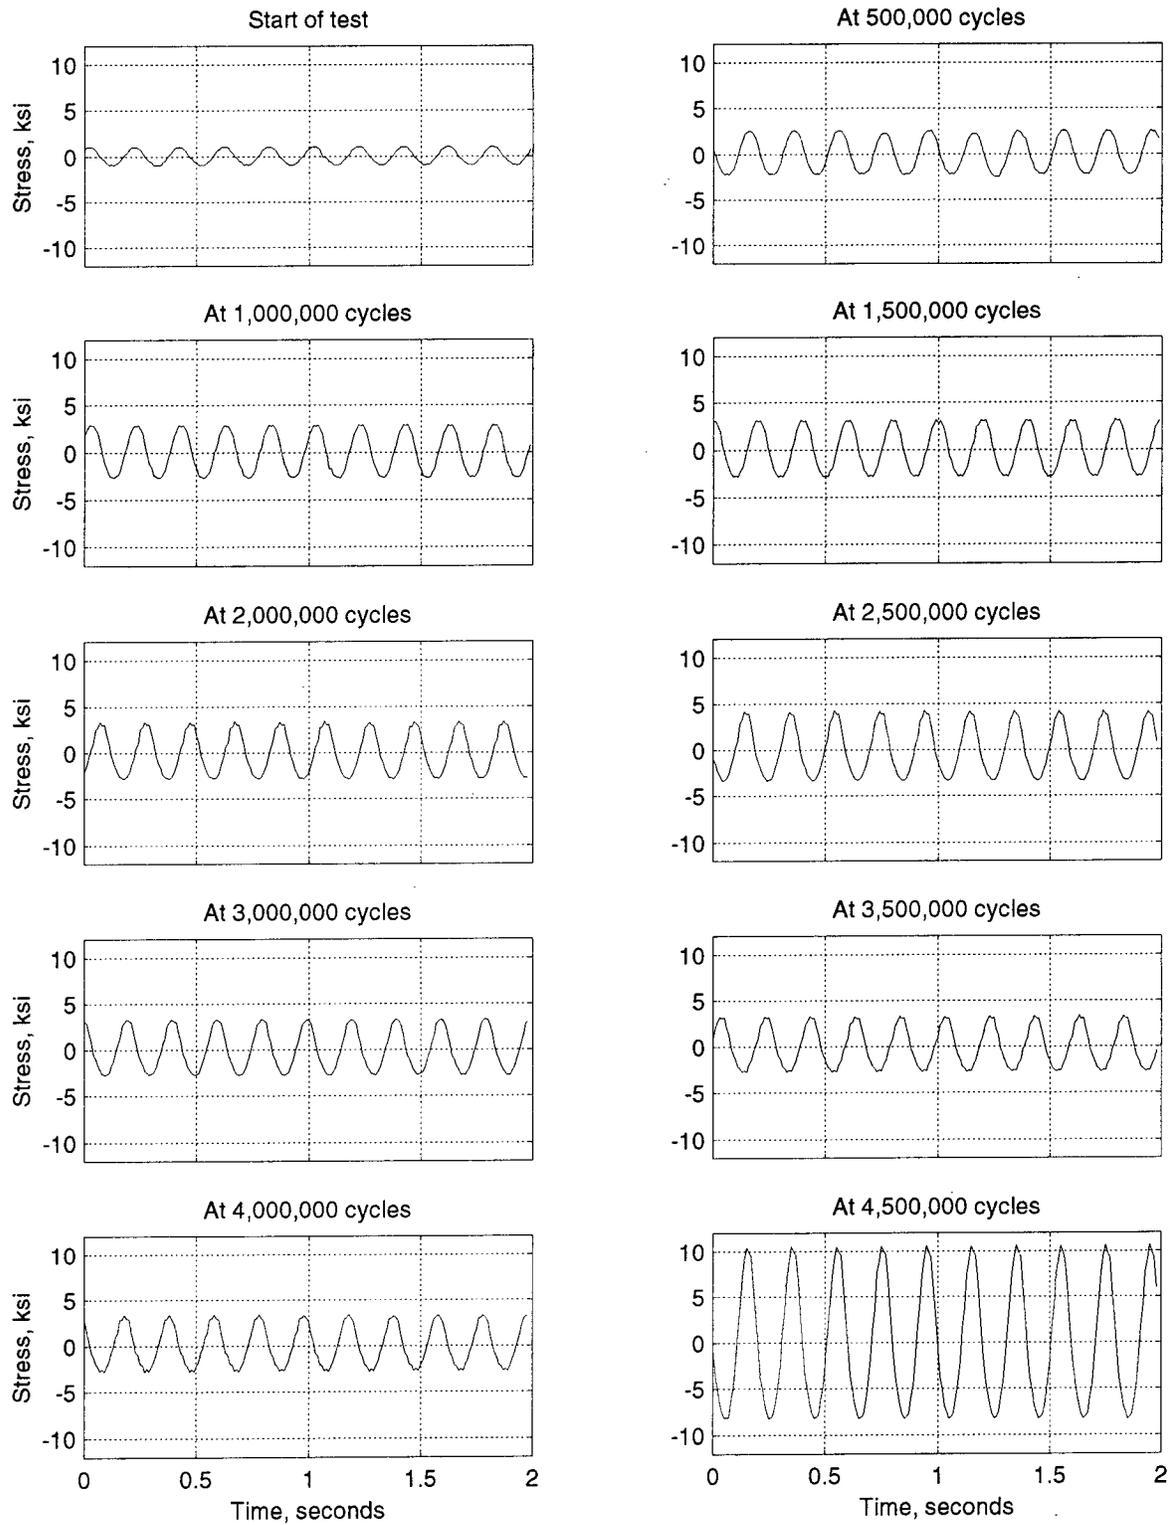
Figure 5.20: Reinforcement stress history at 3 in. above the base plate (sg33) for Specimen CIP1

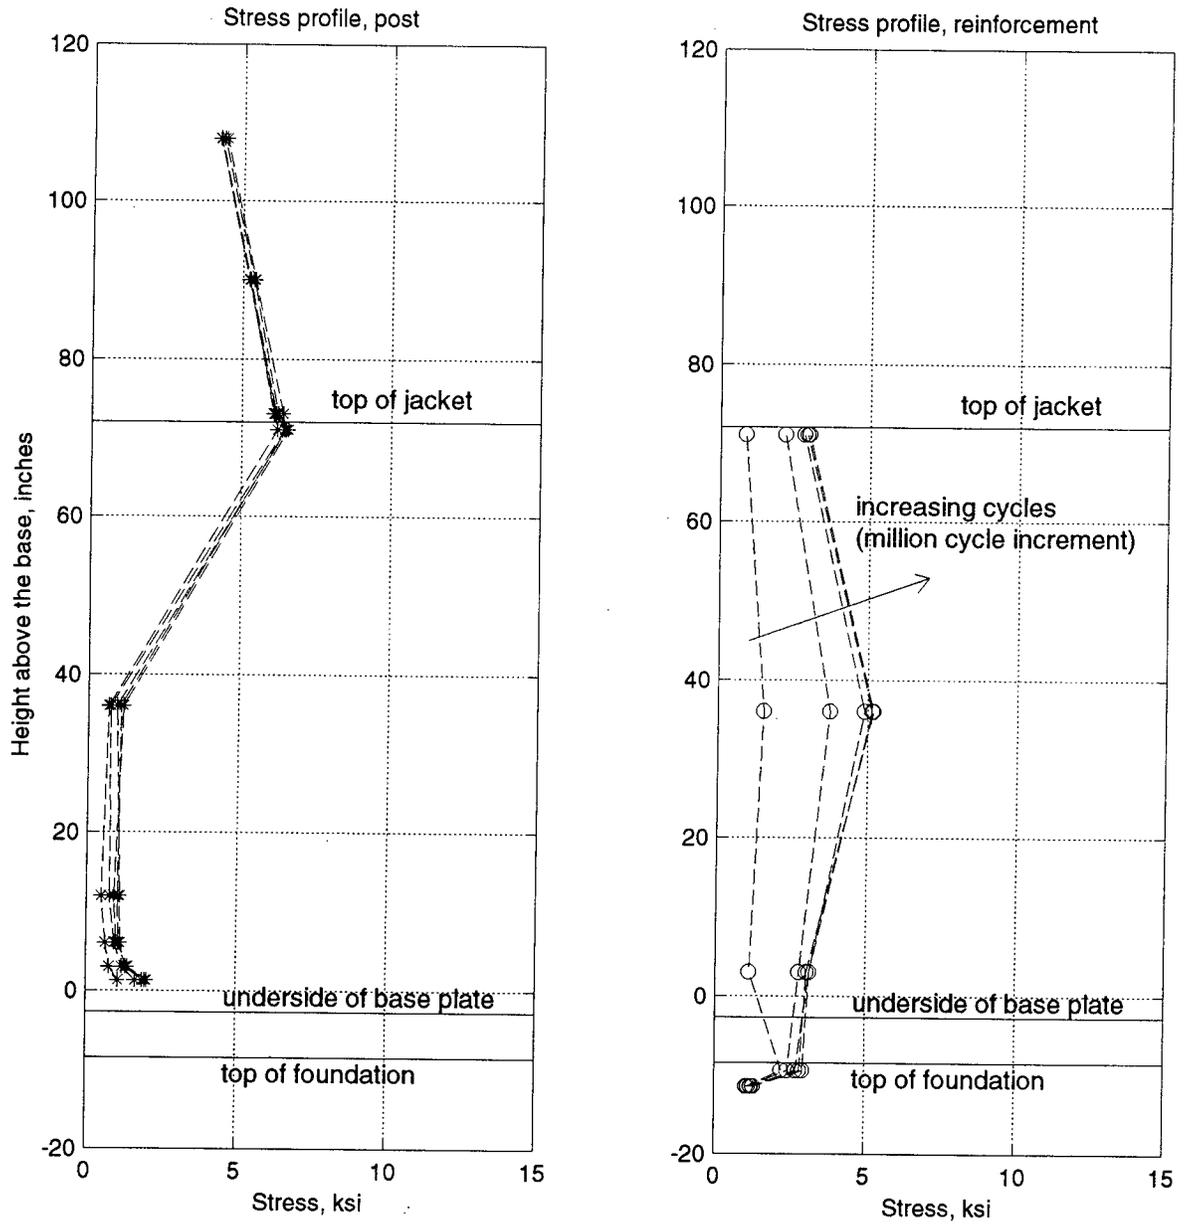
Figure 5.21: Stress profiles for Specimen CIP1

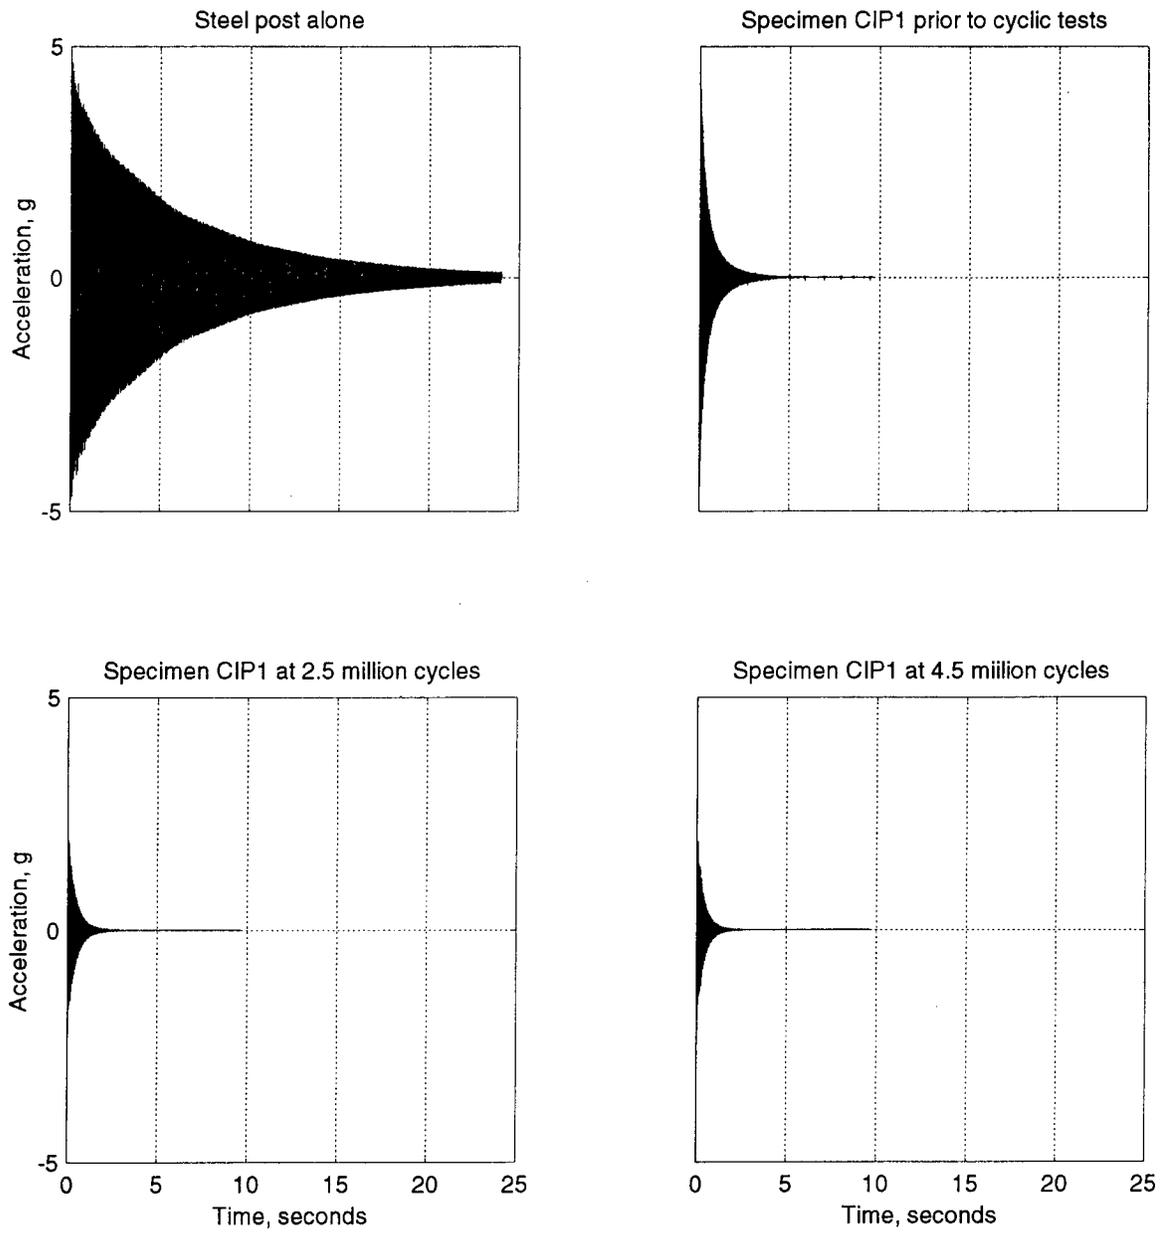
Figure 5.22: Free vibration acceleration response for Specimen CIP1

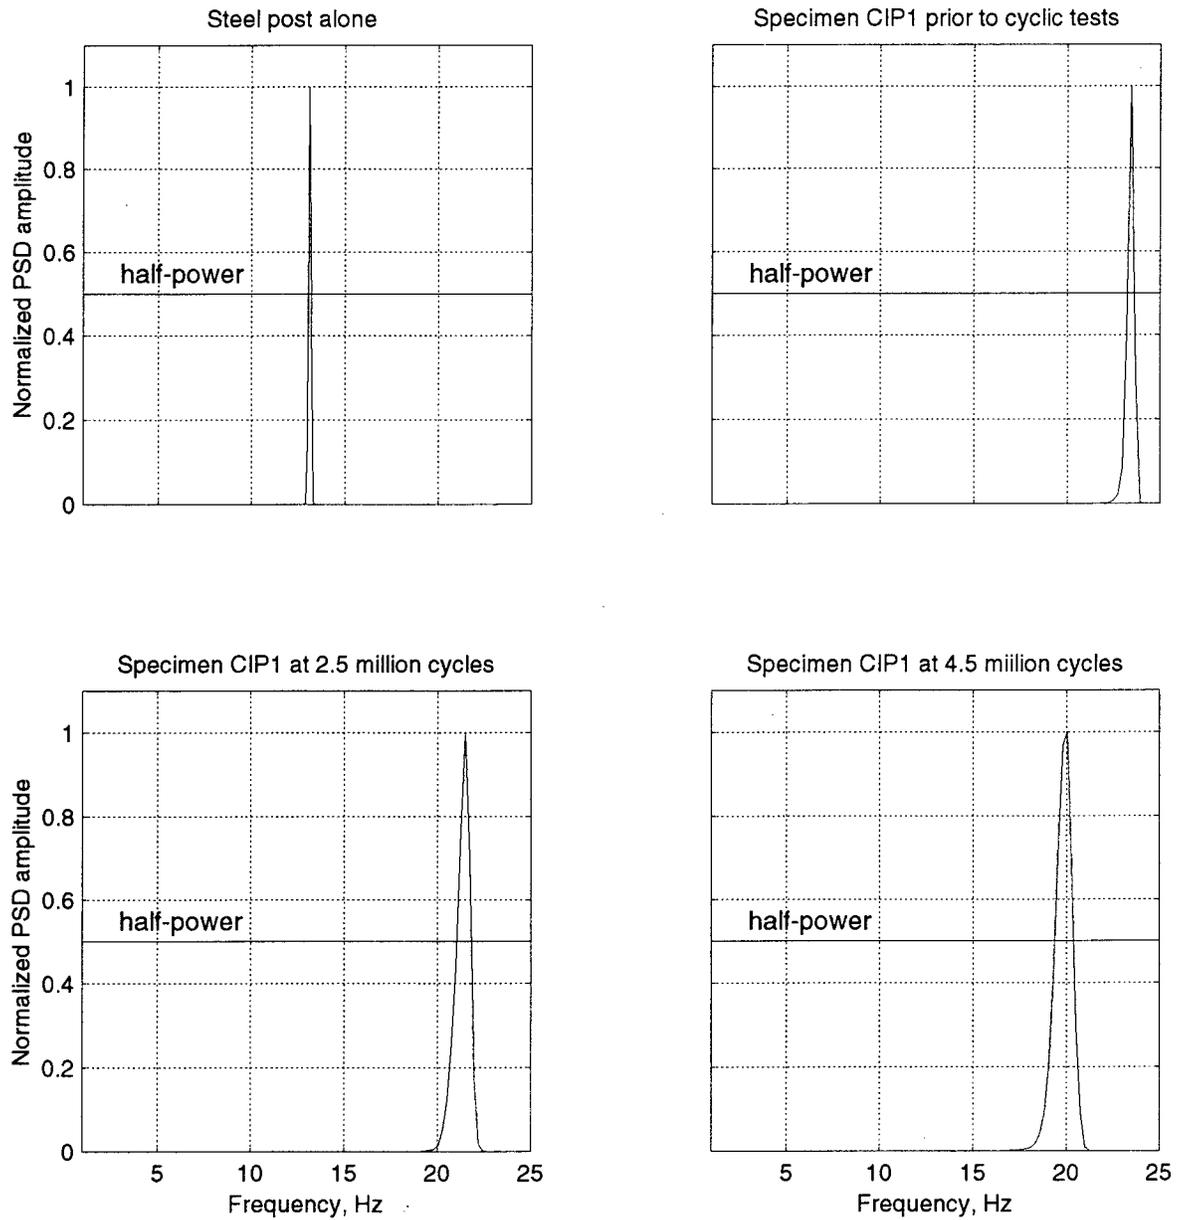
Figure 5.23: Acceleration frequency response for Specimen CIP1

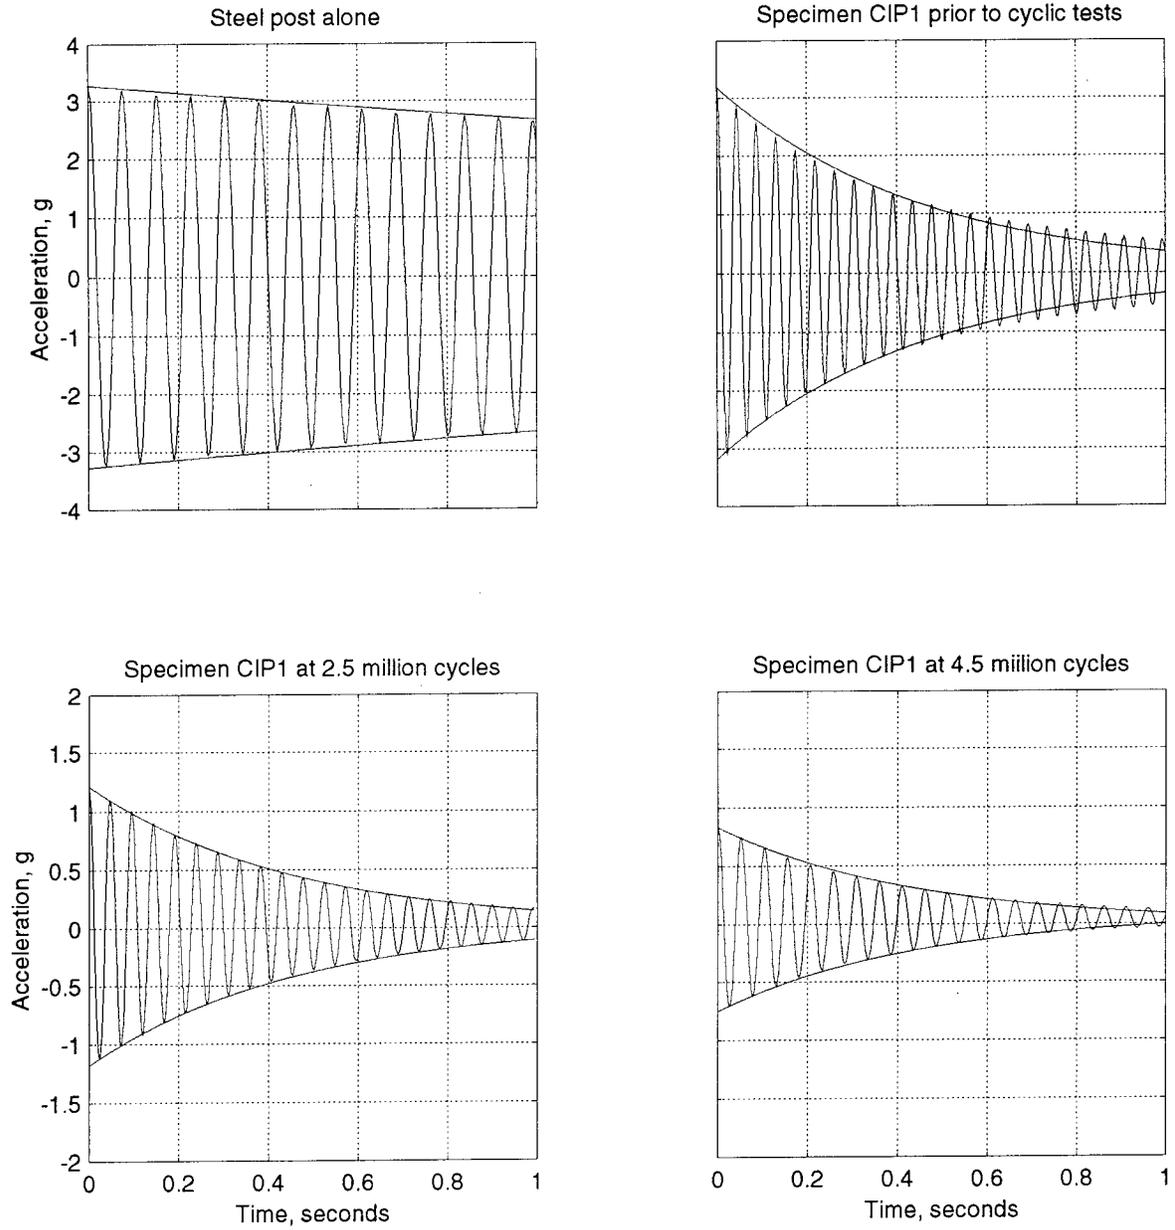
Figure 5.24: Analytical acceleration curve fitting for Specimen CIP1

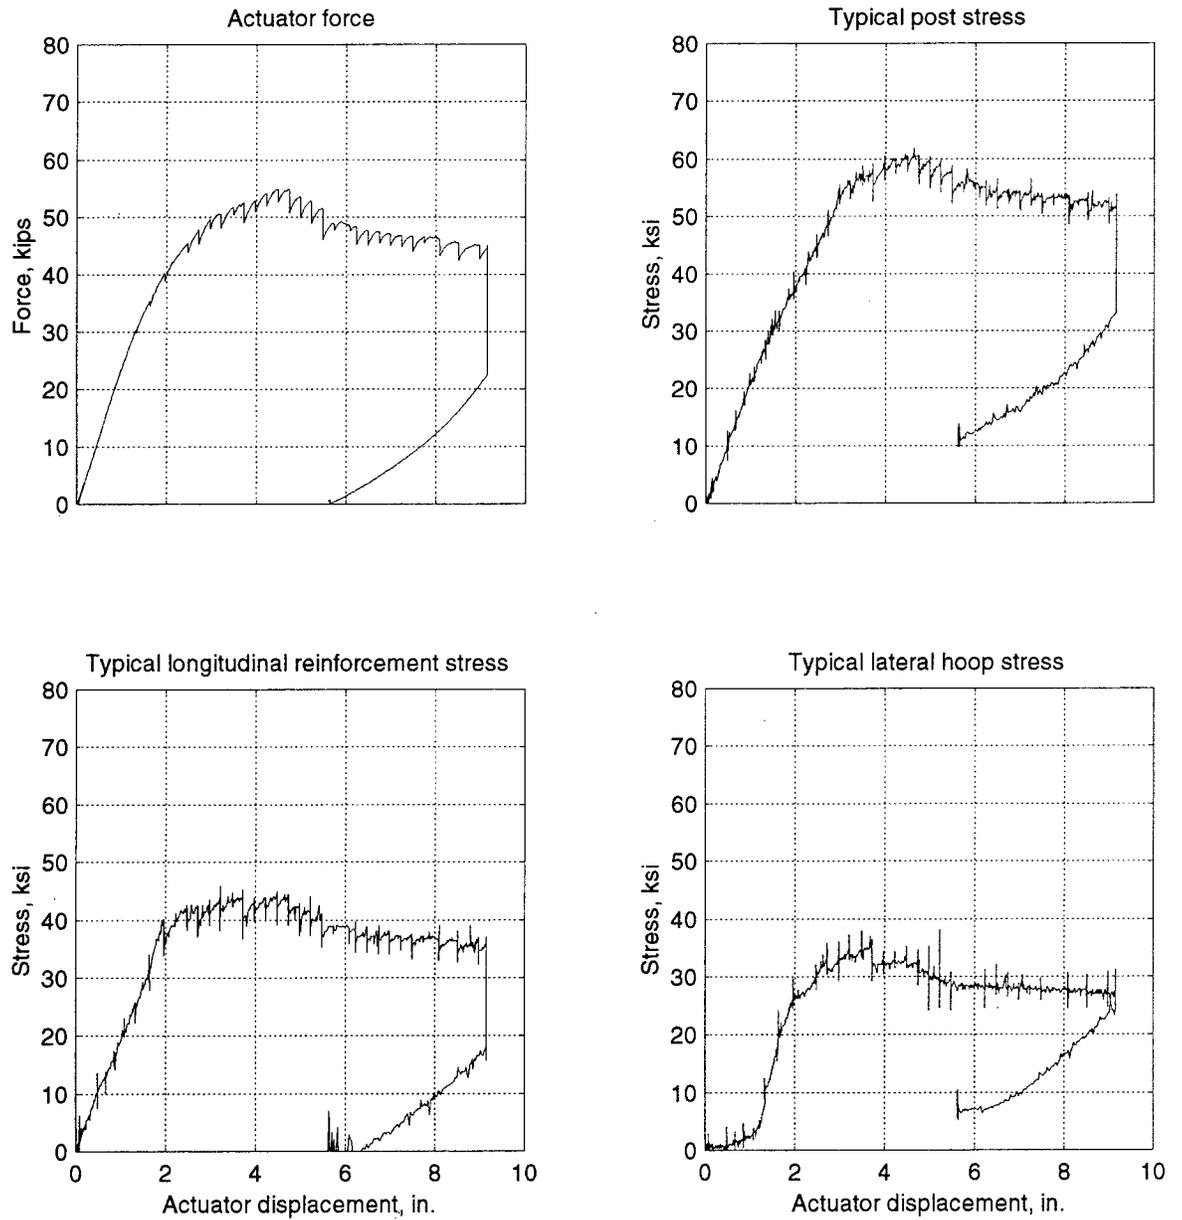
Figure 5.25: Push-over response for Specimen CIP1

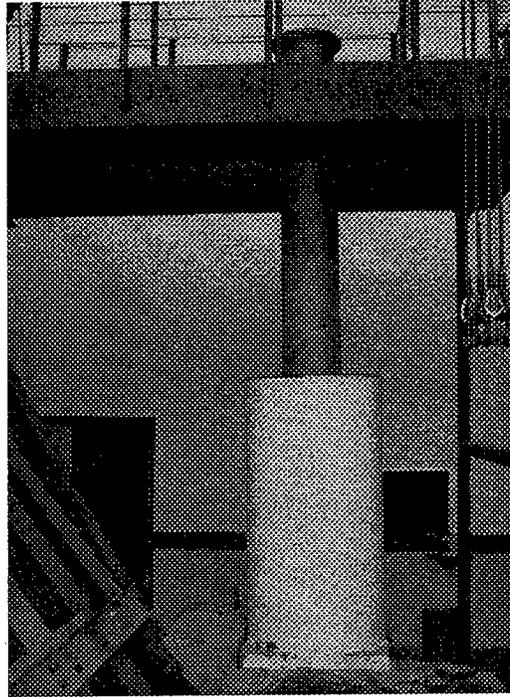
(a) Deformed configuration

(b) Cracks in the footing

Figure 5.26: Photos of Specimen CIP1 at the conclusion of push-over tests
