# Corrosion Evaluation of Epoxy-Coated, Metallic-Clad and Solid Metallic Reinforcing Bars in Concrete

PUBLICATION NO. FHWA-RD-98-153

DECEMBER 1998

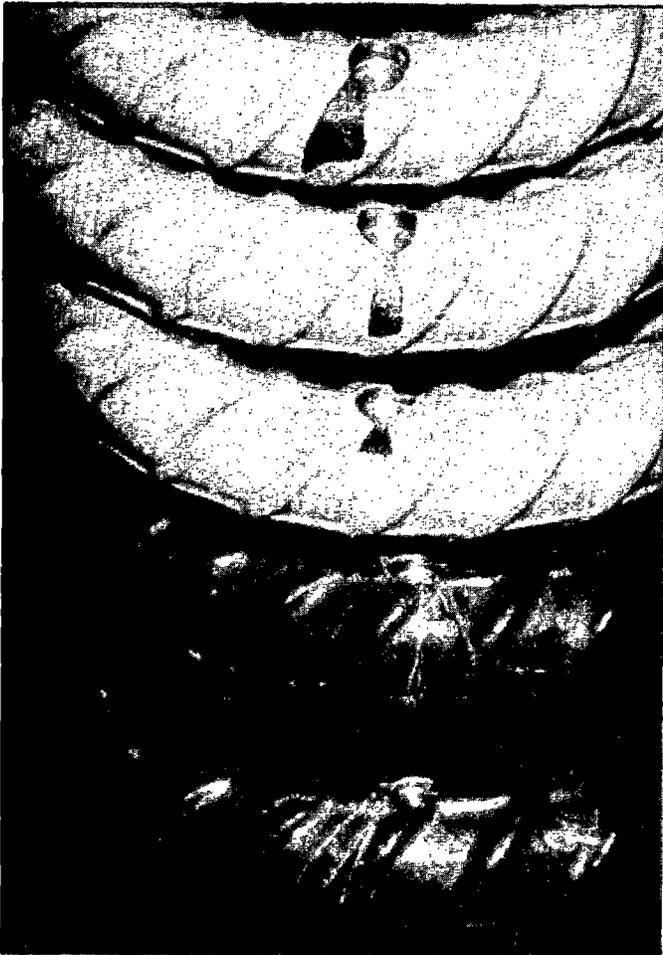
Figure 1. Adhesion of organic coatings.  
Top: Poor - Rating = 5  
Bottom: Excellent - Rating = 1

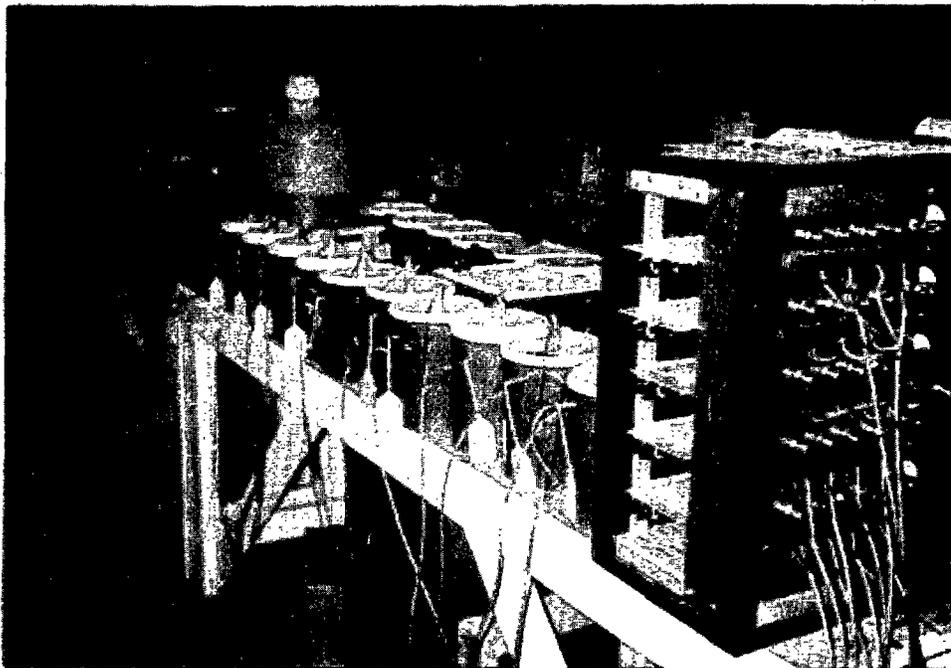
Figure 2. Apparatus used for cathodic debonding (CD) tests.

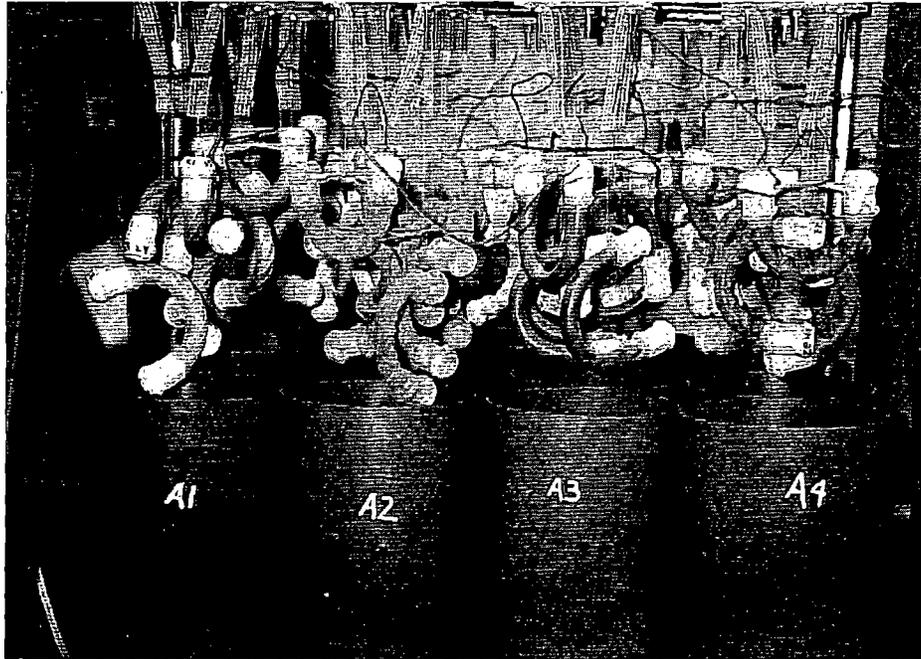
Figure 3. Wetting and drying tests used for evaluation of ceramic-,inorganic-, and metallic-clad and solid metallic bars.

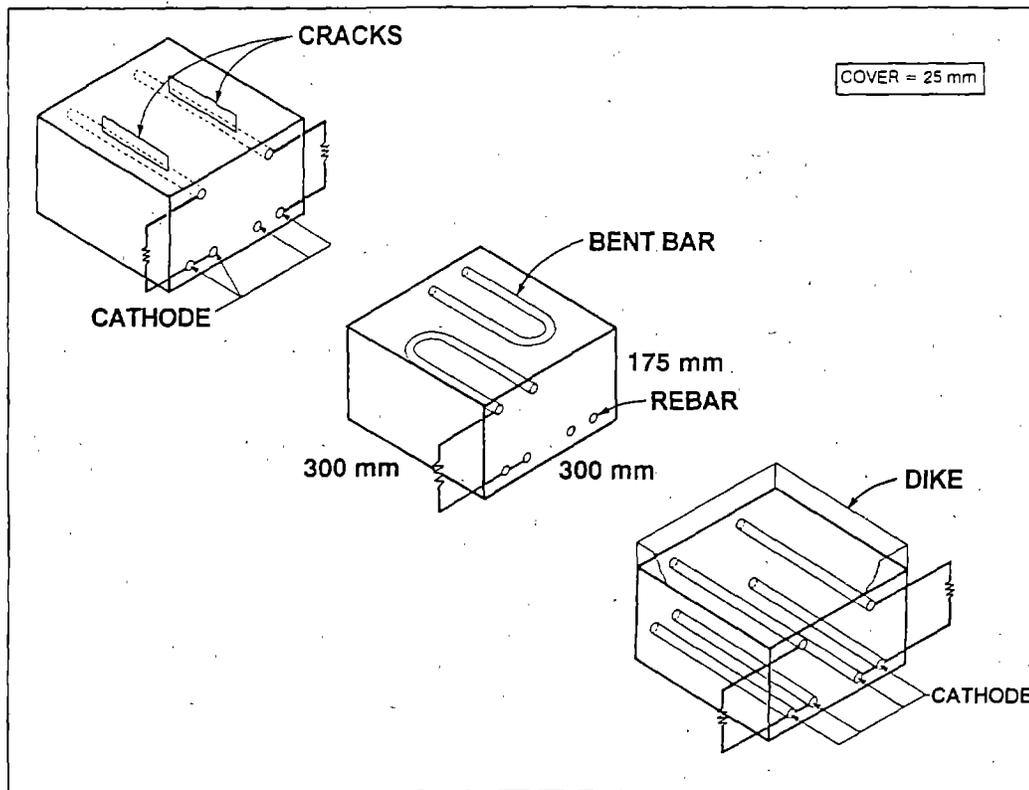
Figure 4. Test specimens used for in-concrete corrosion tests.

Top mat	Bottom mat	Precracked slab	Percent damage to coating
Straight	Black	No	0.5
Straight	Black	No	0.004
Straight	Same as anode	No	0.5
Straight	Same as anode	No	0.004
Straight	Black	Yes	0.5
Straight	Black	Yes	0.004
Bent	Black	No	0.5
Bent	Black	No	0.004

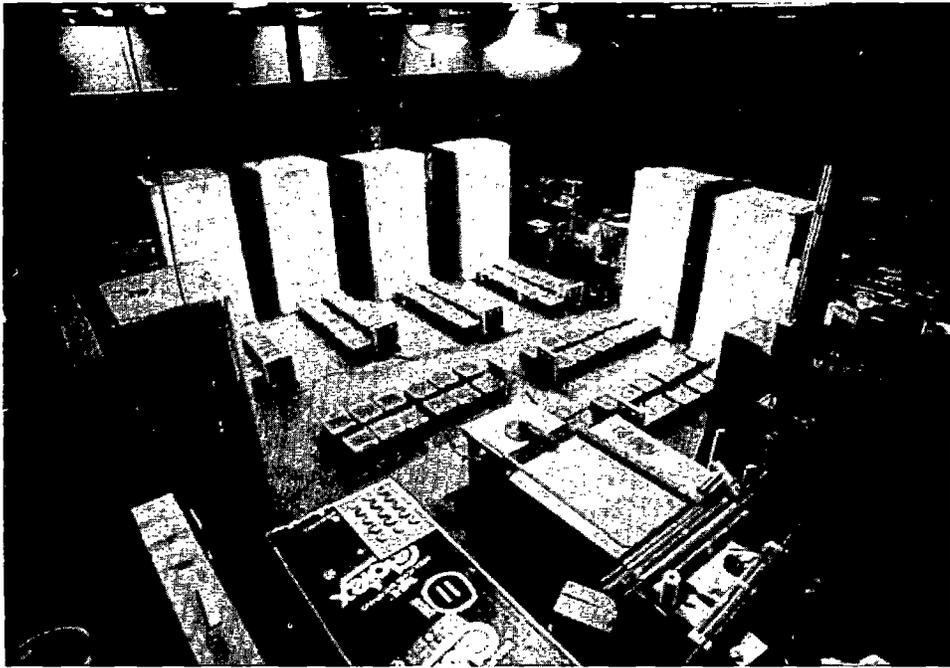
Figure 5. Test area for in-concrete cyclic testing program.

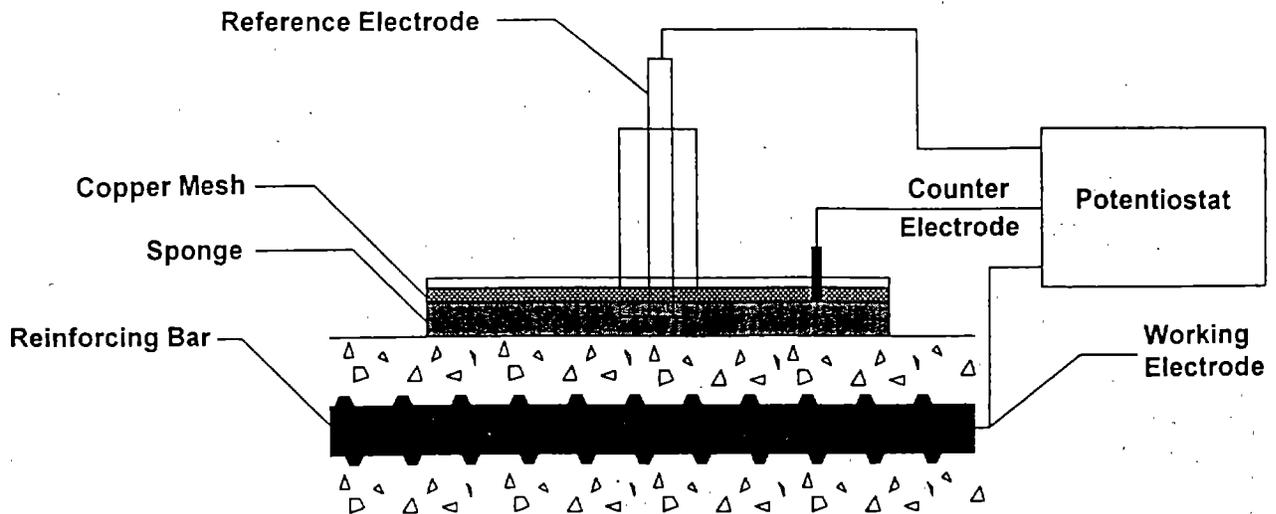
Figure 6. Setup of cell for PR testing.

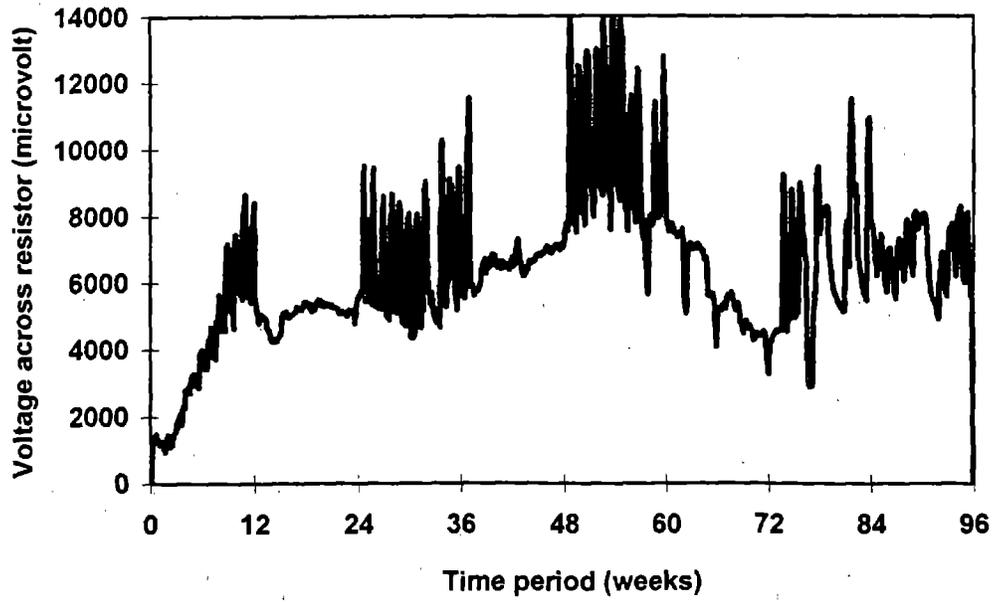
Figure 7. Measured voltage from an uncracked specimen with black bars.

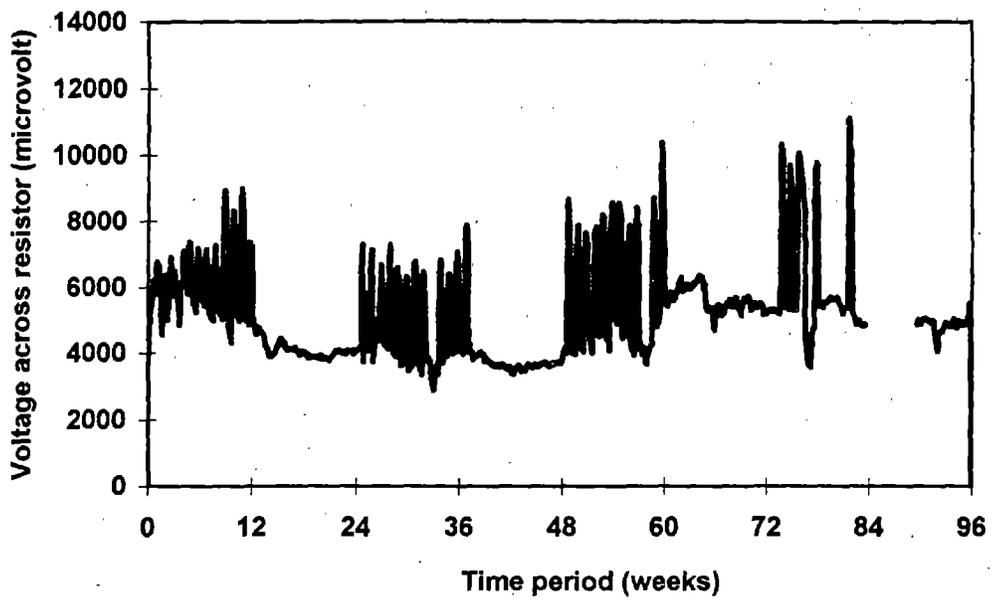
Figure 8. Measured voltage from a precracked specimen with black bars.

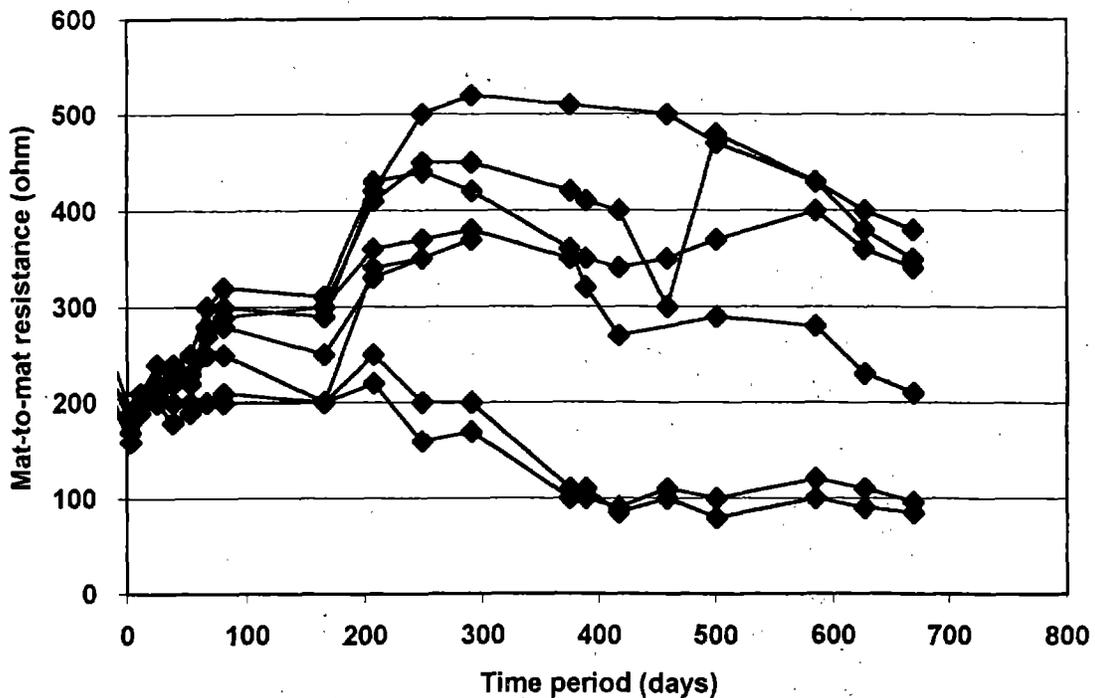
Figure 9. Measured mat-to-mat resistance for uncracked specimens with black bars.

The mat-to-mat resistance measured for a specimen containing black bars in uncracked concrete is shown in figure 9. The average for the specimens containing the black bars during the 96 weeks of testing specimens was 280 ohm.

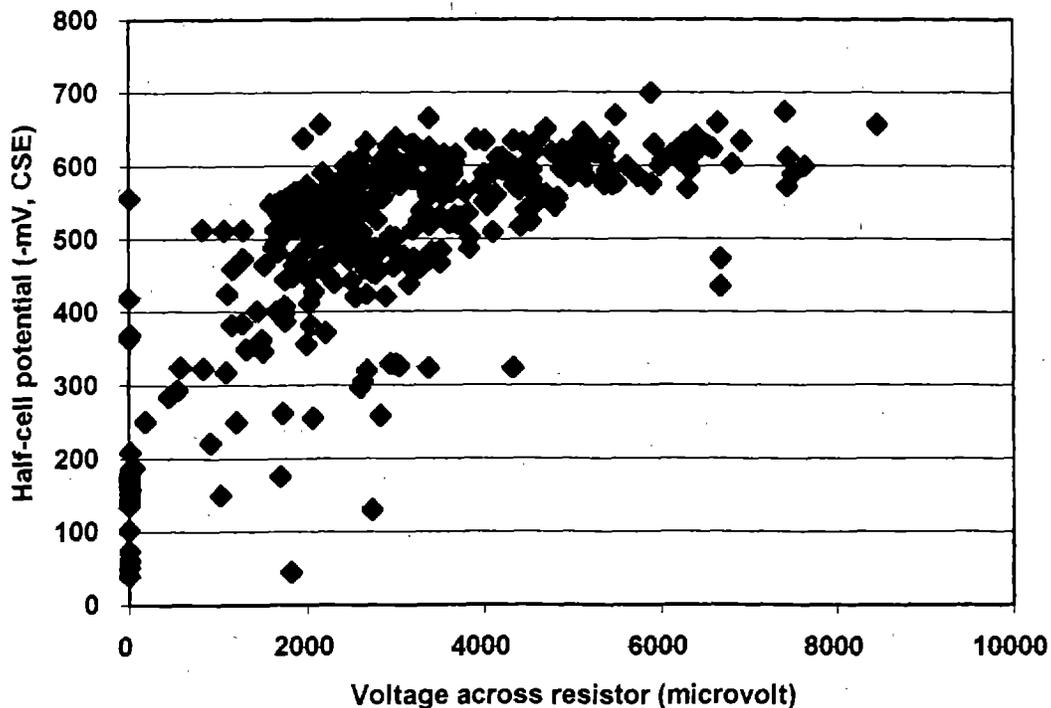
Figure 11. Measured voltage across resistor and half-cell potentials for all specimens with black bars.

Figure 11 shows the relationship between the measured half-cell potential for the black bars and the macrocell currents in uncracked concrete determined at the same time. In general, values more positive than -200 mV indicate no corrosion, while values more negative than approximately -250 mV indicate corrosion activity.

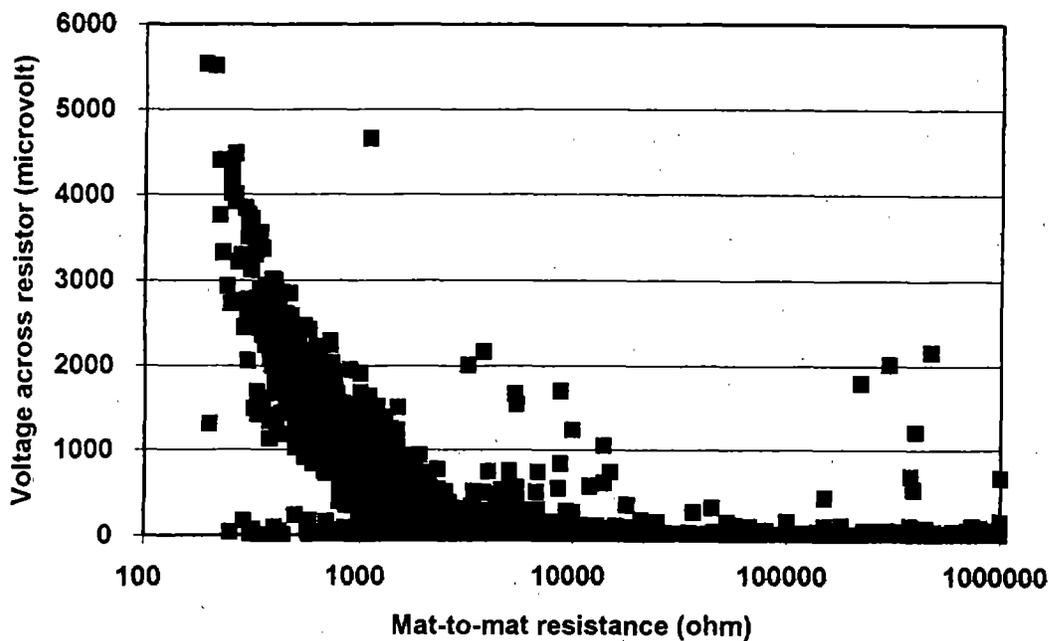
Figure 12. Relationship between mat-to-mat resistance and voltage measured across resistor for epoxy-coated bars.

**Relationship between coating resistance and corrosion current** — Figure 12 shows the relationship between the mat-to-mat resistance determined for the epoxy-coated bars and the voltages measured across the resistor. In general, low corrosion rates are obtained for samples where the mat-to-mat resistance exceeds 10,000 ohm. This resistance value is approximately 25 times greater than that measured for the black bar specimens. As the mat-to-mat resistance falls, there is a roughly linear relationship between lower mat-to-mat resistances and higher corrosion rates. It may be concluded from these data that better corrosion protection will be provided by those coating systems that have high electrical resistivities and/or that the corrosion rates are strongly dependent on the amount of damage in the coating.

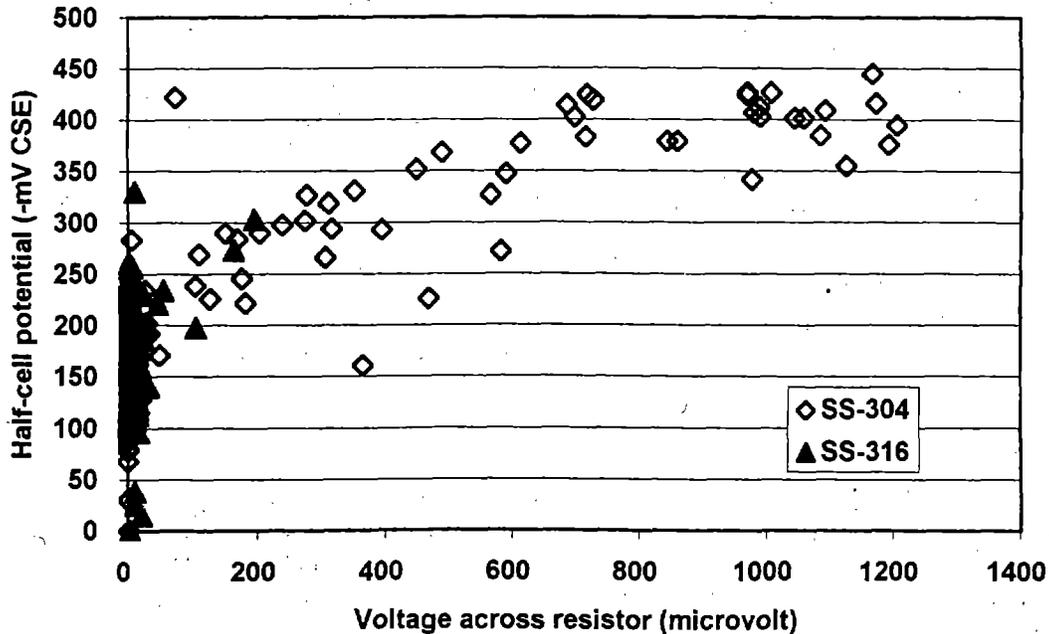
Figure 13. Relationship between half-cell potential and voltage measured across resistor for stainless steel bars.

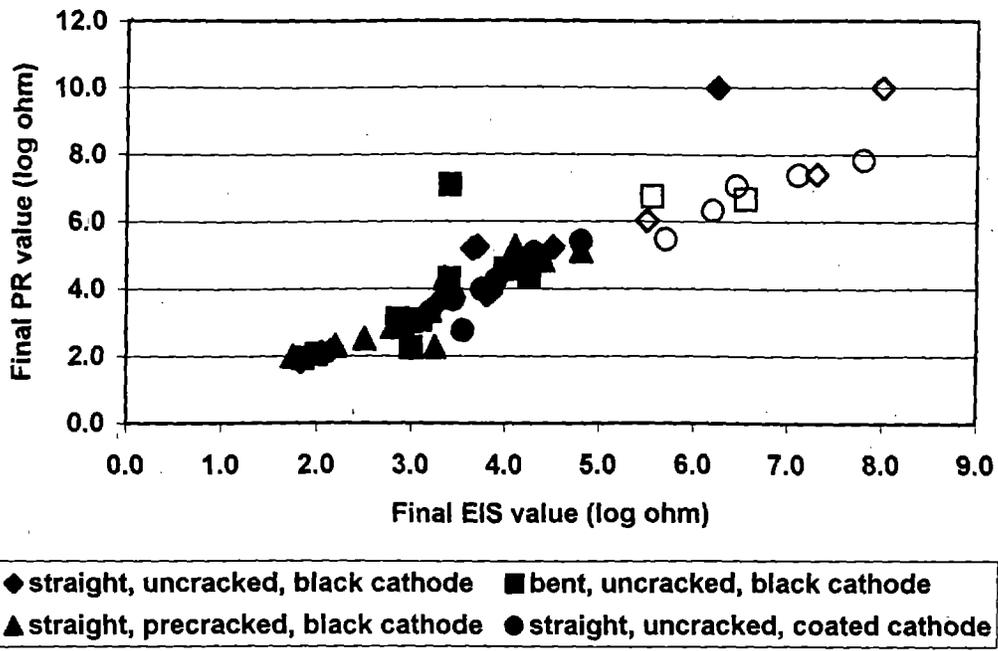
Figure 14. Relationship between PR and EIS measurements after 96 weeks of testing. Note that empty symbols indicate bars with no corrosion at the end of testing.

The relationship between the results of the two test methods can be seen in figure 14, showing the final impedance determined using EIS and the final PR test results for the coated bars. The final measurements are compared because they are most representative of the coating performance, as previously discussed. Also shown are the approximate  $10^5$ -ohm values found to generally indicate good performance in the EIS and PR testing. There is a linear relationship between the test results, with the higher PR results associated with the higher EIS results.

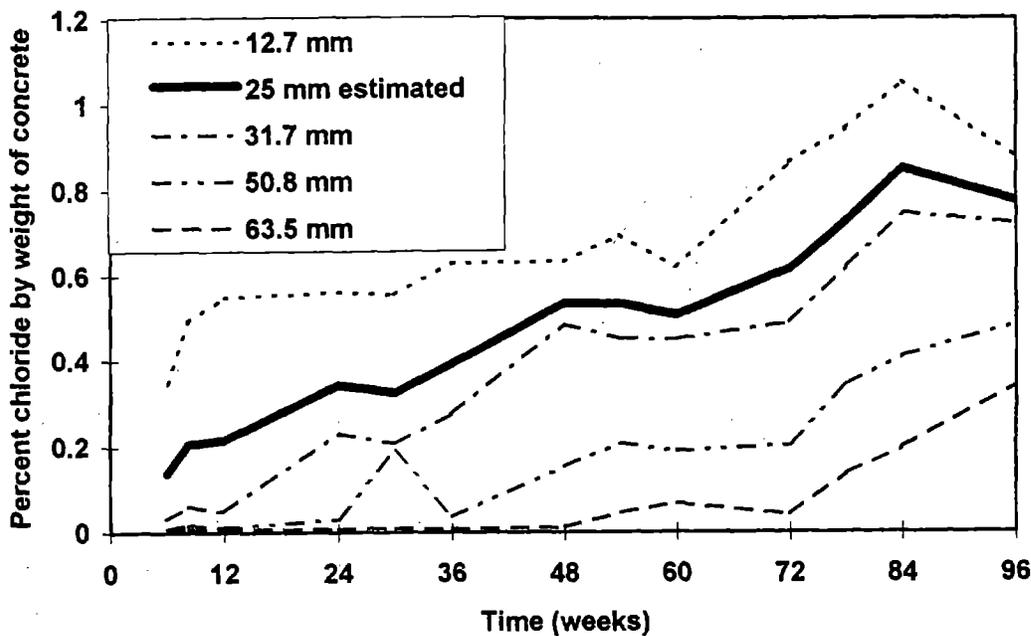
Figure 15. Measured acid-soluble chloride during 96 weeks of testing.

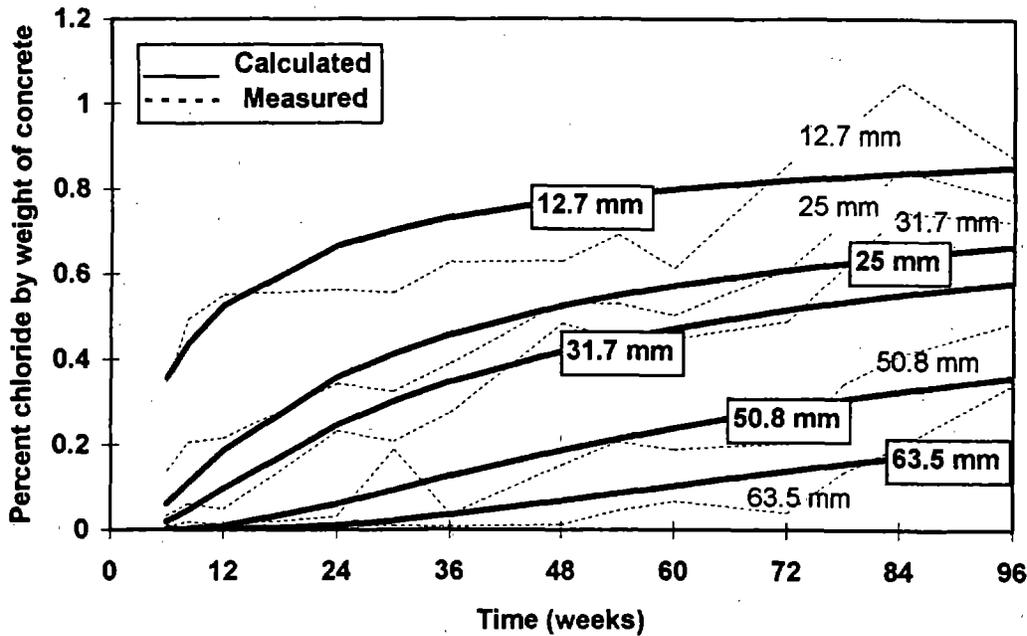
Figure 16. Chloride ingress data and predicted diffusion curves.

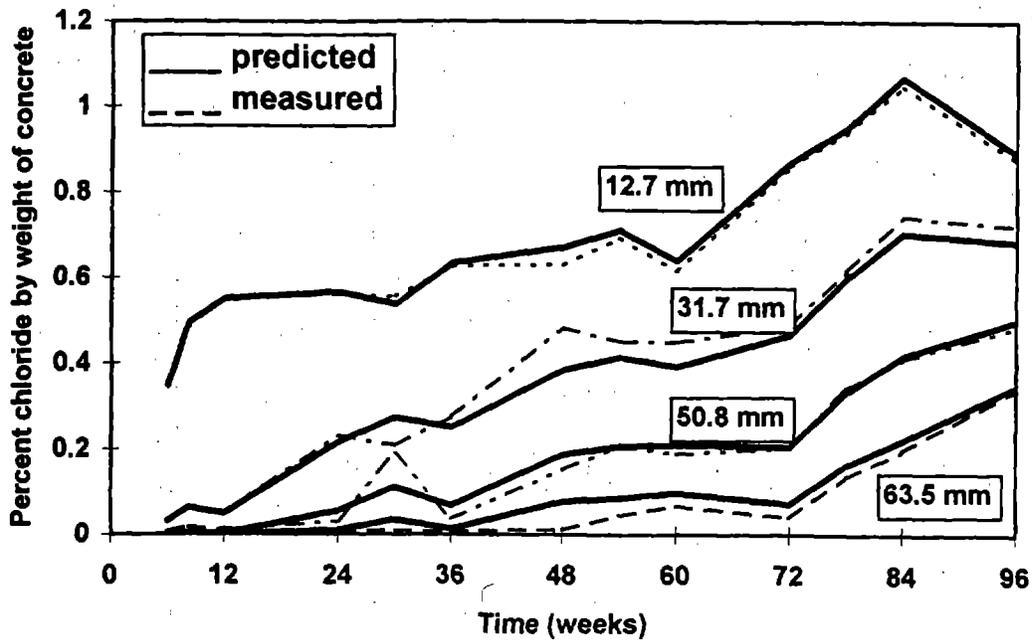
Figure 17. Measured chloride and predicted chloride using Fick's Law at each age.

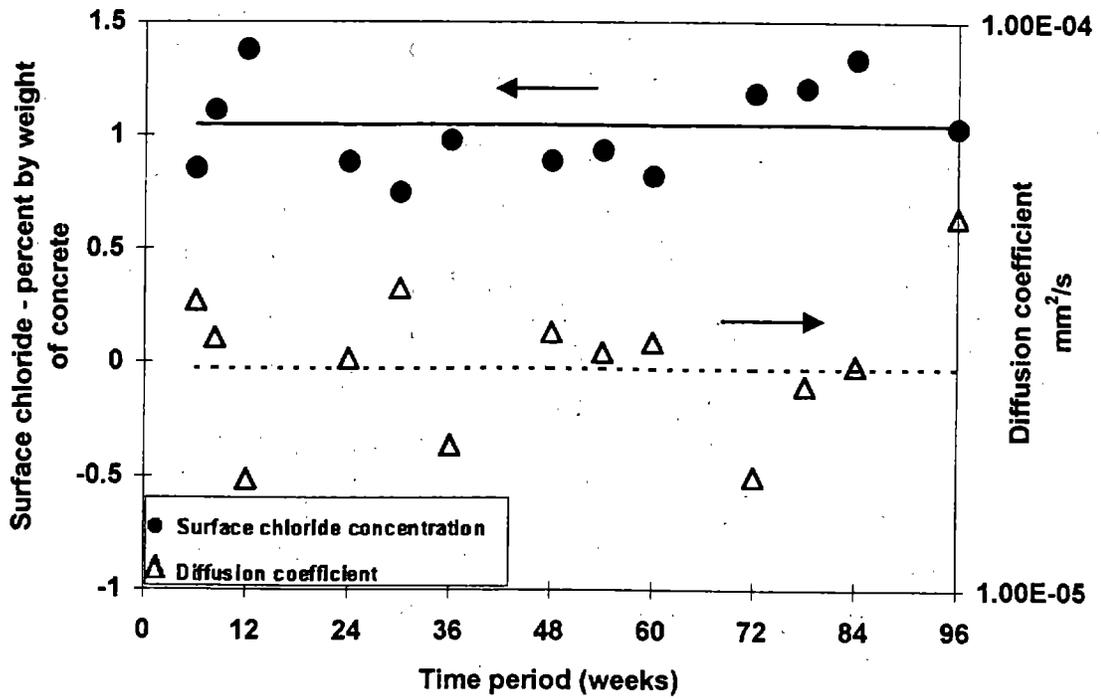
Figure 18. Surface chloride and diffusion coefficients from table 22 determined at various time periods.

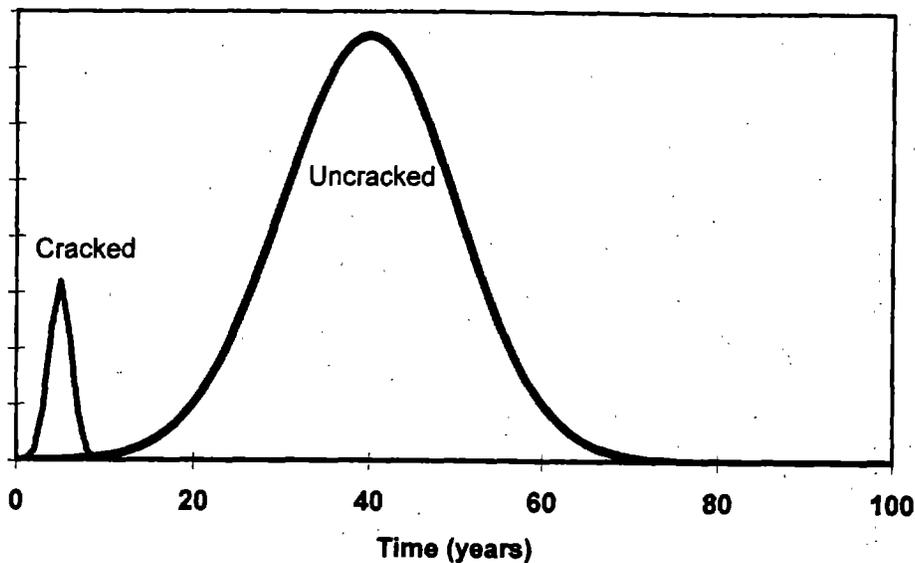
Figure 19. Probability distribution for initiation of corrosion of black bars in cracked and uncracked concrete deck.

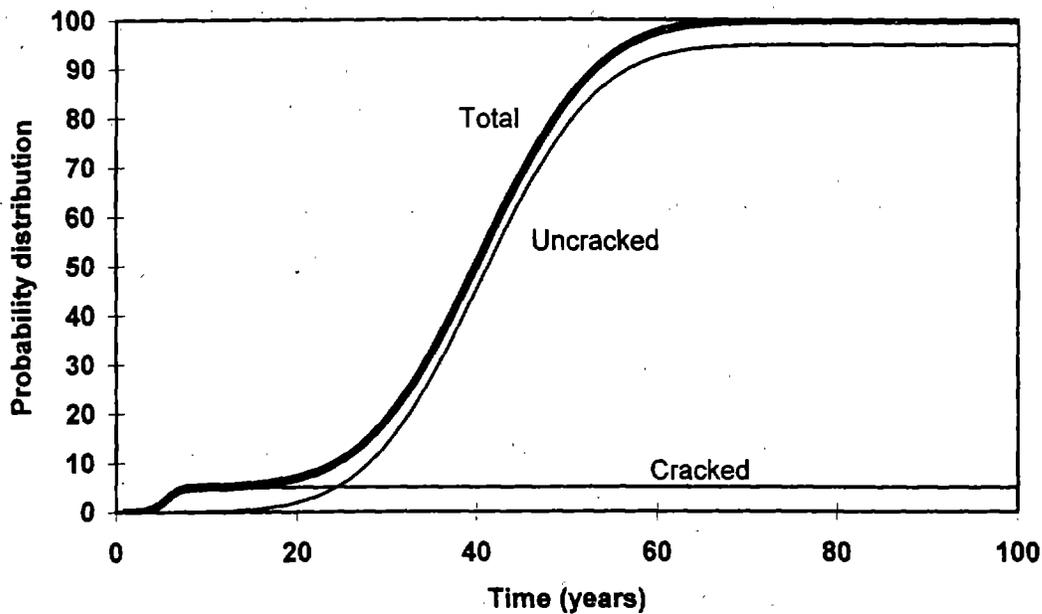
Figure 20. Cumulative distribution for initiation of corrosion in cracked and uncracked concrete deck.

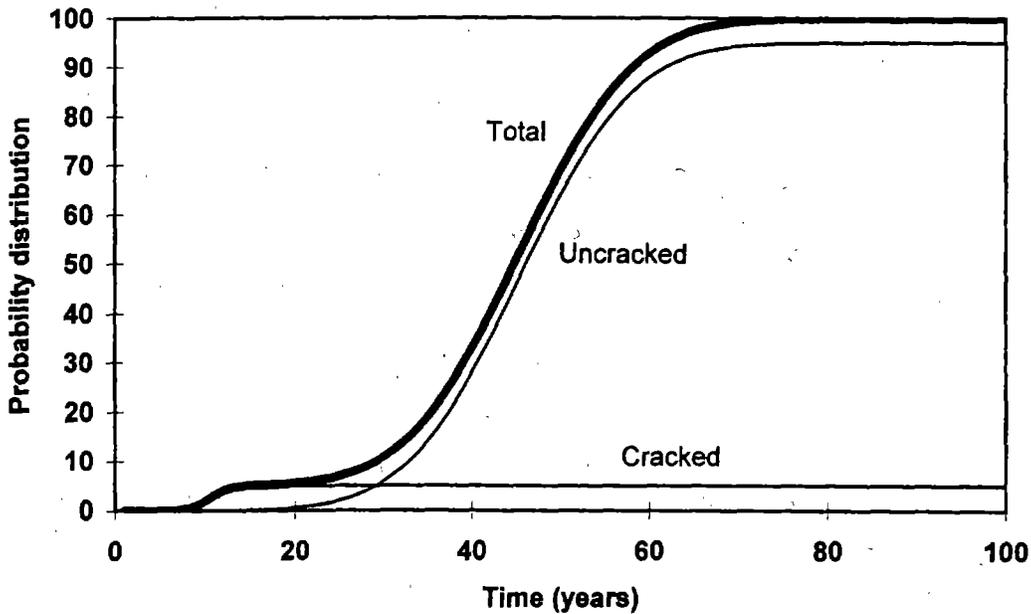
Figure 21. Cumulative distribution for delamination of deck with black bars.

Using these data, one can plot the probability distribution cumulative delamination occurring to the structure as shown in figures 22 and 23. Data shown in figures 21 and 23 are combined in figure 24.

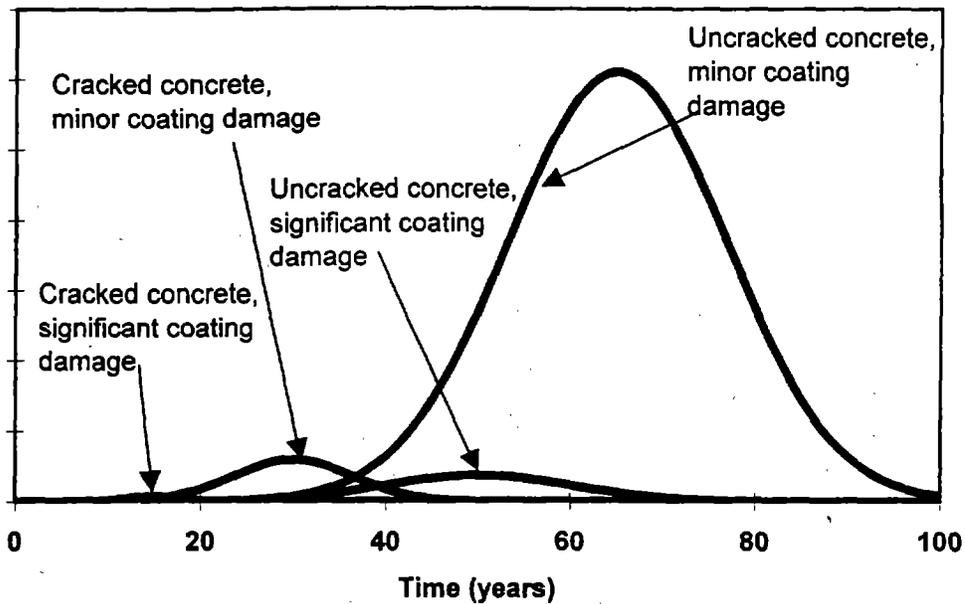
Figure 22. Probability distribution for delamination of deck with epoxy-coated bar in cracked and uncracked concrete.

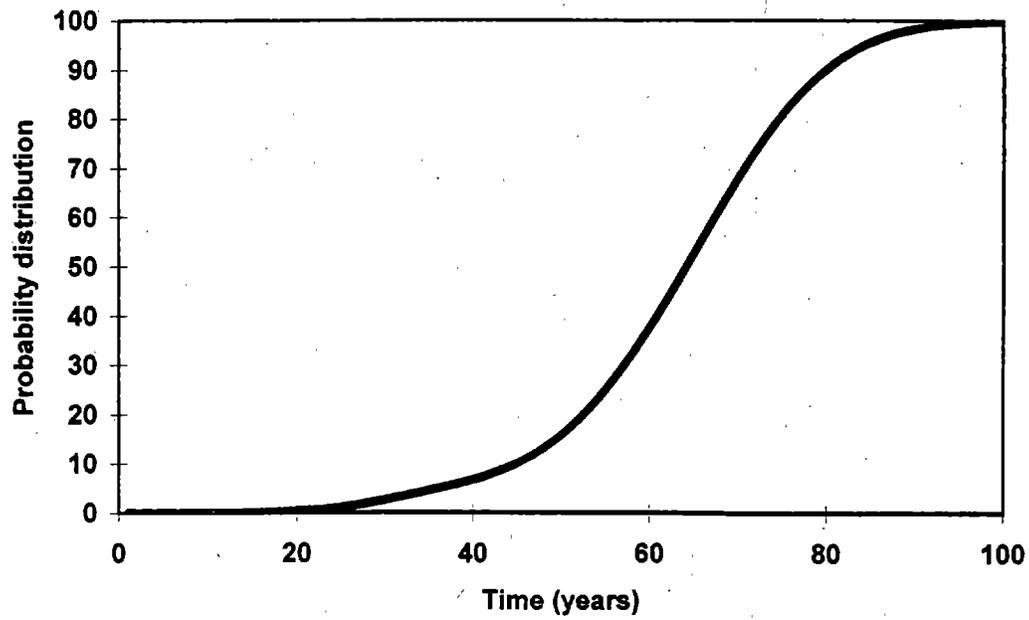
Figure 23. Cumulative distribution for delamination of deck with epoxy-coated bars in cracked and uncracked concrete with minor and significant coating damage.

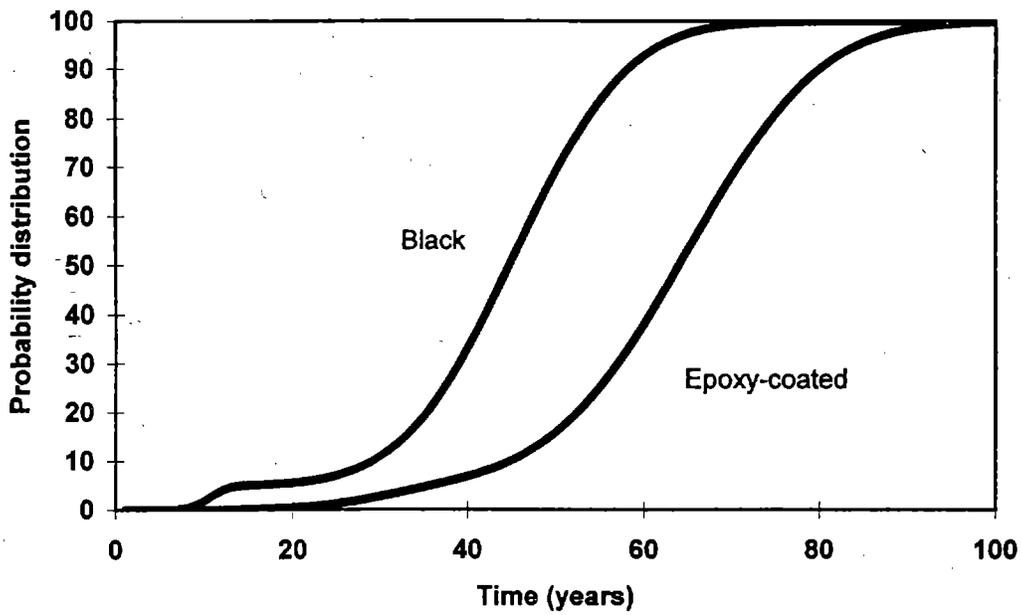
Figure 24. Cumulative distribution for delamination of concrete decks containing black and epoxy-coated bars.

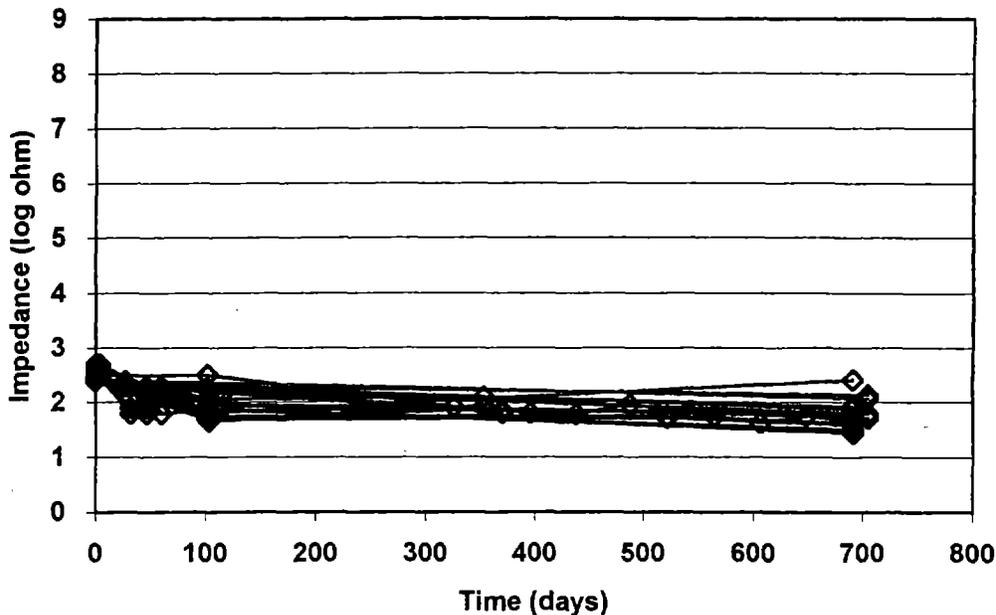
Figure 25. Impedance of black bar specimens during 96 weeks of testing.

The 0.1-Hz impedance values for the black bar specimens measured during the 96-week period of testing are shown in figure 25, for specimens with bent and straight bars, with and without cracks. For the black bars, the values obtained for the various configurations are similar for all conditions and a final impedance of approximately  $10^2$  ohm at 0.1 Hz was obtained at the end of the test period. This impedance is primarily believed to be the impedance of the concrete and does not contain a significant contribution from the polarization resistance value component of the uncoated bar.

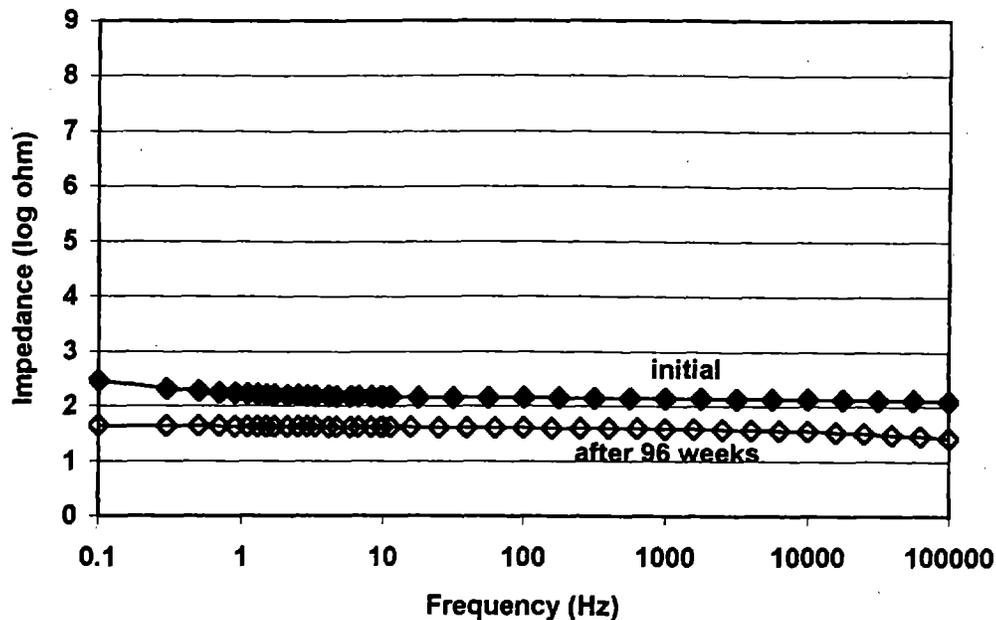
Figure 26. Bode plot for black bar specimens, initial and final measurements.

Figure 26 shows the Bode plot for the black bar specimens determined initially and after 96 weeks. The Bode plot for the black bars is approximately a horizontal line over the frequency range from 0.1 to 100,000 Hz, indicating mainly resistive behavior. It is believed that this relates primarily to the resistance of the concrete between the bar and the measuring apparatus. The decrease in impedance from 0 to 96 weeks indicates a drop in the concrete resistivity, probably due to changes in the concrete moisture content and the addition of a large amount of conductive chloride ions from the salt solution.

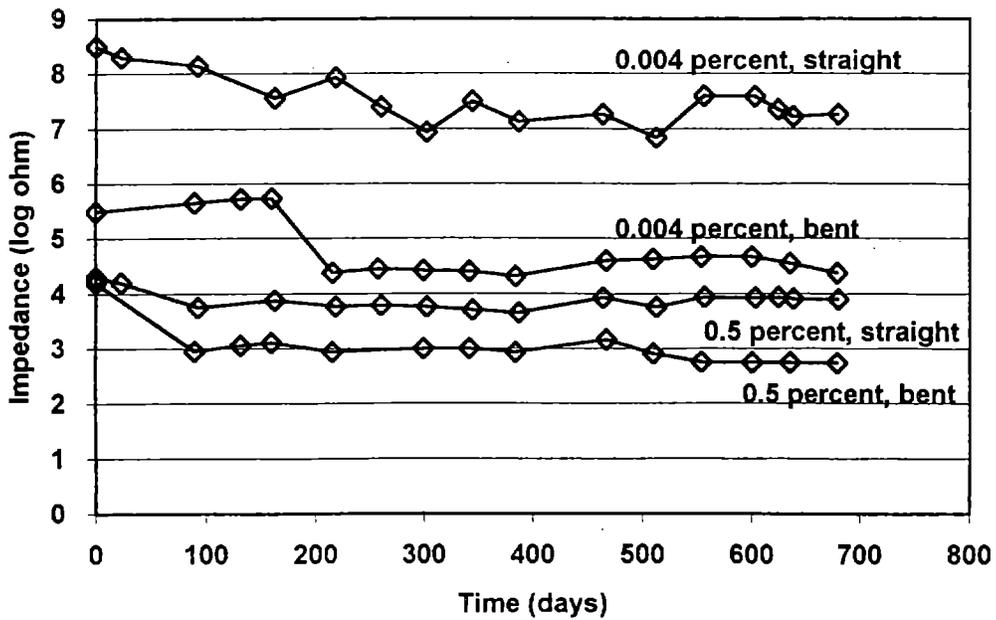
Figure 27. Impedance during 96 weeks of testing for straight and bent Epoxy-A bars, with 0.004 and 0.5 percent damage in uncracked concrete and a black cathode.

As an example of the effect of damage areas, the 0.1-Hz impedance values for Epoxy-A measured during the 96-week test period for the bent and straight uncracked concrete specimens with a black cathode are shown in figure 27. The straight bars with 0.004 percent damage area in uncracked concrete had an initial impedance of  $10^{8.6}$  ohm, as compared to  $10^{4.3}$  ohm for the straight bar with 0.5 percent damage area in uncracked concrete.

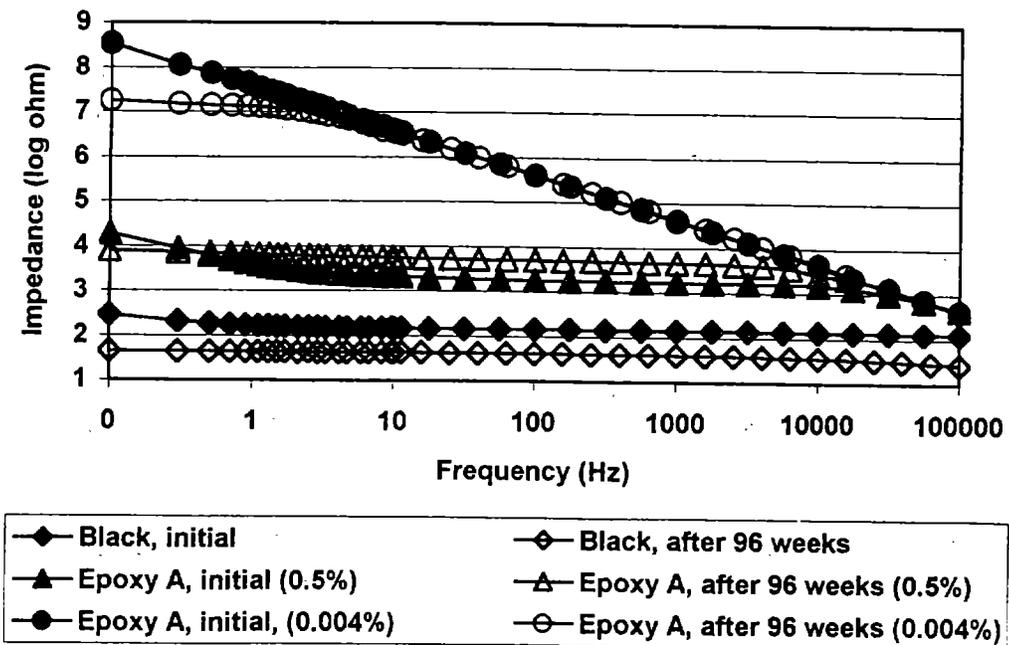
Figure 28. Bode plots for straight black bars and straight Epoxy-A bars with 0.004 and 0.5 percent damage in uncracked concrete with a black cathode.

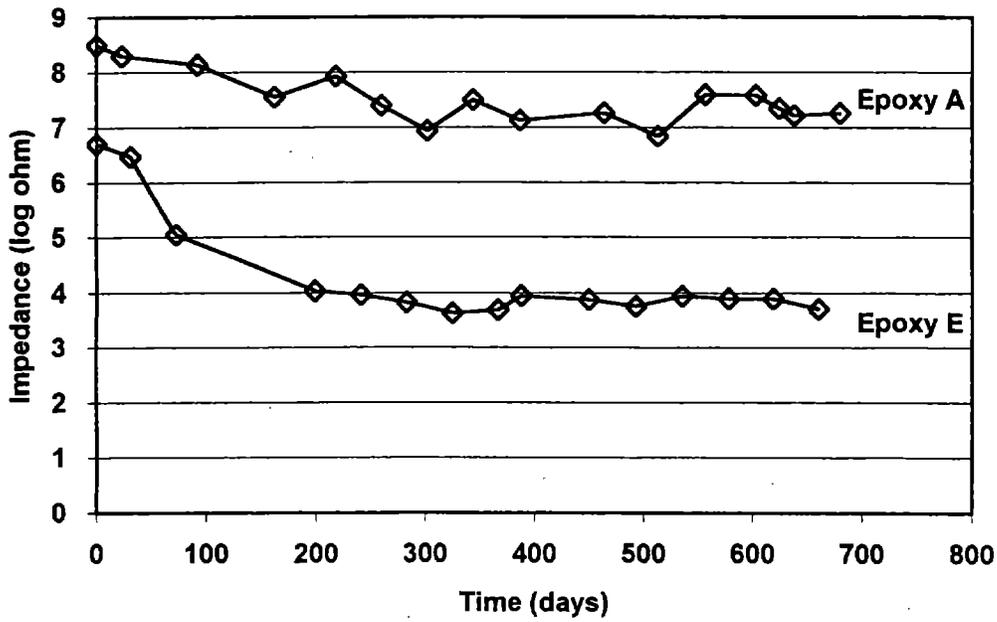
Figure 29. Impedance of epoxy-coated bars with 0.004 percent damage in uncracked concrete.

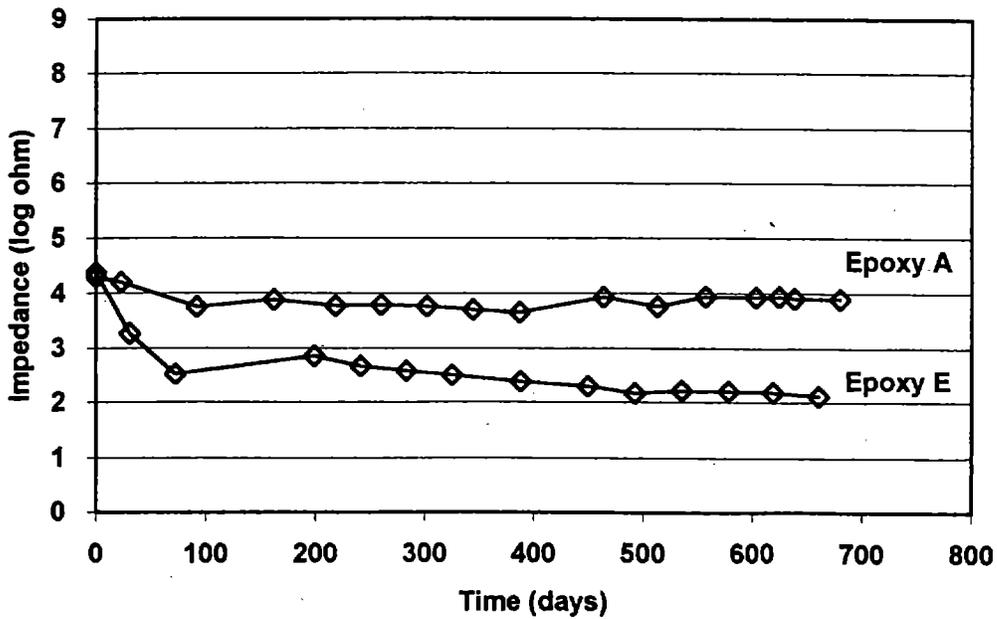
Figure 30. Impedance of epoxy-coated bars with 0.5 percent damage in uncracked concrete.

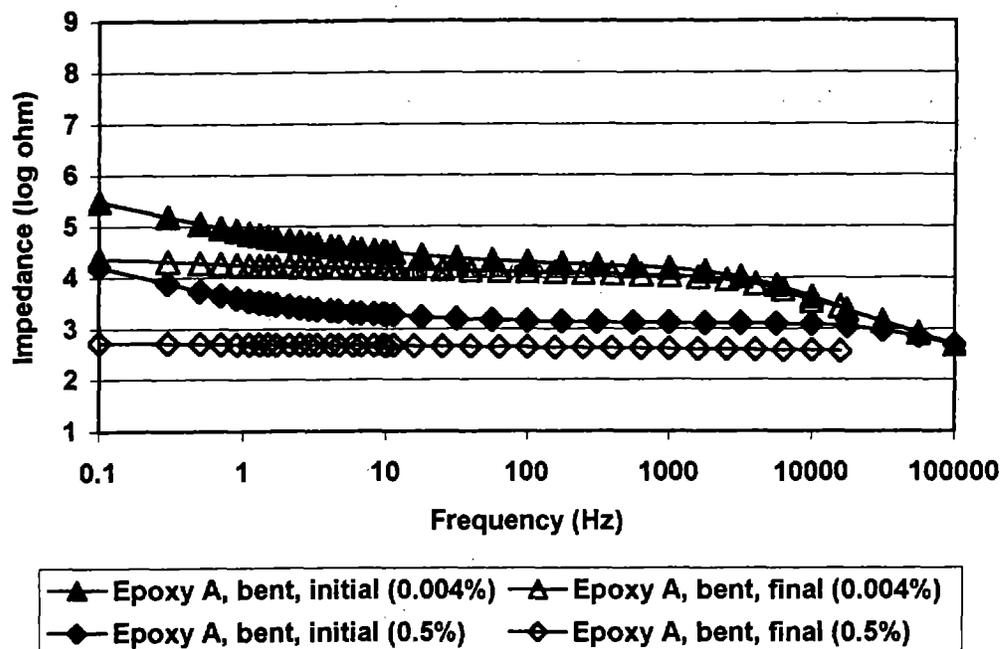
Figure 31. Bode plots for Epoxy-A bent bars with 0.004 or 0.5 percent damage in uncracked concrete.

Figure 31 shows the Bode plot for the Epoxy-A bent specimens, measured initially and after 96 weeks of testing. The scans determined for the bent bars are significantly different than those determined for the straight bars, probably due to the areas exposed by cracks formed during bending. These changes are shown by a comparison between figures 28 and 31. The bars with 0.004 percent damage changed from a primarily capacitive behavior to a mixed resistive and capacitive behavior. Accompanying this change in behavior was a decrease in the 0.1-Hz impedance from  $10^{8.6}$  to  $10^{5.2}$  ohm. A comparison of the curves also shows that the bent 0.004 percent damage bars appear almost identical to the unbent 0.5 percent damage bars. Although less dramatic, a similar change in performance was found for the 0.5 percent damage bars, with the slight capacitive behavior lost and the 0.1-Hz impedance dropping from  $10^{3.9}$  to  $10^{2.9}$  ohm.

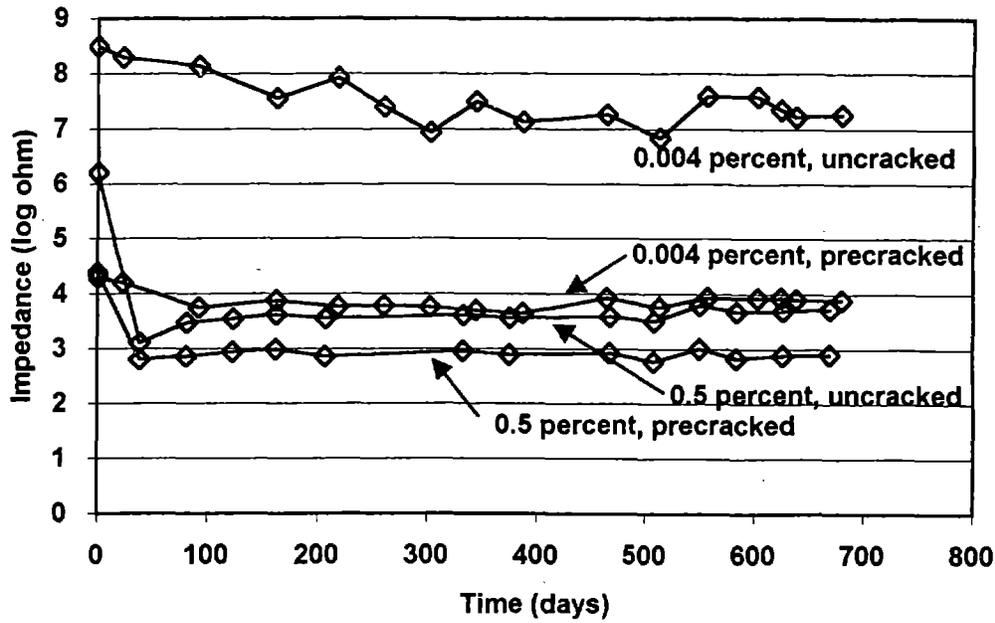
Figure 32. Impedance of Epoxy-A straight bars in uncracked and precracked concrete.

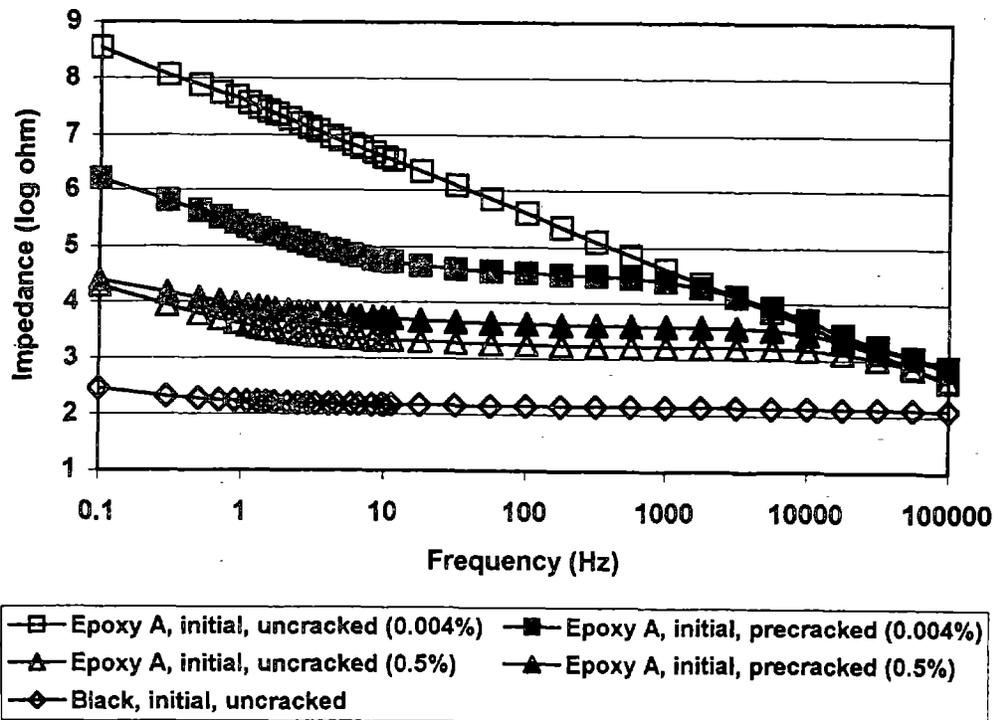
Figure 33. Bode plots of Epoxy-A straight bars in uncracked and precracked concrete.
