# Corrosion Evaluation of Epoxy-Coated, Metallic-Clad and Solid Metallic Reinforcing Bars in Concrete

PUBLICATION NO. FHWA-RD-98-153

DECEMBER 1998

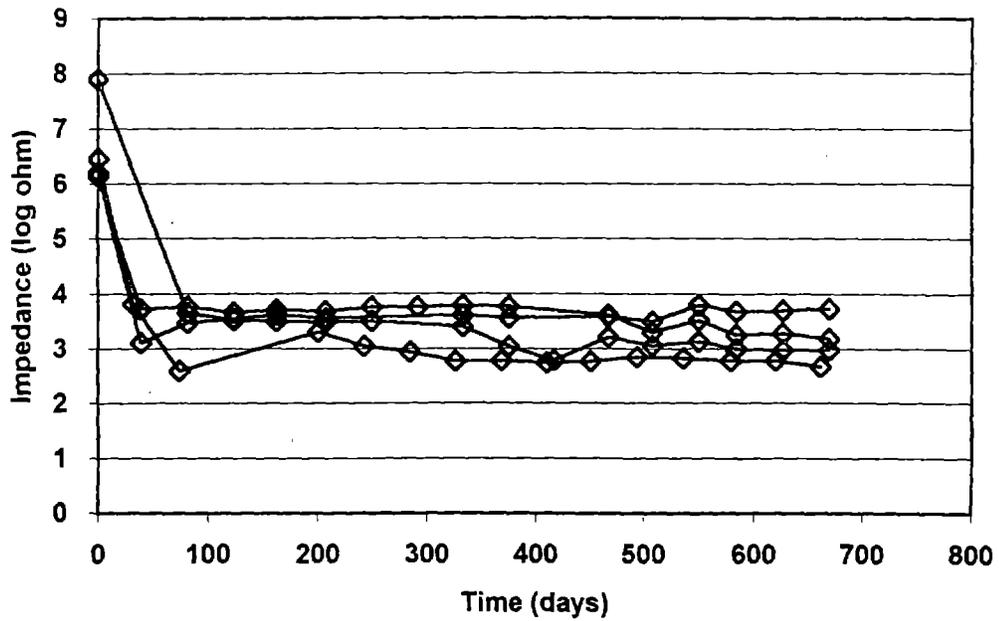
Figure 34. Impedance of straight epoxy-coated bars with 0.004 percent damage in precracked concrete (Epoxies A, B, C and E).

The typical behavior of the 0.004 percent damage bars in precracked concrete is shown in figure 34, which shows the impedance at 0.1 Hz measured during the 96-week test period for the straight bars with Epoxy-A, Epoxy-B, Epoxy-C, and Epoxy-E bars in precracked concrete. The values and behavior for the bar systems were similar. Similarly, figure 35 shows the impedance at 0.1 Hz measured during the 96-week test period for the Epoxy-A, Epoxy-B, Epoxy-C, and Epoxy-E straight bars that were tested with 0.5 percent damage in precracked concrete. The values obtained for all bar systems are similar.

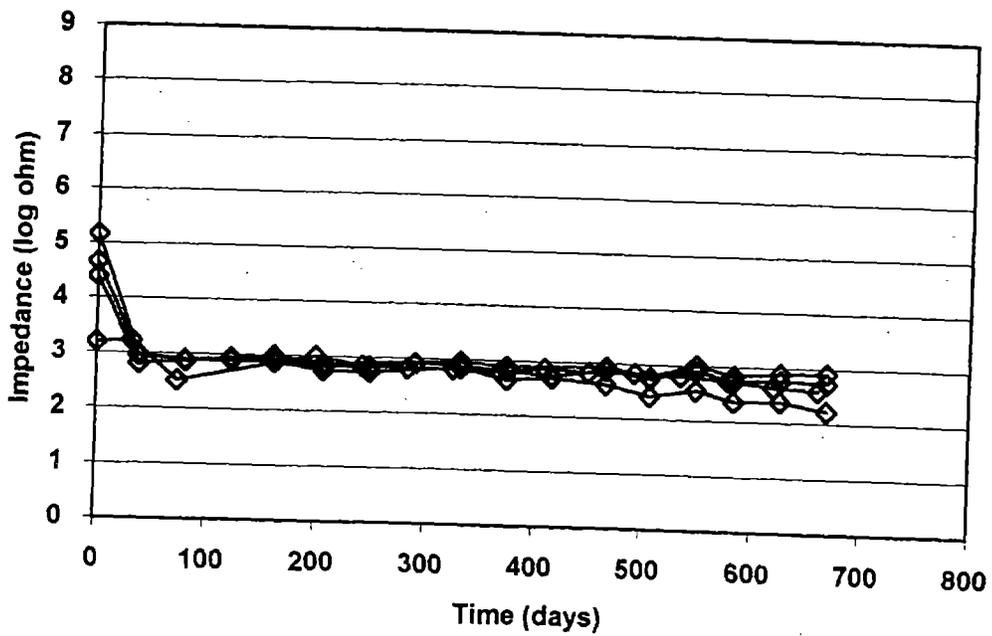
Figure 35. Impedance of straight epoxy-coated bars with 0.5 percent damage in precracked concrete (Epoxies A, B, C, and E).

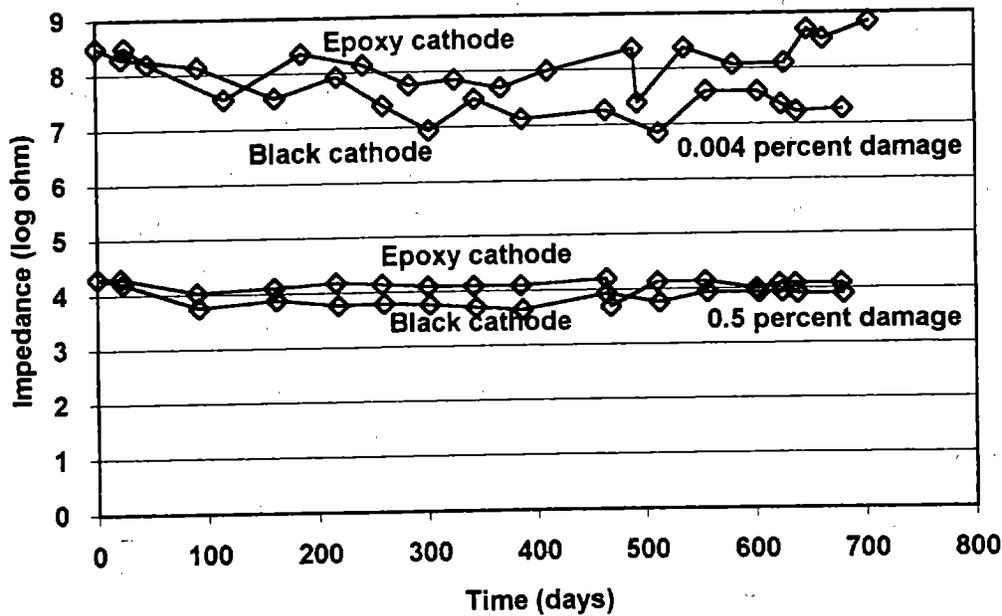
Figure 36. Impedance of Epoxy-A straight bars with either a black or epoxy-coated cathode.

The effect of cathode type on Epoxy-A is shown in figure 36, which shows the impedance at 0.1 Hz measured during the 96-week test period for the straight uncracked concrete specimens with black or epoxy cathodes.

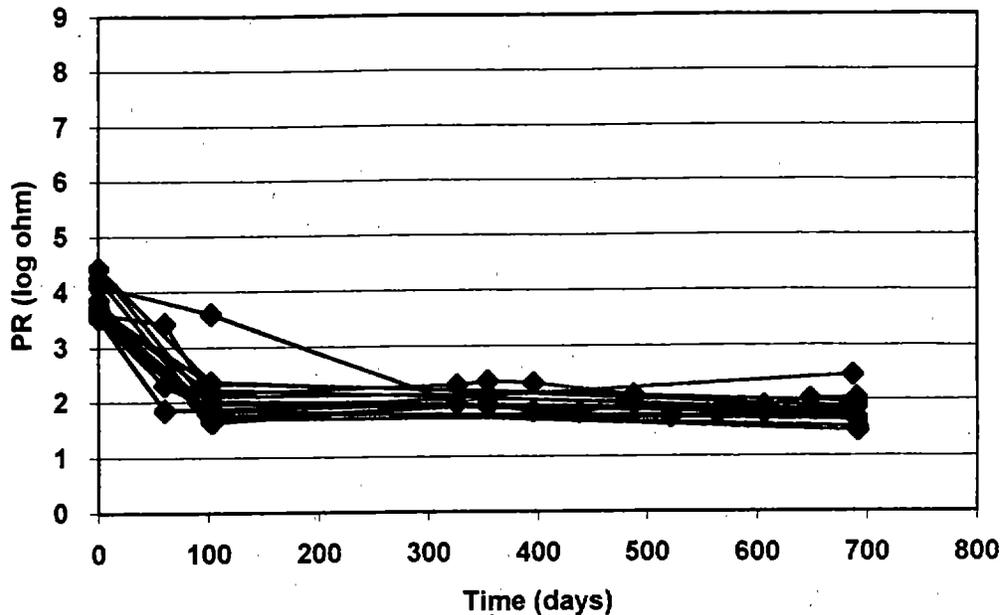
Figure 37. PR of straight and bent black bars in uncracked and precracked concrete.

The PR values measured during the 96-week period of testing for the black reinforcing bar specimens are shown in figure 37, for specimens with bent and straight bars, with and without cracks. For the black bars, the PR values obtained for the various configurations are similar for all conditions, with an average initial value of  $10^{3.9}$  ohm (8000 ohm) and an average final PR of approximately  $10^{1.8}$  (79 ohm). The PR of the bars quickly dropped after the initial measurements were taken and remained stable until the end of the test period.

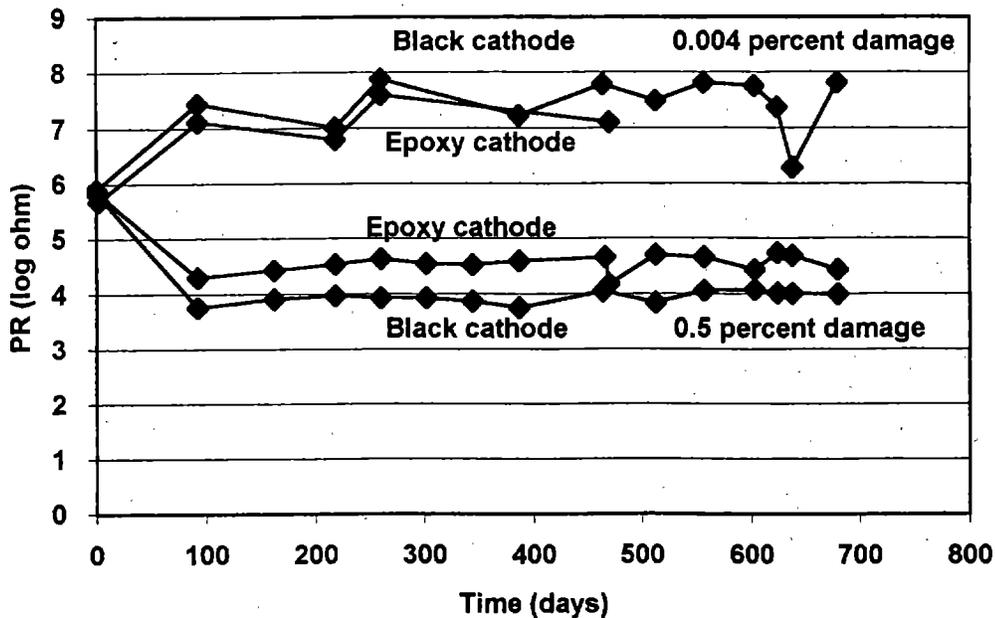
Figure 38. PR for Epoxy-A straight bars with black or epoxy-coated cathode.

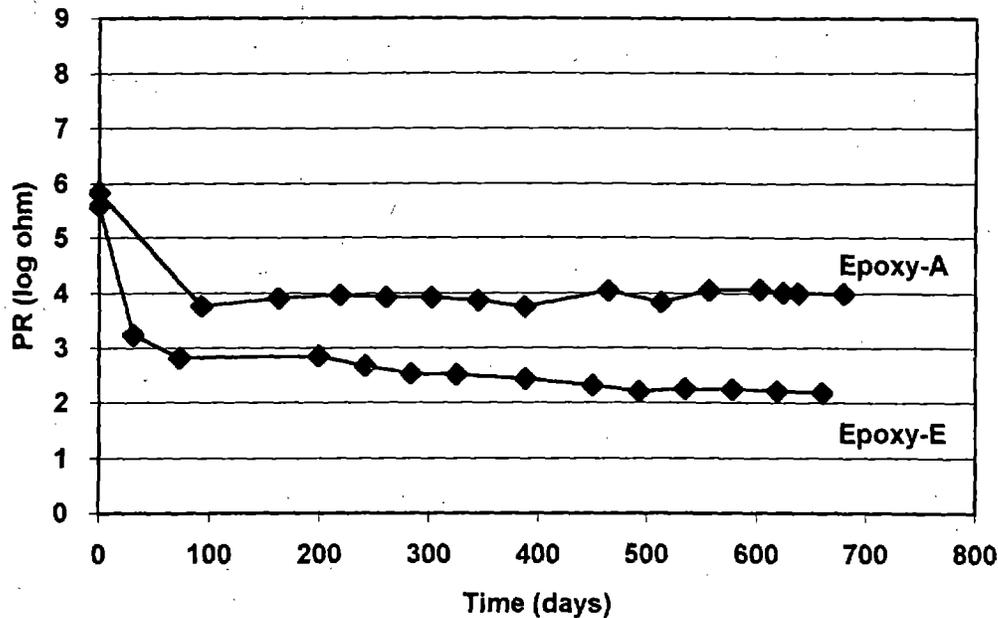
Figure 39. PR for Epoxy-A and Epoxy-E bars with 0.5 percent damage and a black cathode.

An example of the performance of different coatings is shown in figure 39, which shows the time history of one bar with Epoxy-A, and one bar with Epoxy-E. The bars had 0.5 percent damage, were in uncracked concrete and had a black cathode. As shown in the figure, although the PR values of both coatings dropped during the testing, there were some differences between the coatings.

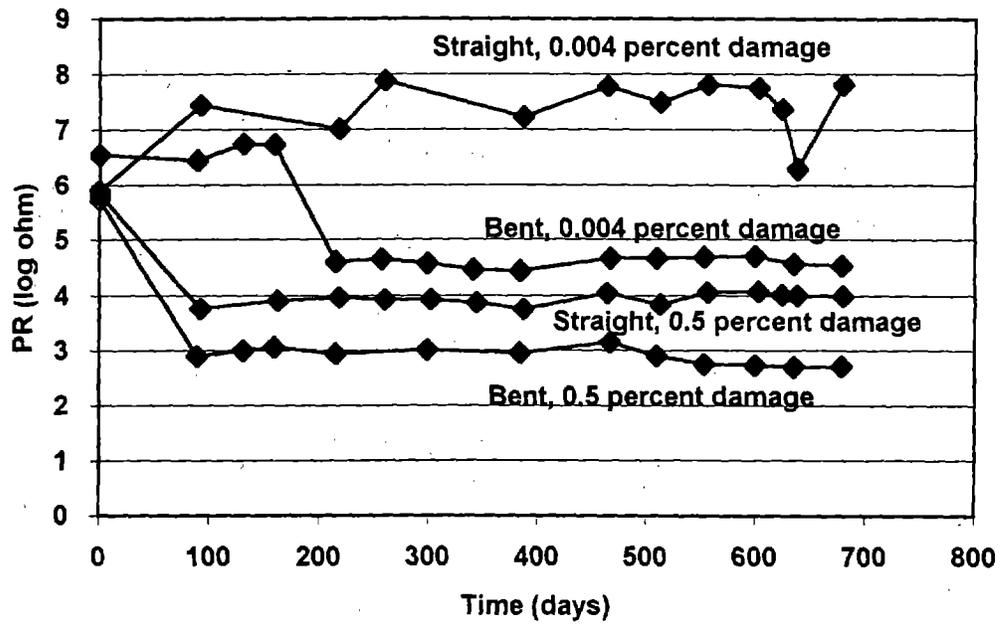
Figure 40. PR of Epoxy-A straight and bent bars, with 0.004 and 0.5 percent damage.

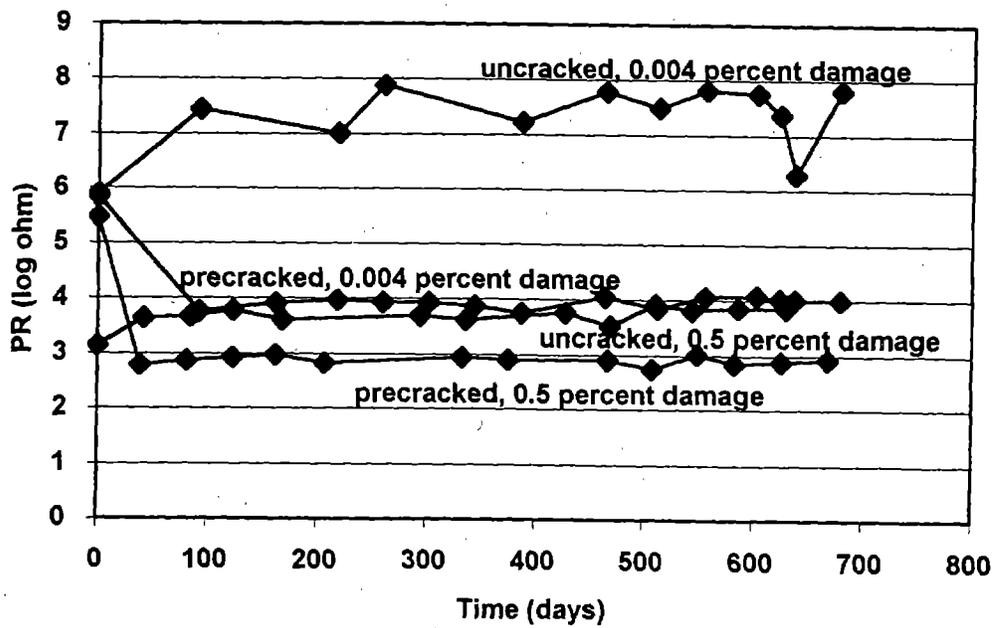
Figure 41. PR of Epoxy-A straight bars in uncracked and precracked concrete.
