# Clean Air Program

## Cylinder Issues Associated With Alternative Fuels

Final Report  
January 1999

6. AUTHOR(S) Vincent R. DeMarco, PE	
--	--

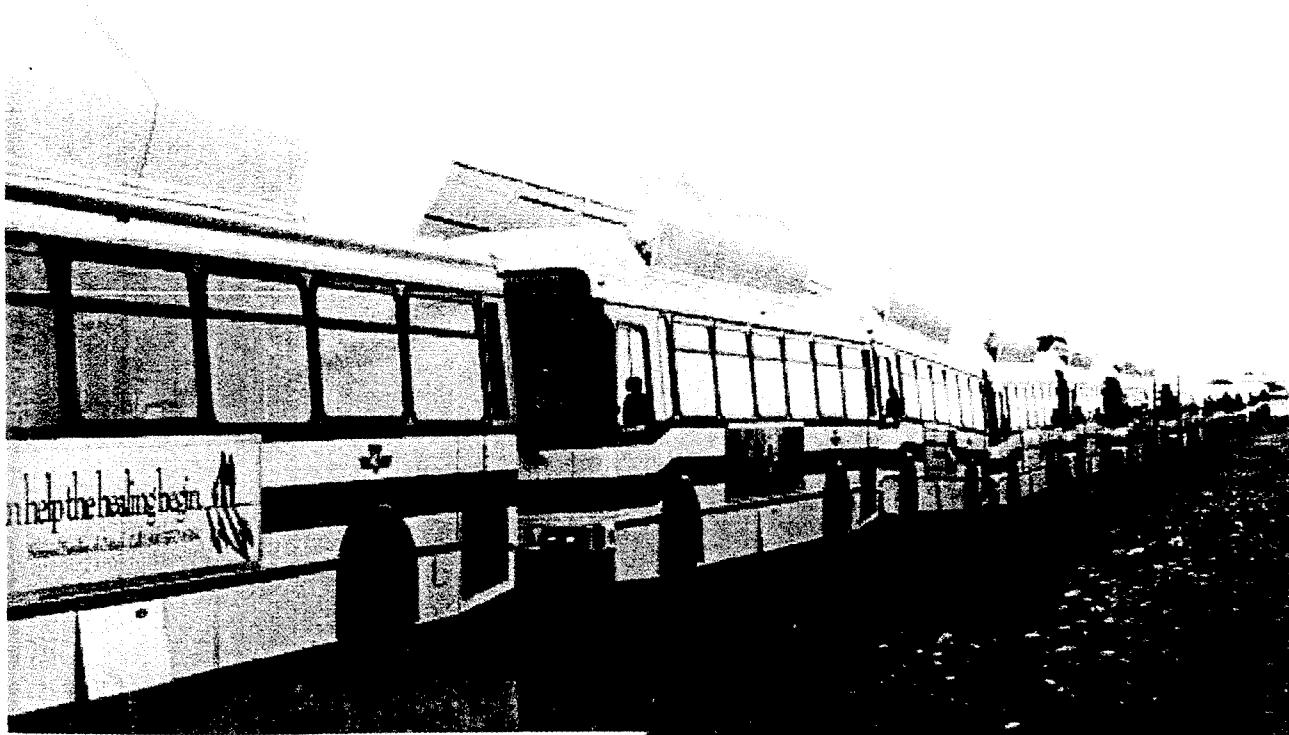
**Client:**  
Toronto Transit Commission

**Tanks:**  
**12 x V 174 NG – Neckmount**

**Service Pressure:**  
**200 Bar**

**Max Fill Pressure:**  
**260 Bar**
