# Testing of State Roadside Safety Systems Volume IV: Appendix C– Crash Testing and Evaluation of a Pennsylvania Transition Design

PUBLICATION NO. FHWA-RD-98-039

7. Author(s) King K. Mak and Wanda L. Menges				8. Performing Organization Report No. Research Foundation 7147-Vol. IV	
9. Performing Organization Name and Address Texas Transportation Institute The Texas A&M University System College Station, Texas 77843-3135				10. Work Unit No. NCP No.

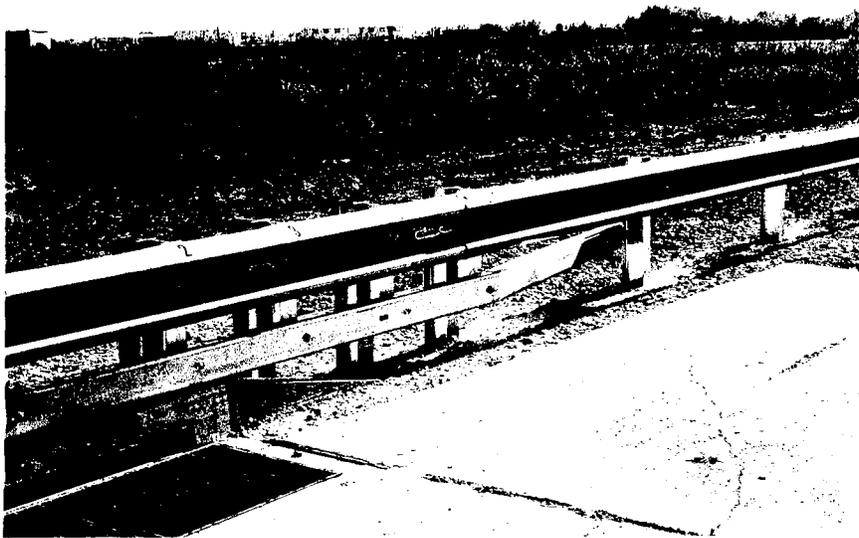
Figure 4. Pennsylvania bridge rail transition prior to test 7147-3.

The test installation for this crash test consisted of a 4.3-m (14-ft) section of simulated concrete bridge parapet and wingwall, a Type C drainage inlet, and 22.9 m (75 feet) of W-beam approach guardrail and transition. Figure 1 shows details of the simulated concrete bridge parapet and wingwall, drainage inlet, and the transition portion of the approach guardrail.

Photographs of the completed test installation are shown in figure 4.

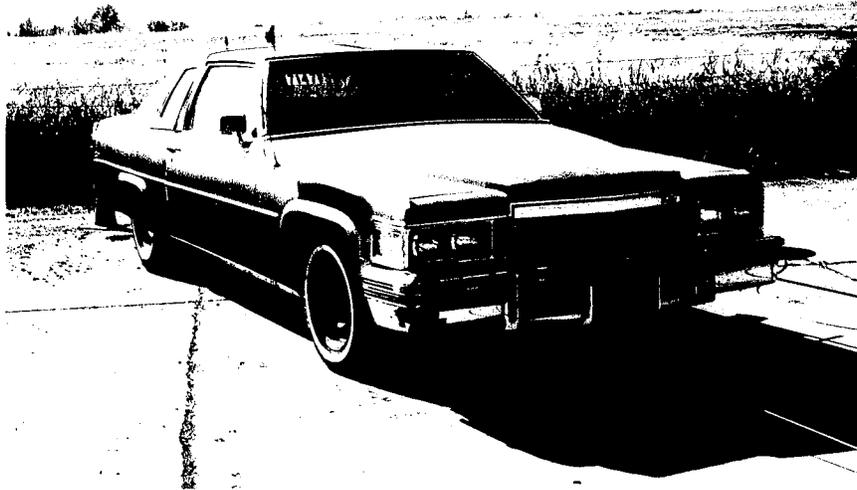
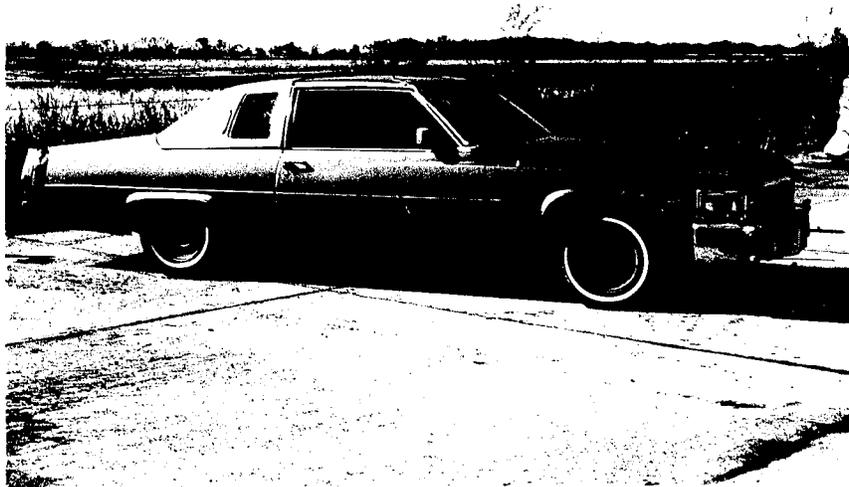
Figure 5. Vehicle prior to test 7147-3.

A 1979 Cadillac DeVille, shown in figures 5 and 6, was used for the crash test. Test inertia weight of the vehicle was 2043 kg (4500 lb) and its gross static weight was 2120 kg (4670 lb). The height to the lower edge of the vehicle bumper was 330 mm (13.0 in) and it was 584 mm (23.0 in) to the upper edge of the bumper. Additional dimensions and information on the vehicle are given in figure 7. The vehicle was directed into the transition system using a cable reverse tow and guidance system, and was released to be free-wheeling and unrestrained just prior to impact.

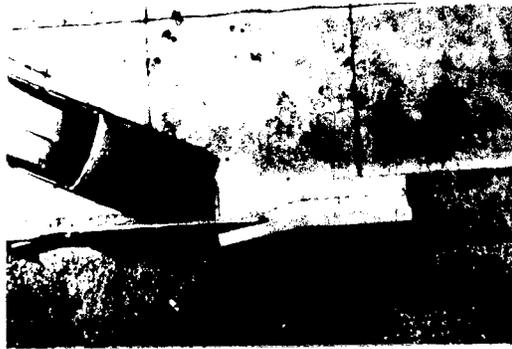
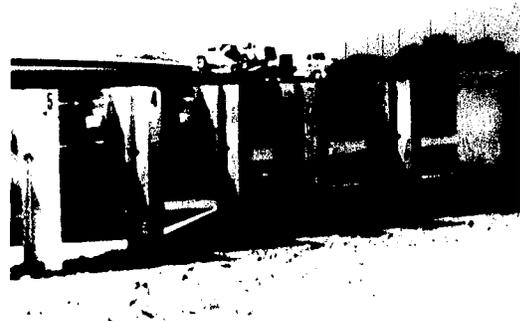
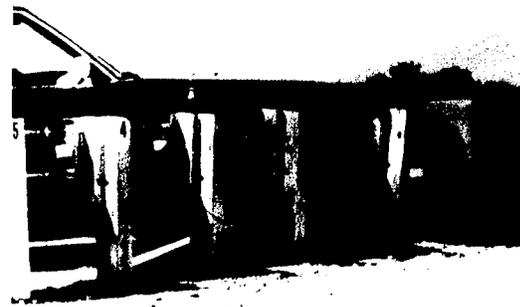
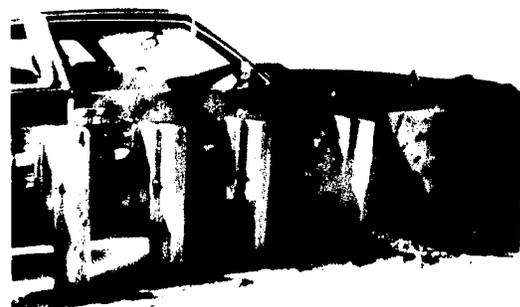
Figure 8. Sequential photographs for test 7147-3 (overhead and behind the rail views).

The vehicle was traveling at a speed of 99.0 km/h (61.5 mi/h) when it impacted the transition system approximately midspan between posts 2 and 3. The impact angle was 25.4 degrees. The vehicle began to redirect at 0.036 s after initial impact. At approximately 0.035 s, the right front tire of the vehicle impacted the curb face of the drainage inlet and the tire aired out at 0.060 s. The right front tire of the vehicle climbed on top of the curb of the drainage inlet at about 0.066 s and the right front of the vehicle started to rise. The right rear of the roof began to deform at approximately 0.073 s, and extensive deformation of the roof of the vehicle was observed throughout the impact sequence.

The W-beam guardrail transition deflected sufficiently to allow the vehicle to impact the wingwall at 0.085 s traveling at a speed of 89.3 km/h (55.5 mi/h) and a 30-degree angle to the wingwall. Shortly thereafter, the simulated concrete safety-shaped bridge rail and wingwall began to move and tilt backwards. By 0.190 s, the simulated concrete safety-shaped bridge rail and wingwall reached a maximum dynamic deflection of 64 mm (2.5 in) at the top.

At 0.196 s, the vehicle was traveling parallel to the transition system at a speed of 68.5 km/h (42.6 mi/h). The rear of the vehicle impacted the transition system at 0.201 s and the vehicle exited the transition at 0.308 s, traveling at a speed of 66.3 km/h (41.2 mi/h), with an exit trajectory of 14.7 degrees. The brakes were applied after the vehicle cleared the test installation. The vehicle rotated counterclockwise and veered to the right because of the orientation of the front tires and damages sustained by the tires on the right side of the vehicle from impact with the guardrail and the transition curb block. The left rear of the vehicle impacted the end of a concrete barrier section downstream of the transition system and subsequently came to rest 46 m (150 ft) downstream from the point of initial impact. Sequential photographs of the test sequence are presented in figures 8 and 9.

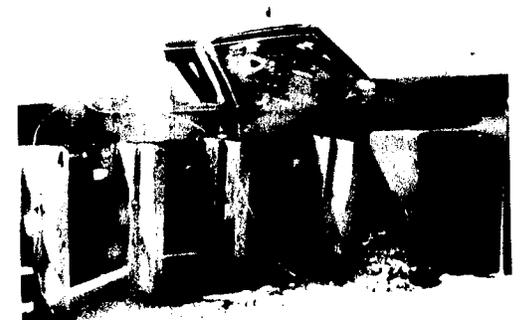
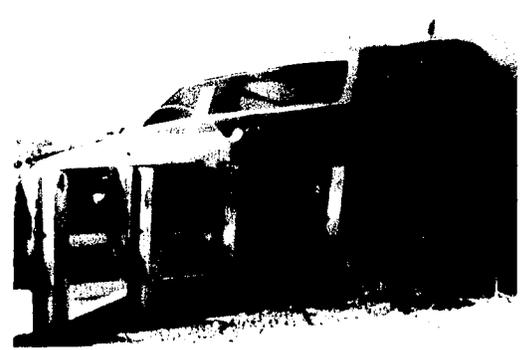
Figure 8. Sequential photographs for test 7147-3 (overhead and behind the rail views) (continued).

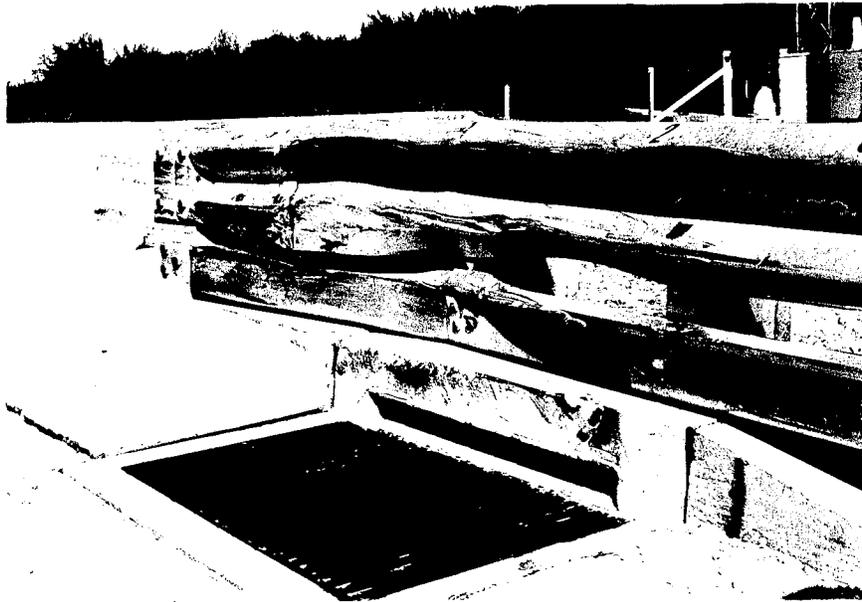
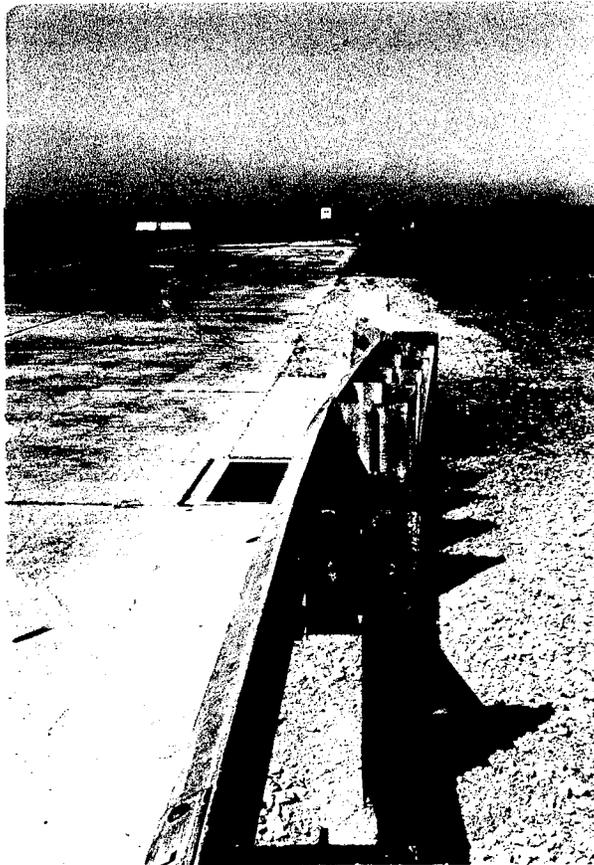
Figure 10. Pennsylvania transition after test 7147-3.

The transition system received moderate damage, as shown in figure 10. The total length of contact of the vehicle with the transition system was 5.3 m (17.5 ft). The maximum

permanent deformation of the W-beam rail element was 191 mm (7.5 in), located at the end of the wingwall. The lower corrugation of the W-beam had been flattened against the wingwall. The tilting movement of the concrete safety shape caused the concrete foundation to move and subsequently to settle 13 mm (0.5 in) above ground level, and it was pushed backwards a distance of 13 mm (0.5 in). The drainage inlet was also pushed back a distance of 16 mm (5/8 in).

The major concern with the transition design, as mentioned above, is the impact of the vehicle with the flared wingwall prior to any significant redirection of the vehicle. This could possibly be improved by increasing the size and embedment depth of the first two or three posts in the transition to increase the lateral stiffness of the W-beam guardrail transition. Also, a blockout with a box or pipe section between the nested W-beam and flared wingwall to reduce the spacing between the guardrail connection to the wingwall and the first post and to absorb some of the impact energy. An engineering analysis and/or computer simulation is recommended to determine the appropriate post size and embedment depth and location and size of the blockout.

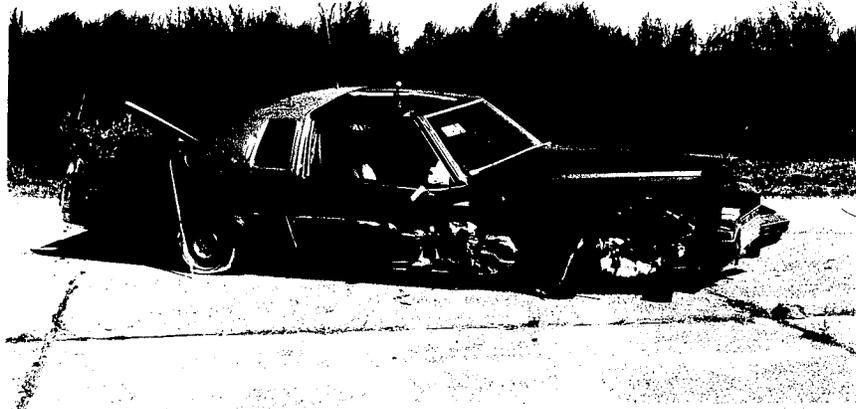
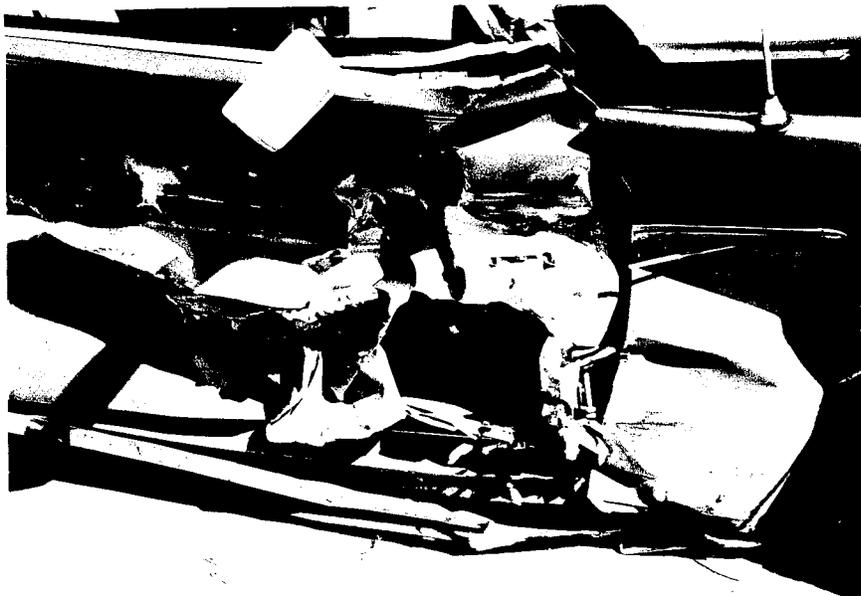
Figure 11. Damage to vehicle, test 7147-3.

The vehicle (shown in figure 11) sustained extensive damage to the right side. The floorpan and roof were bent, the windshield was broken, and the interior instrument panel was deformed. A small section of sheet metal was torn off the right door, evidently by the end of the terminal connector lapped in the direction of impact (because of the nested W-beam, the terminal connector had to be lapped in this manner in order for the bolt hole to fit). There was damage to the front bumper, hood, grill, radiator and fan, right and left front quarter panel, right door and glass, right rear quarter panel, and the rear bumper. The left rear quarter panel was damaged, and the rear glass and rear side glass were broken when the vehicle impacted the other barrier downstream near the end of the vehicle trajectory. The wheelbase on the right side was shortened from 3.08 m (121.25 in) to 2.74 m (108.0 in). The right front and rear rims and tires were damaged. Maximum crush to the vehicle was 838 mm (33.0 in) at the right front corner at bumper height and the front was shifted 64 mm (2.5 in) to the left.

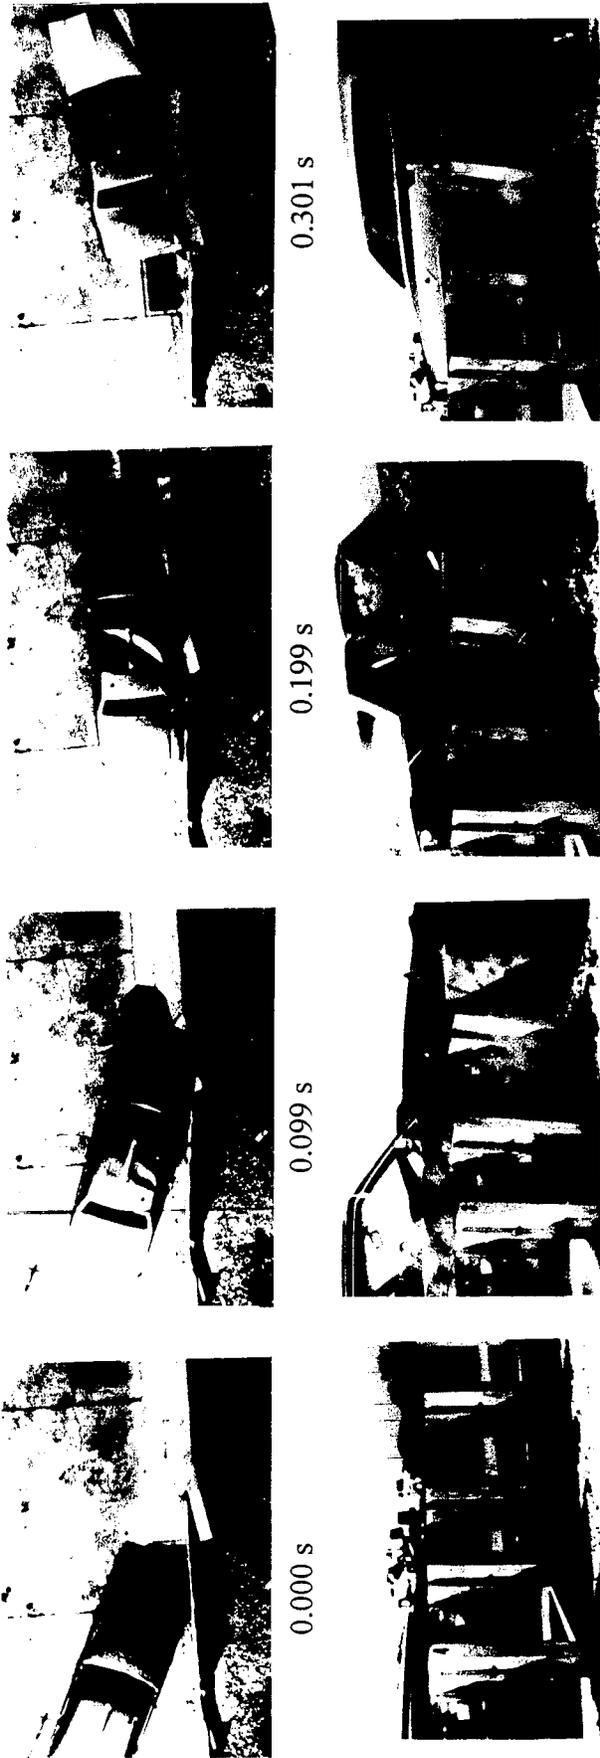
Figure 12. Summary of results for test 7147-3.

Test No. .... 7147-3  
 Date ..... 11/06/90  
 Test Installation ..... Pennsylvania Bridge  
 Rail Transition  
 Installation Length ..... 27 m (89 ft)  
 Max. Dynamic Deflection ..... 0.3 m (0.9 ft)  
 Max. Perm. Deformation ..... 0.2 m (0.6 ft)  
 Test Vehicle ..... 1979 Cadillac de Ville  
 Vehicle Weight .....  
 Test Inertia ..... 2043 kg (4500 lb)  
 Gross Static ..... 2120 kg (4670 lb)  
 Vehicle Damage Classification .....  
 TAD ..... 01FR5 & 01RD6  
 CDC ..... 01FREK3 & 01RDEW3  
 Maximum Vehicle Crush ..... 838 mm (33.0 in)

Impact Speed ..... 99.0 km/h (61.5 mi/h)  
 Impact Angle ..... 25.4 deg  
 Speed at Parallel ..... 68.5 km/h (42.6 mi/h)  
 Exit Speed ..... 66.3 km/h (41.2 mi/h)  
 Exit Trajectory ..... 14.7 deg  
 Vehicle Accelerations  
 (Max. 0.050-s avg)  
 Longitudinal ..... -12.3 g's  
 Lateral ..... -13.1 g's  
 Occupant Impact Velocity  
 Longitudinal ..... 9.1 m/s (29.9 ft/s)  
 Lateral ..... 8.0 m/s (26.1 ft/s)  
 Occupant Ridedown Accelerations  
 Longitudinal ..... -6.4 g's  
 Lateral ..... 23.7 g's

A summary of pertinent data from the electronic instrumentation, high-speed film, and field measurements is given in figure 12. Vehicle angular displacements are displayed in figure 13, and vehicular accelerations versus time traces filtered at 300 Hz are presented in figures 14 through 16.
