INVESTIGATION AND APPLICATION OF FRACTURED SLAB TECHNIQUES FOR PCC PAVEMENTS

FINAL REPORT

**FINAL REPORT WI/SPR-05-99
Federal Experimental Project #WI 93-06**

**Sam Owusu-Ababio, PhD, P.E.
Thomas B. Nelson, PhD, P.E.
Department of Civil And Environmental Engineering
University of Wisconsin-Platteville
1 University Plaza Platteville, WI 53818**

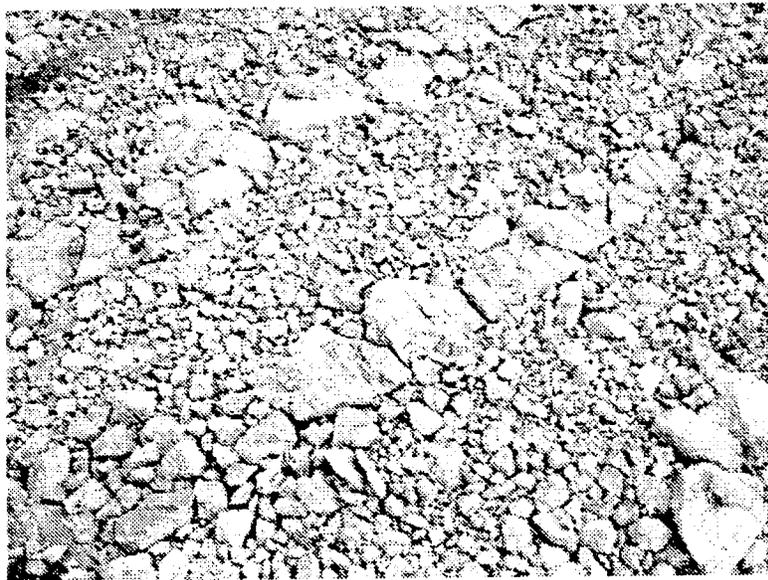
Figure 2-2. Rubblized PCC Pavement Particle Size Distribution Produced by a PB4 Resonant Breaker

Rubblization, if performed by a PB4 resonant pavement breaker or Multiple-Head Breaker, generally produces pieces that range in size from 25 to 75 mm (1 to 3 in.) near the surface, with a maximum particle size of 300 to 375 mm (12 to 15 in.), usually found in the lower portions of the pavement. Figure 2-2 shows the typical distribution of particle sizes following a rubblized PCC pavement performed by a PB4 pavement resonant breaker. Although initially tried for rubblization, a drop hammer or whip hammer device has been found to generally produce larger and more inconsistent fractured slab pieces.¹⁰ This has resulted in most agencies not recommending the drop hammer or the whip hammer for rubblization. It is most important to ensure that the final product does not include many oversize pieces, which will not function as aggregate. Oversize pieces are sometimes subject to further breaking using jack hammers, for example, as commonly done in the State of Michigan¹¹, or oversize pieces are removed and replaced with high quality aggregate. In some instances, where there is the existence of weak spots in the subgrade, the recommended pre-overlay repair is to replace these spots with high quality aggregate material.

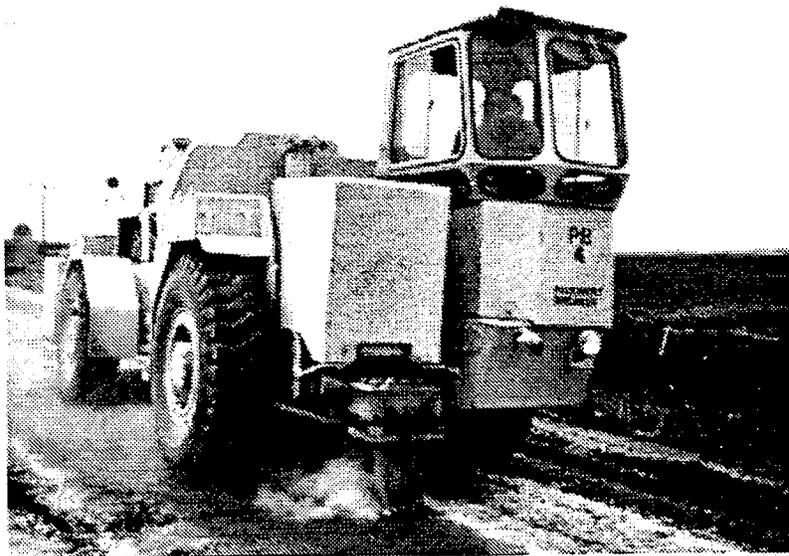
Figure 2-3. PB4 Pavement Resonant Breaker Equipment

A large variety of fracturing equipment is available to contractors for the fracturing process, as indicated in Table 1, on page 9. For **rubblization**, the most effective fracturing equipment includes the self-propelled resonant pavement breaker (PB4) and

the Multiple Head Breaker (MHB), shown respectively in Figures 2-3 and 2-4. The PB4 operates at 5 - 8 km/h (3-5 mph) and delivers 900 kg (2000 pounds) of force, at 44 cycles per second. It produces a low amplitude oscillation over a 300-mm (12-in.) square or a 175-mm (7-in.) square breaker shoe. Typically, 15 passes are required to cover a 3.6-m (12-ft) traffic lane using the 300-mm (12-in.) shoe, and 20 to 24 passes with the 175-mm (7-in.) shoe. This results in a production rate of 210 to 530 lane-m/hr (690 to 1765 lane-ft/hr). The PB4, due to its heavy weight, has the tendency to shove, distort, or punch through pavements that are built on weak subgrades. The MHB was developed in 1995 by Badger State Highway, Inc., Antigo, WI. It uses two rows of 450 kg (1000 lb) hammers mounted laterally in pairs. The heads are lifted by hydraulic cylinders to adjustable heights and dropped at a rate of up to 35 impacts per minute. The breaking width can be adjusted in 0.6 m (2 ft.) increments, from 0.6 m (2 ft.) to a maximum of 4.0 m (13 ft.). Working speeds range from 3 m per minute to 16 m per minute, resulting in typical production rates from 180 to 960 lane-m/hr (600 to 3170 lane-ft/hr).

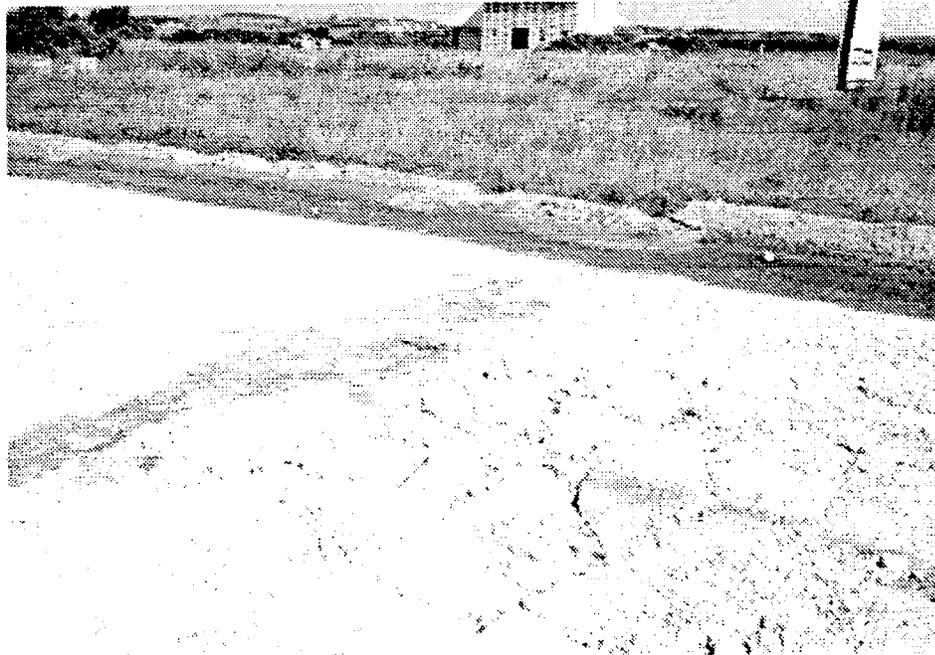
Figure 4-2. Inadequate Rubblization Over Center of Pavement.

asphaltic surface layer, placed in 1975, was milled off of the pavement. This pavement, built in 1946, was placed directly on a compacted A-6 subgrade. High moisture contents were evident in the adjacent fields, and in the shoulder. At the time of the rubblization, the pavement was severely distressed at the underlying concrete joints.

This project was rubblized with the PB4 resonant pavement breaker, and compacted with a 10,886-kg (12-ton) vibratory roller with a herringbone pattern grid on the drum. Rubblization operations on the outside 1.8 m (6 ft.) of each lane progressed well, but the middle 3.6 m (12 ft.) resulted in oversize pieces of 0.3 to 0.6 m (1 to 2 ft.) in diameter, that were shoved at an angle into the underlying soft material, as can be seen in Figure 4-2. During rubblization of the middle section, additional moisture came to the surface. Due to surface irregularities caused by the shoved pieces, these areas were removed. A 75-mm (3-in.) thick crushed aggregate leveling course had to be placed over the rubblized pavement prior to paving. This layer was paved with a 125-mm (5-in.) asphaltic concrete surface. During the first year after rubblization, several sections showed thermal cracking. This section of CTH TT was crackfilled and surfaced with a chip seal in 1998, making tracking of reflection cracks difficult at this time.
