# Galvanic Cathodic Protection of Reinforced Concrete Bridge Members Using Sacrificial Anodes Attached by Conductive Adhesives

PUBLICATION NO. FHWA-RD-99-112

SEPTEMBER 1999

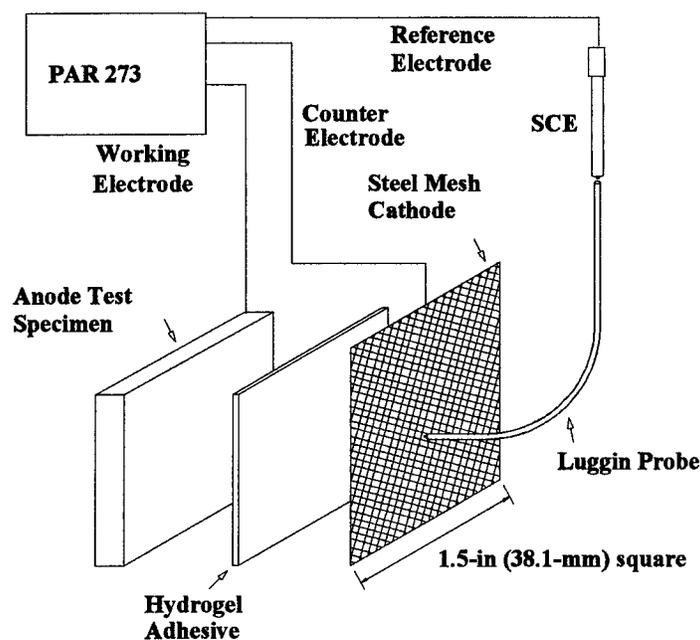
Figure 1. Cell for the testing of anode materials.

The anode test specimen was laminated to hydrogel adhesive, which was in turn placed in contact with a steel mesh cathode. A Luggin probe placed between the strands of mesh allowed the working potential of the anode to be measured versus a stable reference electrode. The working, counter, and reference electrodes were connected to a Princeton Applied Research Model 273 potentiostat.

It was first necessary to develop a test cell and a test procedure to analyze alloys for this application. Since the performance of the alloy was dependent on its environment, it was decided to test the anode directly in contact with the hydrogel adhesive. The configuration of the test cell is shown in figure 1.

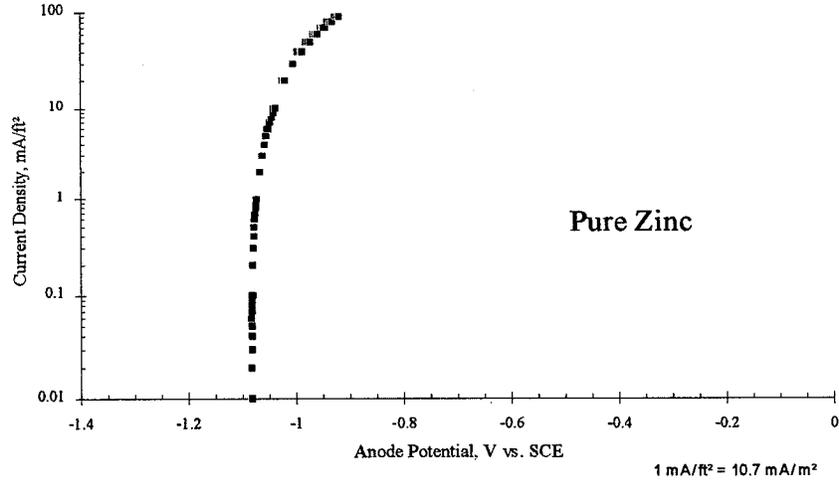
Figure 2. Polarization data for pure zinc/RG-63B hydrogel composite.

The polarization data for pure zinc are shown in figure 2. Zinc in contact with hydrogel adhesive had a working potential at very low current densities of -1.08 V versus a saturated calomel reference electrode (SCE). This agrees favorably with published data (see table 1). The working potential was also stable, and the anode showed no tendency to passivate. As the current steps were slowly increased, the zinc anode polarized only slightly. At a current density of 1.0 mA/ft<sup>2</sup> (10 mA/m<sup>2</sup>), a practical current density for an anode in the field, the working potential was still -1.07 V versus SCE. Even at 100 mA/ft<sup>2</sup> (1000 mA/m<sup>2</sup>), a current density far in excess of that experienced on actual structures, the zinc anode had polarized to only -0.92 V versus SCE. At all levels of current tested, the working potential of the zinc anode was stable and showed no tendency to passivate.

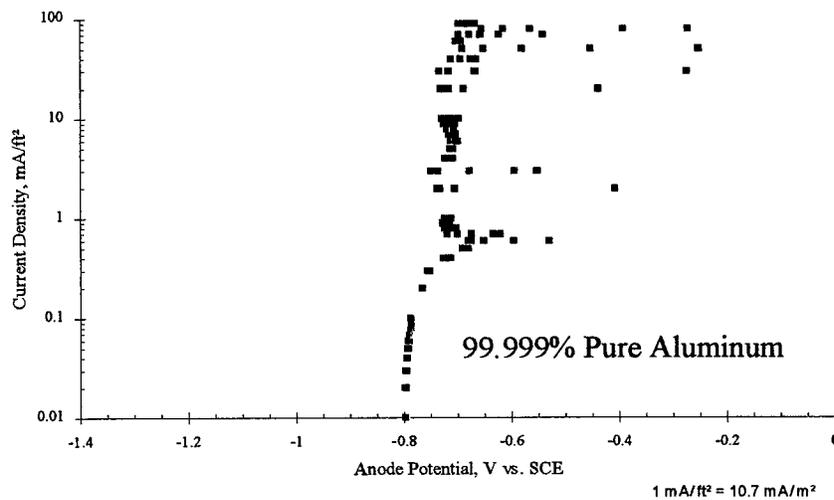
Figure 3. Polarization data for pure aluminum/RG-63B hydrogel composite.

The polarization data for 99.999 percent pure aluminum are shown in figure 3. In this case, aluminum in contact with hydrogel adhesive did not possess a desirable potential at very low current. Anode potential was only -0.80 V at 0.01 mA/ft<sup>2</sup> (0.1 mA/m<sup>2</sup>). This does not compare favorably with the published value of working potential for aluminum anodes (see table 1). Anode working potential at low current density appeared stable, even though not very electronegative. As current was increased during the test, the working potential of the anode became unstable, indicating a tendency to passivate. This can be seen in figure 3 by the broad range of potentials recorded at a given current density. By the time the practical current density of 1.0 mA/ft<sup>2</sup> (10 mA/m<sup>2</sup>) had been reached, the anode potential was ranging freely from -0.52 to -0.72 V versus SCE. The anode potential appeared to remain stable for up to 2 hours, but would then exhibit erratic passive behavior. Pure aluminum is clearly an unacceptable candidate as an anode in contact with hydrogel adhesive.

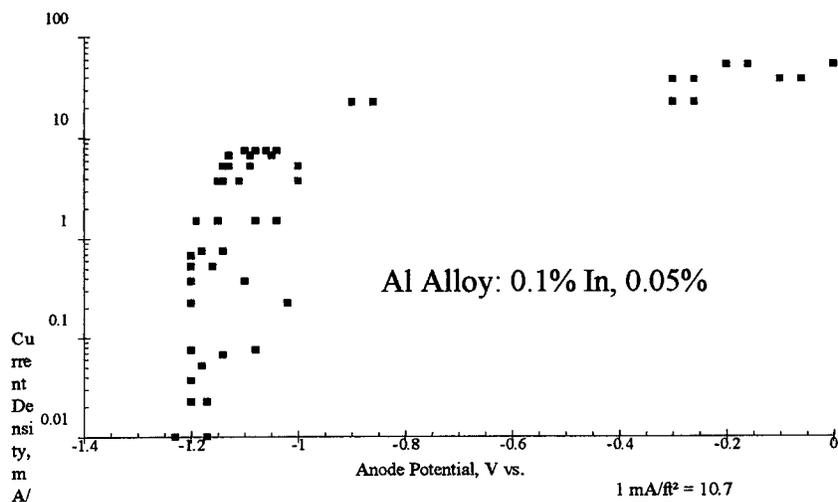
Figure 4. Polarization data for 0.1 percent indium, 0.05 percent gallium-aluminum alloy/RG-63B hydrogel composite.

The polarization data for an aluminum alloy containing 0.1 percent indium and 0.05 percent gallium are shown in figure 4. The working potential of the anode is very favorable, about -1.20 V versus SCE at low current densities. The very negative potential of this anode would result in a maximum amount of delivery of protective current. But the anode potential is also unstable, varying as much as 200 mV during the 20-minute current step. This instability is likely to become even more pronounced over longer periods of time. This is characteristic of passive behavior, and this alloy is therefore regarded as unsuitable for this application.

Other aluminum alloys tested showed different behavior, depending on the alloying elements and the fabrication practice used. Two examples are shown in figures 4 and 5; the polarization behavior of other aluminum alloys tested is presented in the Interim Report.<sup>(6)</sup>

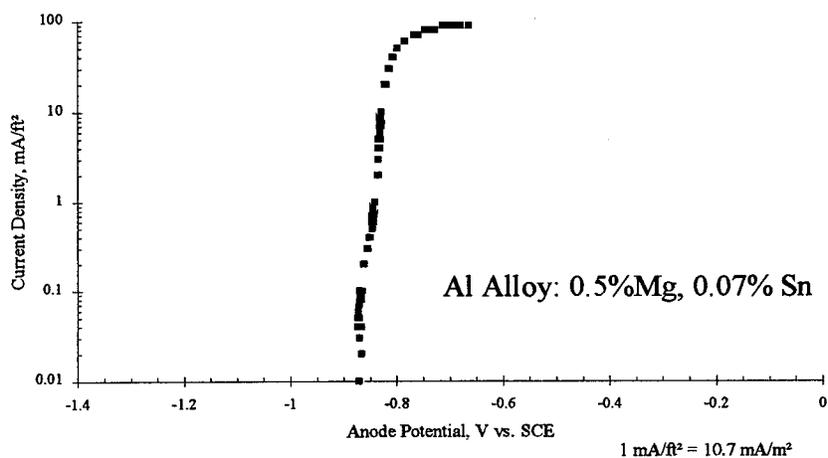
Figure 5. Polarization data for 0.5 percent magnesium, 0.07 percent tin-aluminum alloy/RG-63B hydrogel composite.

Figure 5 shows polarization data for an aluminum alloy that exhibits no tendency to passivate when used as an anode in contact with hydrogel adhesive. Anode working potentials remained stable at all levels of current tested. Unfortunately, anode potentials were not favorable, beginning at -0.87 V at low current and diminishing to -0.82 V at a current density of 1.0 mA/ft<sup>2</sup> (10 mA/m<sup>2</sup>). This alloy was also determined to be unacceptable for this application.

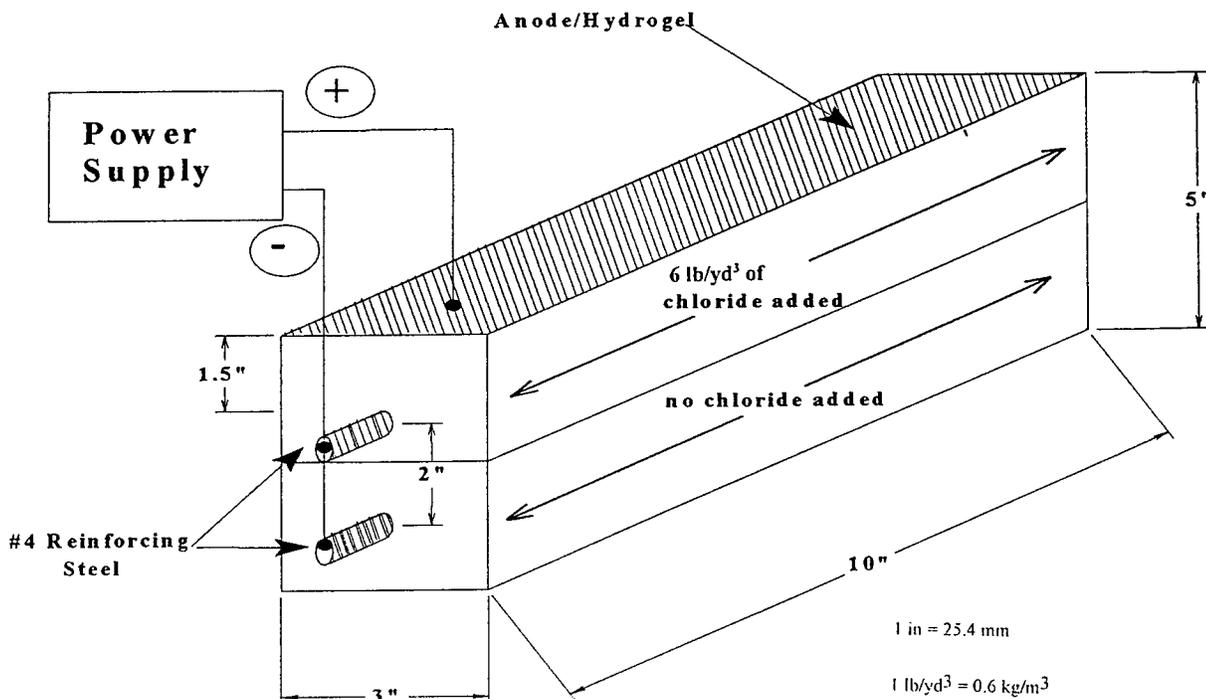
Figure 6. Specimen used for accelerated testing of hydrogel adhesives.

Two types of tests were conducted for the purpose of screening hydrogel adhesives: a galvanic test and an accelerated impressed current test. The specimens for both of these tests were constructed in the same way. The design used for the accelerated impressed current test is shown in figure 6. Concrete blocks 10 in long x 3 in wide x 5 in deep (25.4 cm x 7.6 cm x 12.7 cm) were prepared. The blocks contained two bars of #4 (1.27 cm dia.) reinforcing steel. Concrete was cast in two layers, with the top layer containing 6 lb/yd<sup>3</sup> (3.5 kg/m<sup>3</sup>) (0.16 percent by weight of concrete) of admixed chloride ion, and the bottom layer containing no chloride addition. The chloride-contaminated layer surrounded the top bar of reinforcement. The sides of the blocks were coated with a non-conductive urethane sealant to prevent transport of moisture laterally. The zinc/hydrogel composite was typically placed on the top face of the concrete, which was prepared by light sandblasting. The perimeter of the composite was sealed with urethane caulking to prevent the hydrogel from exchanging water with the atmosphere.

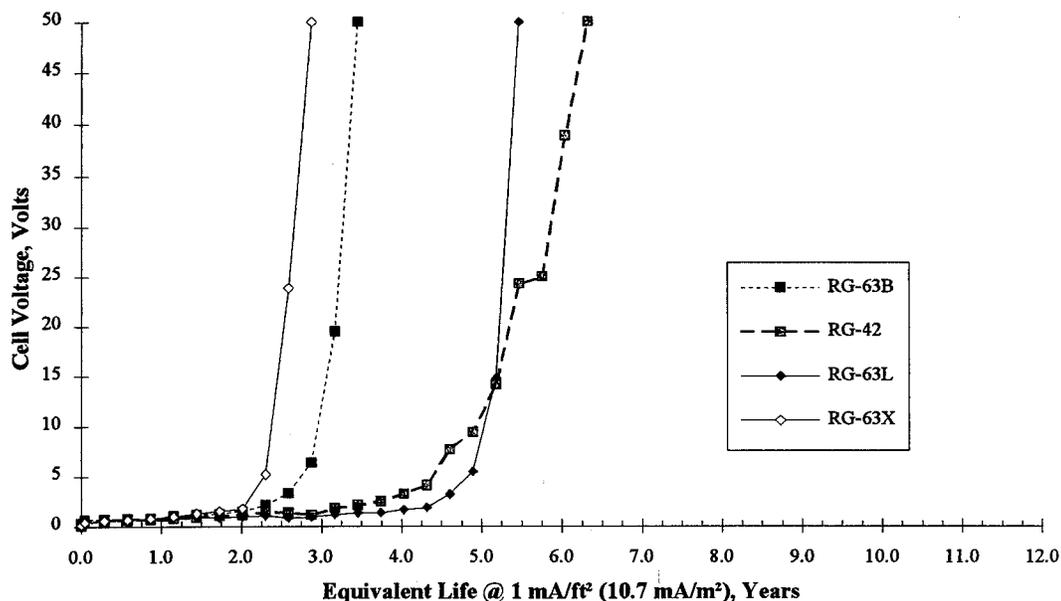
Figure 7. Cell voltage versus equivalent life for medical hydrogel adhesives.

Cell voltage was monitored during the accelerated test at a current density of 15 mA/ft<sup>2</sup> (160.5 mA/m<sup>2</sup>), and voltage was plotted versus equivalent life for a system operated at 1.0 mA/ft<sup>2</sup> (10.7 mA/m<sup>2</sup>). A graph of the data for a few representative samples of medical hydrogels is shown in figure 7. This is a useful depiction since it shows the expected lifetime of the hydrogel in field application.

The goal for the life of the hydrogel was set at 87.6 A-hr/ft<sup>2</sup> (943 A-hr/m<sup>2</sup>), which represents the total charge of a CP system operating at 1.0 mA/ft<sup>2</sup> (10.7 mA/m<sup>2</sup>) for a period of 10 years. To achieve this charge would take an operating period of 243 days in the accelerated test. As seen by the data presented in table 6, the best medical hydrogel RG-42 was able to achieve only slightly more than 60 percent of this goal. It was clear that the hydrogel adhesives developed for medical applications were not adequate for use in CP systems.

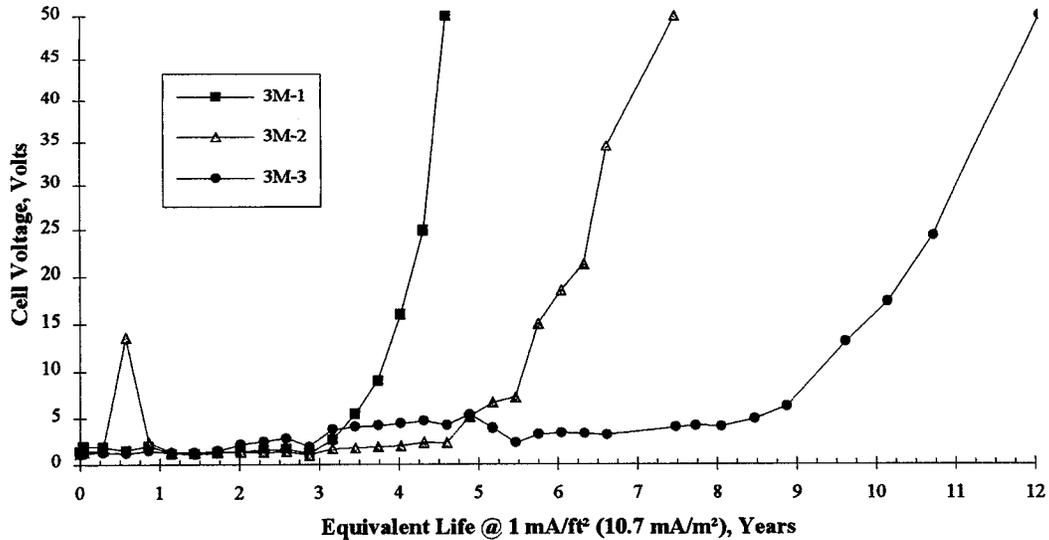
Figure 8. Cell voltage versus equivalent life for CP hydrogel adhesives.

Cell voltage was monitored during these tests, and a graph of voltage versus equivalent life is presented in figure 8.

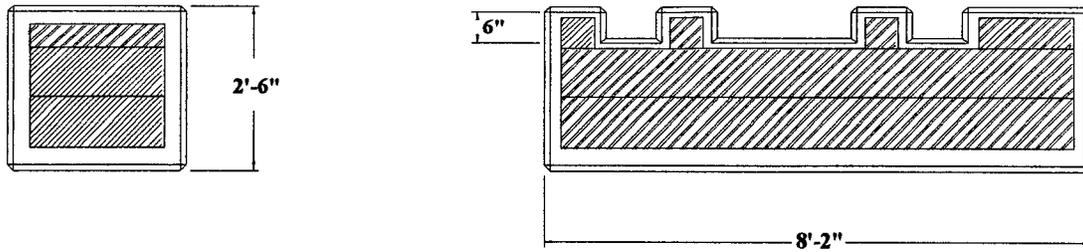
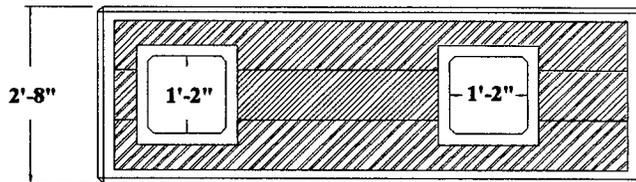
Figure 13. Layout of zinc/hydrogel on pile cap of bent #5.

**Cap of Bent #5W**

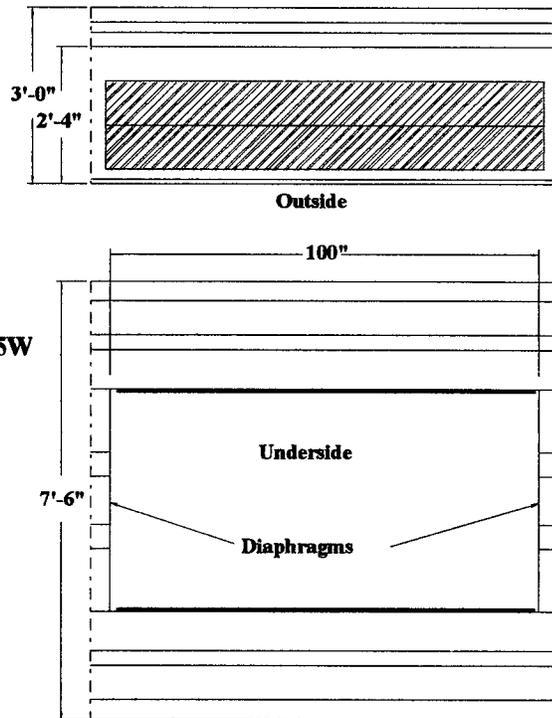
Figure 14. Layout of zinc/hydrogel on beams #4 and #5.

**35' Double-Tee Beam for Spans #4W and #5W**

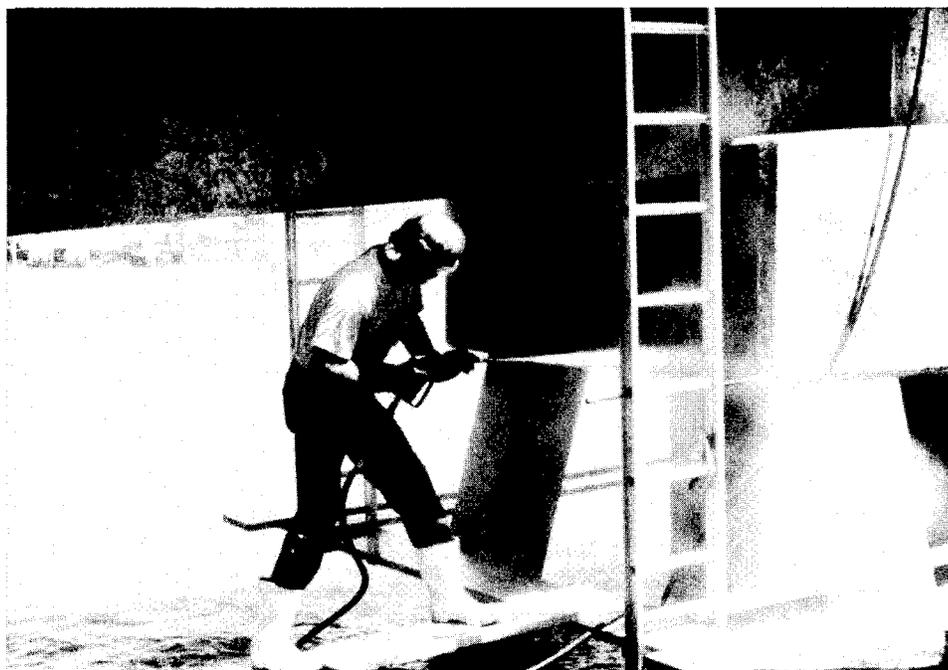
Figure 15. Cleaning of concrete surface prior to installation of zinc/hydrogel.

The first step for the anode installation was to clean all surfaces scheduled to receive cathodic protection. Barnacles and other marine growth were physically scraped from the pilings. All surfaces were then cleaned by water/steam-blasting with hot water at 5000 lbf/in<sup>2</sup> (34.5 MPa) and 225 °F (107 °C). Hot water flow rate was 5.5 gal/min (20.8 L/min). Cleaning of bent #2 pilings and pile cap is shown in figure 15.

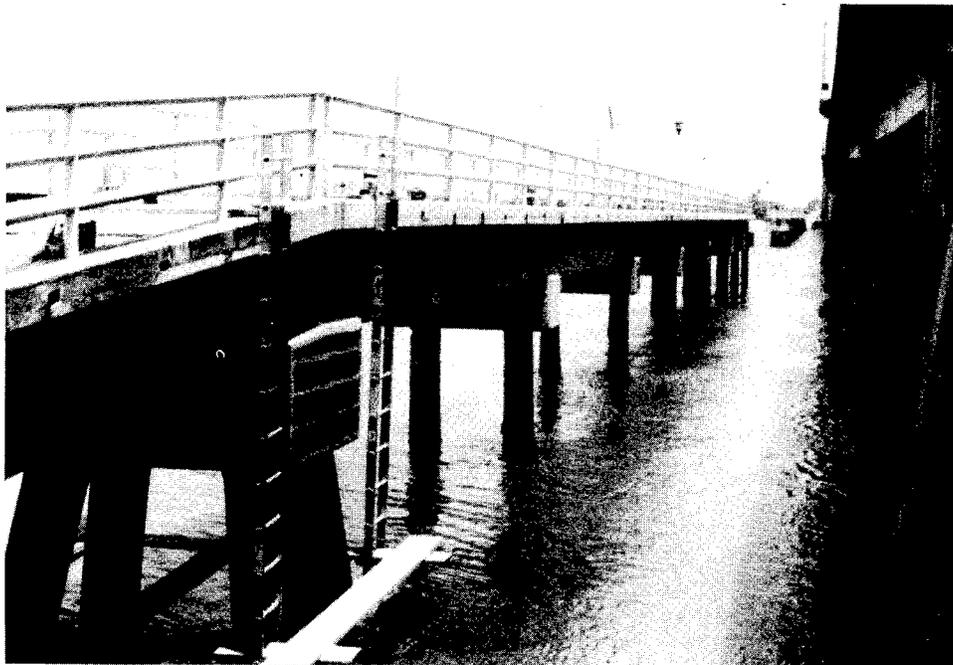
Figure 16. Zinc/hydrogel installed on bent #2 pile cap prior to painting.

The edges of each zinc strip were then sealed with polyurethane caulking using a pneumatic caulking gun. The zinc was cleaned of caulking, hydrogel, and other contaminants by rubbing with isopropyl alcohol, and the entire member was painted with gray XL-70 Bridgecote solvent-based paint. Figures 16 and 17 show the installed zinc/hydrogel system on bent #2 before and after painting.

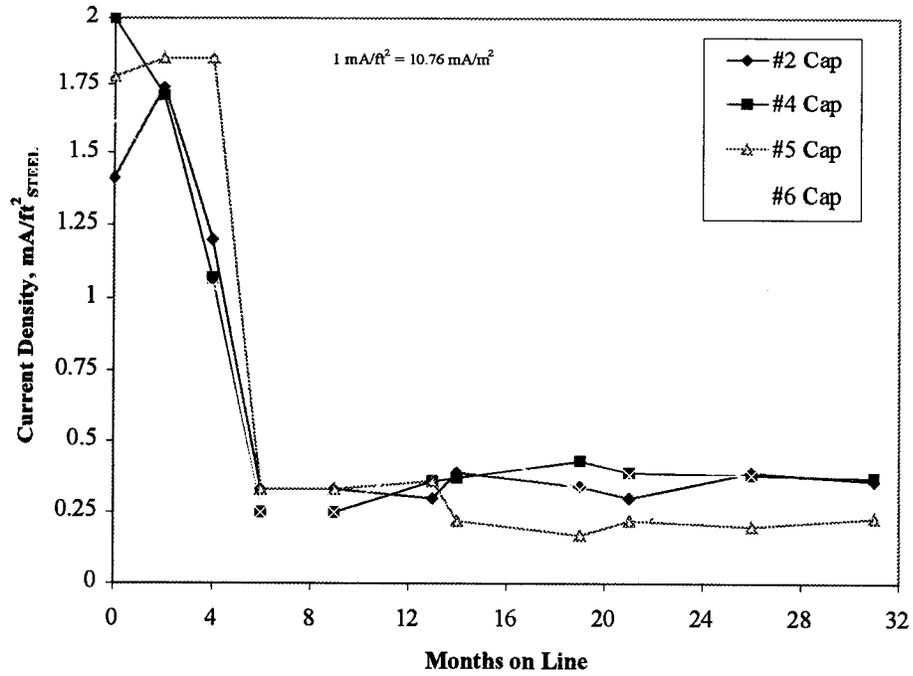
Figure 18. Galvanic current to the pile caps at Ft. Pierce.

Figure 18 shows galvanic current flow to the pile caps for the monitoring period of 31 months. Current density on the caps was high at start-up, and slowly decreased over the first 6 months of operation to about 0.3 mA/ft<sup>2</sup> of steel, which was maintained over the balance of the monitoring period.

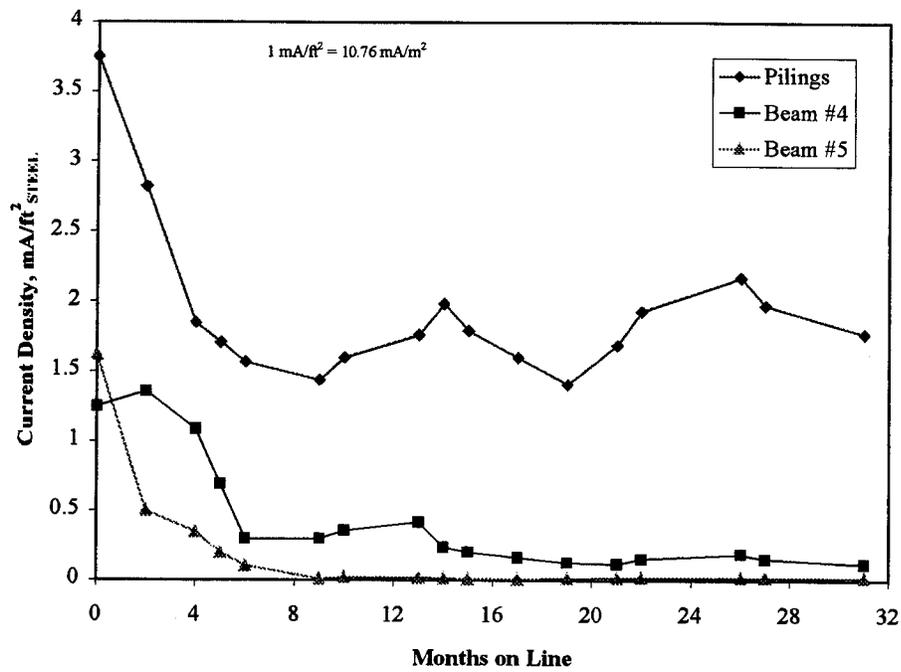
Figure 19. Galvanic current to the pilings and beams at Ft. Pierce.

Figure 19 shows galvanic current flow to the pilings and the beams. Current density on the pilings was also high at start-up, decreasing slightly over the first few months of operation. But current equilibrated at a relatively high level on the pilings, probably as a result of frequent wetting and higher conductivity. Current density on the pilings averaged about 1.7 mA/ft<sup>2</sup> of steel, higher than necessary to meet CP criteria. Current density on the beams also started out at a high level, but quickly declined to very low values. Current density on beam #4 declined to about 0.15 mA/ft<sup>2</sup> of steel, whereas the current density on beam #5 declined to nearly zero after only 9 months. These low currents were attributed in part to low moisture content and low conductivity, a result of sheltered location and distance above the water. It was also discovered that a loss of electrical continuity had occurred, causing most of the CP system on beam #5 to become inoperative. One attempt to restore continuity on beam #5 was unsuccessful.

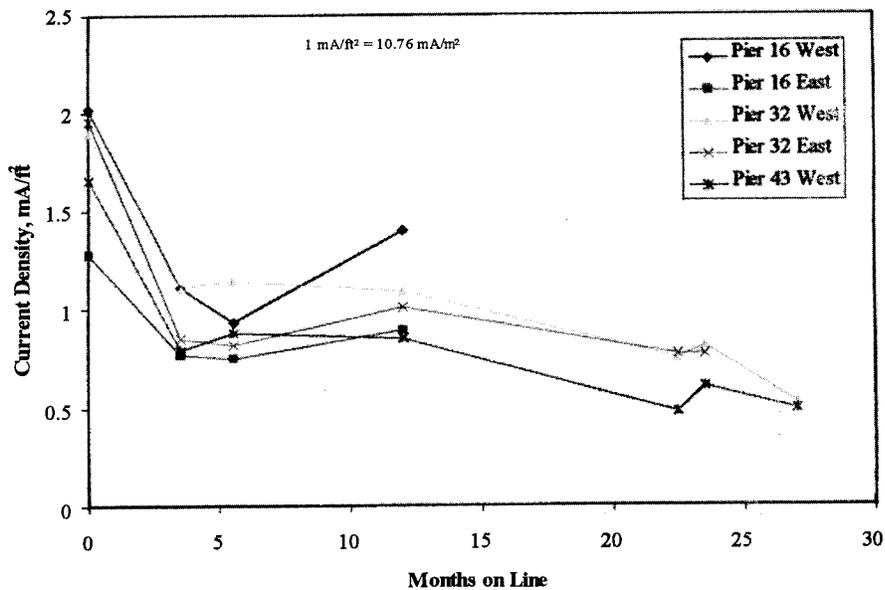
Figure 21. Galvanic current to the V-piers at Long Key.

Installation of zinc/hydrogel on the V-piers of the Long Key Bridge was completed early in 1996, and the CP system was energized on February 28, 1996. Figure 21 shows the galvanic current flow provided by the zinc/hydrogel on five V-piers over a monitoring period of up to

27 months. As at Ft. Pierce, the galvanic current started high and then slowly decreased to about 0.5 to 0.8 mA/ft<sup>2</sup> (5.4 to 8.6 mA/m<sup>2</sup>). The results of potential decay tests taken during the monitoring period are shown in table 13. As shown by the table, potential decay was good at Long Key, rarely dropping below the 100 mV potential decay criterion.

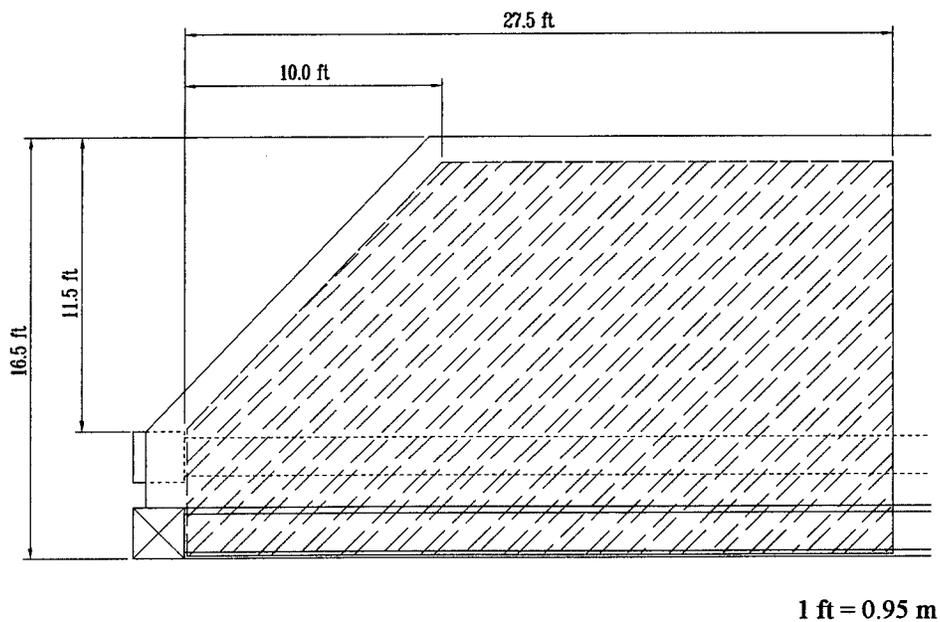
Figure 22. Plan view of the zinc/hydrogel zone at Cape Perpetua.

A plan view of the portion of the half-viaduct where zinc/hydrogel was installed is shown in figure 22, and figure 23 shows a strip of zinc/hydrogel being installed on the curb soffit. The zinc/hydrogel anode was connected through a resistor of known value to the reinforcing steel to permit testing of polarization development/decay. Two reference electrodes, one silver-silver chloride and one graphite, were permanently installed in the zinc/hydrogel zone to facilitate potential decay testing. The galvanic current provided by the anode was passed through a resistor to allow measurement of the protective current provided to the steel, and a battery powered RMU was installed to monitor the flow of current and reference electrode potentials.

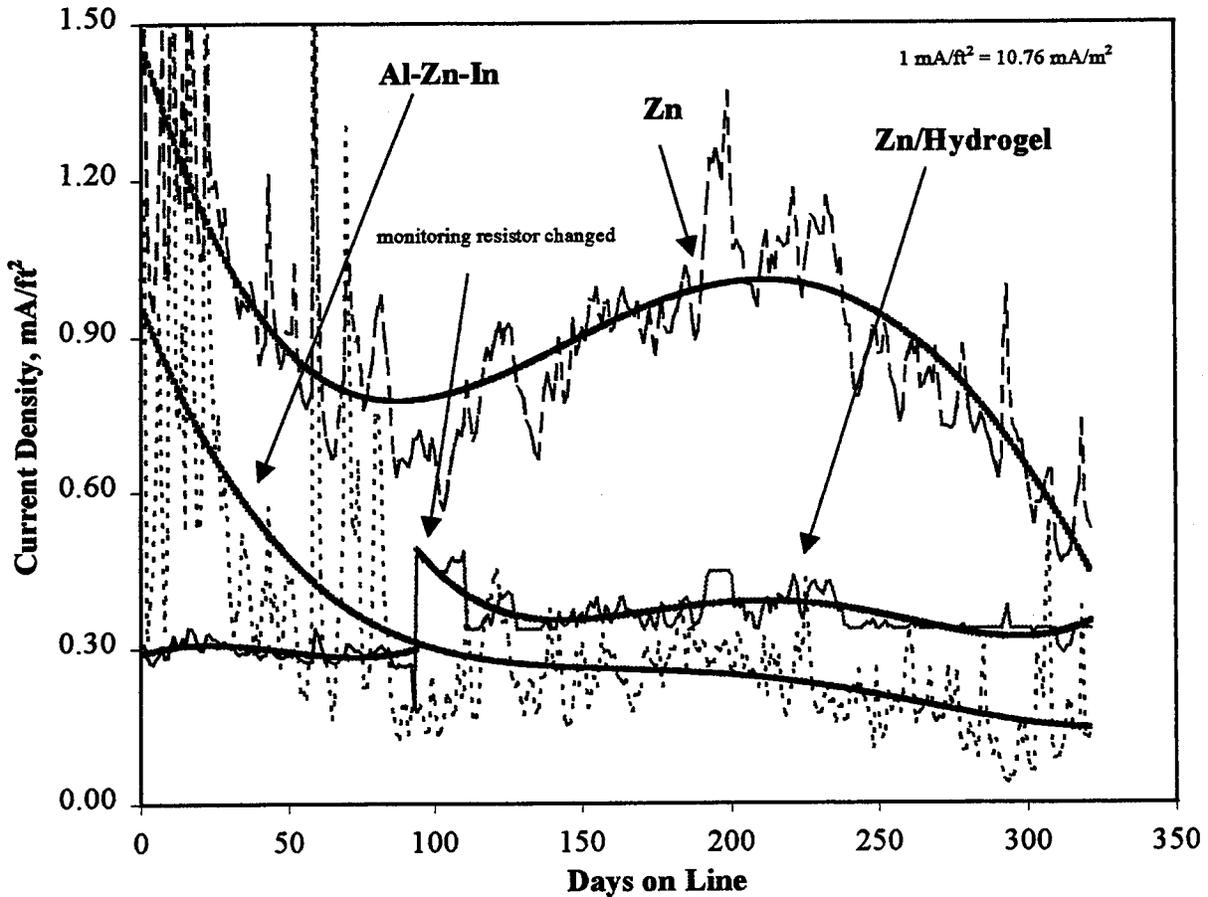
Figure 24. Galvanic current provided by three CP systems at Cape Perpetua.

All three CP systems at Cape Perpetua were energized on January 1, 1998. The flow of galvanic current for the three anode systems is shown in figure 24. Fourth-order polynomial trendlines have been added to provide a smooth representation of the data. Current for all three anodes was initially gauged by measuring the voltage drop across a 0.75-ohm resistor. But this procedure was inappropriate for the zinc/hydrogel zone, where current was being measured on the entire 648 ft<sup>2</sup> (61 m<sup>2</sup>) rather than a small test window. In that case the resistance of the circuit was less than 2.0 Ω and the 0.75-Ω resistor presented too great an impediment to current

flow. This was recognized, and the measuring resistor was changed to  $0.01 \Omega$  in early April 1998. This change is recognized by an increase in current flow shown in figure 24. The flow of current at Cape Perpetua appeared to decline less from start-up than that at Ft. Pierce, and was more influenced by seasonal change. It is also interesting to note that the highest galvanic current at Cape Perpetua was provided by the metallized zinc anode, followed by zinc/hydrogel, and the lowest current was provided by the aluminum alloy anode.
