## **EVALUATION OF CAB CAR CRASHWORTHINESS DESIGN MODIFICATIONS**

### **ABSTRACT**

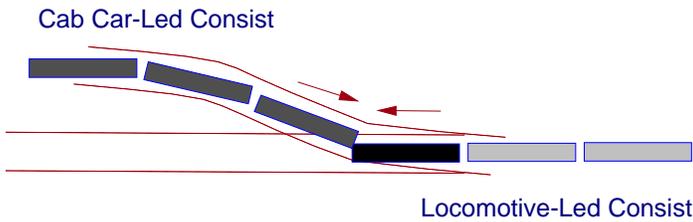
In February of 1996, two unrelated passenger train collisions occurred. In each collision, a cab car and a locomotive were the impacting cars. The initial impact occurred while one of the lead cars was traversing a switch, resulting in an angle between the cars, as well as a lateral misalignment. In both collisions, there was substantial crushing of occupant volume in the cab cars. The main load-bearing structural members of the cab cars (collision posts, draft sill, center sill) were not directly loaded during the collisions. Rather, weaker end members (end beam, side sill) were loaded directly, and failed. Figure 1 schematically depicts the initial conditions of an oblique collision.

**Figure 1: Schematic of an Oblique, Cab Car-to-Locomotive Collision.**

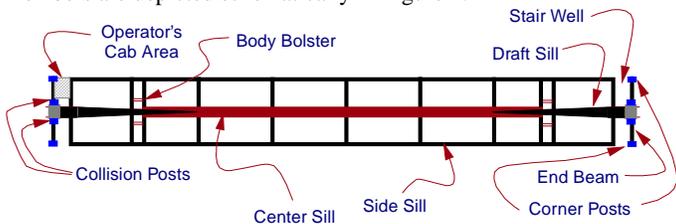
The typical North American passenger cab car structure consists of an underframe, an end structure and a body shell. The underframe consists of four longitudinal members: the center sill, draft sill and two side sills, and two body bolsters, which laterally connect the center sill, draft sill, and two side sills. The end structure consists of an end beam (or buffer wing), two vertical collision posts and two vertical corner posts. The structural members with the largest cross-sectional areas are the center sill, the draft sill, and the body bolster. The main cab car structural members are depicted schematically in Figure 2.

**Figure 2: Schematic of Typical Cab Car Structural Members, Top View.**

During a collision, the vertical members act to transfer loads to the underframe, particularly in the event of vertical misalignment or override between colliding cars. The addition of a second vertical member immediately aft of the stair well – a door post – may provide additional protection to the cab car passengers in an oblique collision in the event of vertical misalignment with a colliding vehicle. The body

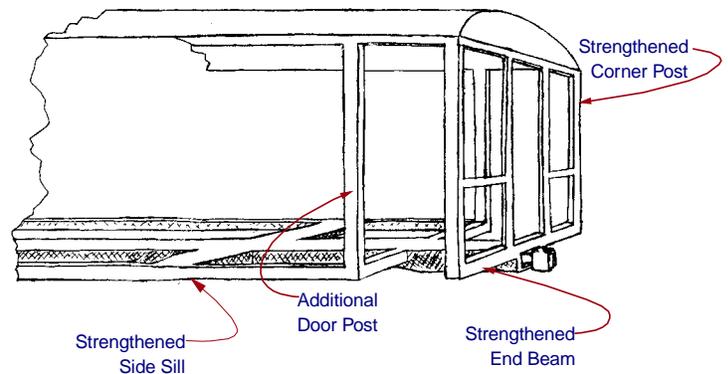
shell acts to stabilize the end structure and underframe members during a collision. Figure 3 illustrates the structural modifications considered.

**Figure 3: Sketch of Cab Car Structural Modifications.**

Increased strength over existing member design was achieved principally by increased cross-sectional area. Modifications were generally made to the various components by replacing them with similar sections or rectangular tubes whose section moduli and/or cross-sectional area were greater than that of the existing component. In general, closed sections whose outer dimensions required little additional space over the existing component designs were selected. In some cases, higher component strength was accomplished by increasing only wall thickness. Table 1 lists the modifications considered. Two potential modifications were considered for both the door post and the side sill to better estimate the relationship between increases in strength, cost and weight.

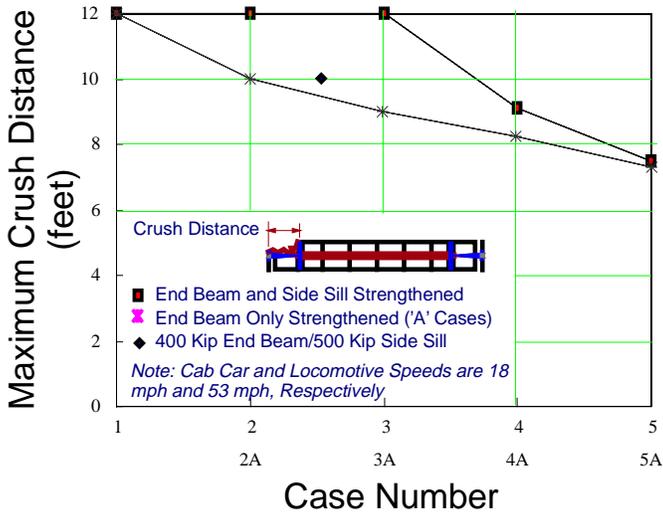
Figure 6 shows a plot of crush distance as a function of end structure strength, with the cab car initially traveling 18 mph and the locomotive initially traveling 53 mph in the opposite direction. The crush distance is the reduction in length along the impacted side of the cab car.

Figure 6: Influence of Cab Car Strength on Cab Car Crush.

The results in Figure 6 for the cases in which only the end beam is strengthened indicate that increasing the force required to crush the end beam increases the deflection of the vehicles out of each other's way. This deflection acts to reduce the crush of the cab car. In contrast, the increased side sill strength tends to increase the engagement of the vehicles, thus maintaining the 12 feet of cab car crush, until the end beam is strengthened by a factor greater than 3.

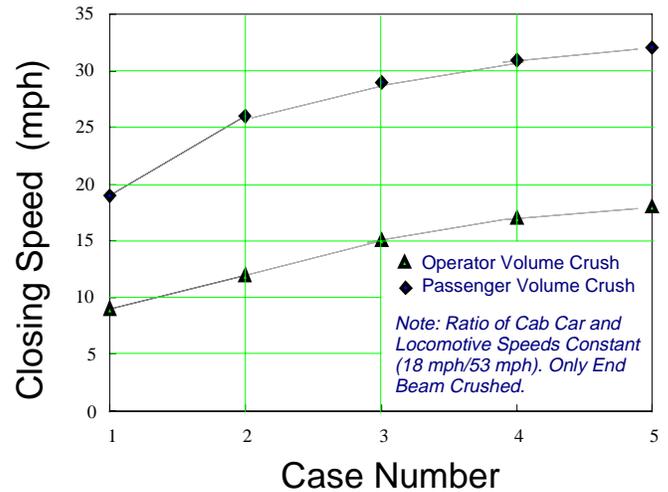
Figure 7 plots the maximum safe closing speed for operators and passengers, assuming that crush greater than 1 foot would reduce the operator's cab volume beyond the survivable limit, and that crush greater than 3 feet would begin reducing the passenger volume beyond the survivable limit for passengers seated near the operator's cab. The maximum closing speed in which the operator may be expected to survive is approximately 17 mph for Cases 5 and 5A and 9 mph for the baseline design (Case 1). The maximum closing speed in which all passengers may be expected to survive is approximately 32 mph for Cases 5 and 5A, with the end beam strengthened by a factor of five greater than the baseline, and 19 mph for the baseline case. Side sill strength does not influence the results depicted in Figure 7, as the side sill is not loaded for these closing speeds.

Figure 7: Influence of Closing Speed on Maximum Cab Car Crush.

The relatively modest decrease in cab car crush (factor of two or less from baseline) for relatively large increases in end structure strength (factors up to 5 from baseline) is principally due to the kinematics of the collision. To a large degree the motion of the locomotive is unaffected by increases in cab car end strength. The locomotive lateral and yaw motions do increase favorably with increased cab car end structure strength, but this increase is modest. Motions of the cab car are influenced by its end-structure strength, however, these influences are not sufficient to allow the crush to decrease substantially.

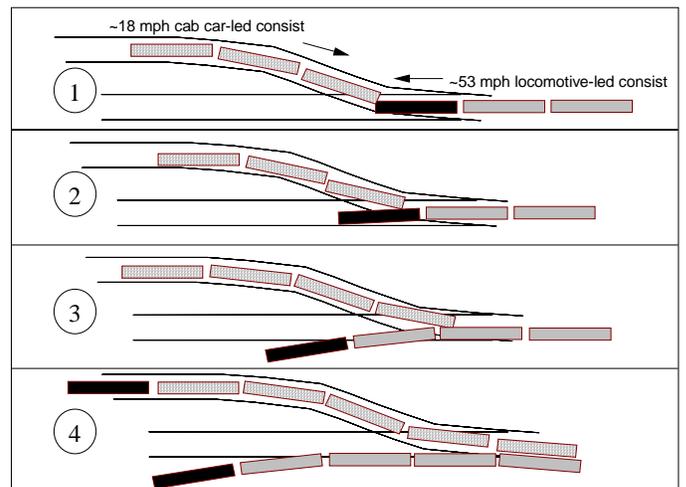
1.) The cab car was traveling at approximately 18 mph when it struck the front, right corner of the locomotive, which was traveling at approximately 53 mph in the opposite direction. Based on the track geometry, the angle between the two vehicles at the instant of impact was approximately 7°. The corner post on the right side of the cab car struck the right side of the locomotive. Both collision posts on the cab car remained in place, though the right post incurred some structural damage. The right corner post was torn away from the cab car. The roof plate from the right side of the cab car broke away and penetrated the window of the locomotive.

2.) The cab car raked down the side of the locomotive. The left rail (field side) under the locomotive rolled over and the locomotive derailed.

3.) The derailed locomotive pulled the trailing cars off the track. The cab car continued to rake the cars trailing the locomotive, damaging stair wells and radius rods as it went.

4.) Most cars in the locomotive-led consist derailed (the last car may have stayed on the track). Only the cab car derailed in the cab car-led consist. The cab car-led consist was stopped by the collision at the switch. The locomotive-led consist slid to a stop on the ties and ballast.

Figure 10: Schematic of February 9, 1996, Secaucus, New Jersey, Cab Car/Locomotive Collision

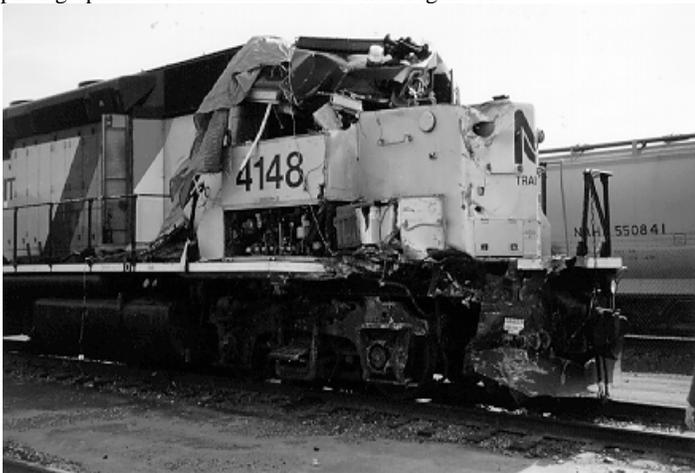
The roof plate of the cab car penetrated the operator's window of the locomotive. Damage to the hood of the locomotive appeared to be due to the roof plate riding up on the hood and through the window. Some superstructure damage to the front of the locomotive, approximately halfway between the coupler and the side of the locomotive, appeared to have been caused by the front of the cab car. The center sill and main structure of the locomotive remained essentially intact. A post-collision photograph of the locomotive is shown in Figure 11.

**Figure 11: Lead Locomotive, NJT Train.**

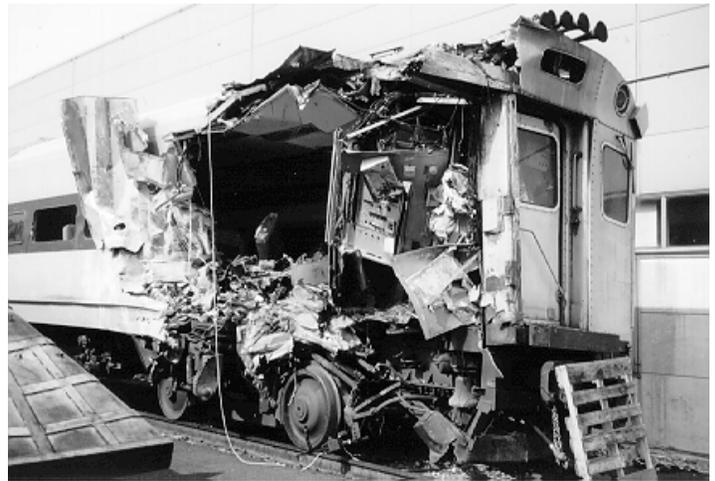
Damage to the lead cab car includes crushing of the right, front corner of the car from the end of the car to the body bolster. This area includes the operator's compartment and approximately five rows of seats. The right (track-side) collision post incurred substantial damage: there are several large cracks in and around the attachment point. This damage may have occurred when the end of the transverse floor member was torn off in the initial collision with the locomotive. The collision post itself may not have been loaded directly. The corner post and a portion of the roof plate were separated from the cab car. A post-collision photograph of the cab car is shown in Figure 12.

**Figure 12: Lead Cab Car, NJT Commuter Train.**

Substantial damage was also incurred by the seats across the aisle from the crushed seats, due to debris from the collision and damage to the floor. In all, approximately 25 seat positions were destroyed during the collision. The remaining seats -- those not directly crushed by the collision -- appeared to be essentially intact. Approximately two seat-pairs were out of position, however, they may have been put out of position by rescue or cleanup personnel.

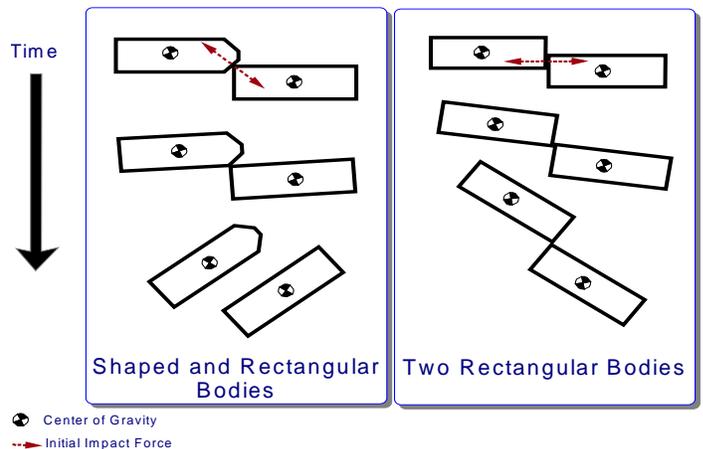
**Figure 13: Time-History Schematic of Oblique Collision of Two Rigid Bodies.**

The undeformed and deformed geometries of the carbody structures influence the direction of the forces, including the magnitude of the lateral force component, consequently influencing the gross motions of the colliding cars during a collision. Figure 13 illustrates the influence

of geometry on the results of an offset collision between two rigid bodies. For rectangular rigid bodies, the impact force causes both bodies to turn into each other (both bodies turn clockwise in the illustration). In a collision between a shaped body and a rectangular body, the bodies turn away from each other.

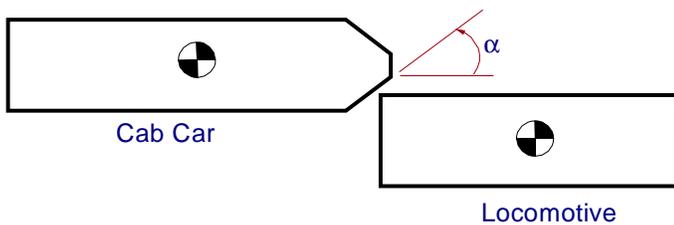
Figure 14 is a schematic of a shaped body (cab car) colliding with a rectangular body. The general plane motions of these bodies can be determined from rigid body mechanics, assuming a perfectly plastic collision and conservation of momentum. Table 6 lists the parameters of the rigid body model.

Figure 14: Model of Oblique Collision of Two Rigid Bodies.

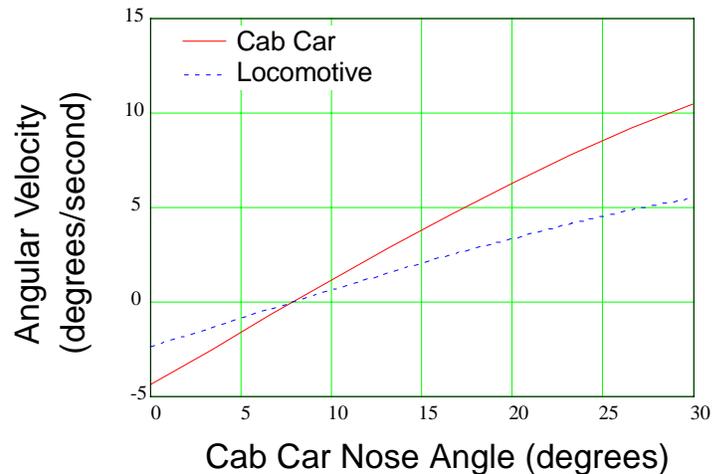
Figure 15 shows the influence of the cab car end structure geometry angle  $\alpha$  for a collision in which the locomotive is initially standing and the cab car is moving with a longitudinal velocity of 30 mph. The centers of gravity of the two cars are offset laterally by 10 feet. For cab car end structure angles less than approximately 8 degrees, the cars turn into each other, i.e., both cars turn clockwise, while for cab car end structure angles greater than 8 degrees, the cars turn away from each other, i.e., counterclockwise.

Figure 15: Influence of Cab Car Nose Angle on Cab Car and Locomotive Yaw Velocity, Rigid Body Model.

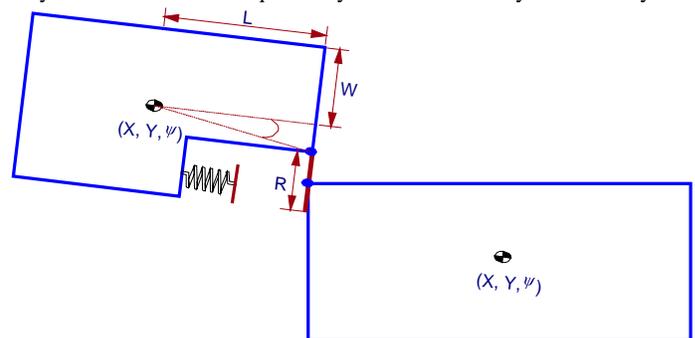
Figure 16 is a schematic of the oblique collision dynamics model. The model allows for the general plane motion of the cab car and the locomotive. The forces acting on the cars include the track forces and the forces due to crushing of the cab car end structure. The locomotive is assumed to be rigid relative to the cab car. Coupler forces are neglected. Due to the location and nature of the draft gear, the coupler cannot develop a significant yaw moment about the center of gravity of the car, and consequently does not significantly influence the gross motions of the impacting cars. In addition, there was minimal, if any, damage to the trailing draft gears of the locomotive or cab car and their associated coupled cars in the Secaucus collision. The lack of damage indicates that the coupler force levels were relatively low.

Figure 16: Schematic of Oblique Collision Dynamics Model.

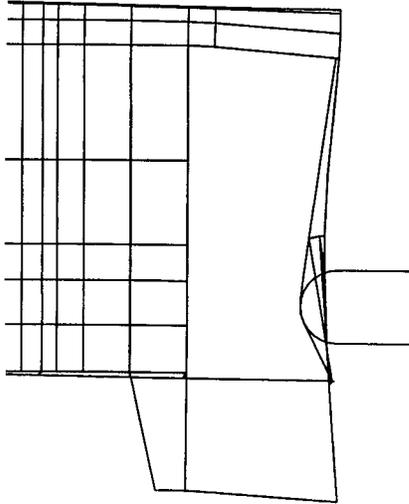
Force/crush characteristics for the end beam and the side sill were developed using a finite element mesh of the entire vehicle length, with the longitudinal midplane treated as a plane of symmetry (Mayville, et al, 1996). This means that the model of a collision or corner post load was a simulation of loading both collision or corner posts. The mesh

was constrained from displacement only at the bolster locations. The load was applied quasi-statically to the components through a simulated rigid, cylindrical body as illustrated in Figure 17. In the figure, the load shown is being applied to the corner post 18 inches above floor level, ahead of the end side door.

Figure 17: FEA Mesh with Load Applicator.

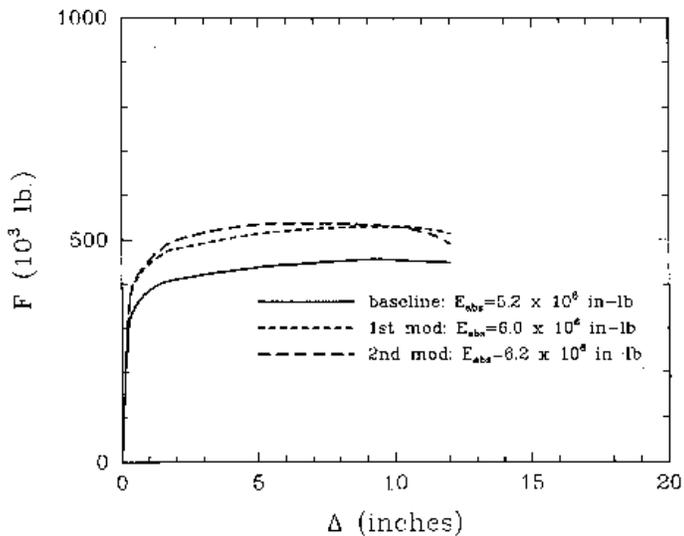
The force/crush characteristics for the side sill aft of the end door for the baseline and modified designs is shown in Figure 18. The side sill is loaded longitudinally, initially just aft of the end side door at floor level. For the baseline side sill, the yield strength calculated is approximately 240 kips, and the ultimate strength calculated is approximately 400 kips. For the modified designs, the yield strength is 300 kips and the ultimate strength is 500 kips. The nature of the force/crush characteristic is essentially the same for the baseline and modified side sill designs.

Figure 18: Modified and Baseline Side Sill Force-Crush Characteristics at Base of Door Post.

Current analysis results show that a load of approximately 400 kips is required to significantly crush the side sill (see Figure 18) ahead of the body bolster. The side sill cross-section is the same ahead and behind the body bolster, and consequently it is likely that it will crush at the same load aft of the body bolster as it does ahead of the body bolster. Aft of the body bolster, this load is principally carried by the center sill and two side sills, as shown in the free body diagram for the load applied at the draft stops in Figure 20. When a load of 800 kips is applied to the body bolster at the side wall of the car, the side sills and center sill are carrying loads near those required to cause significant crush.

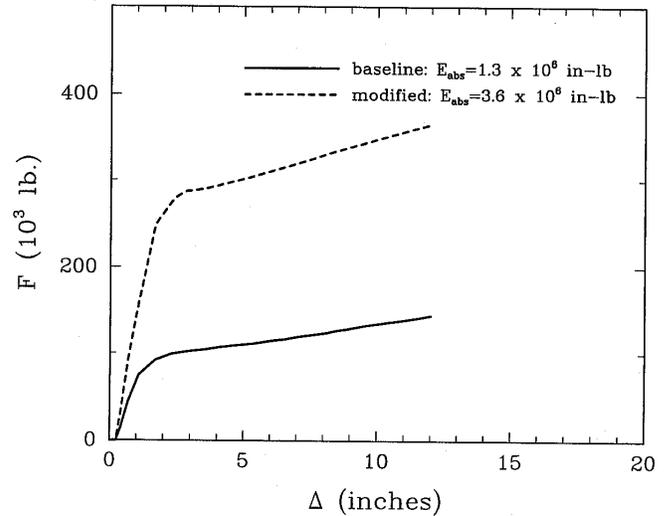
Figure 19 shows the force/crush characteristic for the end beam when loaded at its outboard edge, near the sidewall just ahead of the end side

door. For the baseline end beam design, the yield strength is approximately 110 kips, and the ultimate strength is approximately 150 kips. For the modified design, the yield strength is 300 kips, and the ultimate strength is 400 kips.

Figure 19: Modified and Baseline End Beam Force-Crush Characteristics at Base of Corner Post.

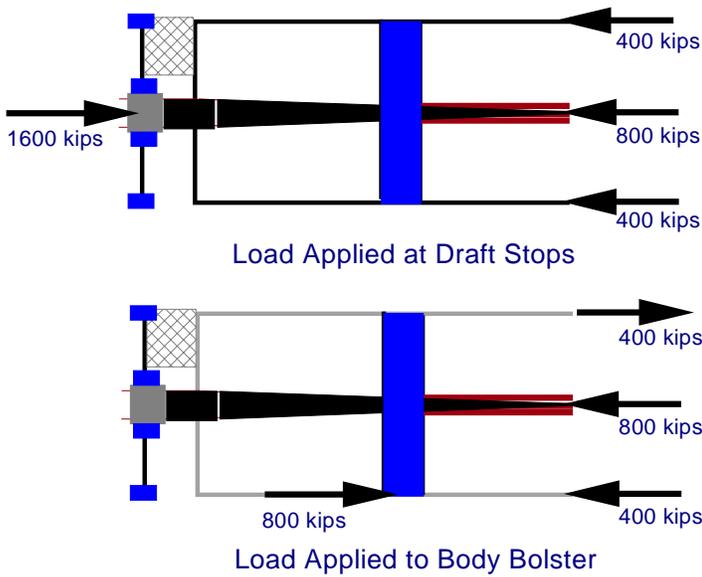
**Figure 20: Car Structure Free-Body Diagrams, Load Applied at Draft Stops and Load Applied at Body Bolster Near Car Sidewall.**

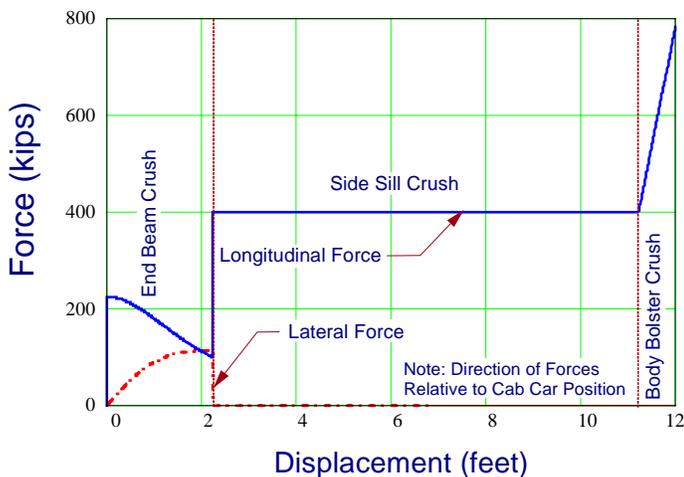
In the train collision mechanics model, the end beam, side sill, and body bolster are loaded sequentially. The end beam is assumed to behave like a rigid beam with the force/crush characteristic shown in Figure 19. A greater load, resulting in the same moment about the connection of the end beam to the draft sill, is required when the load is applied inboard from the sidewall of the car. The load transverse to the end beam is assumed to be small compared with the load normal to the beam. The load applied to the side sill and body bolster is assumed to act in the longitudinal direction of the car, i.e., the transverse loads supported by these members are assumed to be small compared with the longitudinal loads. Loads applied to the body bolster are assumed to increase linearly to 800 kips in 6 inches from the location of collapse of the side sill. The force crush characteristic for the baseline vehicle for a load applied near the sidewall of the car is shown in Figure 21.

**Figure 21: Baseline Cab Car End Structure Force**

**Displacement Characteristic.**

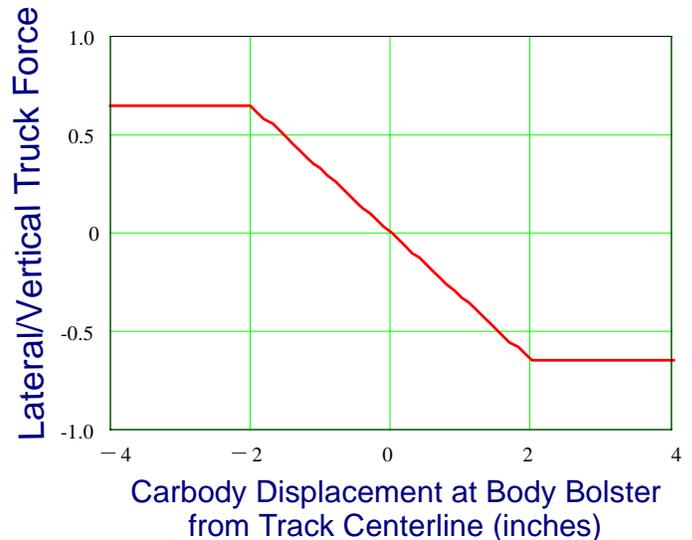
Figure 22 shows the lateral force acting on the carbody at body bolster as a function of body bolster displacement from track centerline. Such a force acts on both body bolsters. This force is assumed to be proportional to displacement, until the displacement has become sufficient to indicate derailment. Derailment is taken to occur at an L/V ratio of 0.6. Subsequent to derailment, the flanges of the wheels are presumed to plow the ballast. The L/V ratio is assumed to be 0.6 for the wheels laterally plowing the ballast.

**Figure 22: Lateral Force Acting on Carbody at Body Bolster.**

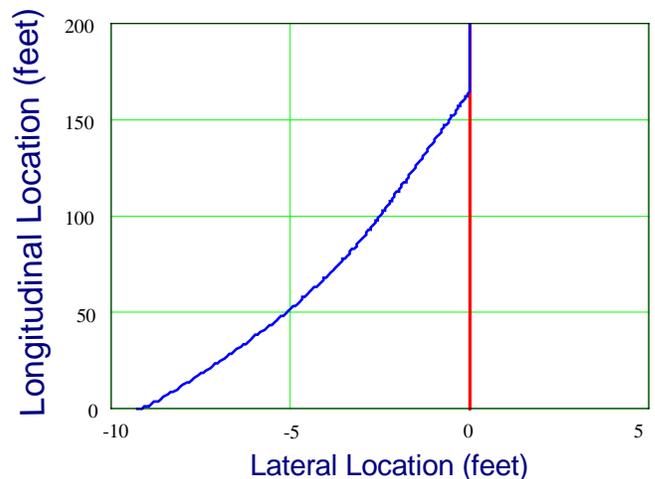
The track layout approximates an AREA No. 15 Turnout (Manual for Railway Engineering, 1972). This layout geometry is illustrated in Figure 23. The locomotive is positioned on the tangent track, while the cab car is positioned on the curved track.

**Figure 23: Track Layout Geometry.**
