Report No. FHWA-KS-02-6  
FINAL REPORT

## **ACCELERATED TESTING FOR STUDYING PAVEMENT DESIGN AND PERFORMANCE – FY 2000**

*Effectiveness of Fiber Reinforced and Plain, Ultra-Thin Concrete Overlays  
on Portland Cement Concrete Pavement (PCCP)*

Hani G. Melhem  
Roger Swart  
Sandy Walker  
Kansas State University

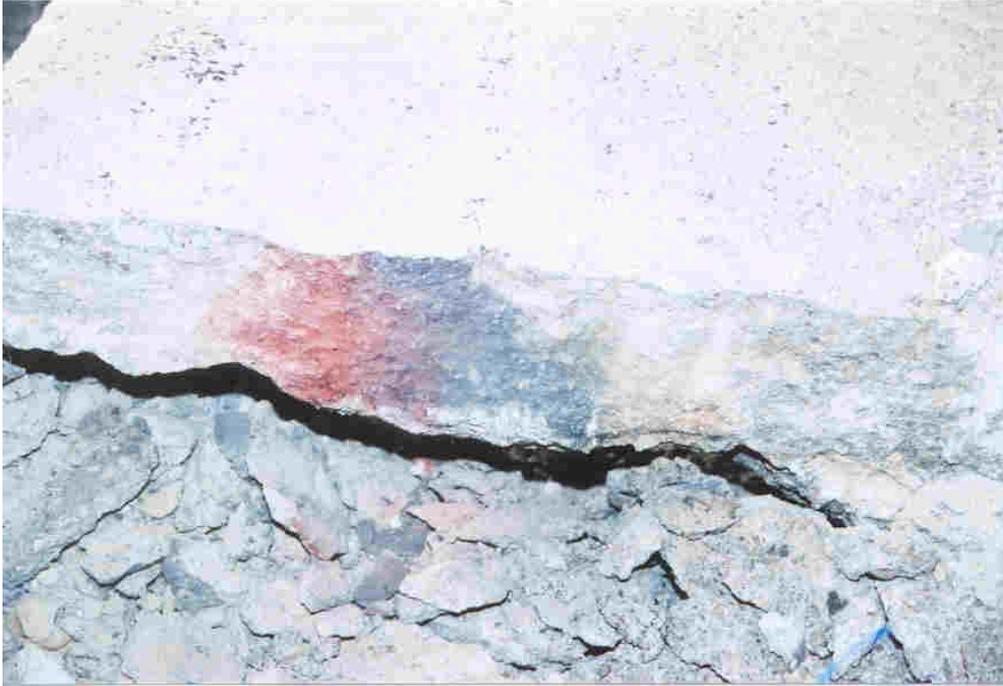
**FIGURE 4.5: Post-mortem investigation – crack depth in the plain PCC Overlay**

Dye was poured in the cracks to determine during the post-mortem analysis if their extended to the full-depth of the overlays, or they developed only at the surface of the overlays. Figures 4.5 and 4.6 clearly show, that the cracks extended on the entire depth for both the plain and fiber reinforced PCC overlays. These photographs were taken at the end of loading, when the pavements were destroyed and removed.
