Report No. FHWA-KS-02-7
FINAL REPORT

ACCELERATED TESTING FOR STUDYING PAVEMENT DESIGN AND PERFORMANCE (FY 2001)

*Evaluation of the Performance of Permeable and Semi-Permeable Unbound
Granular Bases under Portland Cement Concrete Pavement (PCCP) Slabs and
Alternate Load Transfer Devices for Joint Repair*

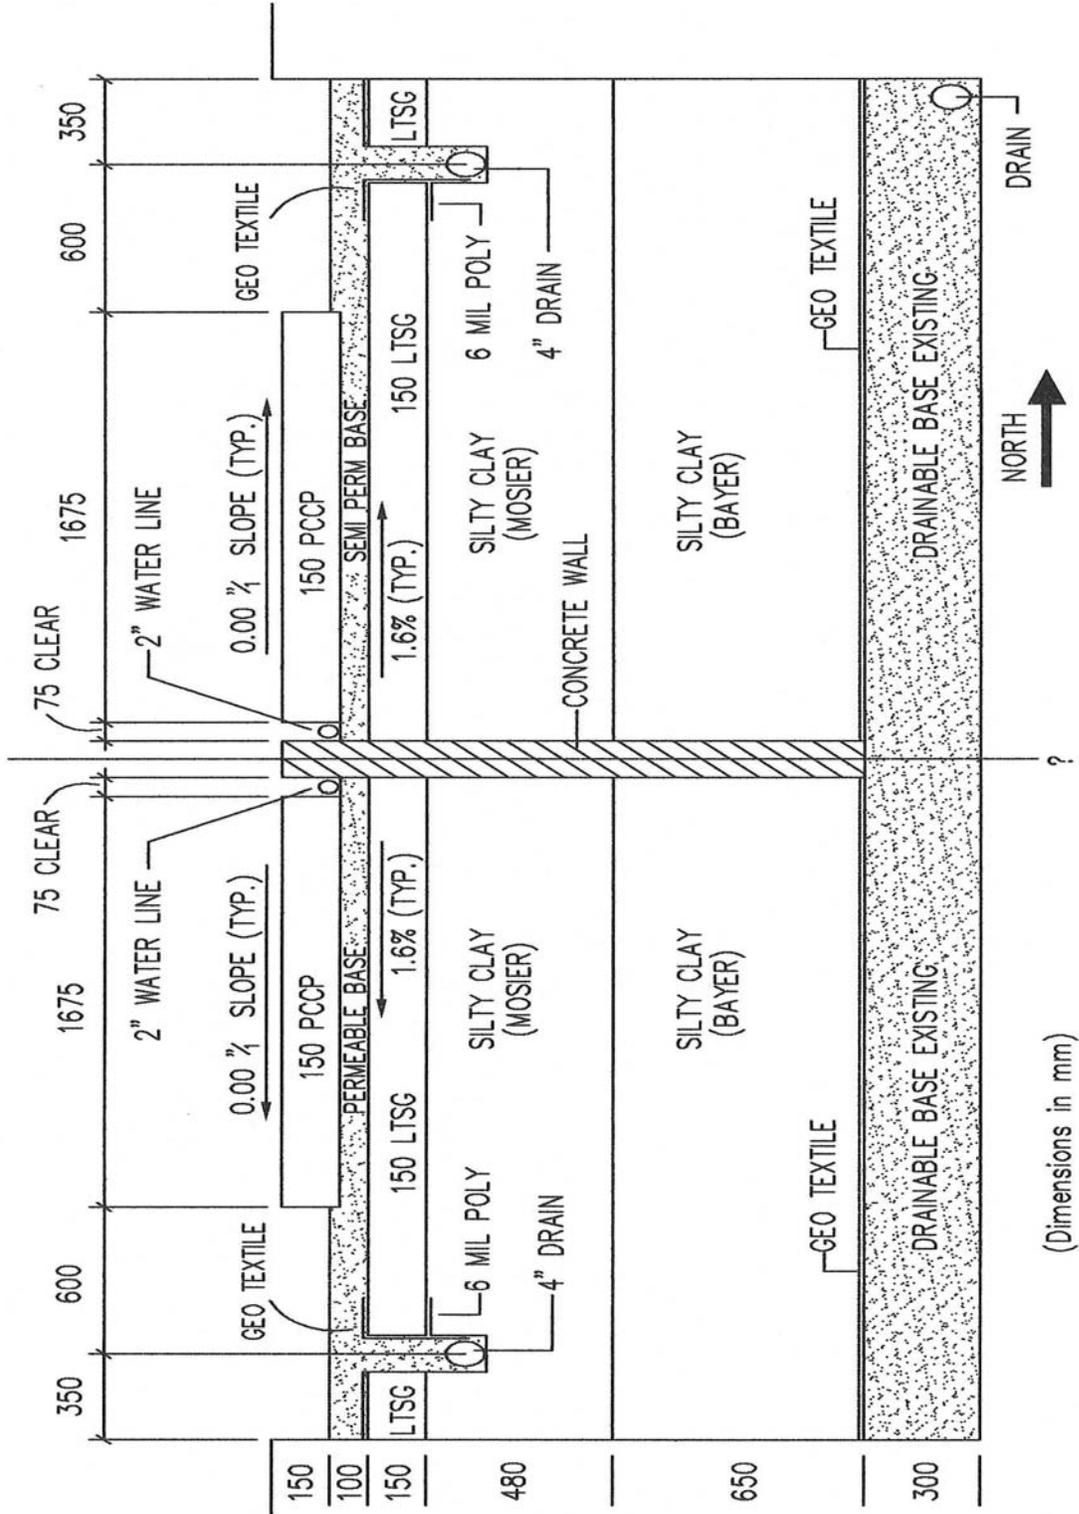
A wall was constructed at the centerline of the pit to separate the two pavements, so that water from one subgrade would not enter the other subgrade, as shown in Figure 3.1. This wall extends from the surface down to the top of the pea gravel, “the geotextile”, and is anchored to the end walls of the pit. The separation wall was made of 6-in. reinforced concrete and is dependent on the fill from either side for its stability. When the separation wall was built it was found that the pea gravel layer was full of water, apparently the result of gradual accumulation from previous tests. This water had saturated the lower portion of the subgrade. Therefore, it was necessary to remove the existing subgrade and dry it out before refilling the pit with the subgrade material from the previous tests.

FIGURE 3.1: Cross Section of the Test Pit

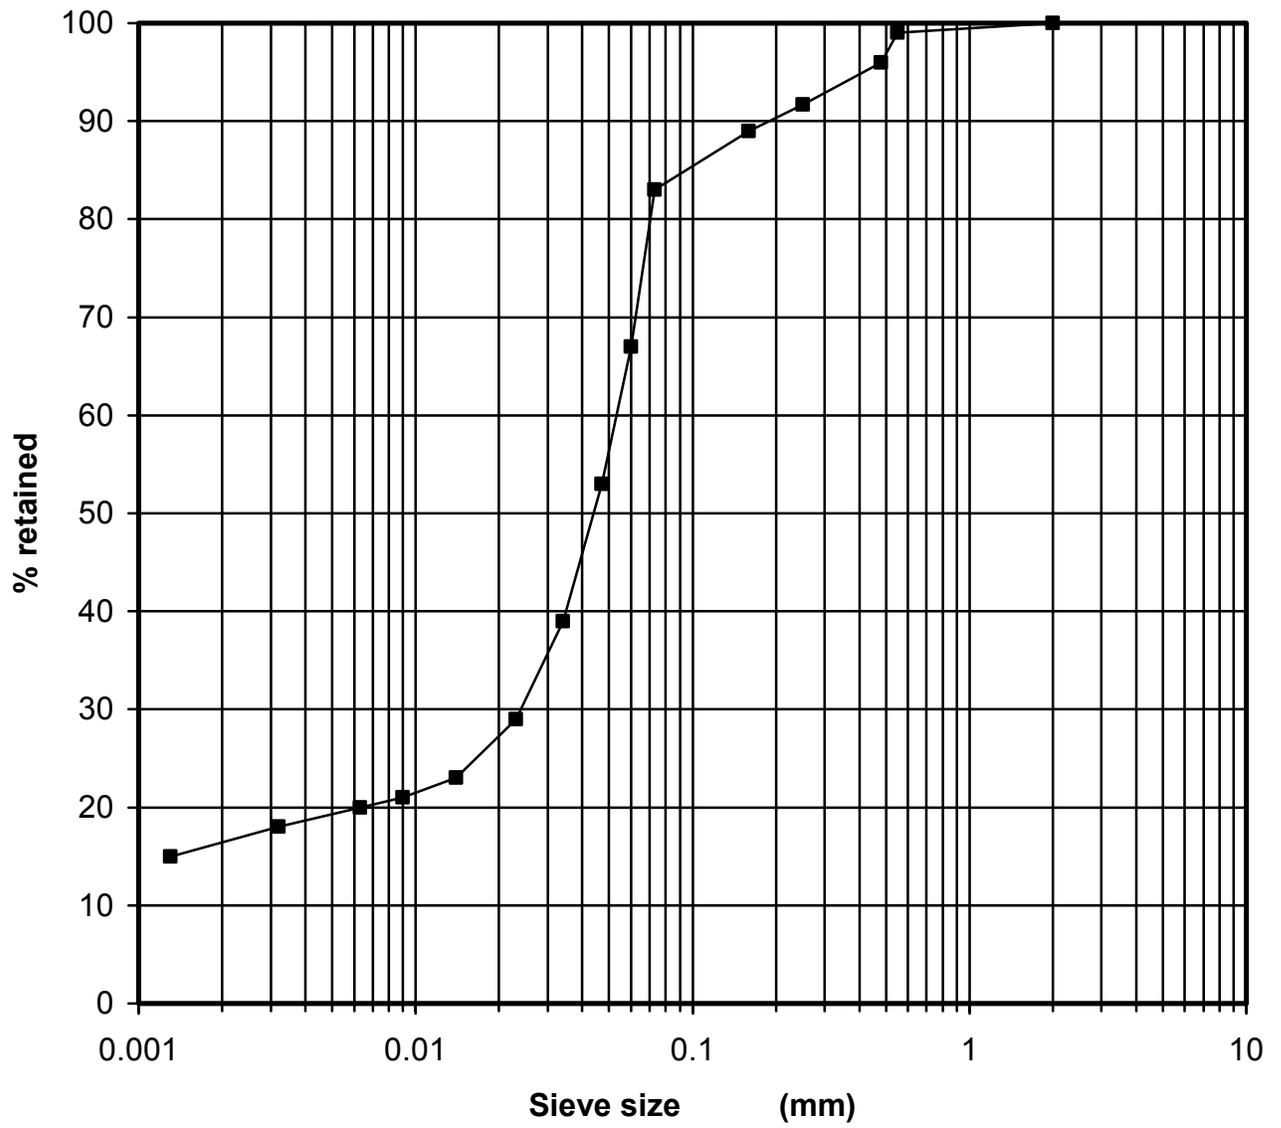
The existing subgrade material was silty clay. Figure 3.2 shows the gradation curve of the existing subgrade soil. After being removed and dried, the subgrade soil was recompacted to a density greater than 90 percent maximum dry density (MDD), at near-optimum moisture content. The Proctor curve for this soil is shown in Figure 3.3. This compaction was done by hand with a whacker type vibrating compactor resulting in densities of the order of 94 to 95 percent maximum dry density. This subgrade was brought up to a depth of approximately 27-in., on both sides of the dividing wall, in 4-in. to 6-in. lifts. This minimized the stress on the wall and, more importantly, maintained uniformity in the moisture and density of the subgrade on both sides of the wall.

FIGURE 3.2: Gradation Curve for the existing Subgrade Soil

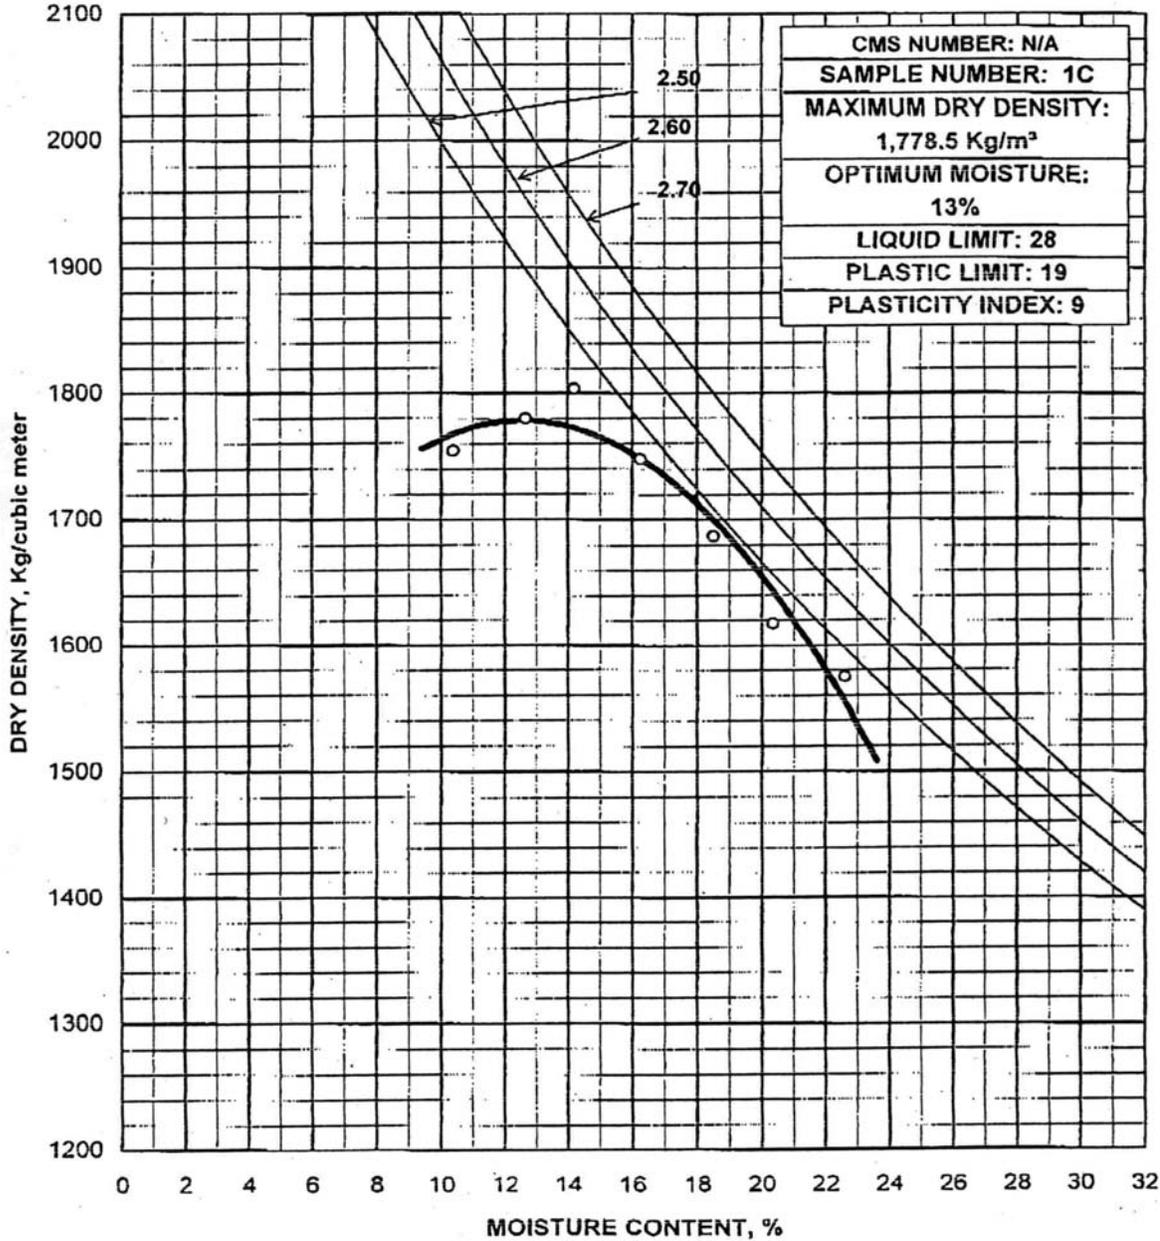
FIGURE 3.3: Proctor Curve for the existing Subgrade Soil

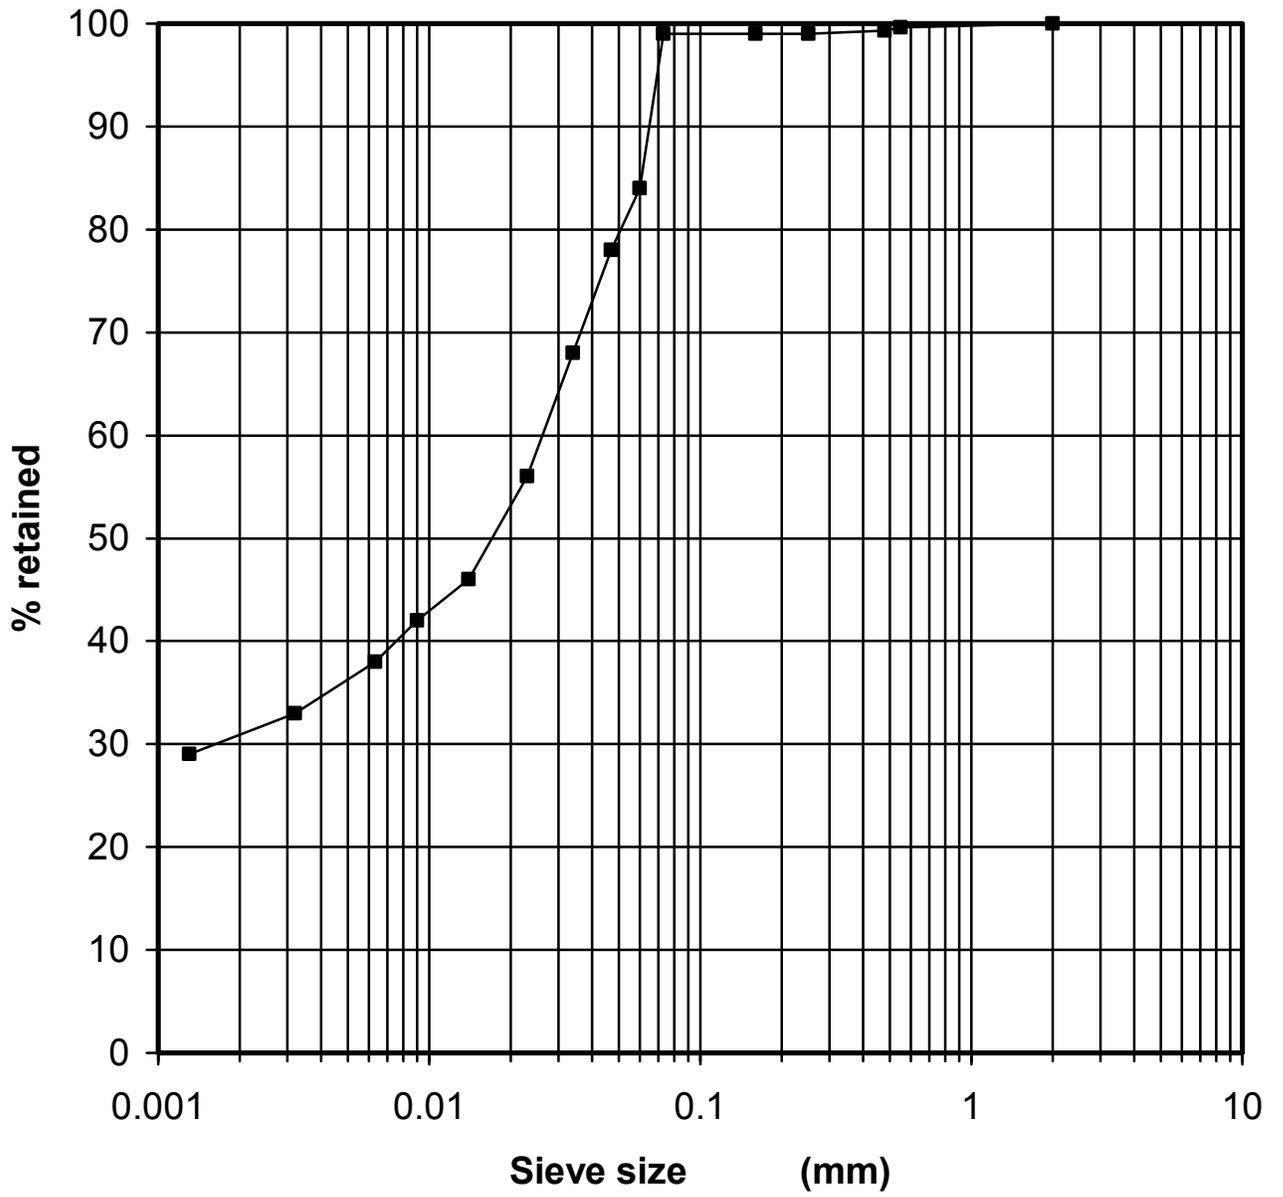
FIGURE 3.4: Gradation Curve for the Mosier Pit Soil

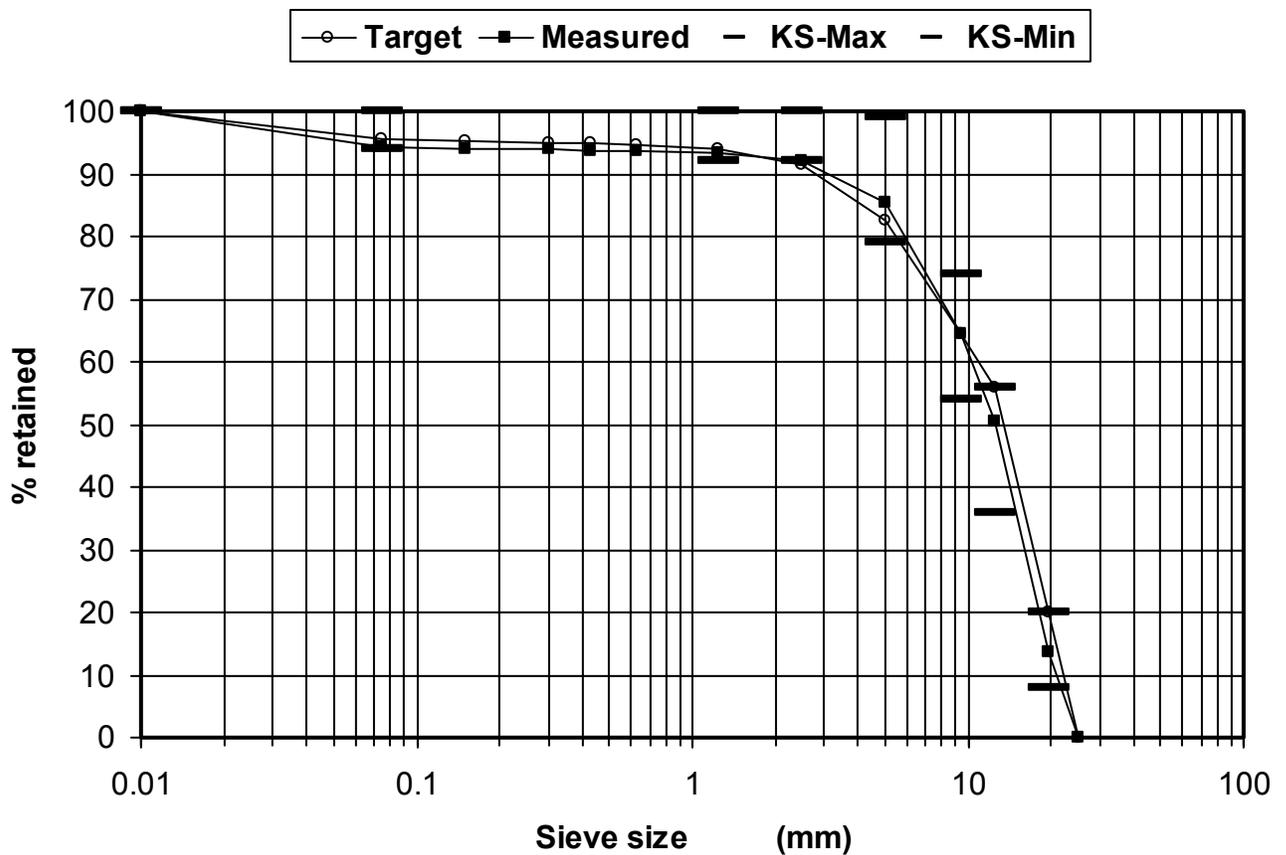
FIGURE 3.6: Design and Measured Gradations-Permeable Base

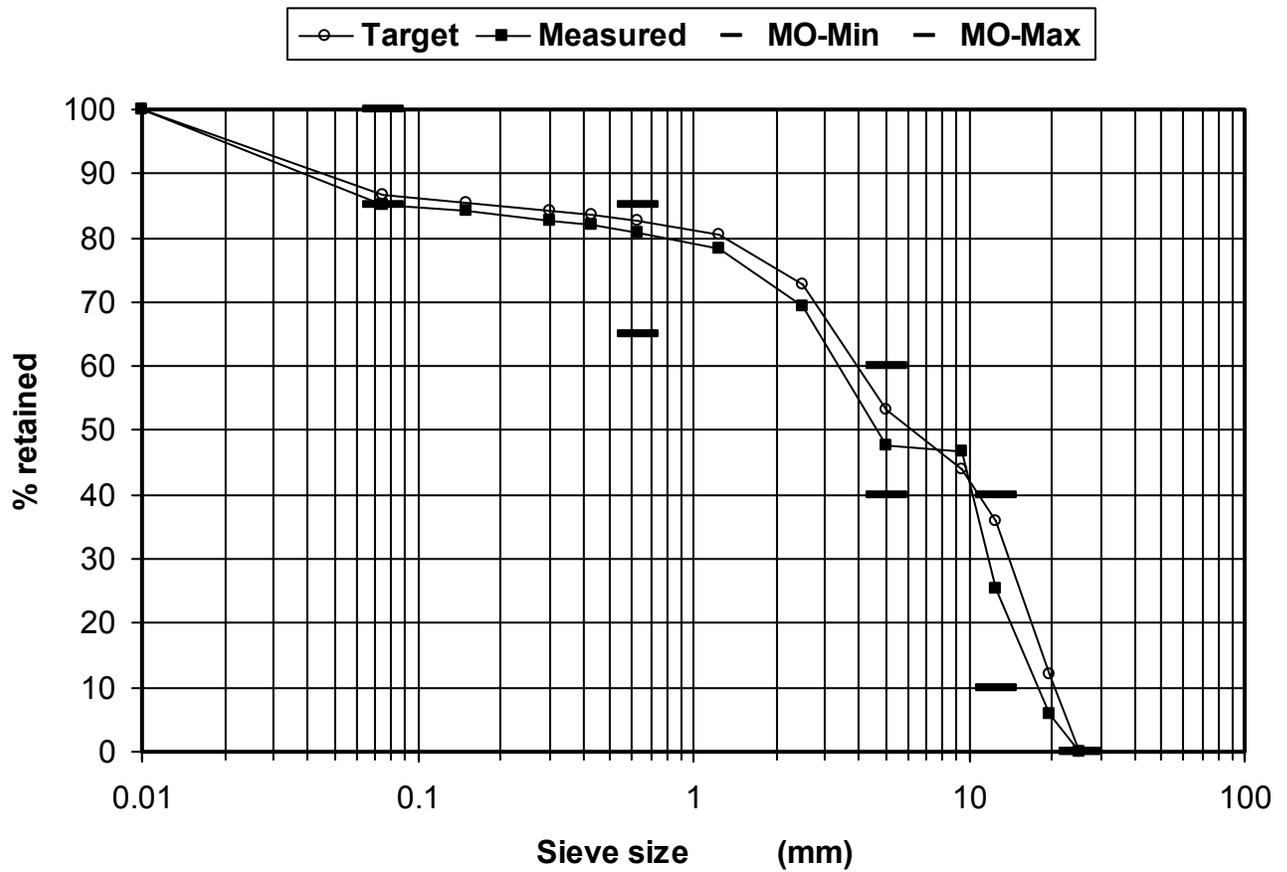
FIGURE 3.7 Design and Measured Gradation-Semi-Permeable Base

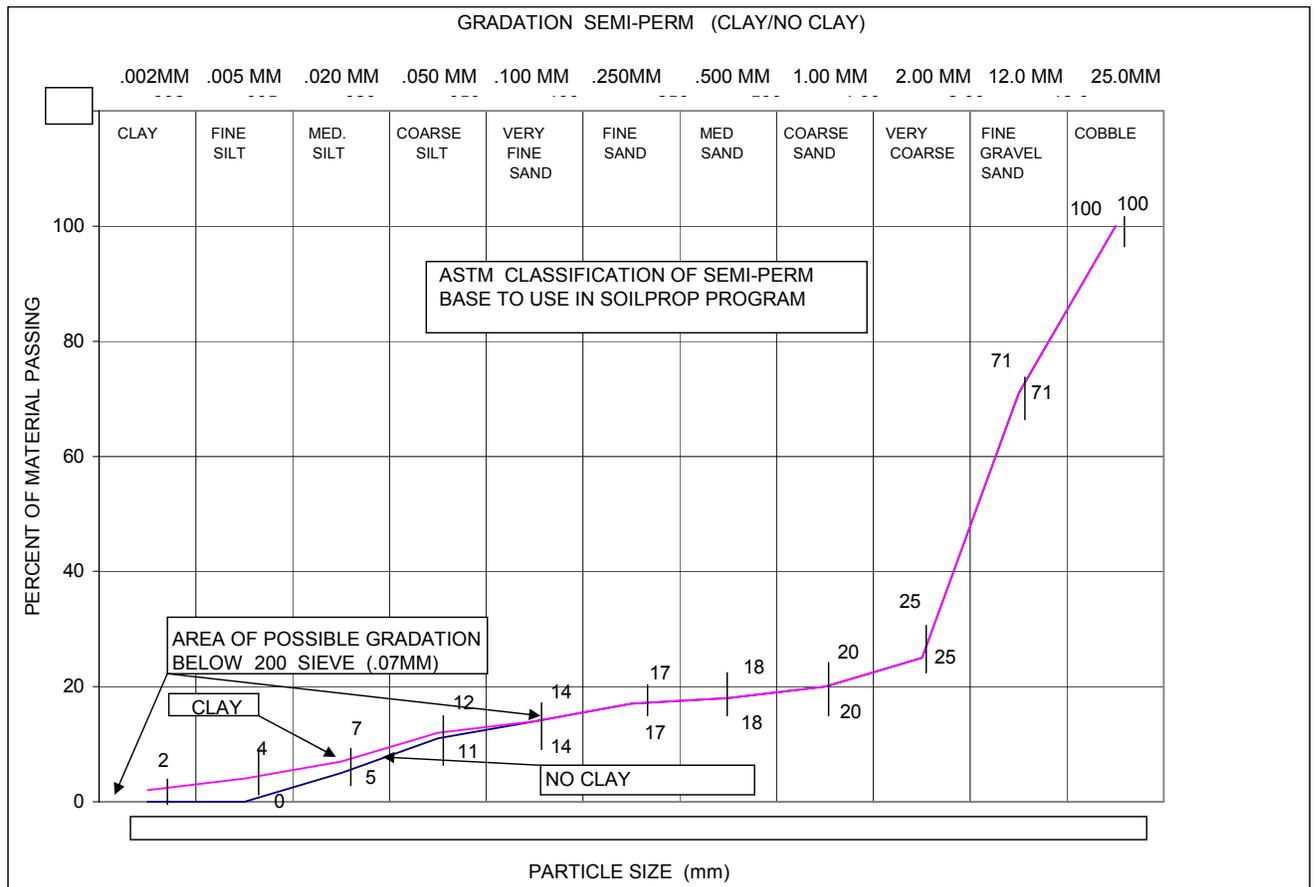
FIGURE 3.8: Gradation of Semi Permeable Material

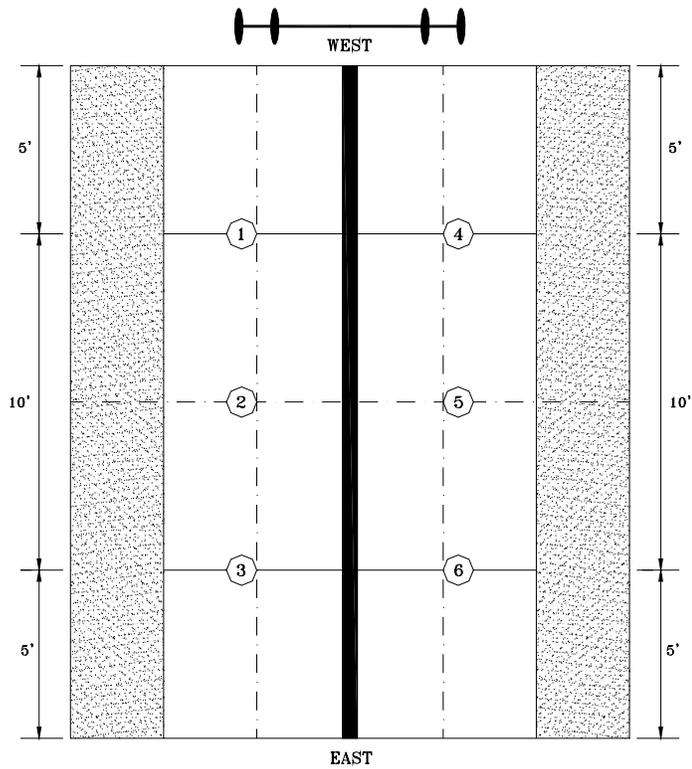
FIGURE 3.9: Soil Pressure Transducer Location

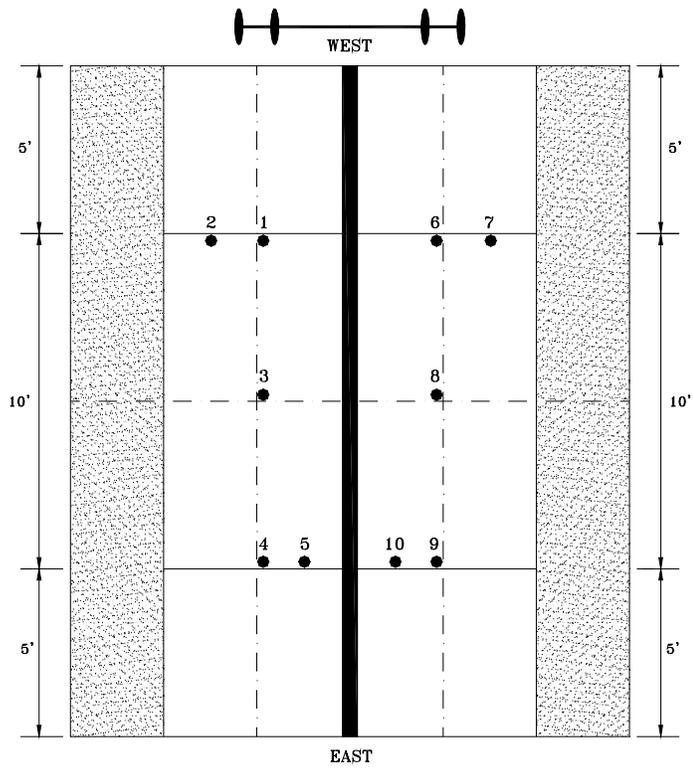
FIGURE 3.10: Thermocouple Transducer Locations

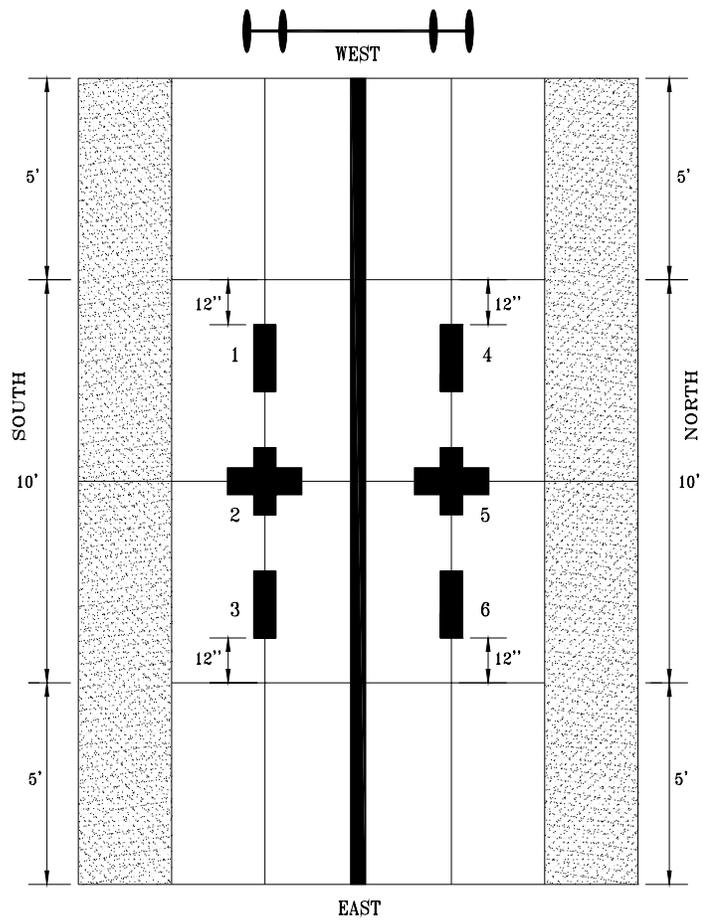
Strain gages were installed in the slab longitudinally along the long axis of the slab at 1-in., 3-in. and 5-in. from the bottom of the slab as shown in Figure 3.11. Six strain gages were installed in the transverse direction at 1.25-in., 3.25-in., and 5.25-in. from the bottom of the slab as shown in Figure 3.11. Table 3.9 shows the channel designation for the strain gages.

FIGURE 3.11: Strain Gauge Locations

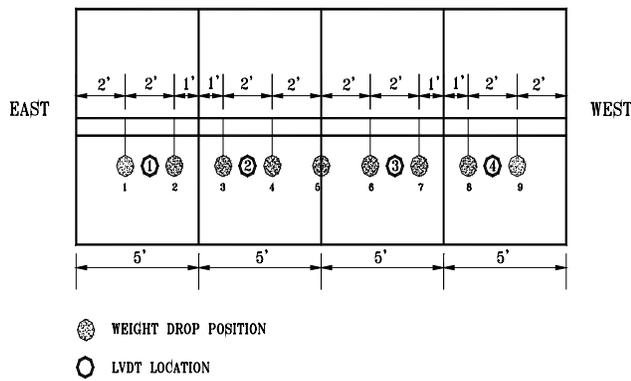
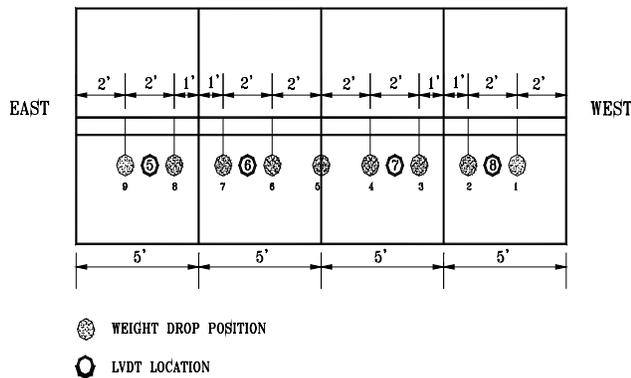
FIGURE 3.12: LVDT Position Diagram

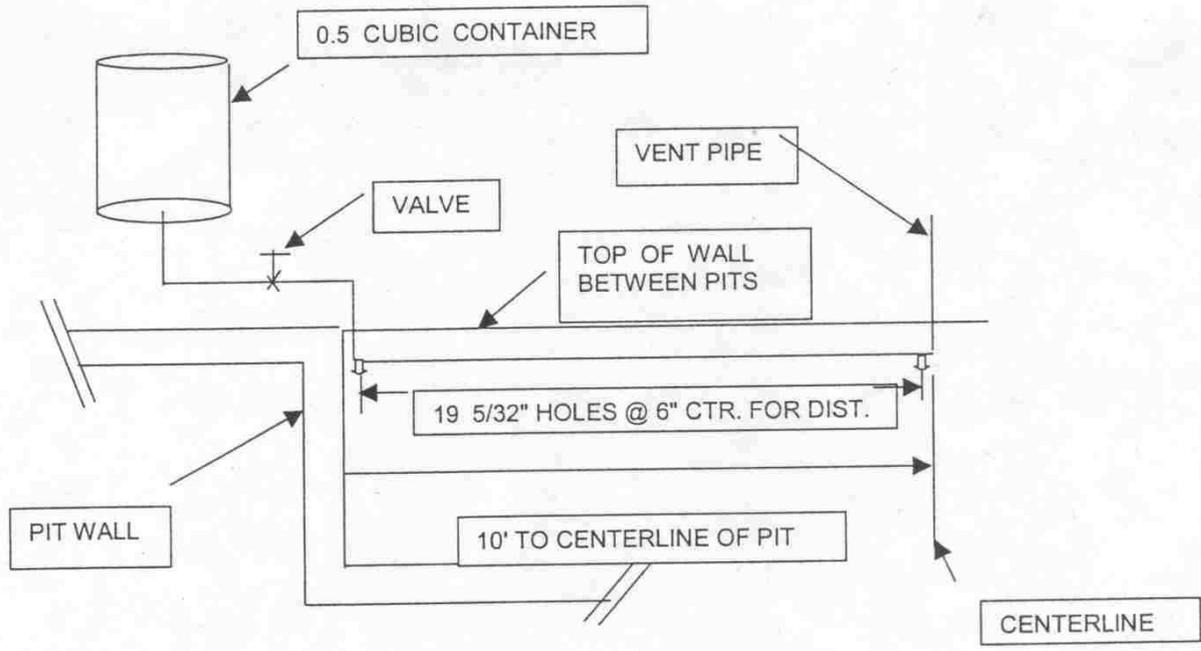
FIGURE 3.13: Water Pipe Diagram

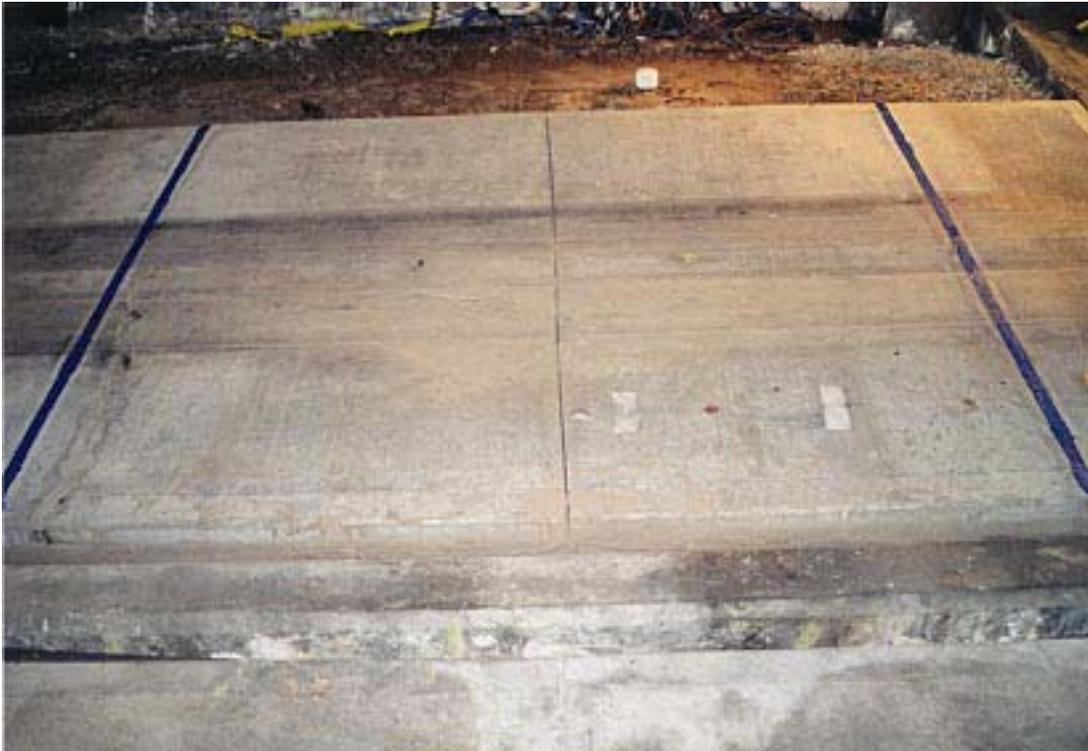
FIGURE 3.14: Saw Cuts and East Transverse Joint before Removal

Experiment #10 used the distressed pavements tested in experiment-#9. A section of pavement approximately 5 ¾-ft. long was removed from the north PCCP, located between 24-in. and 95-in. from the east wall and roughly centered over the East transverse joint. This location coincides with the transverse cracks which developed in the slabs during experiment-#9. Saw cuts were made along the transverse cracks and the section was broken-up and removed. Figure 3.14 shows the saw marks and east transverse joint prior to removal. The existing base from experiment-#9 was covered with a layer of sand and compacted to assume uniform support under the new concrete slab. Prior to replacing the concrete, all longitudinal cracks in the distressed PCCP from experiment-#9 were epoxy injected by KDOT personnel. Figure 3.15 shows the removed section of PCCP and epoxy injection. A thin bond breaker was placed at each end of the distressed PCCP prior to placing the new concrete section. The new 6-in. thick section was placed and allowed to cure for seven days.

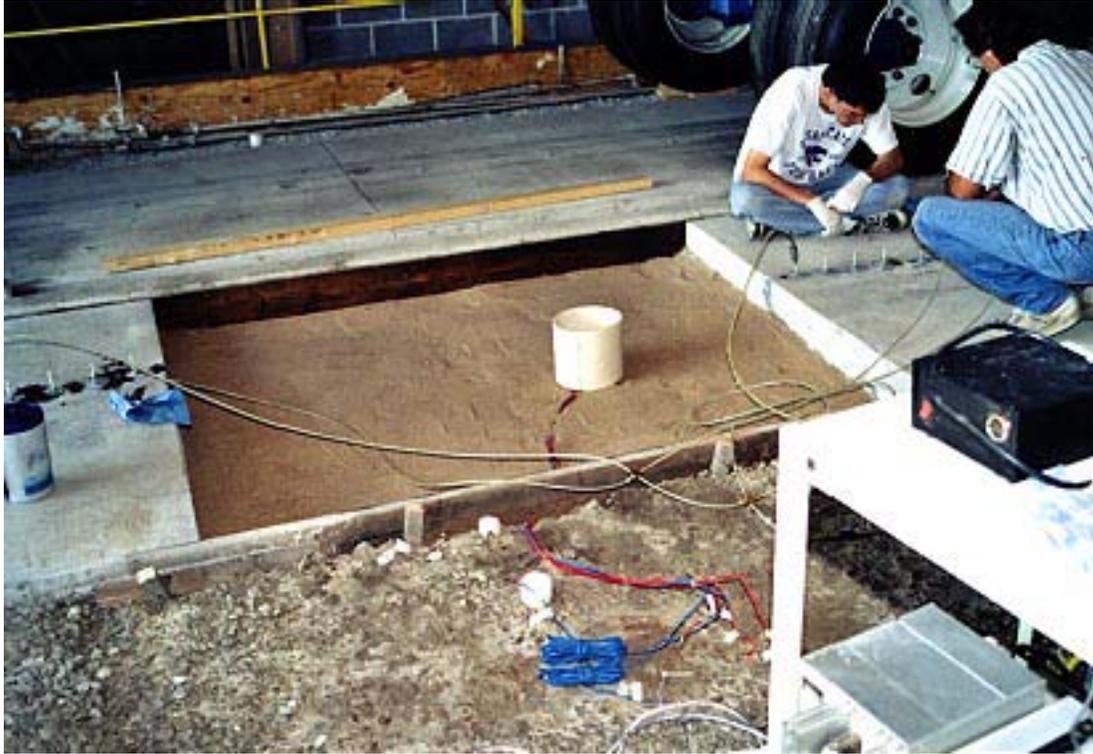
FIGURE 3.15: Removed Section of North Slab and Epoxy Injection

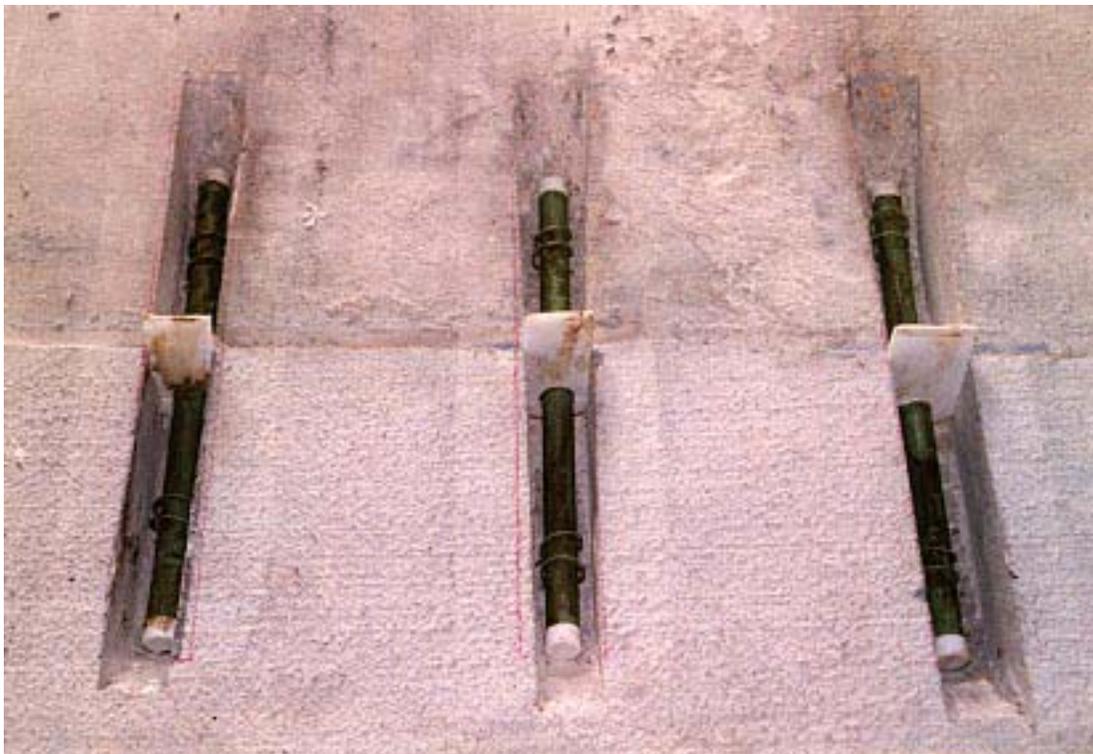
FIGURE 3.16: Steel Dowels (1-in. diameter)

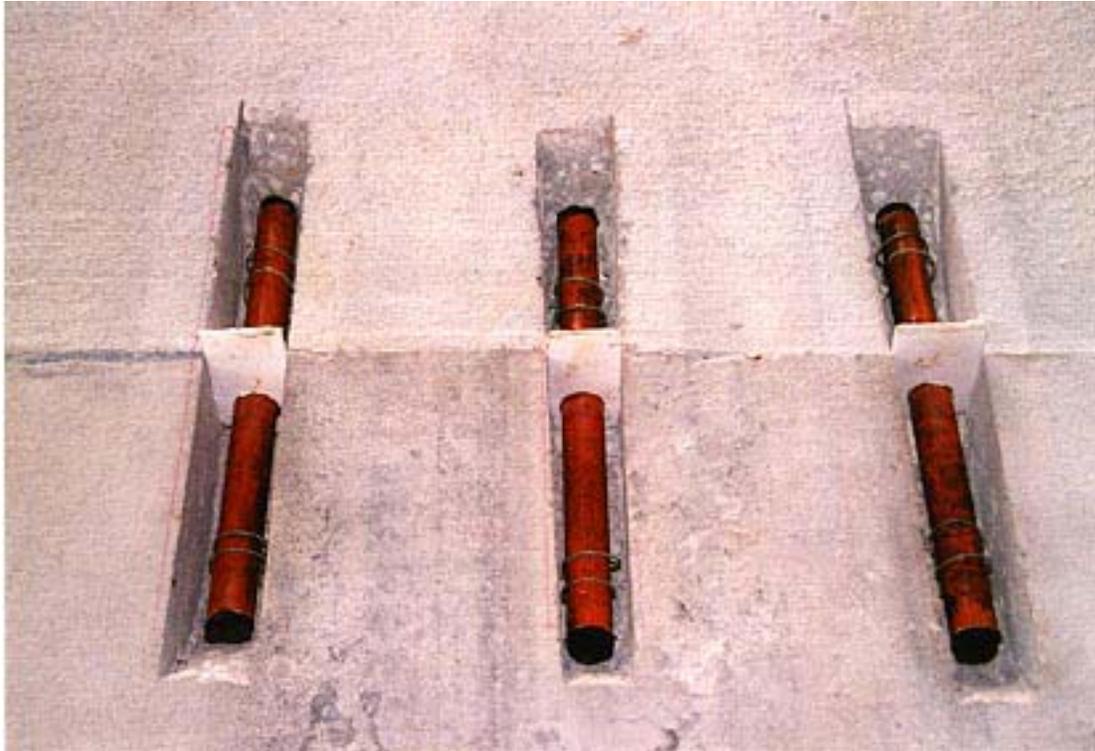
FIGURE 3.17: Fiber Reinforced Dowels (1.5-in. diameter)

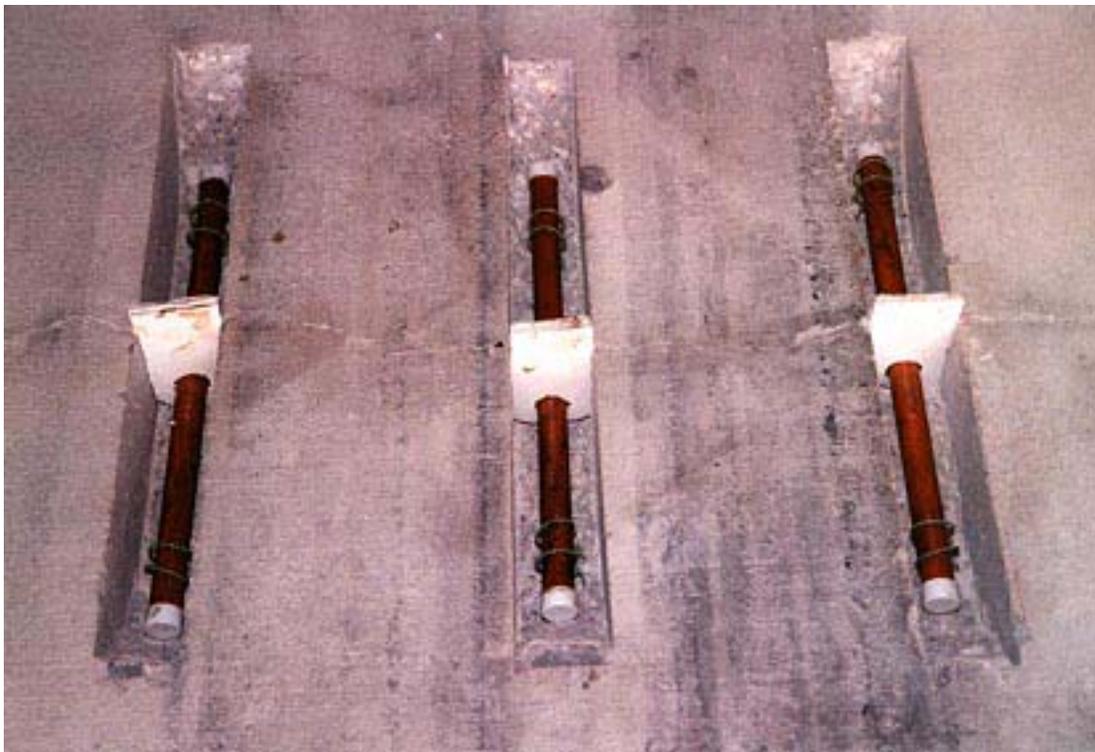
FIGURE 3.18: Fiber Reinforced Dowels (1-in. Diameter)

Another transverse crack which developed in the north PCCP during experiment-#9 was retrofit with 1-in. diameter FRP dowels. This crack was located approximately 30-in. from the west end of the north PCCP. The transverse crack, which developed at 40k cycles in experiment-#9 and repaired with epoxy stitches, was left as is for testing in experiment #10. Figures 3.16–3.18 show the 1-in. steel, 1 ½-in. FRP and 1-in. FRP dowels placed in the north PCCP, respectively. There was no dowel bar retrofit in the south PCCP.

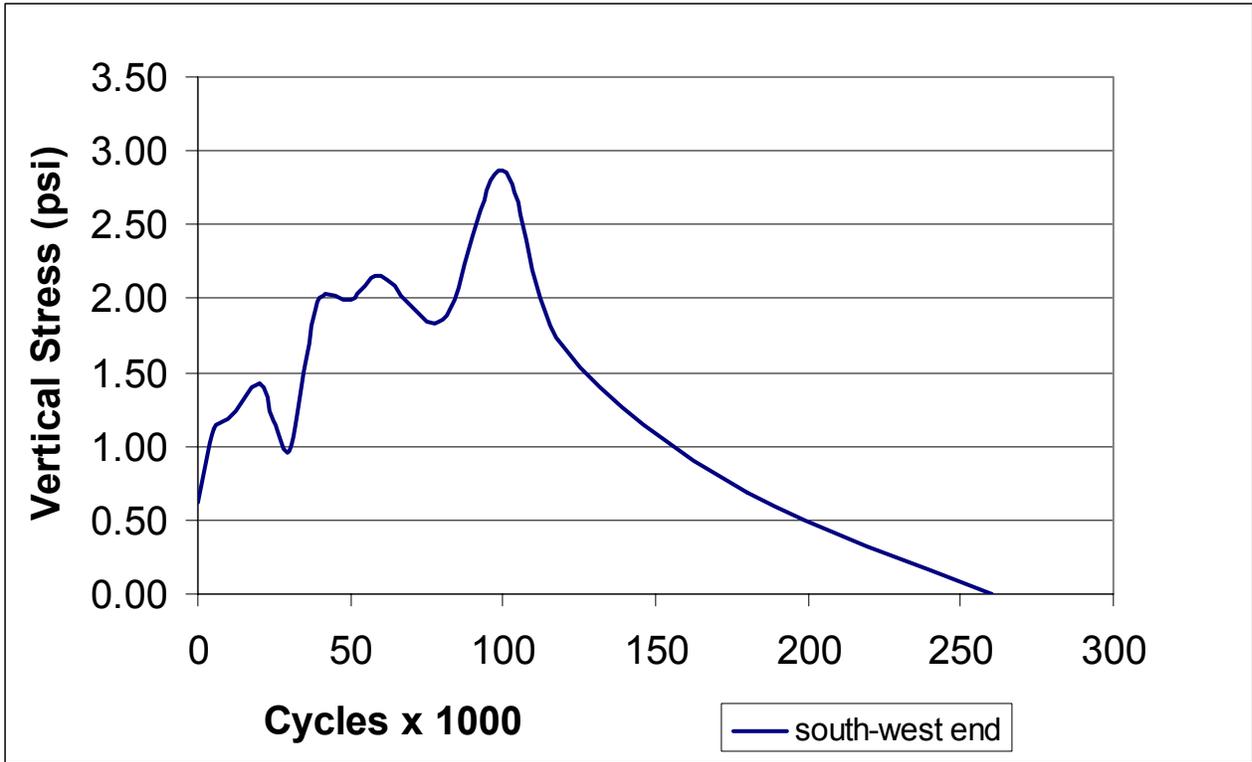
FIGURE 4.1: Vertical Stress vs. Cycles (West End)

Vertical stress in the subbase was monitored for the six locations described in section 3.1.9. The maximum vertical stresses recorded are provided in Table 4.1. The pressure transducer located at the west end of the north pavement failed during the experiment, therefore no data was collected. Figures 4.1 to 4.3 show vertical stress vs. cycles for the west end, midspan and east end locations, respectively. The stress in the west end of the south subbase shows increasing values up to 120k cycles and then drops significantly through the end of the testing. The vertical stresses at midspan initially increase in both the north and south subbases, then decrease in value to 120k cycles. A significant increase in stress occurs at 180k cycles. The stress in both north and south subbases at the east end of the pit are very low (~0 psi), a result of being placed 26-in. below the pavement surface. The stress in the north subbase at the east end jumps to 3 psi between 260k-300k cycles, due to the failure of the pavement in the vicinity. From Figures 4.2 and 4.3 it is observed that the larger compressive stresses were measured under the north lane indicating a weak semi-permeable base.

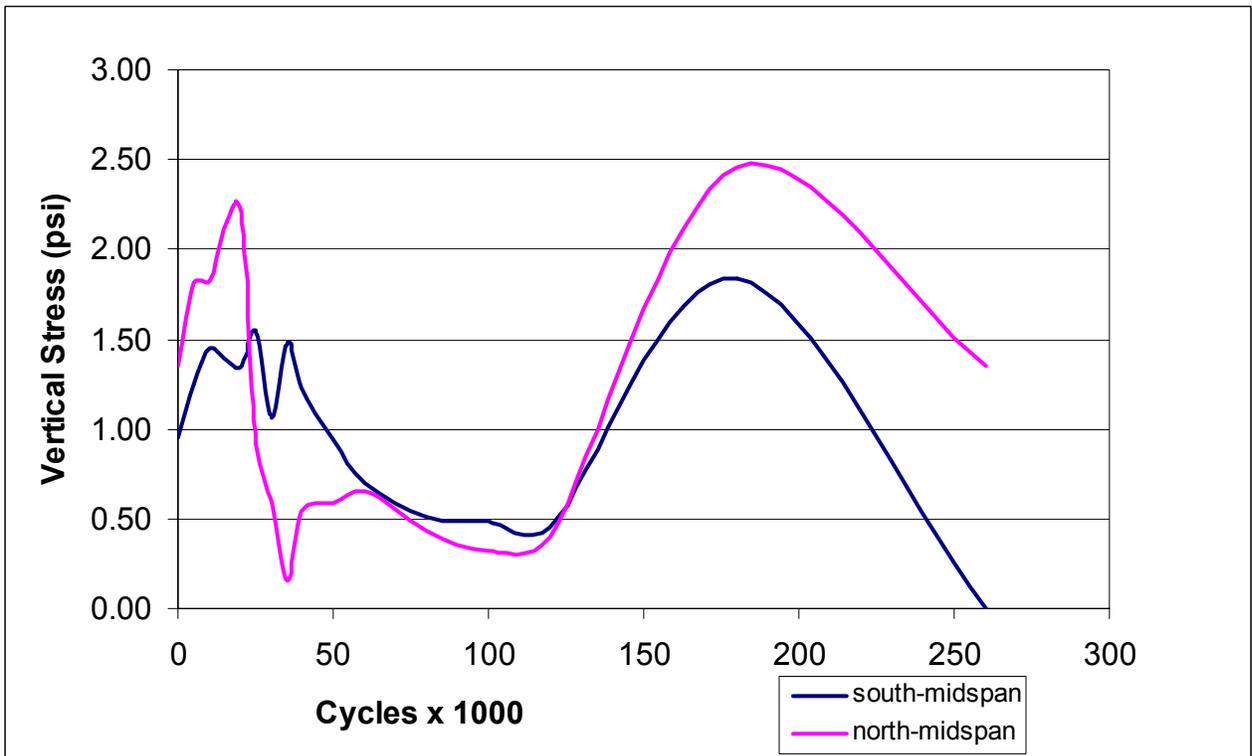
FIGURE 4.2: Vertical Stress vs. Cycles (Midspan)

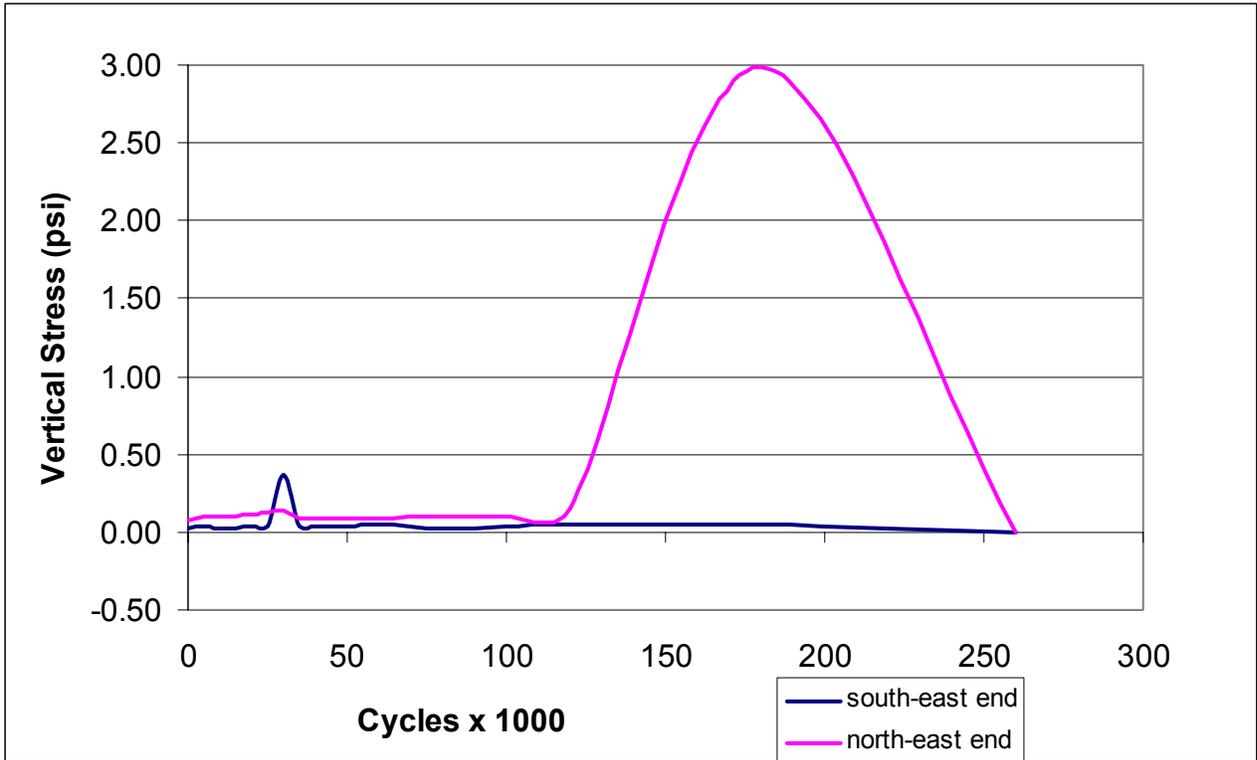
FIGURE 4.3: Vertical Stress vs. Cycles (East End)

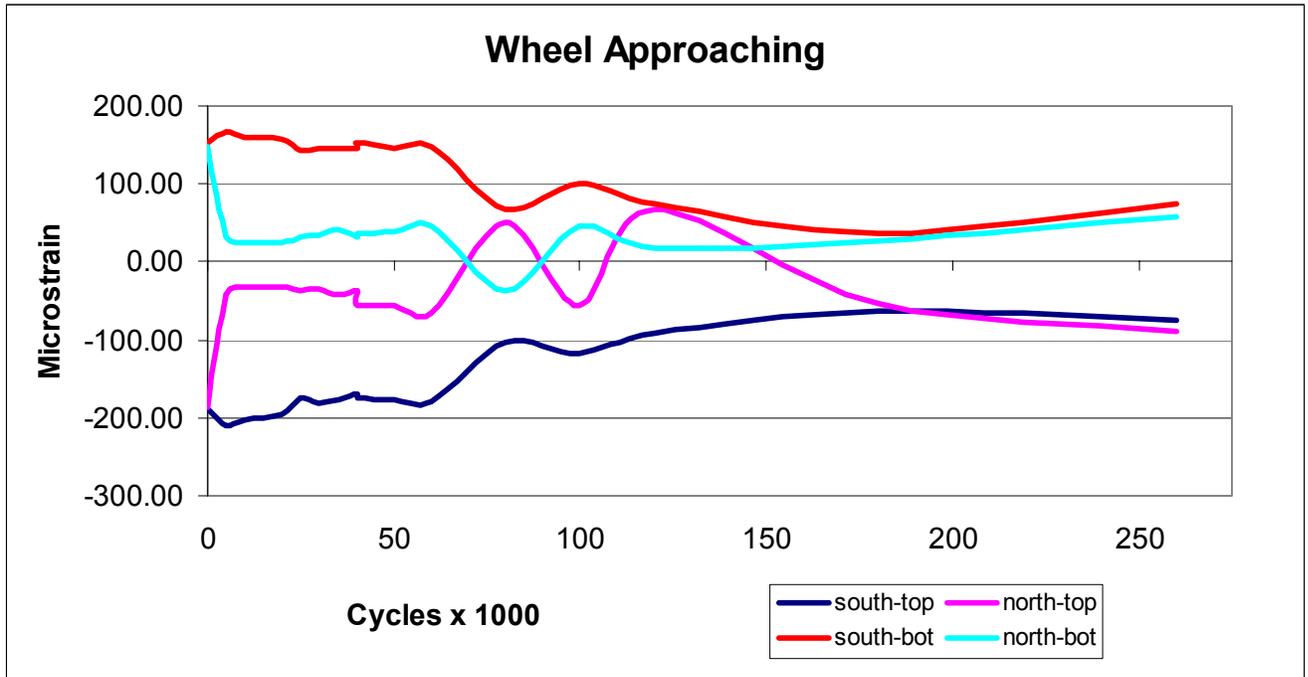
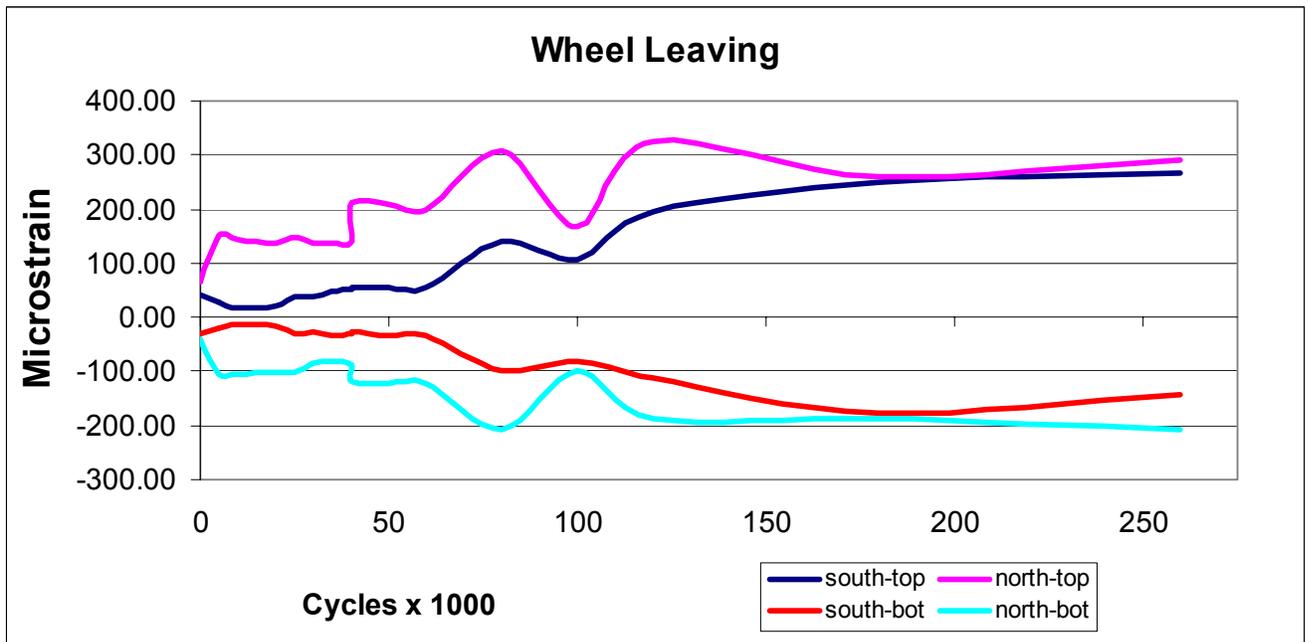
It is observed that the strains on the top surface tend to increase as the wheel approaches the gauge locations and the strains on the bottom surface decrease. The same trends are observed as the wheel load leaves the gauge locations.

FIGURE 4.4: Strain vs. Cycles for Locations #1 and #4

FIGURE 4.5: Strain vs. Cycles for Locations #1 and #4
