Report No. FHWA-KS-02-7
FINAL REPORT

ACCELERATED TESTING FOR STUDYING PAVEMENT DESIGN AND PERFORMANCE (FY 2001)

*Evaluation of the Performance of Permeable and Semi-Permeable Unbound
Granular Bases under Portland Cement Concrete Pavement (PCCP) Slabs and
Alternate Load Transfer Devices for Joint Repair*

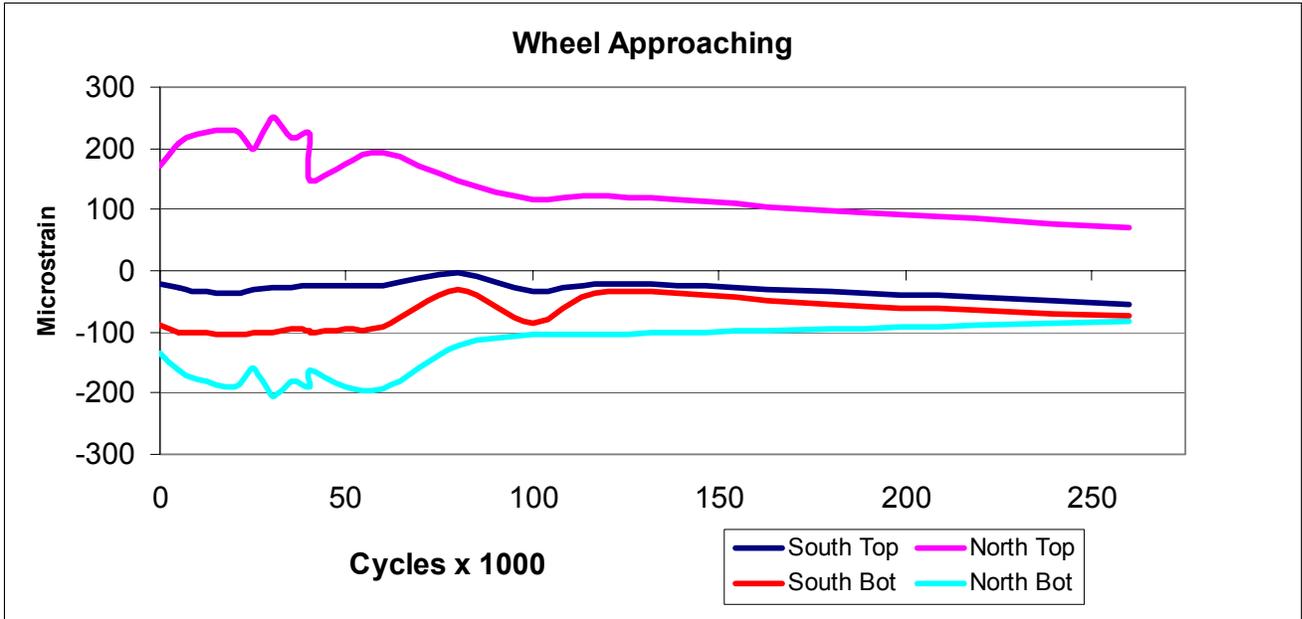
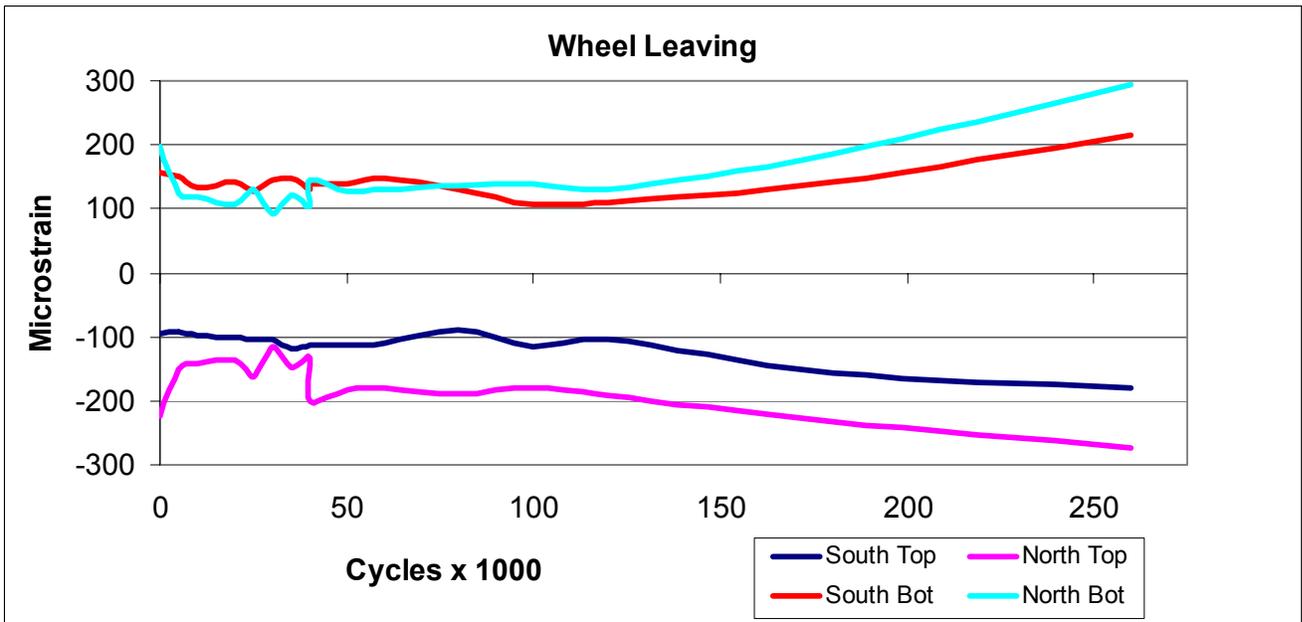
FIGURE 4.6: Longitudinal Strains vs. Cycles for Locations #2 and #5

FIGURE 4.7: Longitudinal Strains vs. Cycles for Locations #2 and #5

The longitudinal strains for positions #2 and #5 tend to decrease on the top surface and increase on the bottom surface in both pavements for the wheel loads approaching and passed.

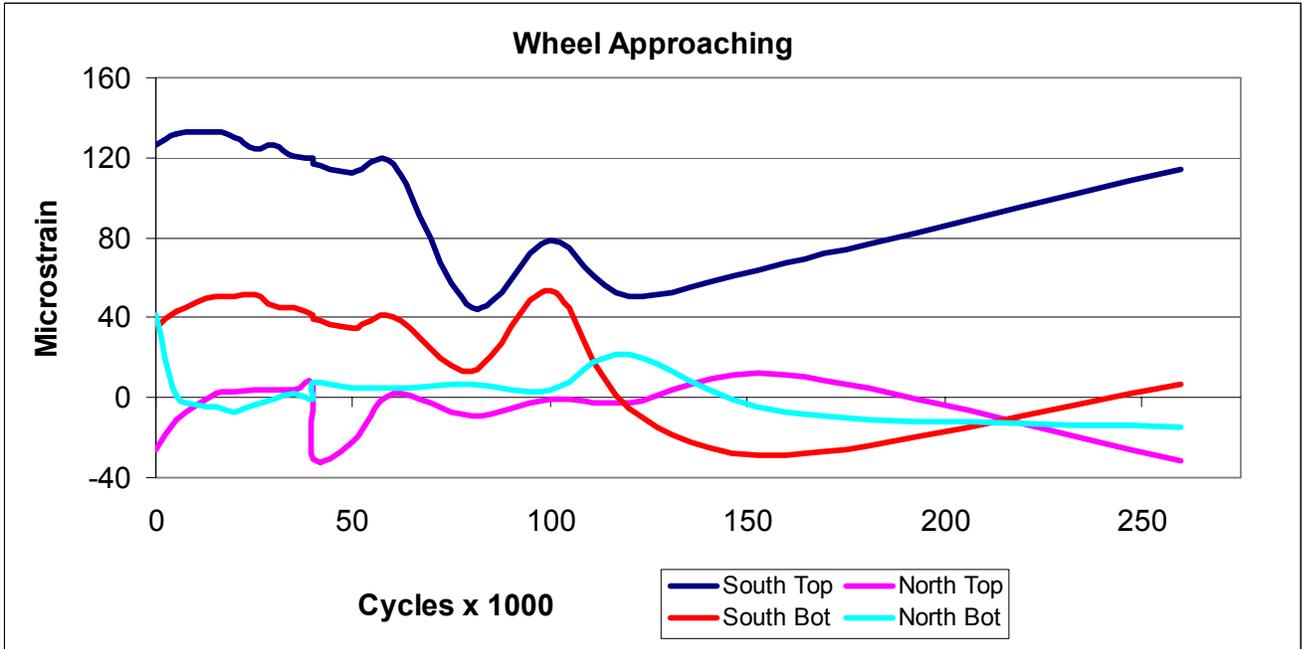
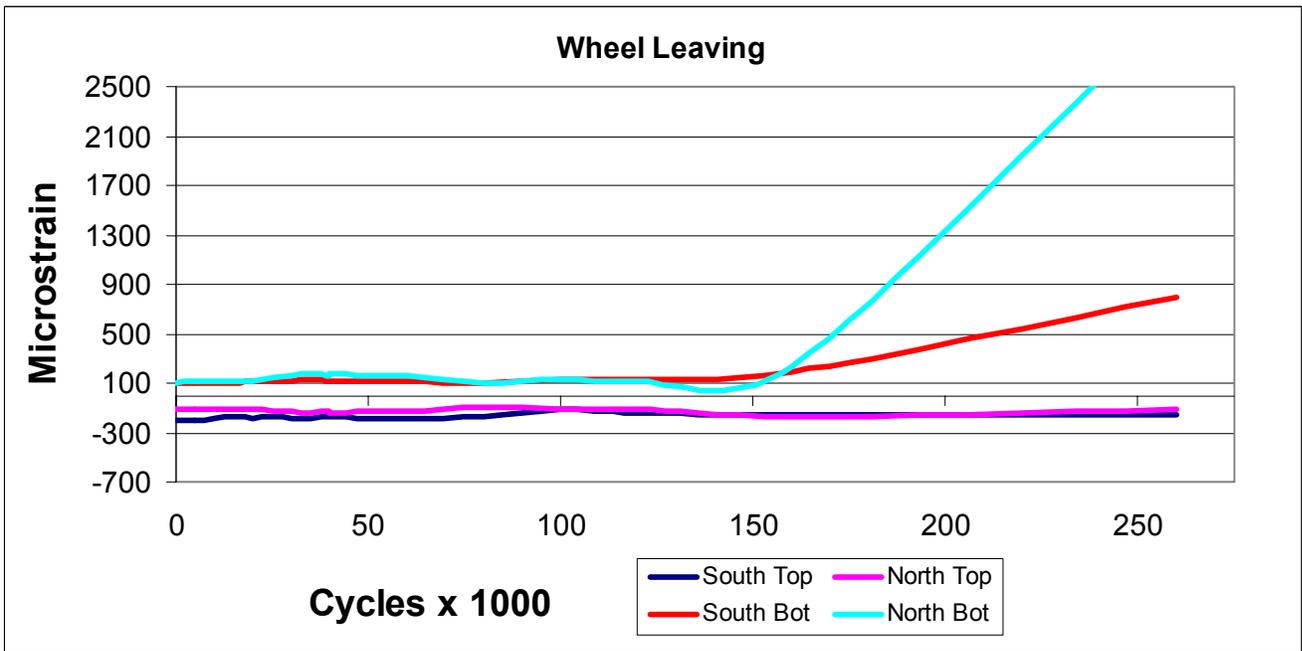
FIGURE 4.8: Transverse Strains vs. Cycles for Locations #2 and #5

FIGURE 4.9: Transverse Strains vs. Cycles for Locations #2 and #5

The transverse strains in the south pavement initially decrease for both top and bottom surface locations, and then increase until the end of testing. The transverse strain in the north pavement decrease for the duration of the testing, revealing the severe degradation of the semi-permeable base.

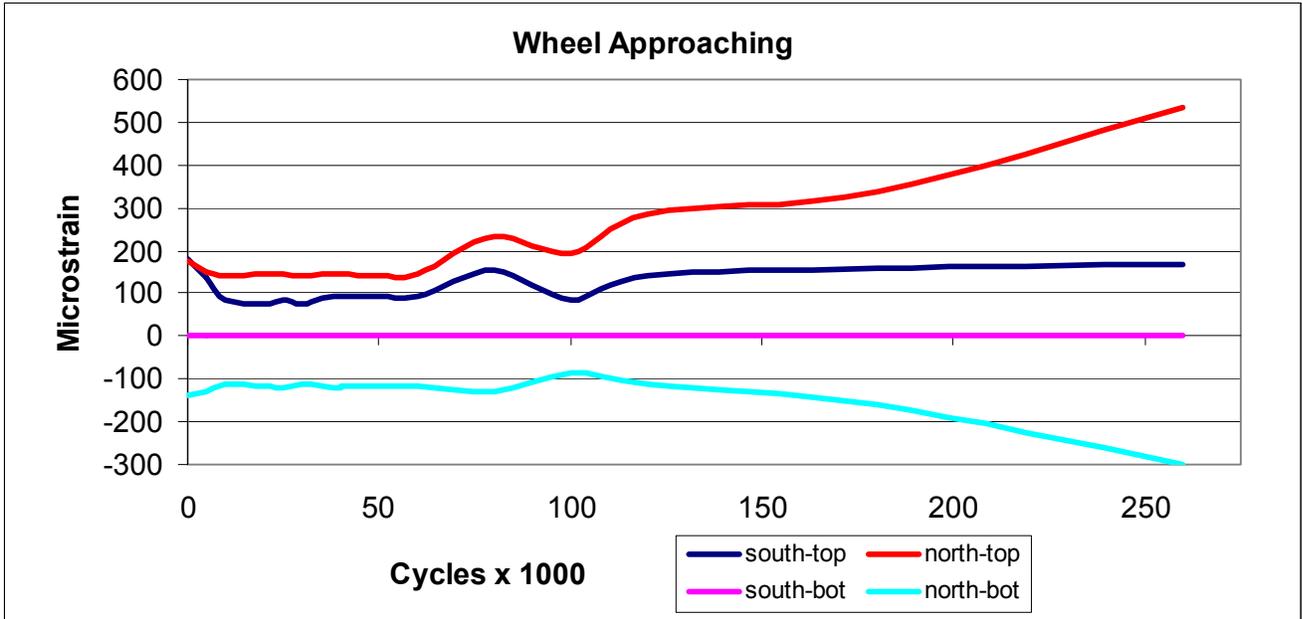
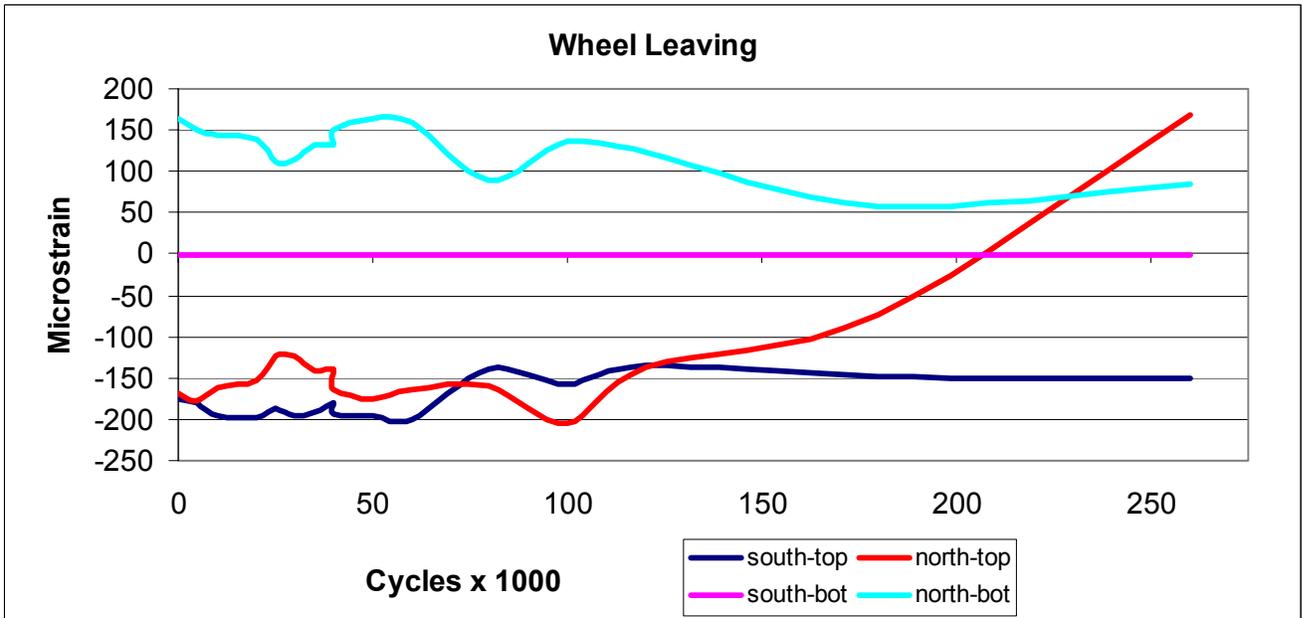
FIGURE 4.10: Strain vs. Cycles for Locations #3 and #6

FIGURE 4.11: Strain vs. Cycles for Locations #3 and #6

The strains on the top surface of both north and south pavements at positions #3 and #6 increases as the wheel load approaches and passes for the duration of the testing. The strains on the bottom surface of the north pavement decrease for the duration of the test. The gage for the

bottom surface of the south pavement did not work properly during the testing. It was only observed that strains alternated from compressive to tensile (or tensile to compressive) as the wheel loads approached and then passed the gage locations in both the north and south pavements.

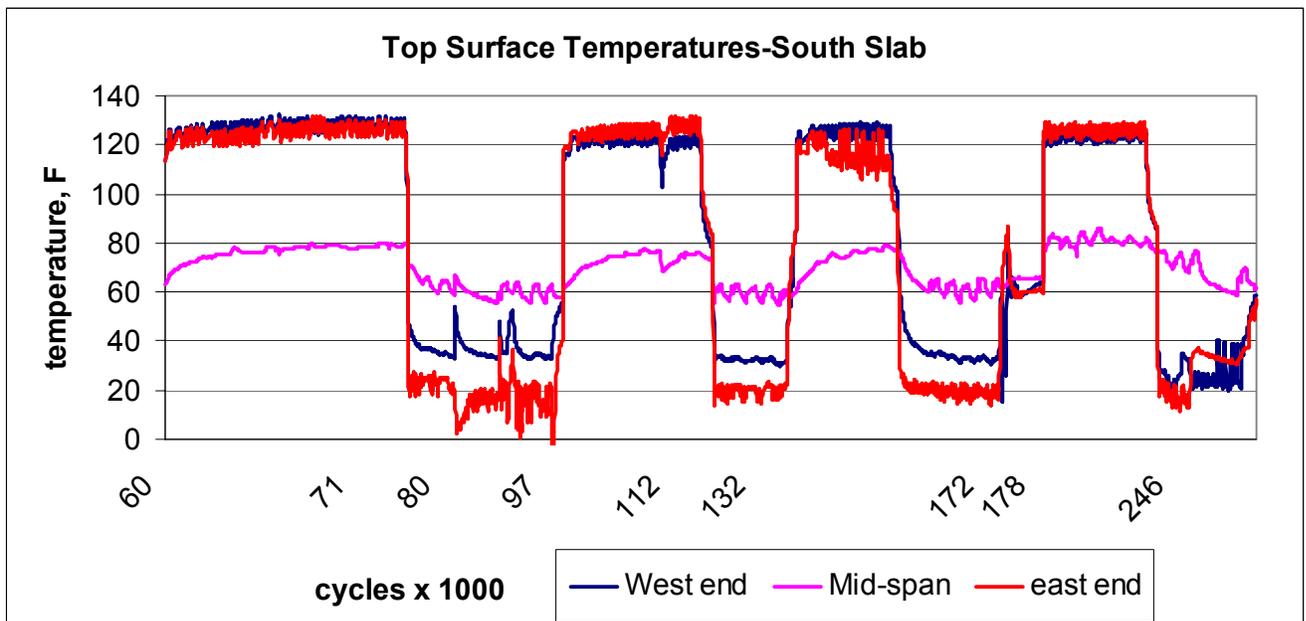
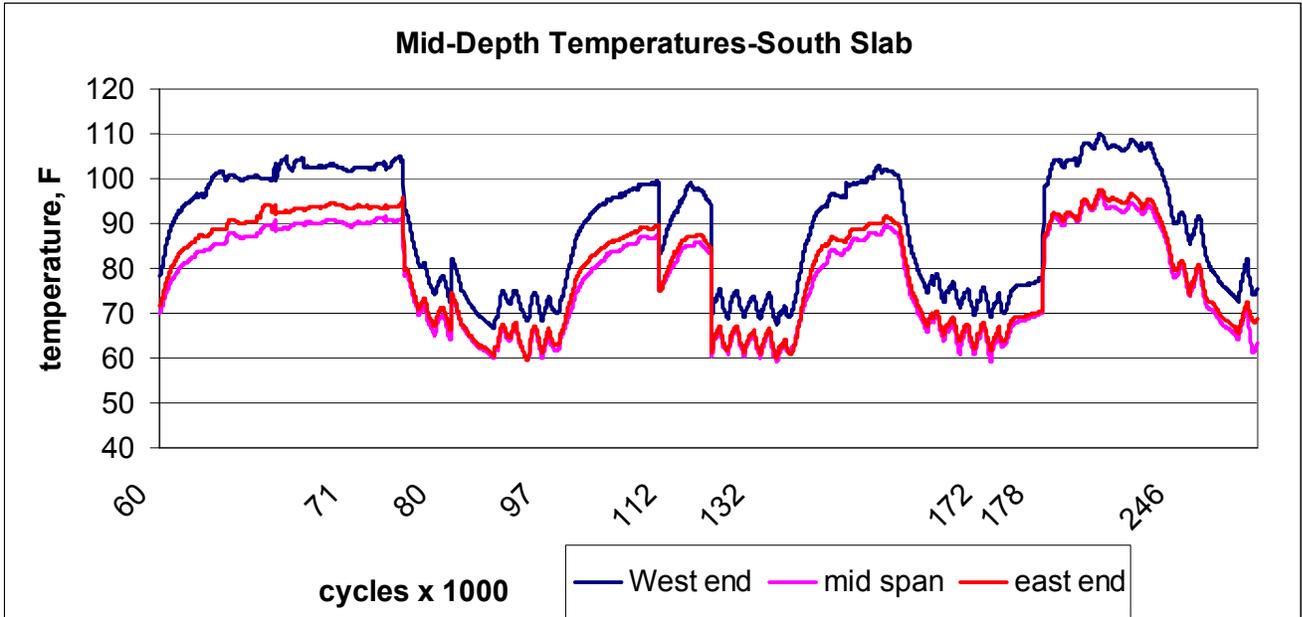
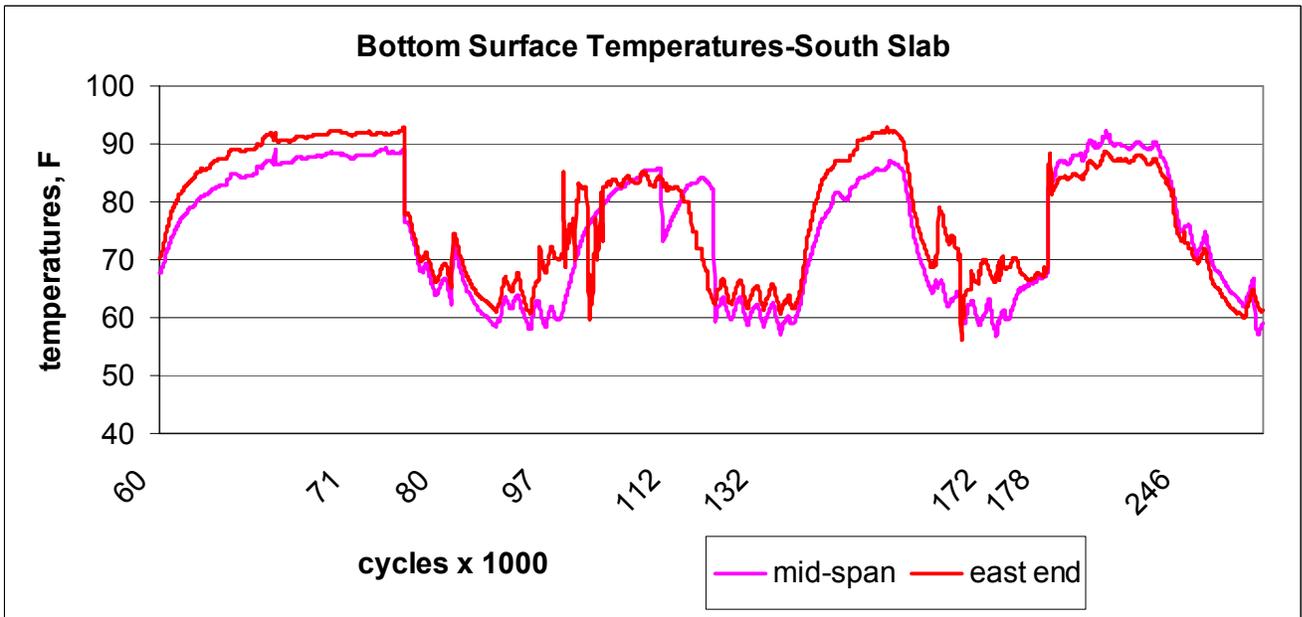
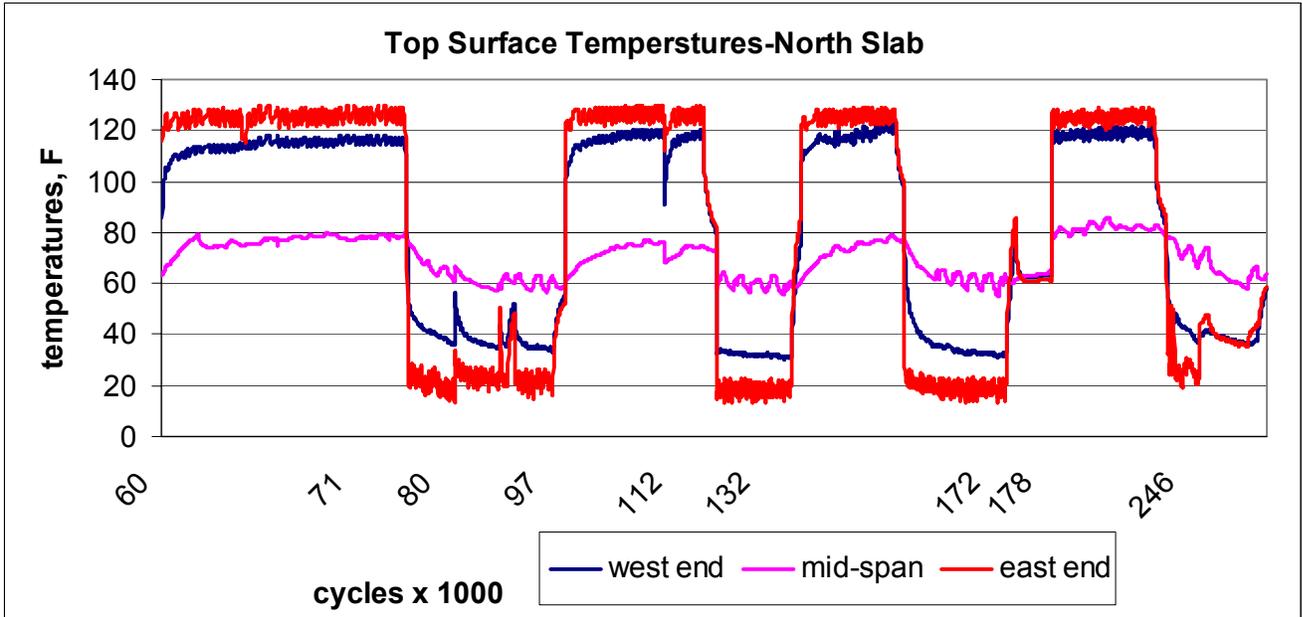
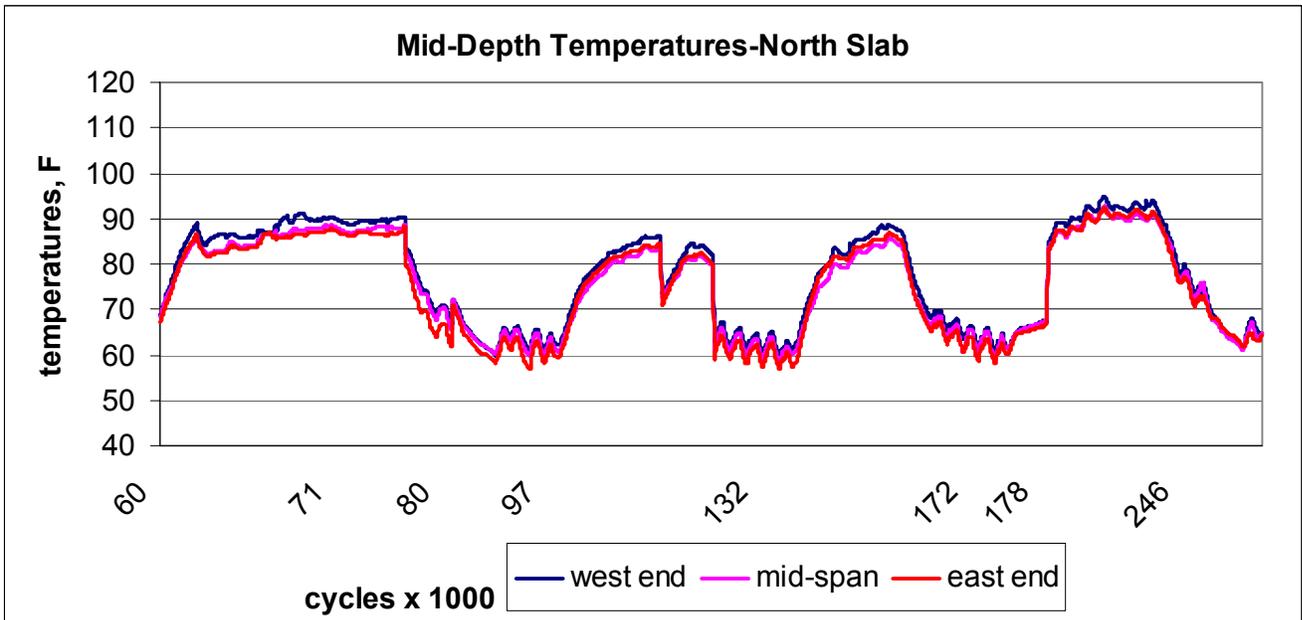
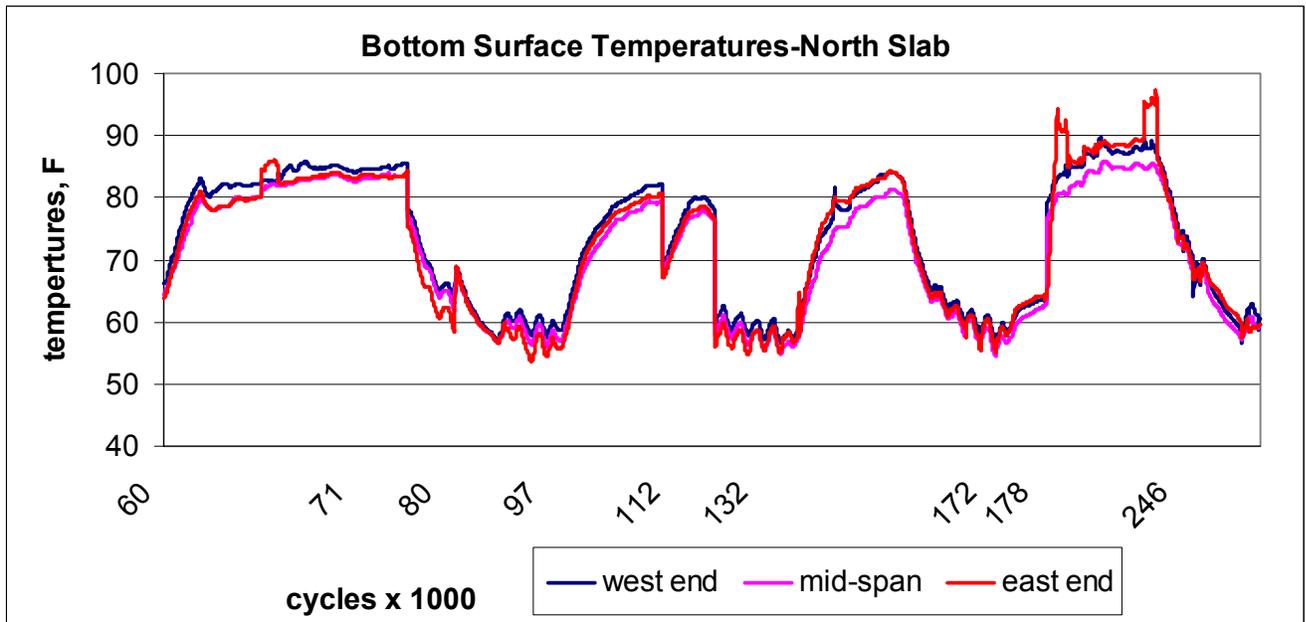
Temperatures were monitored on the surface, 3-in. below the surface and 6-in. below the surface. Figures 4.12 to 4.14 show the profile for the south pavement and Figures 4.15 to 4.17 for the north pavement. It is clear that a temperature gradient exists from the top surface to 6-in. below the surface whether in a hot or cold cycle, and the gradients are higher at the joints than at the center of the slab.

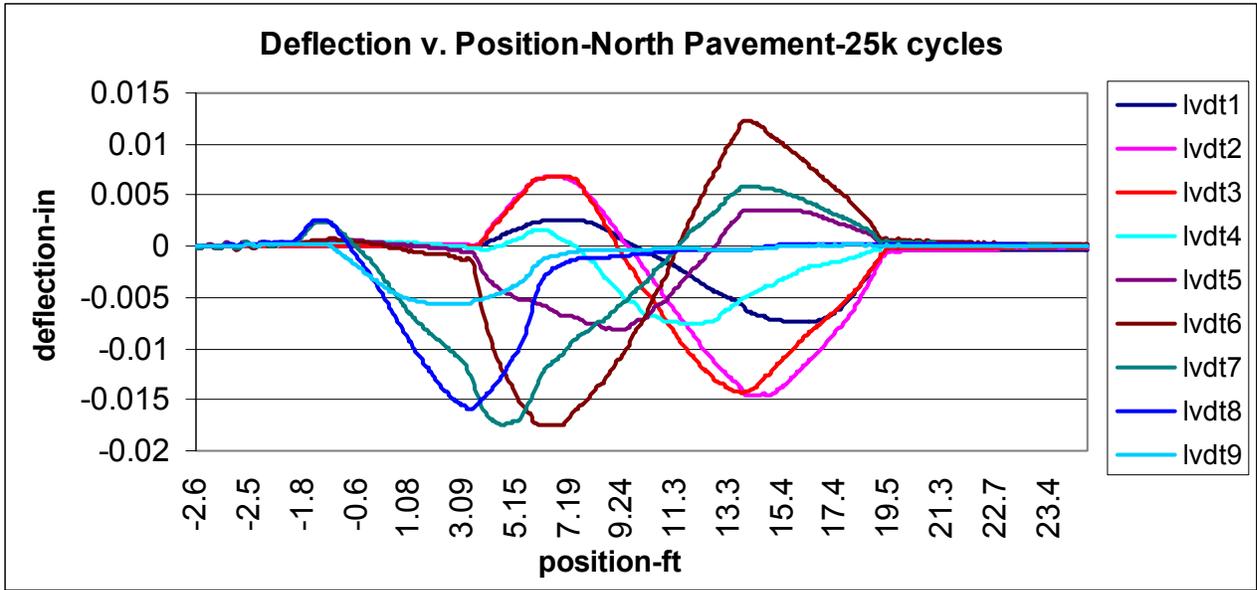
FIGURE 4.18: Deflection Profile in the North Pavement at 25k cycles

The vertical deflection in both the south and north pavements was monitored using LVDTs. The location of each LVDT is described in section 3.1.9 for the rolling wheel loads. A typical deflection response for the north pavement is shown in Figure 4.18. As the wheel travels west to east, LVDT #9 is first to deflect downward and LVDT #1 is last for downward deflection, as observed in Figure 4.18. It is observed that as the wheels travel west to east, for example, LVDT #6 deflects downward as the wheels pass and then deflect upward when the wheels pass the location of LVDT #3. This behavior is observed for other LVDTs as well. The maximum deflections, both upward and downward, for each LVDT are shown in Figures 4.19 and 4.20 for the south and north pavements, respectively.

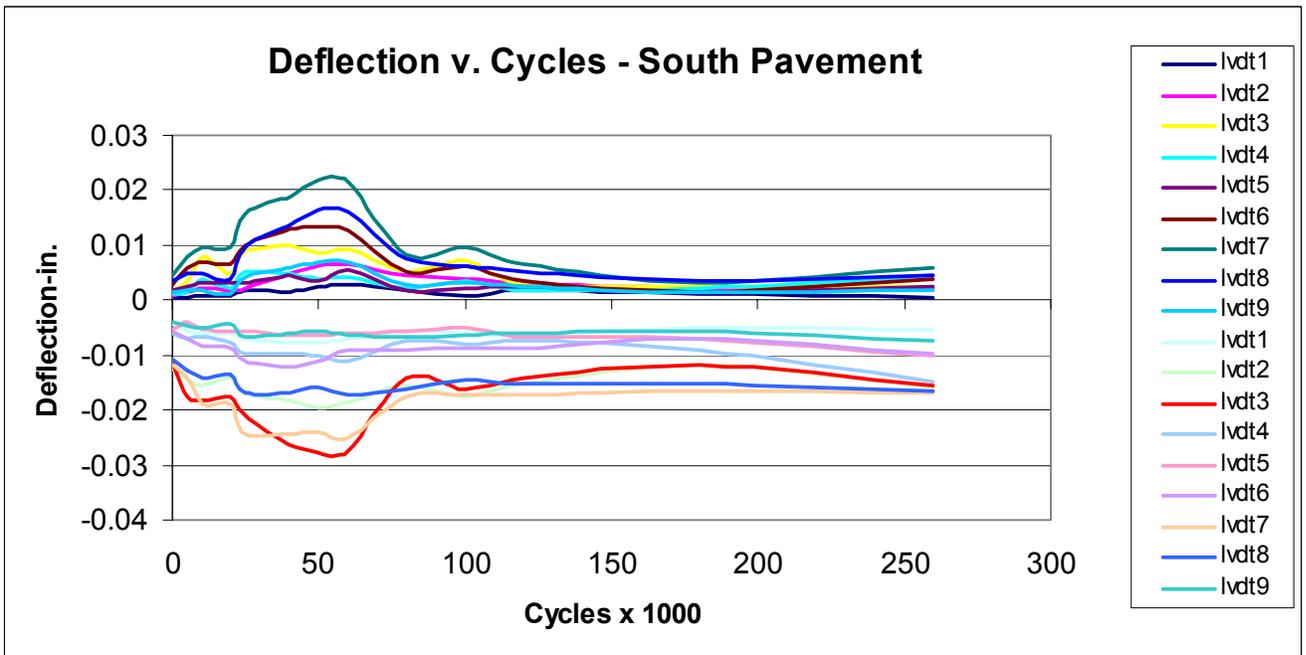
FIGURE 4.19: Max Deflections, South Pavement

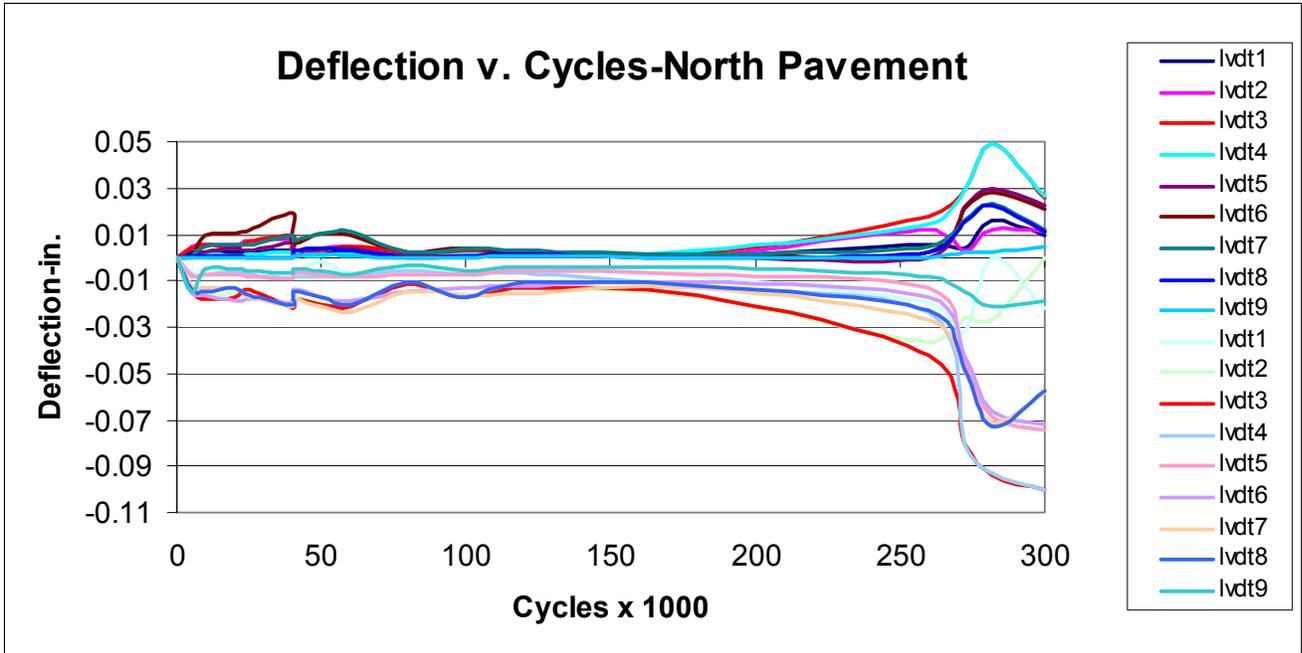
FIGURE 4.20: Max Deflections, North Pavement

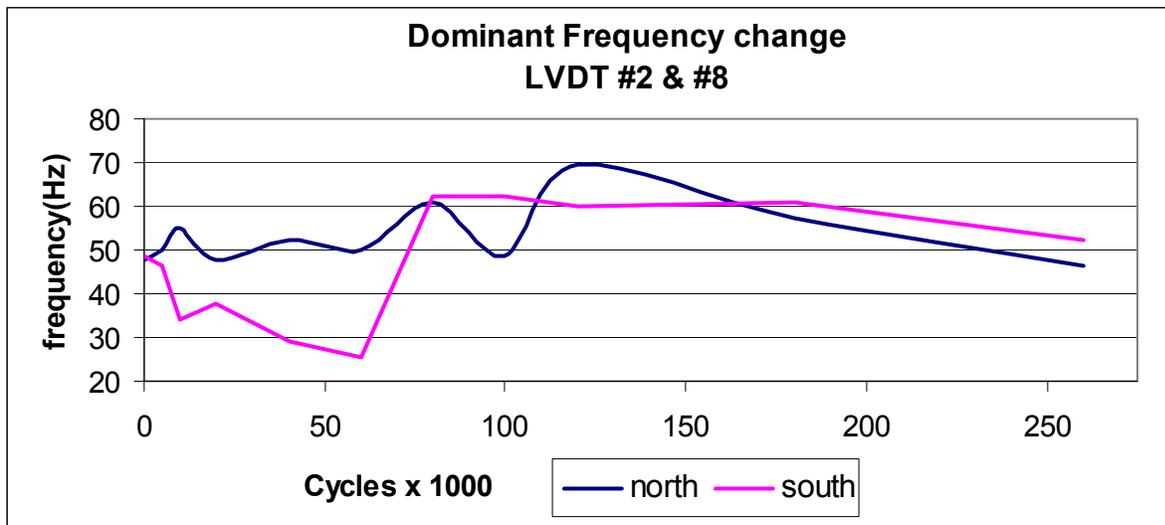
Figure 4.21: dominant Frequency vs. Cycles, Position #3 and #7, LVDT #2 and #8

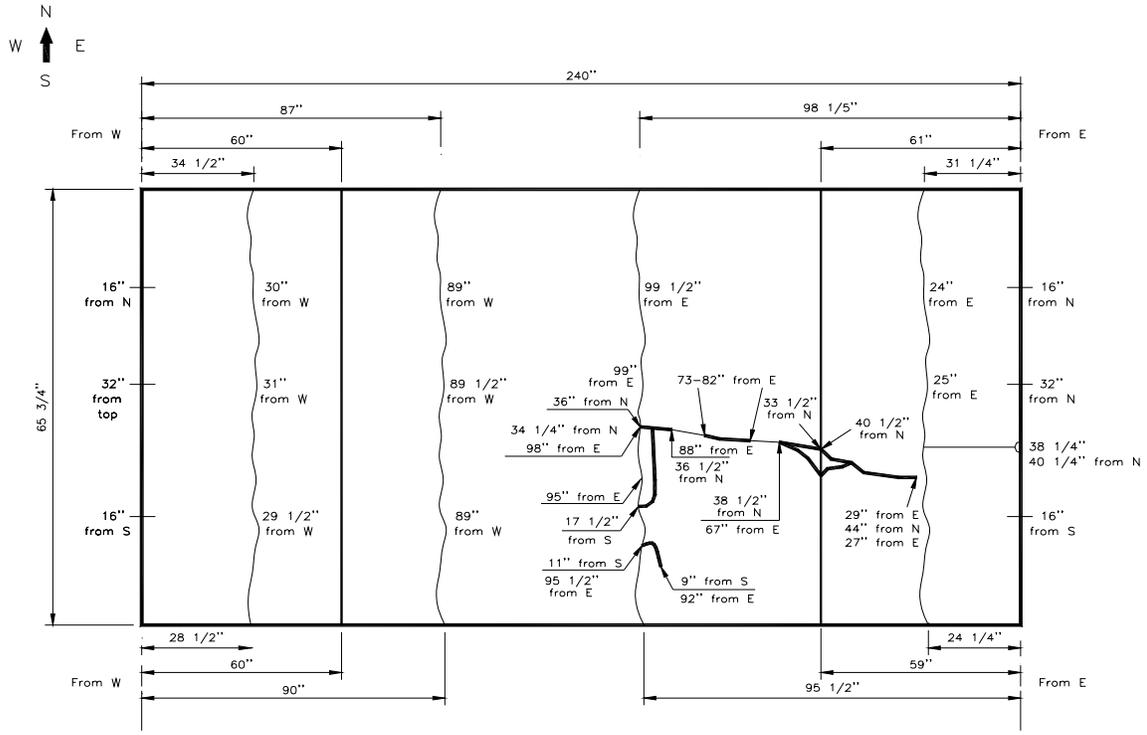
Pavement cracks developed during experiment #9 were monitored and documented for the duration of the experiment. Table 4.7 details the crack developments and the number of applied cycles. Figures 4.22 and 4.23 show the location of the cracks which occurred in the north and south pavements, respectively.

FIGURE 4.22: Crack Mapping for the North Pavement (Exp. #9)

Cycles	Description/Comments
40,000	-North slab, 1 st crack, through width, 28” east of west transverse joint -Repaired with 4 FRP plates (stitches)
180,000	-North slab, 2 nd crack, through width, 37” west of east transverse joint -South slab, 12” transverse hair crack, 37” west of east transverse joint
200,000	-South slab, 1 st crack, through width, 36” east of west transverse joint -South slab, 12” longitudinal hair crack, east from west transverse joint
250,000	-North slab, 3 rd crack, through width, 33” east of east transverse joint -Pumping starts at east transverse joint from north slab
258,000	-North slab, 4 th crack, through width, 28” west of west transverse joint -Pumping increases at east transverse joint, observed at west transverse joint -Cracks 2 and 4 begin to open/work in north slab
280,000	-North slab, longitudinal cracks, both directions from 2 nd crack and from east joint to 3 rd north slab crack

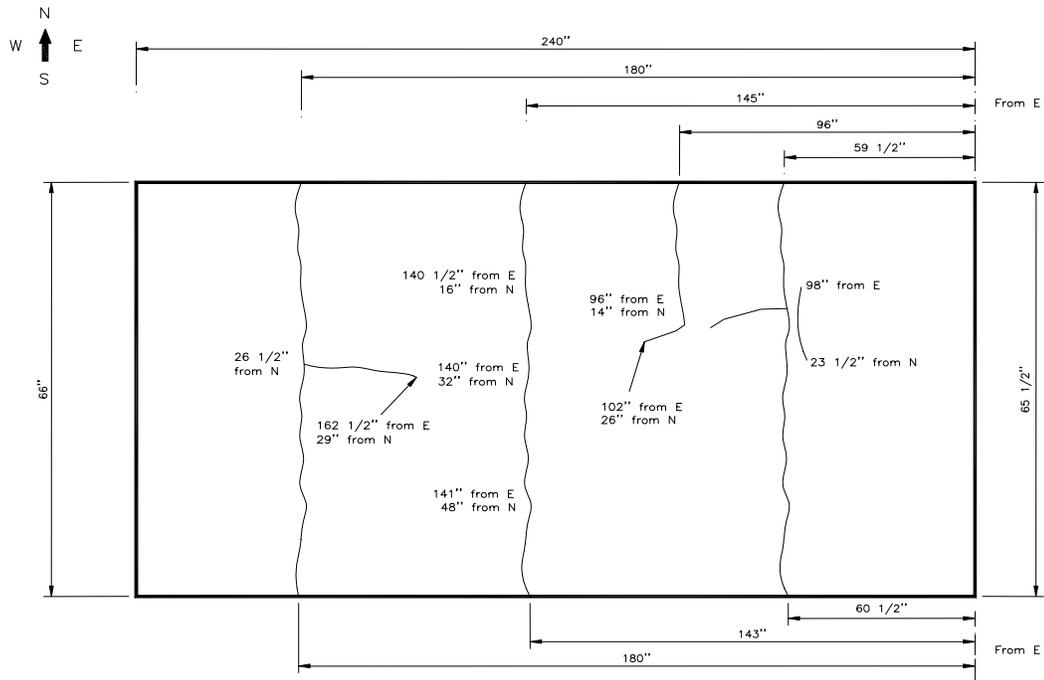
FIGURE 4.23: Crack Mapping for the South Pavement (Exp. #9)

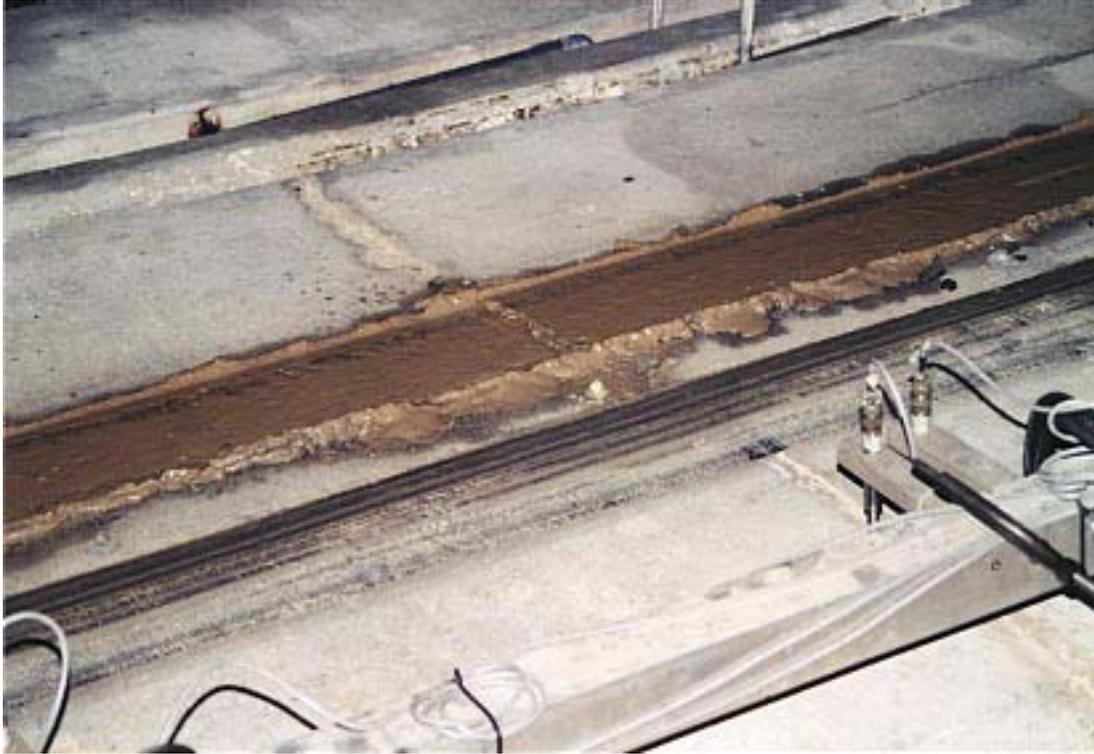
Severe pumping of the fines, both through the cracks and joints at the pavement surface (Figure 4.24), and the side drain (Figure 4.25) were observed in the north lane. The fine material from the semi-permeable base was pumped out. Since no pumping was observed in the south lane, it can be clearly concluded that the permeable base gives better performance than the semi-permeable base.

FIGURE 4.24: Pumping through Cracks and Joints in the North Lane

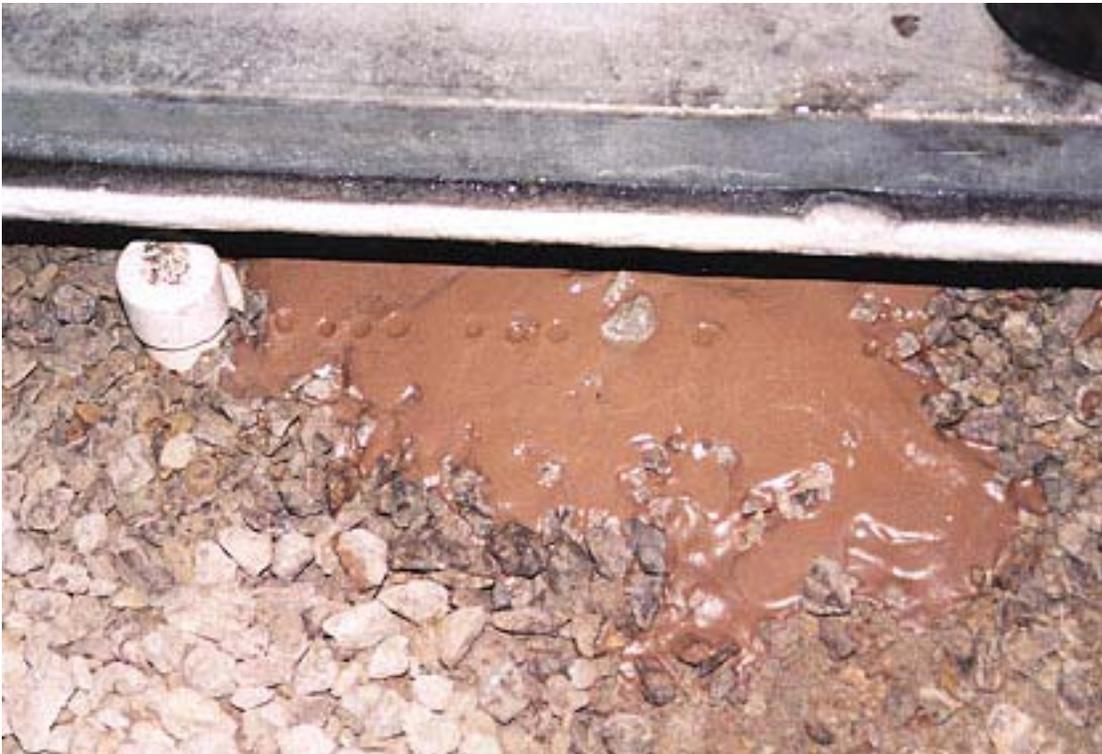
FIGURE 4.25: Pumping on the Side of the North Lane

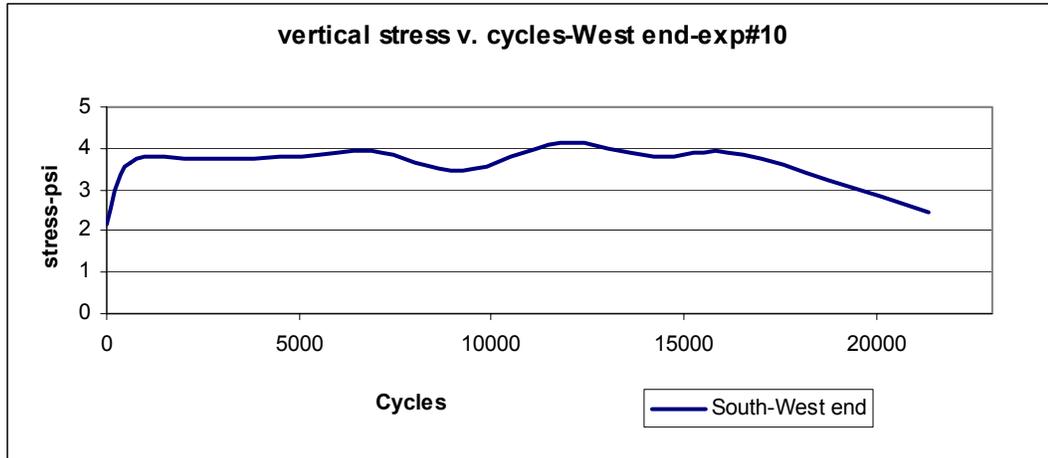
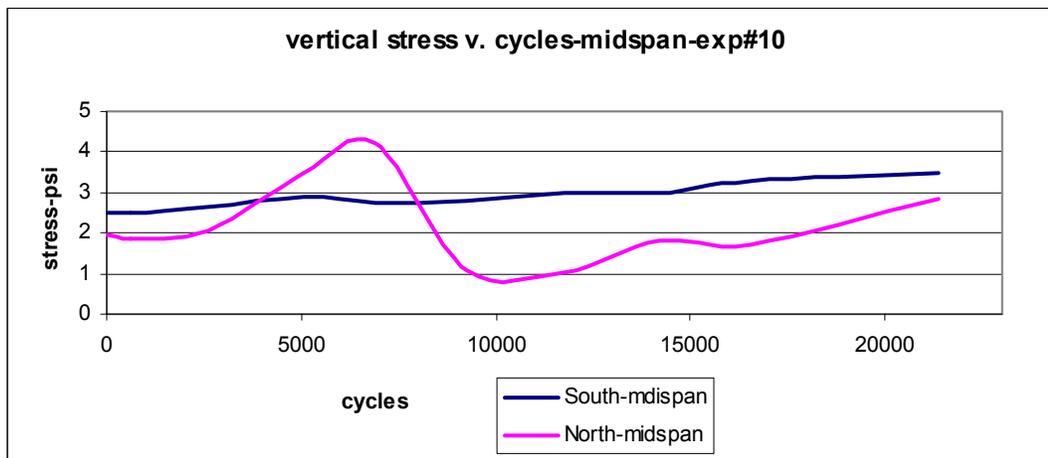
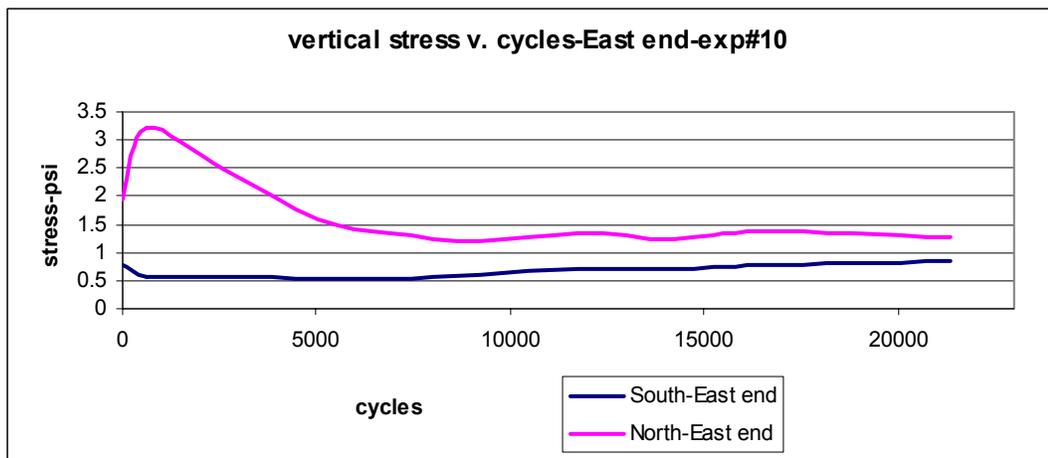
FIGURE 4.26: Vertical Stress vs. Cycles, West End, Exp. #10

FIGURE 4.27: Vertical Stress vs. Cycles, Midspan, Exp. #10

FIGURE 4.28: Vertical Stress vs. Cycles, East End, Exp. #10

The stress for the south pavement for the midspan and east end locations increases slightly over the duration of the experiment. The stress in the north pavement at midspan increases sharply to 4.3 psi at 6500 cycles, then decreases to less than 1.0 psi at 11,000 cycles, then shows an increasing trend to the end of the experiment. The stress at the east end of the north pavement increases above 3 psi at 700 cycles, then decreases to approximately 1.3 psi to the end of the experiment.

Vertical stress in the subbase for experiment #10 was monitored in the same six locations as described in section 3.1.9 for experiment #9, Pressure Cells. The maximum vertical stresses (in psi) are provided in Table 4.8. The pressure transducer located at the west end of the north pavement failed during experiment #9, therefore no data was collected. Figures 4.26 to 4.28 show vertical stress vs. cycles for the west end, midspan and east end locations, respectively. The stress in the west end of the south subbase increases initially, remains constant from 1000 to 17000 cycles, then decreases until the end of the test.

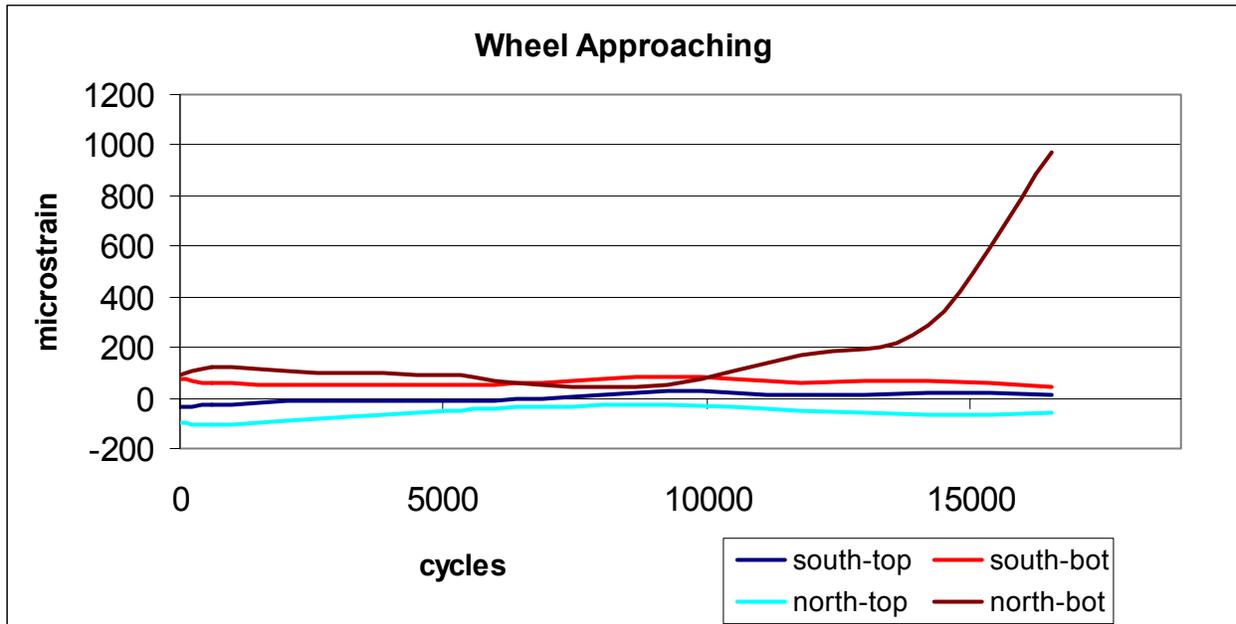
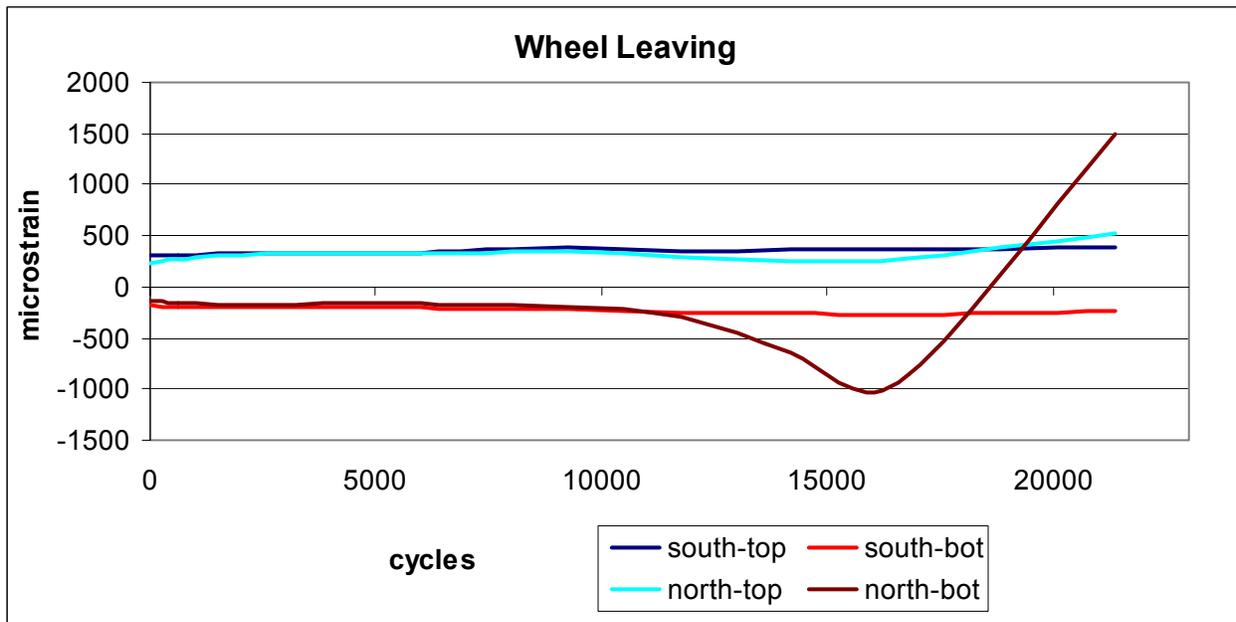
The last four columns show the strains in both pavements as the wheels have passed locations #1 and #4. Figures 4.29 and 4.30 show the strains at the top and bottom positions for locations #1 and #4 as the wheels approach and after passing, respectively.

FIGURE 4.29: Strain vs. Cycles for Location #1 and #4 (Wheel Approach)

FIGURE 4.30: Strain vs. Cycles for Location #1 and #4 (Wheel Leaving)

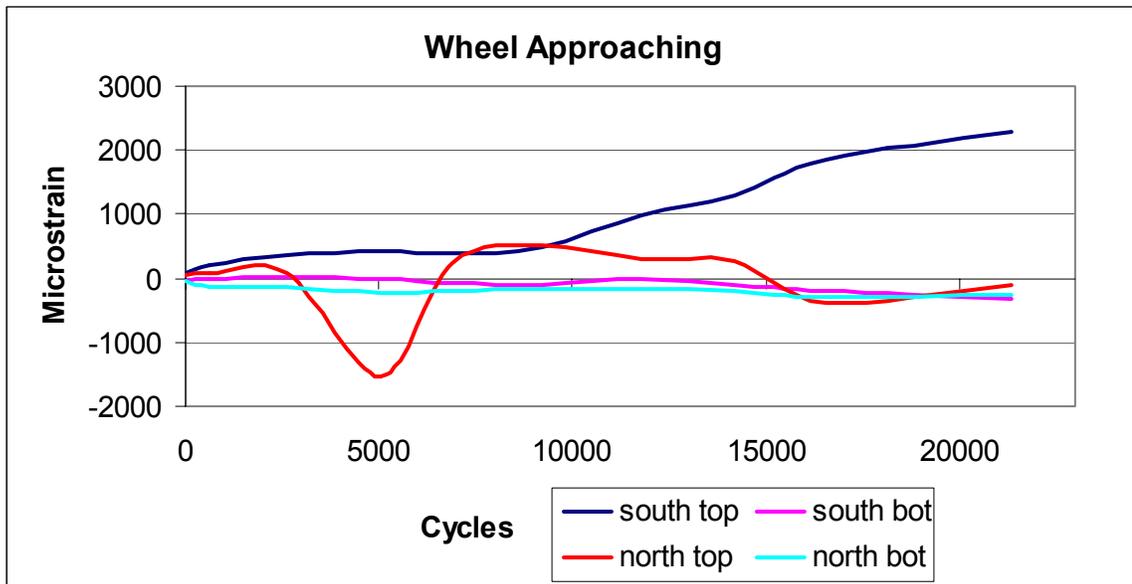
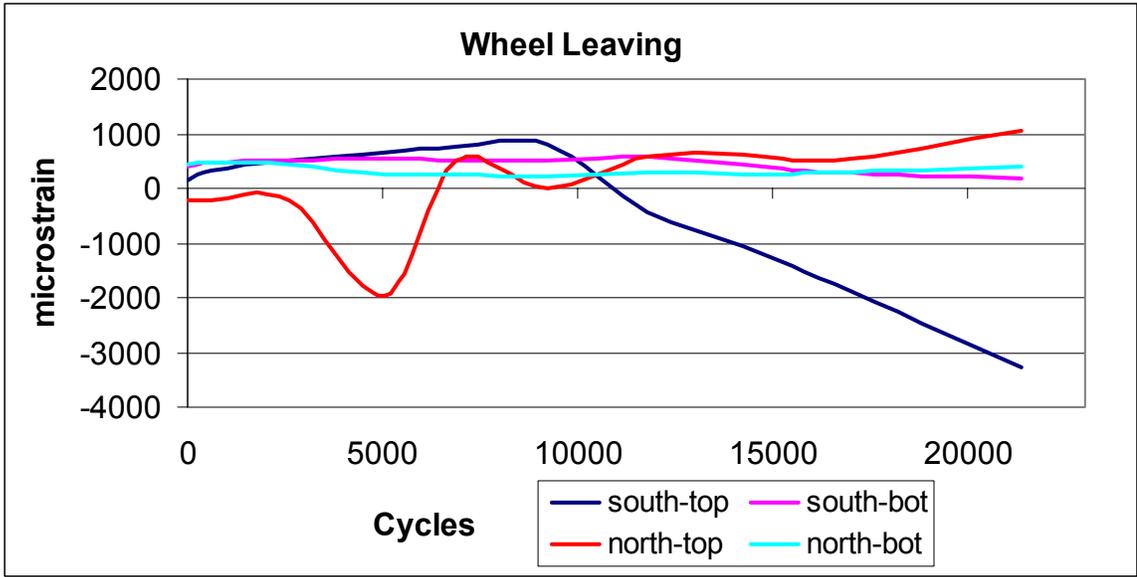
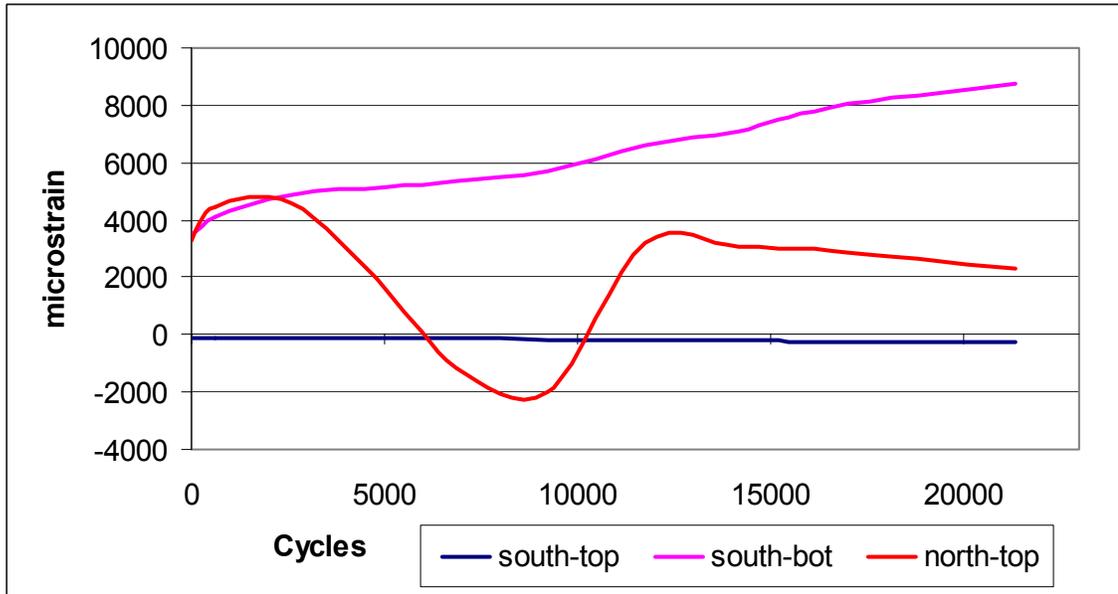
Figures 4.31 and 4.32 show the longitudinal strains at the top and bottom positions for locations #2 and #5 as the wheels approach and after leaving, respectively. Figure 4.33 shows the transverse strains at the top and bottom positions for locations #2 and #5.

FIGURE 4.31: Longitudinal Strain vs. Cycles (Locations #2 and #5)

FIGURE 4.32: Longitudinal Strain vs. Cycles (Locations #2 and #5)

FIGURE 4.33: Transverse Strain vs. Cycles (Locations #2 and #5)
