Report No. FHWA-KS-02-7
FINAL REPORT

ACCELERATED TESTING FOR STUDYING PAVEMENT DESIGN AND PERFORMANCE (FY 2001)

*Evaluation of the Performance of Permeable and Semi-Permeable Unbound
Granular Bases under Portland Cement Concrete Pavement (PCCP) Slabs and
Alternate Load Transfer Devices for Joint Repair*

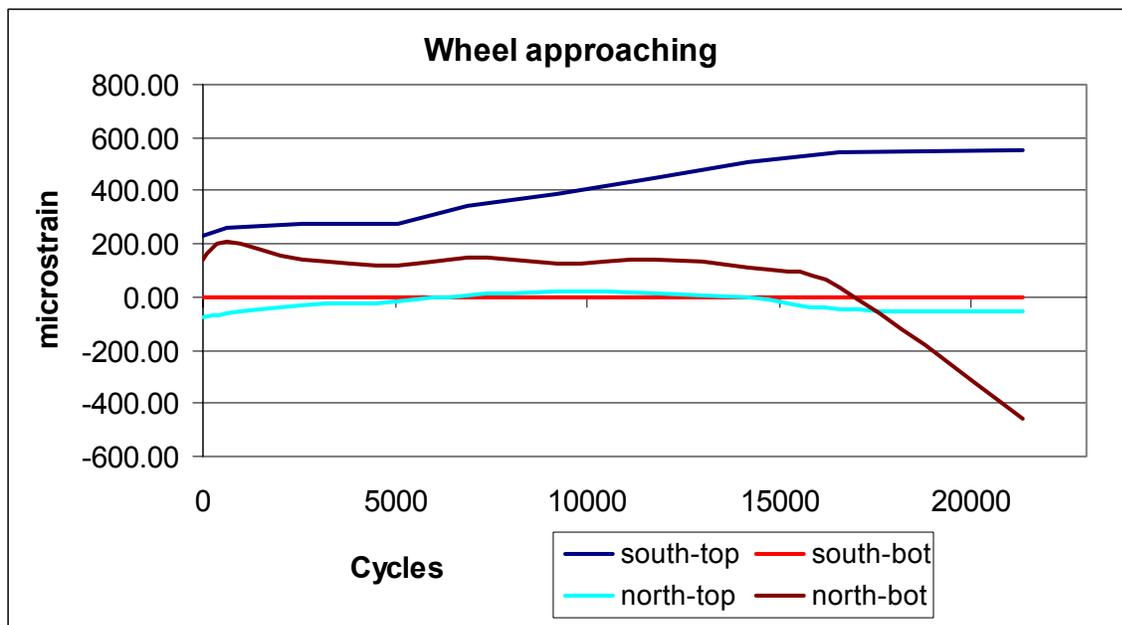
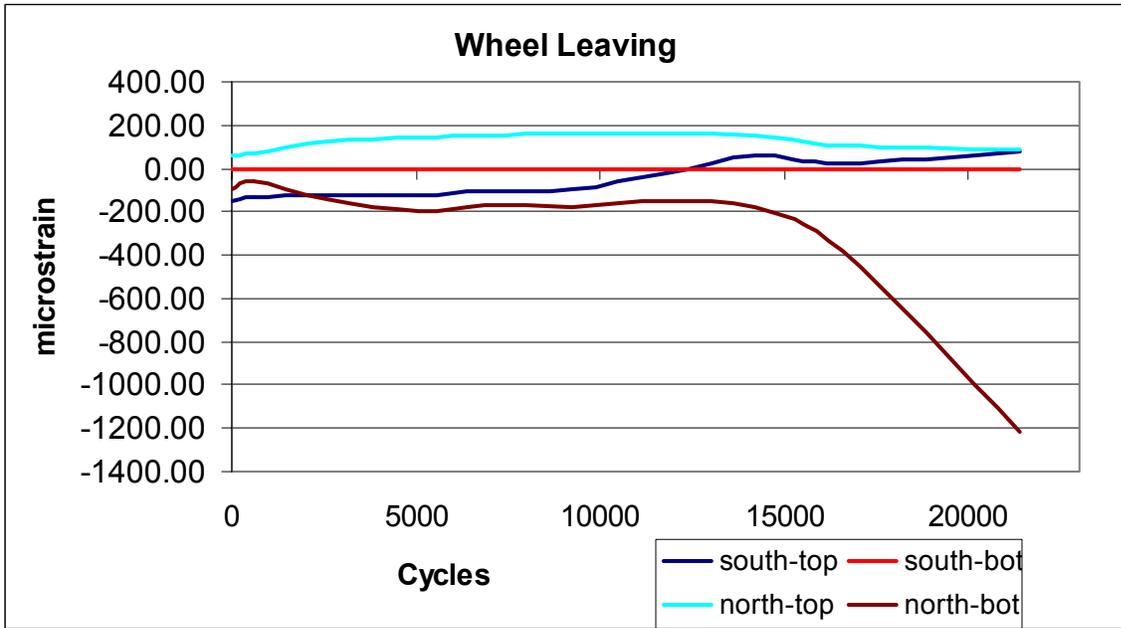
Figures 4.34 and 4.35 show the longitudinal strains at the top and bottom positions for locations #3 and #6 as the wheels approach and after leaving, respectively.

FIGURE 4.34: Strain vs. Cycles for Locations #3 and #6

FIGURE 4.35: Strain vs. Cycles for Locations #3 and #6

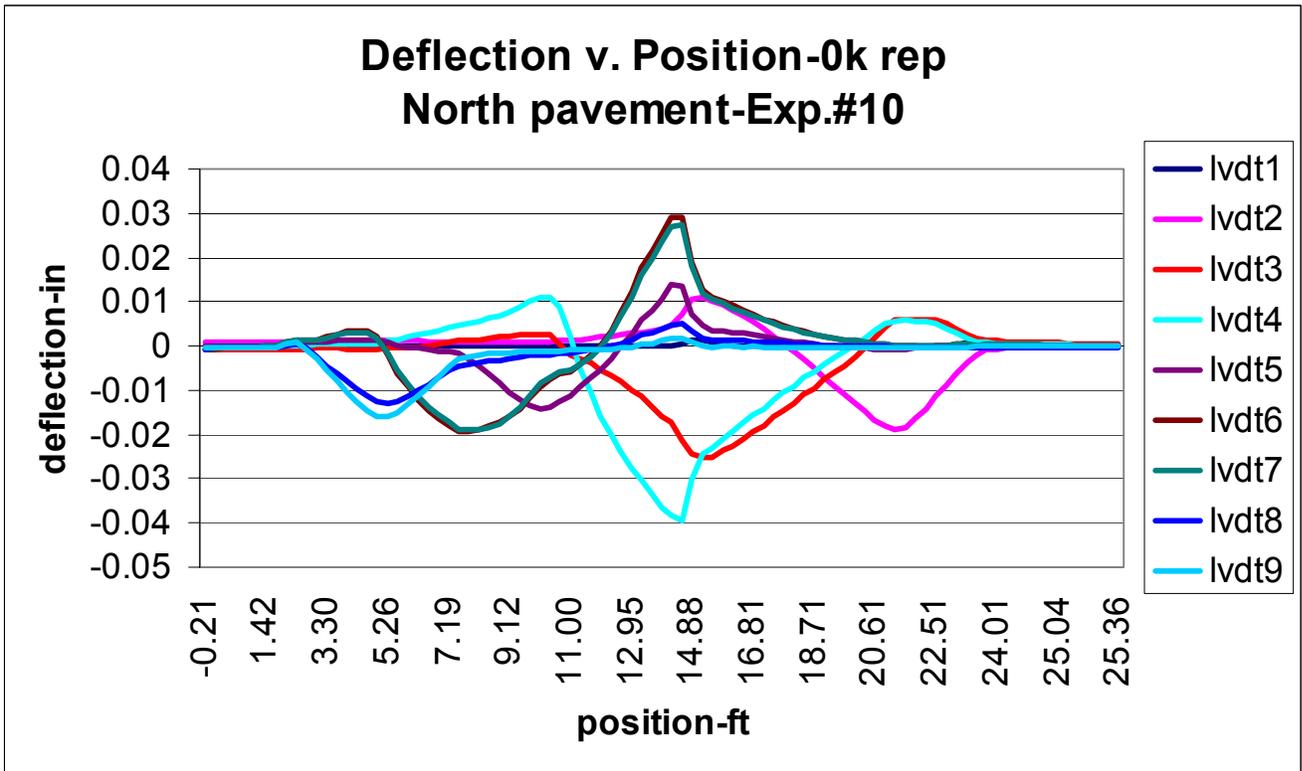
The vertical deflection in only the north pavement was monitored in experiment #10 using LVDT's. The description and location of each LVDT is described in section 3.2.3 for the rolling wheel loads. A typical deflection response for the north pavement is shown in Figure 4.36. As the wheel travels west to east, LVDT #9 is first to deflect downward and LVDT #1 is last to deflect downward, as observed in Figure 4.36. It is observed that as the wheels travel west to east, for example, LVDT #6 deflects downward as the wheels pass and then deflect upward when the wheels pass the location of LVDT #3. This behavior is observed for other LVDTs as well. The maximum deflections, both upward and downward, for each LVDT are shown in Figures 4.37 and 4.38 for the north pavements, respectively.

FIGURE 4.36: Deflection vs. Position, North Pavement, 0k cycles

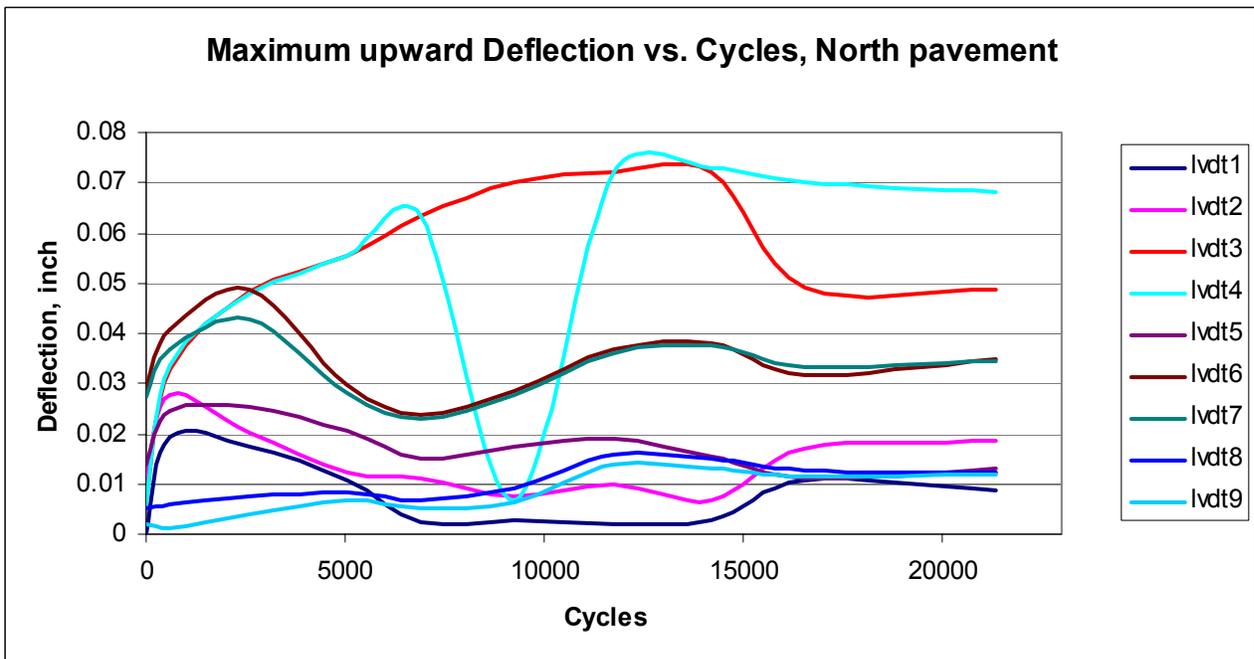
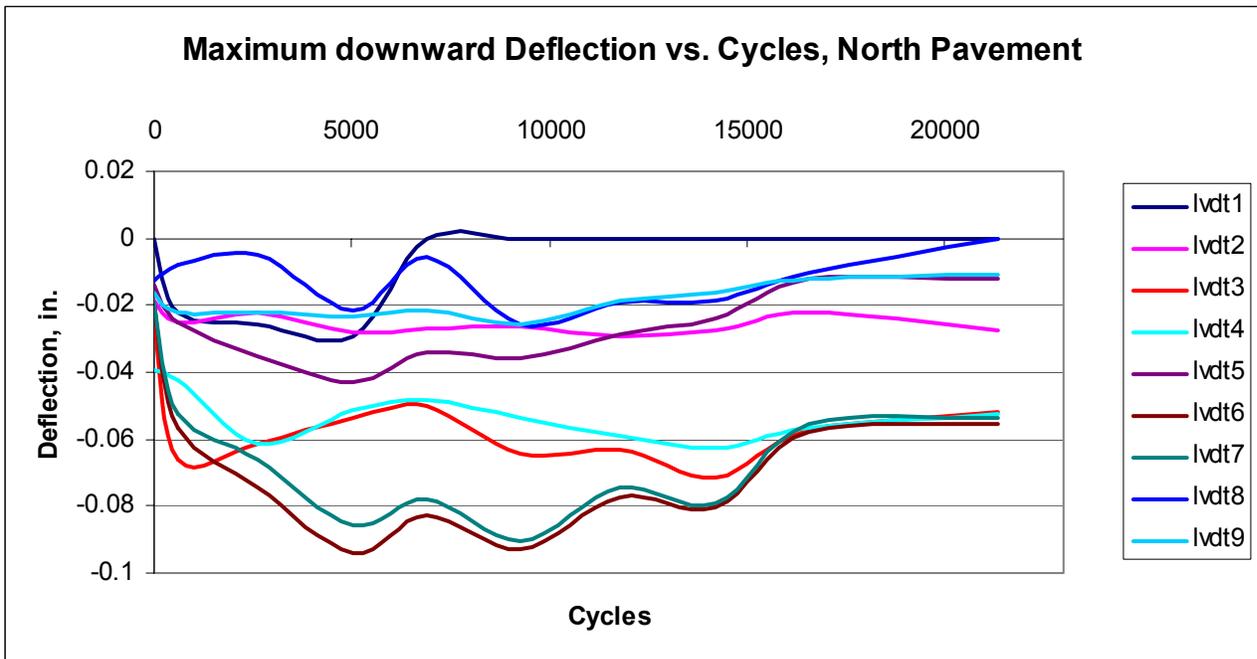
FIGURE 4.37: Maximum Upward Deflections vs. Applied Cycles

FIGURE 4.38: Maximum Downward Deflection vs. Applied Cycles

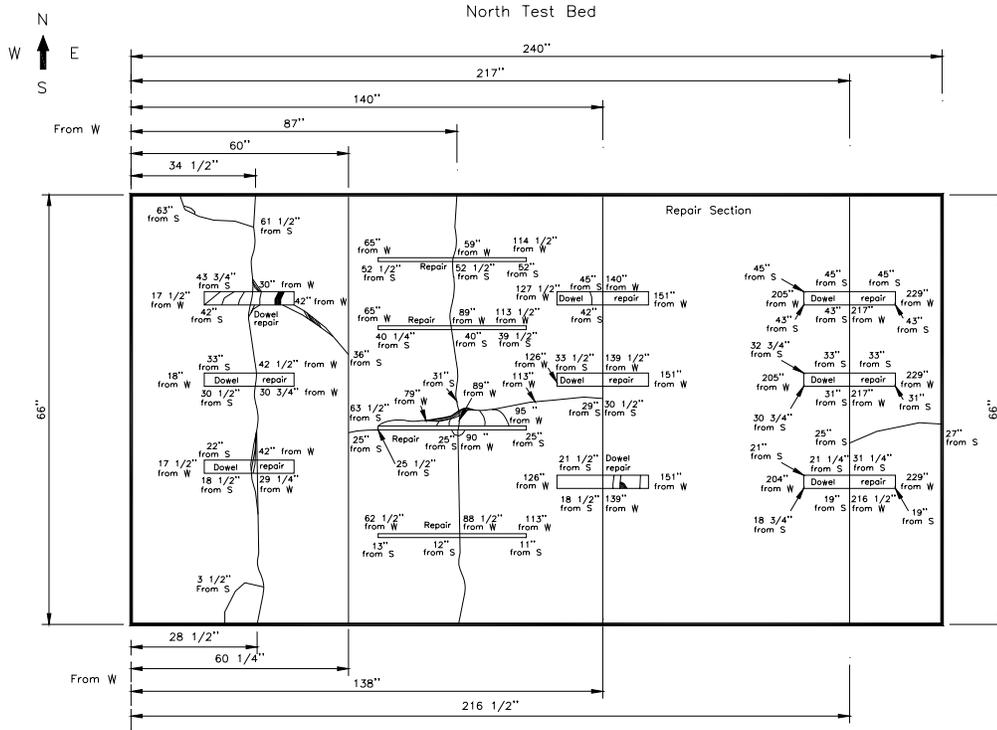
FIGURE 4.39: Crack Mapping in the North Pavement, Exp. #10

Cycles	Description/Comments
302,600	-North slab, crack observed on 1 ½” FRP dowel -Pumping steadily from north slab, several locations
309,236	-North slab, longitudinal crack observed originating at FRP plate (stitch) toward west transverse joint -Pumping significant on north edge of north slab, observable from south edge of north slab
314,205	-North slab, faulting and starts to breakup at west end (4 th crack) 1” FRP dowel retrofit
316,550	-North slab, substantial joint faulting and deterioration at west end retrofit -Original mid-span section of slab (between 1 ½” and 1” FRP dowels) split longitudinally -No significant signs of distress near the epoxy coated steel dowels
321,355	-Test terminated due to severe distresses in the north lane

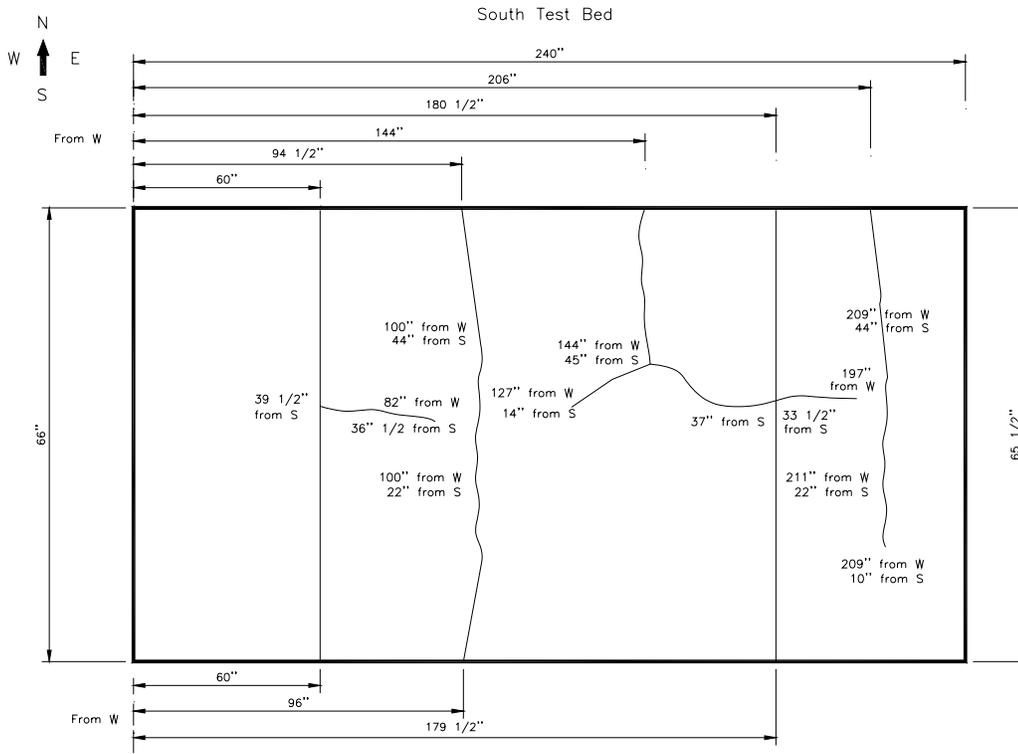
FIGURE 4.40: Crack Mapping in the South Pavement, Exp. #10

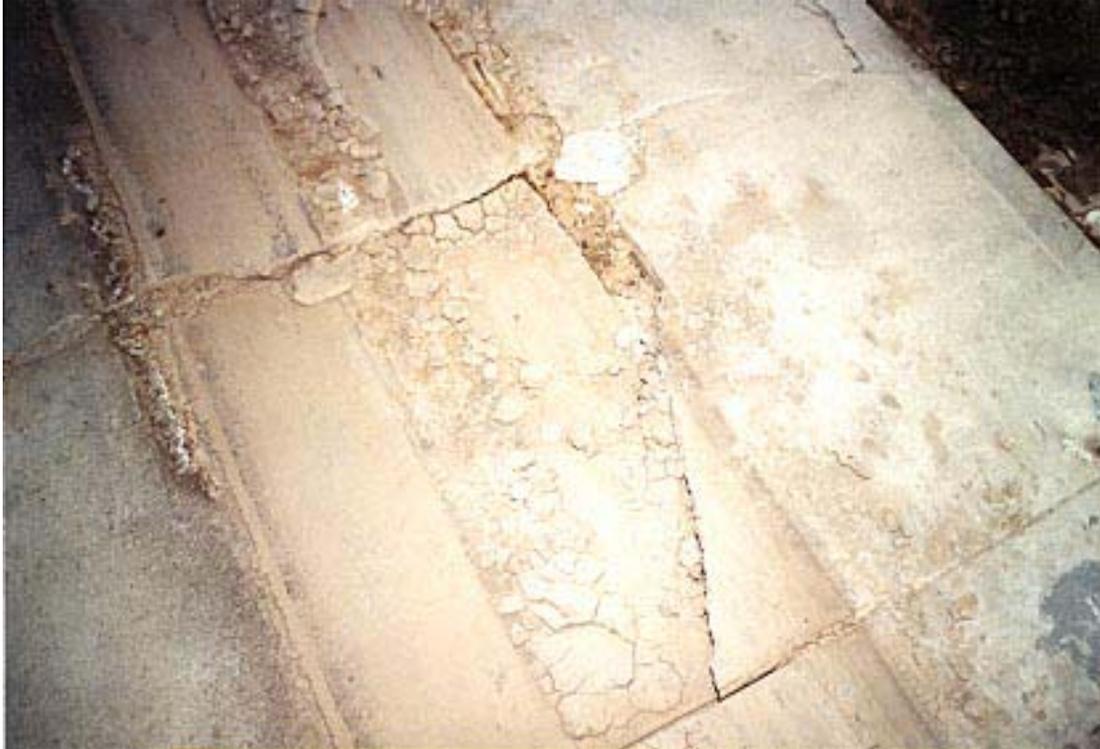
FIGURE 4.41: Severe Crack along FRP Dowel in the North Lane

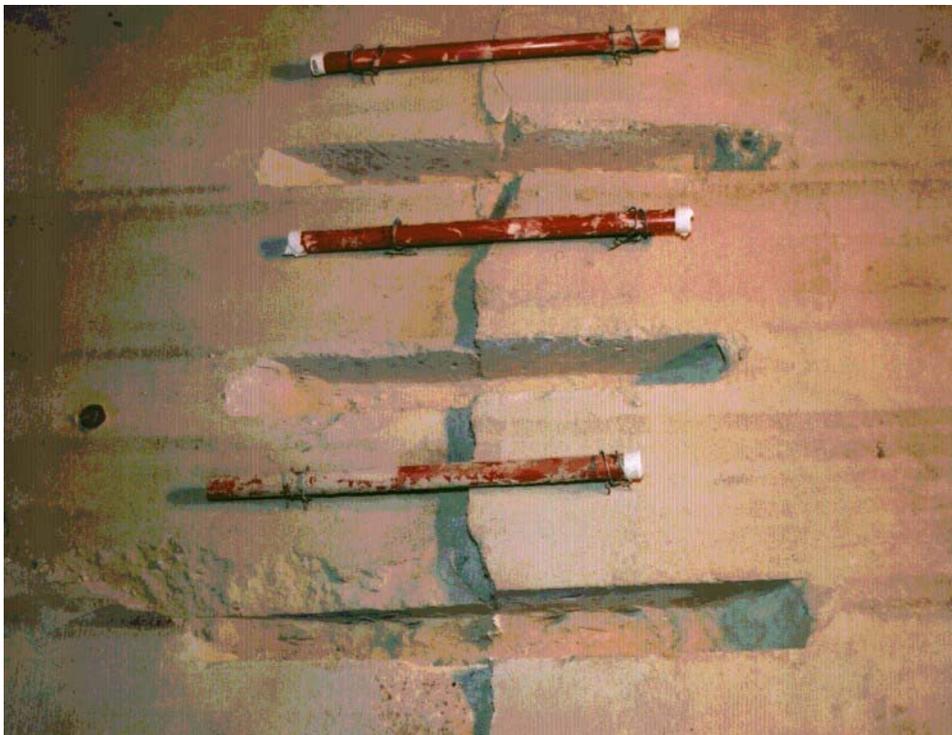
FIGURE 4.42: FRP Dowels after Removal in the North Lane (West End)
