NCAT Report 02-12

# NCAT TEST TRACK DESIGN, CONSTRUCTION, AND PERFORMANCE

November 2002

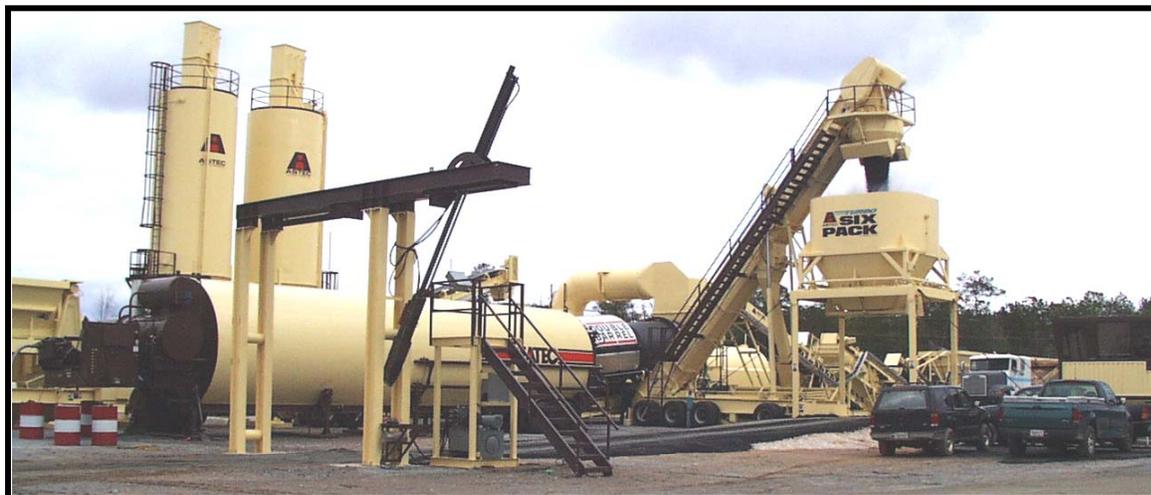
**Figure 2. Onsite Double Drum Asphalt Plant Used to Produce All Track Mix**

Laboratory job-mix formulas were used as a starting point when each mix was trial run through the plant for the first time. Stockpile moisture contents were measured daily on any aggregates that were scheduled for production to minimize the effect on plant operations and resulting final mix proportions. A portable double drum plant (presented as Figure 2) was temporarily located onsite to produce mix exclusively for Track construction with minimal haul times.

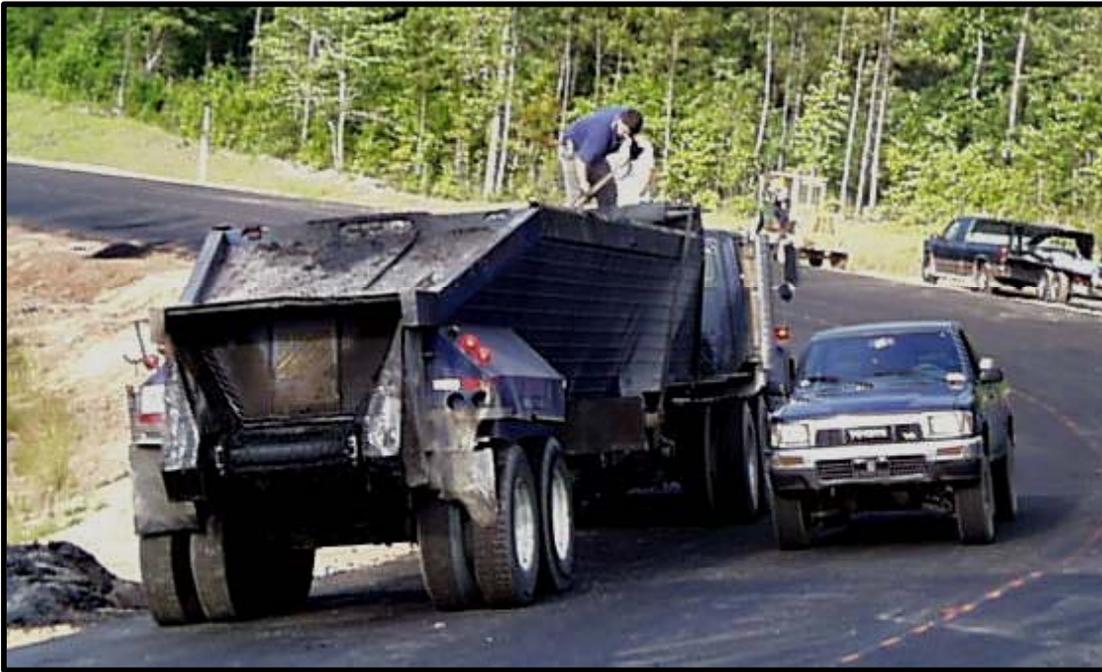
**Figure 3. Removing Shovel Sample from Truck on Roadway**

Two 24-ton haul trucks were loaded and driven the short distance to the location of test section placement, with the balance of the plant run being kept in the integrated 65-ton surge bin. Paving was allowed to begin only when both trucks were lined up and ready to discharge into the material transfer device (MTD). Generally, the inside lane was paved first to establish a rolling pattern and was then utilized for destructive coring so

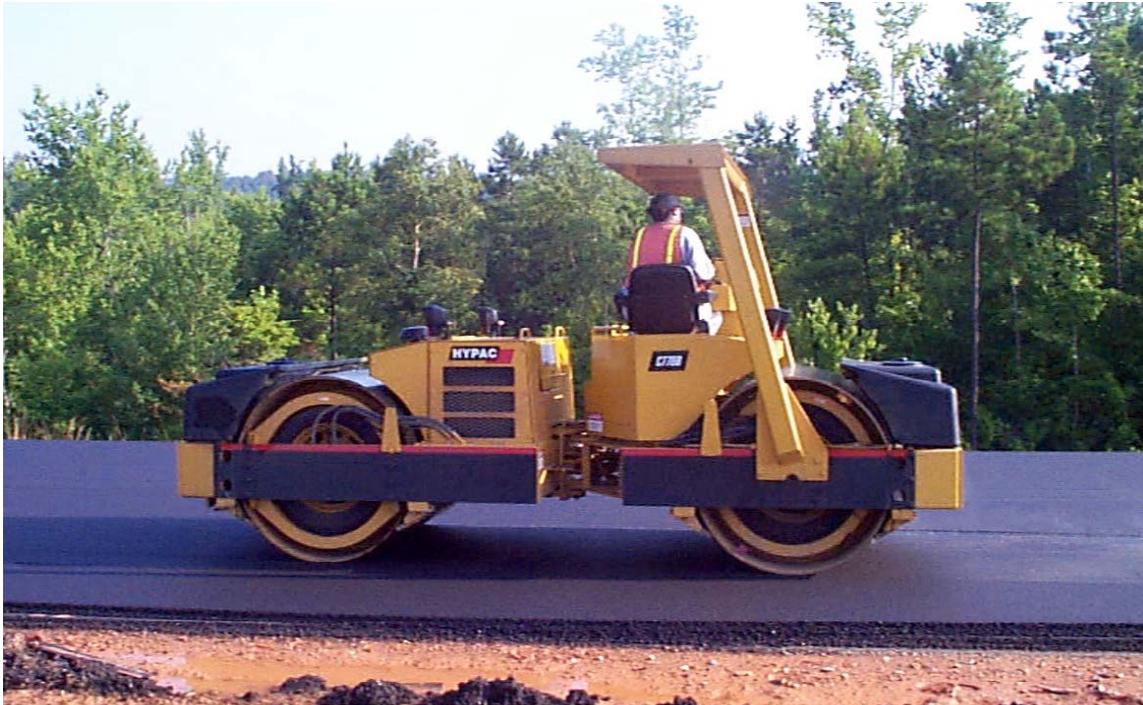
**Figure 8. Vibratory Steel Wheel Roller Compacting Track Mix**

Relative increases in density were monitored in the inside lane to identify the breakpoint in the compaction operation, which was used to establish the roller pattern in the outside (research) lane. Vibratory steel-wheeled rollers (Figure 8) were used for breakdown rolling, a pneumatic rubber-tired roller (Figure 9) was used as necessary for intermediate rolling, and the vibratory steel-wheeled roller was used in static mode for finish rolling.

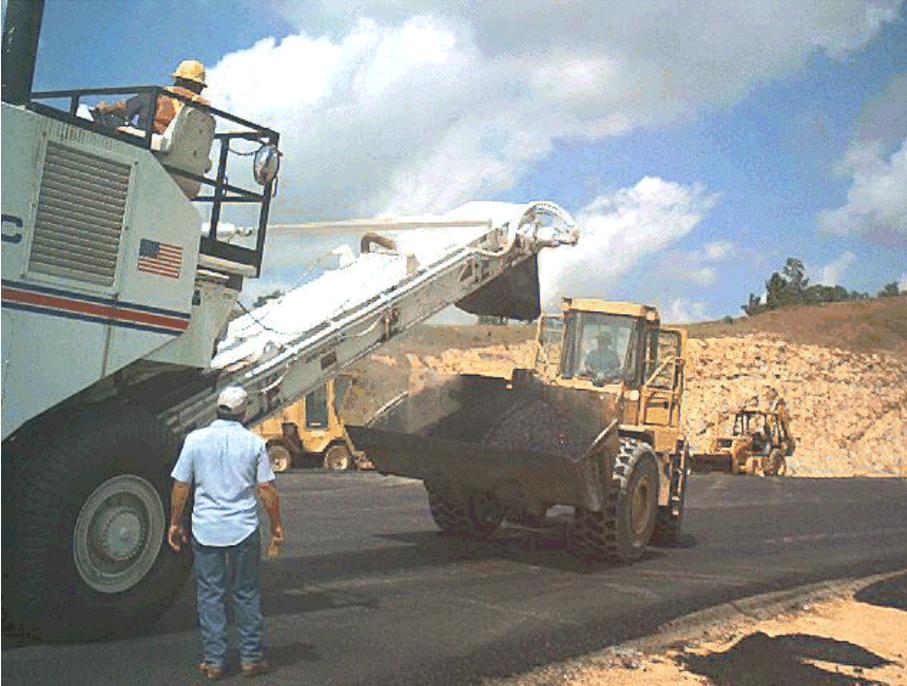
**Figure 10. Sampling Research Mix by Dumping into Front End Loader**

Concurrently, the MTD was advanced slightly and boomed over to accommodate dumping 2 to 3 tons of blended mix into a front-end loader (Figure 10). This material was utilized for the fabrication of numerous research specimens that were later used for laboratory performance testing. When filled, the front-end loader was driven back to the onsite laboratory where material was sampled and stored in buckets for later testing (Figure 11).

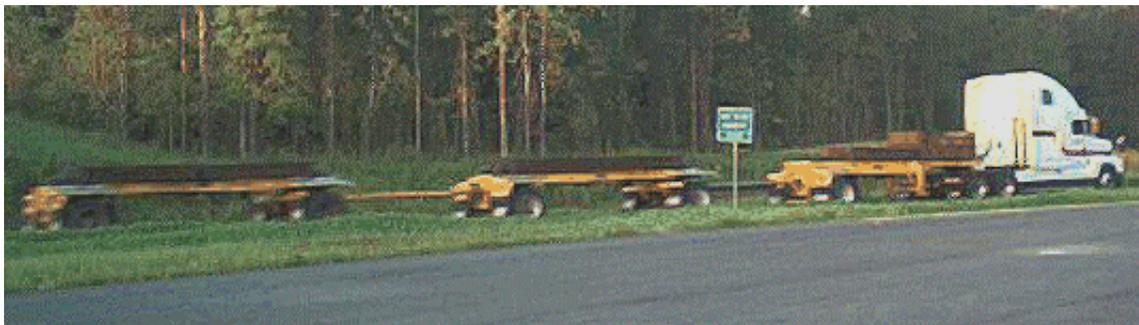
**Figure 14. Traffic Application via Triple Trailer Trains**

Four trucks haul triple trailer (tractor with 3 loaded trailers as shown in Figure 14) assemblies around the Track at 45 mph for 17 hours a day (six days a week) in order to apply 10,000,000 ESALs of traffic to the Track within two years. Although the main focus of the research is the accelerated performance of the test sections, data collected and observations made in support of the trucking operations have provided valuable information upon which future trucking operations can be refined.

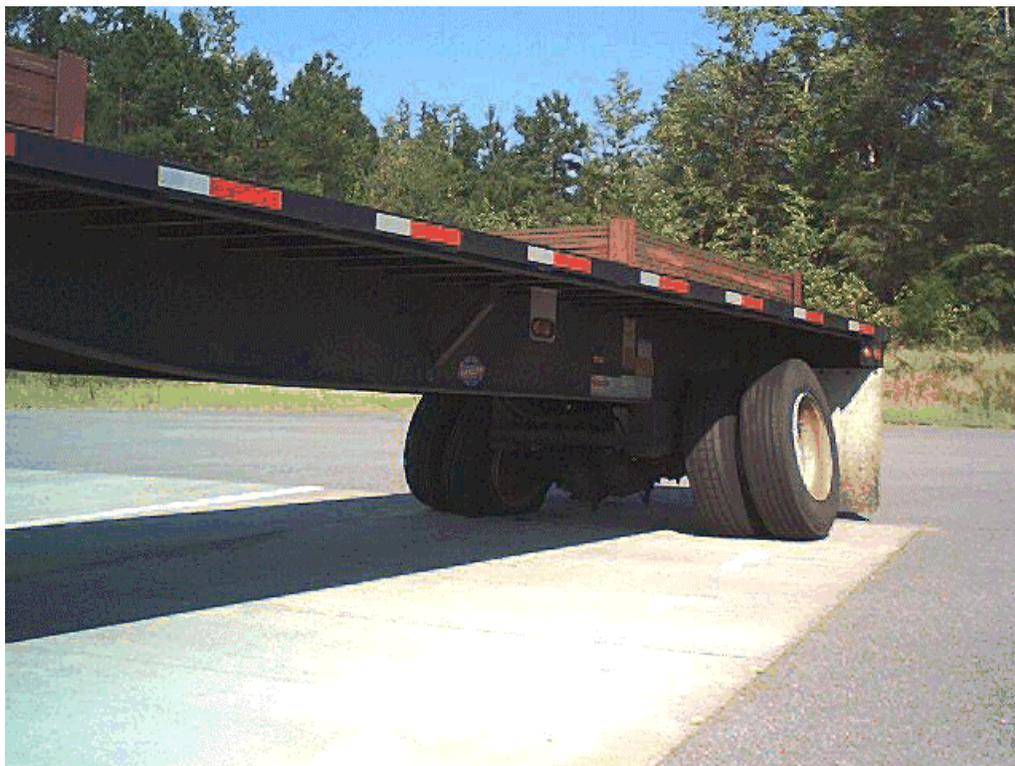
**Figure 15. Broken Rear Axle in Last Trailer of Train**

Due to the weight of the trailers, it took a truck almost a quarter of a mile to come to a complete stop. Because of the strain on the axles and the tires, several sets of tires were lost due to the wheel lug studs sheering off. Three axles failed due to the weight

of the trailers and literally split in half (Figure 15). In consideration of these issues, no one was allowed on the Track while the trucks were running.

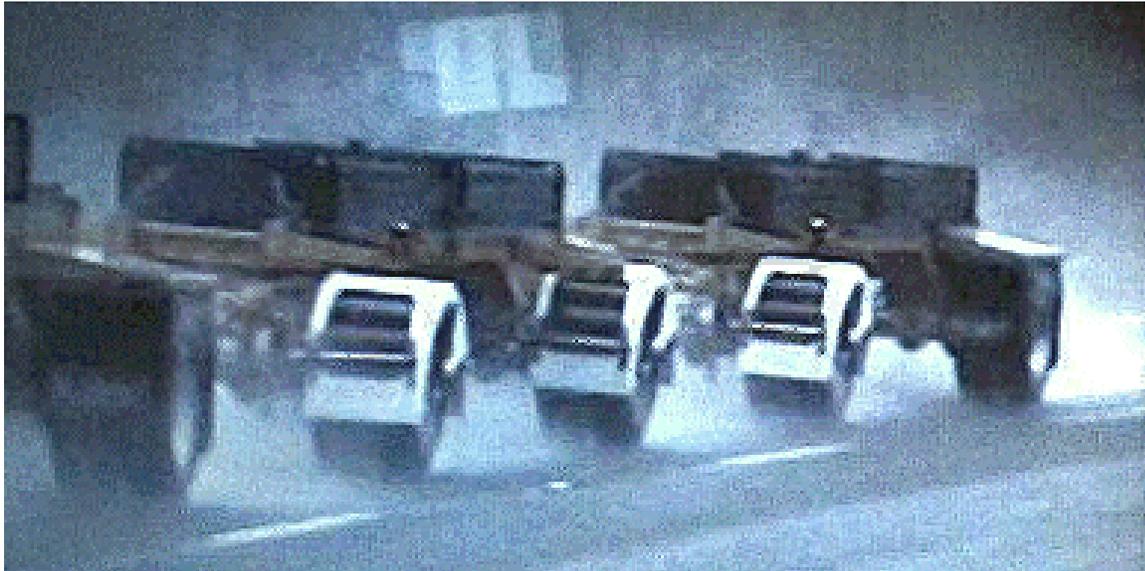
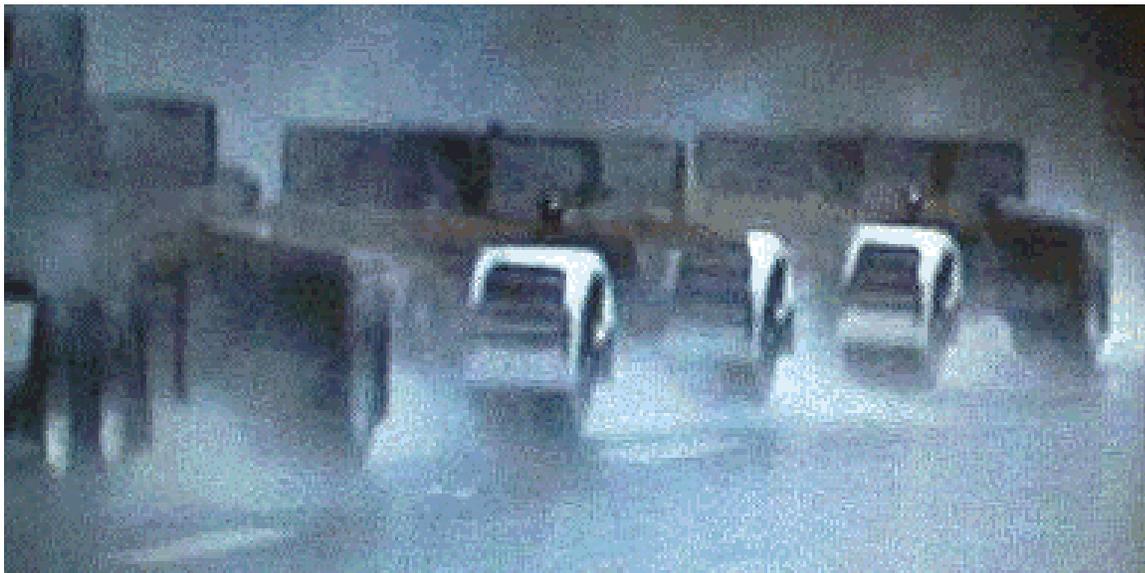
their potential to reduce road spray and extend tire life. Figures 16 through 18 show road spray on three different types of pavement surface: Open Graded Friction Course (Figure 16), Stone Matrix Asphalt (Figure 17), and Superpave (Figure 18). Notice that the spray is much less on the OGFC than on the dense graded Superpave mix and the SMA mix. The spray on the SMA mix was lower than that for the open graded friction course.

**Figure 16. Road Spray on OGFC Mix**

**Figure 17. Road Spray on SMA Mix**

**Figure 18. Road Spray on Coarse Graded Superpave Mix**

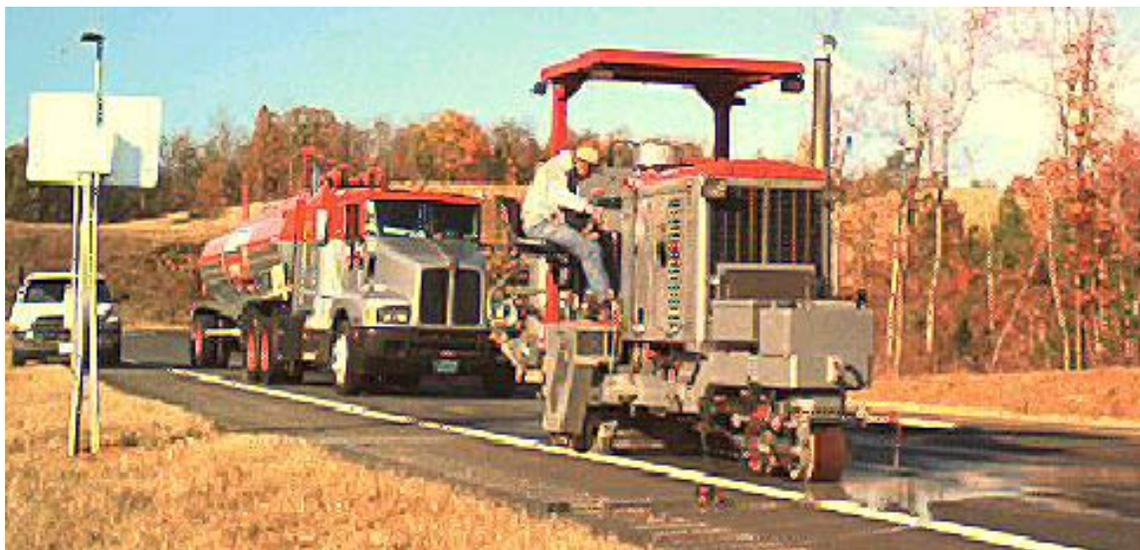
**Figure 22. Typical Diamond Grinding Operation**

Diamond grinding is similar to cold milling except diamond grinding equipment uses diamond saw blades that are gang mounted to a cutting head instead of carbide teeth. This allows more precise profiling. The cutting heads are typically 36 to 37 inches wide (914 to 940 mm), though the cutting heads on new equipment may be up to 47 inches (1194 mm) wide. The diamond saw blades are spaced to provide a corduroy texture in the ground pavement. The groove spacing varies from 50 to 60 grooves per foot (164 to 194 grooves per m). Typically, the grooves are approximately 0.06 in (1.5 mm) deep (4). Water is used to cool the diamond blades during grinding. Diamond grinding machines utilize integrated wet vacuums to remove the grinding slurry. A typical diamond grinding operation is shown in Figure 22 (NCAT Test Track November 2000).

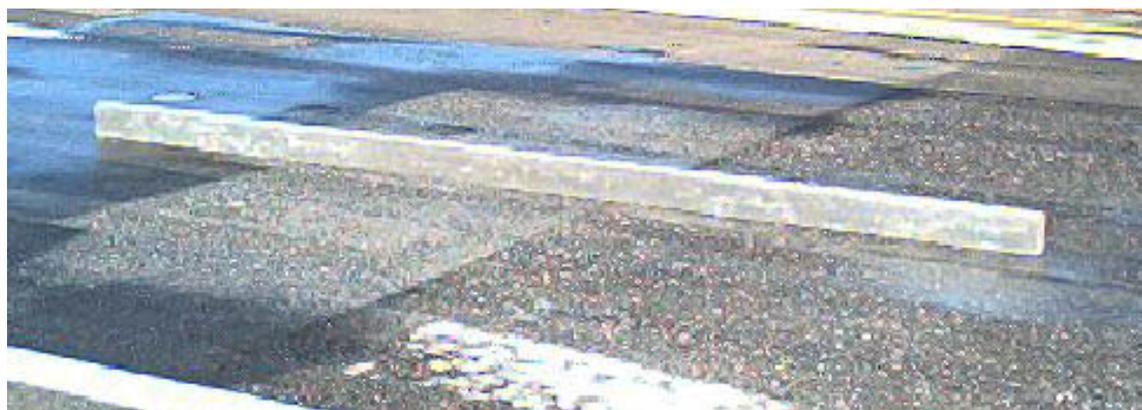
**Figure 24. Typical Ground Joint Texture**

N7 to N8 and S3 to S4. All of the ground sections were left unsealed. A typical surface texture of a ground section is shown in Figure 24.

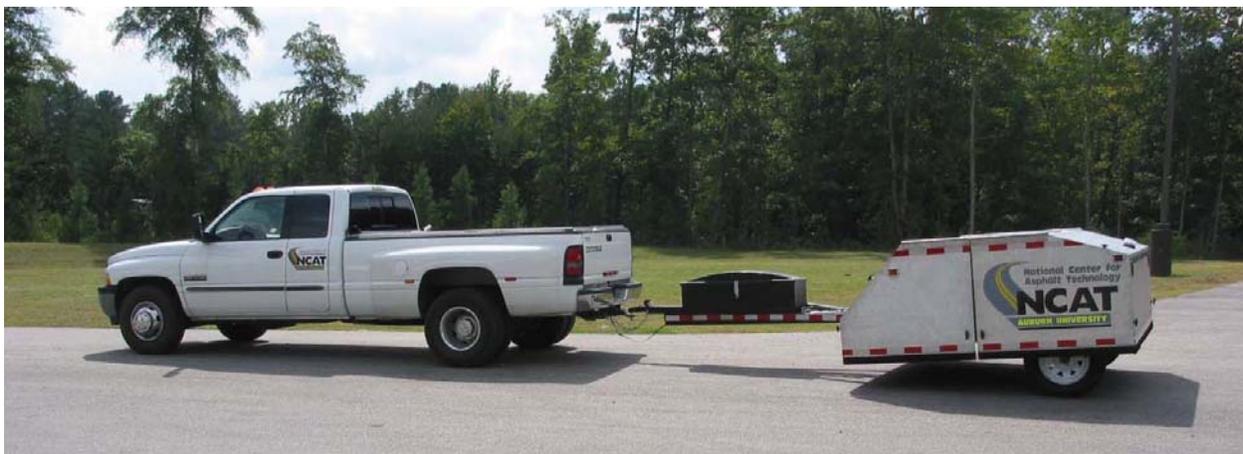
**Figure 56. NCAT CPX Trailer**

The National Center for Asphalt Technology designed and built a CPX trailer for the Arizona Department of Transportation (ADOT) during the Fall of 2001. It was delivered to ADOT in late January 2002 and is being used by ADOT to evaluate a number of pavement surfaces in Arizona. In October 2002 the second generation CPX trailer was delivered to NCAT and is now being used to conduct studies at the Track. Figure 56 shows a picture of that new trailer.
