1. Report No. SWUTC/07/167762-1		2. Government Accession No.		3. Recipient's Catalog No.	
4. Title And Subtitle TESTING AND EVALUATION OF PEDESTRIAN SENSORS				5. Report Date September 2007

TESTING AND EVALUATION OF PEDESTRIAN SENSORS

Development of the WALKSAFE
Pedestrian Safety Testbed in College Station

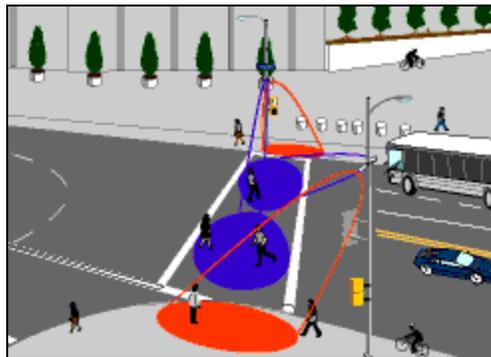
Figure 1. Example of Microwave Detection Zones at Signalized Intersections

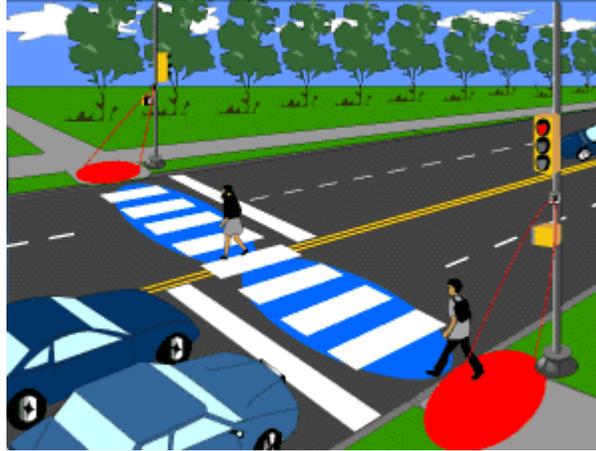
Another technology for pedestrian detection is passive infrared. Portland, OR is using this technology to monitor pedestrians as indicated in Figure 2. The figure illustrates that curbside detections trigger a call to the controller while detection within the street area extends the pedestrian walk phase. ASIM and Sentrol are two manufacturers of passive infrared pedestrian detectors.

Figure 2. Example of Passive Infrared Detection Zones at Signalized Intersections

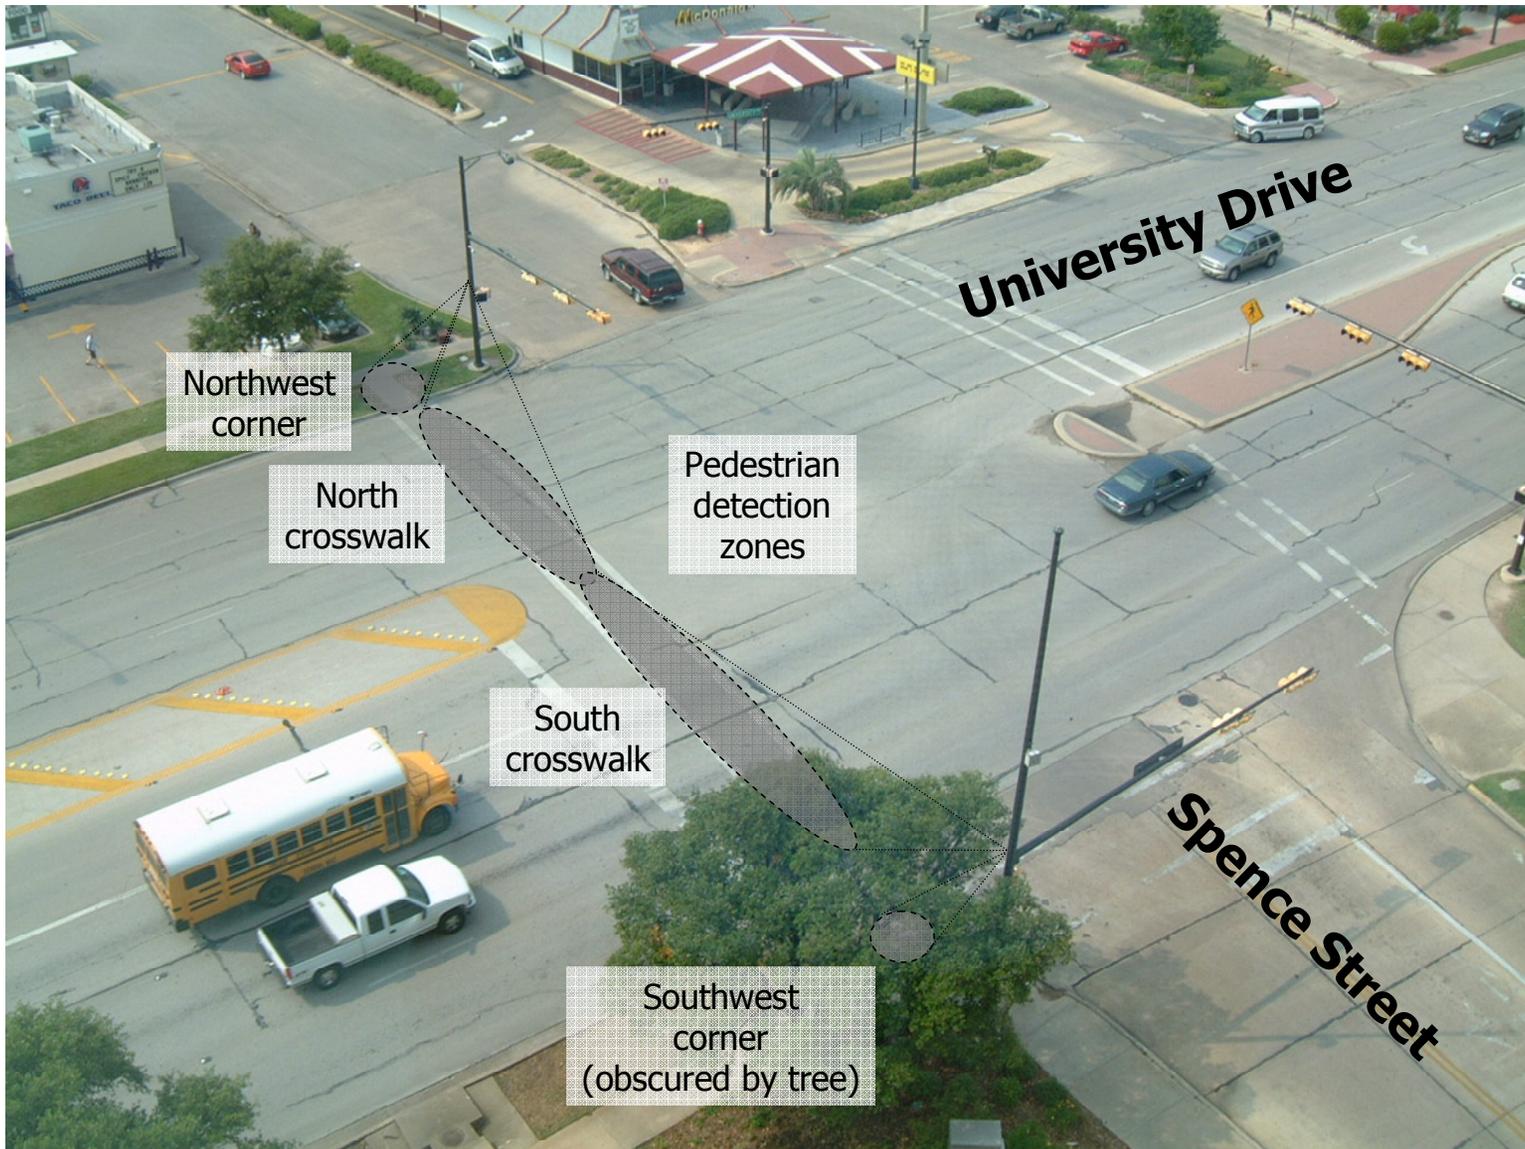
Figure 3. TTI Pedestrian Safety Test Bed: University Drive at Spence Street

Figure 3 shows the general location of the detection zones that were configured at the test bed intersection. Figure 5 shows the pedestrian sensors mounted at the northwest corner (for both the northwest corner and the north crosswalk detection zones). Figure 6 shows the pedestrian mounted sensors at the southwest corner (for both the southwest corner and the south crosswalk detection zones). The test bed surveillance camera can also be seen in Figure 6.

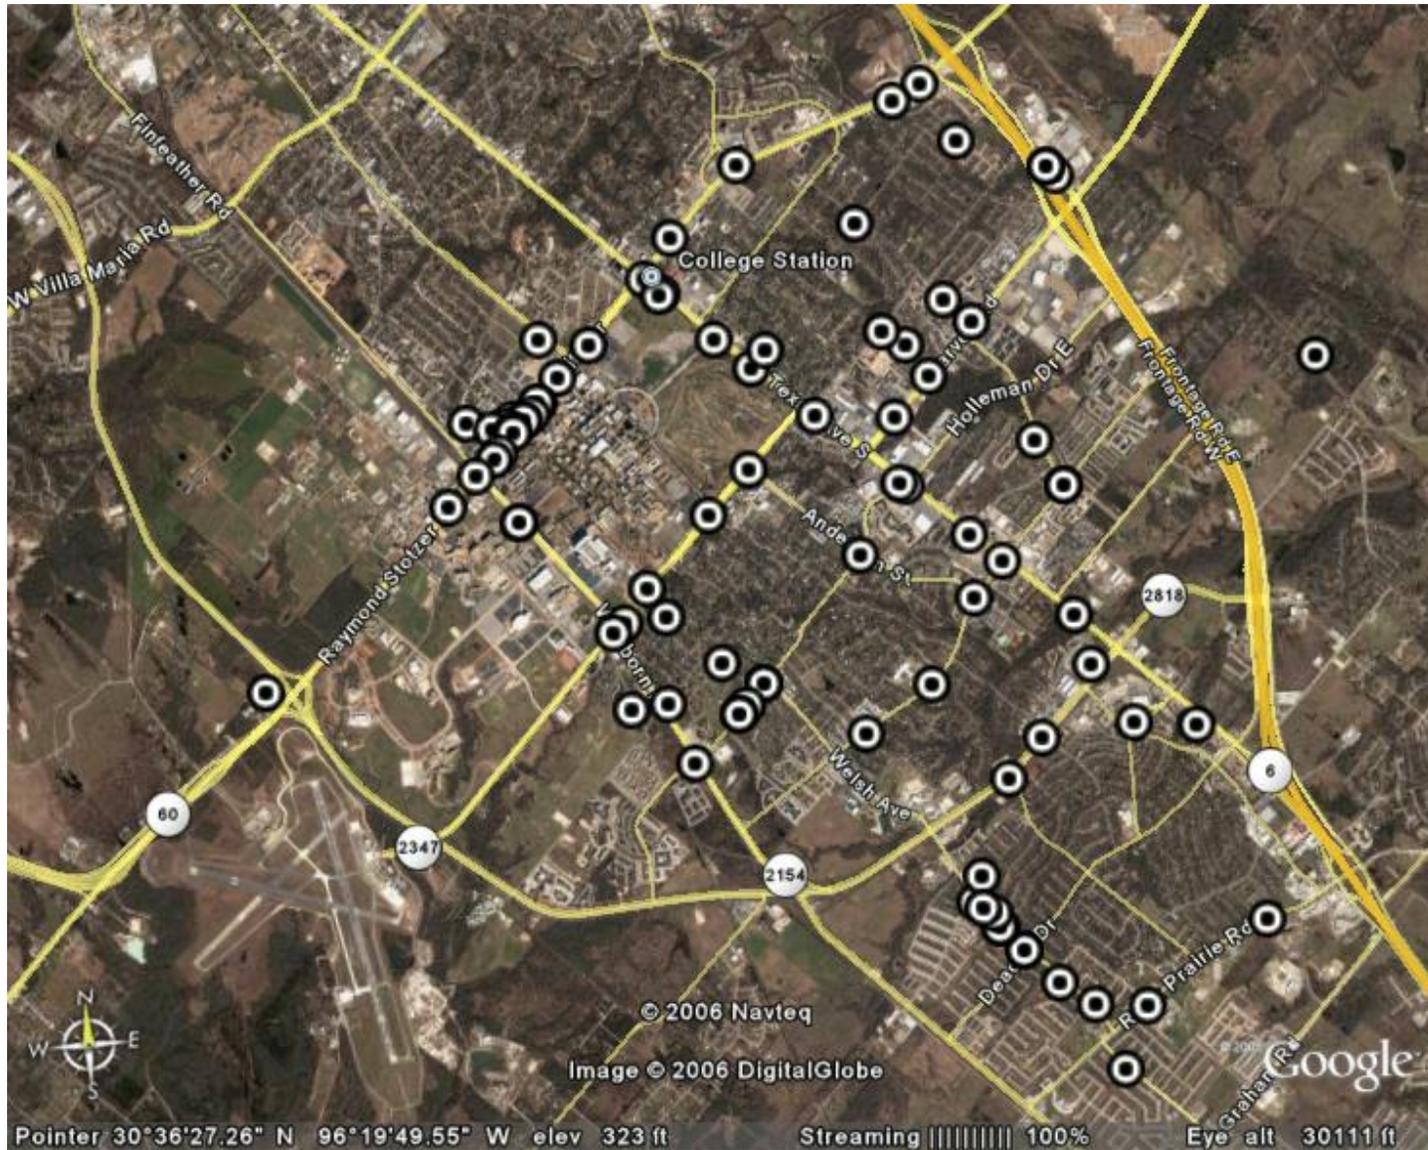
The intersection selected for the pedestrian safety test bed was **University Drive at Spence Street** (Figure 3) in College Station, TX. This signalized intersection is used by many pedestrians crossing University Drive, which is located along the northern edge of the Texas A&M University campus. In the past several years, there have been several vehicle-pedestrian crashes at this intersection.

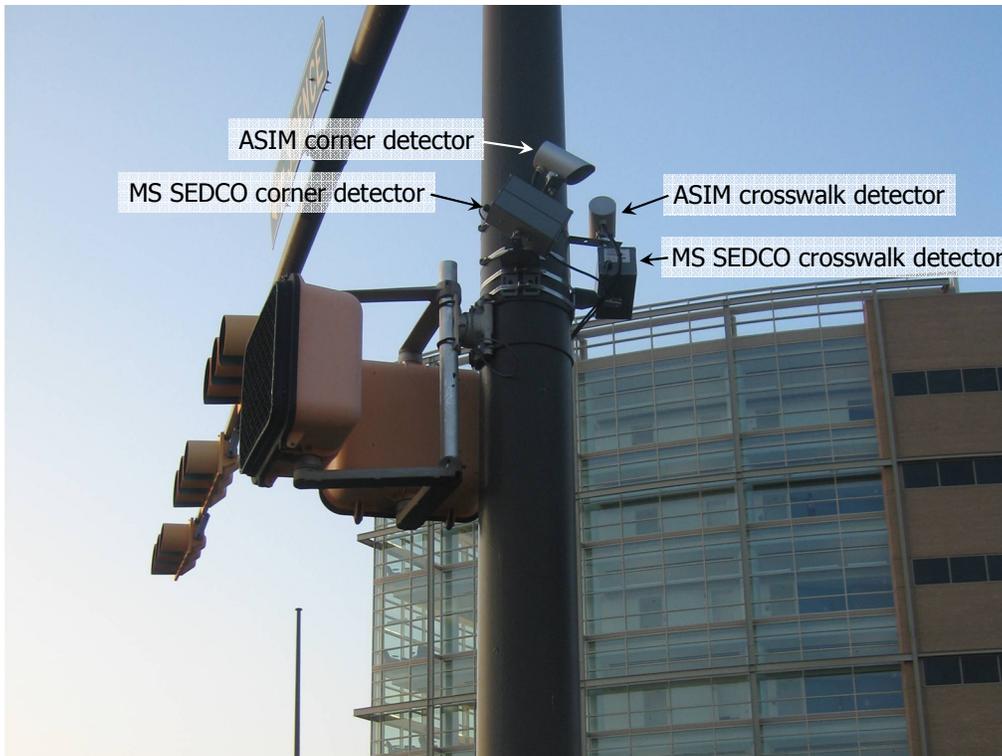
Figure 5. Pedestrian Sensors at the Northwest Corner of Test Bed

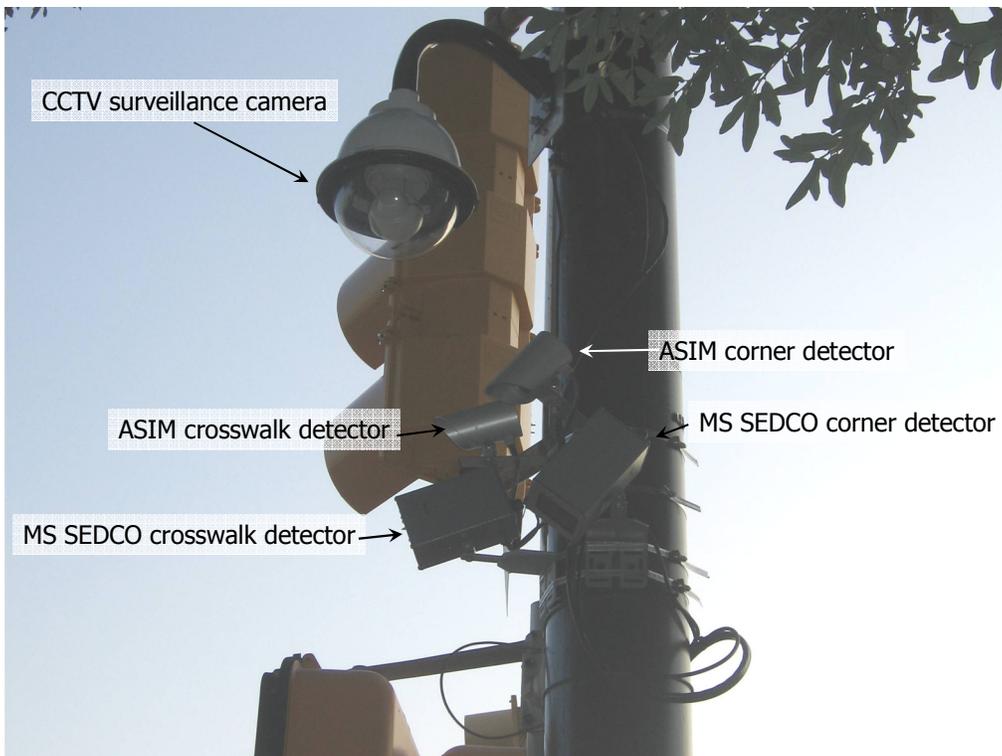
Figure 6. Pedestrian Sensors at the Southwest Corner of Test Bed

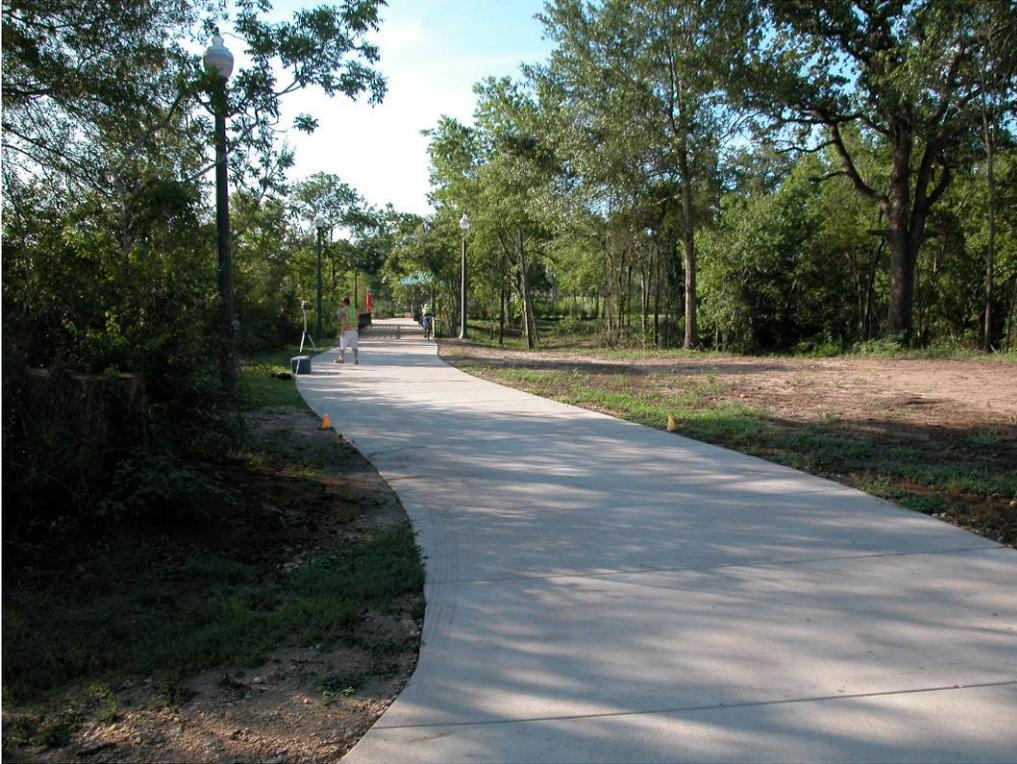
Figure 7. View of Study Site at Wolf Pen Creek

The first study site at the Wolf Pen Creek Trail (Figure 7) laid the foundation for the pedestrian trail counter study. Researchers conducted a series of baseline tests using predefined pedestrian traffic simulated by research personnel. The Wolf Pen Creek Trail is part of a system of multi-use trails in the city of College Station that link parks, residential areas, and commercial districts. This section of the trail provided an abundance of convenient mounting locations with multiple park benches and light poles. The trail has relatively low volumes compared to the other two locations. The low volumes were ideally suited to the controlled testing at this location.

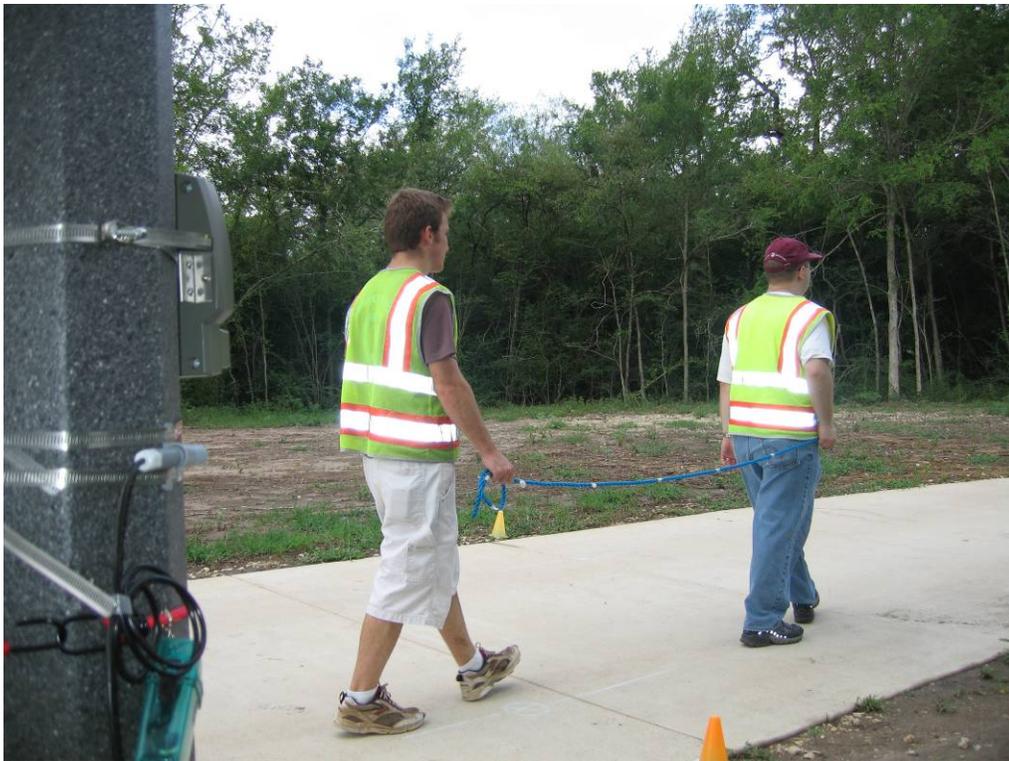
Figure 8. Controlled Test for 5 ft Spacing at Wolf Pen Creek Study Site

The controlled testing at Wolf Pen Creek evaluated the effects on trail sensor performance of the following factors: 1) target speed, 2) group spacing, 3) target distance, and 4) sensor mounting height. Each test consisted of 15 passes in front of the counters in each direction of the trail for each test measurement. Figure 8 shows an example of testing group spacing. To test target speed, researchers traveled in front of the counters at five different speeds: “stopping to talk,” walking, jogging, running, and traveling by bicycle. To test group spacing, pairs of researchers walked in front of the counters side-by-side and at spacings of 1-ft increments from 1 to 5 ft. To measure target range, researchers walked in front of the counters at distances of 30, 40, and 50 ft. Finally, researchers adjusted the mounting height of each counter from its original height of approximately 3 ft to test accuracy at 4 ft, 4.5 ft, and 5 ft.

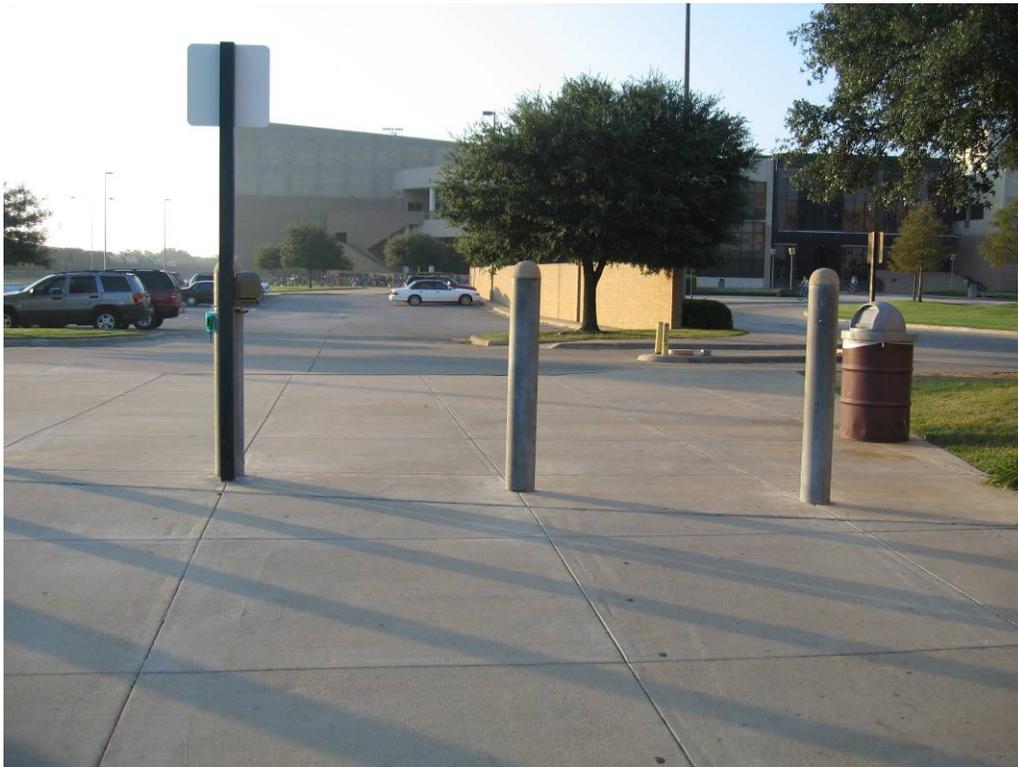
Figure 9. View of Study Site at Texas A&M Recreation Center

The second trail sensor study site was located on the Texas A&M University campus. Researchers observed two locations on the walkways between the Student Recreation Center, the West Campus Parking Garage, and the Wellborn Road pedestrian underpass. This is a high-traffic area as students travel throughout the day between their parked vehicles, the Recreation Center, and their classes on the main campus. Figure 9 shows one of the walkways at this site.

At Wolf Pen Creek, all three counters were mounted on a light pole (Figure 12); the camcorder tripod was positioned near the edge of the sidewalk a short distance away. At the Texas A&M Recreation Center, the counters were installed at two locations. At the Texas A&M Recreation Center location (Figure 9), two counters were mounted on bollards and angled at a wall, limiting the distance of detection to the bounds of both detectors. Due to mounting constraints, the target-based counter was moved to a nearby second location between two trees. Researchers mounted video cameras on top of the West Campus Parking Garage to provide the ground truth volume count at each location. At Town Lake, all three counters were mounted to a light pole, similar to Wolf Pen Creek.

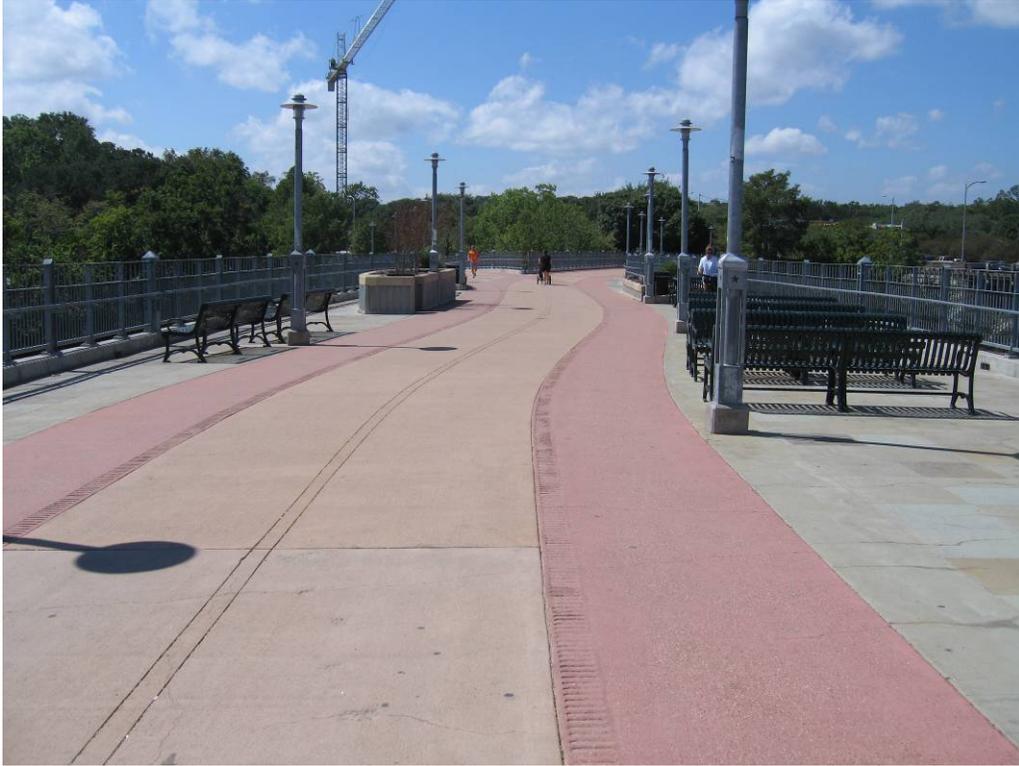
Figure 10. View of Study Site at Town Lake

In an attempt to use the counters in heavy trail traffic, the Town Lake Pedestrian Bridge (Figure 10) in Austin was selected for the third trail sensor study site. This site provided not only higher traffic volumes but also more consistent traffic throughout the study period. The variety of modes of transportation at this site (i.e., bicyclists, joggers, walkers with baby strollers) provided the sensors with a testing scenario that was unavailable at either the Wolf Pen Creek or Recreation Center locations. At this location, a large proportion of groups (two or more pedestrians traveling together) accounted for almost half of the total pedestrian traffic.

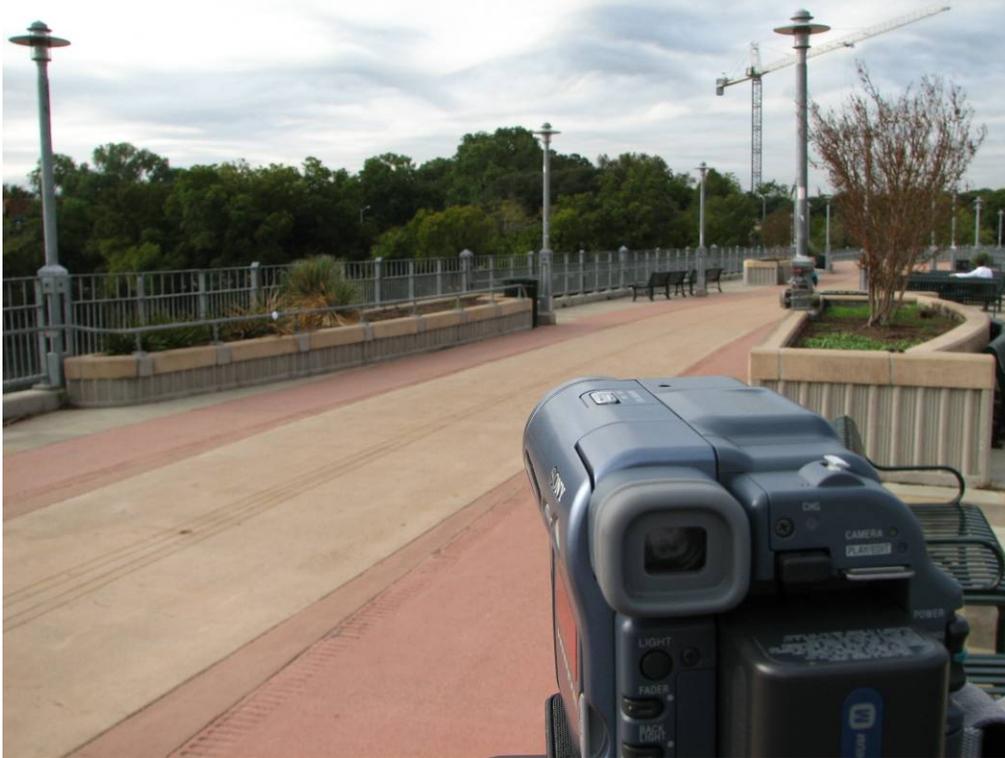
Figure 11. Camcorder Point of View at Town Lake Study Site

Prior to collecting data, researchers synchronized the equipment time and adjusted the timestamp settings on each counter using the configuration programs supplied by the vendors. At each location, the trail counters were mounted on one or more fixed objects and aimed across the trail or walkway under observation. In addition, researchers installed one or more tripod-mounted camcorders to create a video recording of traffic at the site; a camcorder point-of-view is shown in Figure 11. The purpose of timestamp videotaping the detection zone is to provide a “ground truth” count of the actual trail user traffic. During data reduction and comparison of results, researchers used the video to determine the ground truth counts at each site. Reducing video data in an office is more advantageous than reducing data in the field, as a video can be reviewed multiple times to reduce the human error in counting. The ground truth data allowed for multiple viewings and created an error-checking procedure that reduced the subjective human error in the timestamp recording portion of the data reduction. The clock on the camcorder was synchronized with the counter clocks to ensure an accurate reproduction of the observed traffic.

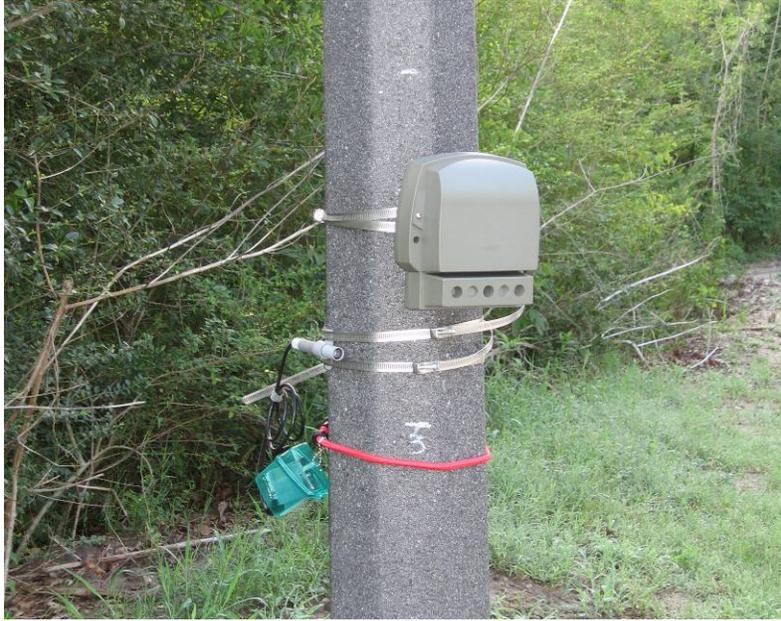
Figure 12. Counter Installation at Wolf Pen Creek Study Site
