## **Detection of Zone of Seepage Beneath Earthfill Dam**

**UTC**  
**R182/188**

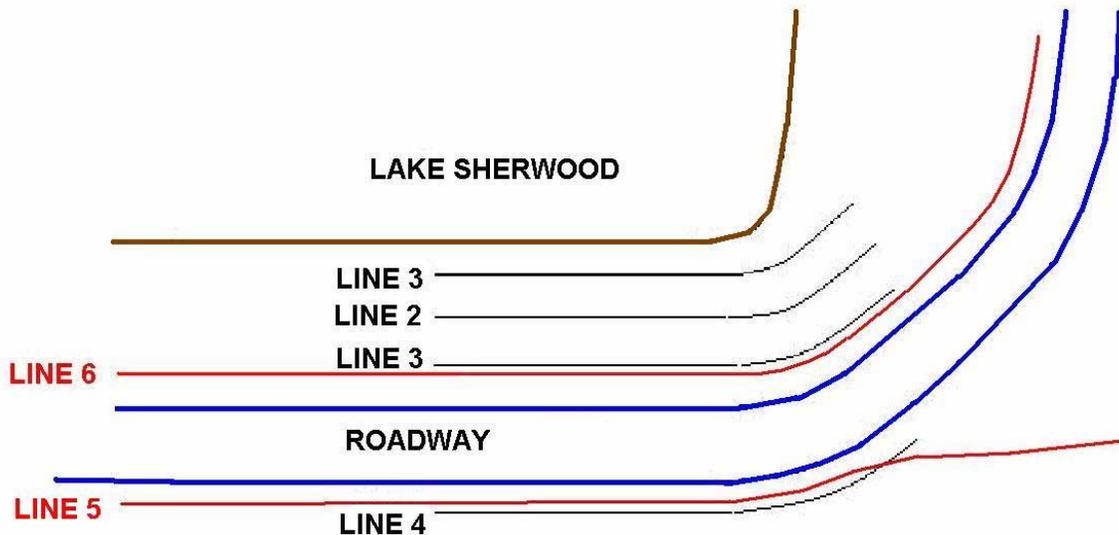
Figure 1: Location of electrical resistivity profiles 1-6.

The four electrical resistivity profiles (1-4) acquired on June 29<sup>th</sup> were recorded using a SuperSting R8 resistivity unit equipped with 40 electrodes centered on borehole location #10, a Wenner array configuration, and an electrode spacing of 6 feet (Figures 1 and 2). These survey parameters provided for depths of investigation on the order of 35 to 40 ft. Note that station 0 is on the shoreward end of the resistivity profiles; Station 240 is on the dam (Figures 1 and 2).

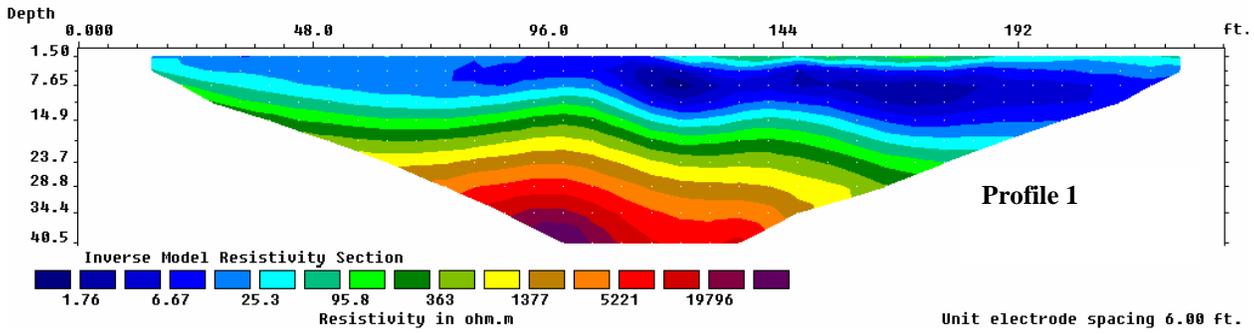
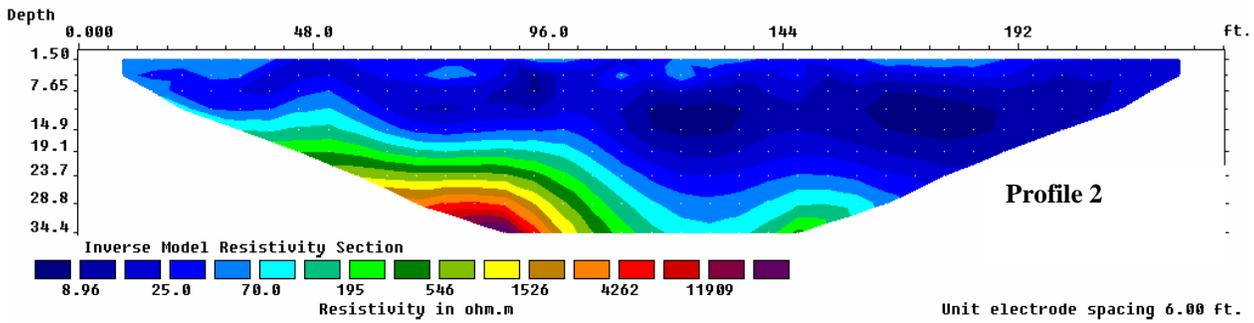
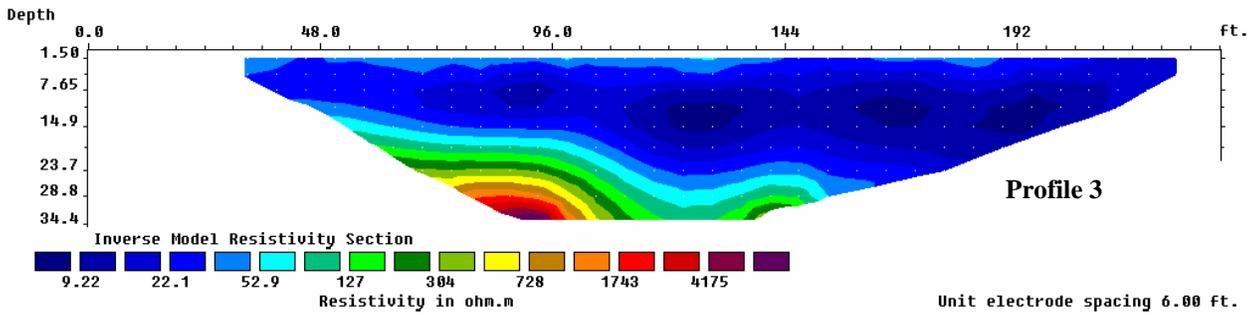
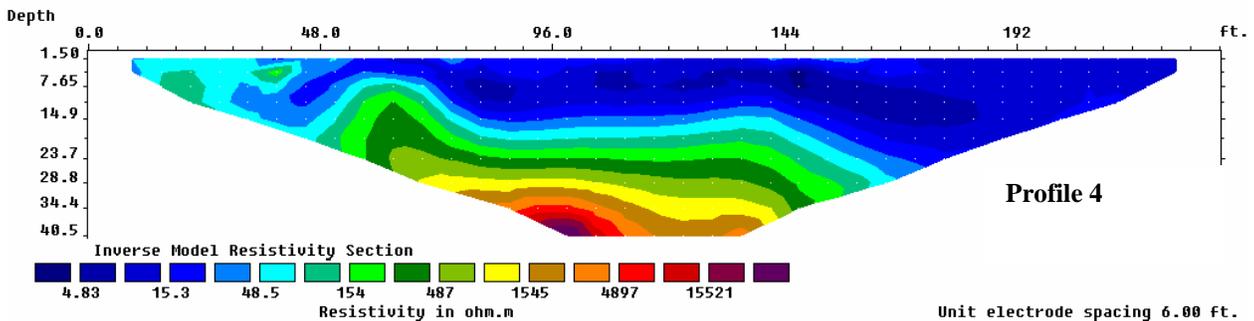
Figure 2: Electrical resistivity profiles 1-4 (Figure 1).

The most significant feature on resistivity profiles 1-4 is the zone of anomalously high resistivity centered between 24 and 36 ft to the landward side of the borehole location #10 (center of each resistivity profile). This zone of anomalously high resistivities (>6,000 ohm-m) is interpreted as grouted soil. Non-grouted soil is characterized by low resistivities; non-

grouted bedrock is characterized by intermediate resistivities. Unfortunately, the resistivity tool did not provide sufficient resolution to image active fracture conduits in the subsurface.

In our opinion, the zone of anomalously high resistivity adjacent to borehole #10 (landward side) is most probably caused by the presence of grout that has effectively sealed the soil making it impervious. Non-grouted soil is characterized by low resistivities; non-grouted bedrock is characterized by intermediate resistivities. Unfortunately, the resistivity tool did not provide sufficient resolution to image active fracture conduits in the subsurface. Unfortunately, the resistivity tool did not provide sufficient resolution to image active fracture conduits in the subsurface.

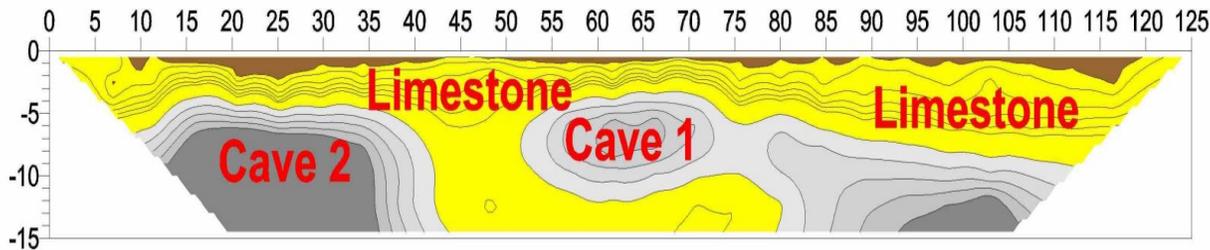
Figure 3: Example electrical resistivity profile across known caves. The electrode spacing was 2.5 ft. Note that the air-filled cavities are characterized by resistivities in excess of 6000 ohm-m (FHWA, 2005).

Cave 2, the Sting cave, was detected during a test measurement over a previously known cave, Cave 1. This cave shows lower resistivity than the Sting cave as Cave 1 has floor to ceiling columns which act as current conduits. The Sting cave does not have any columns. Both caves were confirmed by drilling large diameter, 24 inch, entrance holes. Depth to ceiling for Cave 1 is 1.8 m, for Cave 2 is 7.3 m.

The resistivity section above was calculated from the apparent resistivity data using the RES2DINV automatic inversion software. The graphical presentation was made using the Surfer for Windows software.

Survey date: October 29, 1994  
 Method: Dipole-dipole resistivity (dipole 4.6 m, n=8)  
 Unit: Meter and ohmmeter  
 Instrument: Sting/Swift, 28 electrodes at 4.6 m spacing  
 Survey time: Set-up and take down 1 hour (2 man crew)  
 Data acquisition 40 min

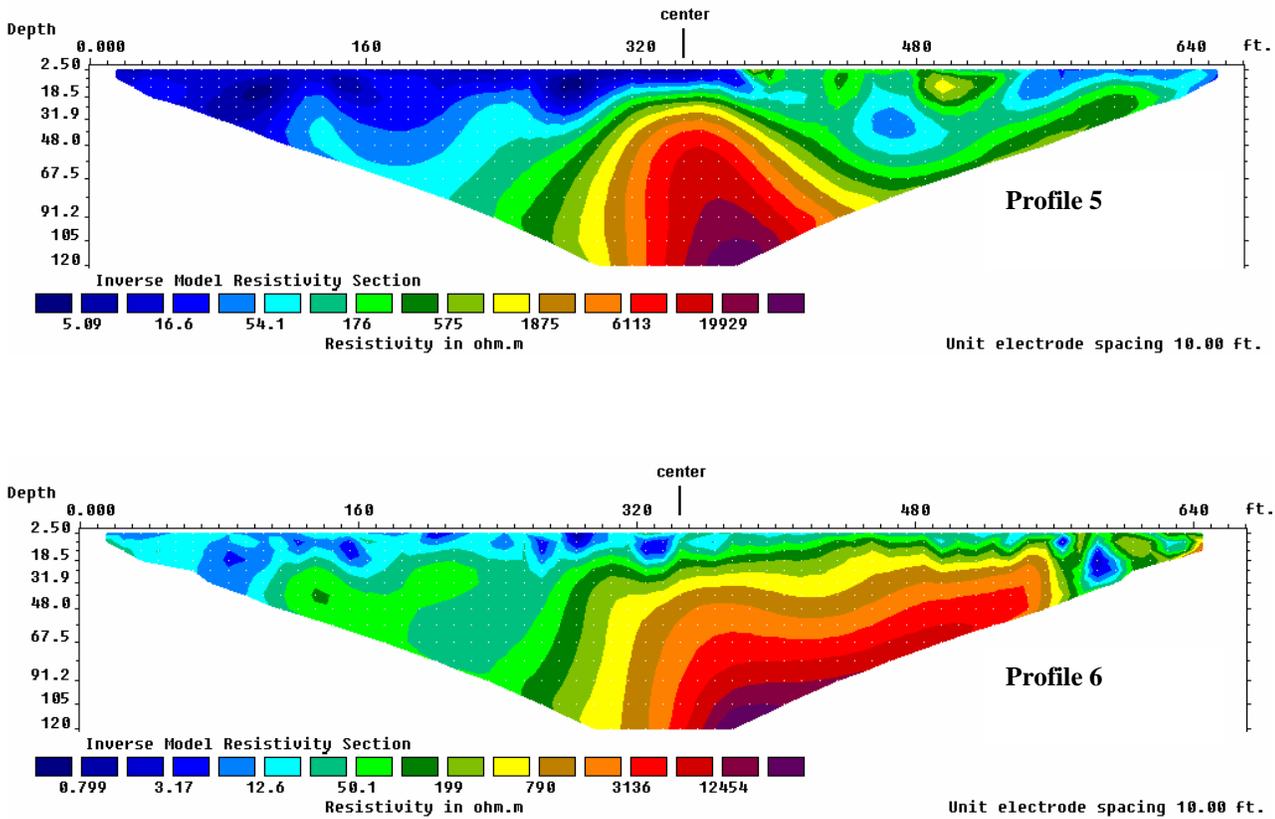
Figure 4: Electrical resistivity profiles 5 and 6. Station 0 is on the shoreward end of the resistivity profiles; Station 680 is on the dam

The two electrical resistivity profiles (5 and 6) acquired on August 10<sup>th</sup> were recorded using a SuperSting R8 resistivity unit equipped with 68 electrodes centered on borehole location #10, a Wenner array configuration, and an electrode spacing of 10 feet (Figure 4). These survey parameters provided for maximum depths of investigation on the order of 120 ft. Profile #5 was acquired on the downstream side of the dam roadway; profile #6 was acquired on the upstream side of

the dam roadway. Note that station 680 is on the shoreward end of the resistivity profiles; Station 0 is on the dam (Figures 1 and 2). (This is reversed relative to profiles 1-4; Figures 1 and 2).

The most significant feature on resistivity profiles 5 and 6 is the zone of anomalously high resistivity centered between 20 and 30 ft. to the landward side of the borehole location #10 (center of each resistivity profile). This zone of anomalously high resistivities (>6,000 ohm-m) is interpreted as grouted soil and/or bedrock. Non-grouted soil is characterized by low resistivities; non-grouted bedrock is characterized by intermediate resistivities. Unfortunately, the resistivity tool did not provide sufficient resolution to image active fracture conduits in the subsurface.

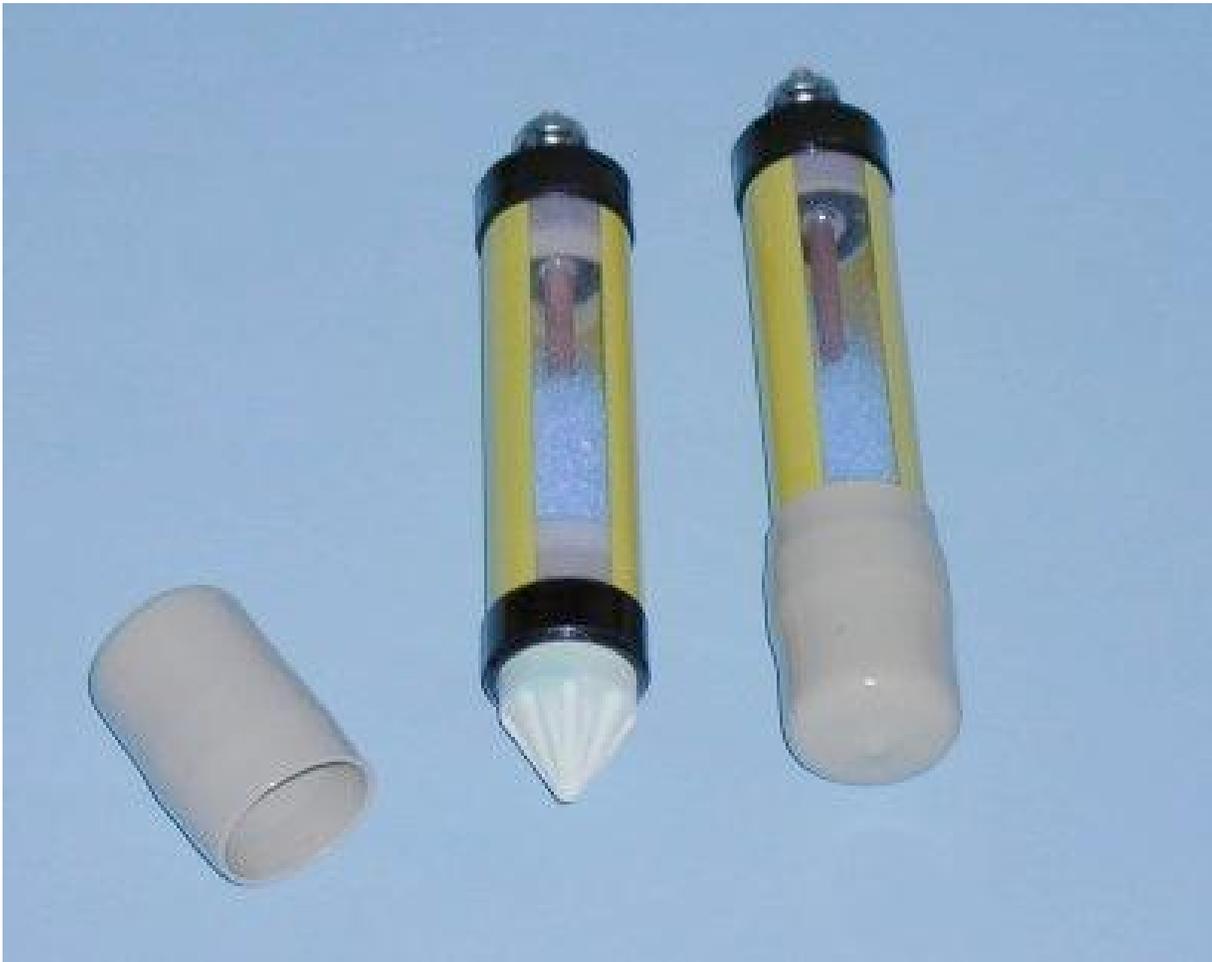
Figure 5: Non-polarizable Model #920 023 SP electrodes.

Self potential (SP) data were acquired at multiple test locations on and immediately adjacent to the Lake Sherwood dam. The trailing electrode was coupled to the base station; located more than 100 ft from the water's edge; the lead electrode was coupled to the ground at each test location (Figure 5).

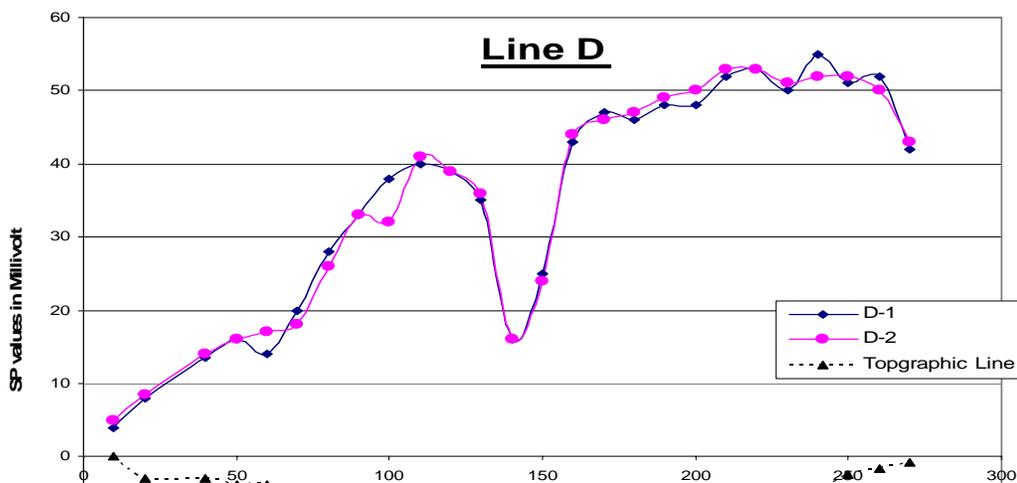
Figure 6: Prominent negative anomaly is observed on example SP profile D-1 and D-2 (Kentucky test site). The prominent negative anomaly is attributed to the flow of water into bedrock at the test location.

The SP tool is unique because it is the only geophysical method that responds directly to the presence of flowing/seeping water (into the subsurface). Locations where water is flowing/seeping into the ground are typically characterized by prominent negative anomalies; locations where water is flowing/seeping out of the ground are normally characterized by prominent positive anomalies (FHWA, 2005). Figure 6 shows two example parallel SP profiles (D-1 and D-2) that were acquired at a study site in northern Kentucky. A prominent negative anomaly is observed on this profile near the center of the profile, at a location where run-off is known to flow into the subsurface along a “losing” stream.

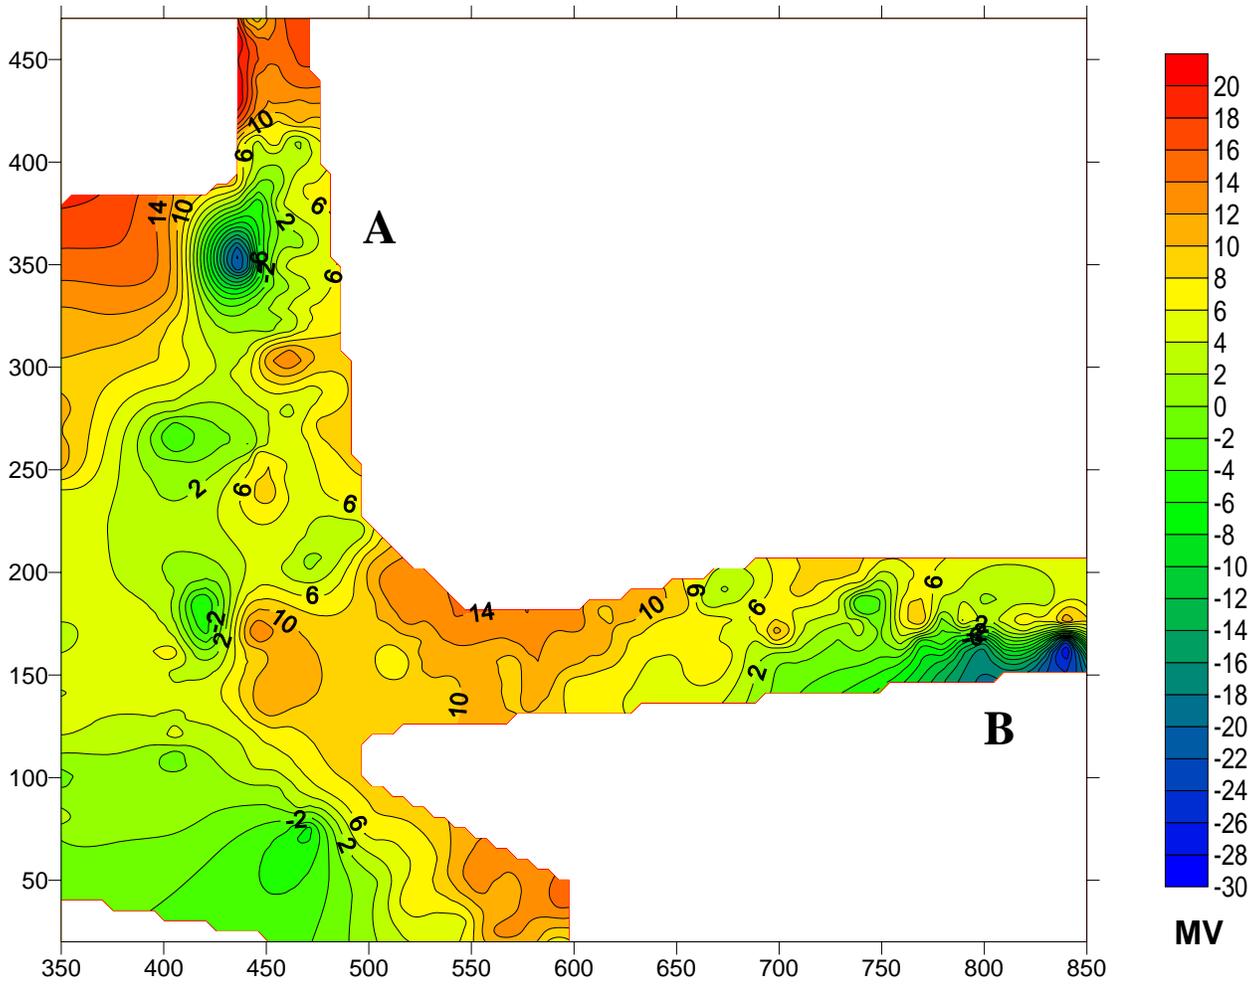
Figure 7: Lake Sherwood dam SP data.

The SP data acquired at the Lake Sherwood dam site are presented as Figure 7. Two prominent negative anomalies are observed on this plan view map. The first anomaly, designated as “A” on Figure 7, is located on the crest of the dam. This anomaly is thought to be caused by seepage through the face of the dam at this location and at depths of less than 40 ft. However, the anomaly could also be caused by the presence of undetected metal casing, if such casing straddles the water table and is undergoing active corrosion. The second prominent anomaly, designated by the letter “B” on Figure 7, is located at what is thought to be an inlet point for the higher temperature waters that exit the downstream face of the dam at the site denoted as the “waterfall”.

In our opinion, the zone of anomalously low (negative) SP readings represents the most probably inlet point for the higher temperature waters that exit the downstream face of the dam at the site denoted as the “waterfall”. This interpretation should be considered by any geotechnical engineers involved in ongoing mitigation efforts.
